CIVIL AERONAUTICS BOARD
ACCIDENT INVESTIGATION REPORT

TRANS WORLD AIRLINES, INC. - CASTLETON, INC.,
NEAR GREATER CINCINNATI AIRPORT, COVINGTON, KENTUCKY,
JANUARY 12, 1955

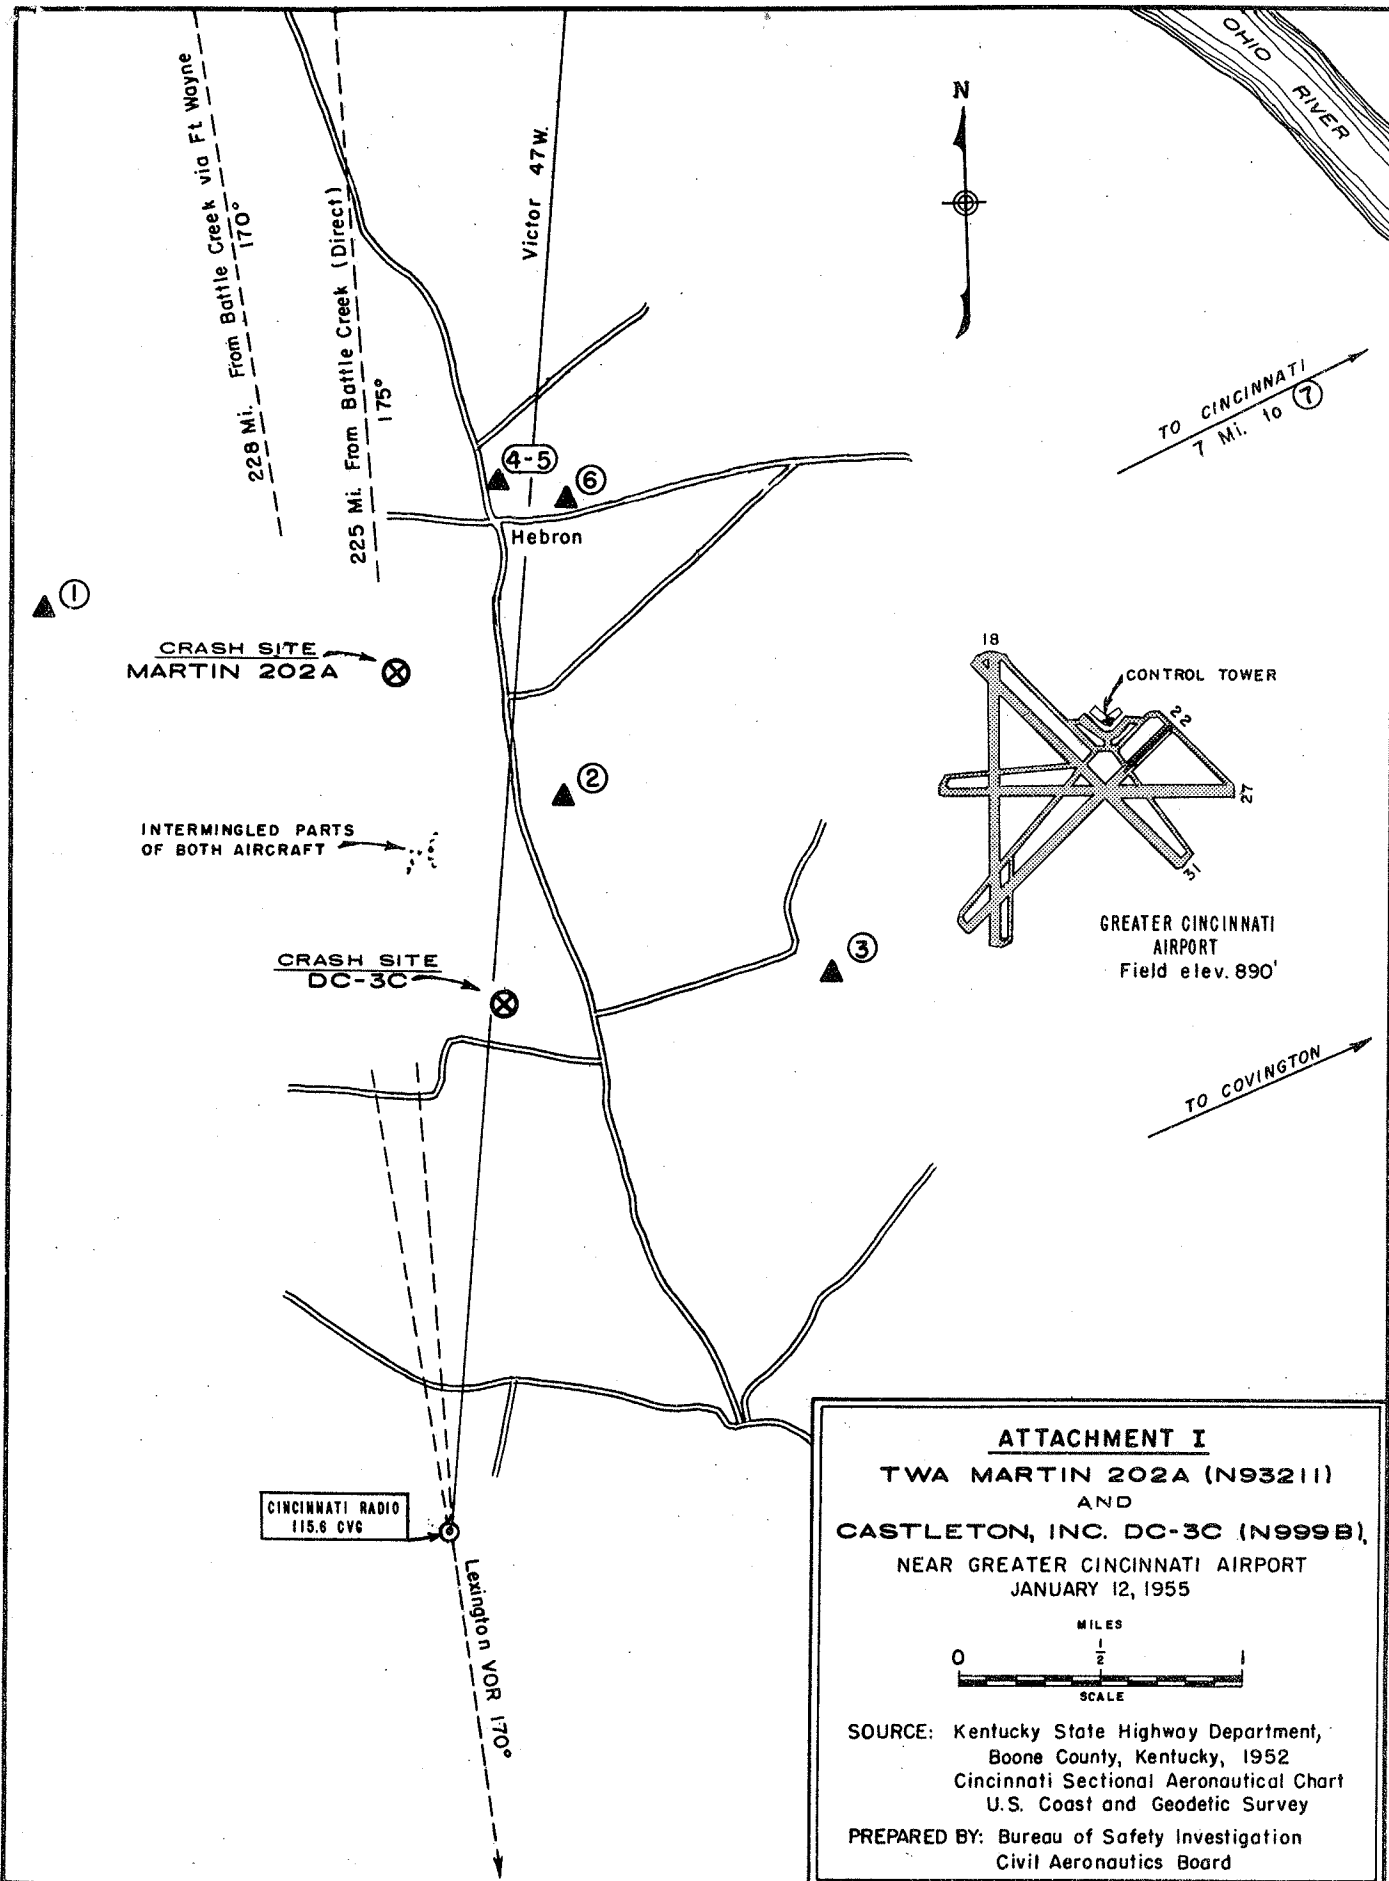
ATTACHMENT I
TWA MARTIN 202A (N93211)
 AND
CASTLETON, INC. DC-3C (N9998B),
 NEAR GREATER CINCINNATI AIRPORT
 JANUARY 12, 1955

The main portion of the Martin wreckage was about 2-1/2 miles west of the airport control tower and approximately the same distance from the southwest end of runway 22,^{3/} strewn for 685 feet on both sides of a gully. Examination of the Martin wreckage showed that the right wing was partially severed chordwise at collision about 22 feet from the centerline of the fuselage, and wrenched off while the aircraft was still in the air. The aircraft struck the ground in a fairly steep dive, which resulted in disintegration of the cockpit and its components to such degree

The DC-3 struck in an open, flat field about one mile south of the Martin, approximately 2-1/4 miles west-southwest of the control tower. The wreckage was strewn for 250 feet, but generally concentrated at the gouge formed by impact. A number of battered and torn sections of the left wing outboard of the flap and portions of the vertical tail were recovered between the two main wreckage sites. Further examination of the wreckage, coupled with this evidence, established that several feet of the left wing panel and portions of the vertical tail were torn off at the time of collision. The aircraft struck the ground in a steep dive, on the stub of the left wing, the nose section, and engines. The cockpit was demolished. No portions of the Martin structure were found at the main DC-3 wreckage site. Four propeller cuts were found across the top of the fuselage, two in the vertical

About halfway between the two main wreckage areas various pieces of the DC-3 left wing structure, left aileron, and the base of the vertical tail were intermingled with a portion of the Martin right wing leading edge and wing skin.

^{4/} Position denoted on Attachment I by numeral 1; other witness positions are similarly noted by appropriate number, in the order mentioned in the report.
