# **PHASE II DEVELOPMENT OF A NON- PROPRIETARY, FOUR-CABLE, HIGH TENSION MEDIAN BARRIER**

## **MIDWEST ROADSIDE SAFETY FACILITY**

MwRSF Research Report No. TRP-03-253-12

March 21, 2012

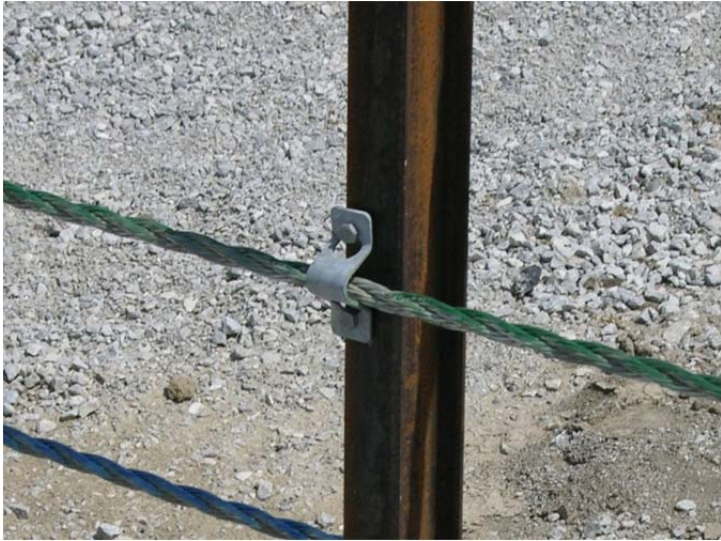
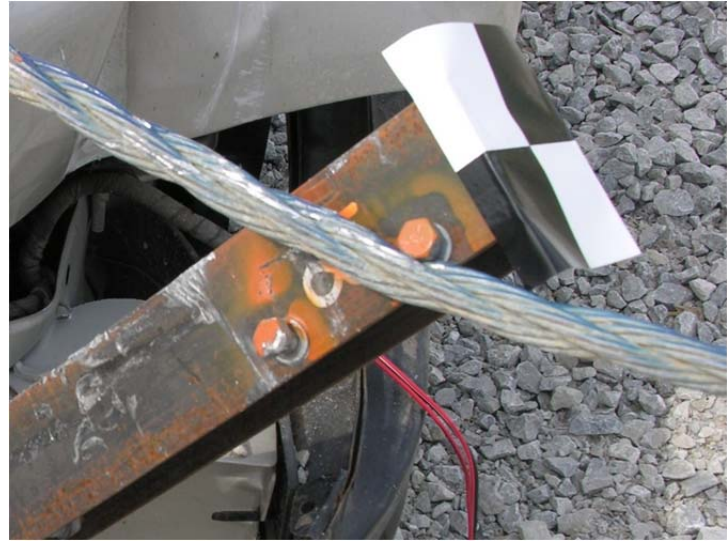
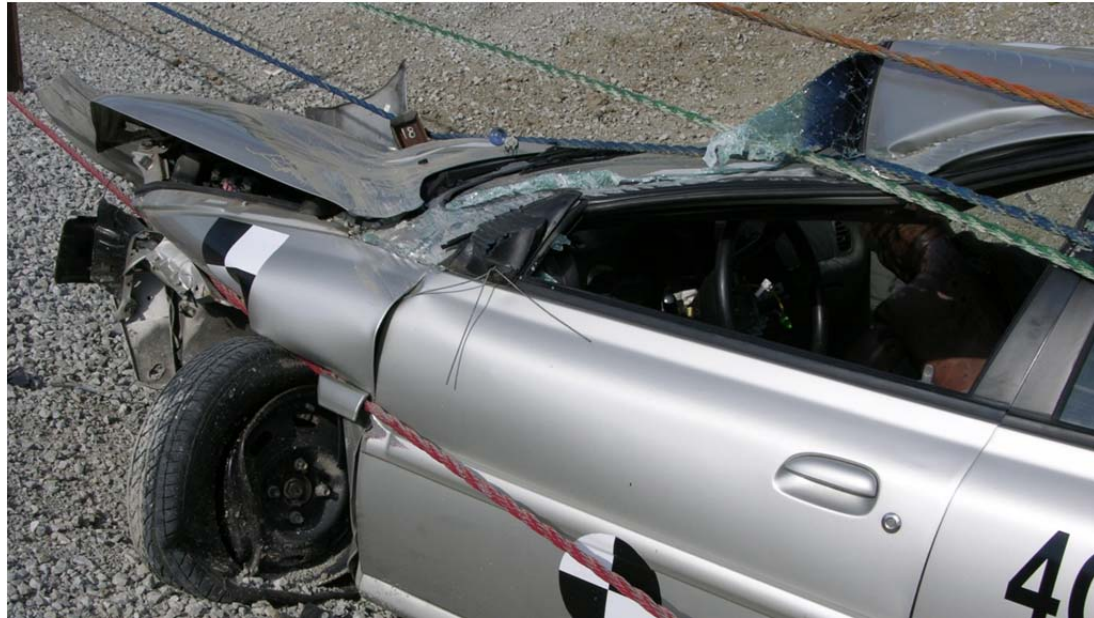
Figure 1. Test No. 4CMB-3: Slotted Bracket, Cable Snag, and A-Pillar Damage

The keyway bracket cable clips used for test no. 4CMB-3 released at the desired load, but the remaining attachment caused a snag point for the cables, which produced unacceptable results, as shown in Figure 1. In order to improve the cable release, while maintaining the attachments ability to dissipate energy through post deflection, an angled keyway bolt was developed for use with a keyway slot in the post. The shape of the bolt was optimized so that the cables would not snag on the bolt once they were released. In addition, the angled keyway bolt design utilized fewer parts, was easier to install, and less costly. Development and testing of the angled keyway bolt designed is detailed in a separate report [10]. No other design modifications were made to the system aside from the change in the cable attachment.

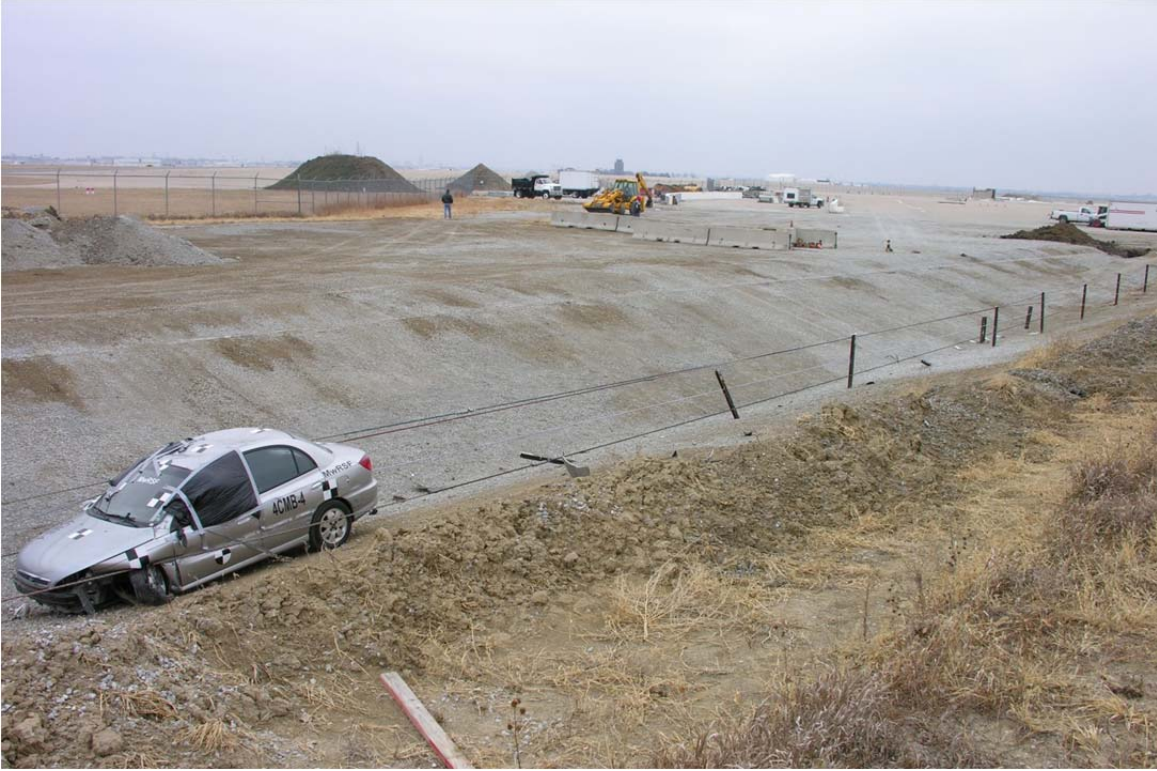
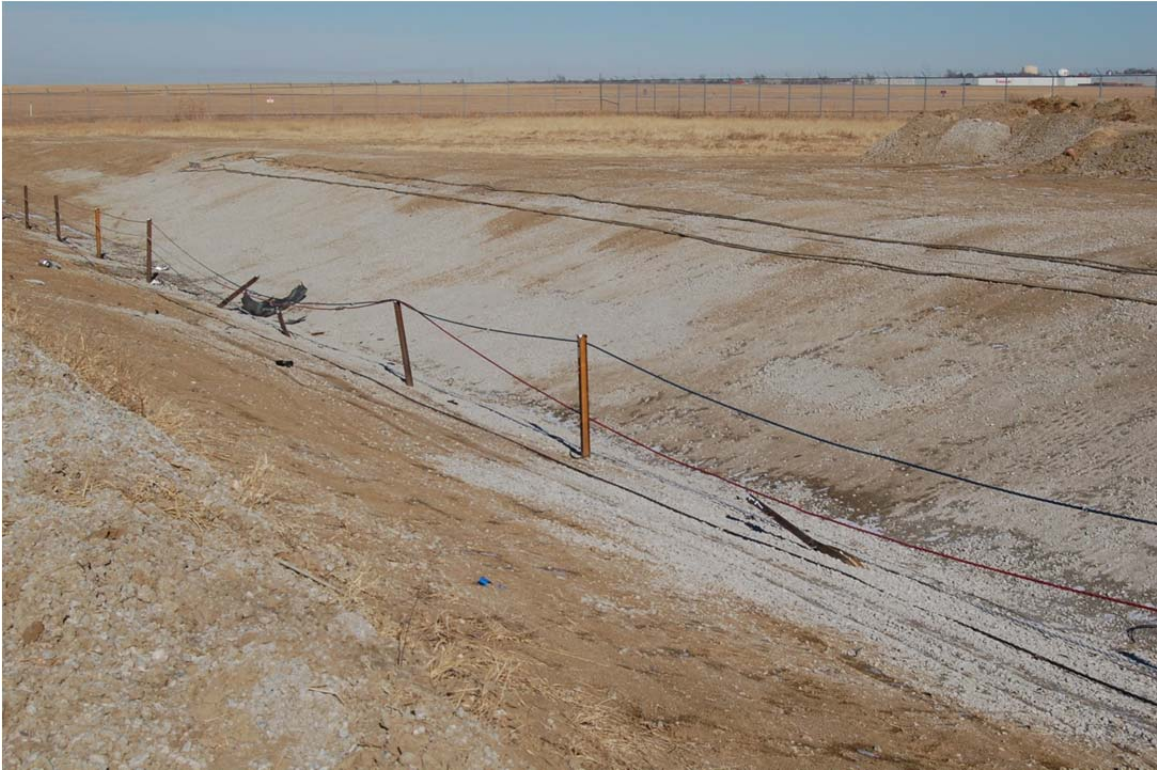
Figure 42. System Damage, Test No. 4CMB-4

Damage to the barrier was moderate, as shown in Figures 42 through 44. Barrier damage consisted of deflected posts and disengaged cables and keyway bolts. At its final resting position, the vehicle was still in contact with the cables; having cable no. 4 on the impact side and the remaining three cables on the non-impact side.

Cable no. 1 disengaged from post nos. 17, 19 through 21, and 33 when the keyway bolts bent and/or fractured. Cable no. 2 disengaged from post nos. 16 through 21. Cable no. 3 disengaged from post nos. 16 through 21. Cable no. 4 disengaged from post nos. 12 through 23.

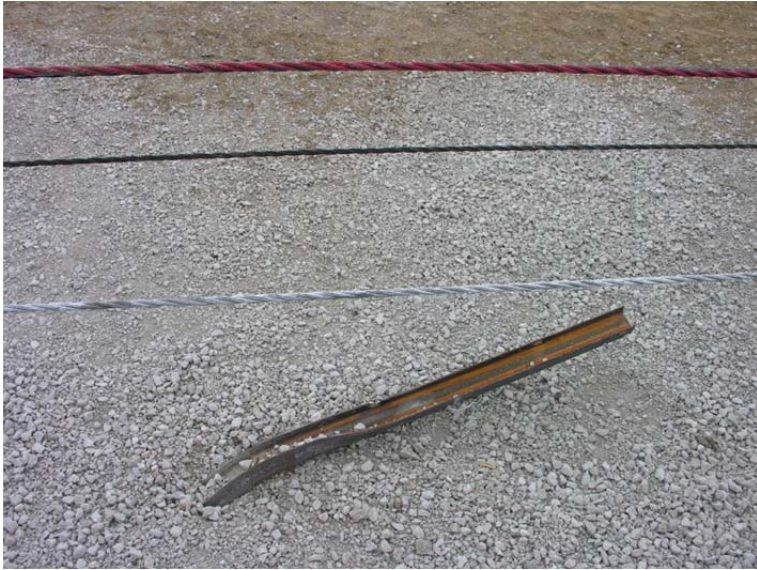
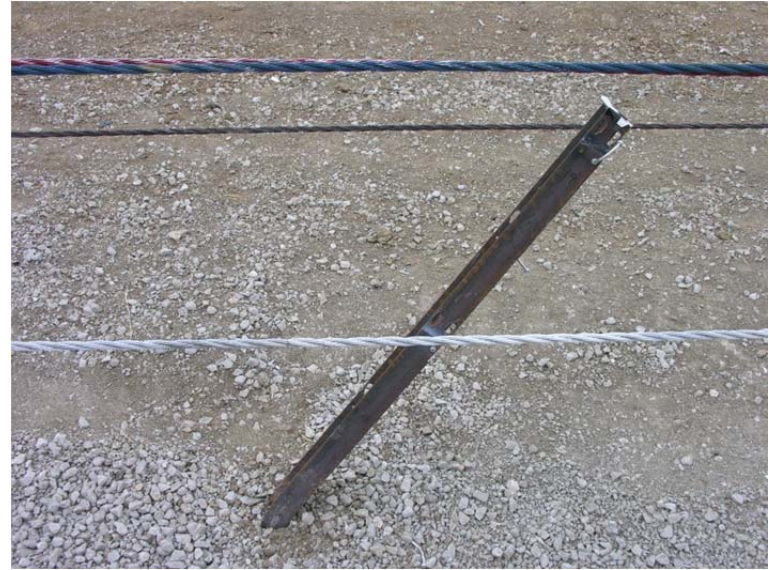
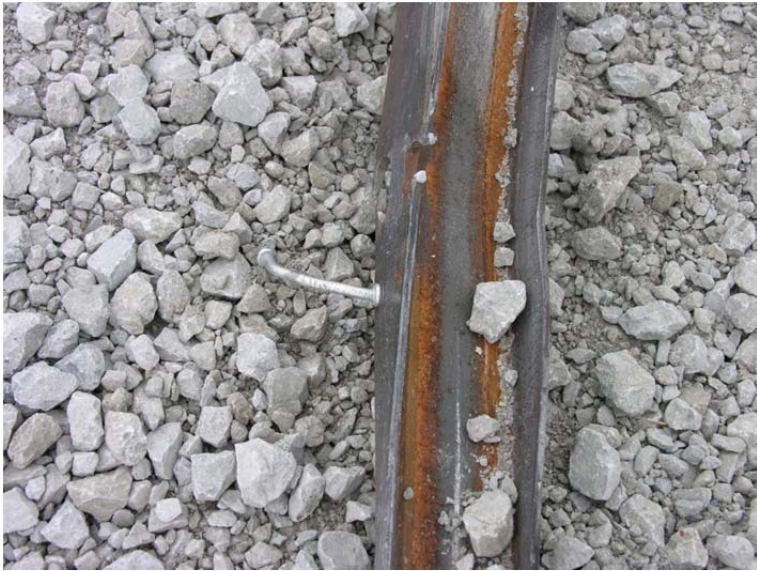
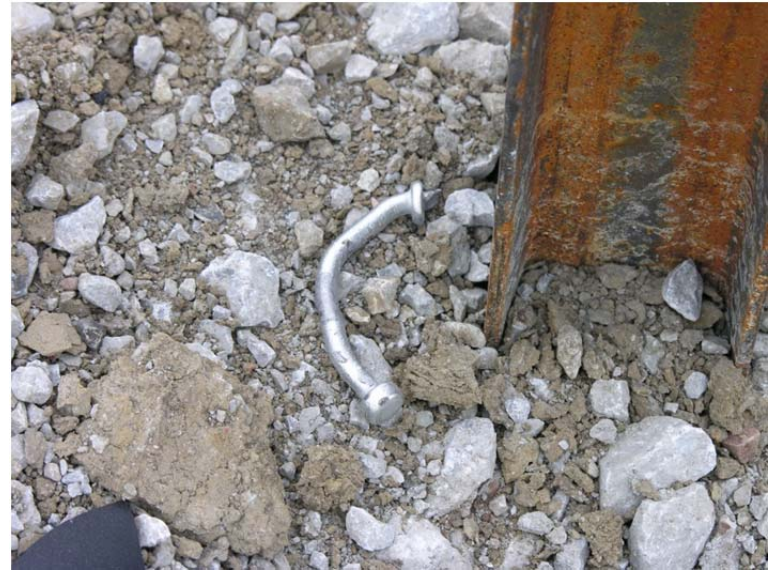
Figure 43. Post and Keyway Bolt Damage, Test No. 4CMB-4

upstream side of the flanges. Post no. 18 was bent backward slightly, and contact marks and gouging were found near the top of the post on the front side. Post no. 19 was bent downstream, and both flanges were dented at the location of cable no. 4. Post no. 20 was bent downstream and twisted to face downstream. The cable no. 4 keyway slot at post no. 20 was torn, and contact marks were found on the upstream side of the back flange near the top of the post. Post no. 21 was bent downstream with the right-rear wheel of the vehicle was resting on the post. Contact marks were found on the upstream side of both flanges extending the entire height of the post, and cable nos. 3 and 4 keyway slots were deformed. Post no. 22 was bent forward, and a  $\frac{3}{4}$  in. (19 mm) soil gape was found on the back side of the post. Post no. 24 was deflected backward, and a  $\frac{7}{8}$  in. (22 mm) soil gap was found on the front side of the post.

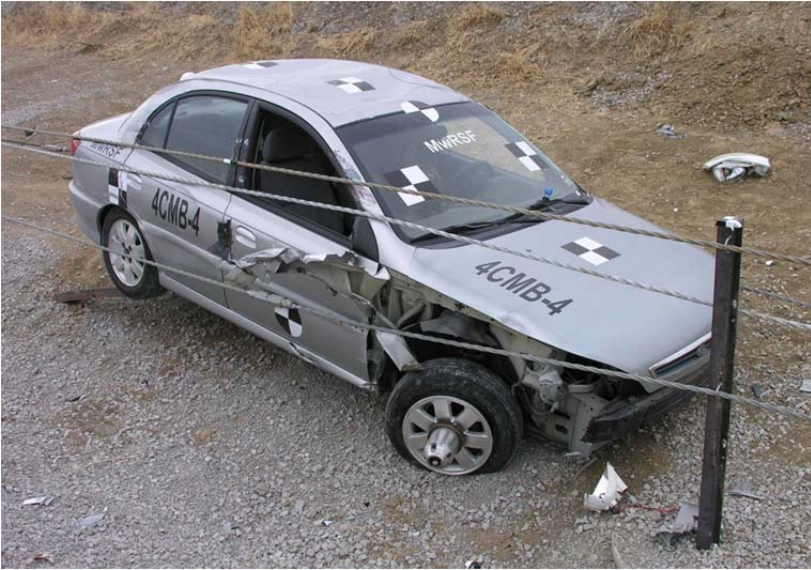
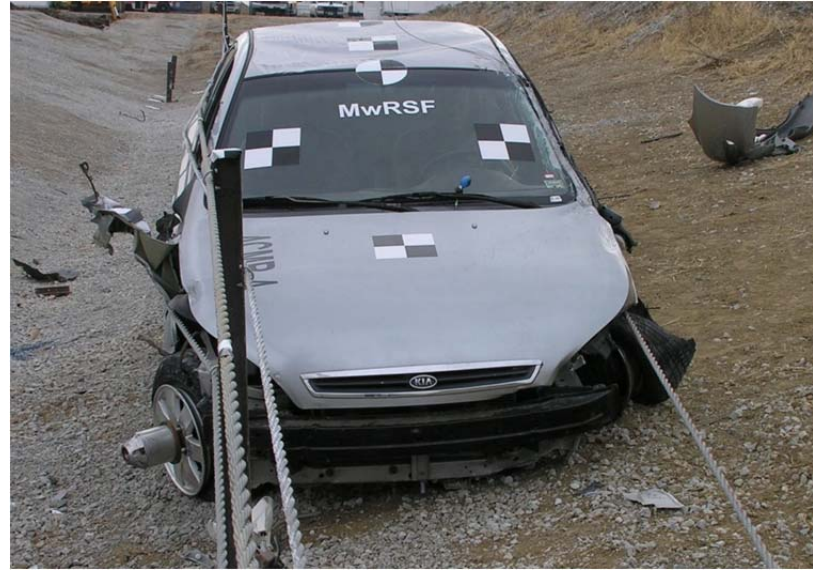
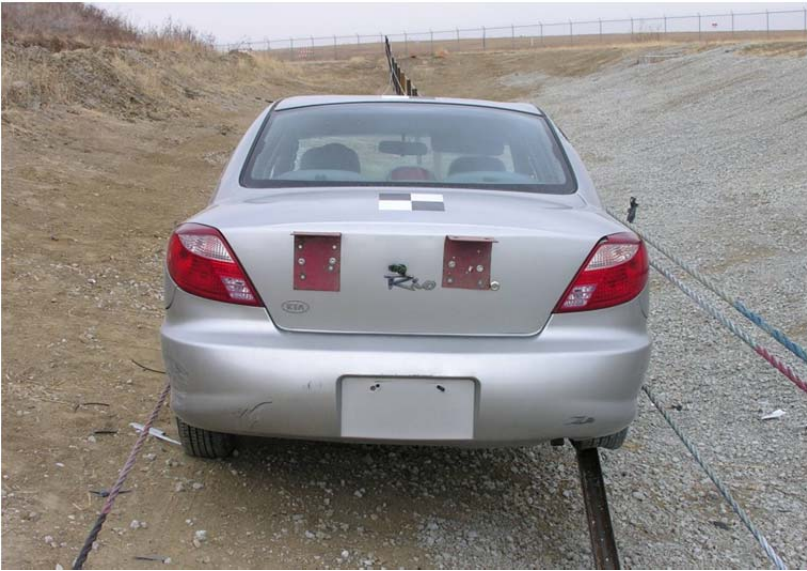
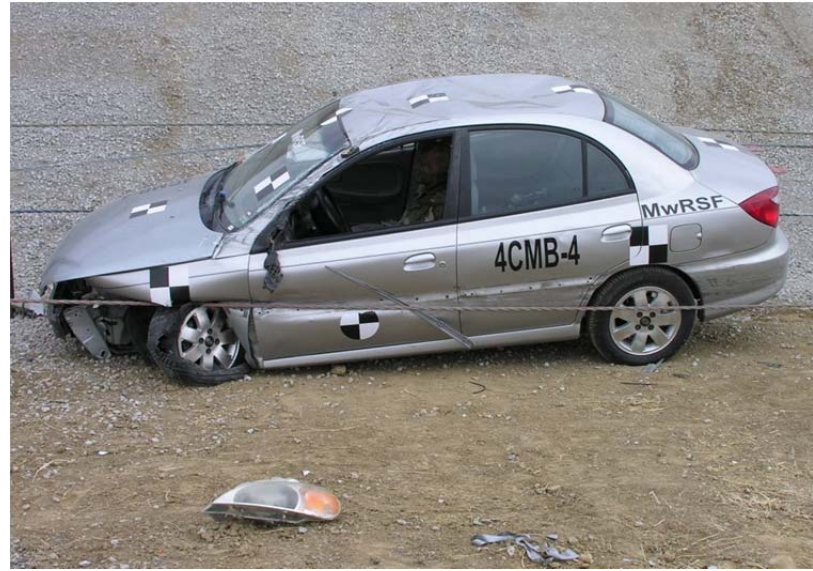
Figure 45. Vehicle Damage, Test No. 4CMB-4

The damage to the vehicle was moderate, as shown in Figures 45 through 48. The maximum occupant compartment deformations are listed in Table 6 along with the deformation limits established in MASH for various areas of the occupant compartment. Note that none of the MASH established deformation limits were violated. Complete occupant compartment and vehicle deformations and the corresponding locations are provided in Appendix D.

Damage occurred to all sides of the vehicle. The vehicle came to rest in the middle of the system with cable 4 against the left side of the vehicle and cables 1, 2, and 3 against the right side of the vehicle. The right-rear tire came to rest on top of post no. 21. The front bumper cover disengaged on the backslope. Both headlights disengaged near the bottom of the ditch. The left-front fender was dented inward approximately 7 in. (178 mm). The left-front tire was torn on the inner and outer sidewalls. A 5-in. (127-mm) long gouge was found in the left-front rim. The left tie-rod was bent. Cable contact marks extended the length of the vehicle on both the left and right sides. Both side mirrors were disengaged. Denting from the cables occurred on the left side of the hood and left A-pillar. The left 4 in. (102 mm) of the windshield had moderate spiderweb cracking. Gouges were found on the left-rear rim. Folding and denting occurred in the right C-pillar. Both front side windows were shattered. Cable contact marks were found on the right-rear side window. A 7-in. (178-mm) gouge was located below the right-front door 17 in. (432-mm) behind the right-front wheel well. Denting occurred at the center of the front and center of the back of the roof. Denting occurred in the gear box of the transmission and fluid was leaking from it. The vertical bumper horn was torn. A hole was also found in the spare tire storage floorboard.

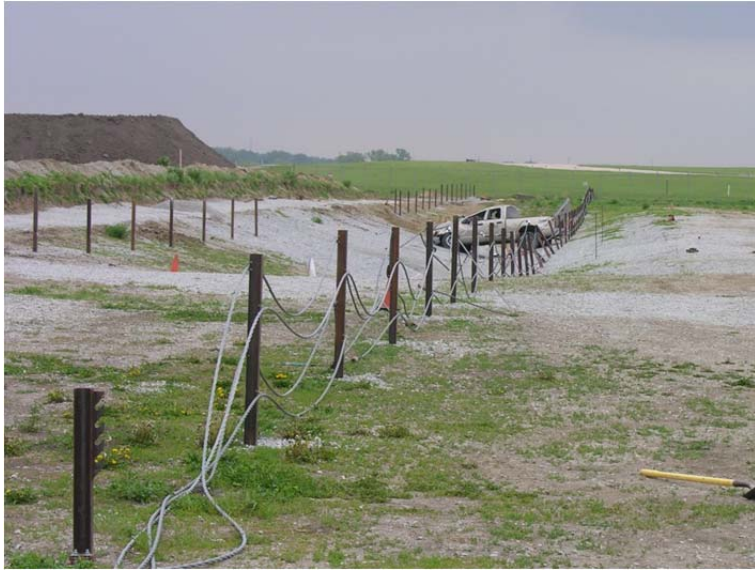
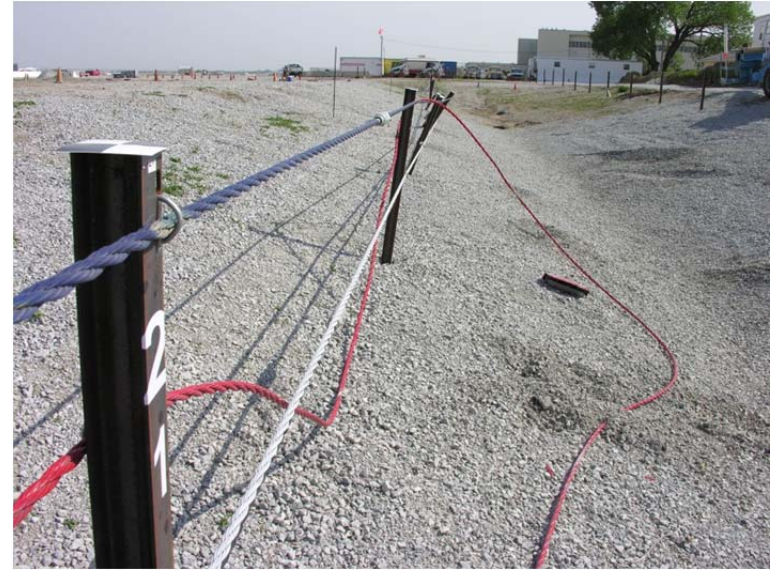
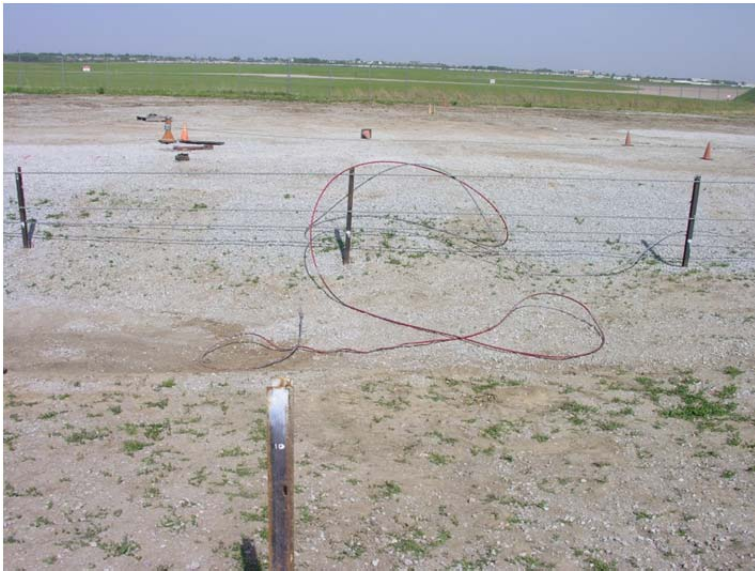
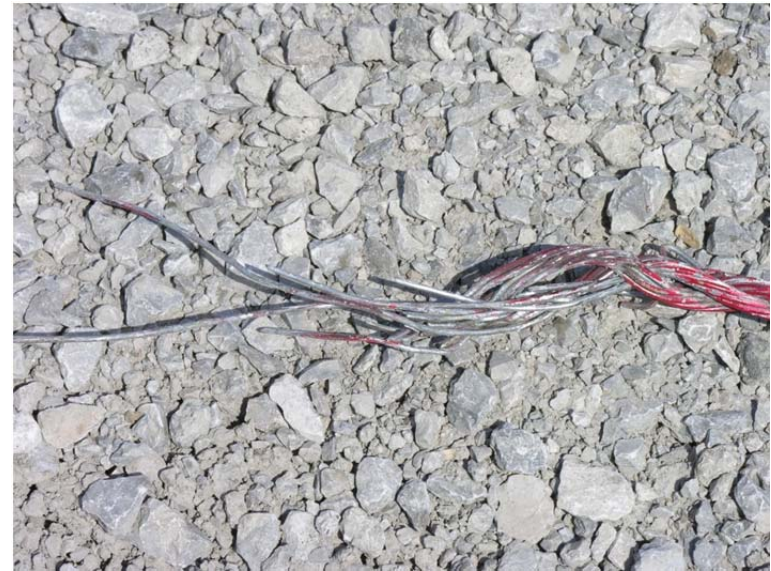
Figure 80. System Damage, Test No. 4CMB-5

Damage to the barrier was moderate, as shown in Figures 80 through 82. Tension was released in the cables prior to taking all post-test documentation photos. Barrier damage consisted of deflected posts and disengaged cables and keyway bolts.

Cable no. 1 disengaged from post nos. 15 through 17 when the keyway bolts bent and/or fractured. Cable no. 2 disengaged from post nos. 13 through 19. Cable no. 2 also fractured approximately between post nos. 17 and 18 after it snagged on the rear end of the pickup truck. Cable no. 3 disengaged from post nos. 14 through 17. Cable no. 4 disengaged from post nos. 16 and 17.

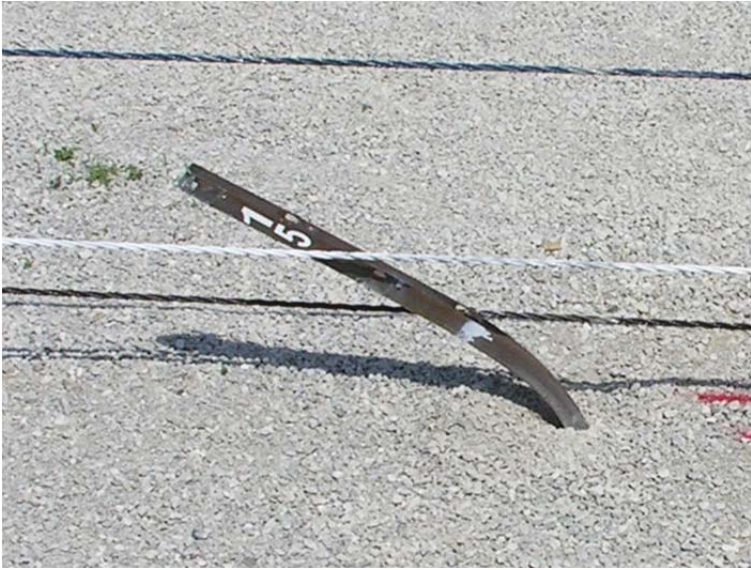
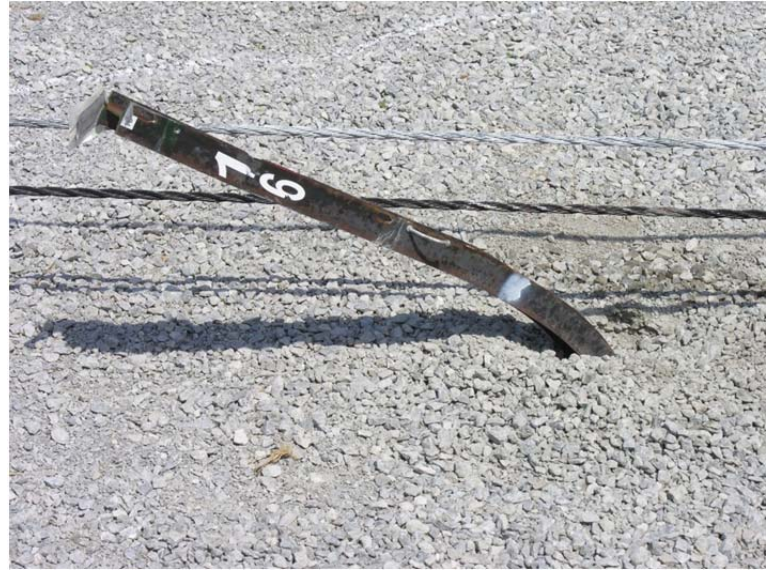
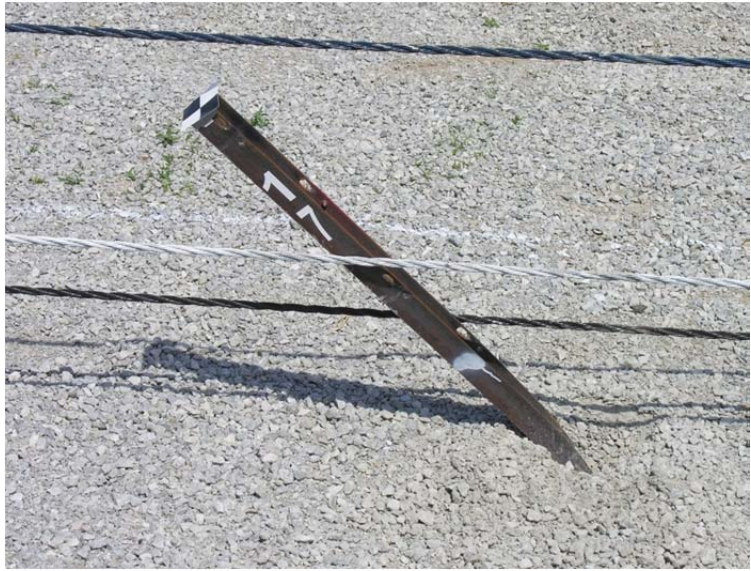
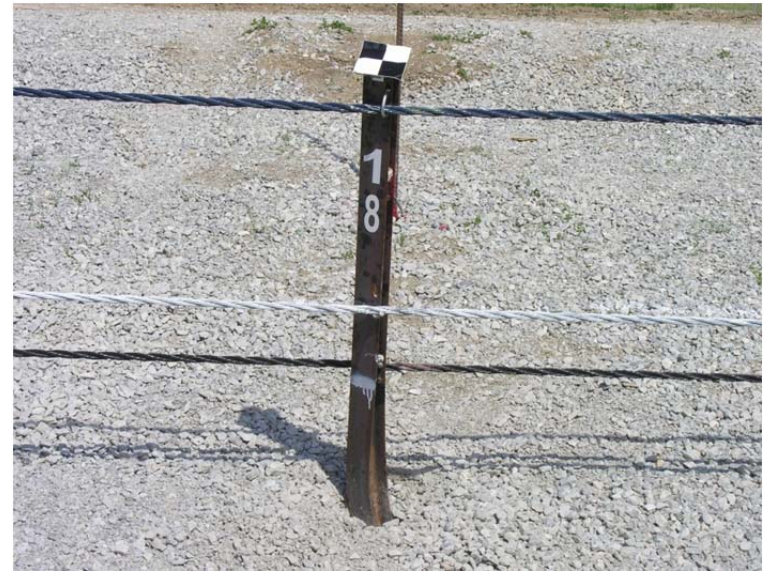
Figure 81. Post Damage, Test No. 4CMB-5

The maximum lateral permanent post deflections were not calculated for this test. The maximum lateral dynamic post deflection was 57.5 in. (1,461 mm) at post no. 17 and the maximum lateral dynamic cable deflection was approximately 101.5 in. (2,578 mm) in cable 2 just prior to failure, as determined from high-speed digital video analysis. The working width of the system was not calculated for this test.

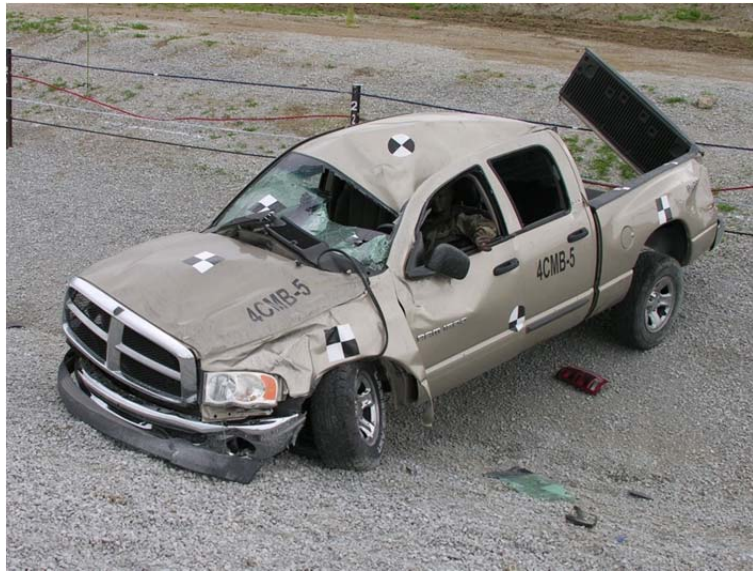
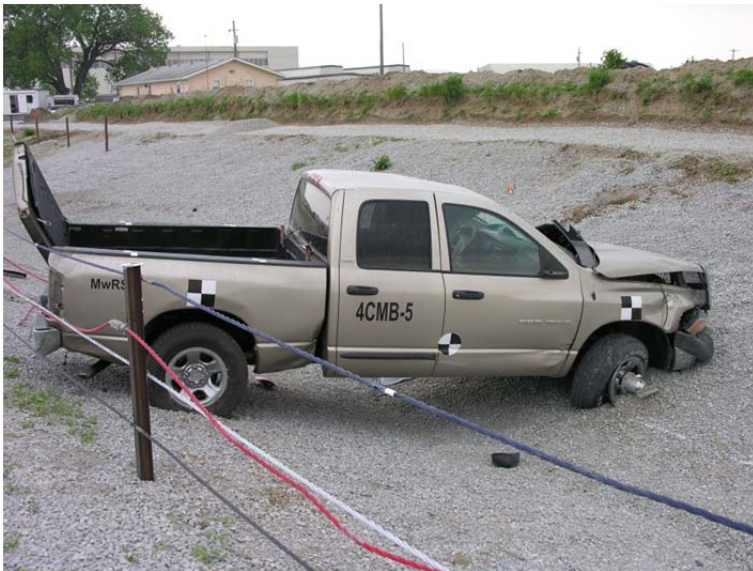
Figure 83. Vehicle Damage, Test No. 4CMB-5

The damage to the vehicle was severe, as shown in Figures 83 through 86. The maximum occupant compartment deformations are listed in Table 12 along with the deformation limits established in MASH for various areas of the occupant compartment. The roof deformation of  $15\frac{1}{2}$  in. (394 mm) exceeded the MASH limit of 4 in. (102 mm). Complete occupant compartment and vehicle deformations and the corresponding locations are provided in Appendix D.

Damage occurred to all sides of the vehicle due to the rollover. The plastic bumper cover was disengaged and torn on the right side, and the bumper was dented near the center and the left side. The front frame member was bent and torn. The hood was crushed and ajar. The left side of the grill was fractured. The dash was fractured and deformed upward. The left side of the roof was severely crushed. The windshield was shattered and torn on the left side. The left headlight was disengaged and fractured. The left-front upper control arm, tie rod, and brakes were disengaged. The left-front lower control arm was fractured. The left fender was crushed inward at the front and deformed outward by the left-front door. The front and top of the left-front door and mirror were crushed inward. Both left windows were shattered and disengaged. The left-rear door was crushed at the top. The left-rear quarter panel was crushed inward behind the wheel. Both taillights disengaged. The tailgate disengaged on the right side. The right-rear quarter panel was scratched and dented behind the wheel well. The front of the right side of the box was crushed inward. The right-rear shock mount and shock fractured and disengaged. The right-front door was slightly ajar. Denting occurred at the lower-front of the right-front door. The right
