# HEATWURX PATCHING AT TWO LOCATIONS IN SAN ANTONIO

Project 5-9043-01  
Report 5-9043-01-1  
Project Title: Evaluation of Asphalt Pavement Patching Using Infrared Heat

March 2012  
Published: June 2012

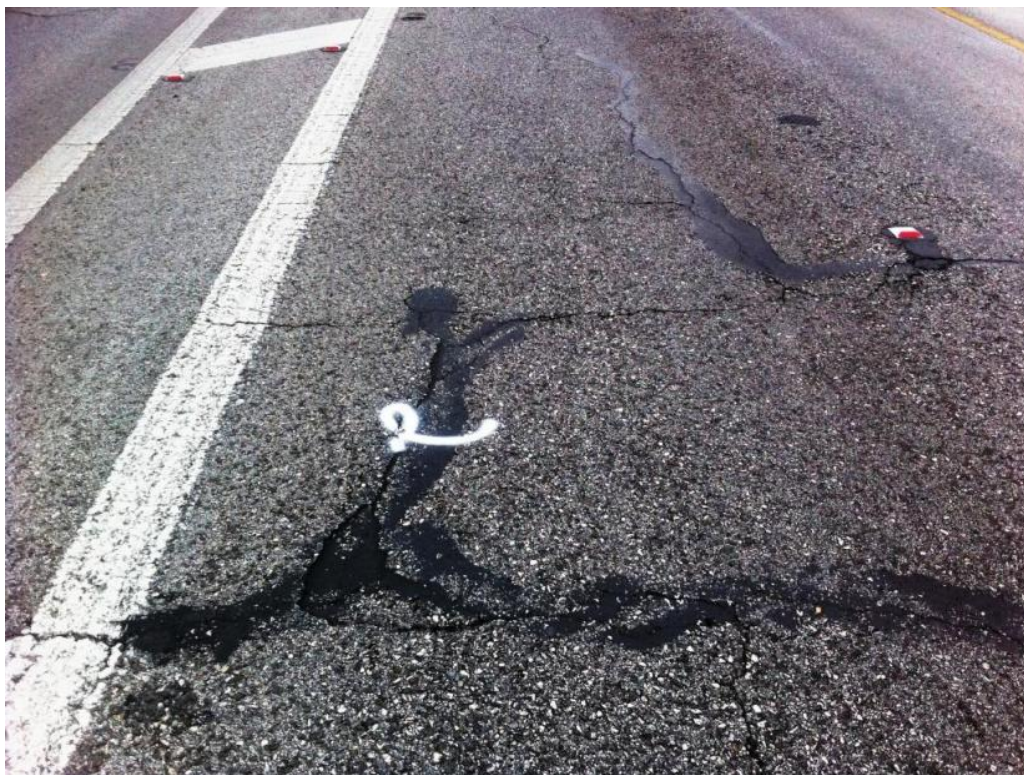
This site had block cracking and raveling. Cracks were as wide as 0.5 inches and the raveling was extensive and severe (see Figures 24 through 27). Deterioration of the cracks resulted in considerable roughness. This site has lower volumes of high speed traffic as compared to IH410Fr-2, which has higher volumes of slower traffic near an intersection. Two patches were placed at this site.

As can be seen in Figures 24 through 32, these sites were good candidates for minor patching. Due to their high traffic volume and a need to provide a more durable repair, the mostly likely fix for these sites would have been to mill the top two inches and replace the surface. Some locations where there was alligator cracking would need spot repairs prior to placing the final surface.

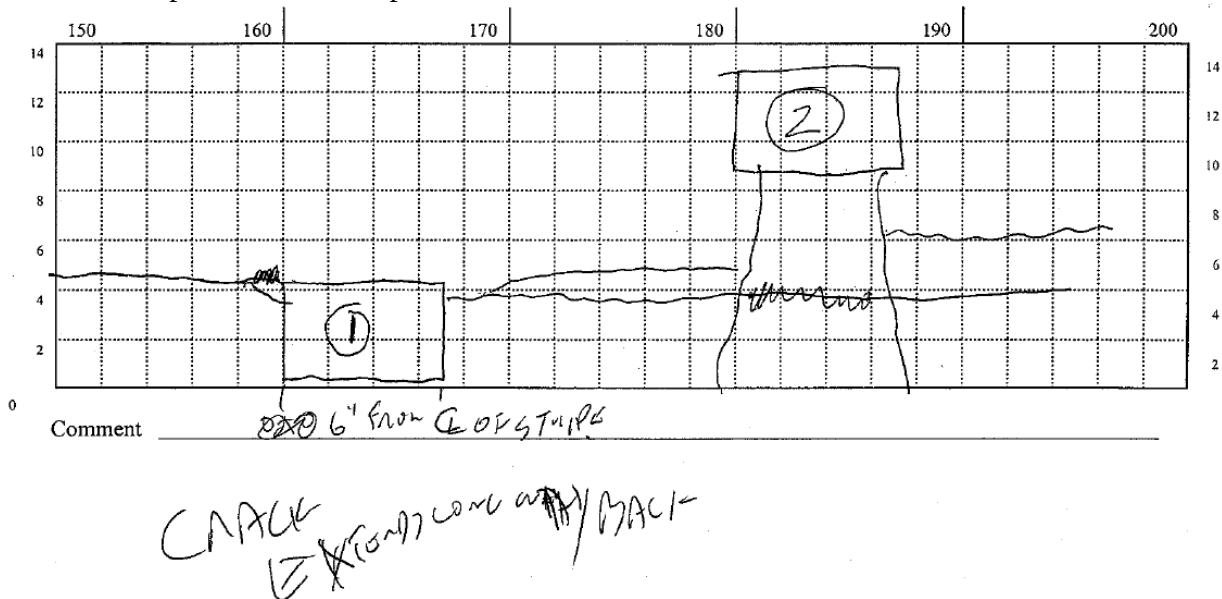
Figure 43. Crack Map of Site IH410Fr-1, Patch 1 and 2.

As noted earlier, the pavement at all three sites prior to patching was oxidized and cracked, with the cracks beginning to deteriorate. No alligator cracked areas were patched and most patches were placed on longitudinal cracks, with some intersecting cracks. Figure 43 shows an example of a crack map for Site IH410Fr-1, Patch 1 and 2.

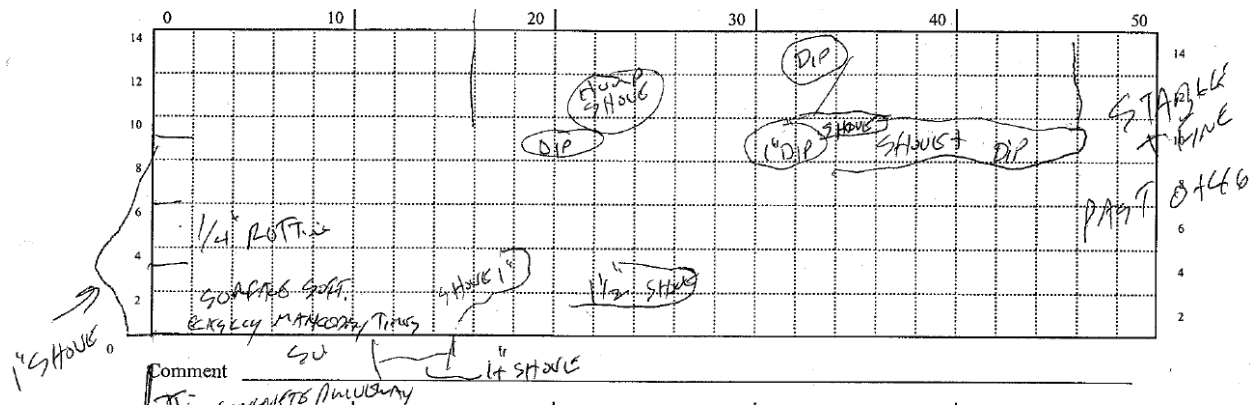
**Figure 50. Distress Map of Site IH10Fr.**

However, at the IH10Fr site, patches did not perform well. Patch 2/11-3 had 0.25 inches of rutting, patch 2/10-4 was soft and had 1-inch high shoving, as did patches 2/10-7 and 2/10-9. Patch 2/14-10 had a dip and a hump, as did patches 2/14-1 and 2/14-2. Figure 50 shows the crack map diagram. Figures 51 through 58 document the performance.

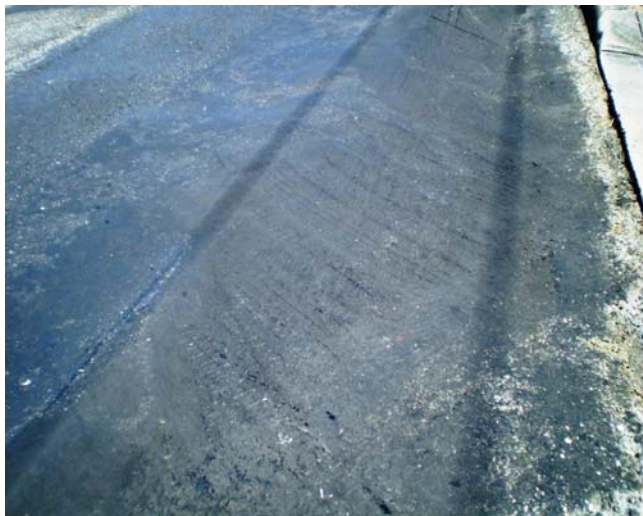
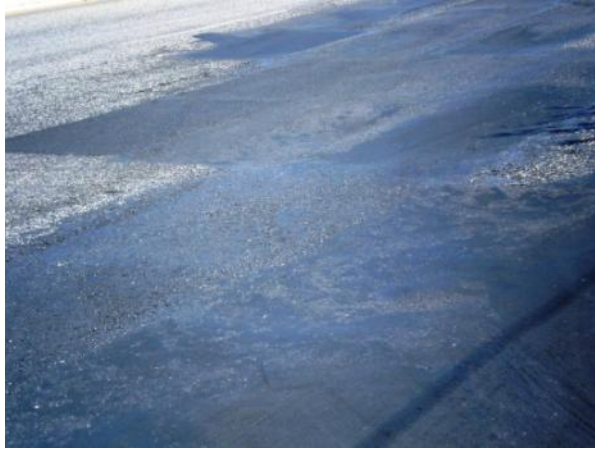
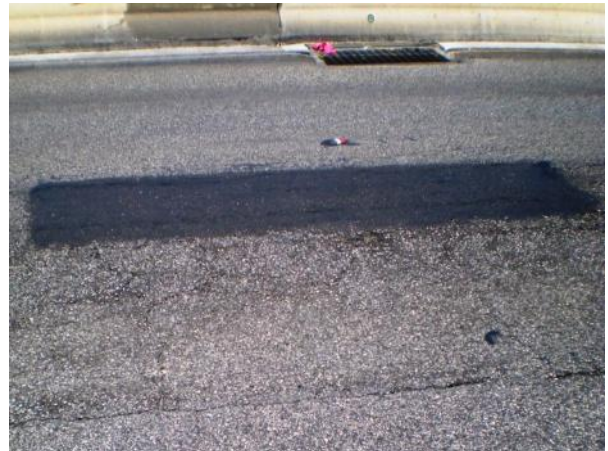
These figures, especially Figure 54, demonstrate that many of the patches were failing by shoving and settling. Due to the overall condition of this area, the entire area was milled and replaced. In the outside lane, 18 of the first 26 patches showed signs of significant distress. Patches in the middle lane and those further from the beginning performed better, but were replaced.

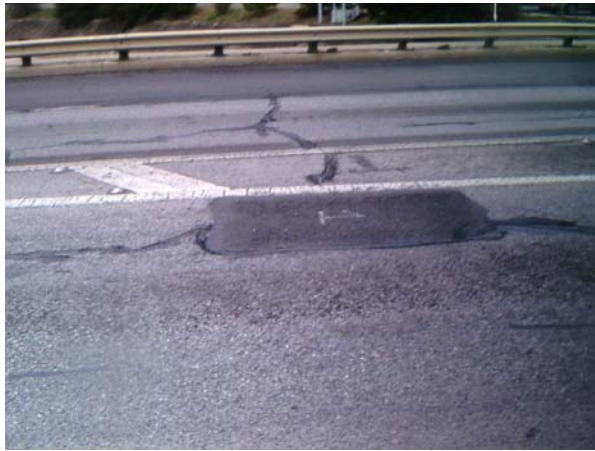
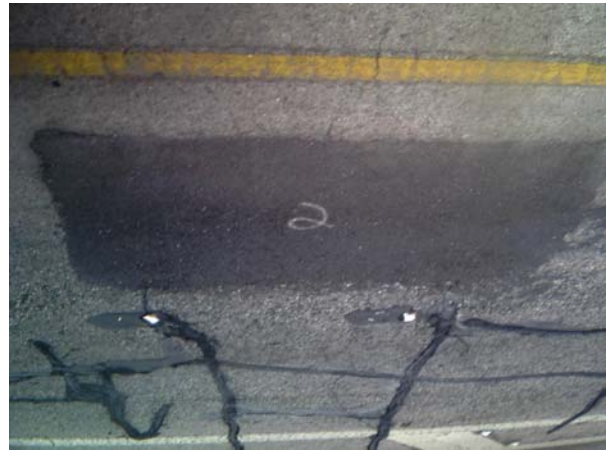
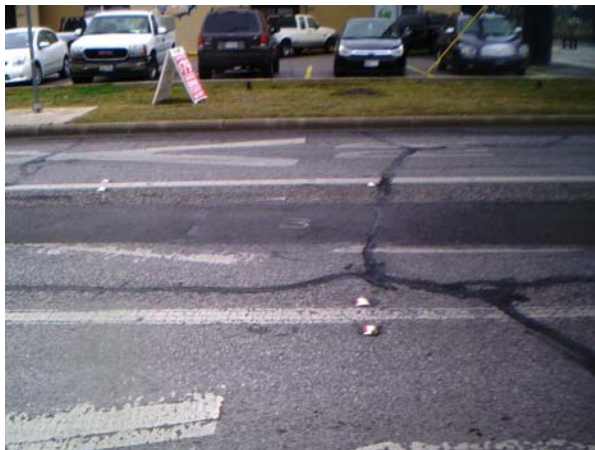
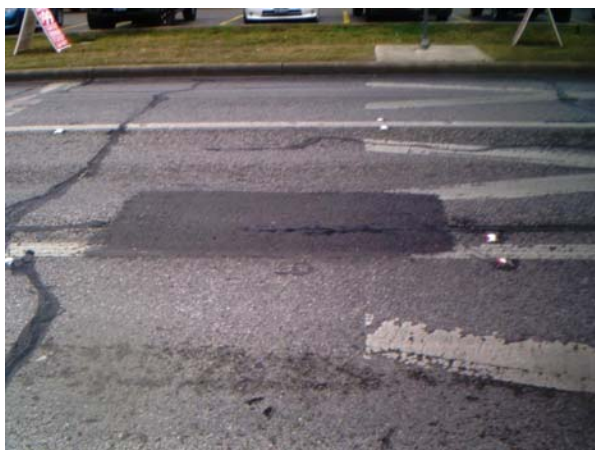
The sites were reinspected on January 20, 2012, after approximately 12 months of service. At the IH410Fr-1 and -2 sites location, patches were performing well, but patches 1, 2, 3, and 9 were settled approximately ½ inch.
