FAILURE OF RIPRAP PROTECTION - PHASE II (FINAL REPORT)

Report NM04STR-04

JUNE, 2008

Paola Bandini, Ph.D., P.E.
Associate Professor
Civil Engineering Department
New Mexico State University

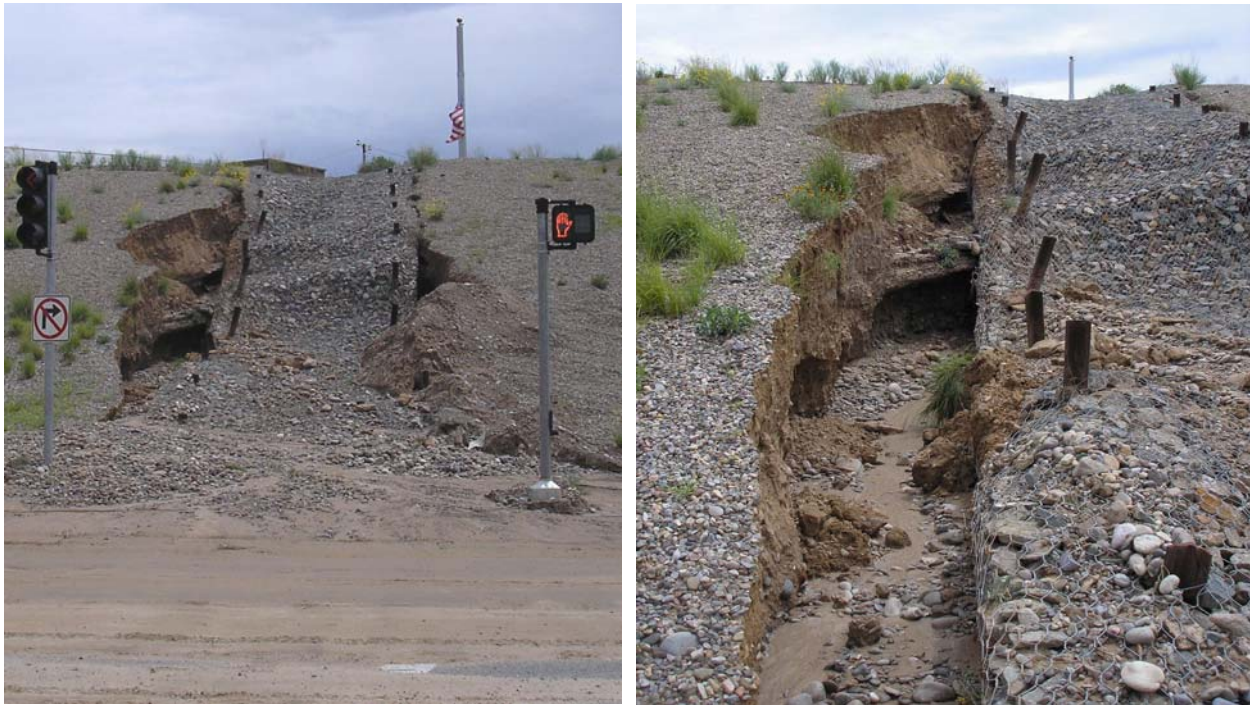
Figure 4. Wire enclosed riprap rundown No. 1 in site 1: (a) failed structure; (b) close view of the north edge showing the severe undermining and erosion of the supporting soil after a heavy rain event. Photos are courtesy of David Trujillo, Jr.

The collapse of this riprap structure was caused by the extensive erosion and piping of the supporting embankment soil due to large flow and high flow velocities at this location. The soil of this embankment is a mixture of non plastic alluvial silt, sand, gravel and cobbles. Figure 5d clearly shows a scoop-shape failure surface in the lower half of the rundown. Even though the area of the drainage basin (or catchment area) of this rundown could not be measured, the field observations and satellite images indicated that the flow could be considerable. Additionally, the slope is steep (approximately 2:1) and the riprap rundown is long.

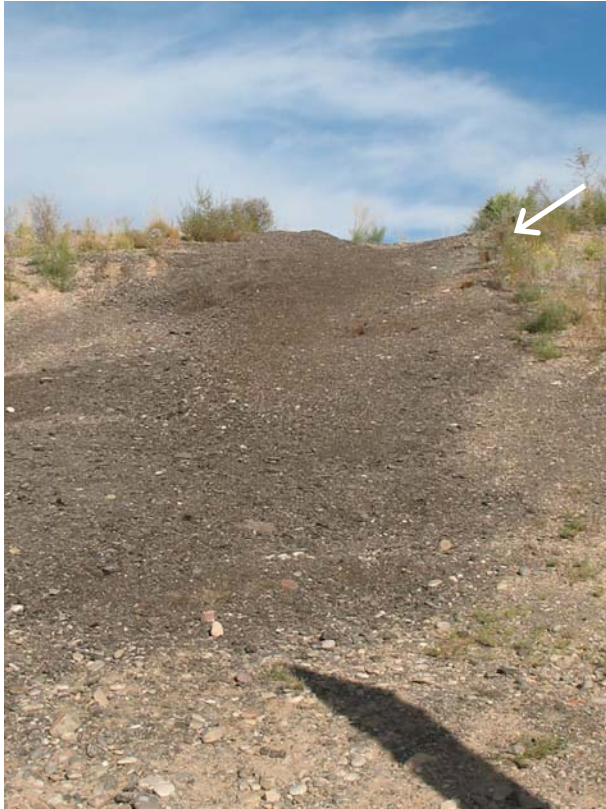
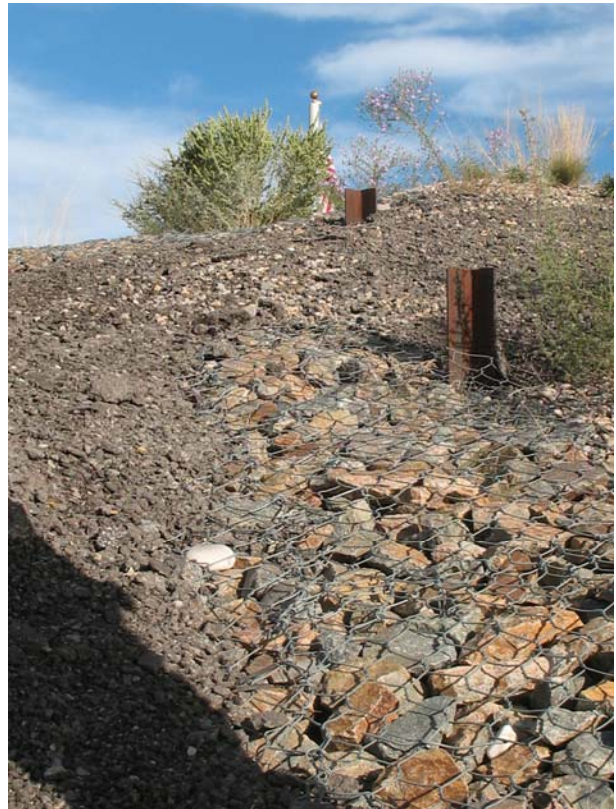
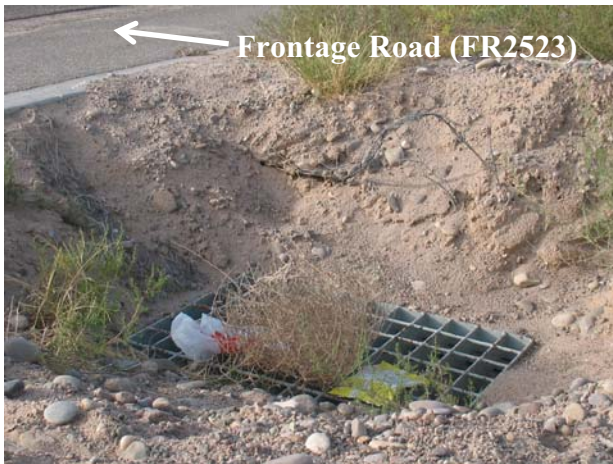
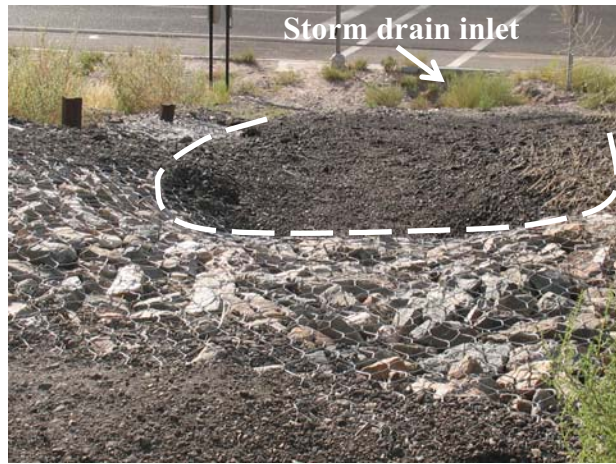
Figure 5. Wire enclosed riprap rundown No.1 in site 1: (a) upslope view of the failed structure repaired with milled asphalt material; (b) close view of the south edge, indicated with an arrow in (a); (c) storm drain at the toe of the rundown; (d) scoop-shape failure indicating piping, associated erosion, and collapse of the riprap mass (downslope view).

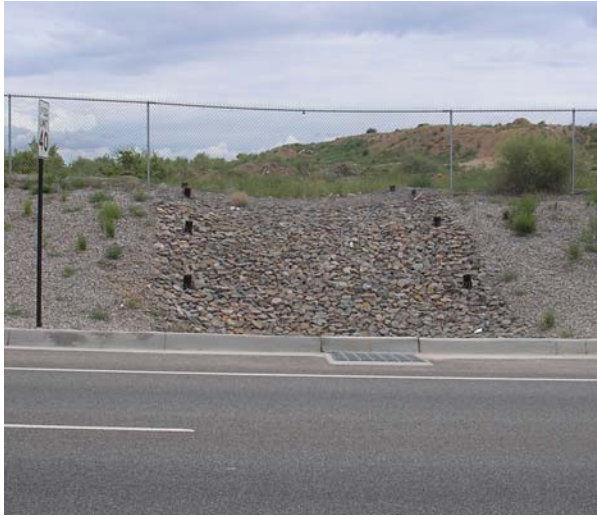
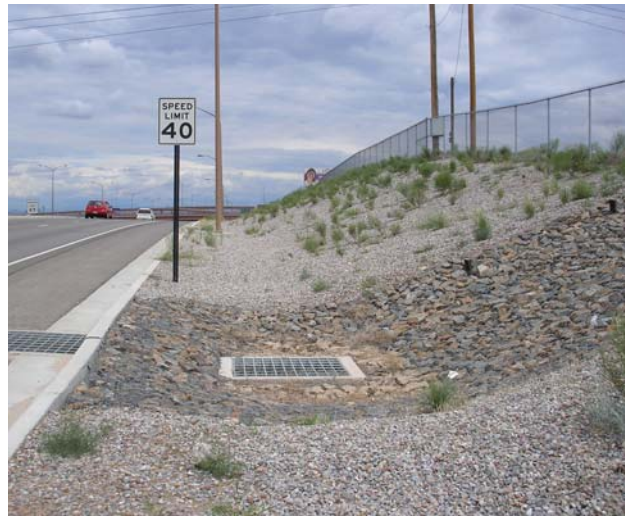
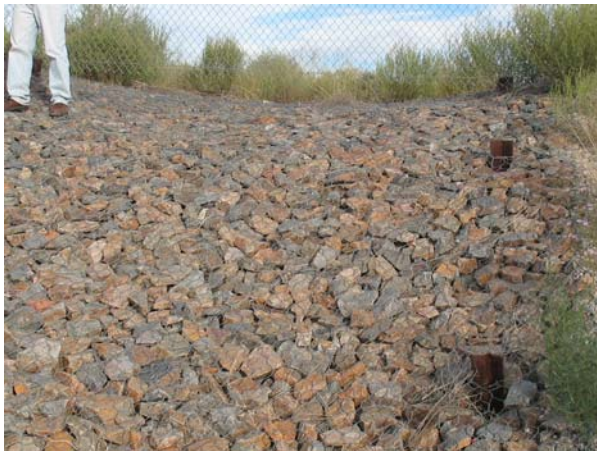
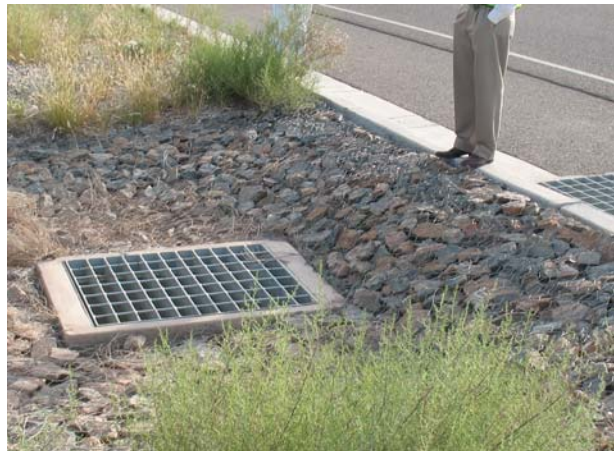
wire mesh, L4"×4" angle irons driven about 1 ft (0.3 m) from the edges of the rundown, and non-woven geotextile (David Trujillo, Jr., Personal Communication, 2008). The rock riprap layer is well embedded into the supporting soil (Figure 6). The embankment soil and slope are the same as in the rundown structure No. 1. The water flows to a storm drain inlet at the toe of the riprap structure. The storm drain inlet is approximately 1.5 ft (0.45 m) below grade (Figures 6b and 6d). The riprap rundown structure is in very good condition. The area of the drainage basin (or catchment area) of this rundown could not be determined, but the field observations and satellite images indicated that it is much smaller than the catchment area of the rundown No.1 in this site. Additionally, the length of the structure for rundown No. 2 is about half of the length for rundown No. 1. The combination of these factors may have contributed to its good performance.

Figure 6. Wire enclosed riprap rundown No. 2 in site 1: (a) front view; (b) lateral view; (c) upper section of the structure (upslope view); (b) storm drain at the toe of the riprap rundown. Photos (a) and (b) are courtesy of David Trujillo, Jr.

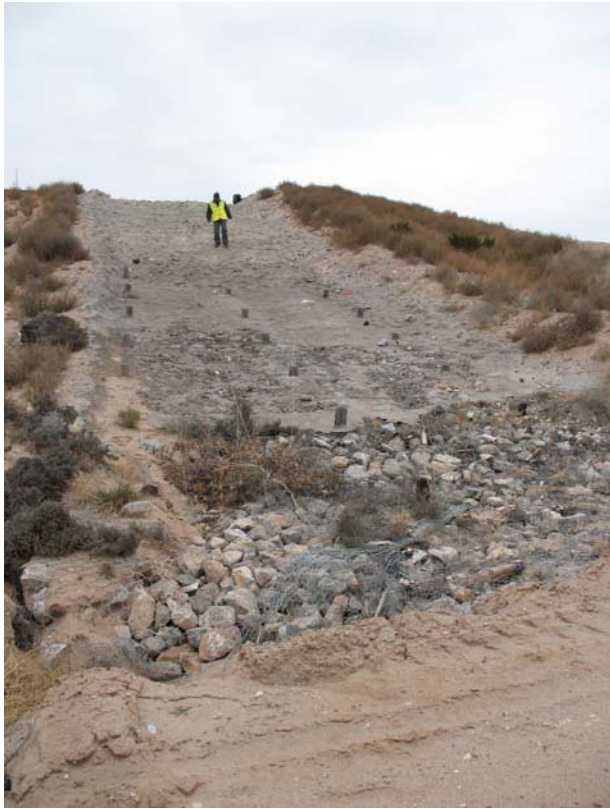
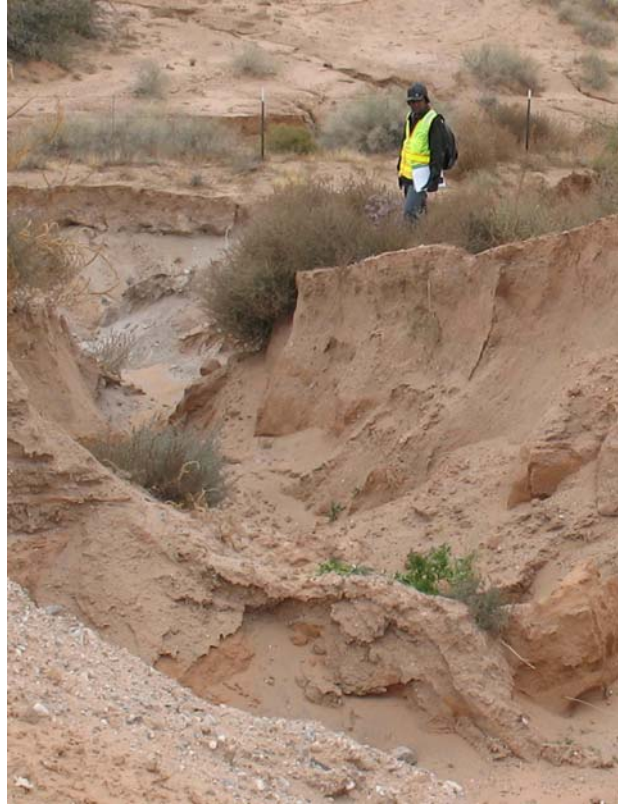
Figure 7. (a) Wire enclosed riprap rundown in highway NM 143, at milepost 6.2; (b) highly erodible soil in the area.

maintenance repairs. The soils in the area are highly erodible, very dry and relatively loose. The embankment is composed of loose poorly graded sand (SP) (non plastic medium sand). Figure 7.b shows the extensive and fast progressing erosion of the soils at this location. Wind erosion and wind-blown sand are also significant in the area. The toe of the rundown structure (not grouted) shows signs of damage, including broken wire mesh and loose riprap stones (Figure 8b). The likely mode of failure is the progressive scour and undermining of the riprap end, resulting in the loss of foundation support and partial collapse of the riprap mat. Scour occurs because the riprap does not extend far enough to allow energy dissipation, the flow is large, the slope is steep, and the soil is highly erodible.

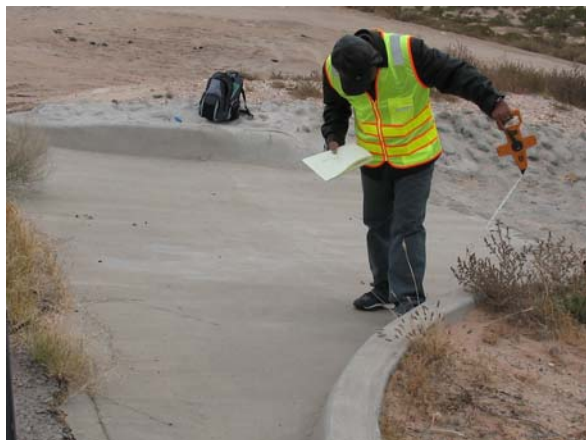
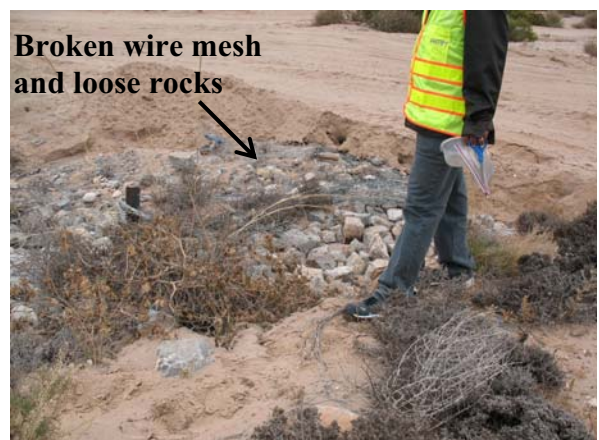
Figure 8. Riprap rundown in highway NM 143, at milepost 6.2: (a) rundown flume; (b) rundown toe.

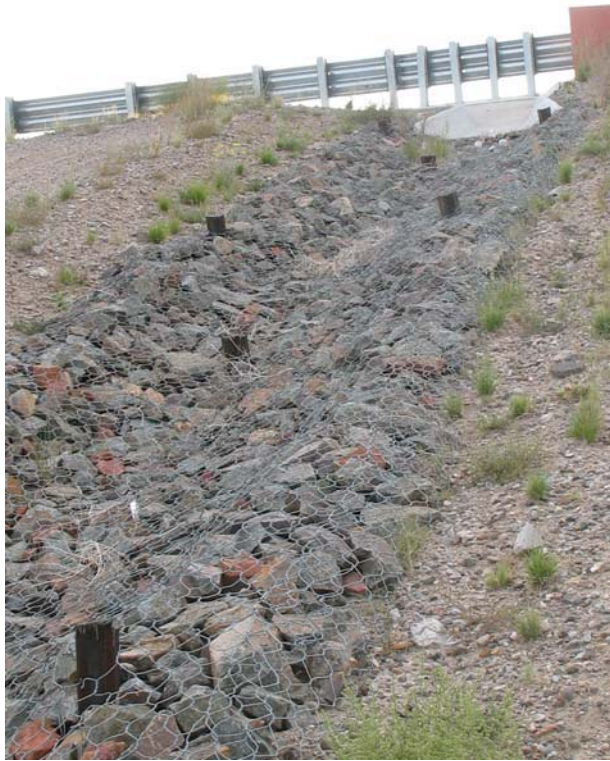
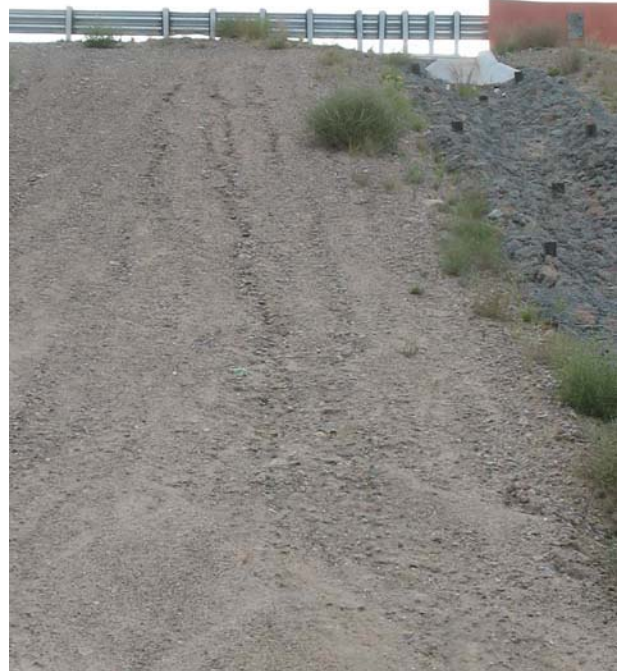
Figure 9. Wire enclosed riprap rundown in first off-ramp (IN2215) of southbound Interstate 25: (a) rundown; (b) rill erosion on the bridge abutment.

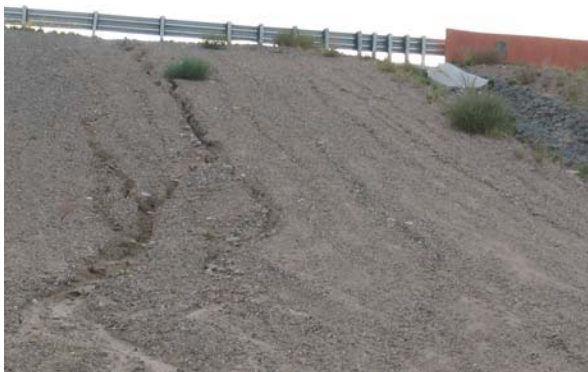
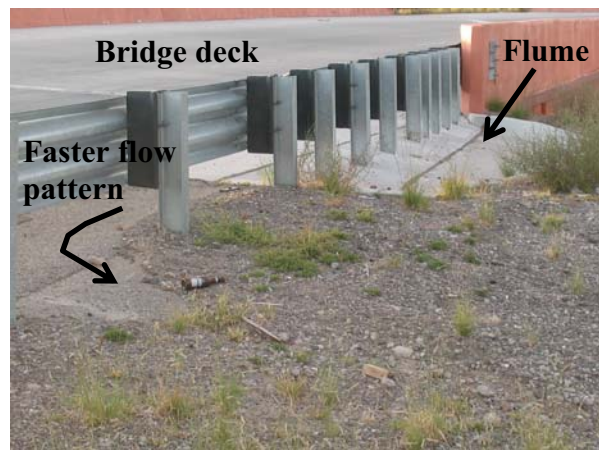
Figure 10. Slope erosion next to a rundown in ramp IN2215.

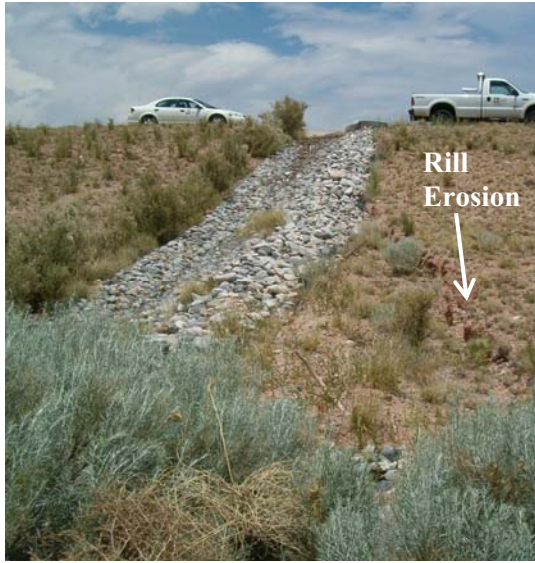
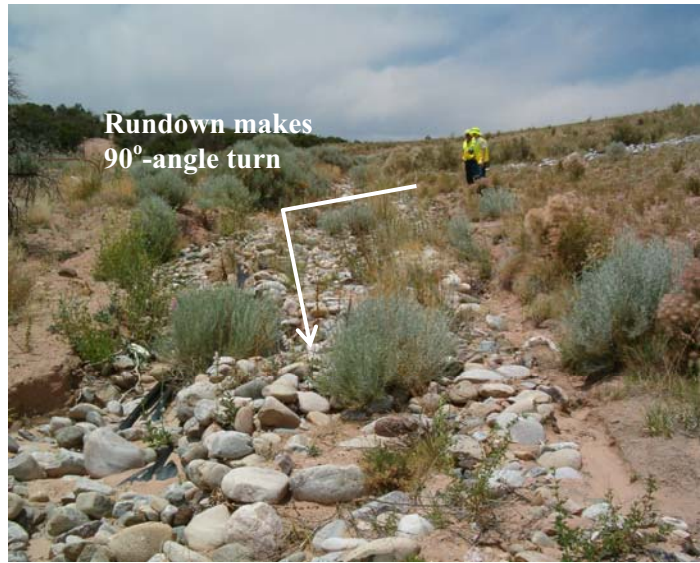
wire enclosed riprap with concrete flumes. The rundown channels are about 6-ft (1.8-m) wide and the riprap layer is about 1-ft (0.3-m) thick. They all exhibit clear signs of failure (Figures 11 and 12). The riprap stones have fairly rounded edges and the filter used is woven geotextile (woven slit-film type), which is not allowed by the NMDOT specifications for erosion control applications. The rundowns are constructed in fairly steep, long slopes. The drainage channels of two of the rundowns make a 90°-turn (i.e., a sharp turn forming a corner so that the channel runs almost parallel to highway NM 599) before reaching the right-of-way, as illustrated in Figure 11b. The embankment soil is a poorly graded sand/gravel mix.

Figure 11. Non-enclosed riprap rundown in highway NM 599 (2006 visit): (a) rill erosion from the rundown structure; (b) failure of the rundown. Photos are courtesy of Jose A. Silva.

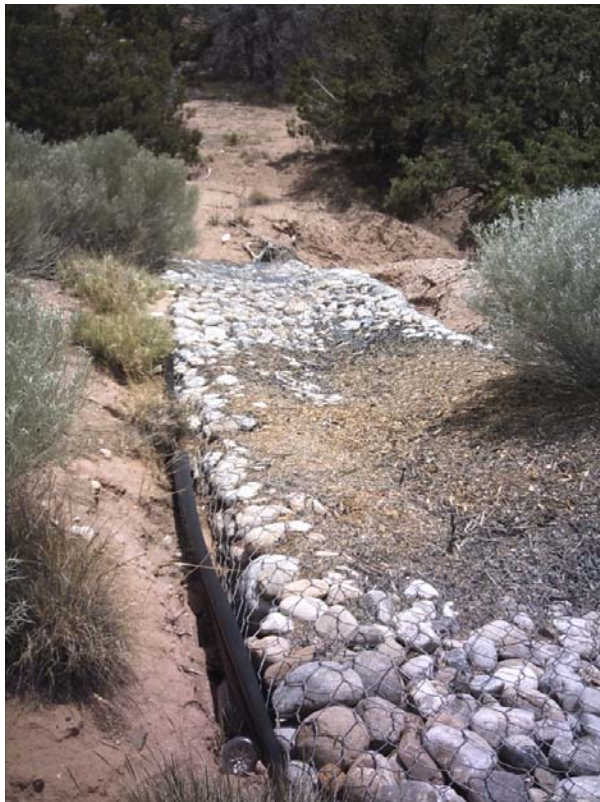
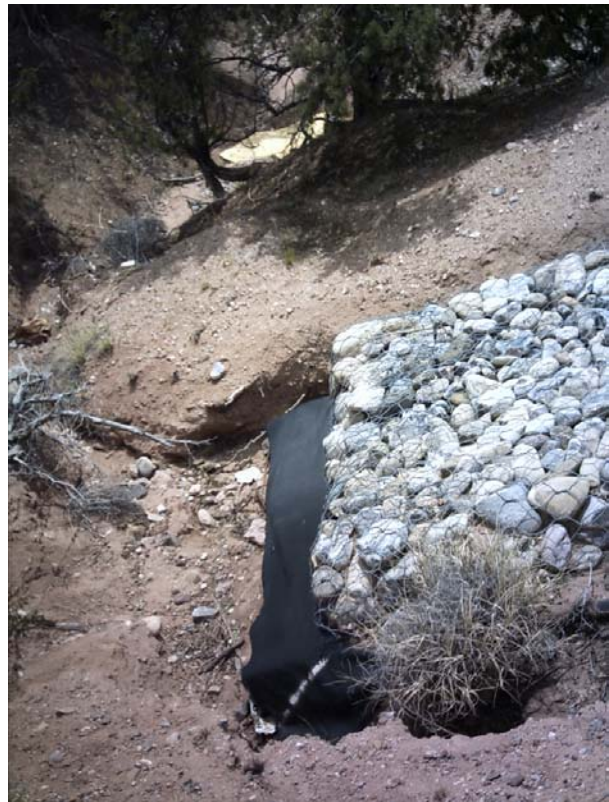
The wire enclosed riprap rundowns studied in 2006 failed by a combination of loss of foundation support, especially in the most upper part of the structures, near the flumes, and erosion along the sides and scour at the end of the riprap channels (Figures 12 and 13). This embankment is composed of dry, non plastic, poorly graded sand/gravel mix, which has the characteristics of erodible soils. In addition, the riprap was only partially embedded into the foundation soil. This condition may have allowed the water to migrate laterally and outside the

Figure 12. Wire enclosed riprap rundown in highway NM 599 (2006 visit): (a) side erosion; (b) scour at the end of the rundown.

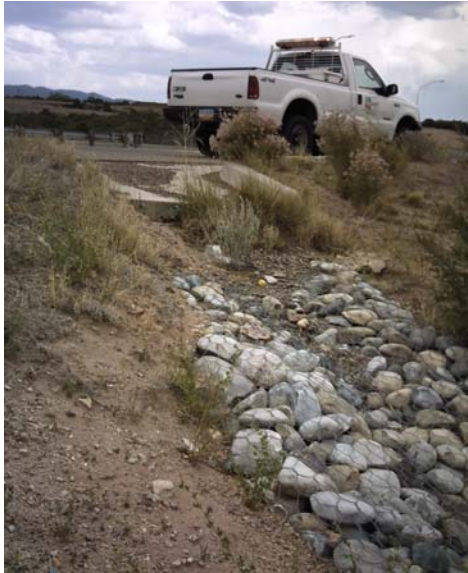
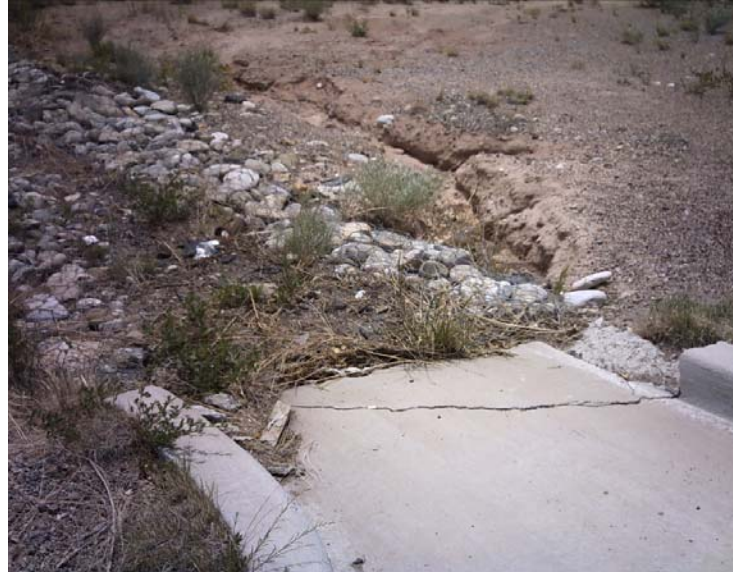
Figure 13. Failure of two wire enclosed riprap rundowns in highway NM 599 (2006).

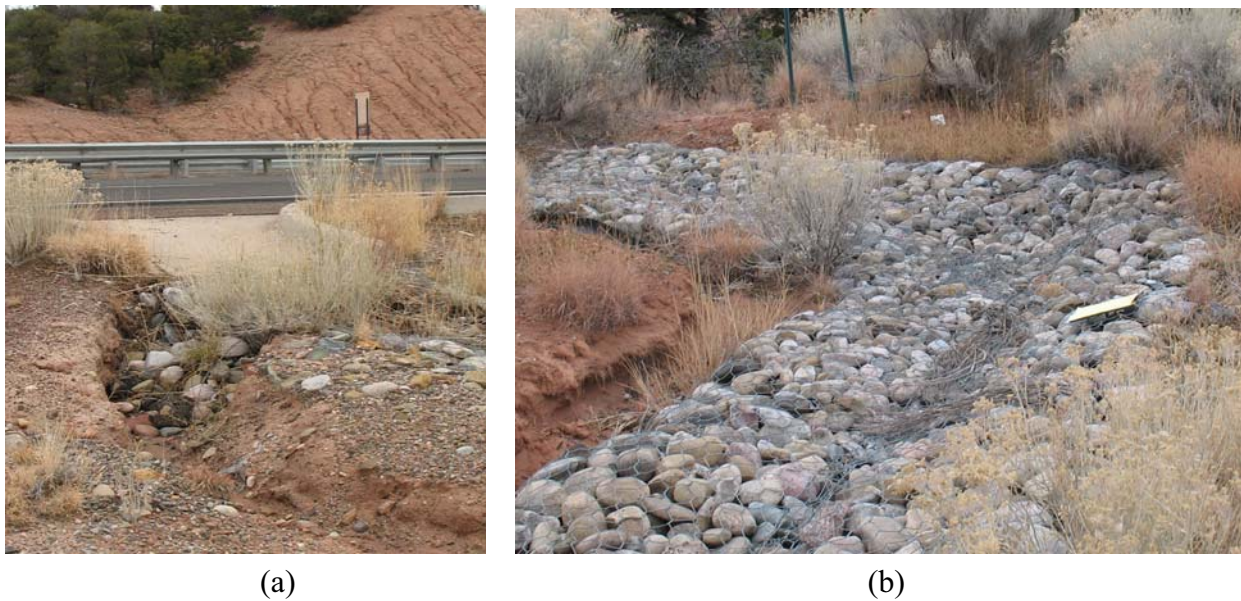
installed. Despite having been built a few months before the site visit in 2007, this riprap rundown already exhibited extensive damage, including severe undermining of the riprap layer and erosion of the sides with partial collapse of the structure (Figure 15a). A curb was added to the flume at the bridge end (Figure 15b) in an attempt to divert the runoff water away from the bridge abutment. Also, a short riprap gabion wall was built along the west side of the new

Figure 14. Condition of riprap rundowns in highway NM 599 in 2007: (a) same structure as in Figure 11; (b) same structure as in Figure 12, 18 months later.

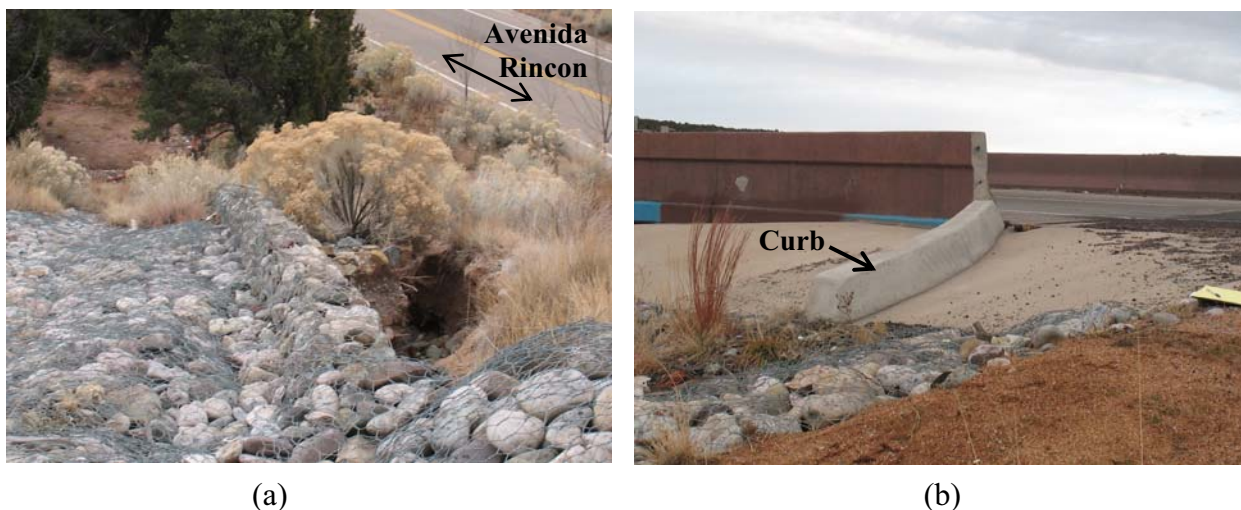
Figure 15. Reconstructed riprap rundown in highway NM 599 (2007): (a) extensive erosion (downslope view); (b) flume with curb added.

rundown (Figure 15a). However, the curb and the gabion wall did not prevent the water from draining to the northwest side of the slope (Avenida Rincon), following the steepest gradient. Because of the pervious and erodible nature of the embankment soil and the very steep side slope (towards Avenida Rincon), high hydraulic gradients and large seepage velocities are expected. Erosion protection of the northwest slope should be incorporated into future repairs of this site.

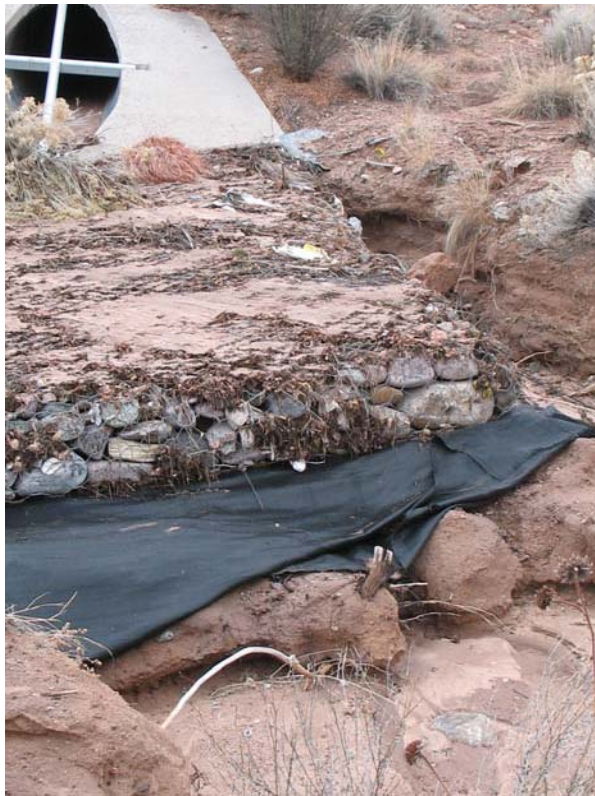
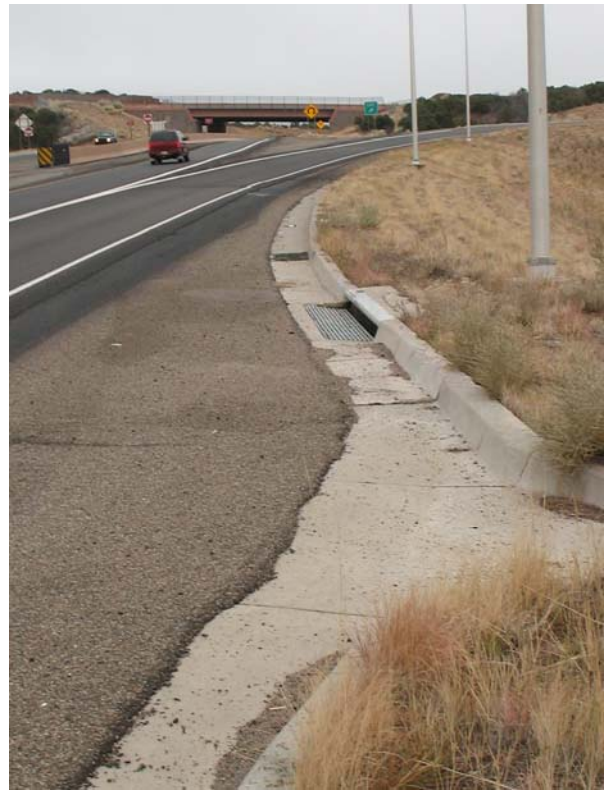
As mentioned earlier, there is a drop inlet structure with two 48" pipes and a wire enclosed riprap pad, approximately 10-ft (3-m) long, at the pipe outlet (Figure 16a). Woven slit-film type geotextile was used as filter material underneath the riprap. The drop inlet structure drains storm water from highway NM 599 (Figure 16b). Inspections in 2006 and 2007 indicated

Figure 16. Wire enclosed riprap pad at the pipe outlet in highway NM 599 (2007): (a) extensive erosion and scour around the riprap pad; (b) storm water drop inlet.

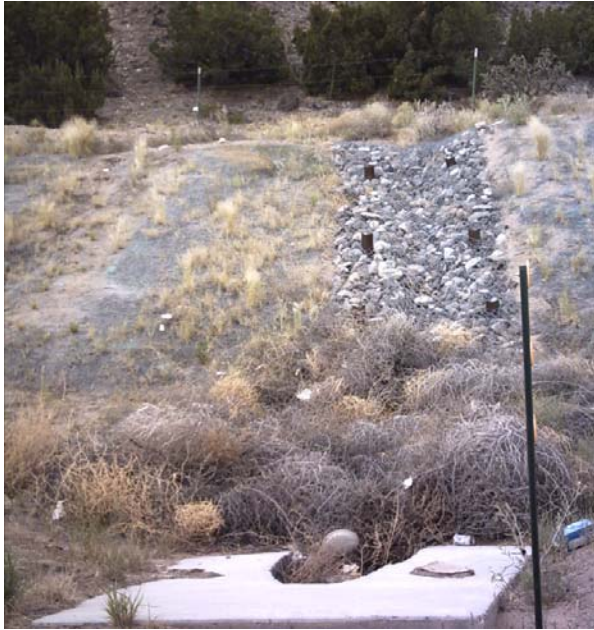
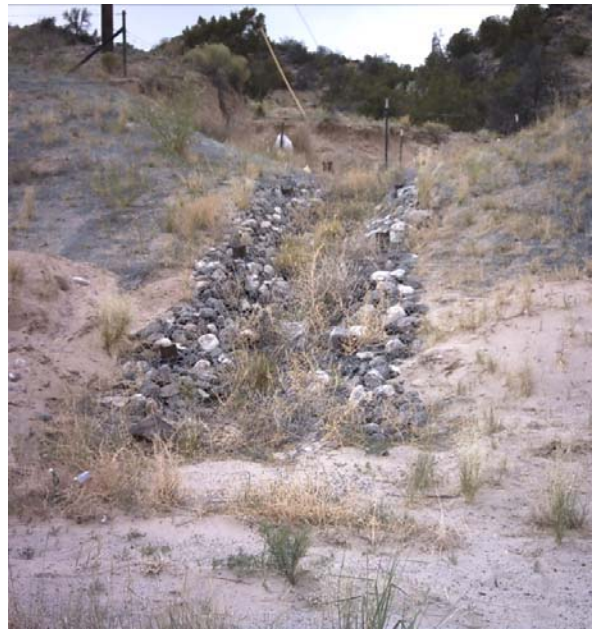
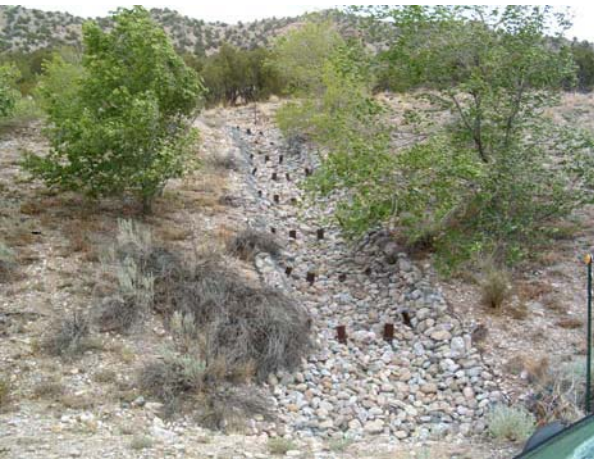
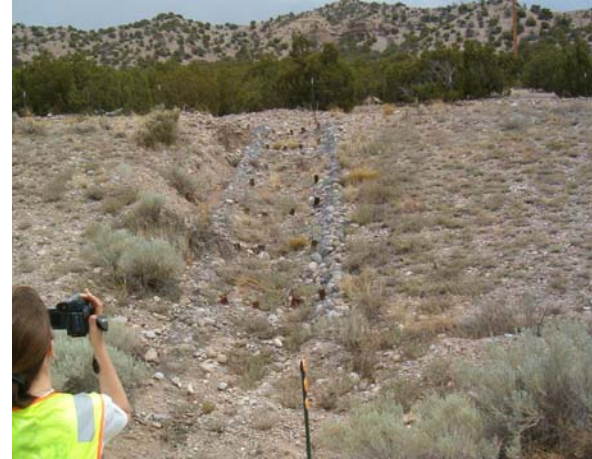
Figure 17. Wire enclosed riprap rundowns in highway NM 68, between mileposts 13 and 14. Photos (c) and (d) are courtesy of Jose a. Silva.
