MASH TL-3 TESTING AND EVALUATION OF A STEEL BRIDGE RAIL WITH PICKETS

Test Report 9-1002-12-2

**TEXAS A&M TRANSPORTATION INSTITUTE
THE TEXAS A&M UNIVERSITY SYSTEM
COLLEGE STATION, TEXAS**

TEXAS DEPARTMENT OF TRANSPORTATION

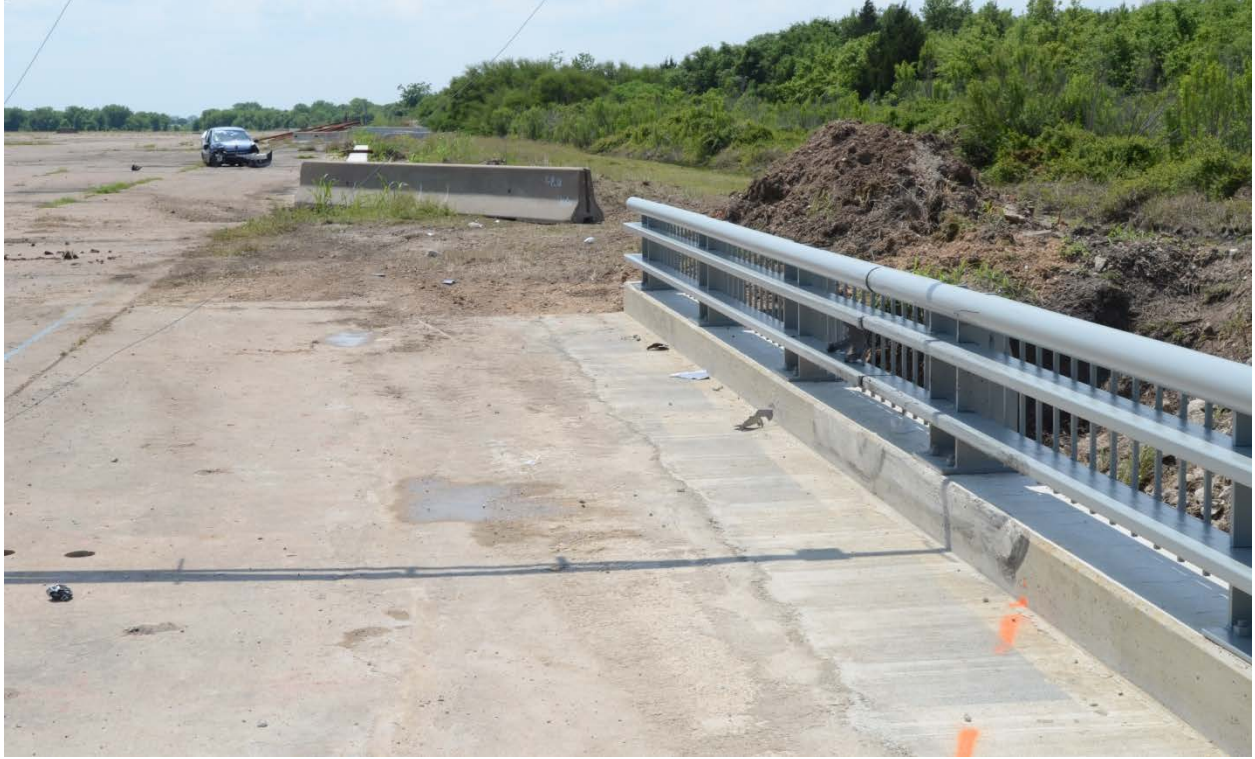
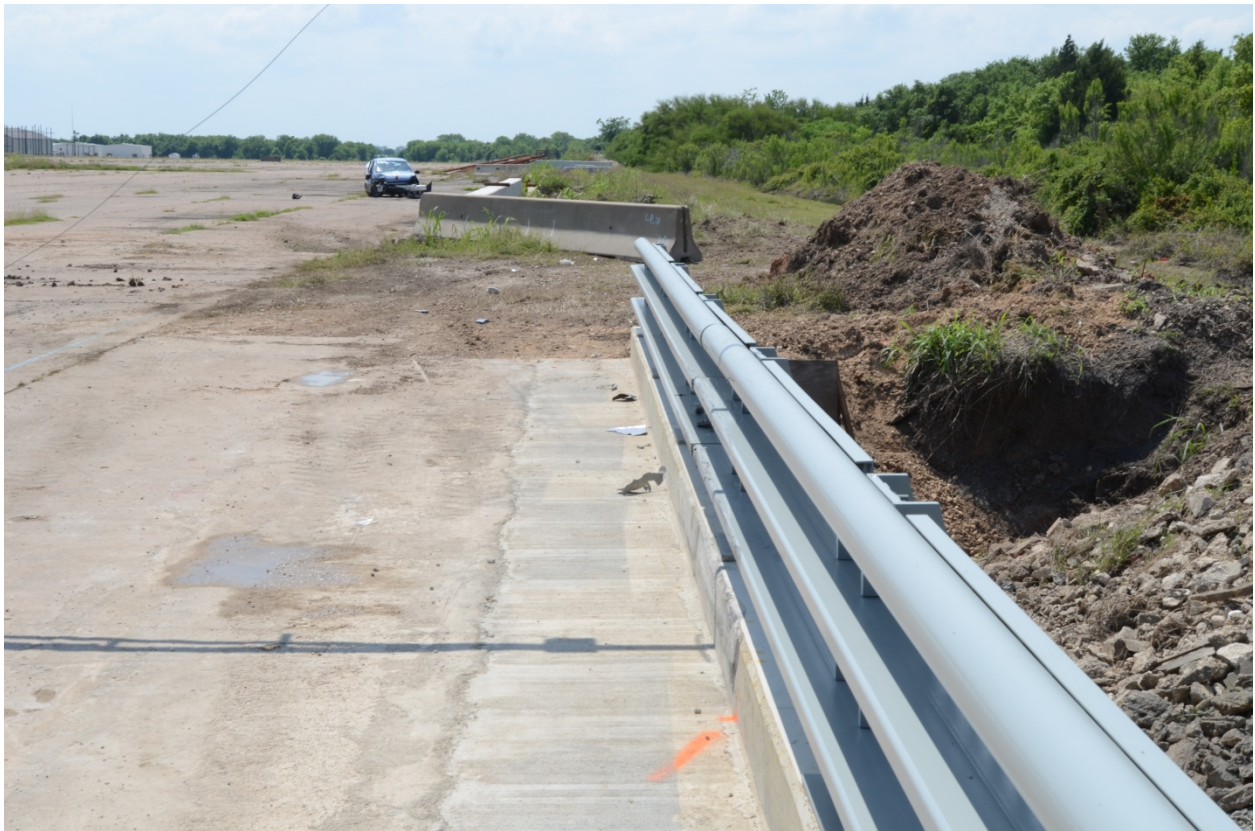
Figure 5.3. Vehicle/Installation after Impact for Test No. 490022-2.

Figures 5.3 and 5.4 show damage to the TxDOT Picket Rail. Cracks in the curb radiated from the front and rear anchor bolts toward the field side at post 9, and from the rear anchor bolt on the upstream side of post 10. Tire marks were evident on the traffic face of all the horizontal metal rail elements from 3.7 ft upstream of post 9 for a length of 10.0 ft. There was no evidence of contact on the vertical pickets. Working width was 10.7 inches, and maximum dynamic deflection of the horizontal metal rail element was 0.9 inch. Residual permanent deformation was minimal and not measureable.

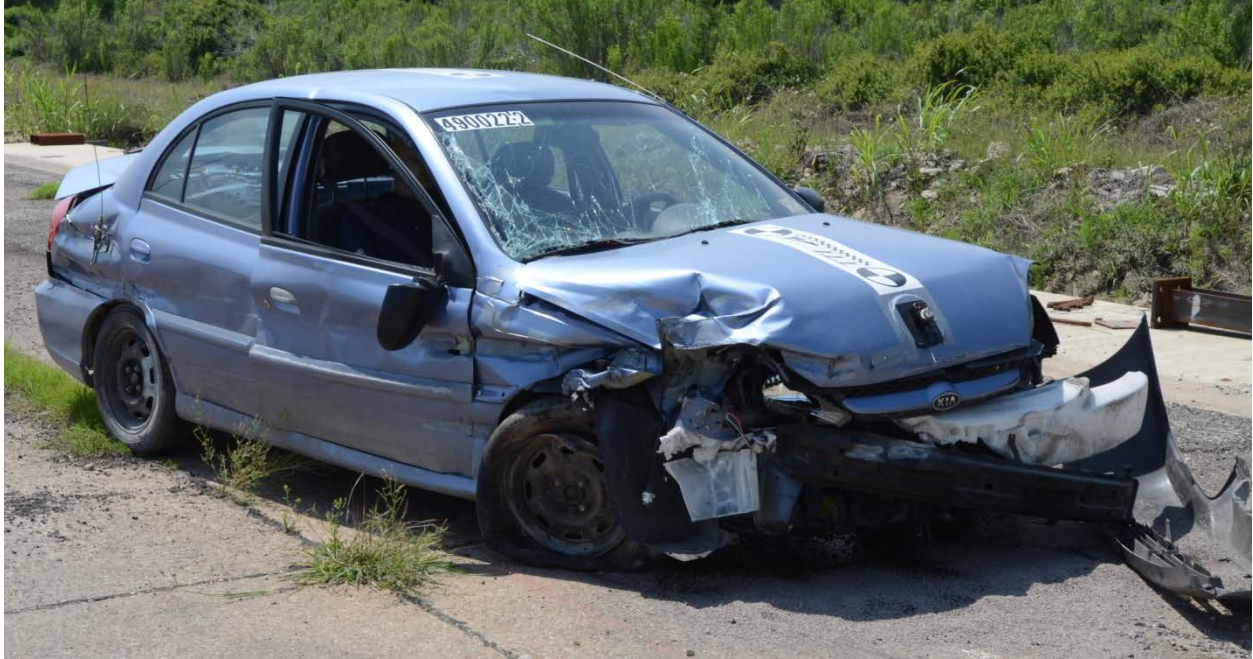
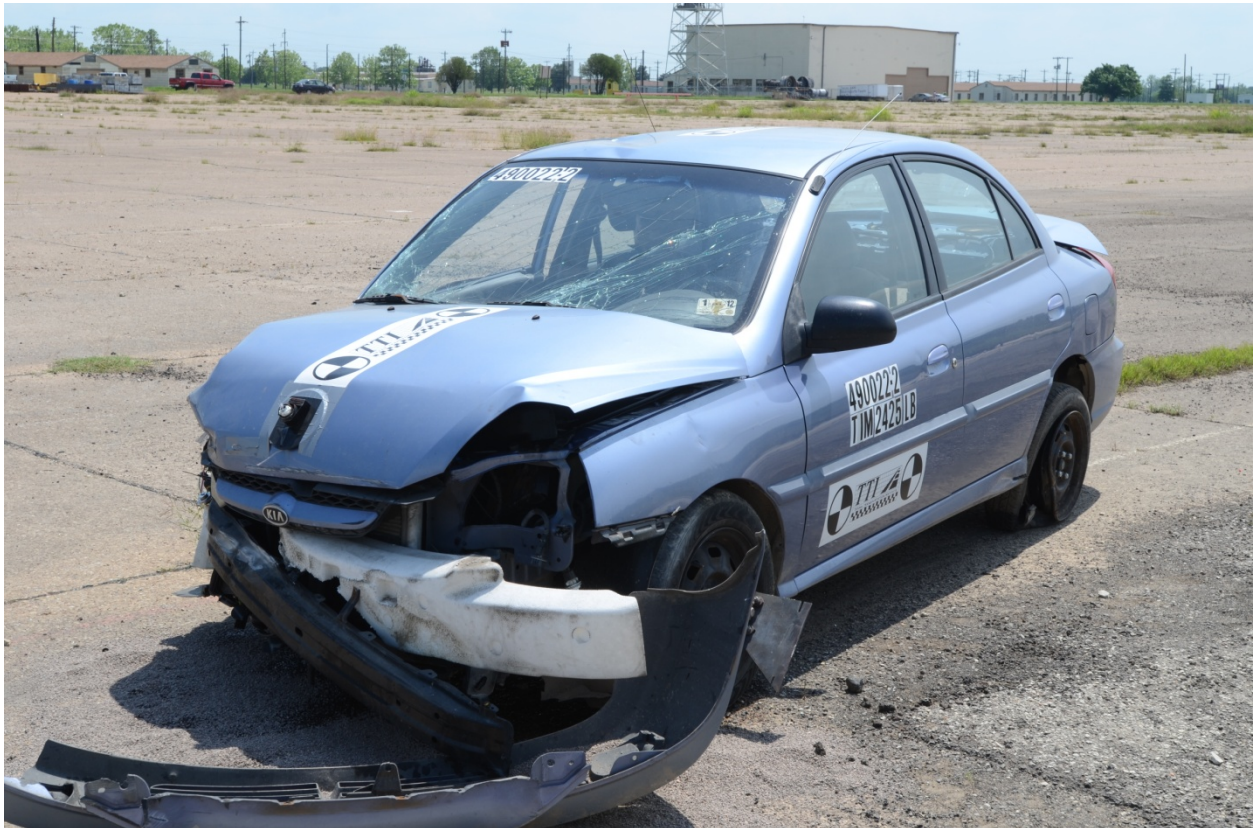
Figure 5.5. Vehicle after Test No. 490022-2.

Figure 5.5 shows damage to the vehicle. The right front strut and strut tower were deformed. The front bumper, hood, right front tire and wheel rim, right front fender, right front door and door glass, right rear door, right rear wheel rim, right rear quarter panel, and rear bumper were also damaged. Maximum exterior crush to the vehicle was 11.0 inches in the side plane at the right front corner at bumper height. The right side floor pan was also deformed, with a maximum occupant compartment deformation of 3.0 inches. Figure 5.6 shows the interior of the vehicle. Exterior vehicle crush and occupant compartment measurements are shown in Appendix C, Tables C2 and C3.

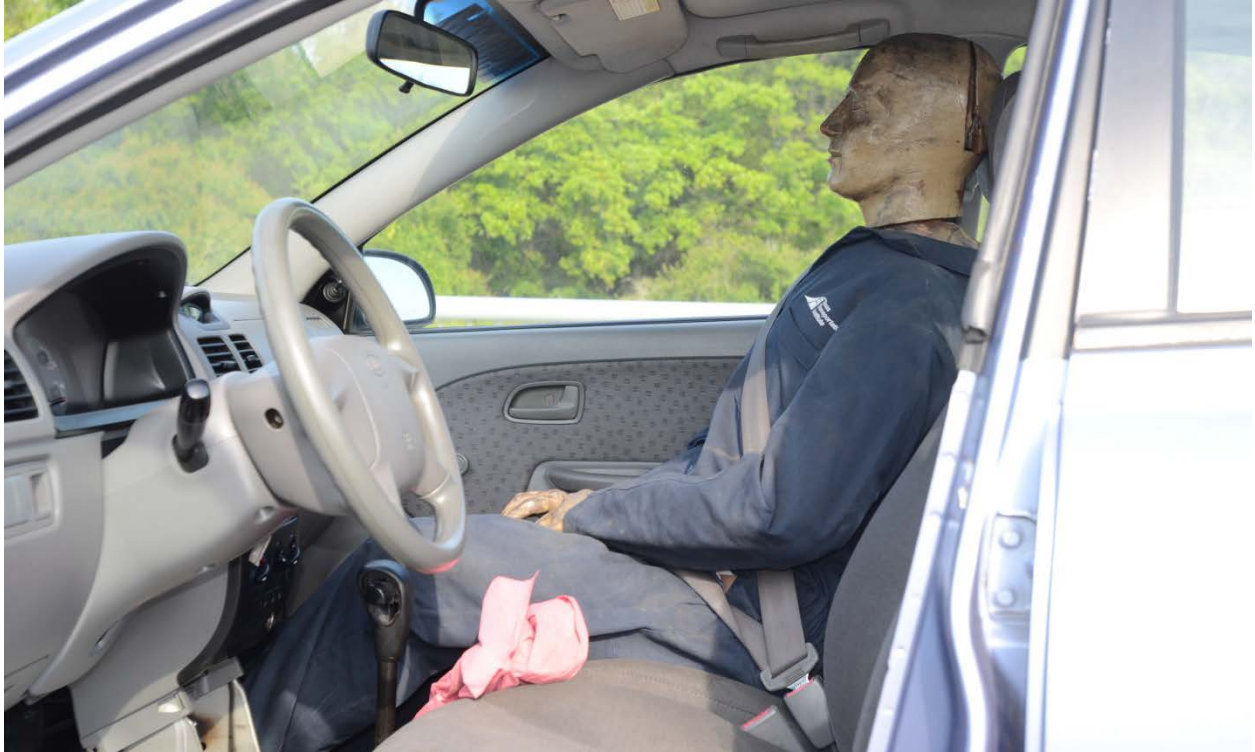
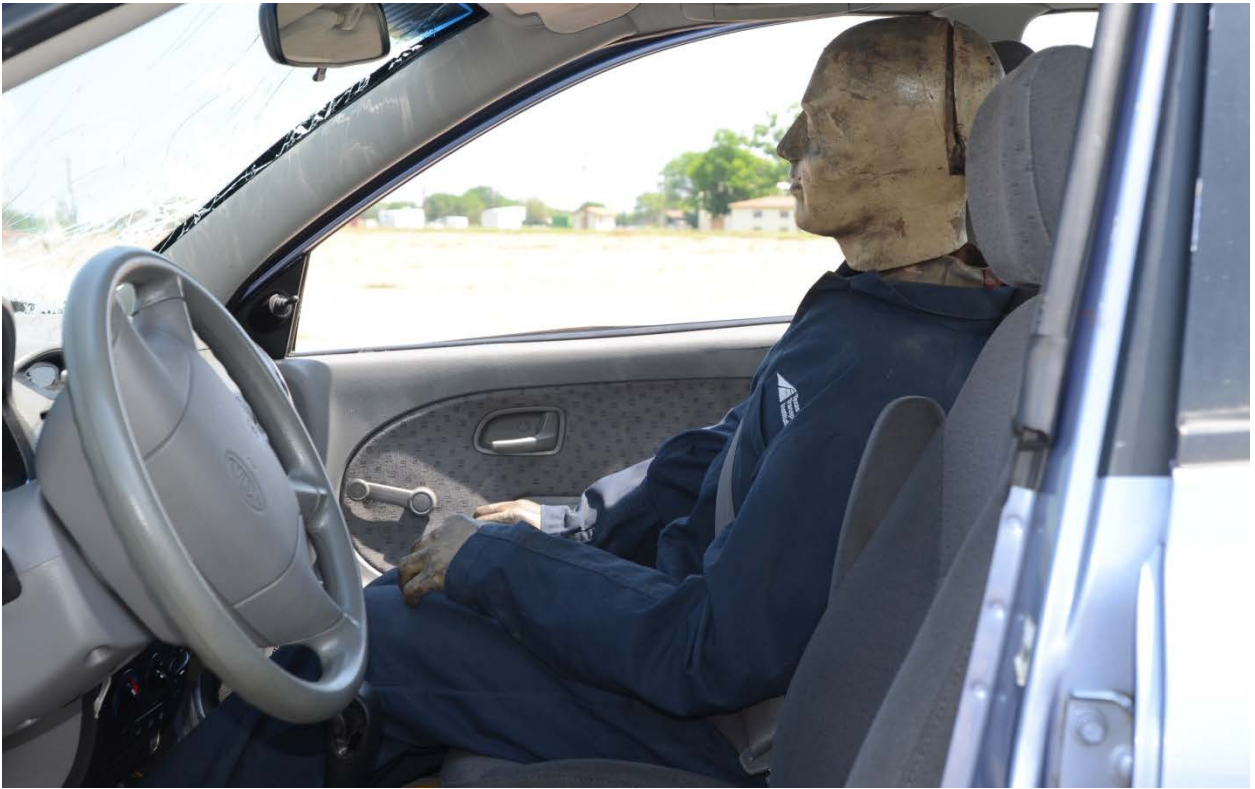
Figure 5.6. Interior of Vehicle for Test No. 490022-2.

Results: No detached elements, fragments, or other debris was present to penetrate or show potential for penetrating the occupant compartment, or present undue hazard to others. (PASS)
Maximum occupant compartment deformation was 3.0 inches in the right floor pan area. (PASS)

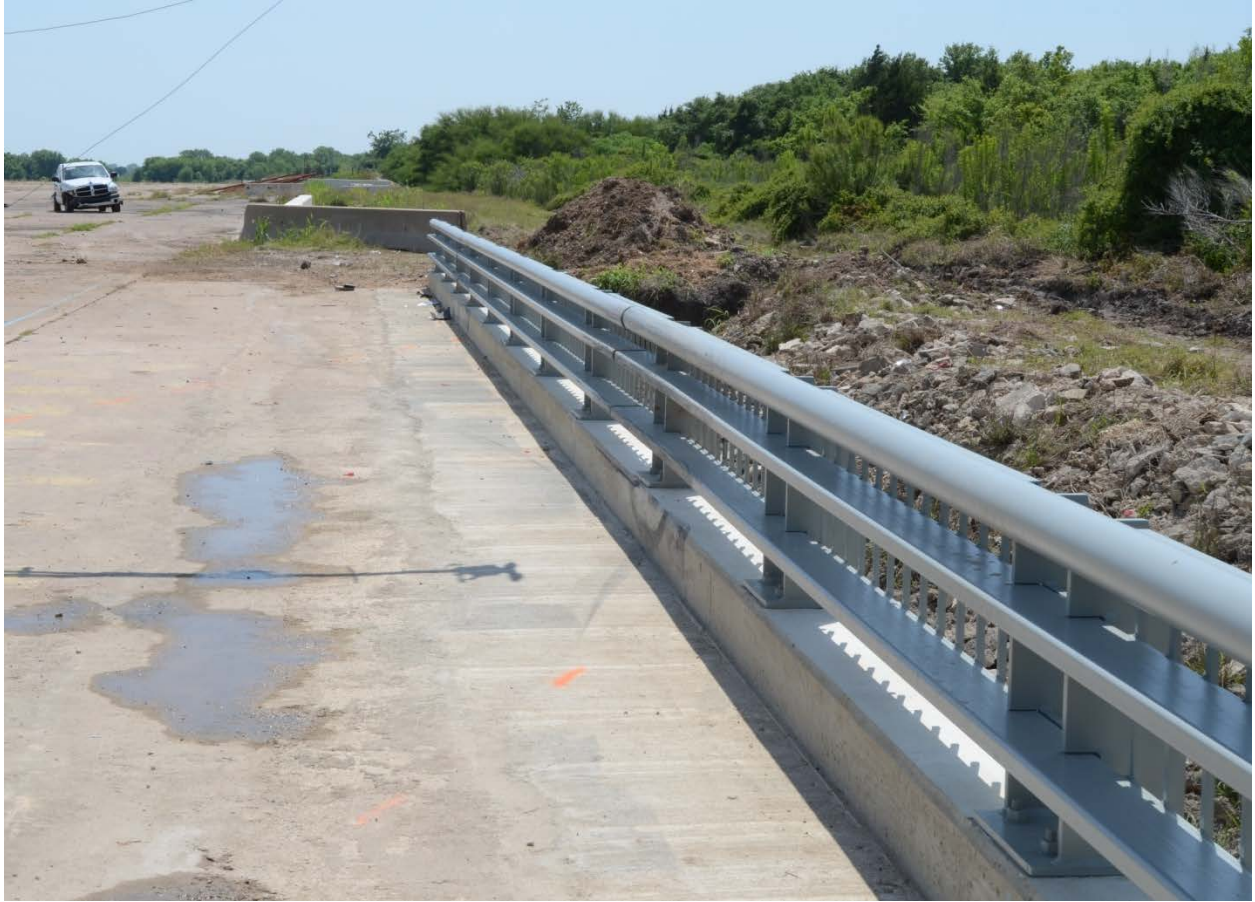
Figure 6.3. Installation/Vehicle after Impact for Test No. 490022-3.

Figures 6.3 and 6.4 show damage to the TxDOT picket rail. A crack in the concrete curb radiated toward the field side from the rear anchor bolt on the impact side of post 3. Cracks in the concrete curb radiated toward the field side from the front and rear anchor bolts on both sides of post 4, and extended into the concrete deck where each radiated downward and outward on each side of the post. Working width was 10.4 inches. Maximum dynamic deflection of the top rail was 2.8 inches. Maximum permanent deformation of the rail elements was 0.8 inch on the top rail, 0.7 inch on the middle rail, and 0.9 inch on the bottom rail.

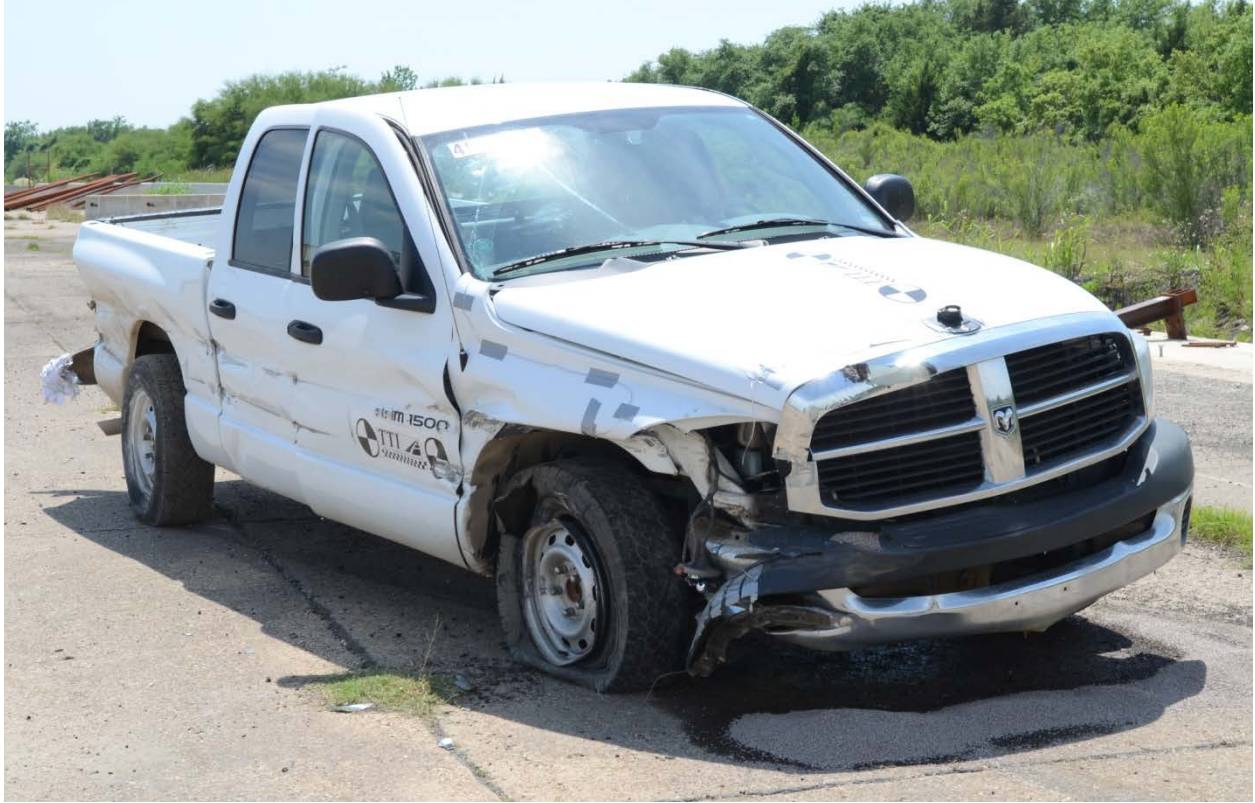
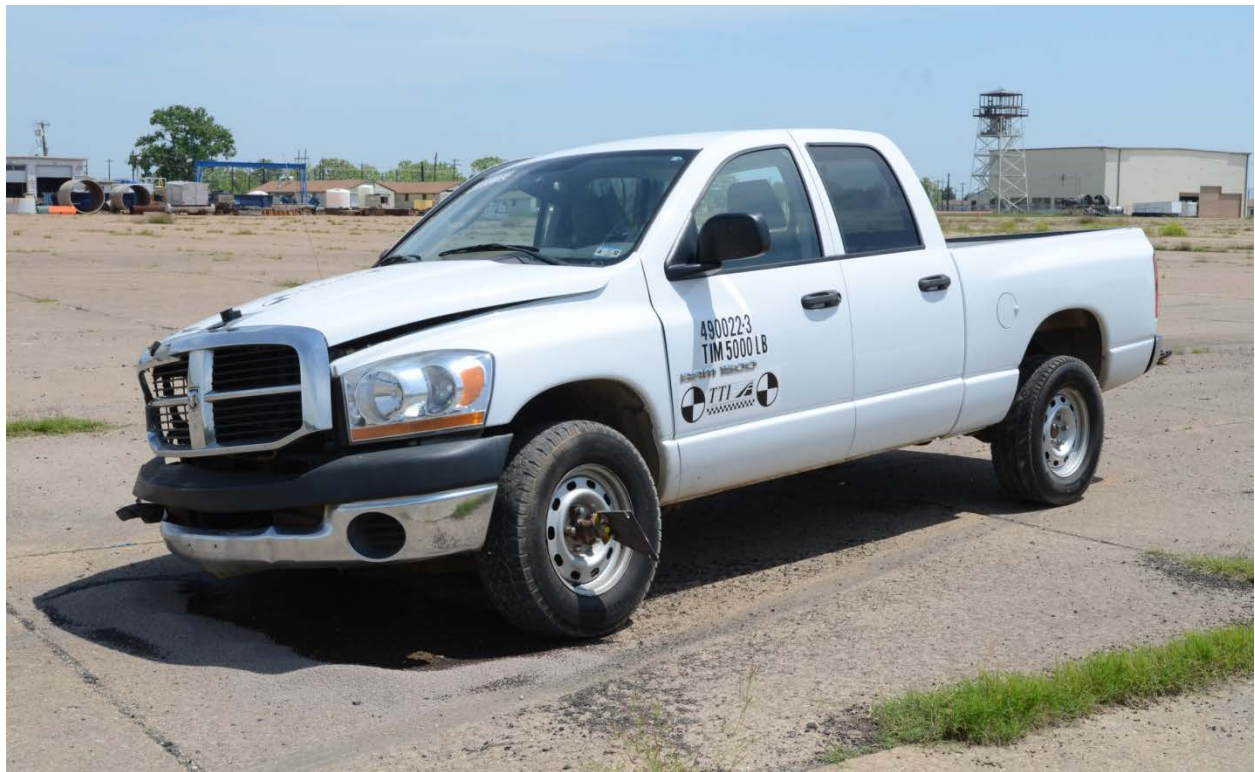
Figure 6.5. Vehicle after Test No. 490022-3.

Figure 6.5 shows damage to the 2270P vehicle. The right front frame rail and right front upper and lower A-arms were deformed. Also damaged were the front bumper, hood, right front tire and wheel rim, right front fender, right front and rear doors, right exterior bed, right rear tire and wheel rim and the rear bumper. The windshield sustained stress cracks in each lower corner near the hood. Maximum exterior crush to the vehicle was 11.0 inches in both the front and side planes at the right front corner at bumper height. Maximum occupant compartment deformation was 2.75 inches in the lateral area across the cab at the passenger side kickpanel. Figure 6.6 shows the interior of the vehicle, while Tables D3 and D4 in Appendix D show the exterior vehicle crush and occupant compartment measurements.

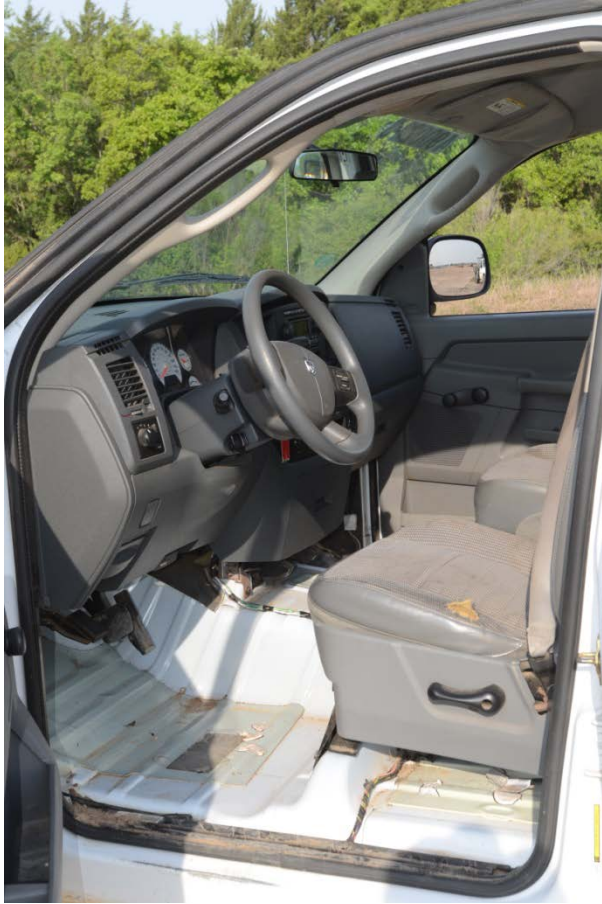
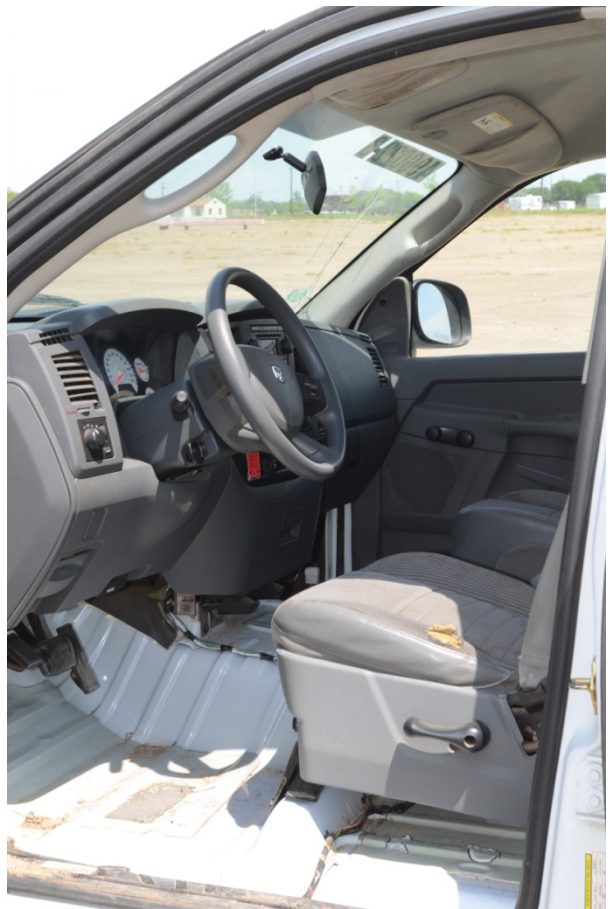
Figure 6.6. Interior of Vehicle for Test No. 490022-3.

Results: No detached elements, fragments, or other debris were present to penetrate or show potential for penetrating the occupant compartment, or present undue hazard to others. (PASS)
Maximum occupant compartment deformation was 2.75 inches in the lateral area across the cab at the front passenger kick panel. (PASS)
