REPORT APPENDIX

IDENTIFICATION OF CAUSES AND SOLUTION STRATEGIES FOR DECK CRACKING IN JOINTLESS BRIDGES

Appendix to Report No. CEE-RR – 2012/04

Research Report for MDOT under Contract No. 2009-0746/Z1
SPR No. 108522

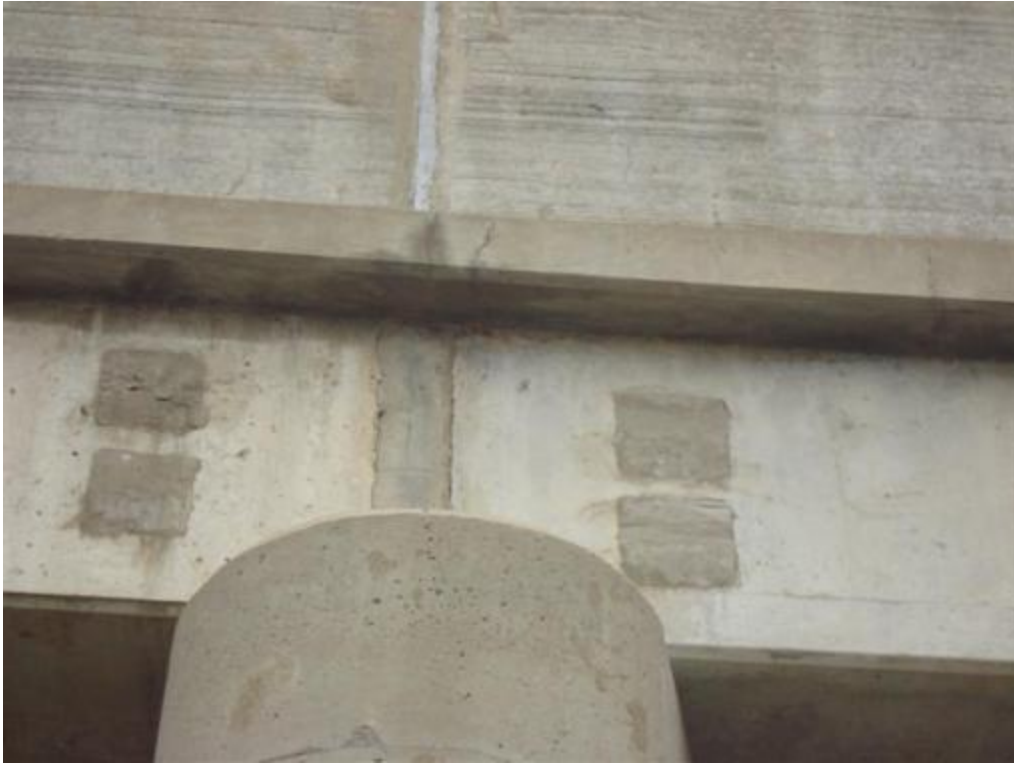
Figure 6. Transverse cracking in deck fascia

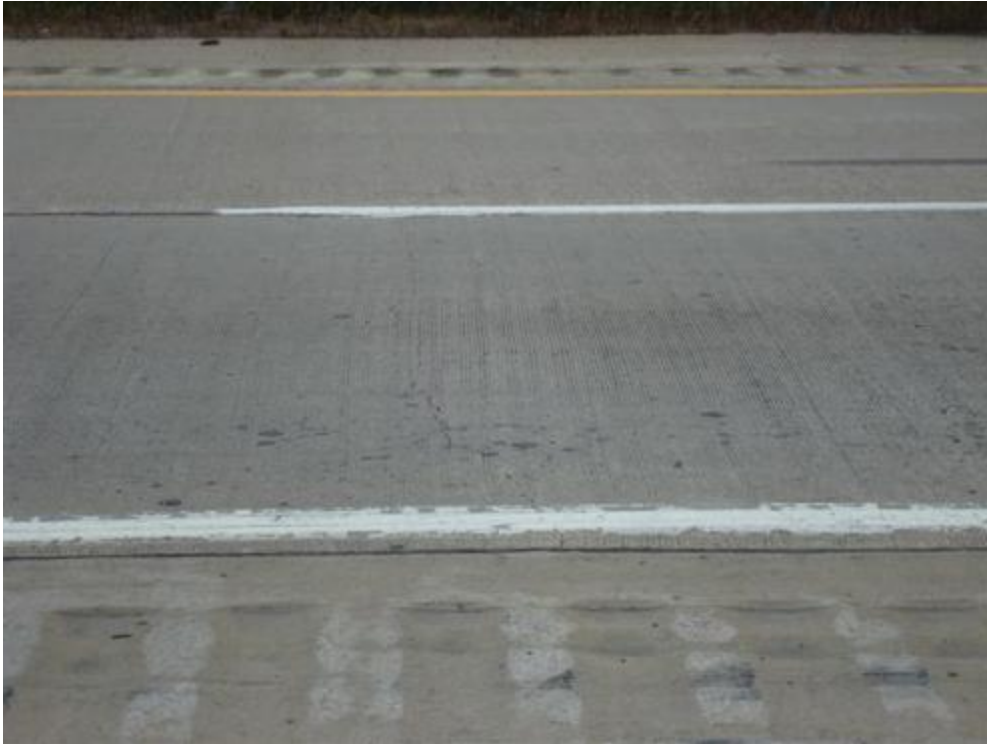
Figure 8. Cracking in approach pavement

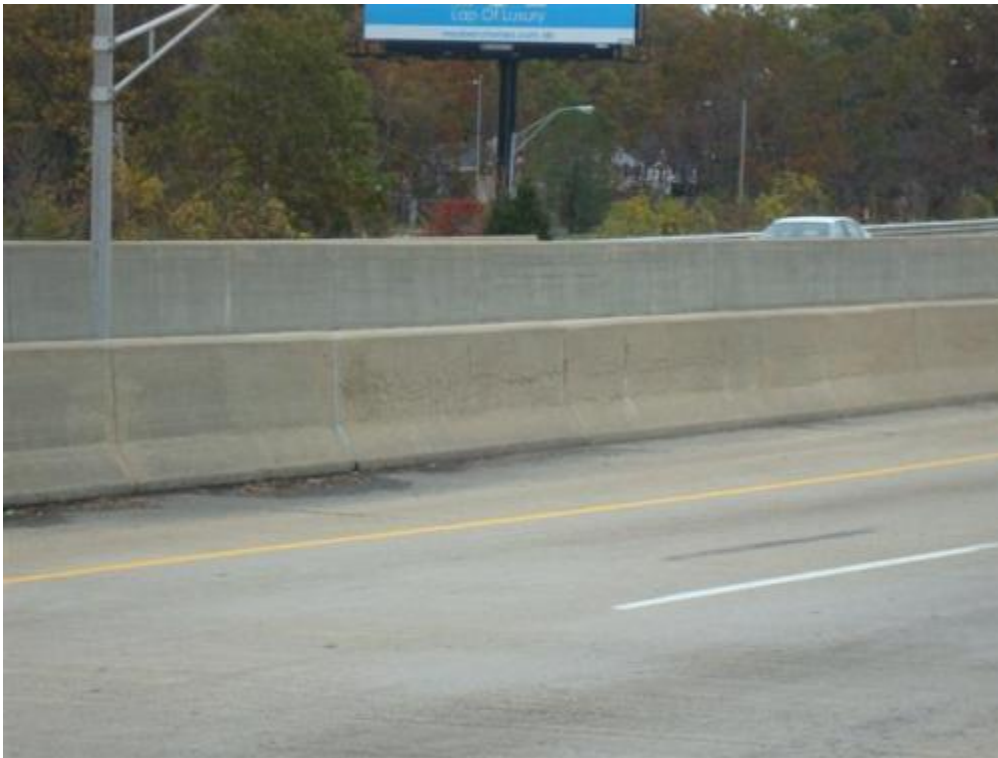
Figure 9. Extensive cracking in barrier wall

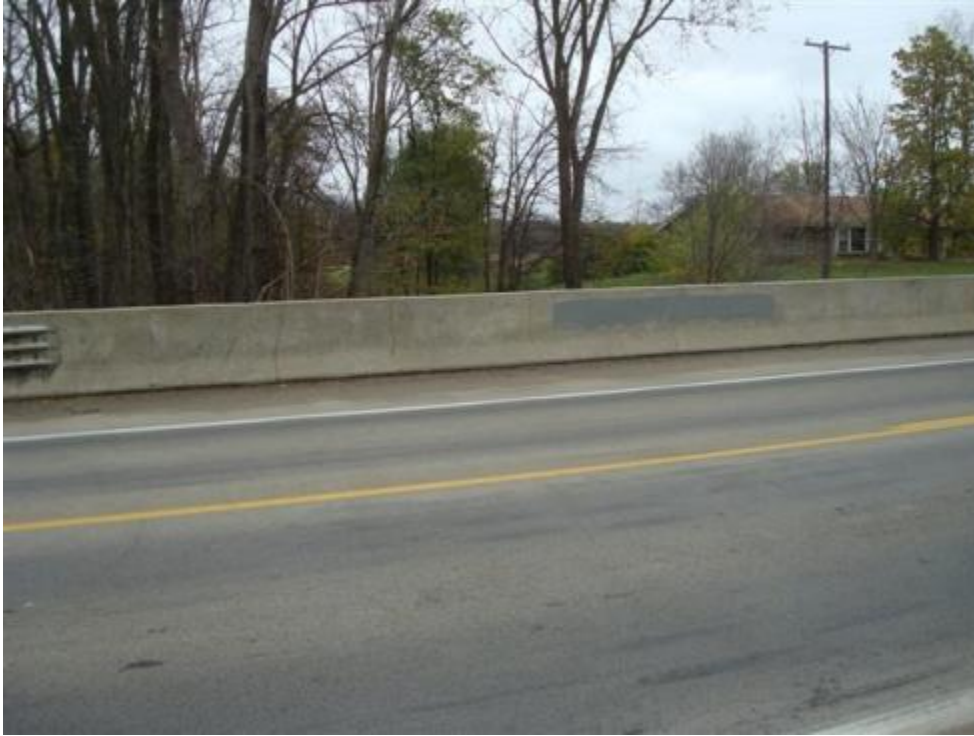
Figure 13. Vertical cracking in barrier wall, transverse cracking in the deck

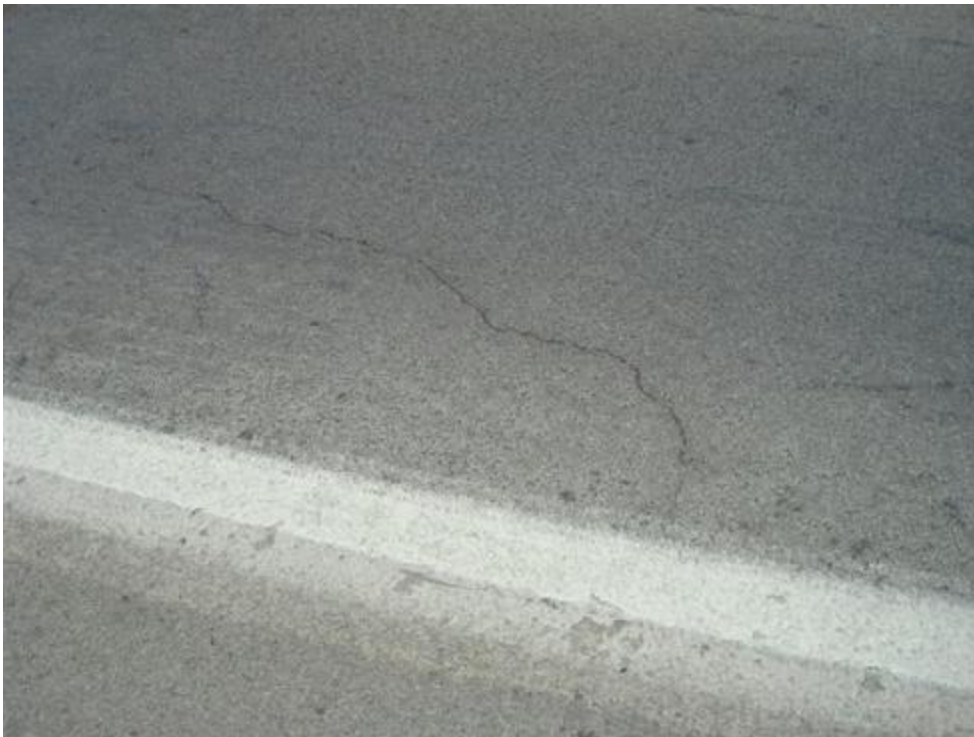
Figure 14. Longitudinal crack in the deck

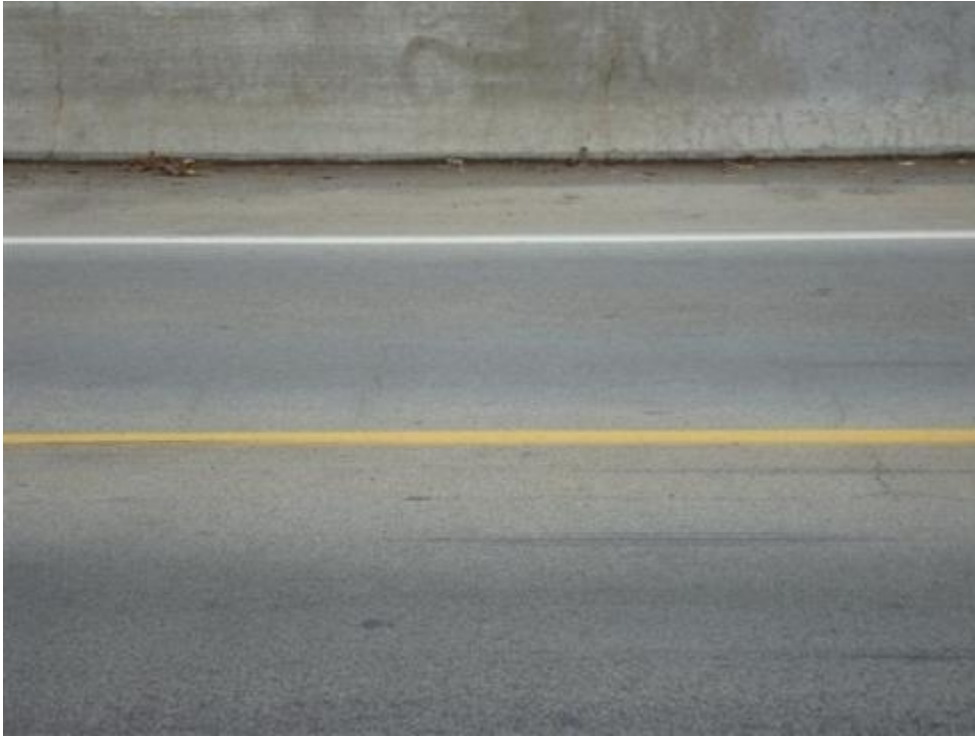
Figure 15. Transverse cracking in the deck

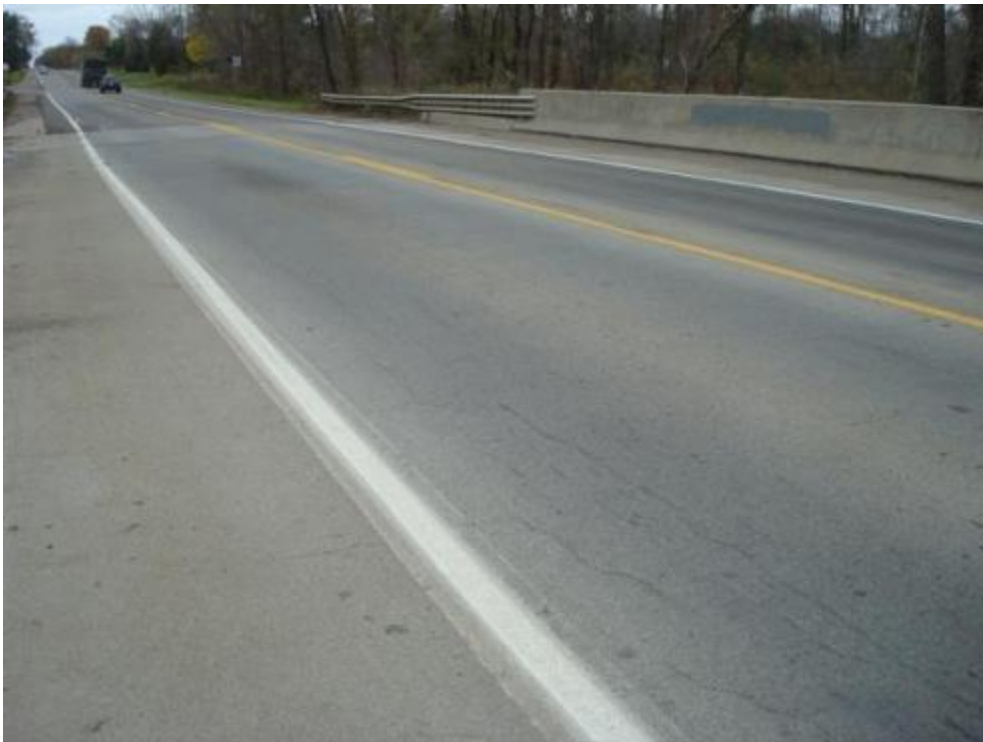
Figure 16. Longitudinal cracks

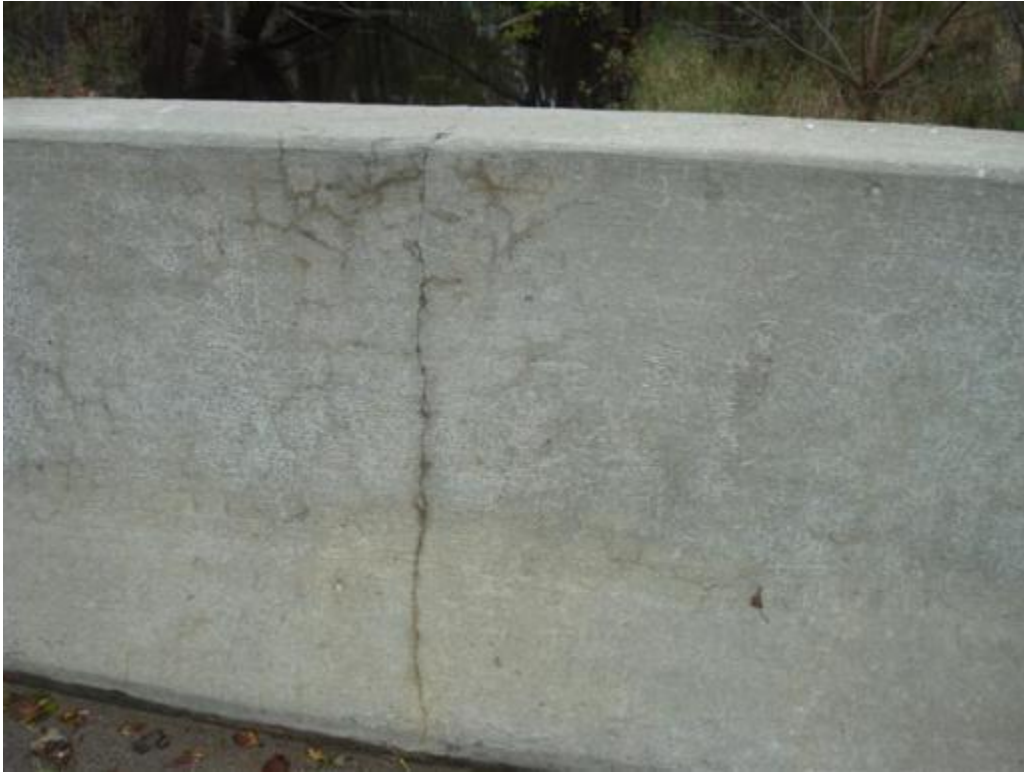
Figure 17. Large crack in barrier wall

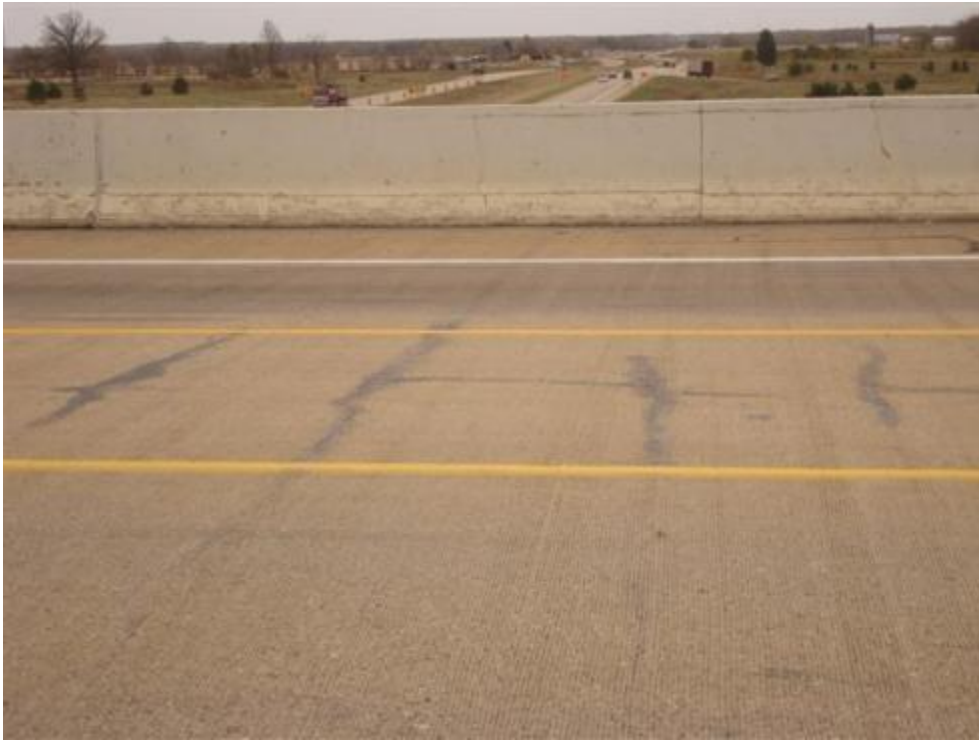
Figure 26. Transverse cracks in deck surface

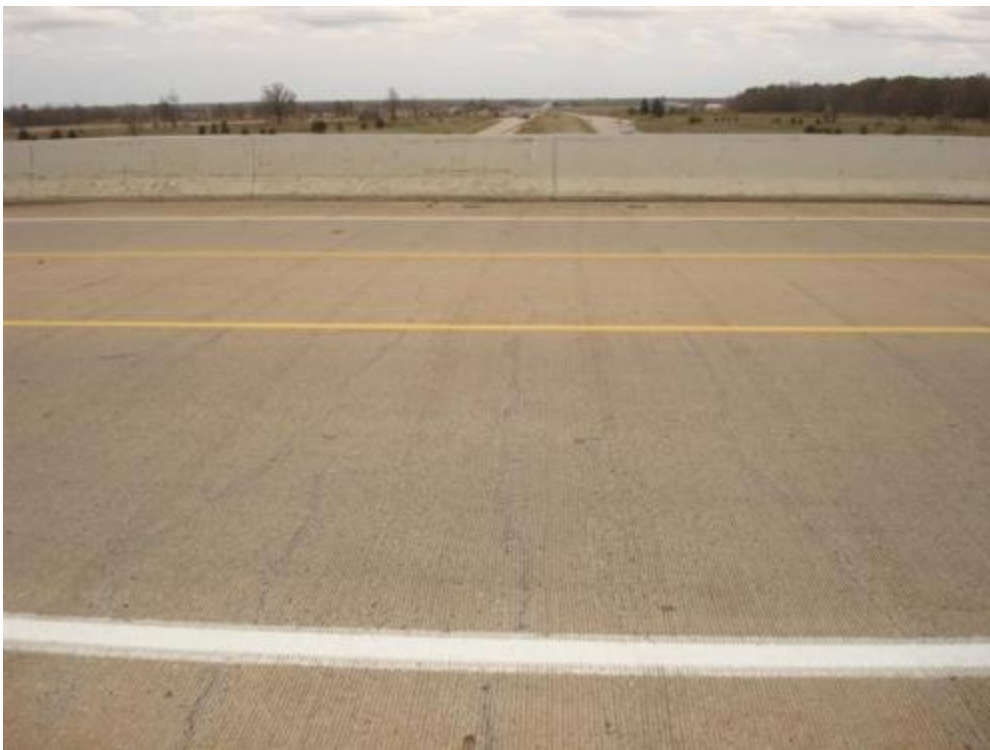
Figure 27. Transverse cracking in deck

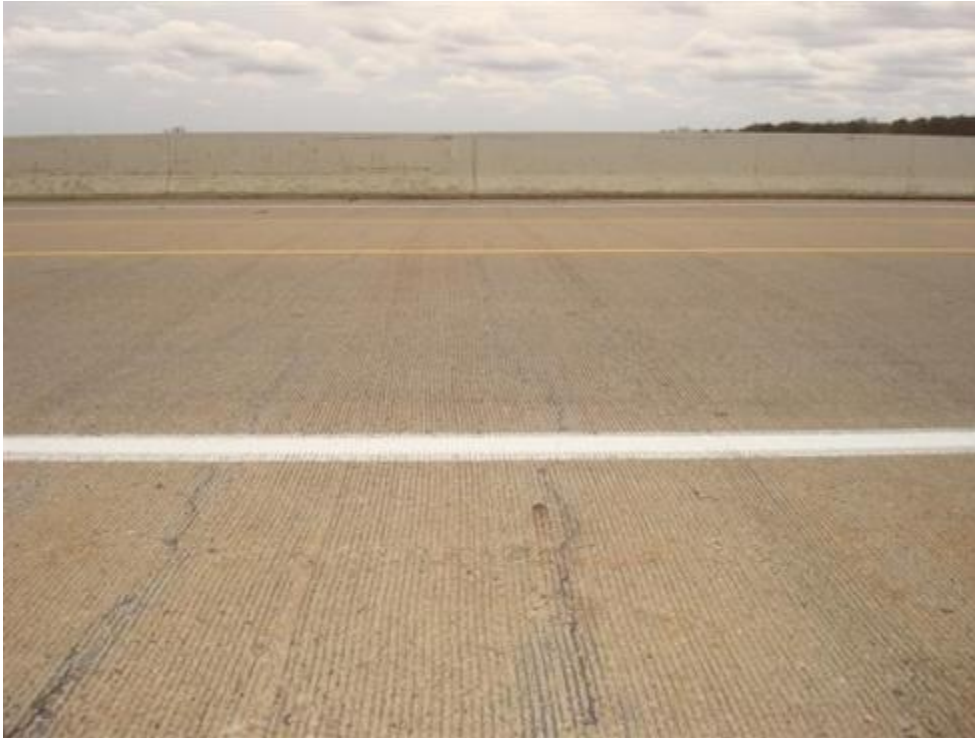
Figure 28. Transverse cracks in deck

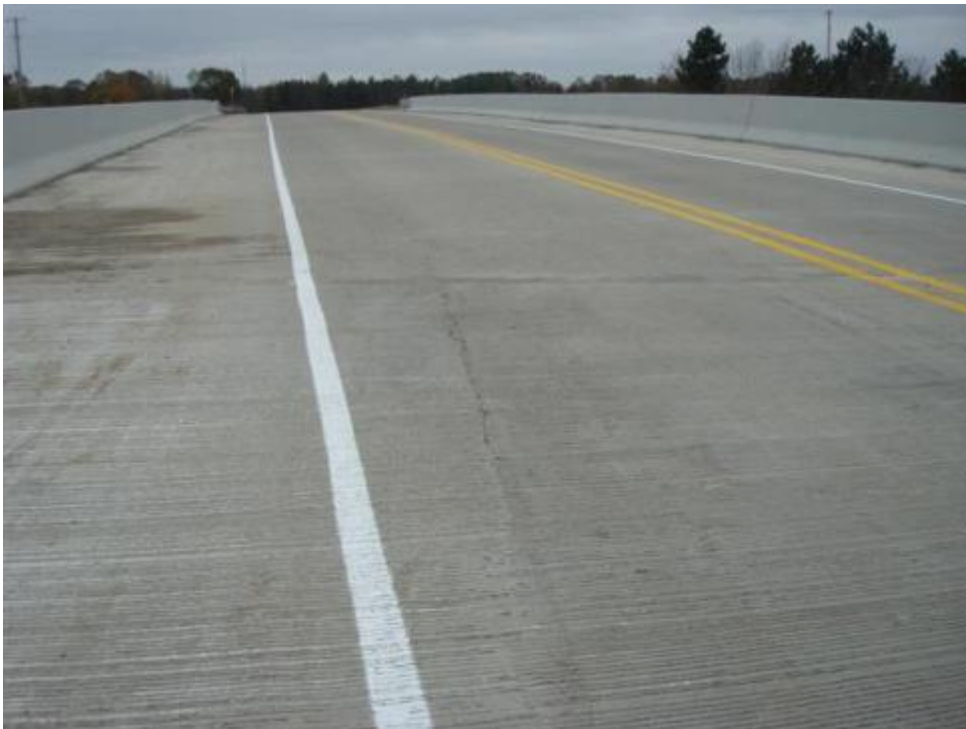
Figure 37. Longitudinal cracking in bridge surface

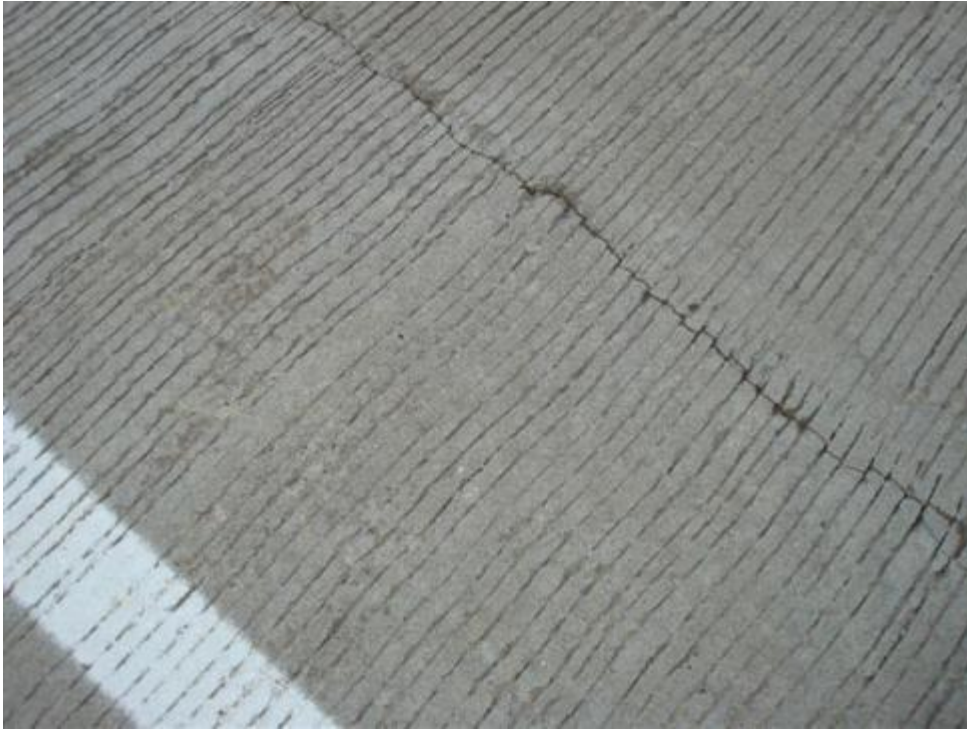
Figure 38. Close-up of longitudinal crack

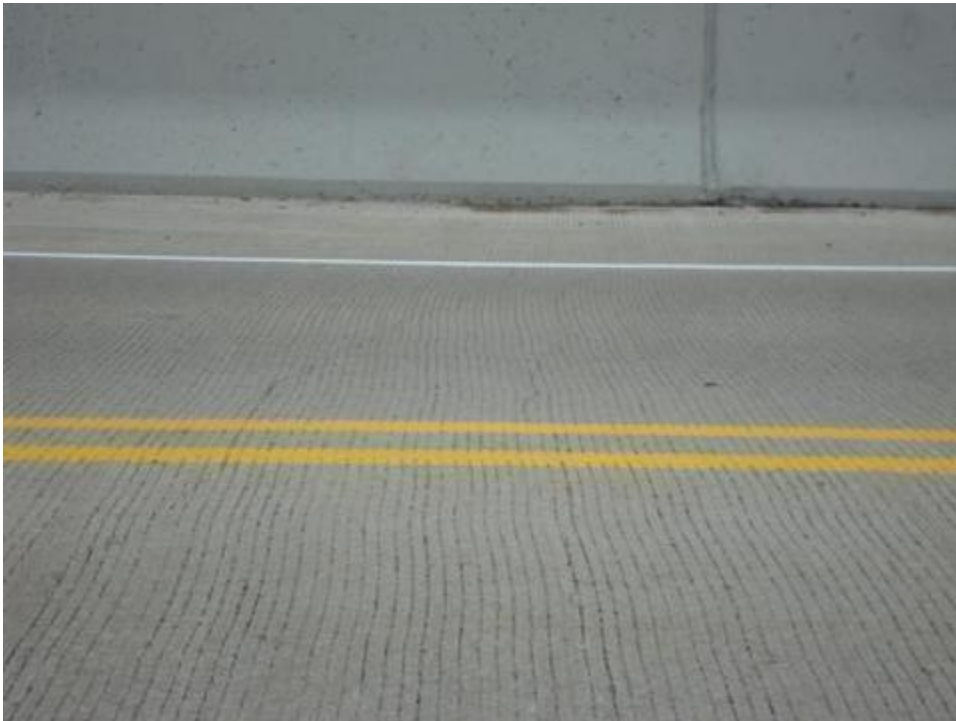
Figure 39. Transverse cracking in pier area

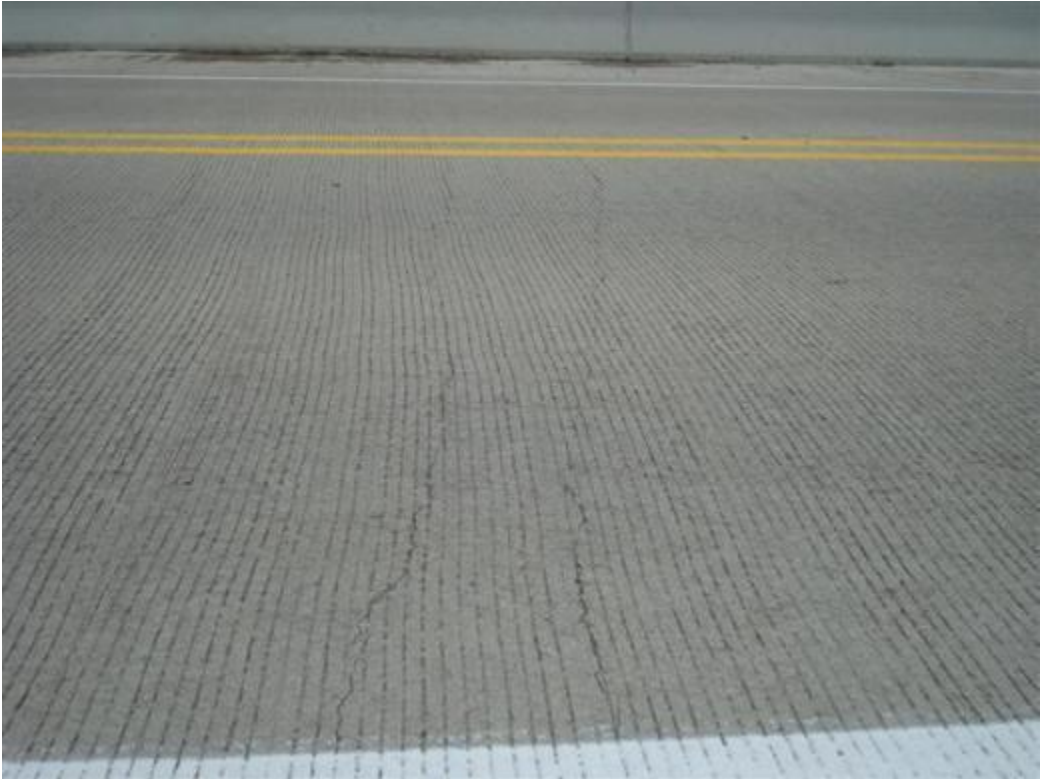
Figure 41. Transverse cracking in pier area

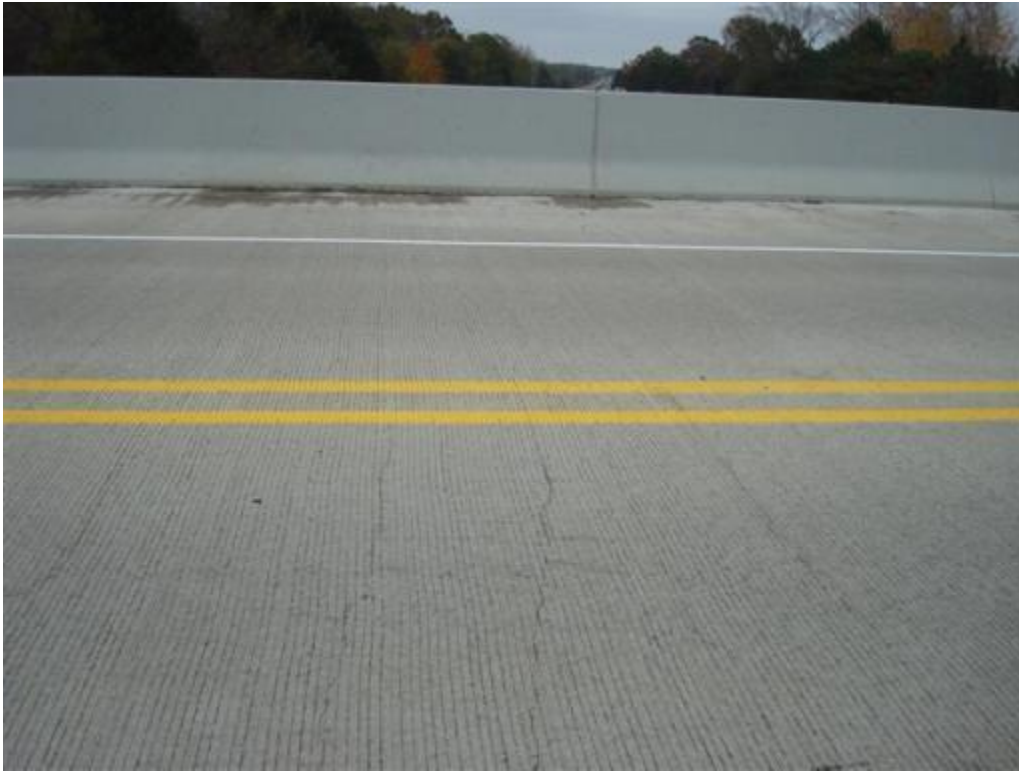
Figure 42. Transverse cracking in pier area

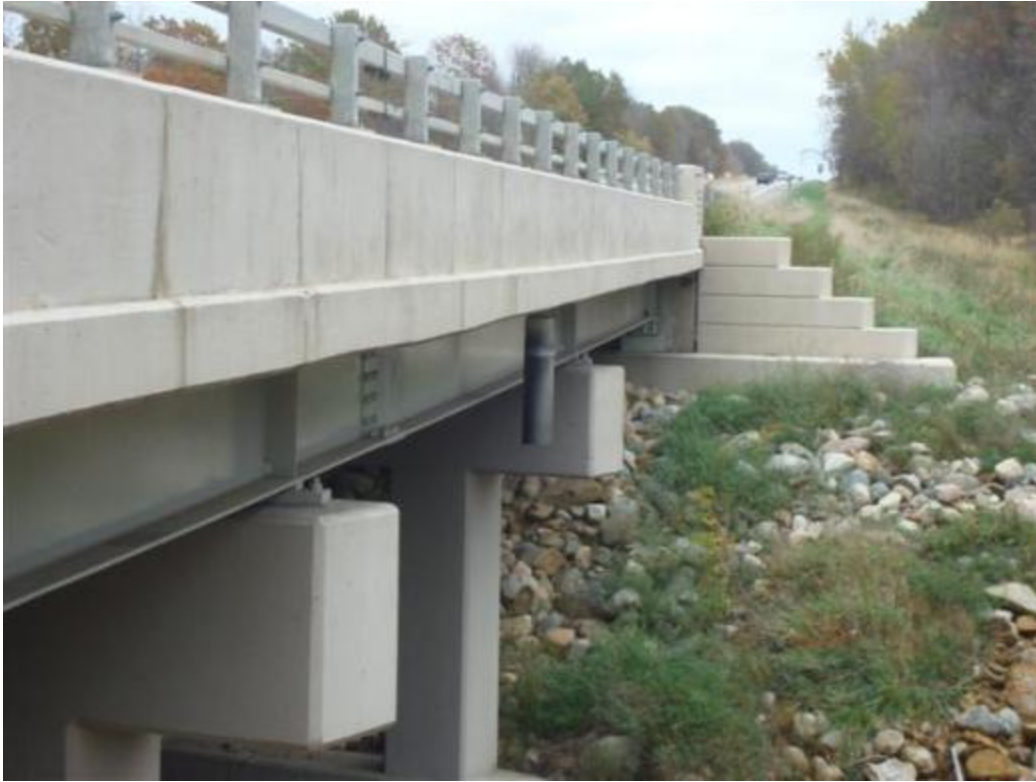
Figure 47. Cracking in barrier wall and deck fascia

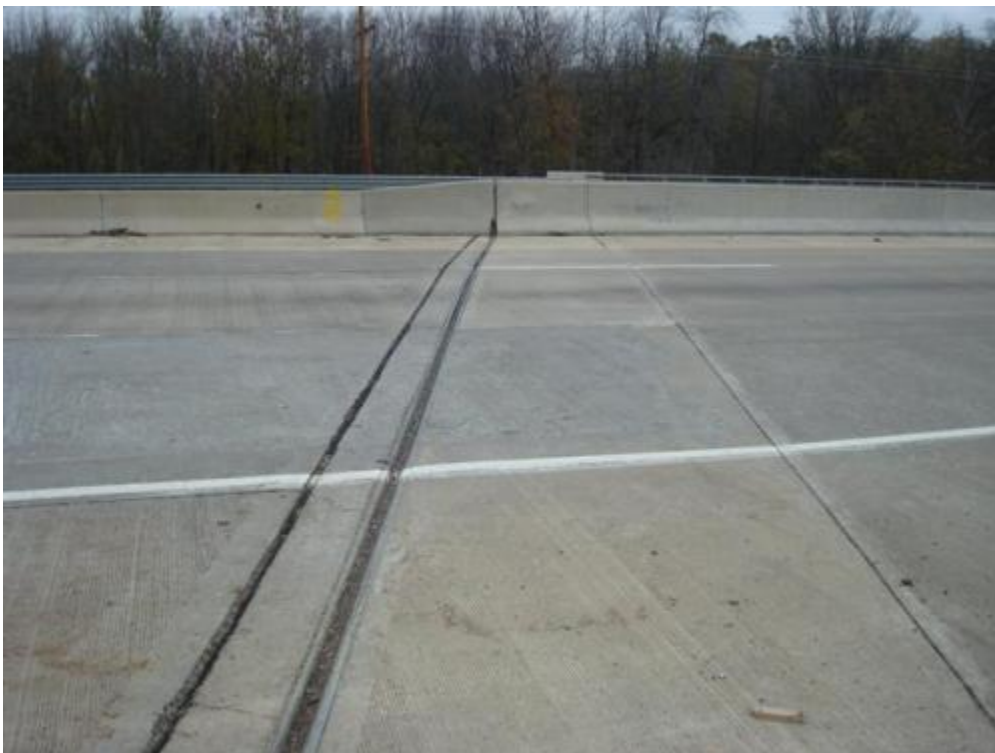
Figure 48. Bridge expansion joint and approach slab (some cracking in approach)

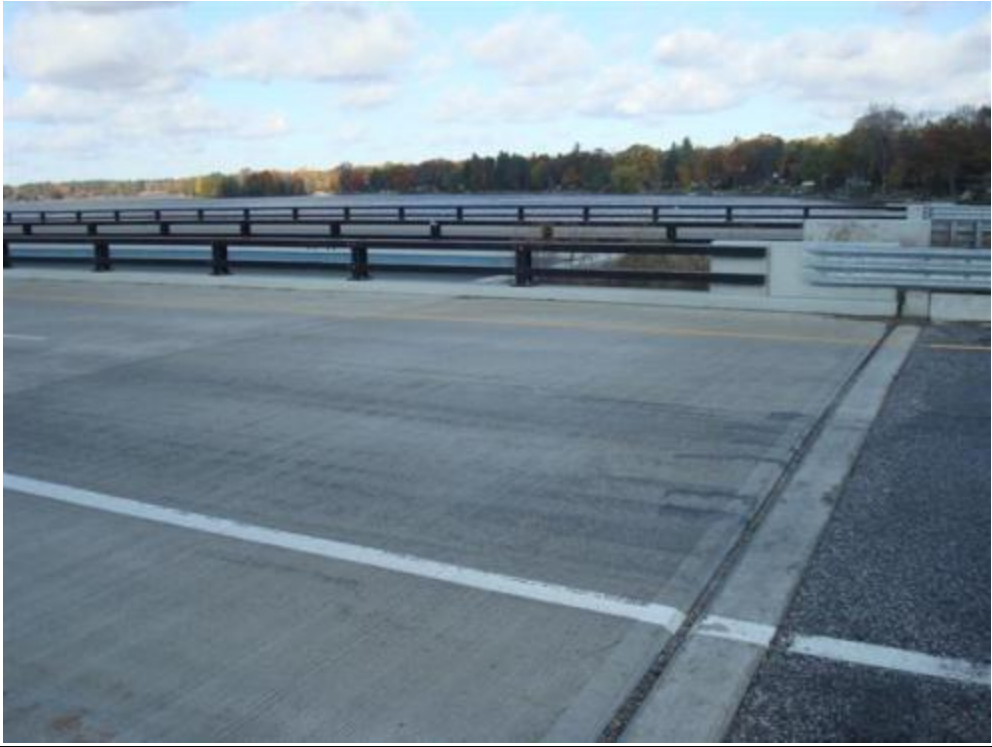
Figure 54. Deck approach slab and expansion joint (some longitudinal cracking)

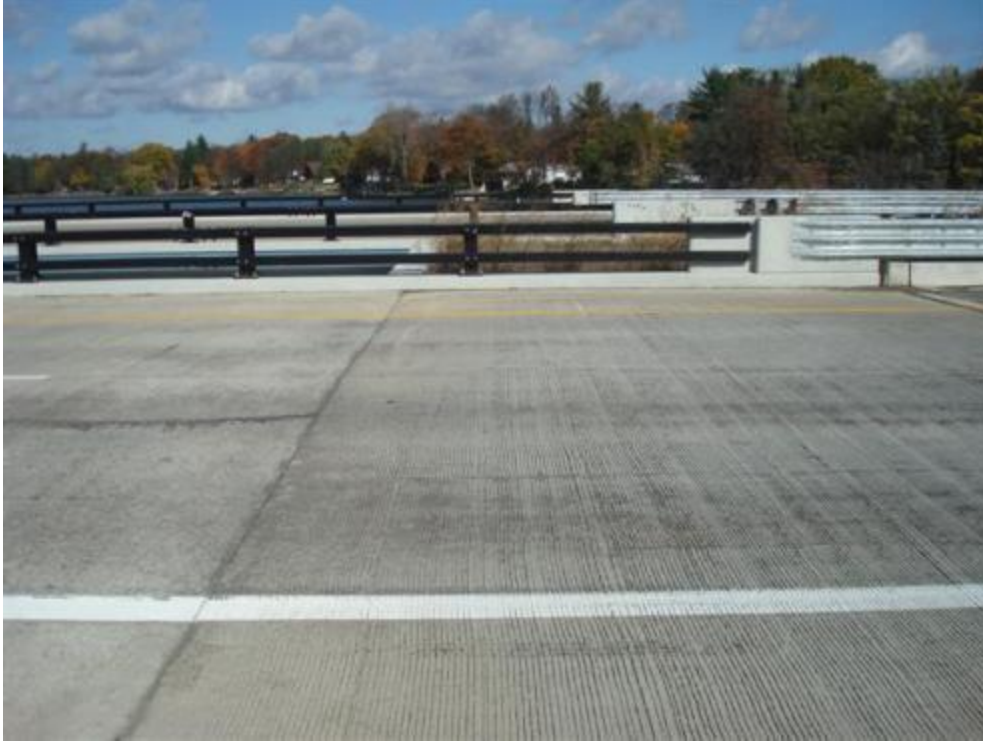
Figure 56. Longitudinal cracking in bridge deck

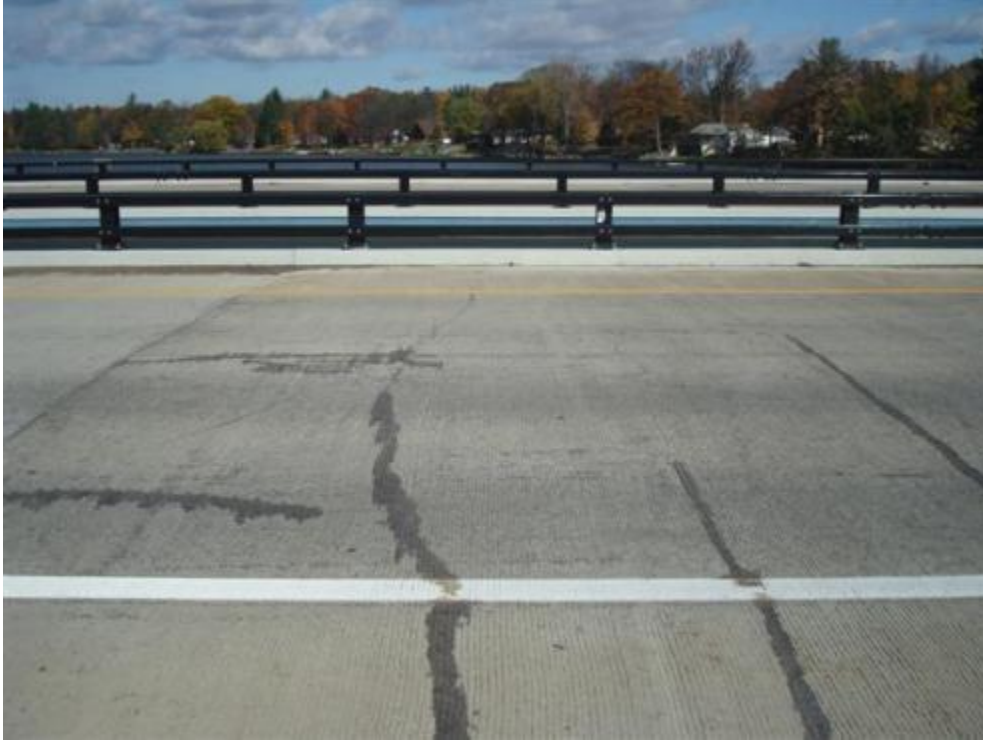
Figure 57. Transverse cracking near the first pier

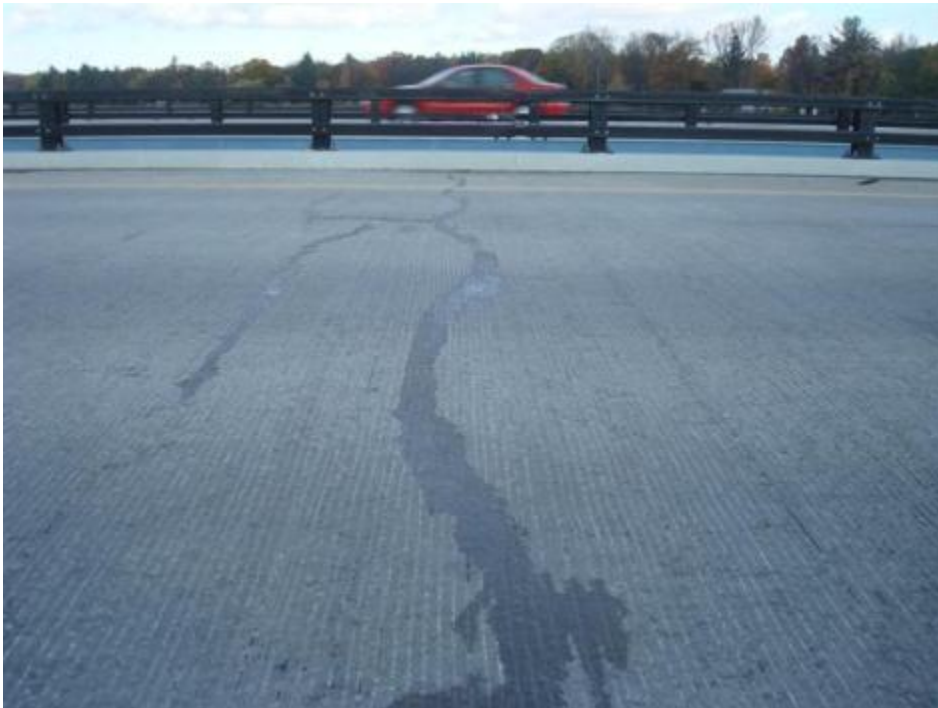
Figure 58. Transverse cracking close-up

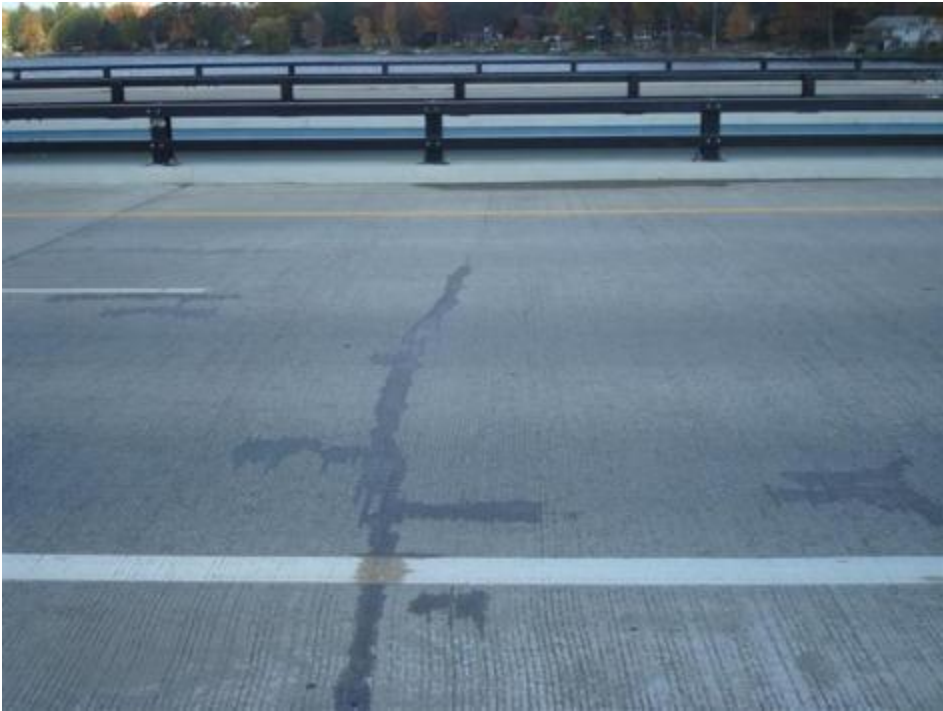
Figure 59. Additional transverse cracking at pier 2, as well as some longitudinal cracking

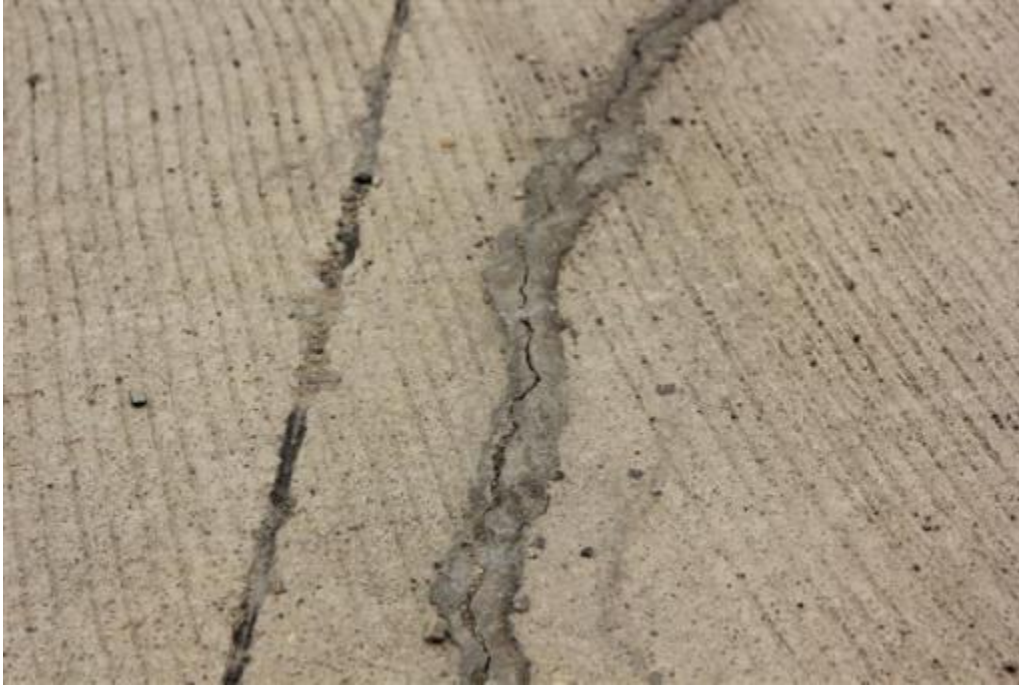
Figure 66. Close-up of transverse crack (note how it cracked through the repair)

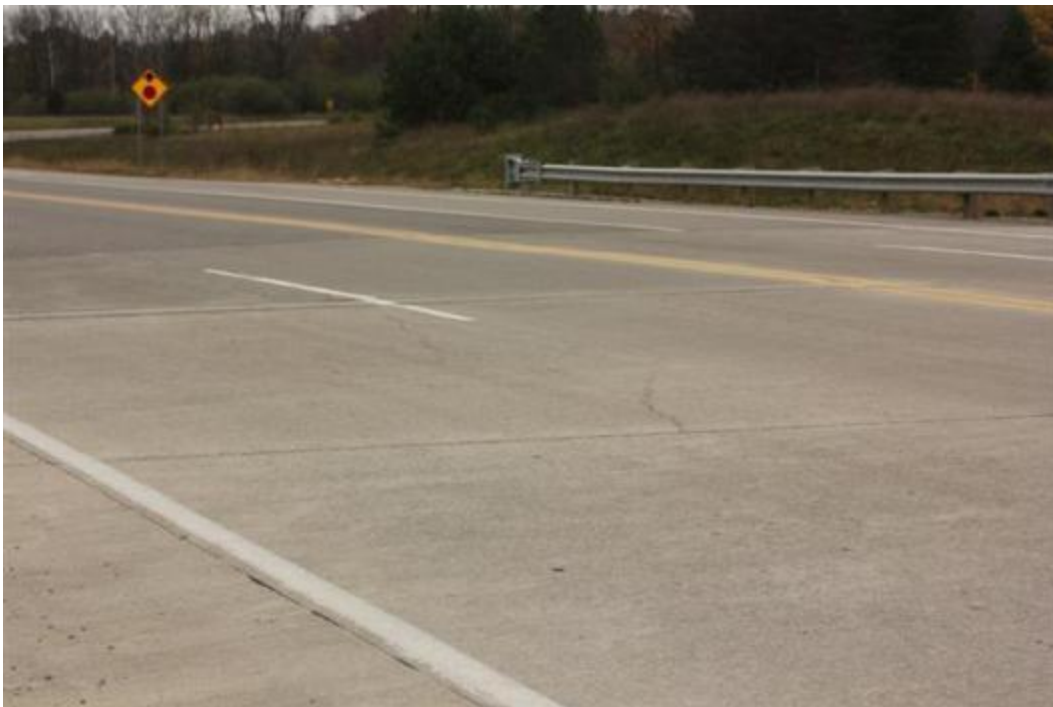
Figure 67. Longitudinal cracks in the deck

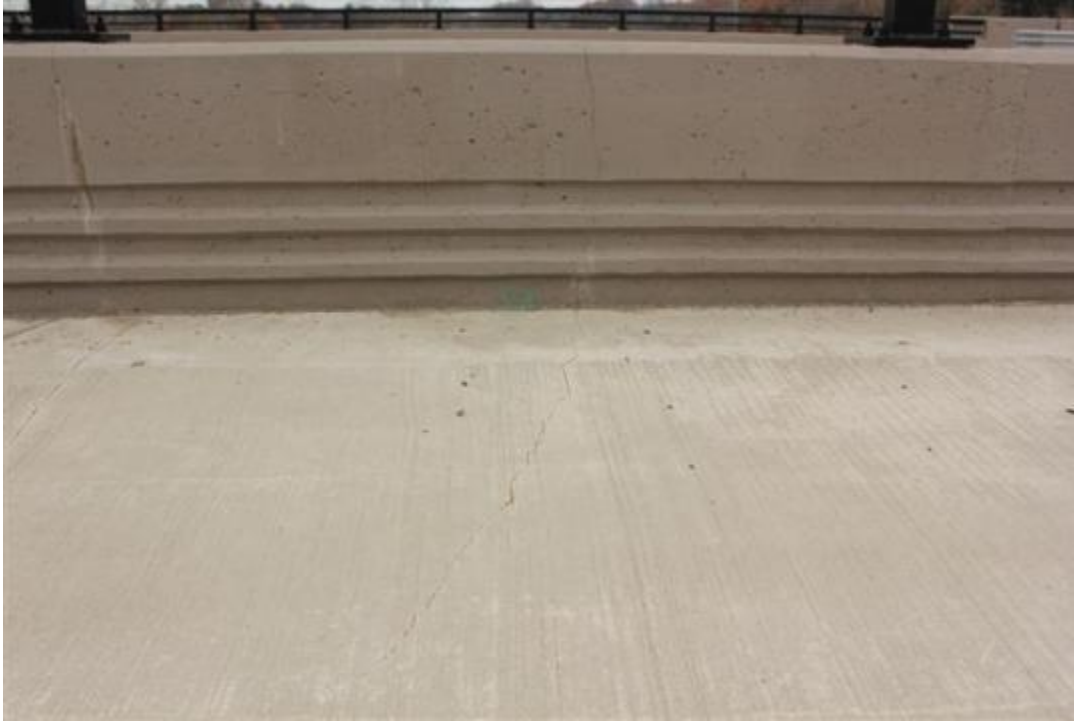
Figure 68. Transverse/vertical cracking in sidewalk and barrier wall

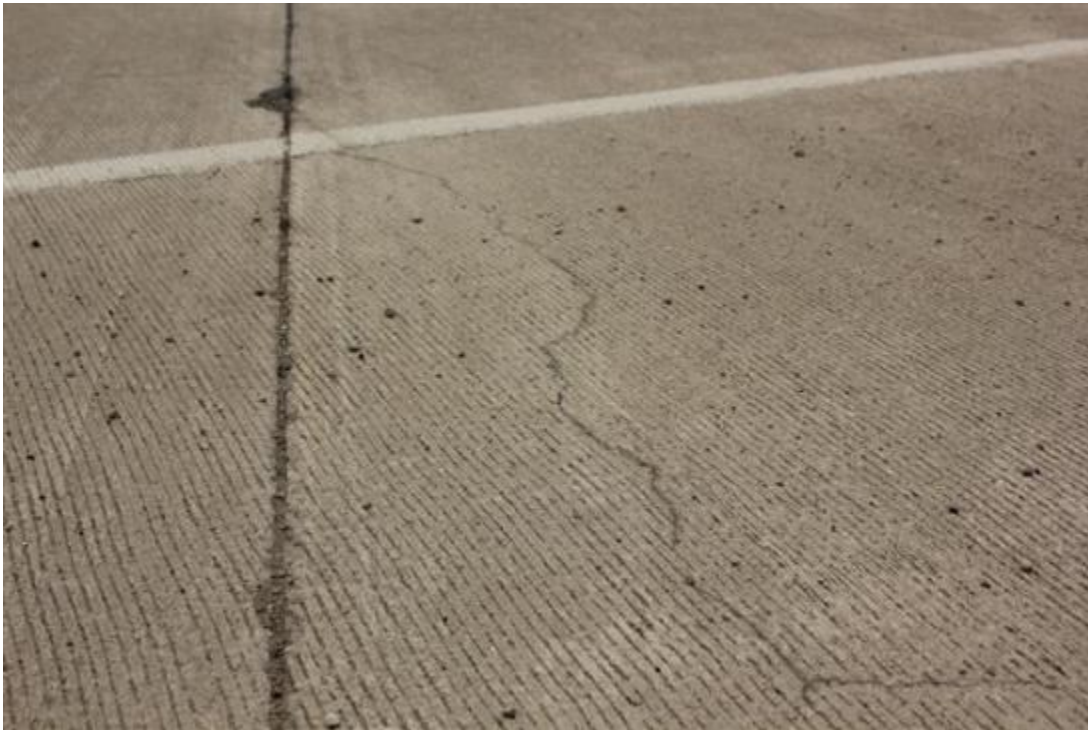
Figure 69. Transverse cracking by construction joint

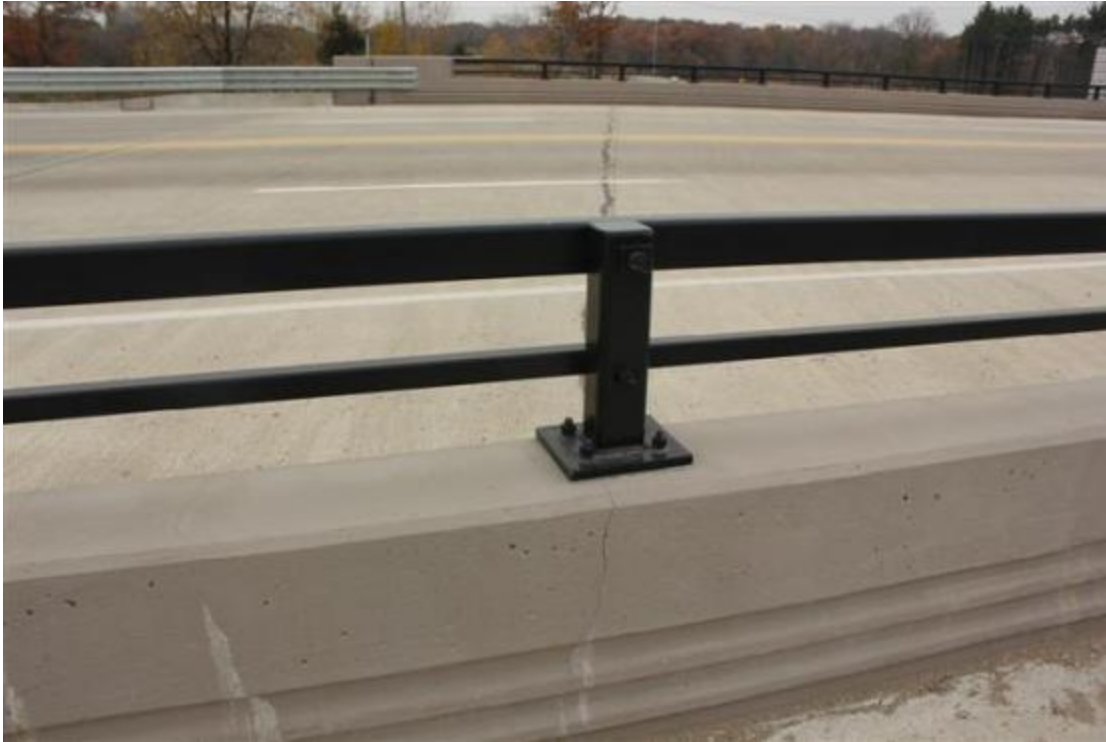
Figure 70. Transverse cracking in barrier continuing to deck surface

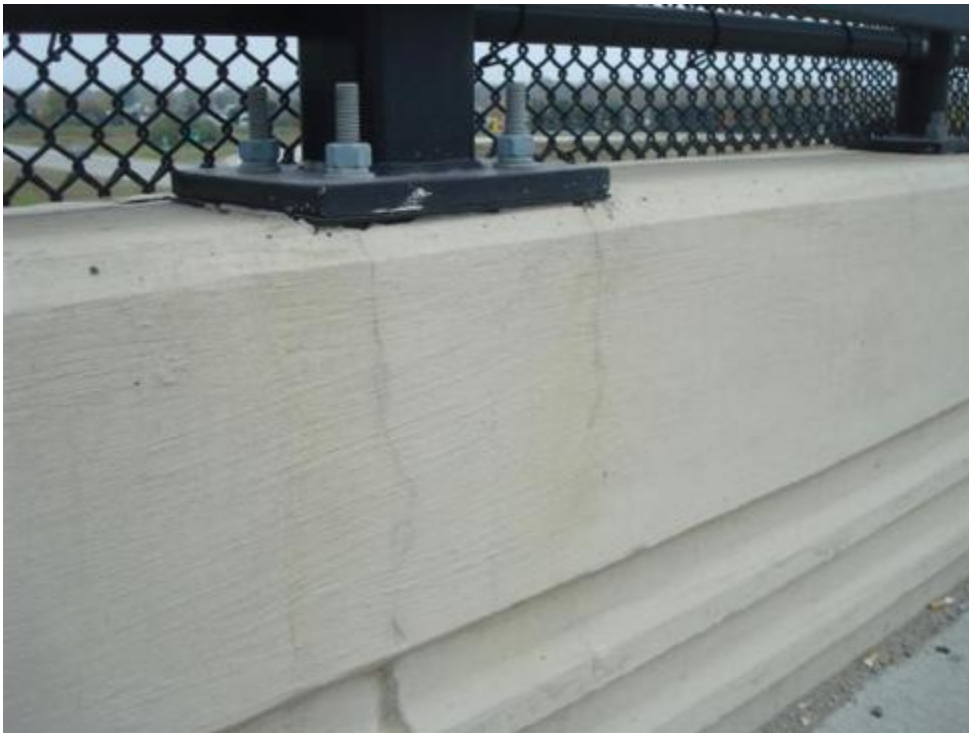
Figure 76. Cracking in barrier, at railing connection (typical)

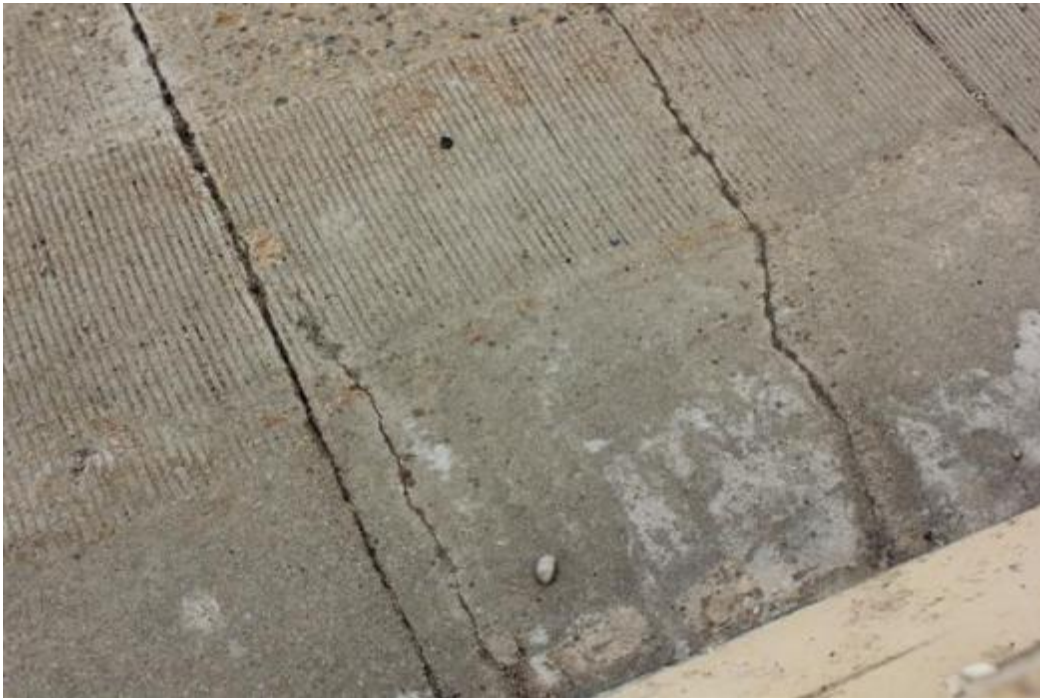
Figure 100. Close-up of transverse cracks

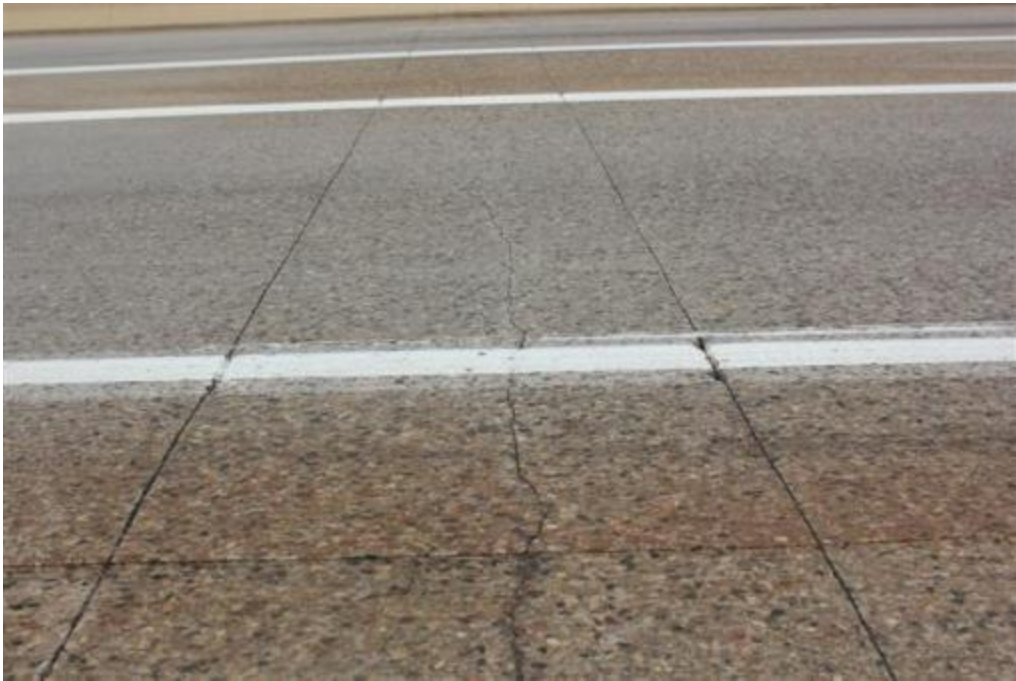
Figure 104. Transverse cracking in bridge deck
