REPORT APPENDIX

IDENTIFICATION OF CAUSES AND SOLUTION STRATEGIES FOR DECK CRACKING IN JOINTLESS BRIDGES

Appendix to Report No. CEE-RR – 2012/04

Research Report for MDOT under Contract No. 2009-0746/Z1
SPR No. 108522

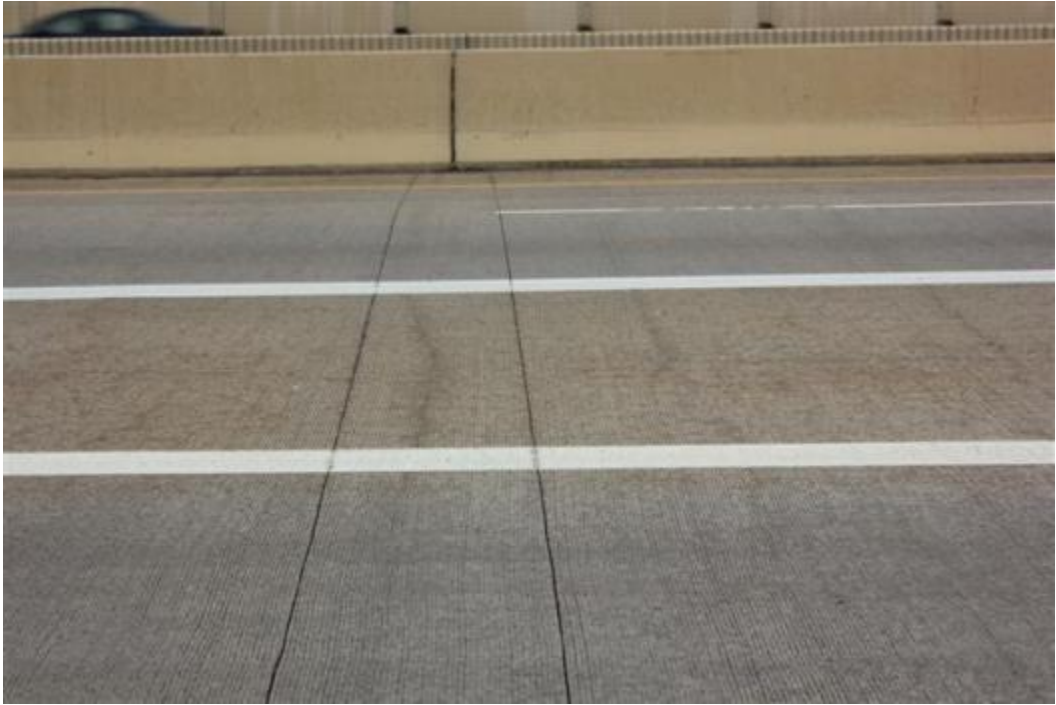
Figure 105. Extensive and evenly-spaced transverse cracks

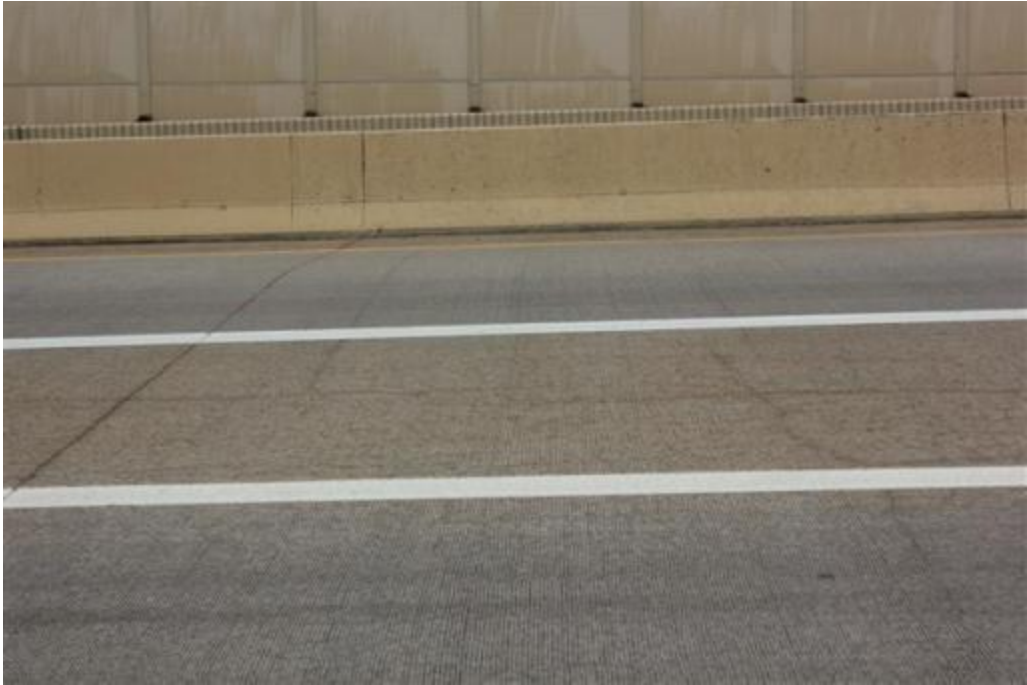
Figure 106. More transverse cracks in bridge deck

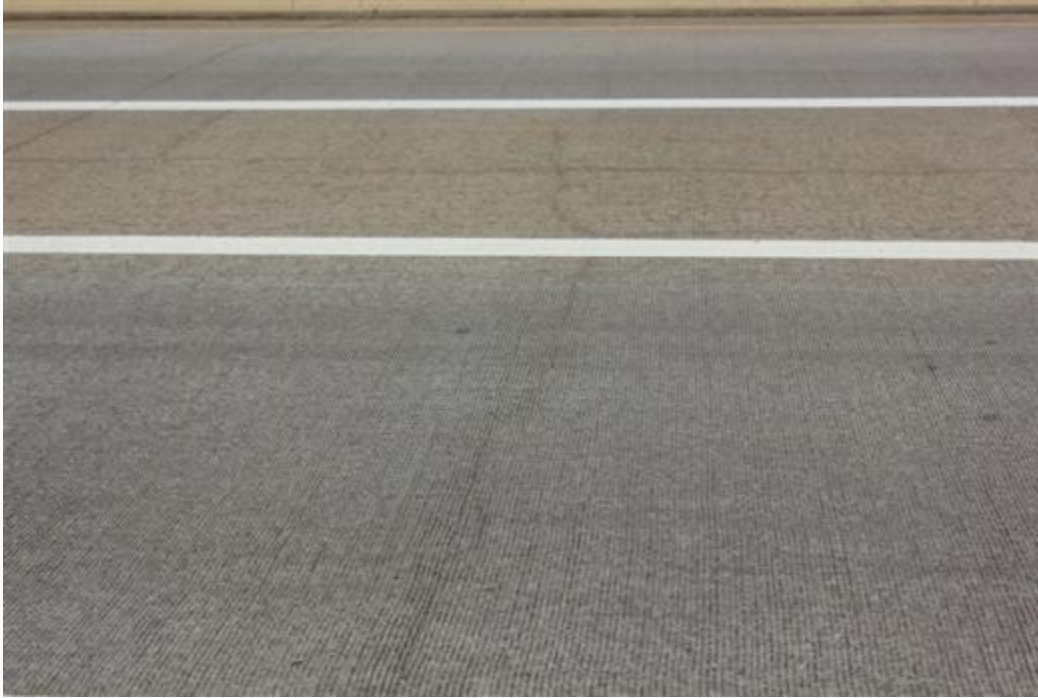
Figure 107. Transverse cracking in bridge deck

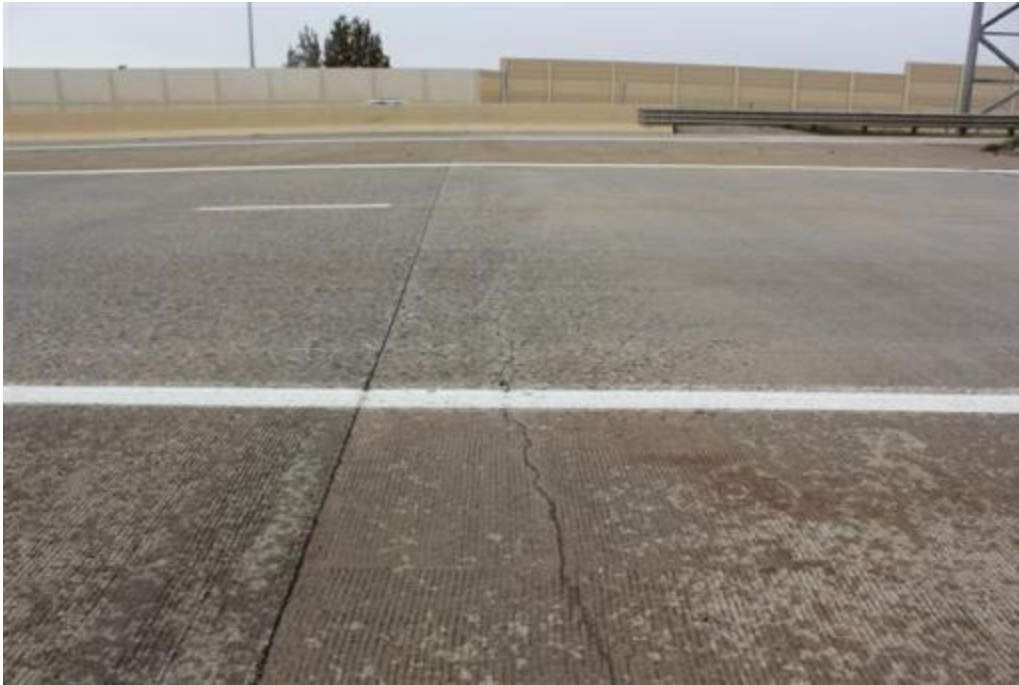
Figure 108. Large transverse crack at opposite abutment

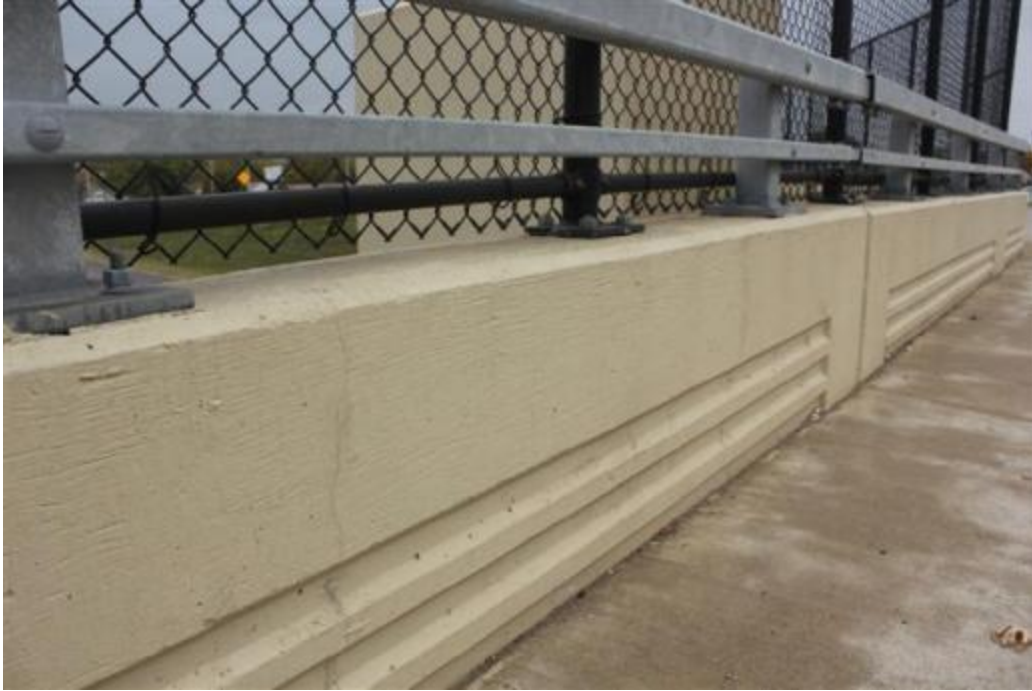
Figure 110. Cracking in barrier wall

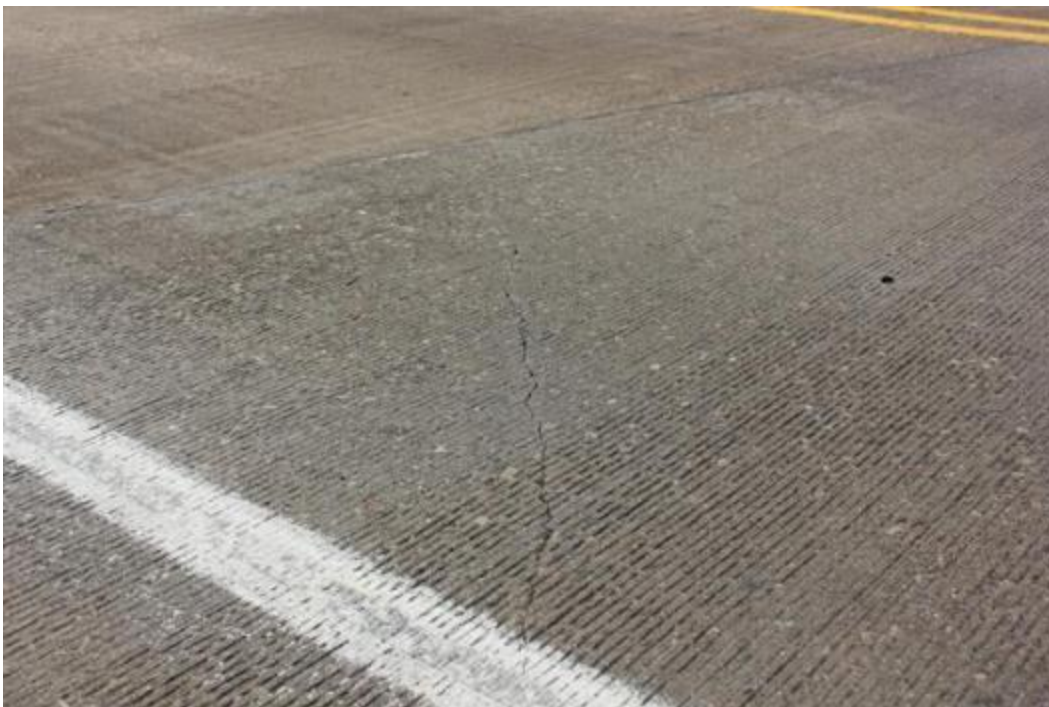
Figure 119. Diagonal cracking near the abutment

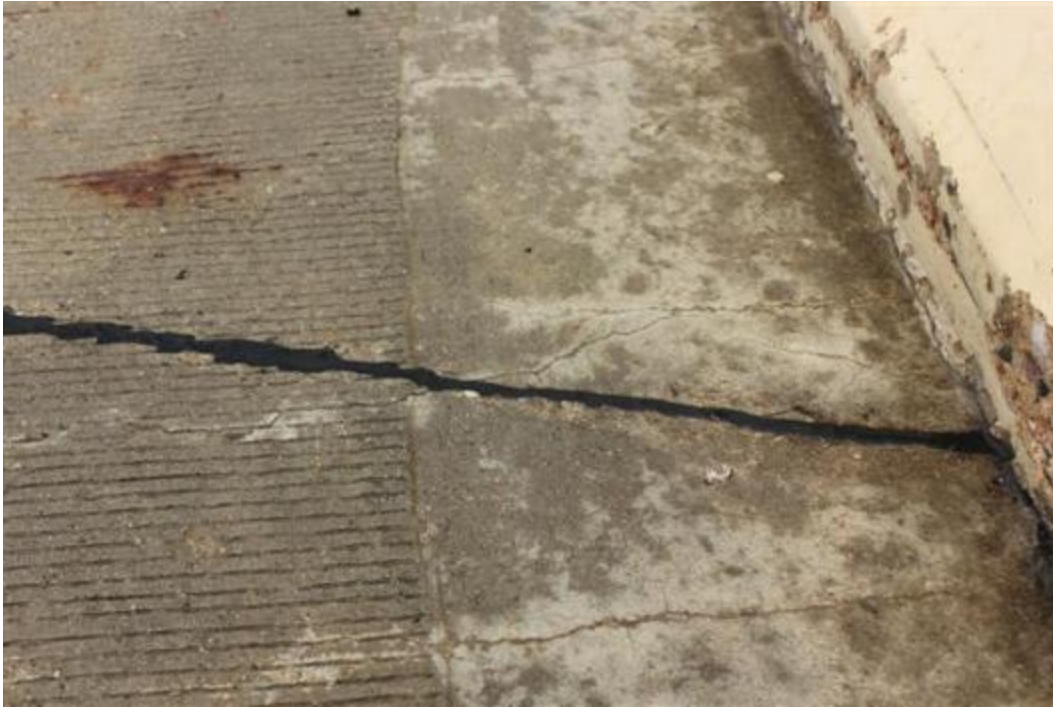
Figure 120. Transverse cracking in pier area

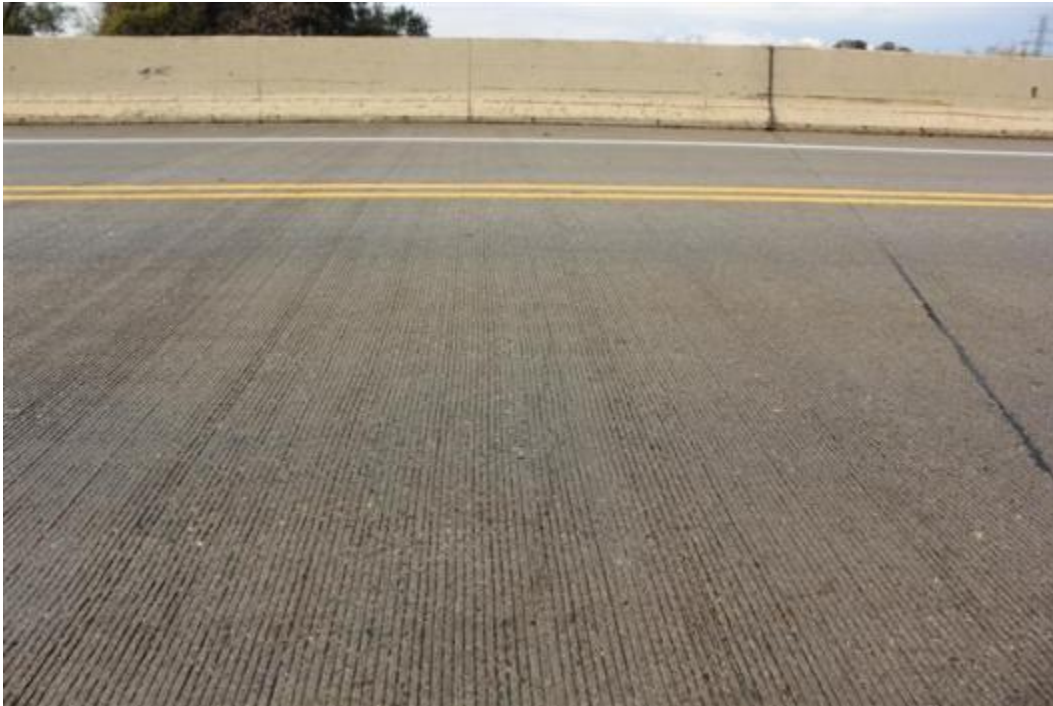
Figure 121. Transverse cracking at the pier area

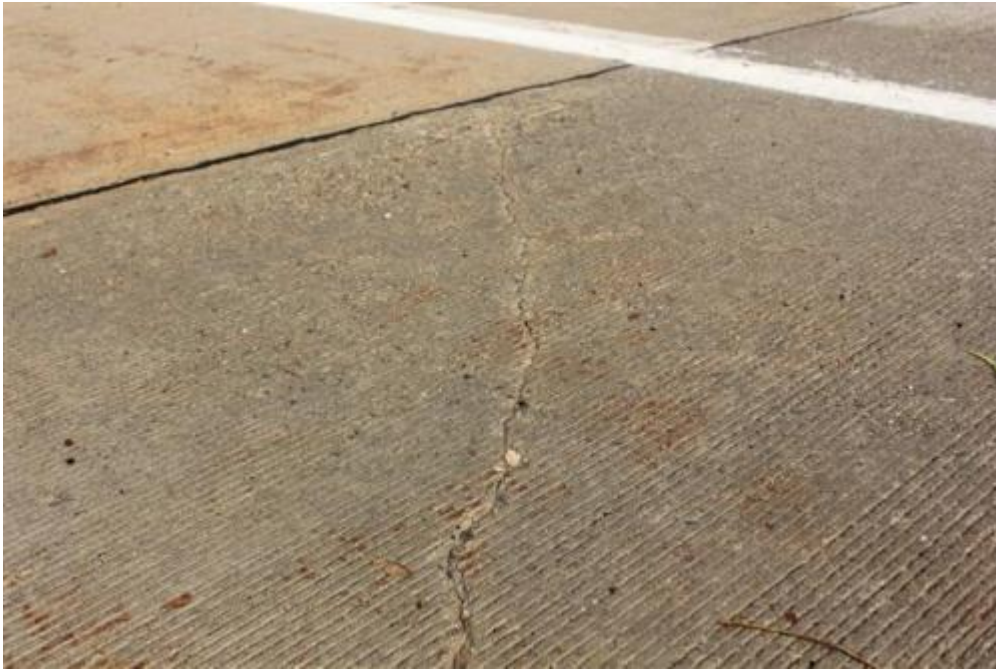
Figure 124. Diagonal cracking near the abutment

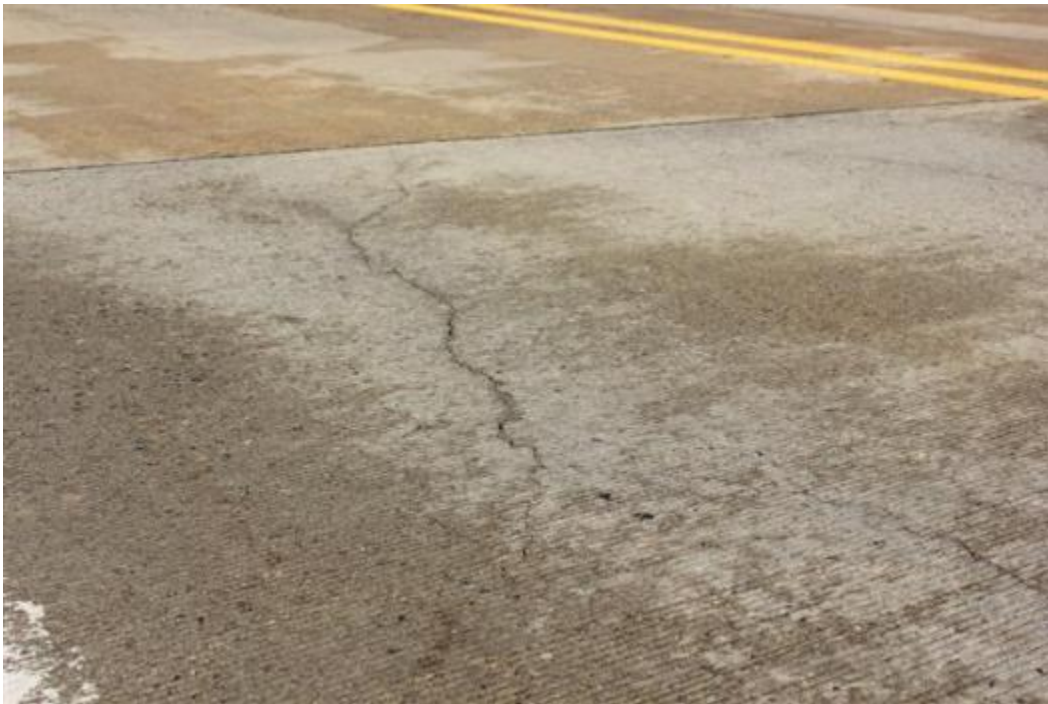
Figure 125. Longitudinal cracking

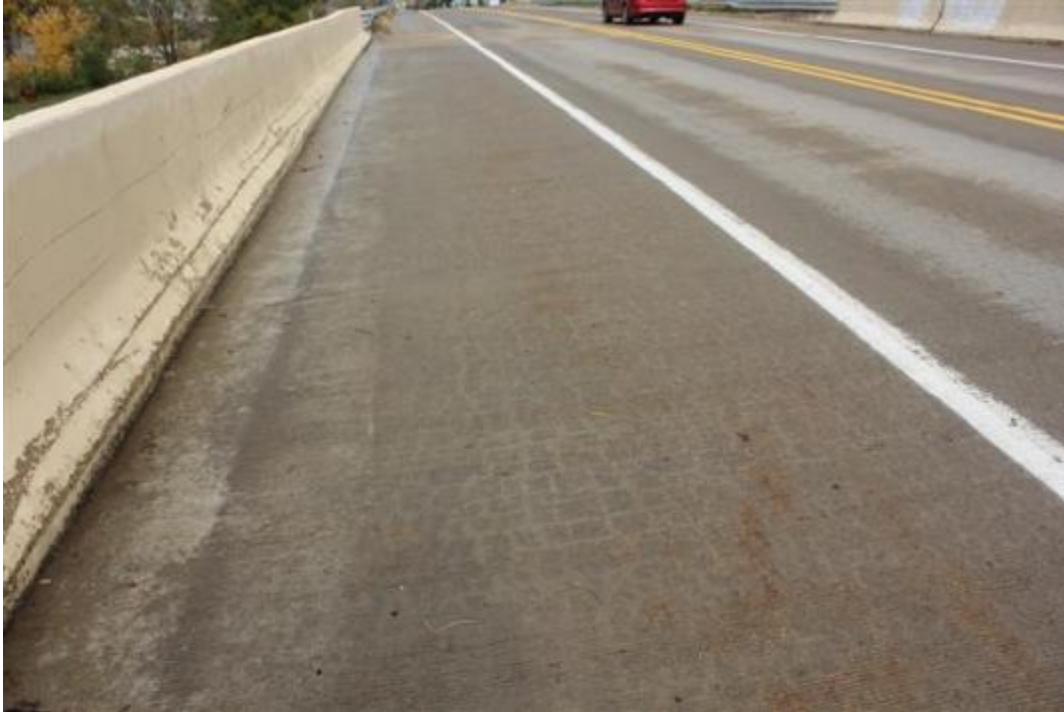
Figure 126. Random/map cracking on the shoulder

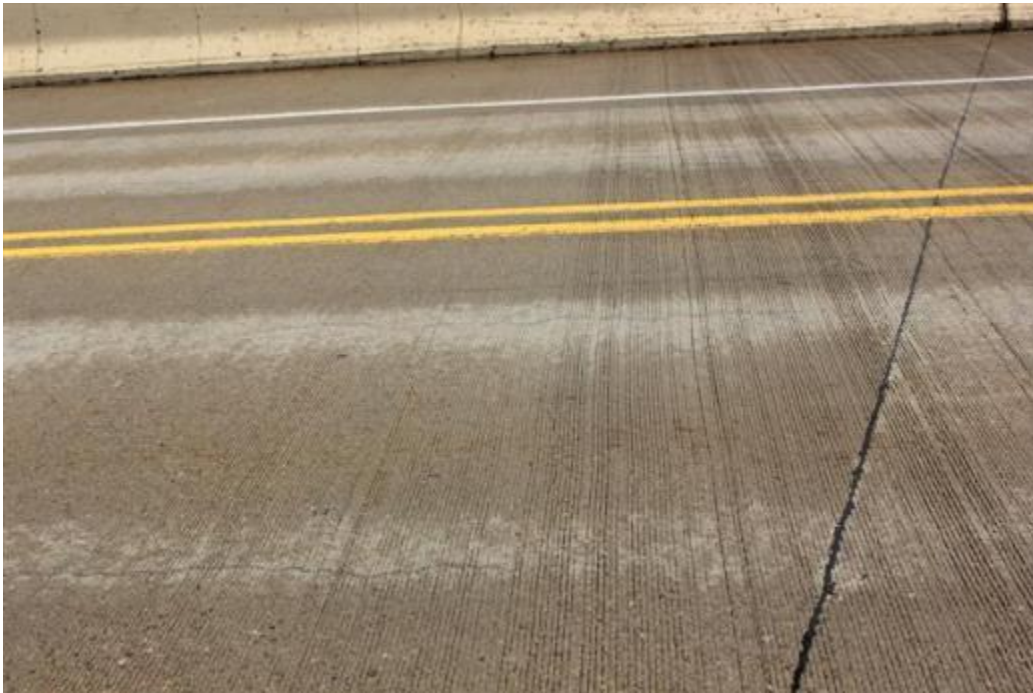
Figure 127. Evenly-spaced longitudinal cracks

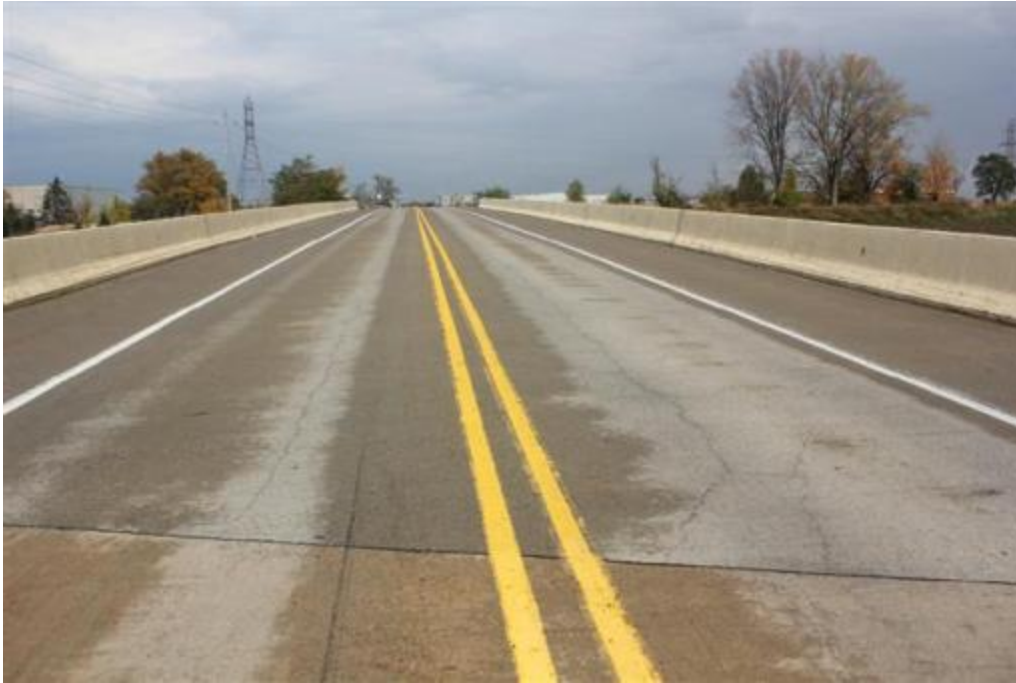
Figure 128. Longitudinal cracks running through entire deck

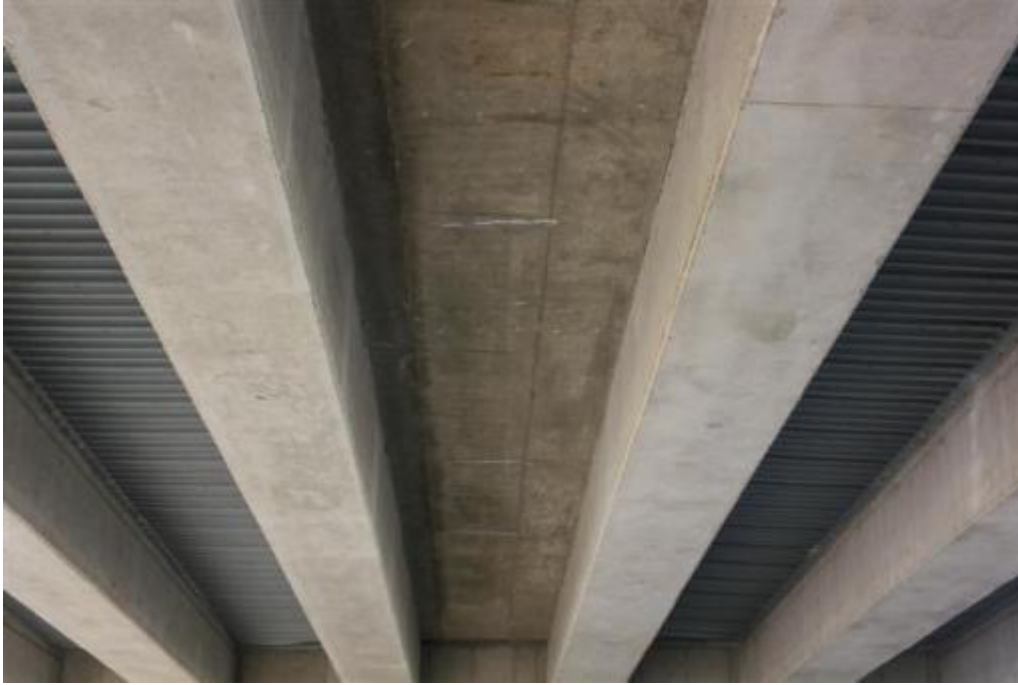
Figure 133. Transverse cracking in bridge underside

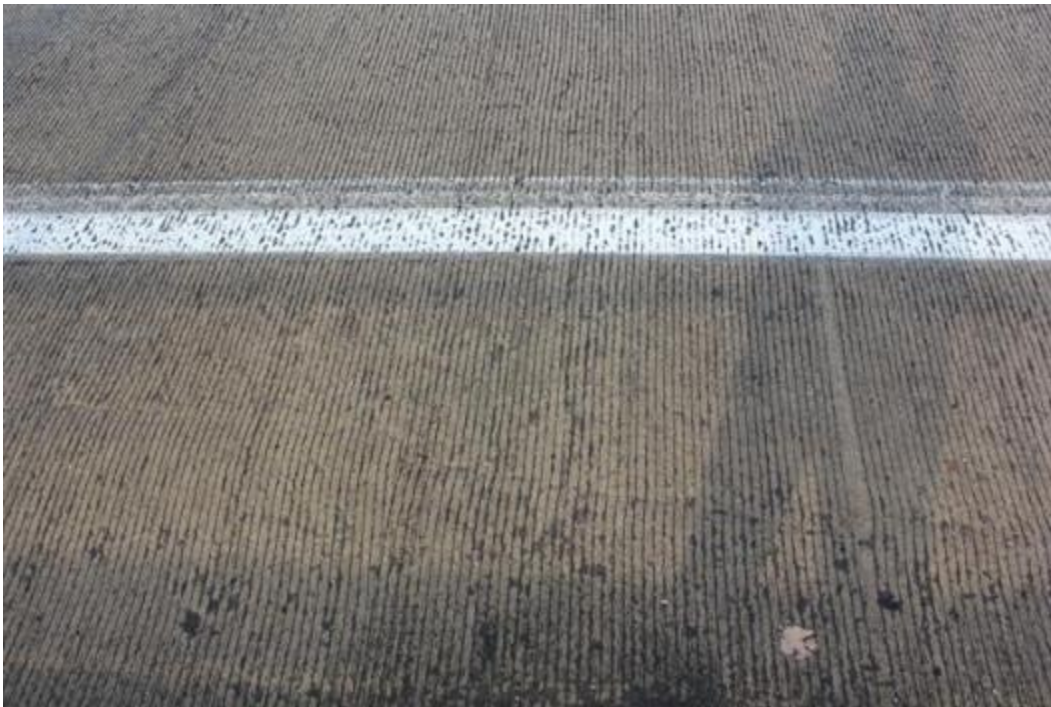
Figure 134. Transverse cracking

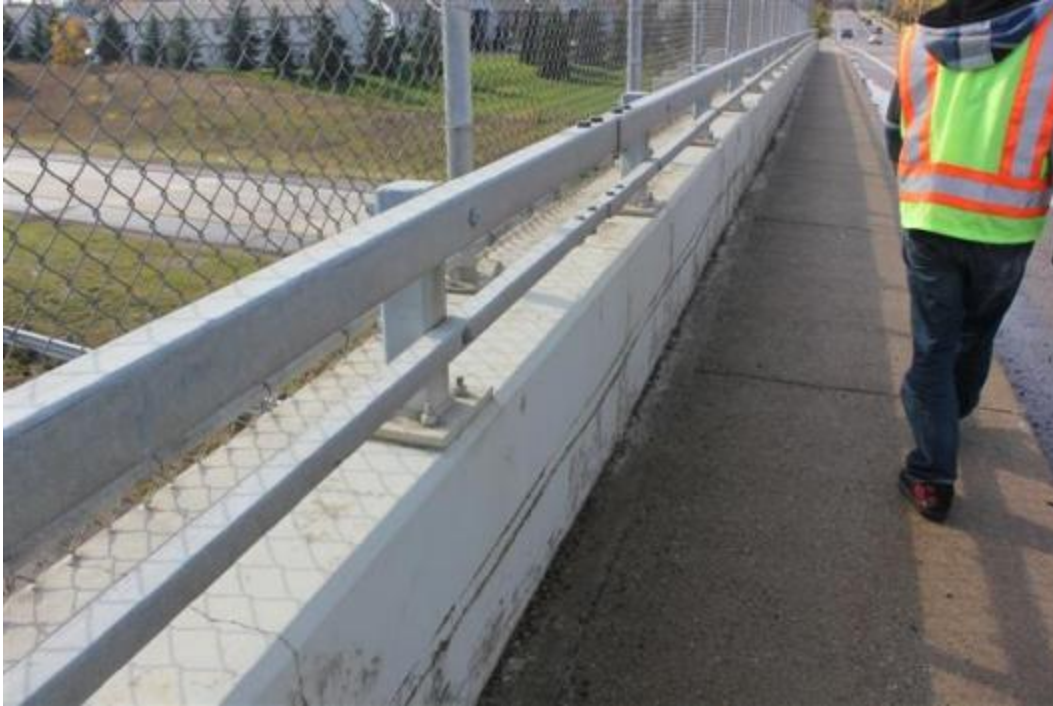
Figure 135. Cracking in barrier wall (typical)

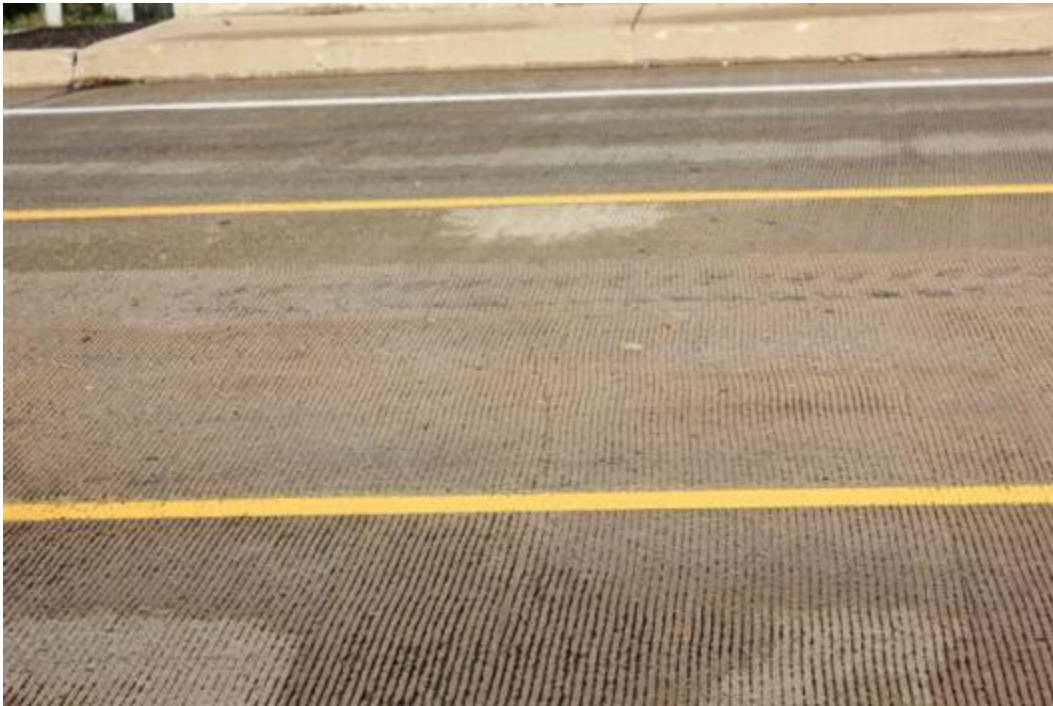
Figure 136. Transverse cracking in bridge deck

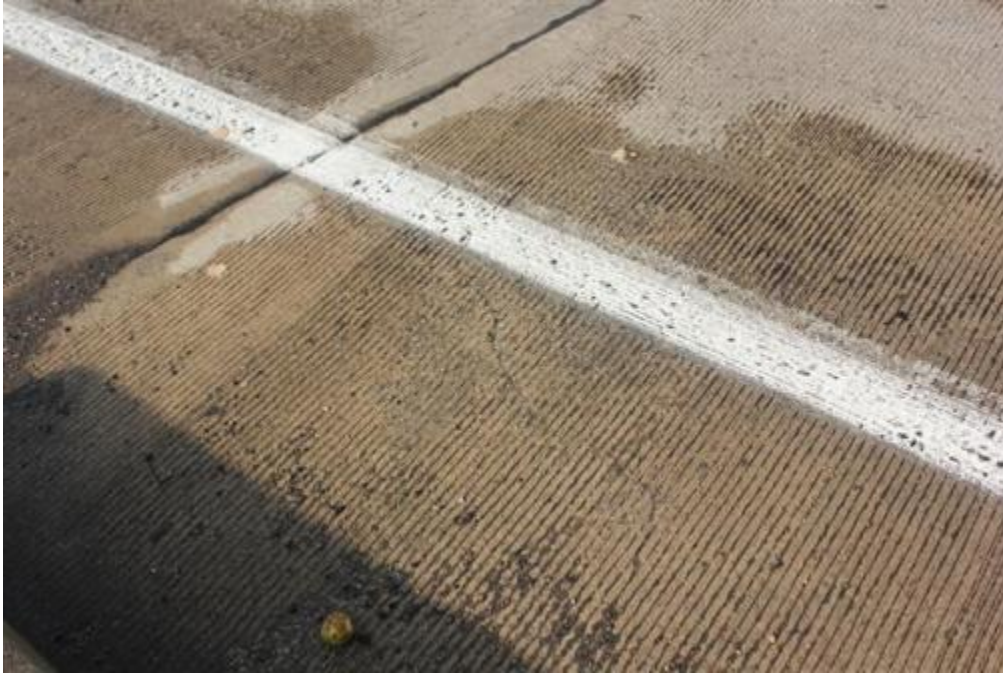
Figure 137. Longitudinal/diagonal cracking near the abutment

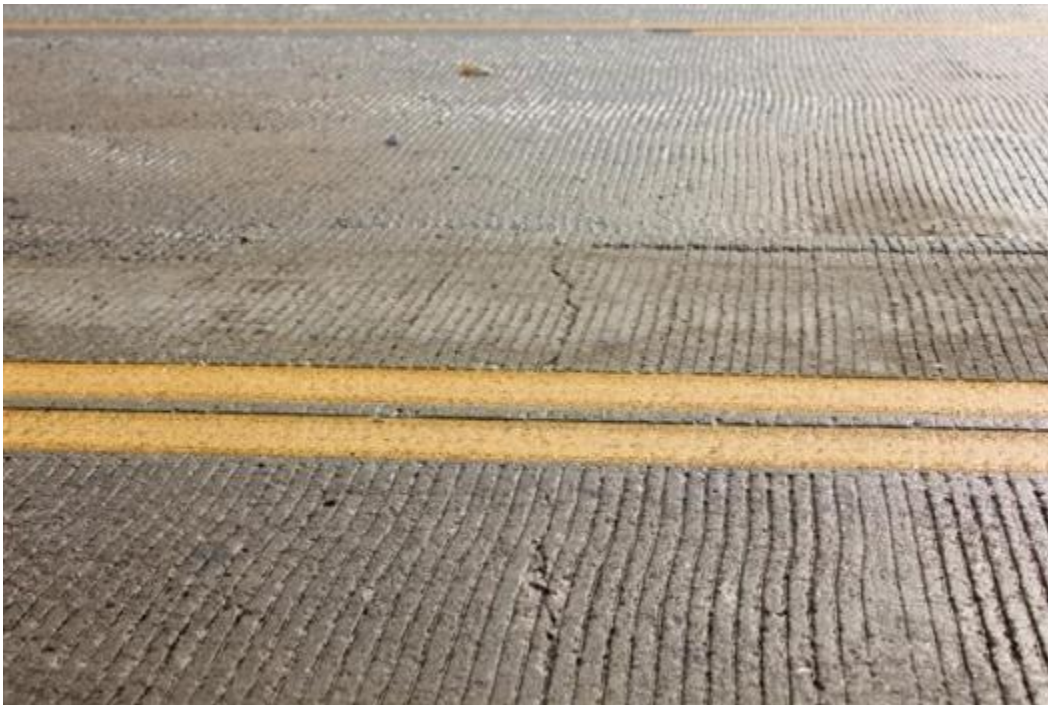
Figure 138. Transverse cracking in the middle of the bridge

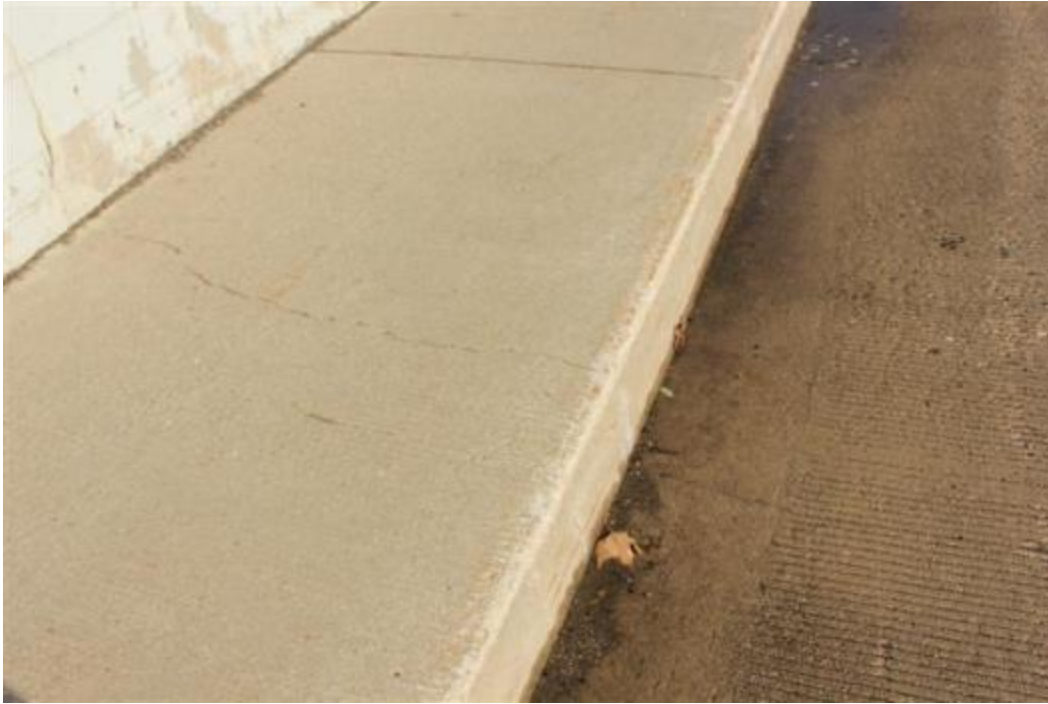
Figure 139. Transverse cracking in bridge deck and continuing into the sidewalk

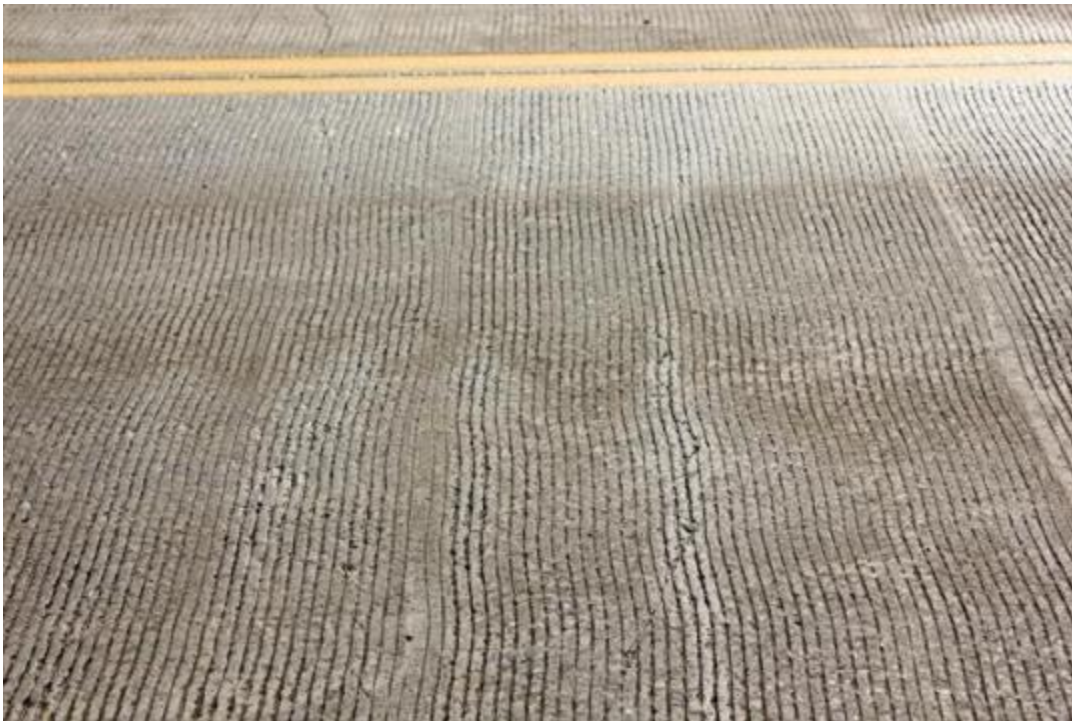
Figure 140. Evenly-spaced transverse cracks

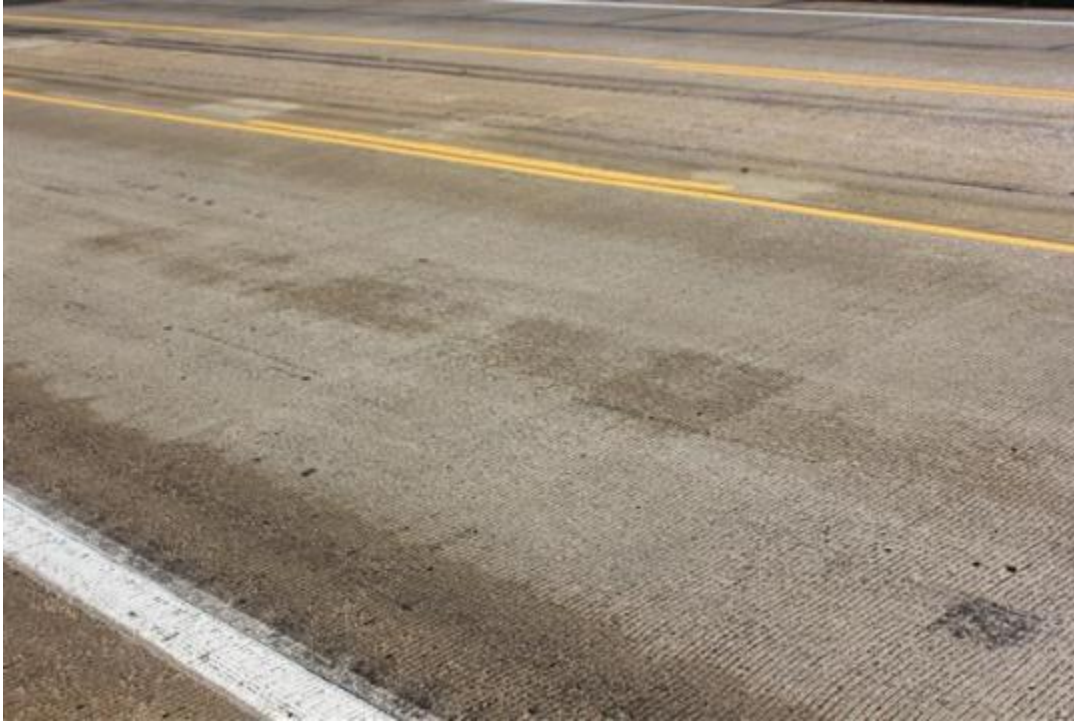
Figure 141. Random small longitudinal cracks
