FINAL REPORT

Corrosion of Spiral Rib Aluminized Pipe

Final Report to Florida Department of Transportation

August 2012

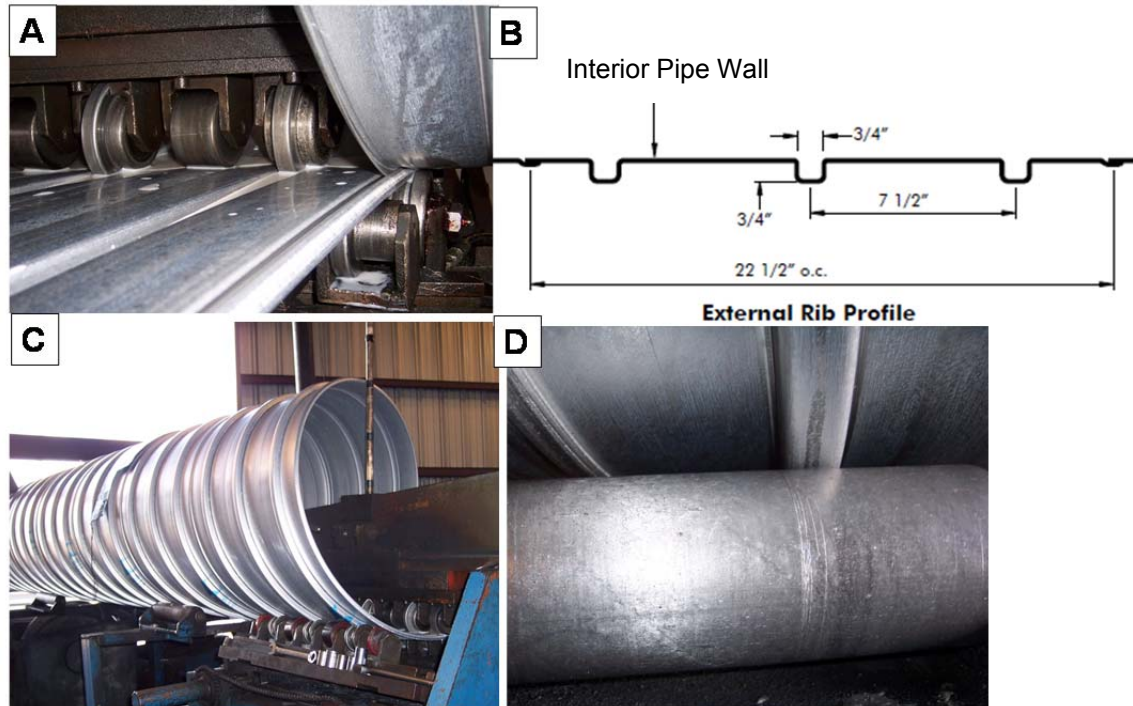
Figure 2: SRAP manufacturing process (A-C); Minor scratches during fabrication of SRAP (D). [Photographs by the Author]

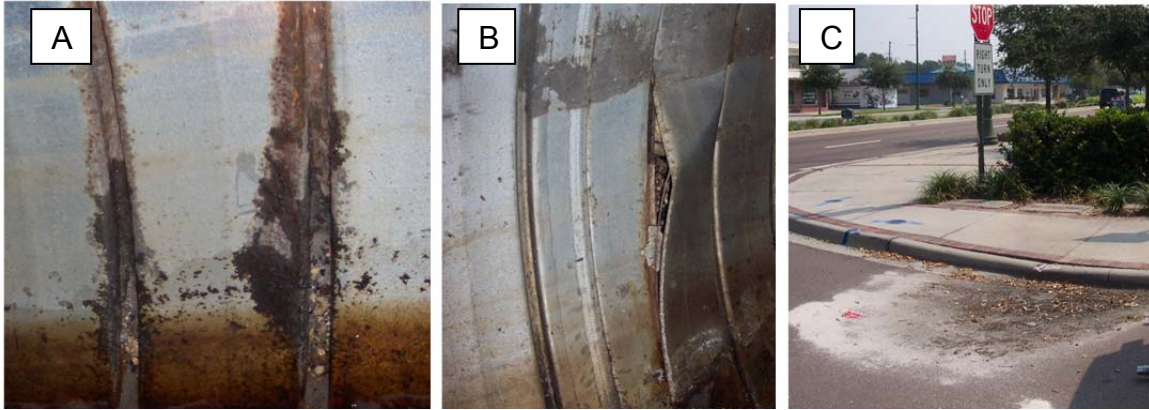
In the first (Mode A) much of the corrosion occurred along formed ribs and often also extended into the intervening smooth regions (Figure 3 A and Figure 4). This mode was first reported in 2005 for the drainage system owned by the city of St. Cloud, FL where severe corrosion was accompanied by roadway depressions. The affected pipes had been installed only about 2 years earlier, around 2003. A similar failure was reported also in 2005 for drainage pipes owned by the city of Largo, FL (Figure 3). These pipes were also installed in 2003. At some locations in both sites, the failure was clearly due to mechanical damage during either manufacturing or installation of the pipes (Figure 3B).

Figure 3: Premature failure of installed SRAP after 2 years in service at City of Largo, FL. (A: Corrosion initiation at ribs; B: Failure due to mechanical damage; C: Road depression due the pipe failure). Photographs by Leonardo L. Cáseres

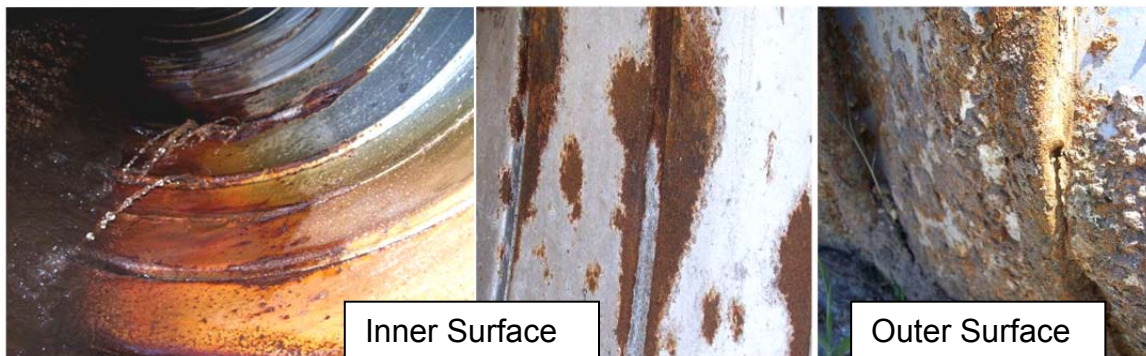
In 2006, pipe inspections at an FDOT project site at SR-54 & US-19 in Pasco County revealed severe corrosion (but not full penetration) of aluminized pipes installed five years earlier in 2001. Failures comparable to those seen in St. Cloud, were reported in 2007 for a 10 years old installation at SR 586, Curlew Road in Clearwater, FL (Figure 4).

Figure 4: Premature failure of installed SRAP after 10 years in service (From Curlew installation at SR 586, Clearwater, FL)

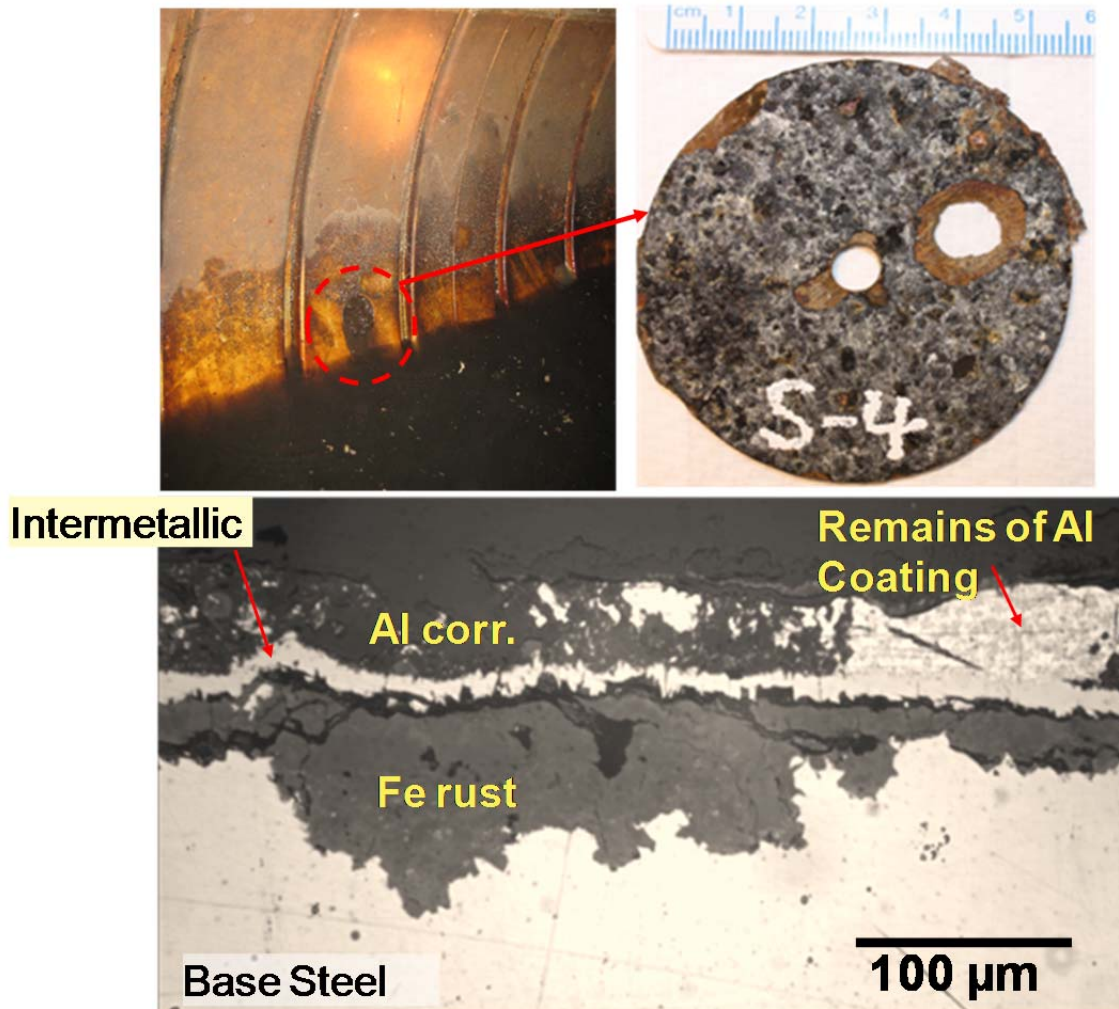
Figure 5 : Location of the bore [top left], extracted coupon [top right] and metallographic cross-section of the coupon [bottom].

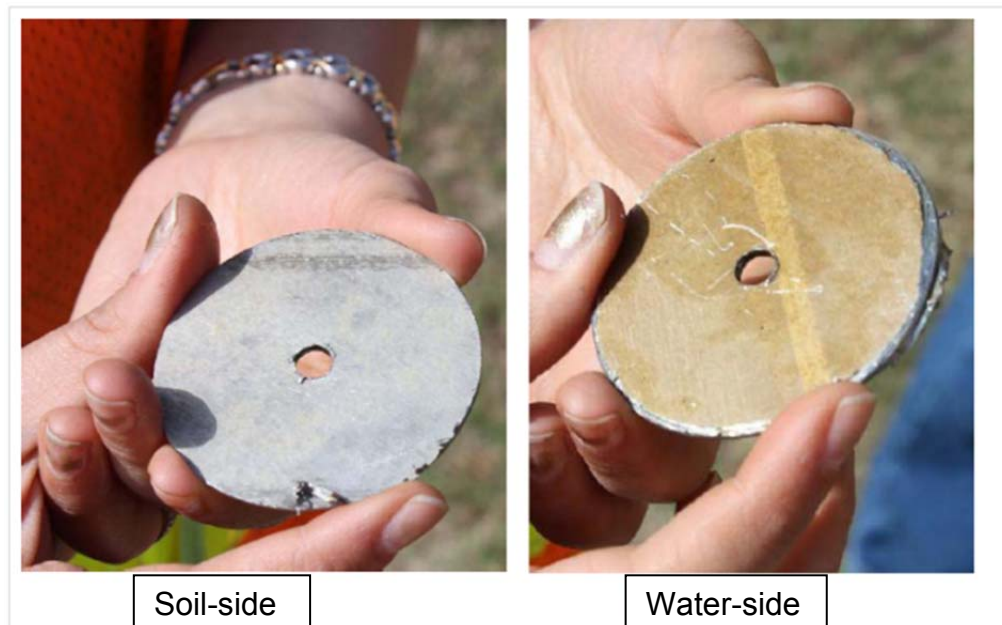
Figure 6 : The pipe coupon from a site that was near SR 212 failure [at Wolf Creek/Beach Blvd] did not show signs of corrosion at either side.

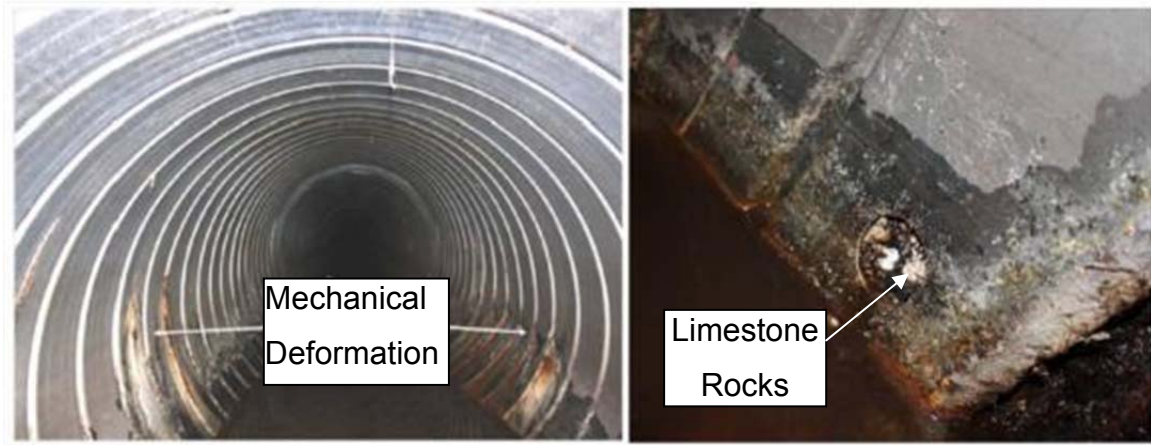
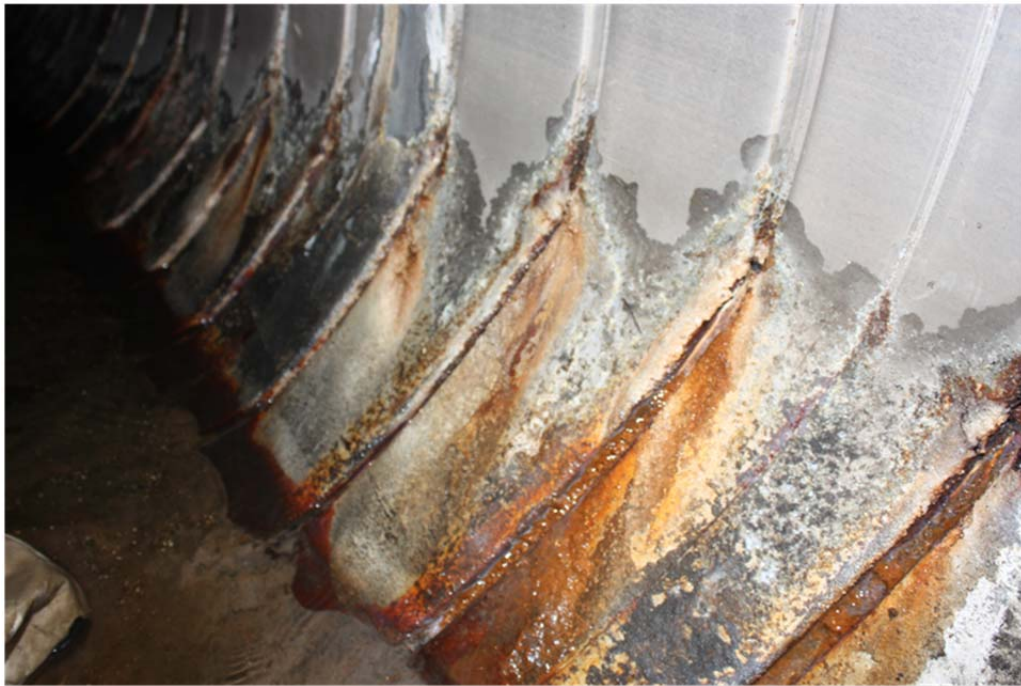
Figure 7: Photograph of in-situ pipe located in Jacksonville, near Highland Glen and Beach Blvd. Mechanical damage (top left, bottom), Limestone rocks present beneath the bore location (top right).

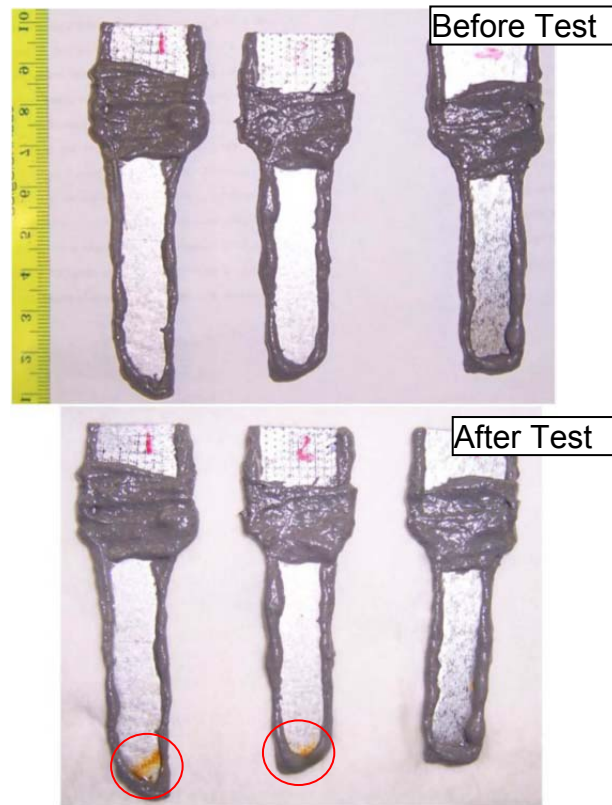
Figure 12: Tensile specimens before (Top) and after few days of immersed in simulated natural waters (Bottom). Minor corrosion signs appeared at a short distance from the necking zone. The control specimen (far right) doesn't show signs of corrosion.

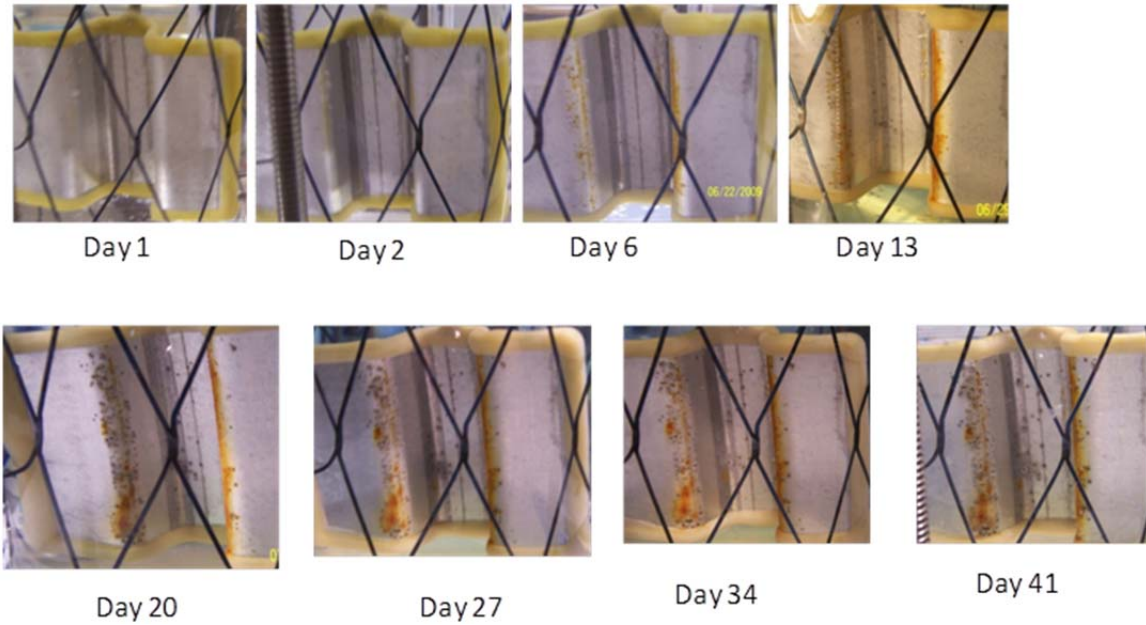
Figure 15 : Corrosion progression of small ribbed specimens in S solution; the ribbed regions show significant pitting while the flat regions look bright.

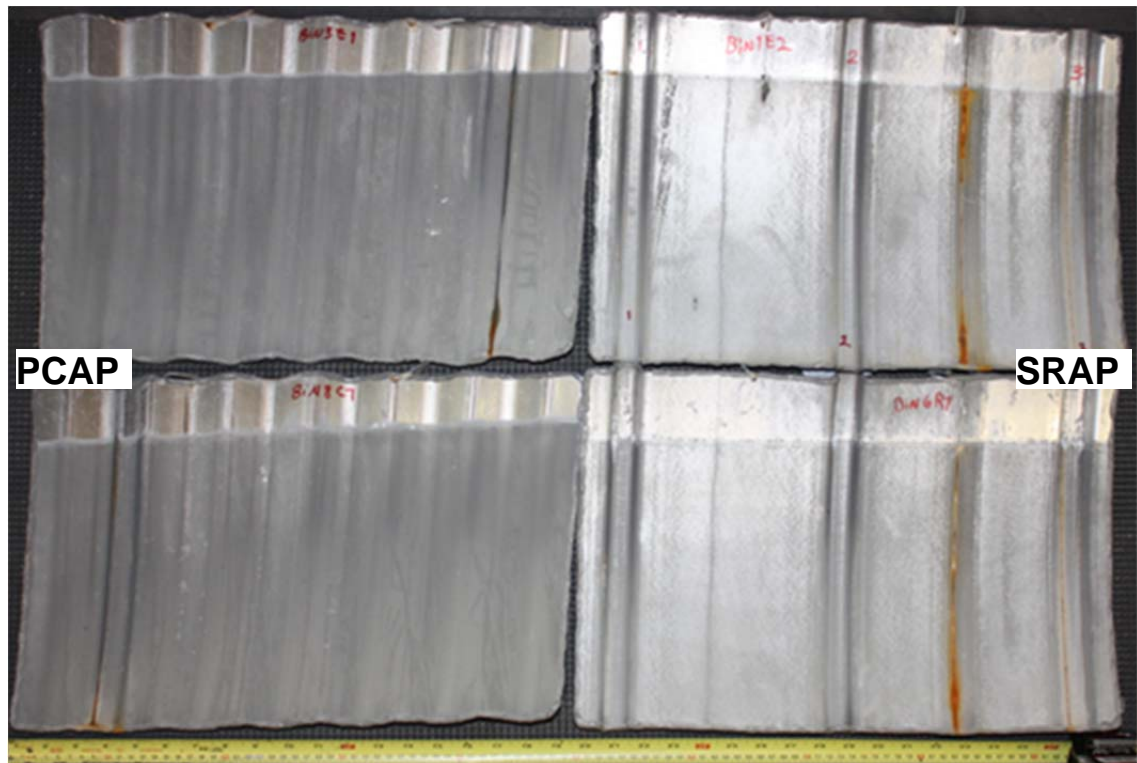
Figure 17 illustrates the typical surface discoloration occurred on both SRAP and PCAP specimens after about two years of exposure. The discoloration occurred below the water line, while the top of specimens above the water line stayed bright. Minor pitting of aluminum occurred after a year of exposure in both solutions. Figure 18 shows the typical appearance of a pit at the rib region after a year of exposure. EDS confirmed the present of aluminum corrosion products at the dark grey regions and iron corrosion products at seams regions.

Figure 17 : PCAP and SRAP specimens in S solution [Top] and S⁺ solution [Bottom] after ~700 days of exposure.

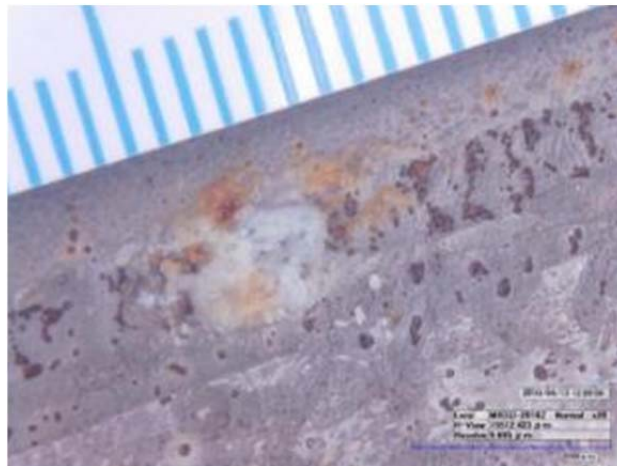
Figure 18 : Pits and corrosion product at ribbed regions of an in-situ SRAP specimen after ~300 days of exposure. 1 mm markers.

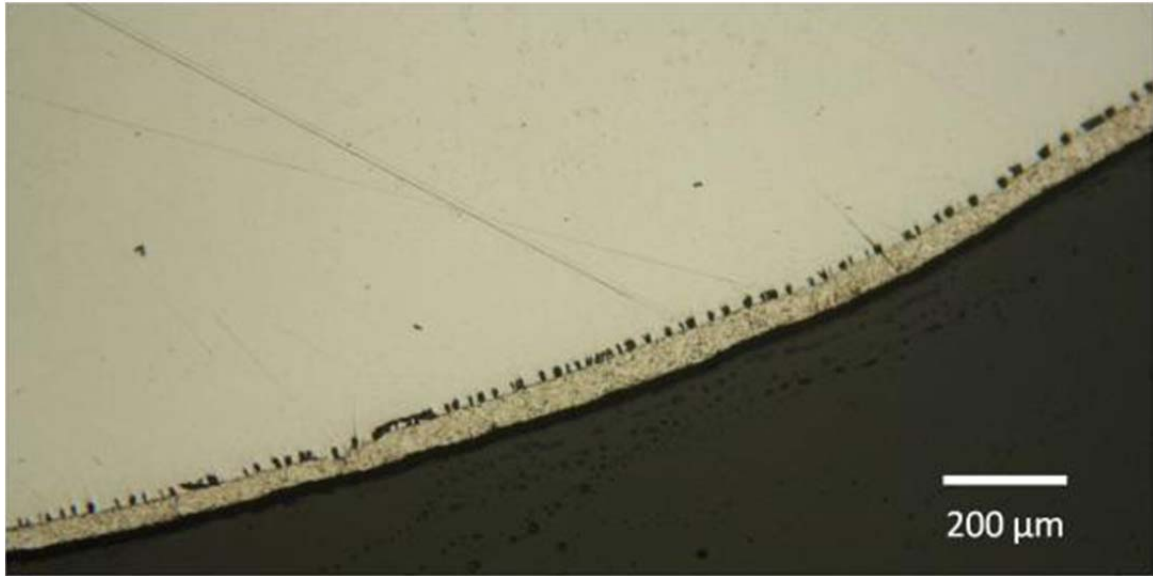
was compared to unexposed specimens (Figure 19). Coating loss was observed after two and half years of exposure was insignificant.

Figure 19 : Metallographic cross-section of SRAP at rib regions after two years of exposure to solution S. No significant coating loss is observed.

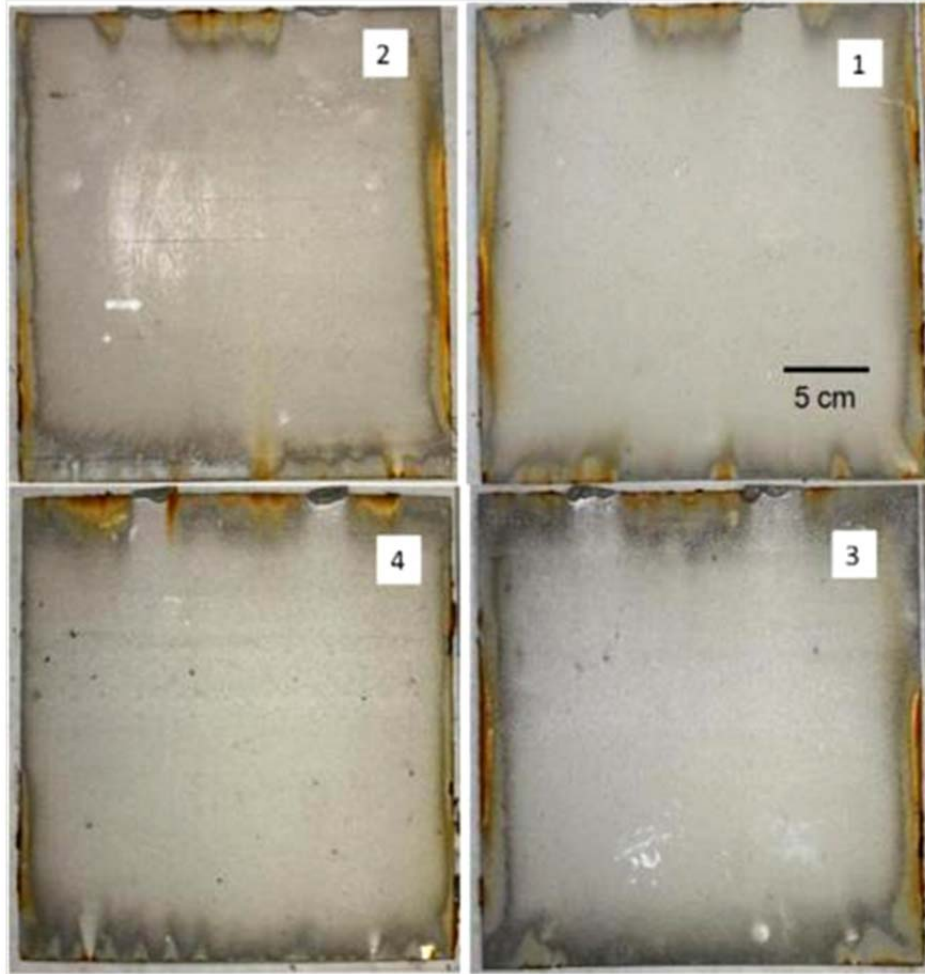
In summary, after about two years of exposure the evidence shows that the cut edges corroded readily in both solutions S and S+ , indicating inefficient aluminum galvanic protection even in the more aggressive environment.

Figure 29 : Exposed cut edge experiment: Specimens extracted from solution S (top) and solution S+ (bottom). Lateral progression of corrosion is observed.

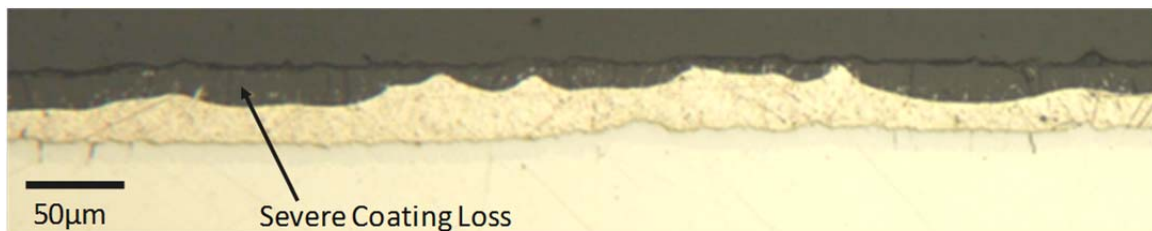
Consistent with the resulting mild conditions, corrosion in the cells with no flowing water was relatively unimportant during the test period and those results will not be further addressed. In contrast, and as expected from the high solution pH, rapid corrosion of the aluminized coating took place in the flowing water cells. Direct observation of extracted specimens revealed that severe coating damage and surface discoloration took place starting after a short (about two weeks) exposure. Metallographic and SEM observations confirmed severe loss of aluminized coating later on, as illustrated in Figure 37. As shown there, the coating loss was rather generalized as opposed to sharply concentrated in the form of pits. The corrosion products (dark gray) stayed in place; Al-Fe intermetallic particles remained uncorroded in the matrix similar to observations in the field sample.

Figure 37 : Coating condition after ~150 days exposure to flowing water.
