EVALUATION OF THE NEW YORK LOW-TENSION THREE-CABLE BARRIER ON CURVED ALIGNMENT

MIDWEST ROADSIDE SAFETY FACILITY

New York State Department of Transportation
50 Wolf Road, 6th Floor
Albany, New York 68502

MwRSF Research Report No. TRP-03-263-12

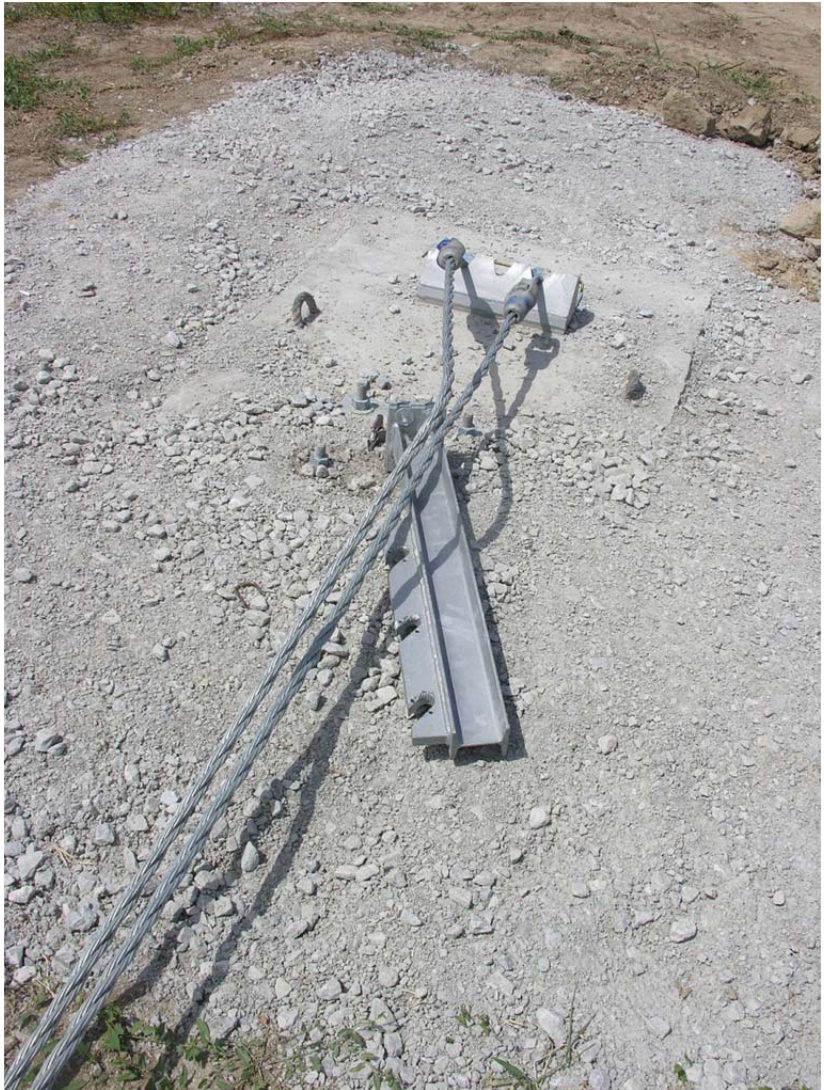
Figure 44. System Damage: Downstream Anchor and Post No. 40, Test No. NYCC-1

The downstream anchorage experienced similar damage. The weld between the bottom slip base plate and the post stub failed, as shown in Figure 44. The post came to rest adjacent to the stub with the slip base completely intact. All three cables were disengaged from the post. The middle cable anchor rod fractured, as shown in Figure 45, due to the cable being snagged on the vehicle. The downstream end of the middle cable came to rest behind the vehicle, about 6 ft (2 m) in front of post no. 38.

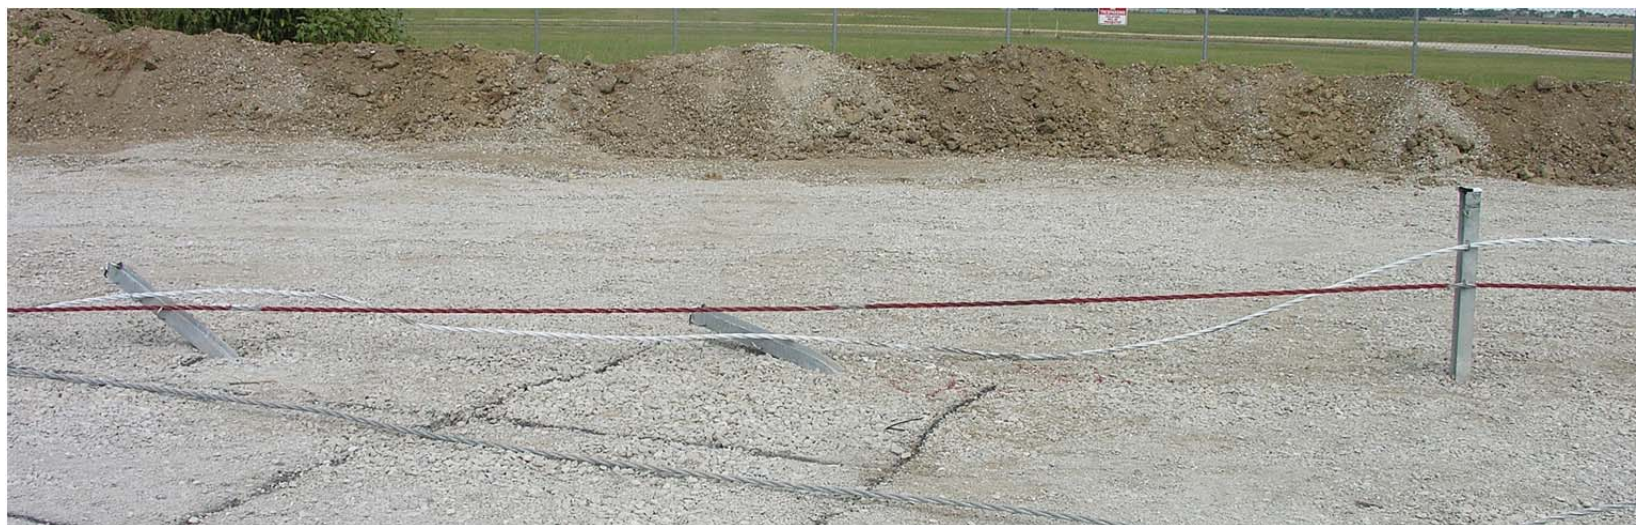
Figure 46. System Damage: Middle Cable between Post Nos. 17 and 18, Test No. NYCC-1

through 19, 30, and 33. The middle cable between post nos. 17 and 18 frayed. The fray consisted of two broken wire strands, as shown in Figure 46.

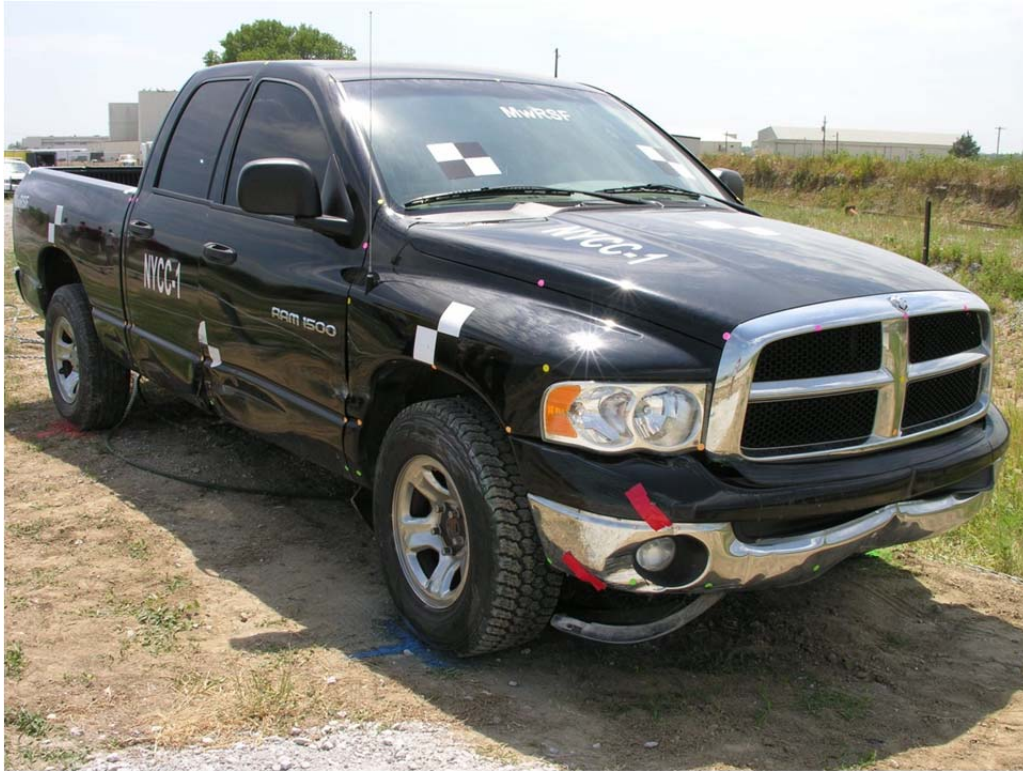
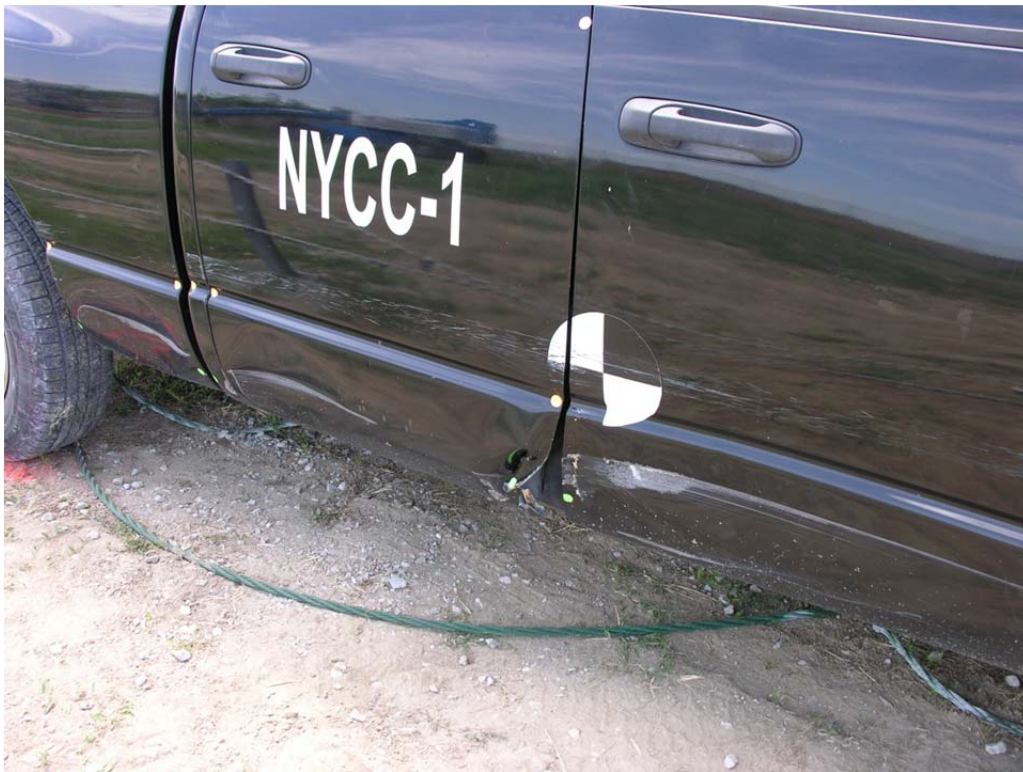
Figure 57. Vehicle Damage: Right Side, Test No. NYCC-1

The majority of the damage was concentrated on the right-front corner and right side of the vehicle where the impact occurred. The lower front bumper trim was disengaged, and the front bumper was dented and bent inward near the vehicle centerline due to contact with posts. The right side of the front bumper had contact marks from the cables as well as denting and kinking due to contact with posts. The left side of the front bumper had dents and contact marks from the cables and posts. The right-front door experienced some gouging and denting. The right-rear door was dented and had a tear and fold at the front edge of the door, caused by the top cable contact. The right-rear quarter panel experienced gouging. The left-front wheel experienced gouging along the edge of the rim. The left-rear door was gouged along the bottom. The left-rear quarter panel had a small dent near the cab. Contact marks from the cables extended along the entire right side of the vehicle.

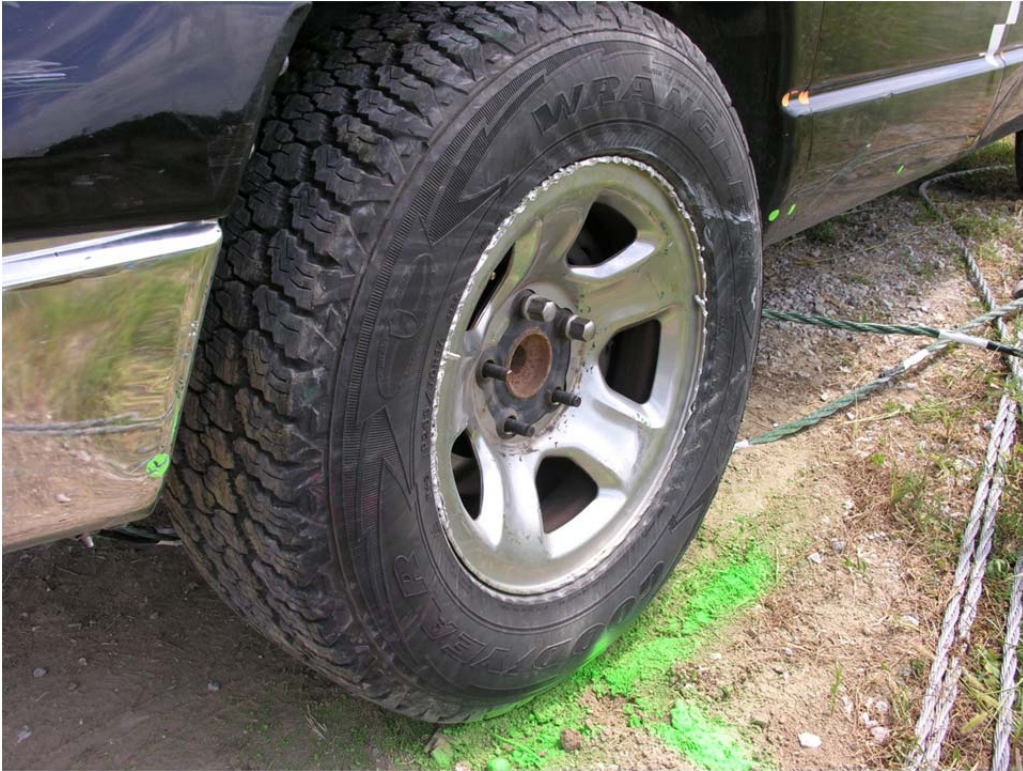
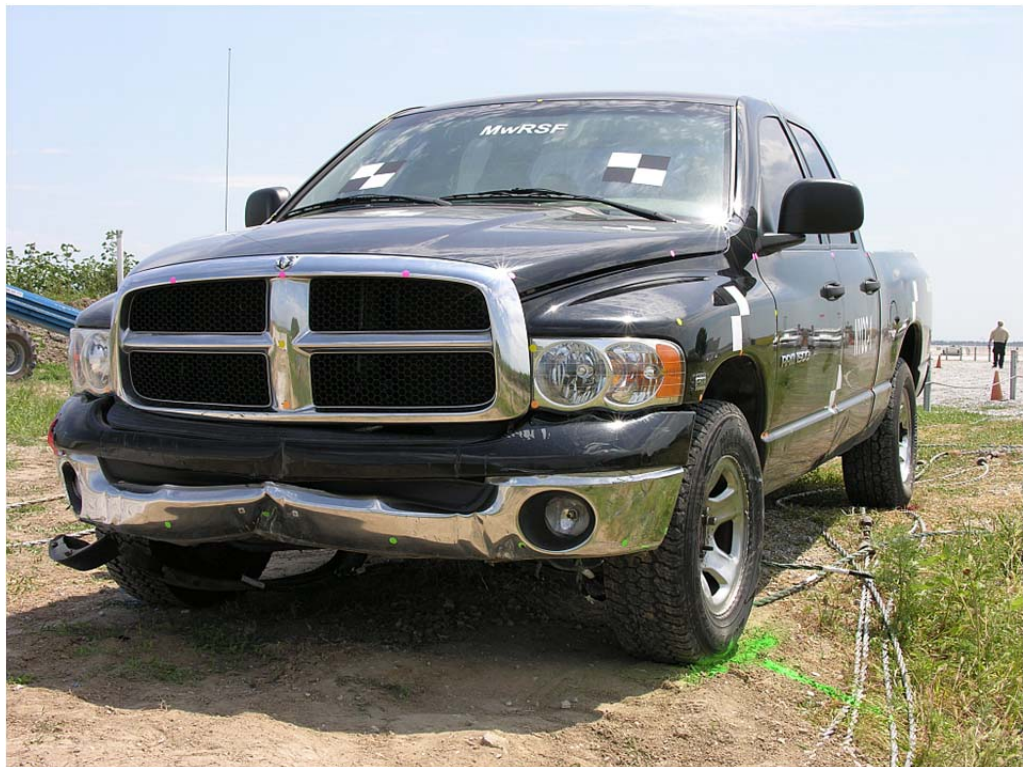
Figure 58. Vehicle Damage: Front and Left Side, Test No. NYCC-1

The damage to the vehicle was minimal, as shown in Figures 57 and 58. The maximum occupant compartment deformations are listed in Table 5 along with the deformation limits established in MASH for various areas of the occupant compartment. Note that none of the MASH established deformation limits were violated. Complete occupant compartment and vehicle deformations and the corresponding locations are provided in Appendix D.

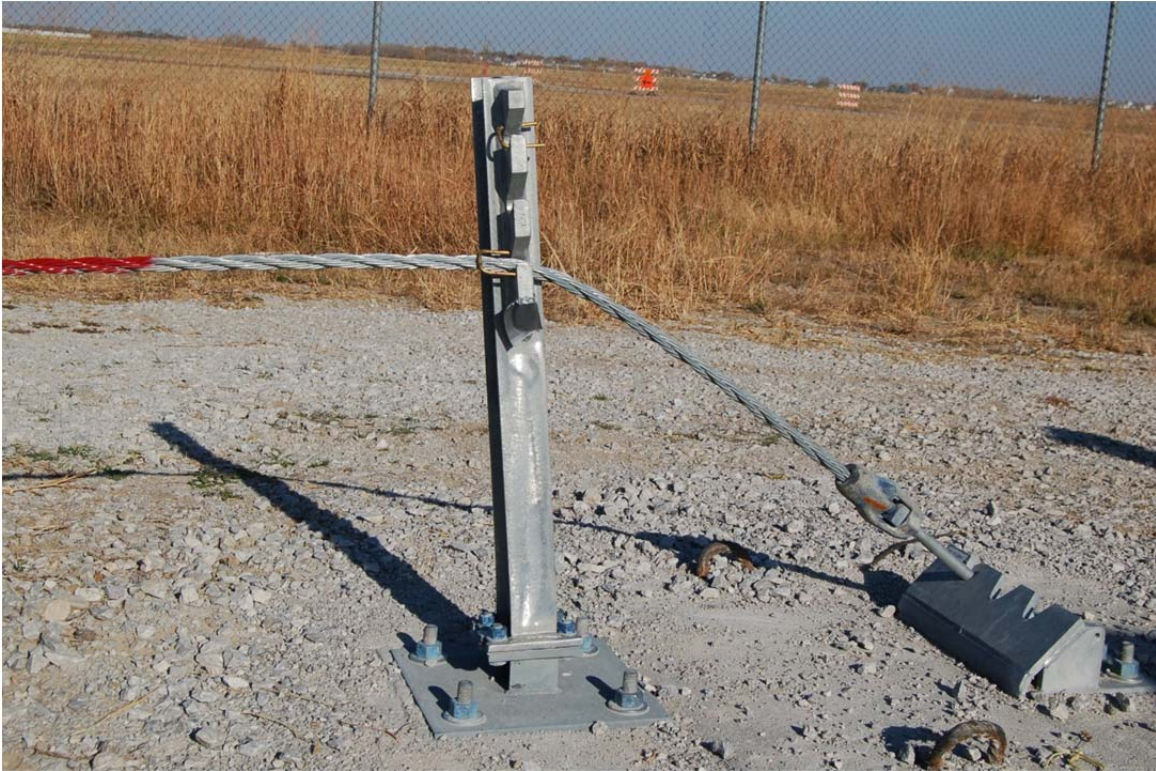
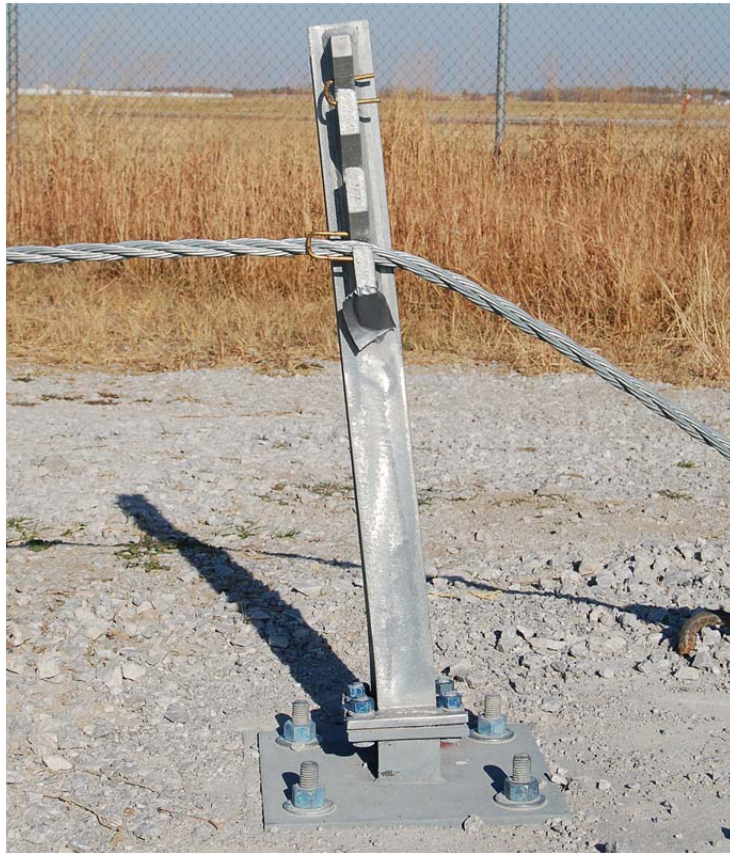
Figure 72. System Damage: Upstream Anchorage, Test No. NYCC-2

The upstream cable anchor assembly experienced minor damage. The top and middle cables had disengaged from both the angled anchor bracket and post no. 1. Post no. 1 was slightly bent downstream. Post nos. 17 through 19 were all bent backward and downstream.

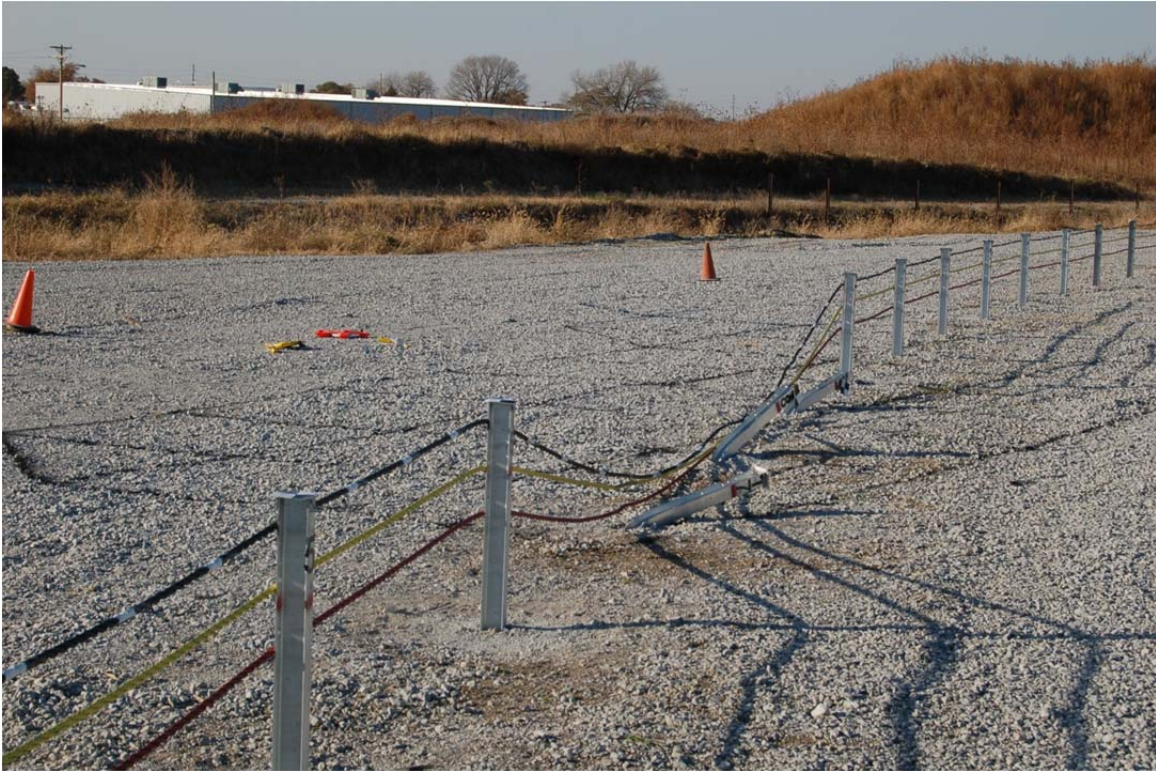
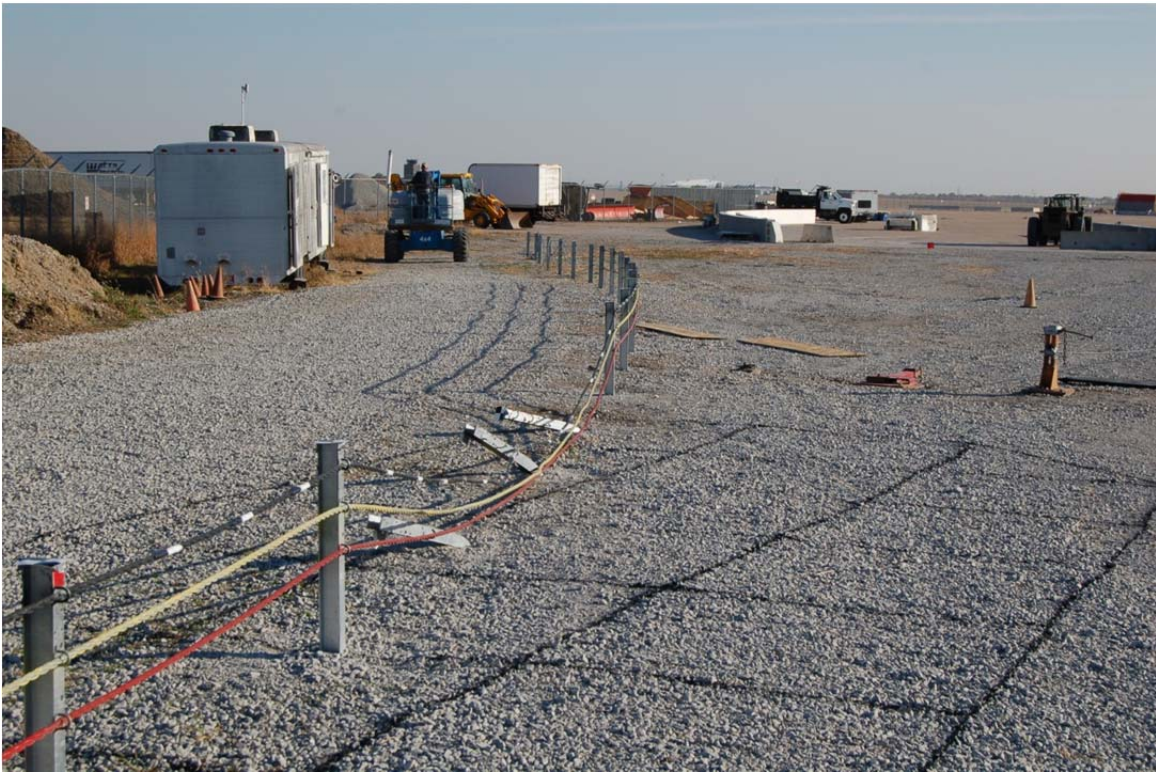
Figure 73. System Damage, Test No. NYCC-2

Damage to the barrier was minimal, as shown in Figures 71 through 74. Barrier damage consisted of bent posts and disengaged cables. The length of vehicle contact along the barrier was approximately 24 ft (7.32 m), which spanned from 2 ft (0.6 m) upstream from post 17 through 2 ft (0.6 m) upstream from post 20.

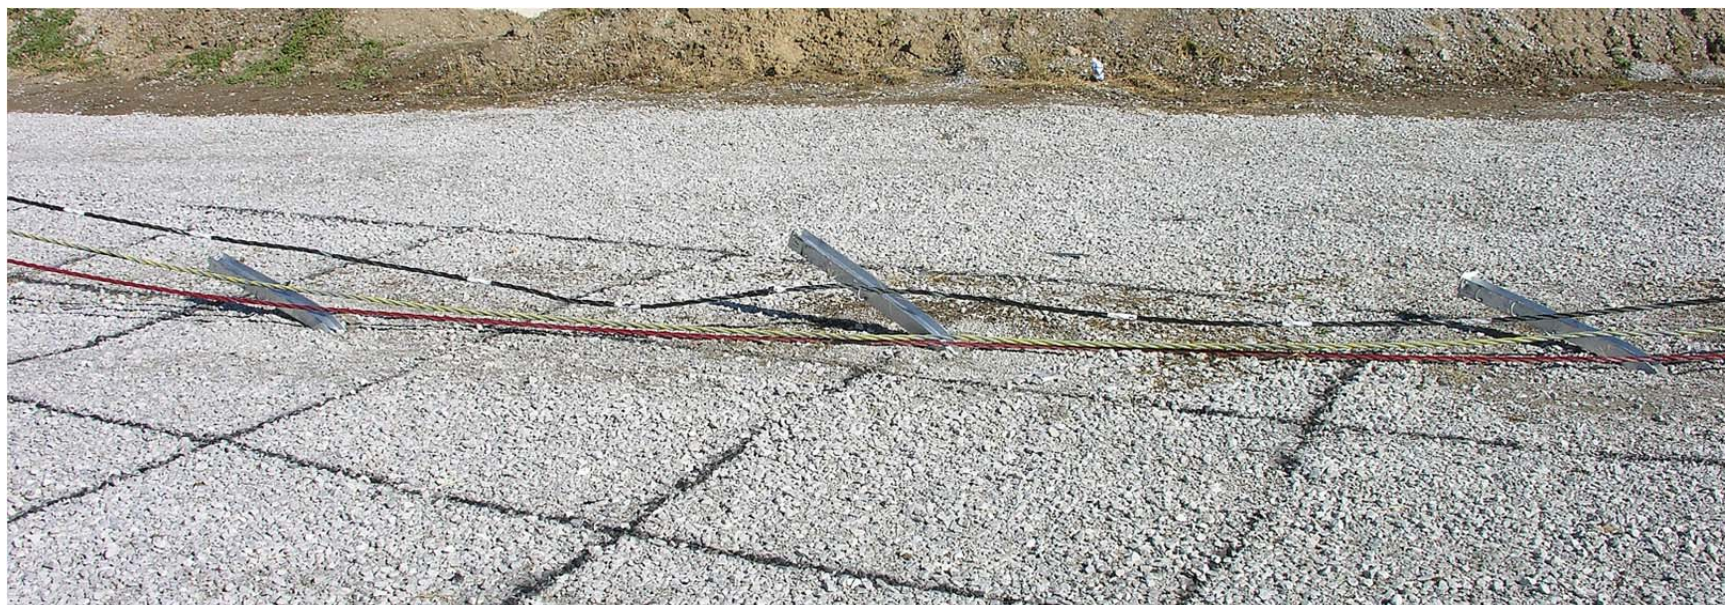
Figure 74. System Damage: Post Nos. 17 through 19, Test No. NYCC-2

The top, middle, and bottom cables disengaged from post nos. 17 through 19. All cable-to-post J-bolt attachments on post nos. 17 and 18 were bent. Additionally, the top and middle J-bolts on post nos. 17 and 18 were rotated upstream. The top and middle J-bolts on post no. 19 were fractured and the bottom J-bolt was bent and rotated upstream.
