Evaluation of MEMS-based In-place Inclinometers in Cold Regions

Margaret M. Darrow, Ph.D.
David. D. Jensen, E.I.T.

December 2012

INE/AUTC 12.38

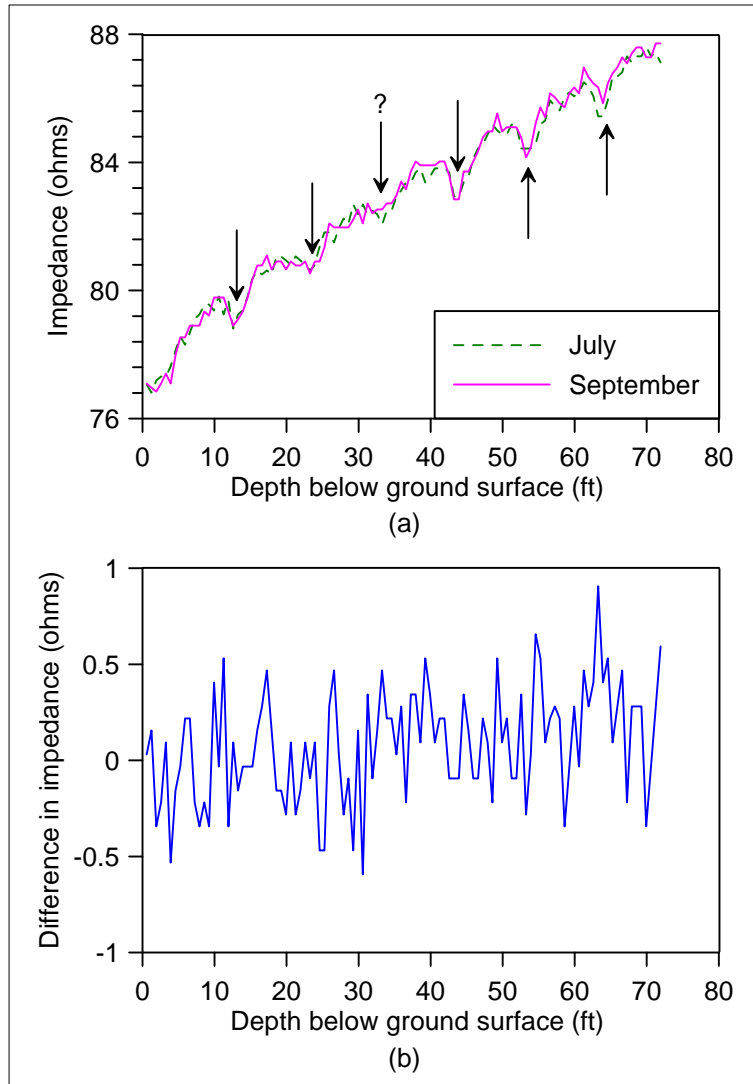
Figure 7. Measurements from the TDR cable. (a) Readings from July and September; the September readings were corrected to account for the overall difference in impedance from July. Impedance “lows” (indicated by arrows) indicate positions of the hose clamps (the “low” near 30 ft bgs is not as apparent). (b) Difference in impedance between the July and September readings.

using the TDR device at Rich113 since the creep movement is similar to bending. The TDR device also may not indicate the zone of movement at Rich113 due to the backfill method. Turner (2006) noted that a grout mix must be stiff enough to deform the coaxial cable when shearing. The dry sand backfill, although potentially frozen, may have been loose enough so as to provide space for the cable to move rather than crimping it.

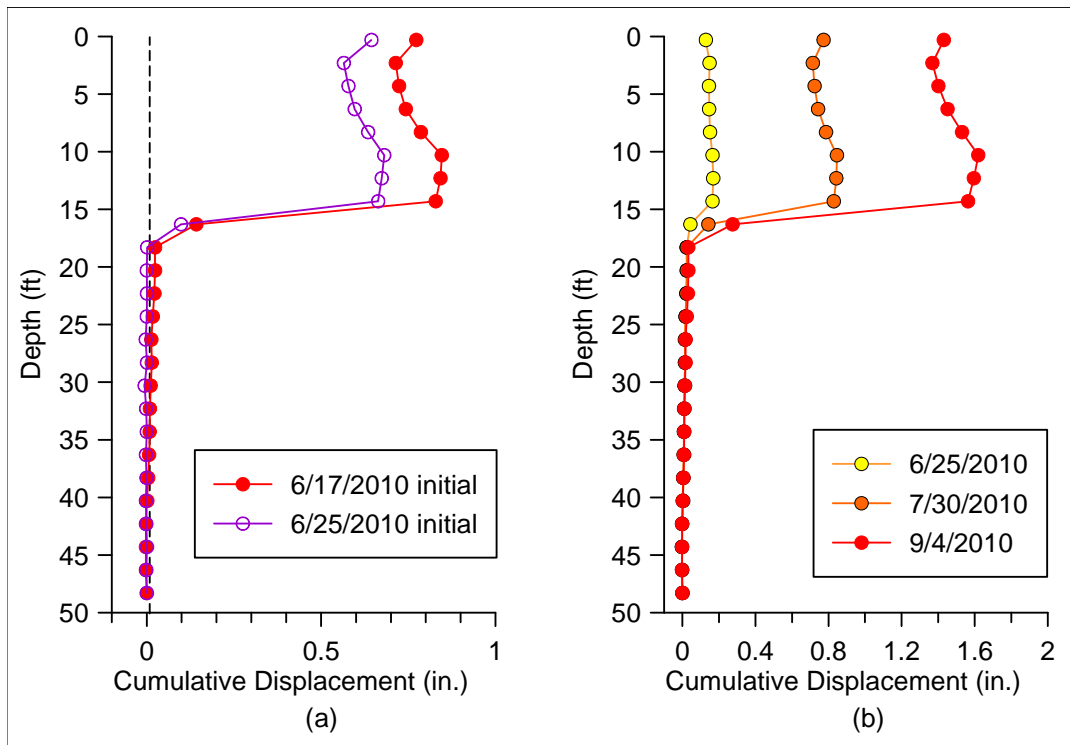
For spatial reference of the measured locations, Figure 8 is a photograph of the casing locations relative to each other. As a first step in analysis, inclinometer probe measurements were used to evaluate the effectiveness of tamping the sand backfill around the casing within the boring. Voids created by bridging within the loosely poured sand into the annular space in a boring often are evident in sagging of the casing within a few weeks after the initial installation. The data collected during the summer of 2010 was evaluated by assigning two different initial dates, June 17 (date of installation) and June 25 (one week later). Below the shear zone, these sets of readings differed by 0.03 in. at the most; thus, we considered any sagging of the casing as minor, and used June 17 as the initial reading for the rest of the analysis. Figure 9b contains all of the cumulative displacement measurements from 2010, which indicate a shear zone between 14.3 and 18.3 ft bgs and about 1.7 in. of movement over the three month measurement period.

Figure 9. Cumulative displacement measurements from the inclinometer probe for TH10-1551. (a) Evaluation of slump of the casing within the tamped sand backfill using two different start dates (note the enlarged horizontal scale for better resolution); (b) all cumulative displacement measurements from 2010.

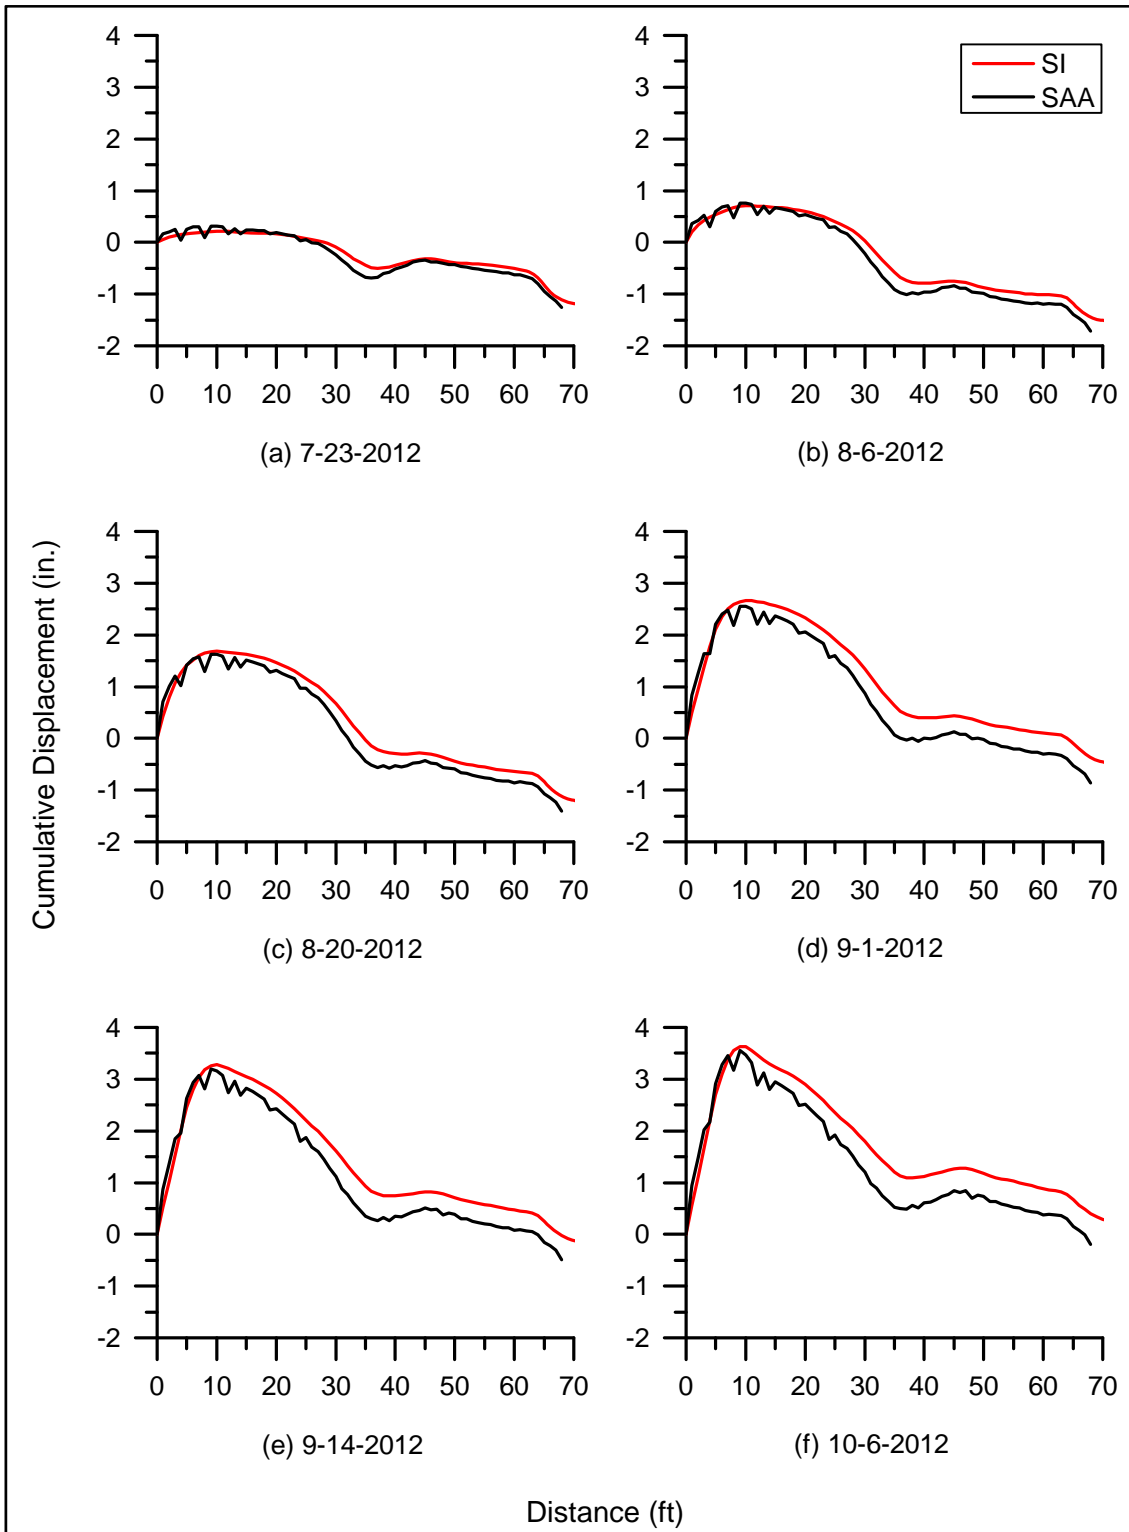
Figure 15. Comparison of SAA and inclinometer probe performance using the uncorrected data referenced to the near casing end.

the entire embankment width, readings from this device were limited to the interval from 0 to 68 ft. Measurements from both instruments suggest that the bottom of the embankment is rising over time. This is erroneous as the embankment should move only downwards due to post-construction settlement during the summer months (some upward movement could occur as a result of frost heaving during sub-freezing temperatures). As displayed in Figure 15, both instruments demonstrate the same trend in displacement; however, the difference in cumulative displacement recorded by each instrument increases slightly over time with a maximum difference of 0.69 in. This difference may be due to differential settlement of the near end of each casing.

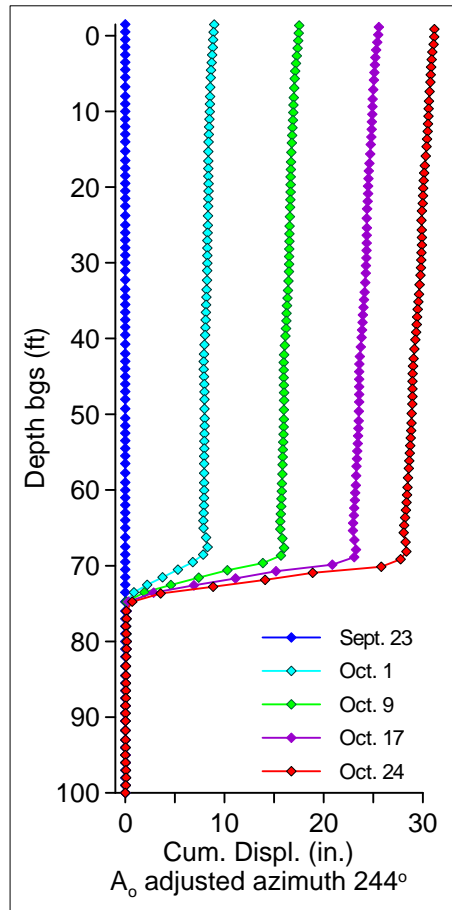
Figure 26. Cumulative displacement measurements for TH12-9004 until the INC500 began to demonstrate signs of failure.

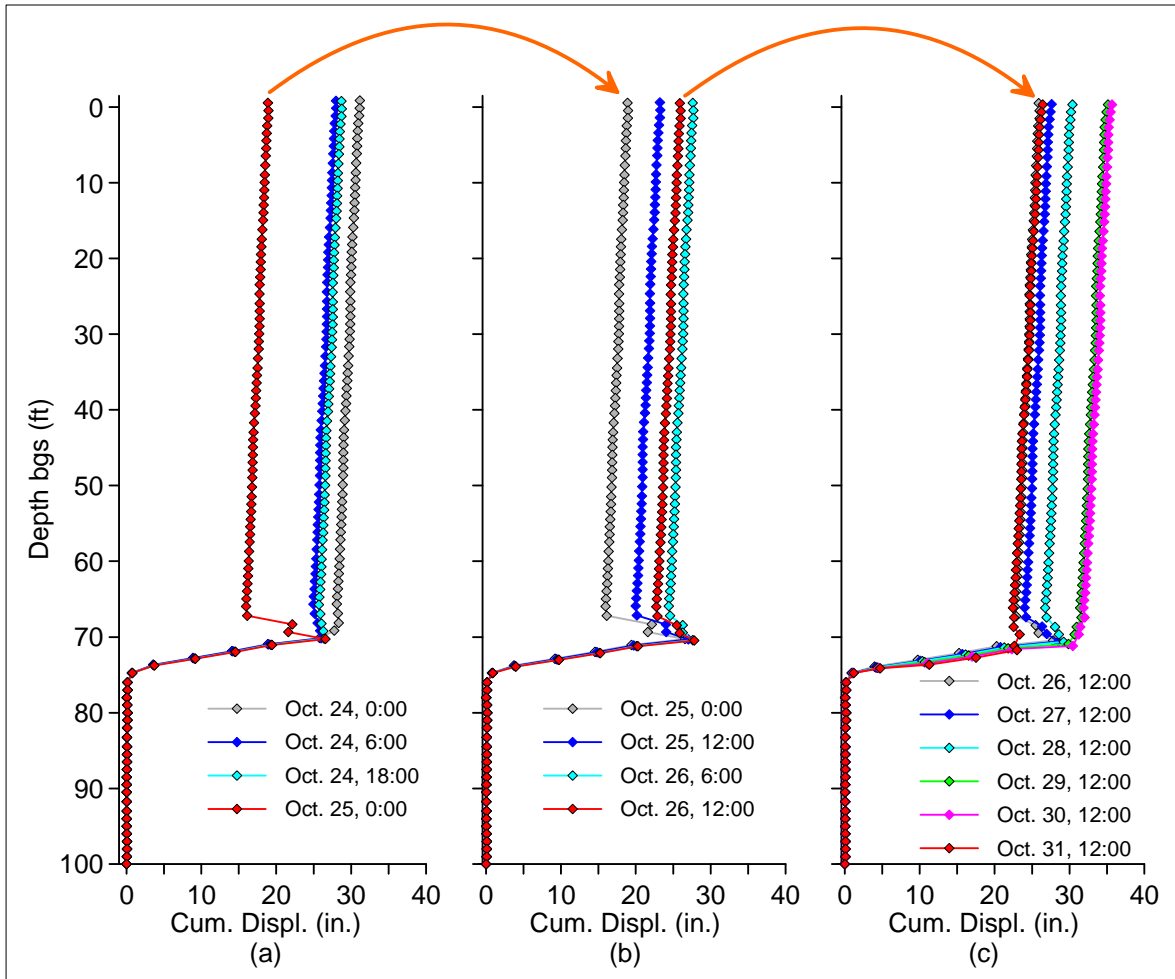
Early in the morning of October 24, the M-IPI began to record apparent “retrograde motion” upslope between 67 and 70 ft bgs (see Figure 27a). Considering an earlier failure of a thermistor string and the subsequent failure of a piezometer below this depth, we suspected that a few of the INC500 sensors were damaged in the shear zone. The manufacturer of the device agreed, indicating that the sensors “probably deformed or rotated within the housing” (J. Lemke, pers. comm., Nov. 2012). The INC500 continued to record downslope motion above the shear zone, with episodes of “retrograde motion” intermixed (see Figure 27b and Figure 27c). Despite the damaged sensors, the entire INC500 continued to record data, acquiring reasonable measurements of cumulative displacement below the depth of 70.5 ft. Then on October 31, the INC500 sensors below 66 ft bgs ceased reporting data (see Figure 27c). The manufacturer suggested that either the cable was physically pulled apart, or perhaps more likely, that one of the underwater connectors between modules pulled apart (J. Lemke, pers. comm., Dec. 2012). The sensors above the shear zone, however, continued to report movement and temperature data. In the summer of 2013, the PI intends to return to the FDL-A site and try to retrieve the upper modules from the casing, which may confirm how the modules became detached.

Figure 27. Evidence of failure of the INC500 at FDL-A. (a) Apparent “retrograde motion” began at 6:00 on October 24, with major “retrograde motion” at 0:00 on October 25. (b) The lobe above the shear zone continued to move downslope, with another episode of “retrograde motion” on October 26 at 12:00. (c) Final readings of the INC500 until failure of the lower modules after October 31 at 12:00. For each plot, the set of readings in gray represents the last reading from the previous plot (for (a), this is the last reading shown in Figure 26). The sequence of readings is given the same color scheme, with red indicating “retrograde motion”.

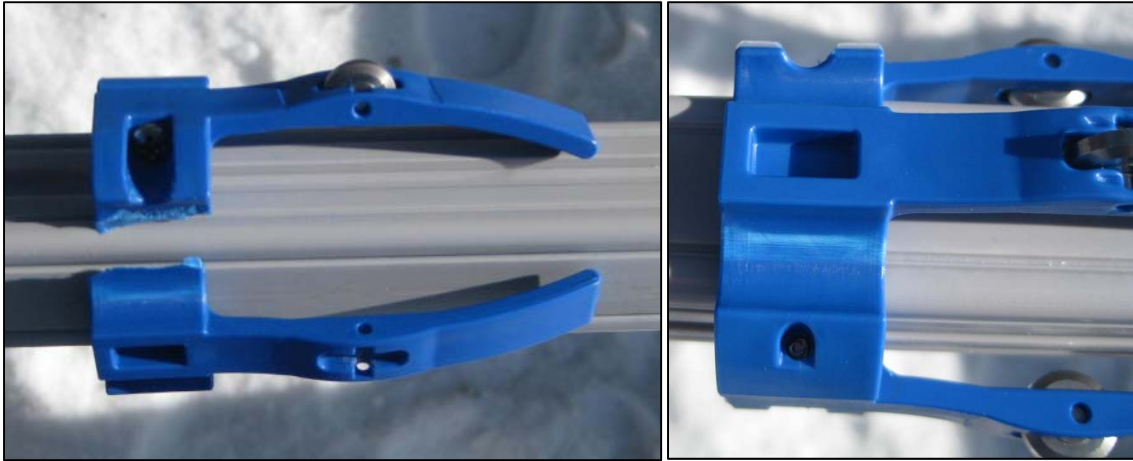
Figure A-7. Damage to centralizers due to improper alignment during the March 2010 installation. (Photographs by M. Darrow)
