1. Report No. FHWA/TX-13/9-1002-12-6		2. Government Accession No.		3. Recipient's Catalog No.	
4. Title and Subtitle <b>MASH Full-Scale Crash Testing of 4-ft Mounting Height, 24"×30" Chevron Sign Installed on 5.5H:1V Slope Ditch</b>				5. Report Date Published: March 2013

***MASH* Full-Scale Crash Testing of 4-ft Mounting Height 24"×30" Chevron  
Sign Installed on 5.5H:1V Slope Ditch**

Report 9-1002-12-6  
Project 9-1002-12  
Project Title: Roadside Safety Device Crash Testing Program

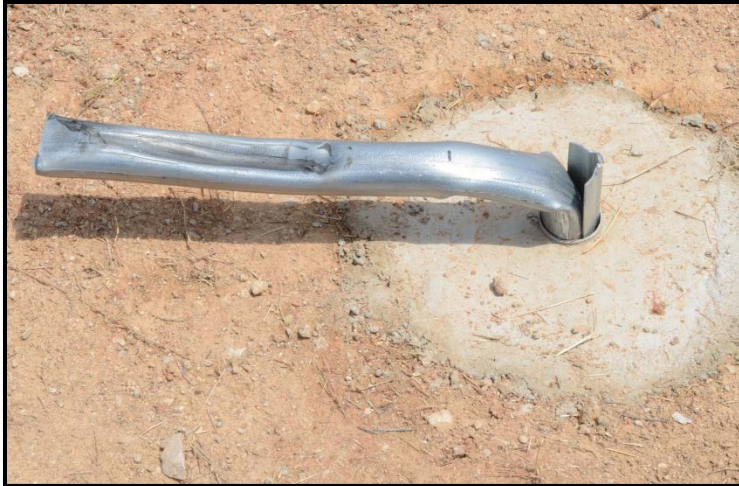
**Figure 5.4. Installation after Test No. 490022-9.**

As shown in Figures 5.3 and 5.4, the sign support did not completely pull out of the socket. The support deformed at bumper height and ground level, and subsequently fractured near bumper height approximately 21 inches above ground. During impact, the support post wrapped around the front end of the vehicle and the sign impacted the hood. The sign panel slid up the support post, causing the upper sign bracket to slide off the top of the post while remaining connected to the sign. The support and the sign panel came to rest 126 ft downstream of the impact point.

Results: The sign support fractured at approximately 21 inches above wedge and socket system. (PASS)

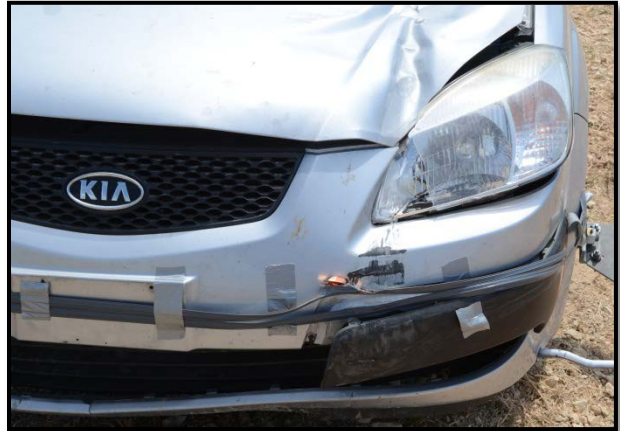
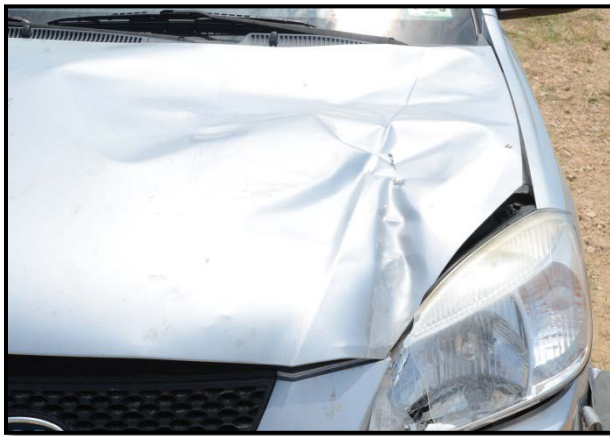
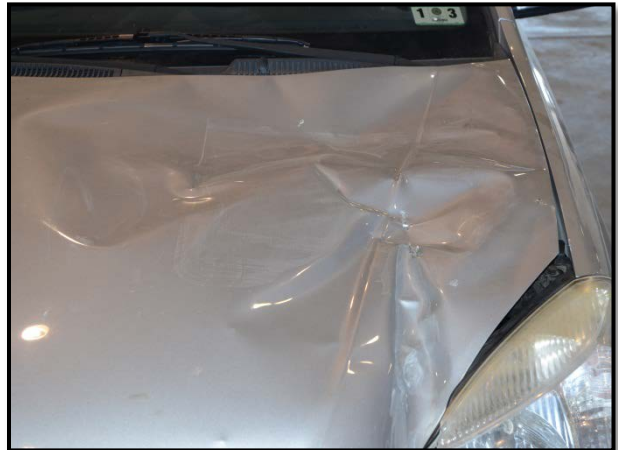
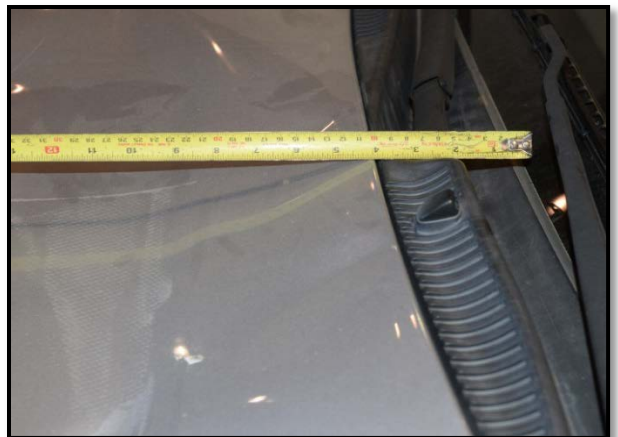
**Figure 5.5. Vehicle after Test No. 490022-9.**

Figure 5.5 shows damage sustained by the 1100C vehicle. The front bumper, hood, and left head light were damaged. The impact of the chevron sign support system with the vehicle caused a 31-inch  $\times$  21-inch dent in the left-central portion of the hood. Maximum exterior crush to the vehicle was 1.75 inches on the hood. Figure 5.5 shows deformation and striations left by the sign during impact with the vehicle's hood. The upper edge of the striations caused by contact with the sign panel was approximately 8.5 inches from the base of the windshield. There was no deformation to the occupant compartment. Tables B2 and B3 in Appendix B provide exterior crush and occupant compartment measurements, respectively.

Results: The released sign support did not penetrate or show potential for penetrating the occupant compartment, or to present hazard to others in the area. (PASS)  
There was no deformation of or intrusion into the occupant compartment. (PASS)
