Appendix C–SR-72 Tests

1 Introduction

2 Girder and Deck Design

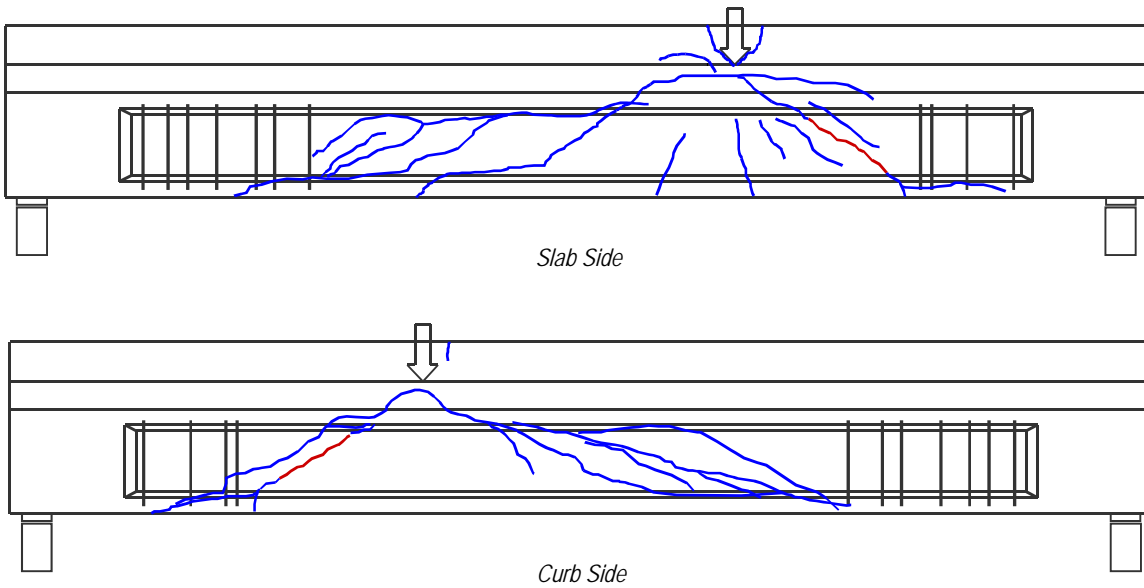
Figure 14–X7 cracks (initial crack in red)

The girder behaved linear-elastically until the formation of cracks. Visible cracking was first observed in the web at a superimposed shear load of approximately 51kip (Figure 14). Although cracks were not visible prior to 51kip, data from rosette R7 indicates that the crack first formed at a shear of 41kip (Figure 15). At 58kip of shear, the initial crack in the web was observed to have joined with a flexural crack in the bottom flange. This load corresponds to the change in slope on the shear-displacement plot; the change in stiffness being attributed to cracking.

Referring to Figure 12, the abrupt changes in the shear-displacement curve between 65kip and 70kip correspond to the formation of additional cracks. Cracks formed farther from the load point and at shallower angles as the load increased. Comparing the final crack pattern with the location the transverse reinforcement (Figure 14), it is noted that with only one exception, the cracks did not cross transverse reinforcement. Thus, after cracking the load could not have transferred through truss action, but rather was carried through arch action. Girder X7 supported a maximum superimposed shear of 84kip. At this load a punching shear failure occurred in the slab and curb. Figure 16 is a photo of the curb side of X7 showing the location of the punching failure. The red strap in the picture is from the crane which was lifting the girder as the photo was taken.

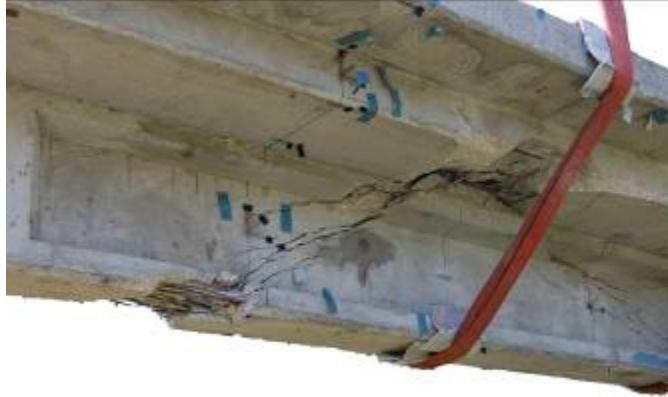
Figure 16–X7 punching failure bottom view

- Tied-arch behavior controlled the experimental strength of girders X7, X4 and I2A. Arches in these girders failed due to punching, flexural compression, and arch instability, respectively.

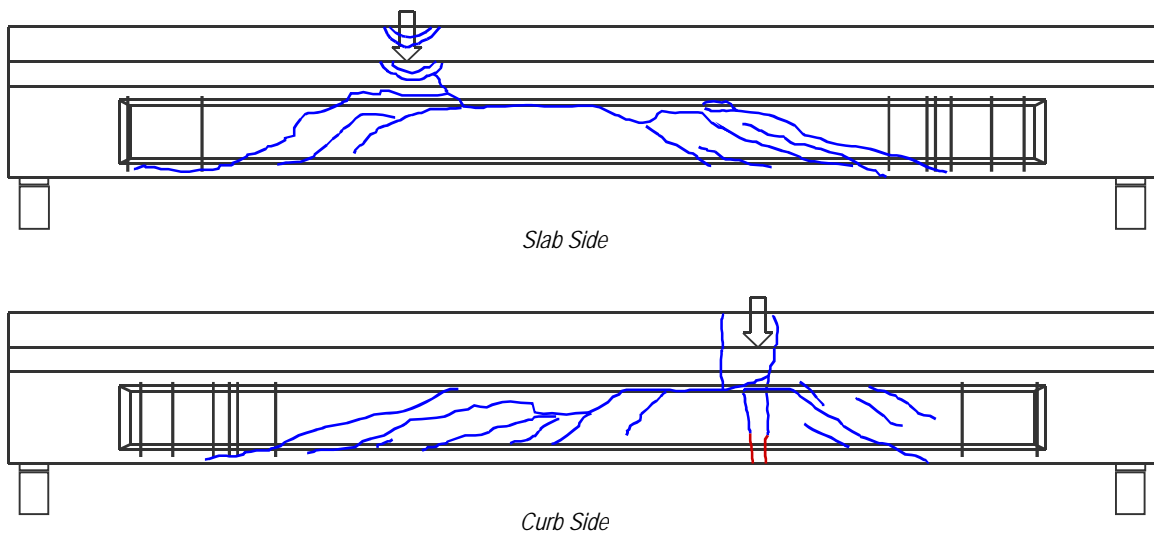
Figure 20–X4 cracks (initial cracks in red)

Referring to Figure 18, girder X4 behaved linear-elastically until a superimposed shear of about 45kip. The transition from linear-elastic behavior corresponded to the formation of flexural cracks at the bottom of the girder below the load point (Figure 20). Data from gage S25 (Figure 21) indicate that cracking initiated at a shear of 44kip. Initial cracks were first visually observed at a shear of 56kip.

The abrupt changes in the shear-displacement plot at 62kip and 66kip correspond to the formation of incline cracks in the web. Cracks continued to form farther from the load point and at shallower angles as the load increased. At the final stages of the load test incline cracks had a maximum width of 1 in. As shown in Figure 20 vertical reinforcement was not engaged by the inclined cracks. The relatively large crack widths and absence of engaged vertical reinforcement suggest that the girder supported load by arch-action.

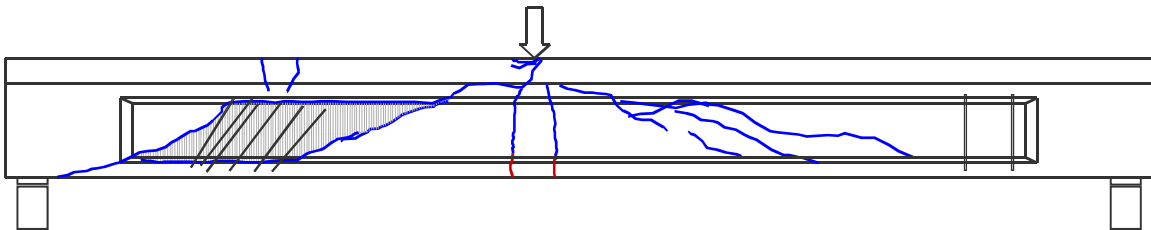
Figure 28-I2A cracks (initial cracks in red)

After evaluating I2A for effective prestress, the specimen was loaded to ultimate load. Load was applied at an a/d ratio of 4.5. Shear-displacement data from the ultimate load test is presented in Figure 27. Contrary to X4 and X7, girder I2A did not rotate about its long axis during loading. Flexural cracks reopened at a load 40 kip, corresponding to 22 kip superimposed shear. According to the shear-displacement plot, significant deviation from linear-elastic behavior did not occur until the shear reached 36k. Softening of the girder corresponded to the propagation of flexural cracks. The abrupt changes in the shear-displaced data at shear forces near 40 kip were due to the formation of inclined cracks in the web. As the load increased, additional cracks formed farther from the load point and at shallower angles. Cracking in the web between the load point and the near support was particularly severe, as noted by the shaded area in Figure 28 and shown in Figure 29.

Cracks along the web-flange interface in the shear span prevented the transverse reinforcement from developing and carrying forces. On the far support side of the load, the cracks did not engage the transverse reinforcement. Incline cracks on both ends of the beam were too wide to allow force transfer by aggregate interlock. Without aggregate interlock and effective transverse reinforcement, the girder behaved as a tied-arch during the final stages of loading.

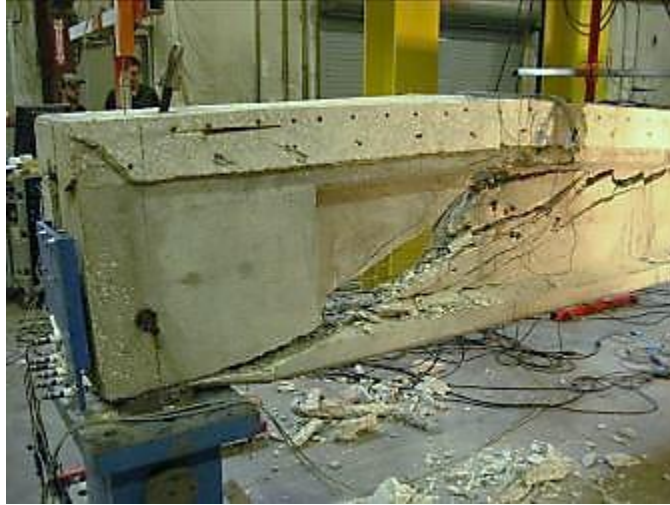
Figure 29-I2A incline cracks in web

Failure was precipitated by the formation of tensile cracks in the top of the arch between the near support and load point. After the cracks formed, the arch became unstable, buckled upward (Figure 29) and lost load carrying capacity. Failure occurred at a superimposed shear of 51 kip. This behavior was captured by gage S1 (Figure 31) located on top of the girder. After inclined cracks formed in the web, the compressive strains on top of the slab at gage S1 decreased suddenly. As testing continued strain reported by S1 became tensile. This tensile action at the top of I2A resulted in cracking and instability of the compression load path. This type of failure has also been reported by Kostovos (1987).

Extensive cracking and spalling in the web exposed the transverse reinforcement (Figure 29). Orientation and spacing of the transverse bars were not consistent with the girder plans.

Rather than being oriented vertically, bars were inclined towards the load point. Also, the bars were spaced much closer than the specified 6" o.c. spacing.

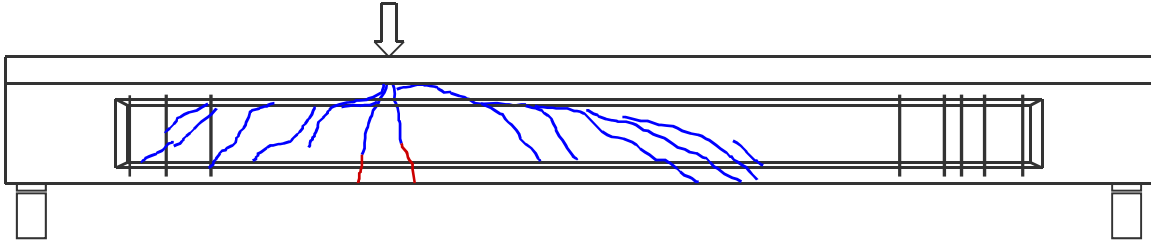
Figure 33–I2B crack pattern (initial cracks in red)

Comparing the locations of cracks and transverse reinforcement (Figure 33), it can be seen that cracks between the load and near support intersected transverse bars whereas cracks towards the far support did not. As the cracks towards the far support were large, it is unlikely that shear was carried by aggregate interlock at that end of the beam. Thus it is believed that the near side of the girder supported load by some combination of arch and truss action, and the far side supported load by arch action.

The limiting factor on ultimate strength of I2B was capacity of the web near the far support to withstand the formation and propagation of inclined cracks. Additional displacement beyond peak displacement would have resulted in failure of the truss and/or arch mechanisms; however it is unlikely that additional displacement would have accompanied load in excess of the previous peak. It is concluded that the girder strength was controlled by the web capacity, and it is presumed that the displacement capacity would have been controlled by failure of the arching action.

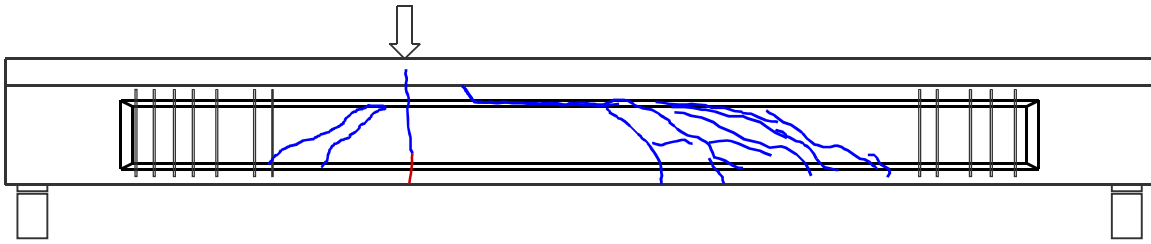
Figure 39-I6 cracks (initial crack in red).

Comparing the cracks with the locations of transverse steel (Figure 36), cracks intersected transverse reinforced on the near side of the beam, but not on the far end. Shear was carried by truss action to the near support, and arch action to the far support.

The limiting factor on girder strength was capacity of the web on the far support side to withstand the formation and propagation of inclined cracks. Additional displacement beyond the tested peak would likely have resulted in failure of the truss and/or arch mechanisms, however it is unlikely the additional displacement would have resulted in that the loads in excess of the observed peak. Girder strength was controlled by the web capacity and it is presumed that displacement capacity would have been controlled by failure of the arch and/or truss mechanisms.
