# **Long Term Monitoring of Mechanical Properties of FRP Repair Materials**

Rebecca A. Atadero, Assistant Professor  
Douglas G. Allen, Graduate Research Assistant  
Oscar R. Mata, Graduate Research Assistant  
Department of Civil & Environmental Engineering  
Colorado State University  
Fort Collins, CO

Mountain-Plains Consortium  
and  
Colorado Department of Transportation  
DTD Applied Research and Innovation Branch  
Denver, CO

June 2013

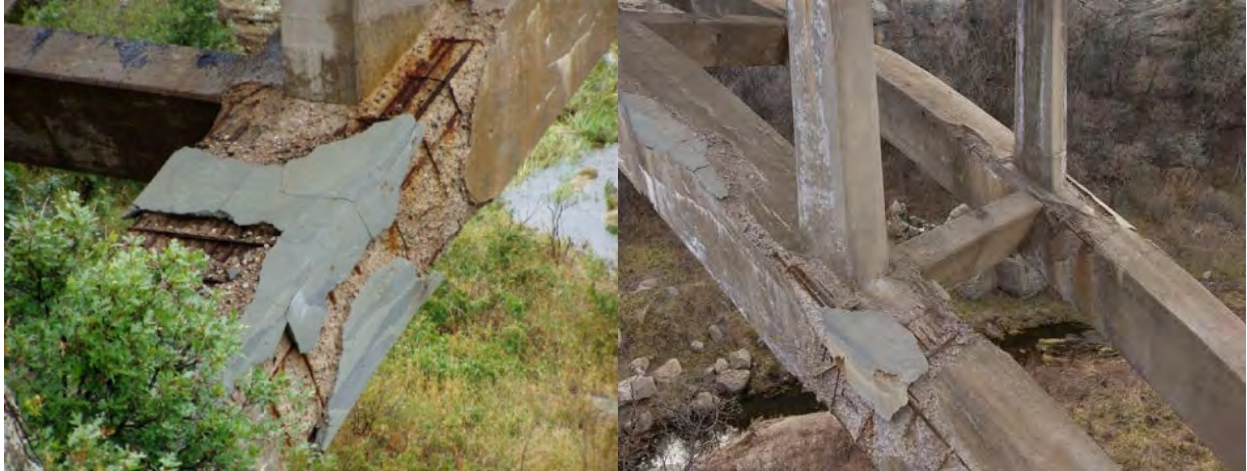
Prior to repair, the concrete arches had severe spalling due to the corrosion of the internal steel reinforcement as seen in the photographs in Figure 2.8.

**Figure 2.8** Concrete spalling on arch section prior to repair (Mohseni, CDOT)

Loose concrete, typically no more than the few inches of concrete cover, was removed with 6.8 kg (15 lb.) jack hammers and the exposed steel reinforcement was sandblasted free of rust. As seen below, the cross-section was restored with shotcrete, which included a corrosion inhibitor, Sika FerroGard 903, to prevent further corrosion of the steel reinforcement.

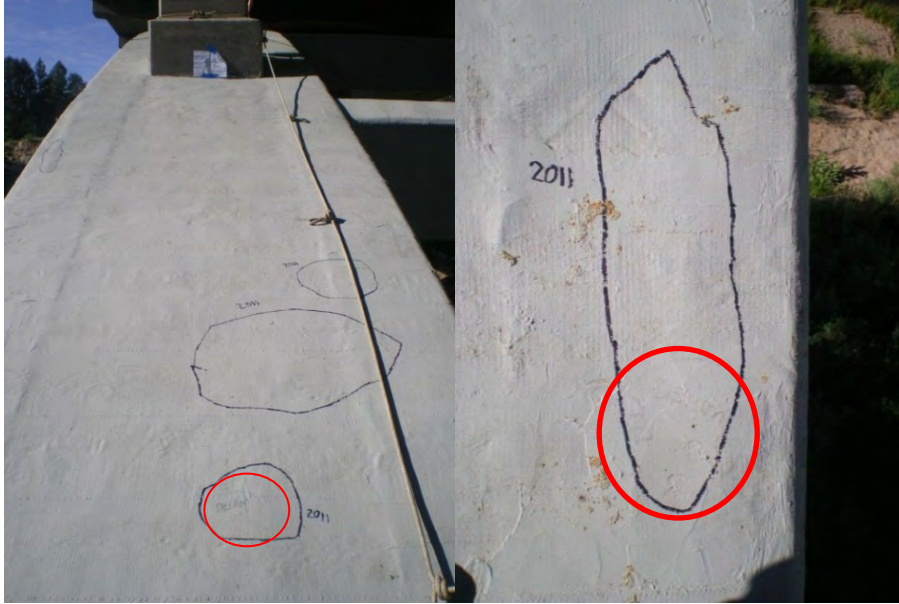
Markings made with a permanent marker on the bridge from the 2007 bridge inspection were barely visible at the time of the 2011 field assessment. Depending on the exposure from moisture and sun, markings on the bridge can exist for only a relatively short time with respect to the life span of the bridge. Below are three photographs of the areas identified from June 2007, two of which were barely visible at the time of the July 2011 visit. There were no markings found on the east arch from the inspections in 2005 and 2009. In addition to the three voids, three cracks in the CFRP were also identified in 2007, one of which can be seen below.

**Figure 2.14** Outlined in permanent marker are identified areas of debonding between the FRP and the substrate developed in the structure between inspections in 2007 and 2011. Faintly denoted in the bottom of the photographs (enclosed in red circles) are previously found voids identified with “DELAM 07” and lines distinguishing the boundaries of the voids.

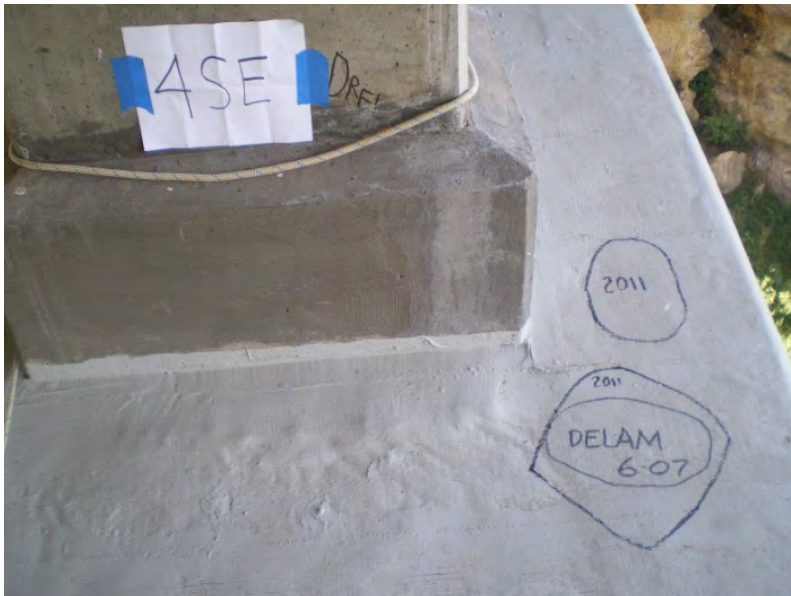
**Figure 2.15** Enclosed in permanent marker are identified areas of debonded areas between the FRP and the substrate from 2011 and June, 2007. Notice in this more protected bay of the structure the markings from 2007 are more clearly visible.

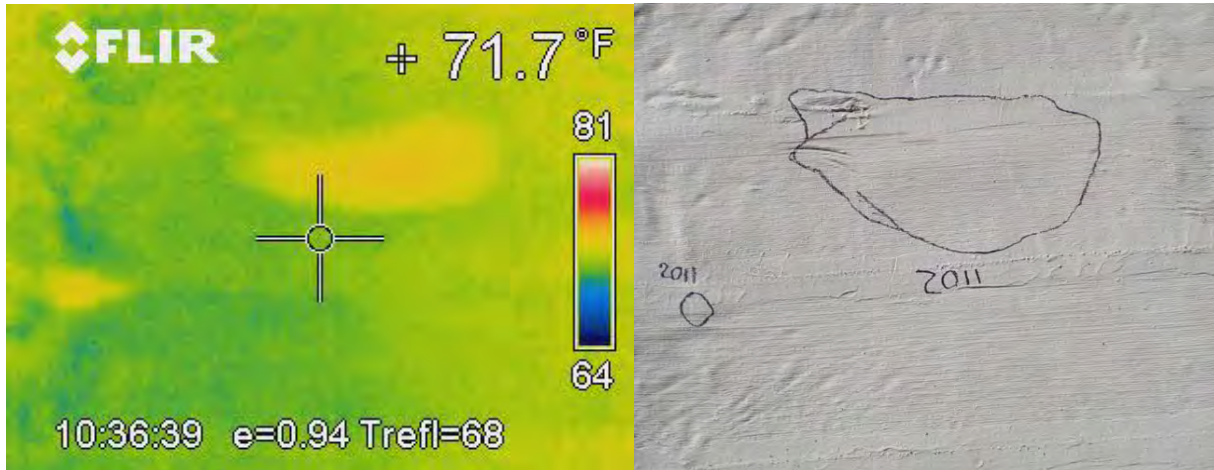
**Figure 3.1** Photograph and thermal image from an infrared camera of two voids, (appearing yellow), found in 2011 on the first bay on the north side of the east arch

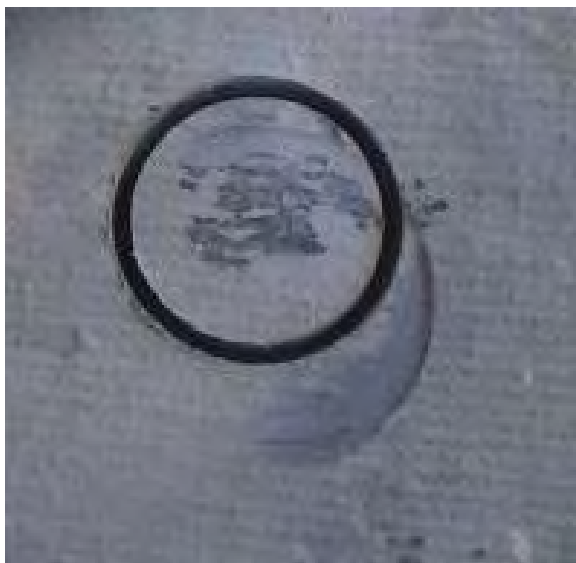
**Figure 3.4** Damage caused by core bit without the use of the jig

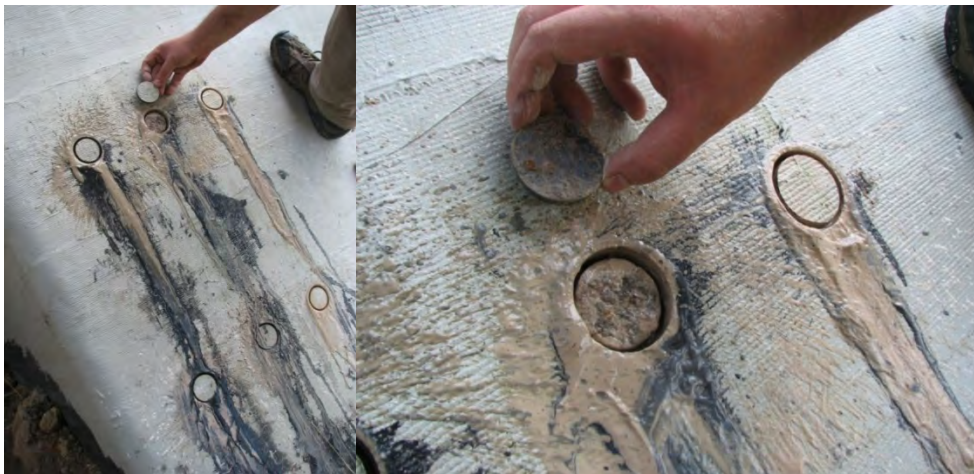
Adding torsional stresses to the circular area of CFRP and substrate inside the cored circle was inevitable due to the drilling process. These stresses were minimized by using a less aggressive drill bit with diamonds instead of a coring bit, which has more aggressive carbide teeth for instance. Wet drilling by use of the ice also reduced stresses by adding water, which created a slurry that removed displaced debris while using the finer particles to aid the diamonds in the cutting process. In one instance out of the 27 cored locations, the stresses induced by the drilling were enough to fail the cored section at the interface between the CFRP and the substrate. Figure 3.6 illustrates this occurrence.

**Figure 3.6** The core drilling location that failed due to torsional stresses during the core drilling process, bay 1NW

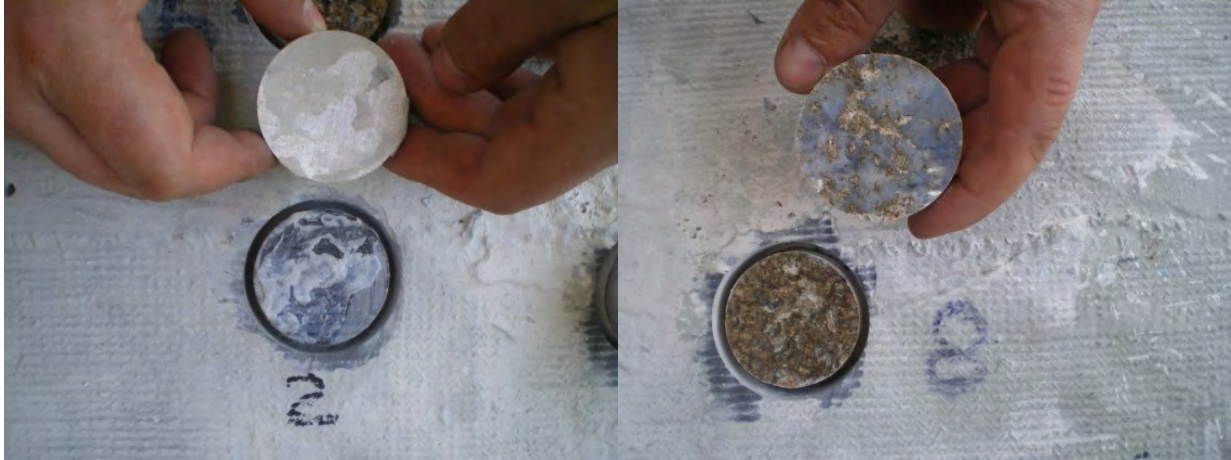
**Figure 3.14** Failure Mode A: bonding adhesive failure at loading fixture (on left), Failure Mode E: Adhesive failure at CFRP/substrate adhesive interface (on right)

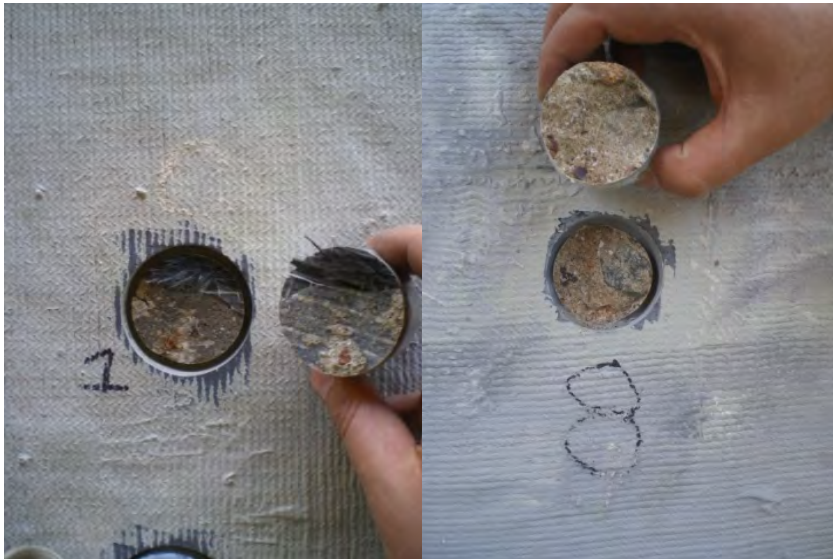
**Figure 3.15** Failure Modes B and F: cohesive failure in FRP laminate, and mixed cohesive failure in substrate and adhesive failure at the adhesive/substrate interface, respectively (on left), Failure Mode G: cohesive failure in concrete substrate (on right)

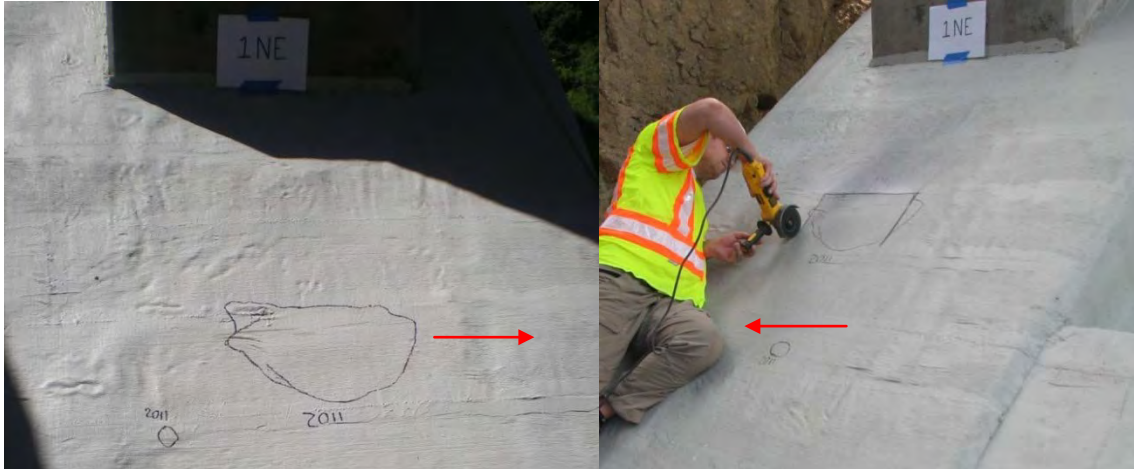
Upon cutting the lower edge of the CFRP rectangle, water exited the cut at the bottom of the void, revealing standing water at the interface between the CFRP and substrate. Photographs of the void and the removal of the CFRP layer are shown in Figures 3.20, 3.21, and 3.22.

**Figure 3.20** Void in CFRP with transverse crack identified with red arrows and Cutting the perimeter of the void in the CFRP

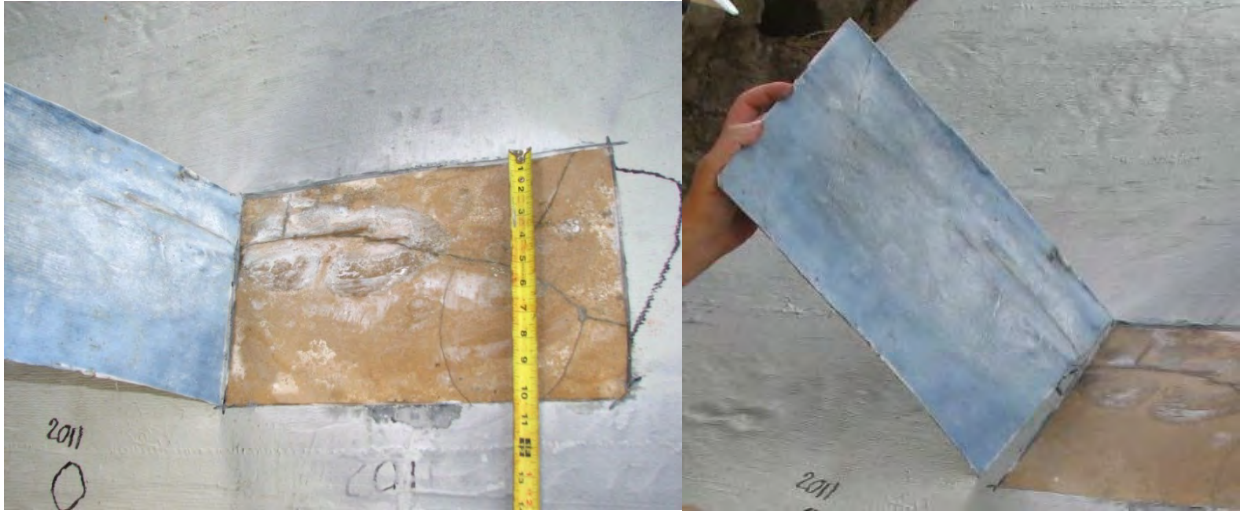
**Figure 3.22** Cracks in the substrate were transmitted through the CFRP and notice the smooth texture and blue and white color of the underside of the CFRP

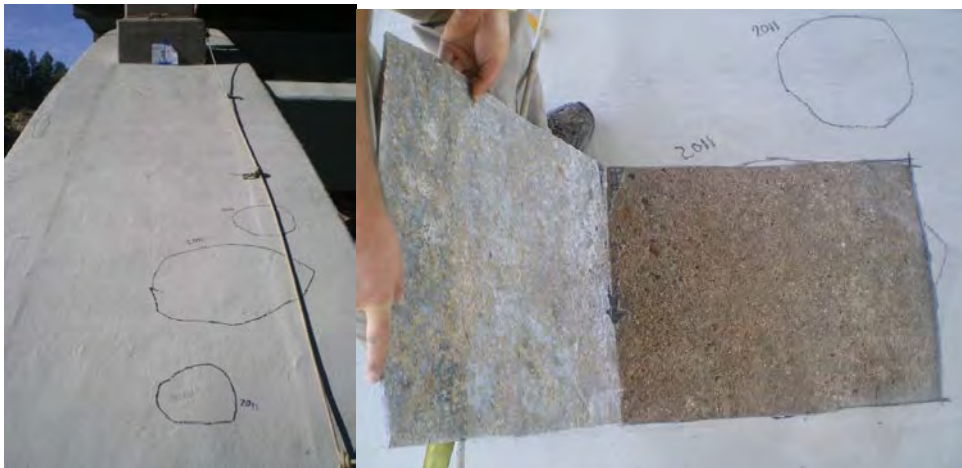
The second void was removed from the third bay on the north end of the east arch. A rectangular section of the CFRP was removed with the same procedure previously described. Photographs of the area of the void and the removal of the CFRP rectangle are in Figure 3.23. There was no standing water or evident moisture in this larger void area, but there was significant pieces of the substrate adhered to the underside of the CFRP patch removed.

**Figure 3.23** Voids found in the third bay on the north end of the east arch and removal of the CFRP of the largest void

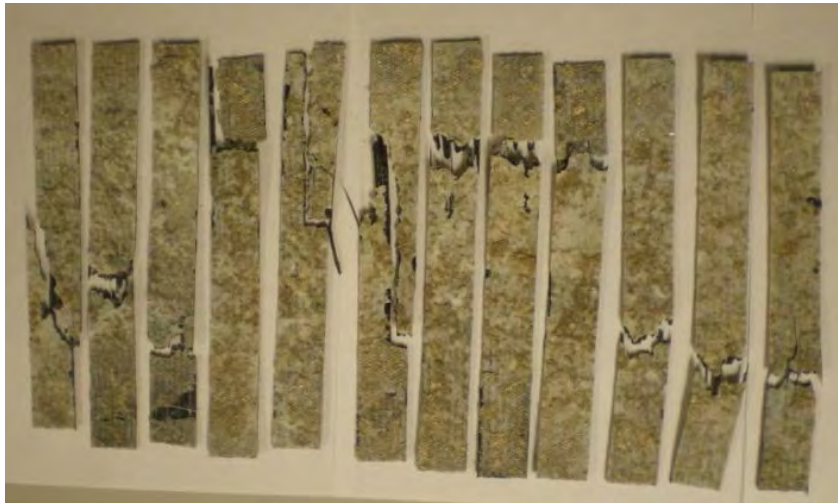
**Figure 4.2** Failed tensile test specimens from the large void removed from bay 3NE. Note the oatmeal appearance

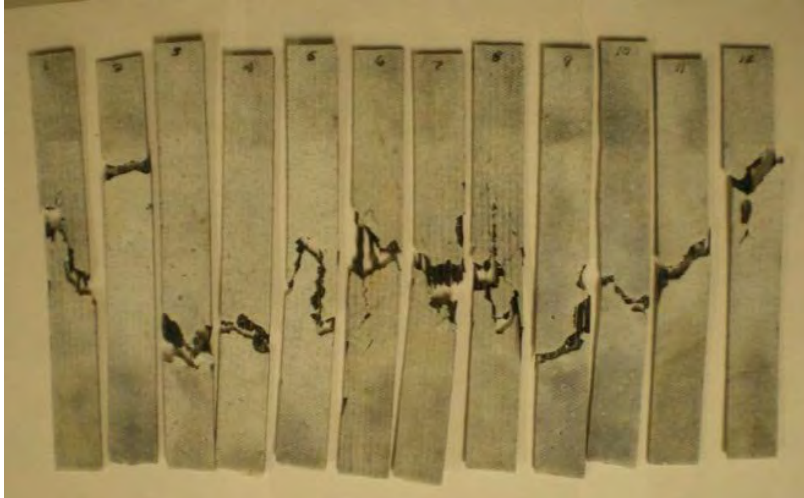
**Figure 4.3** Failed tensile test specimens from the small void removed from bay 1NE. Note the milky appearance.

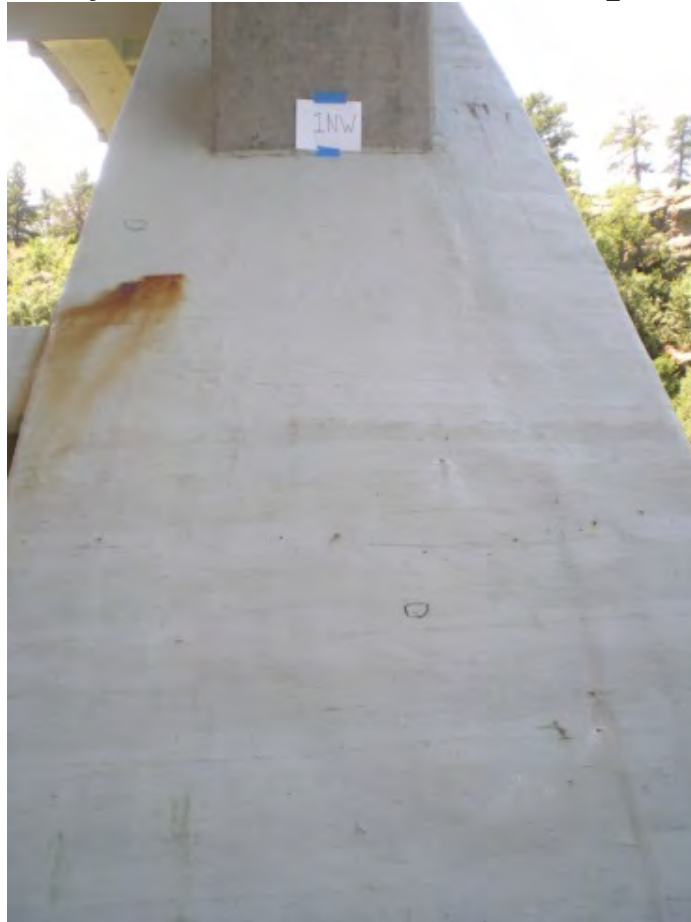
**Figure A1.** Bay 1NW, 2 of the 3 small voids and rust spot

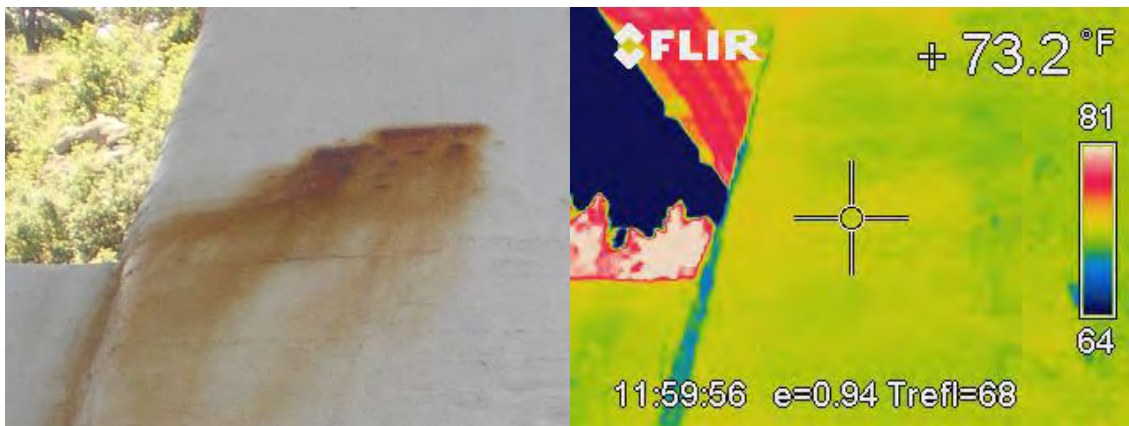
**Figure A2.** Photograph and thermal image of rust spot

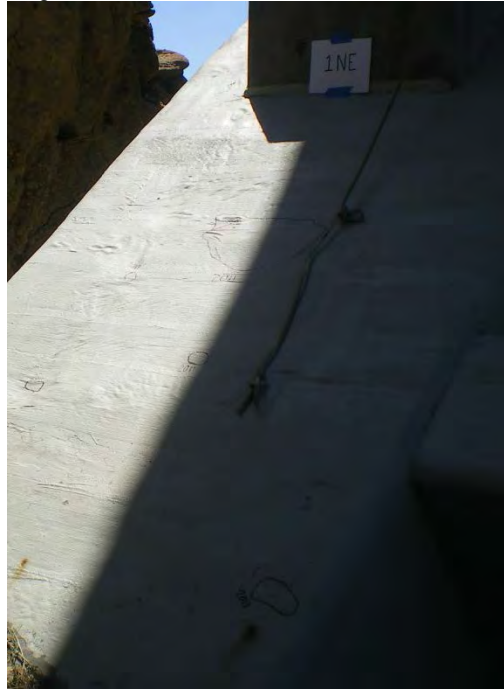
**Figure A3.** Bay 1NE, 5 voids

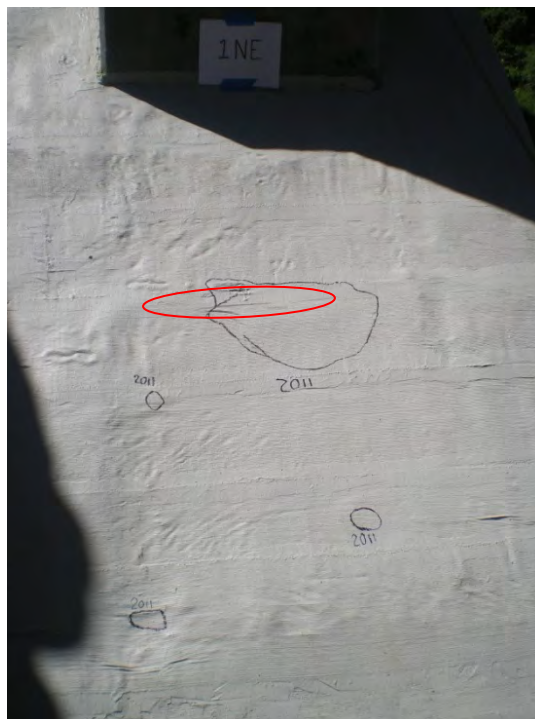
**Figure A4.** Bay 1NE, 4 of the 5 voids; Crack exists, enclosed in red oval, in the top of the largest void

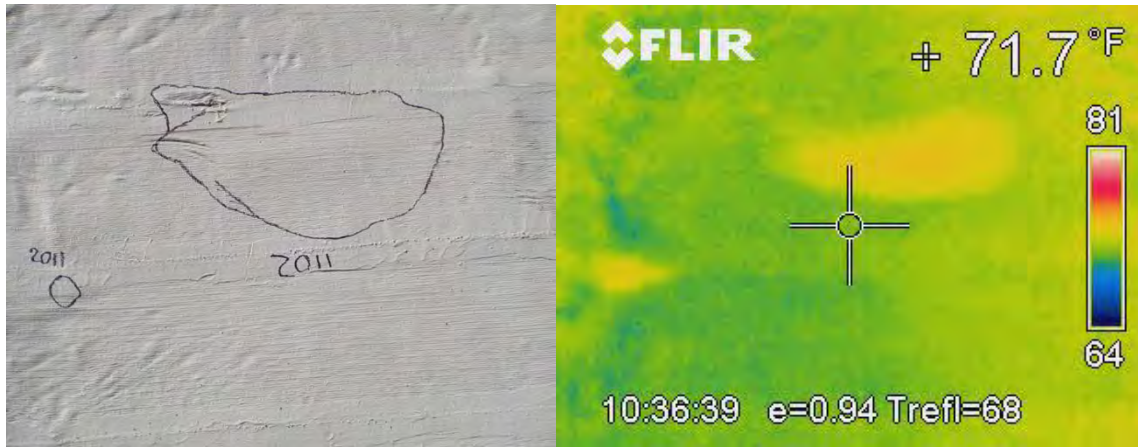
**Figure A5.** Photograph and thermal image of two voids in Bay 1NE

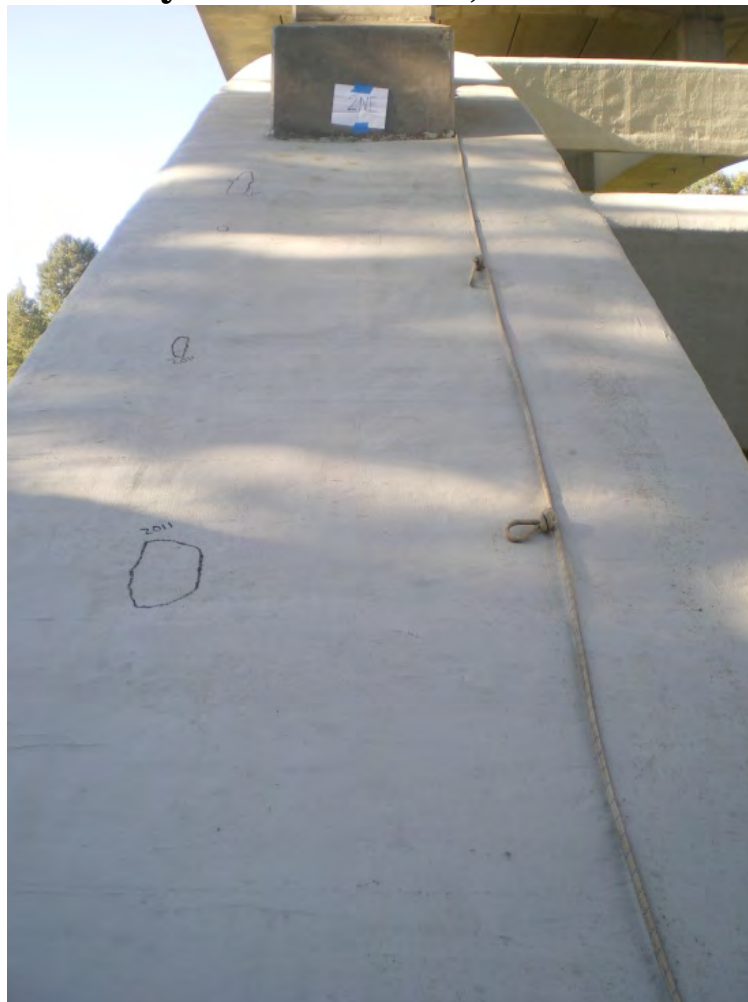
**Figure A6.** Bay 2NE, 3 Voids

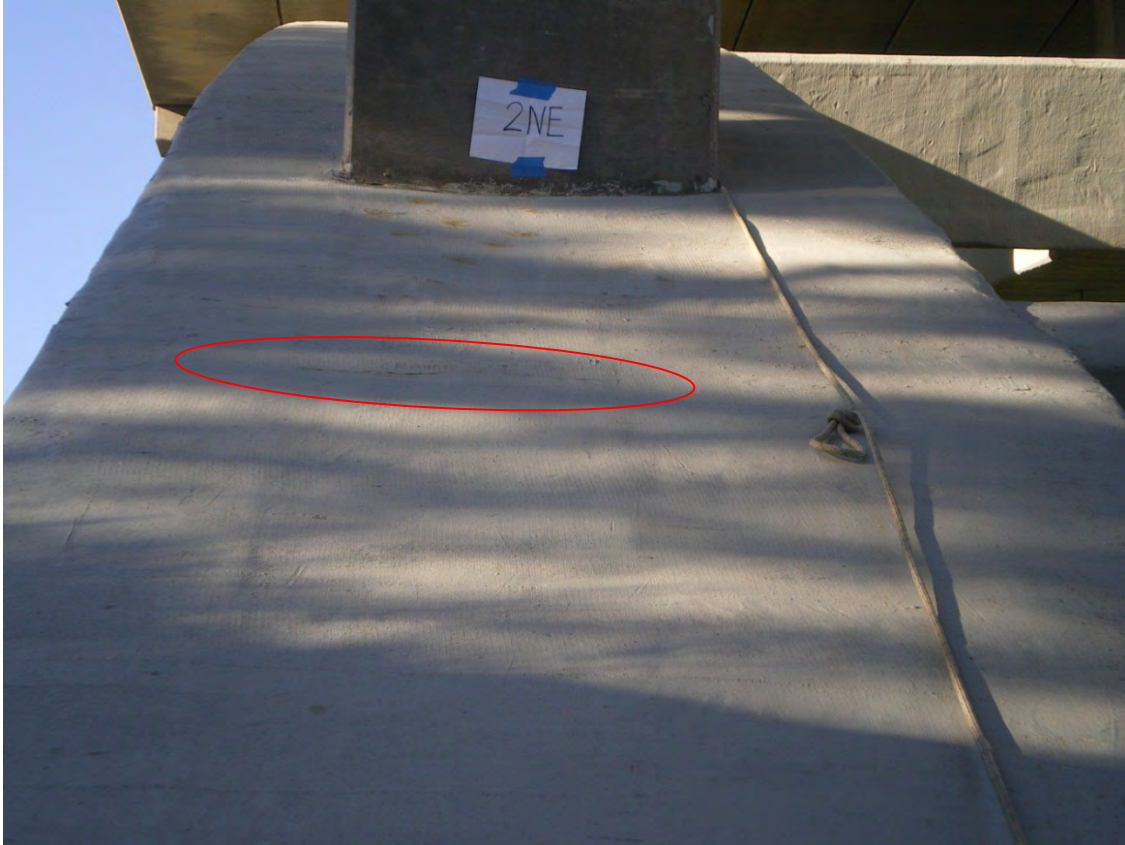
**Figure A7.** Bay 2NE, Crack enclosed in red oval was identified in 2007

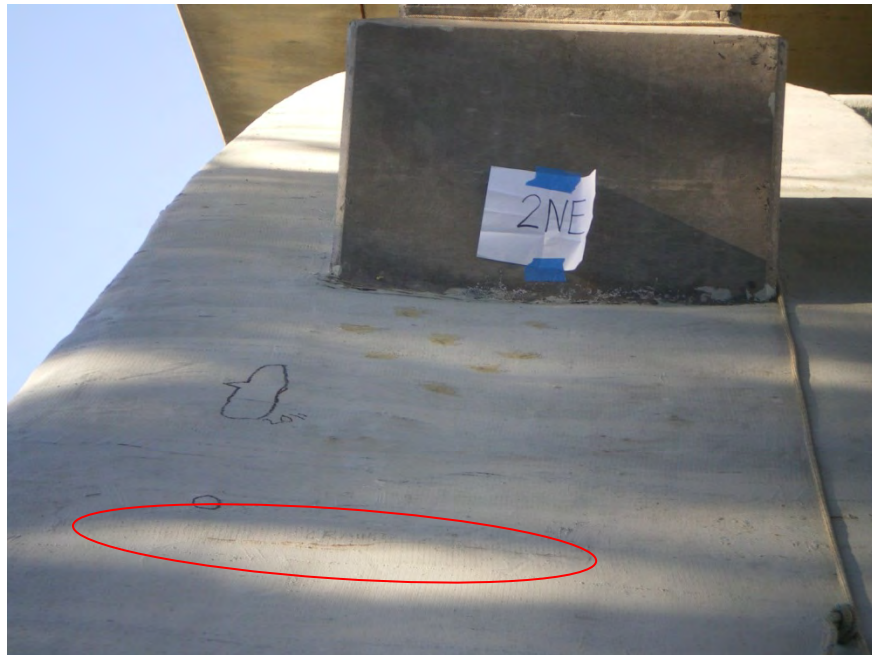
**Figure A8.** Previously identified in 2007, a crack enclosed in the red oval, no debonding at the location of the crack

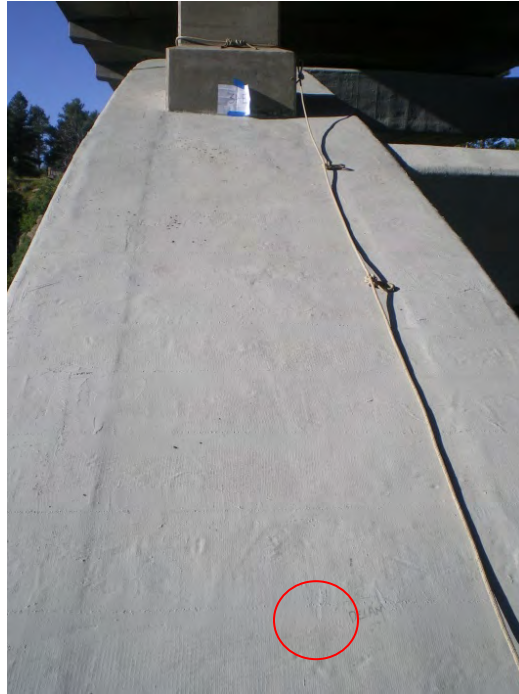
**Figure A9.** Bay 3NE with 1 of the 2 defects found in 2007 shown

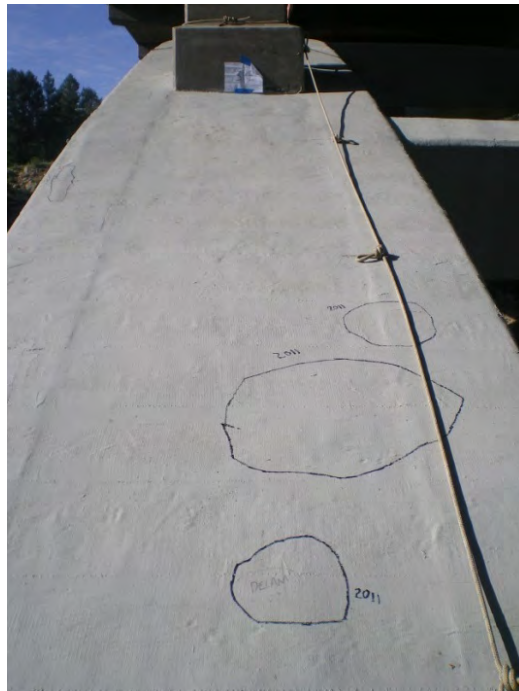
**Figure A10.** 4 of the 5 voids found in 2011

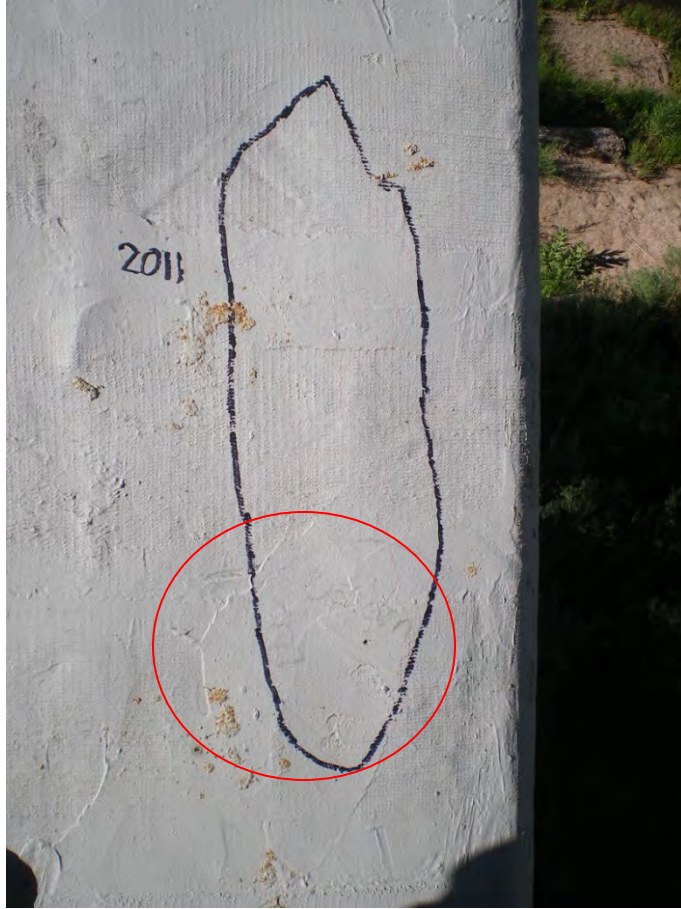
**Figure A11.** Enclosed in the red circle is 1 of the 2 voids found in 2007

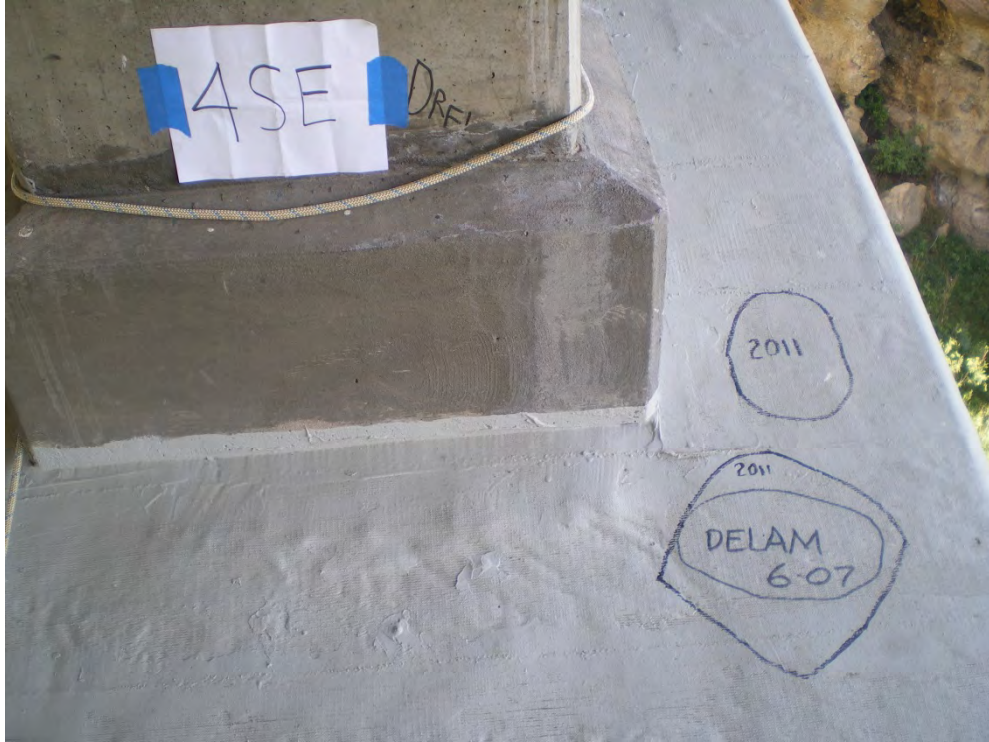
**Figure A17.** Void from 2007 has grown and a new void developed

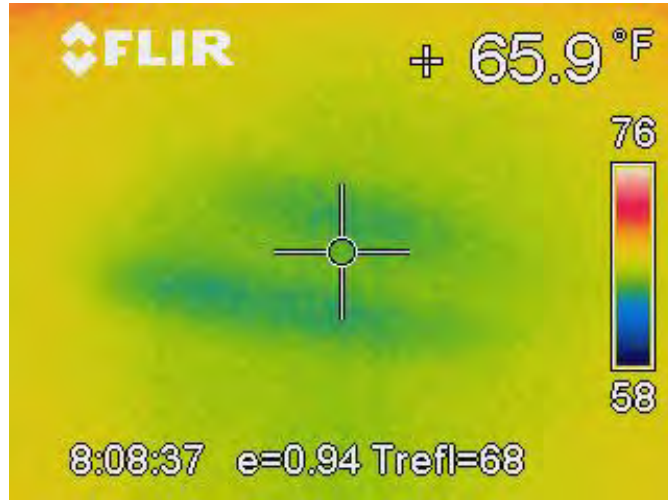
**Figure A19.** Thermal image of cracks previously identified in 2007

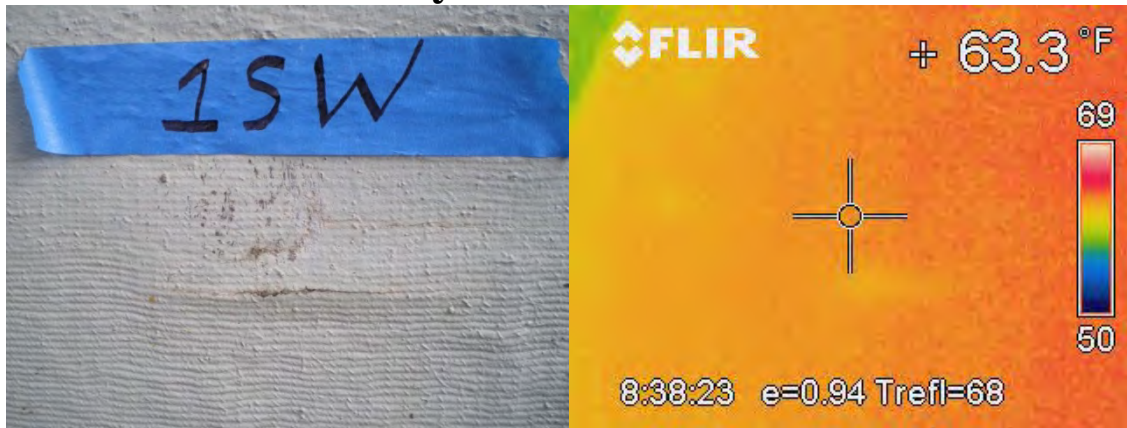
Figure A24. Photograph and thermal image of a defect found in Bay 1SW

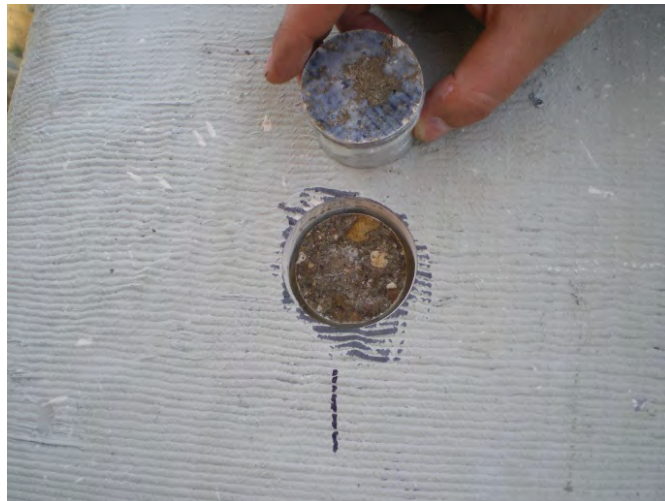
**Figure B9.** Test No.10, weak bond strength, and Test No.11 not available, cored area failed during drilling
