LONG-TERM MONITORING OF MECHANICAL PROPERTIES OF FRP REPAIR MATERIALS

July 2013

COLORADO DEPARTMENT OF TRANSPORTATION
DTD APPLIED RESEARCH AND INNOVATION BRANCH

Report No. CDOT 2013-13

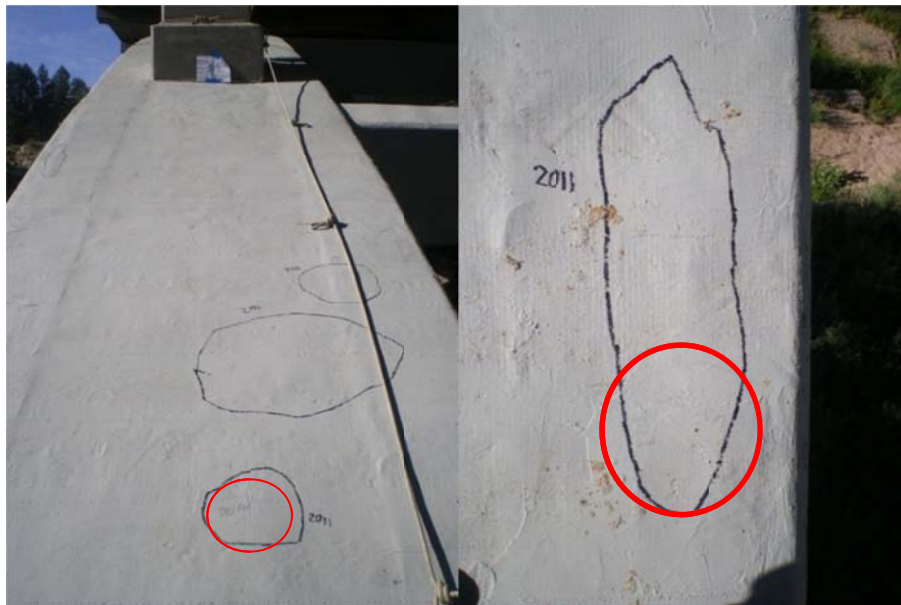
Figure 2.14. Outlined in permanent marker are identified areas of debonding between the FRP and the substrate developed in the structure between inspections in 2007 and 2011. Faintly denoted in the bottom of the photographs (enclosed in red circles) are previously found voids identified with “DELAM 07” and lines distinguishing the boundaries of the voids.

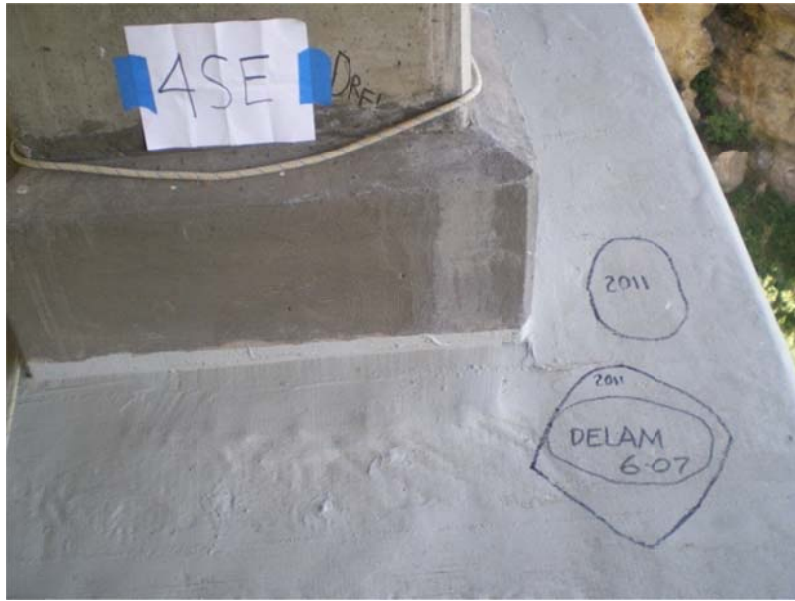
Figure 2.15. Enclosed in permanent marker are identified areas of debonded areas between the FRP and the substrate from 2011 and June, 2007. Notice in this more protected bay of the structure the markings from 2007 are more clearly visible.

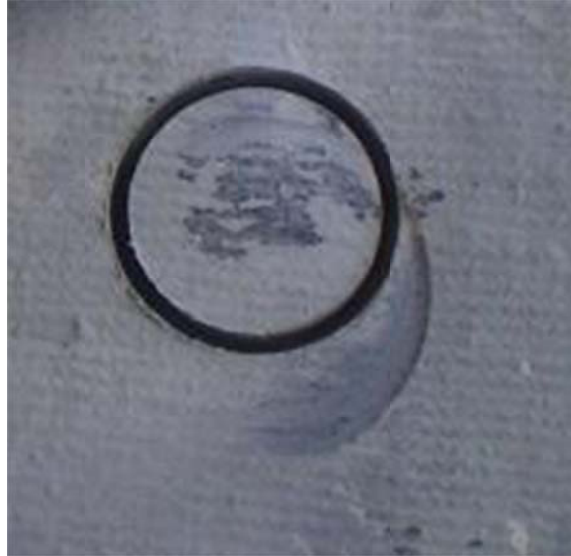
Figure 3.4. Damage caused by core bit without the use of the jig

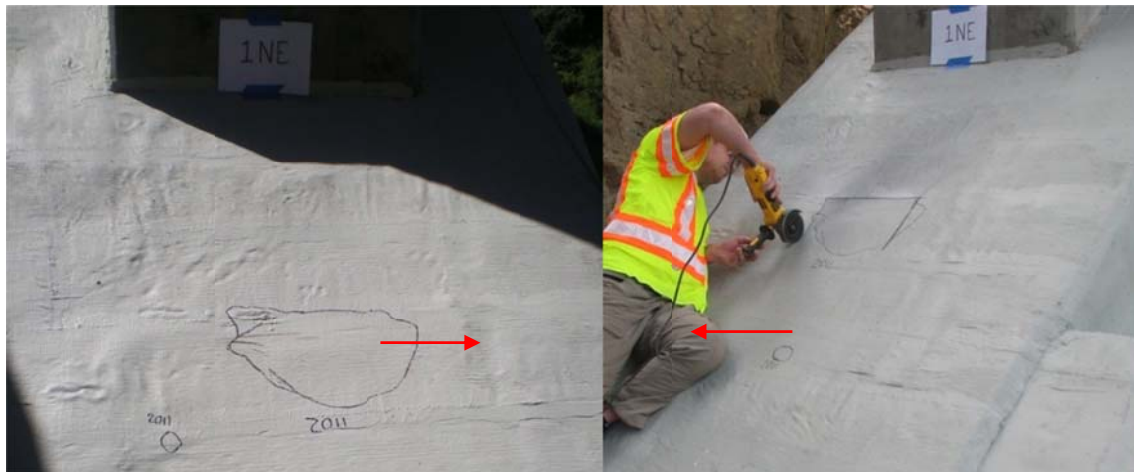
Upon cutting the lower edge of the CFRP rectangle, water exited the cut at the bottom of the void revealing standing water at the interface between the CFRP and substrate. Photographs of the void and the removal of the CFRP layer are shown in Figures 3.20, 3.21 and 3.22 below.

Figure 3.20. Void in CFRP with transverse crack identified with red arrows and cutting the perimeter of the void in the CFRP

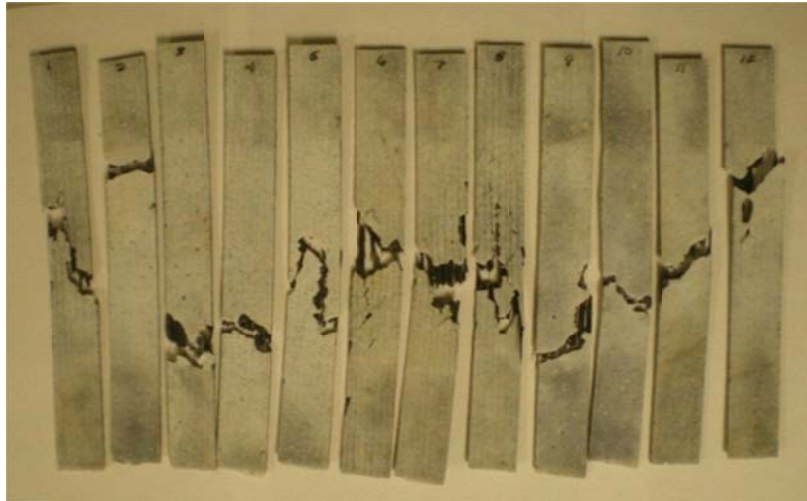
Figure 4.3. Failed tensile test specimens from the small void removed from bay 1NE, note the milky appearance

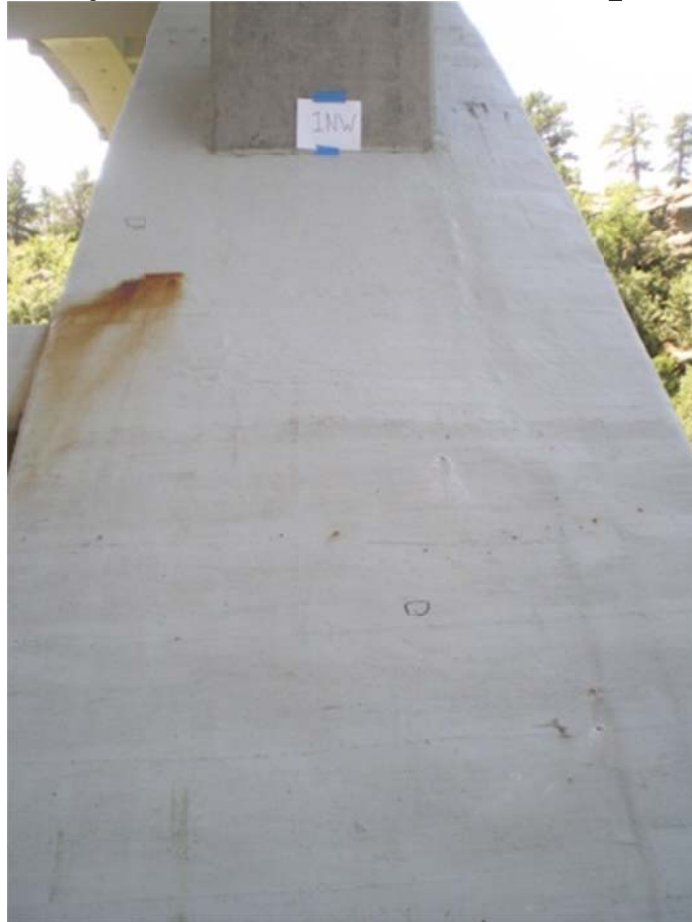
Bay 1NW: 3 Voids, 1 Rust Spot

Figure A1. Bay 1NW, 2 of the 3 small voids and rust spot

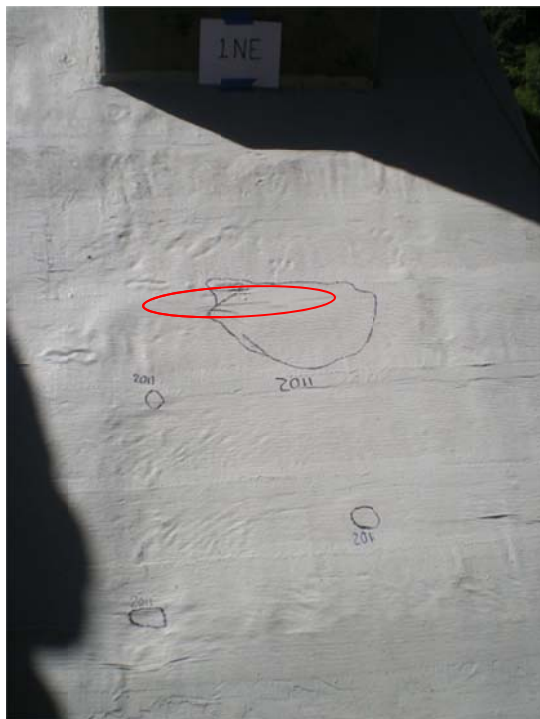
Figure A4. Bay 1NE, 4 of the 5 voids; crack exists, enclosed in red oval, in the top of the largest void

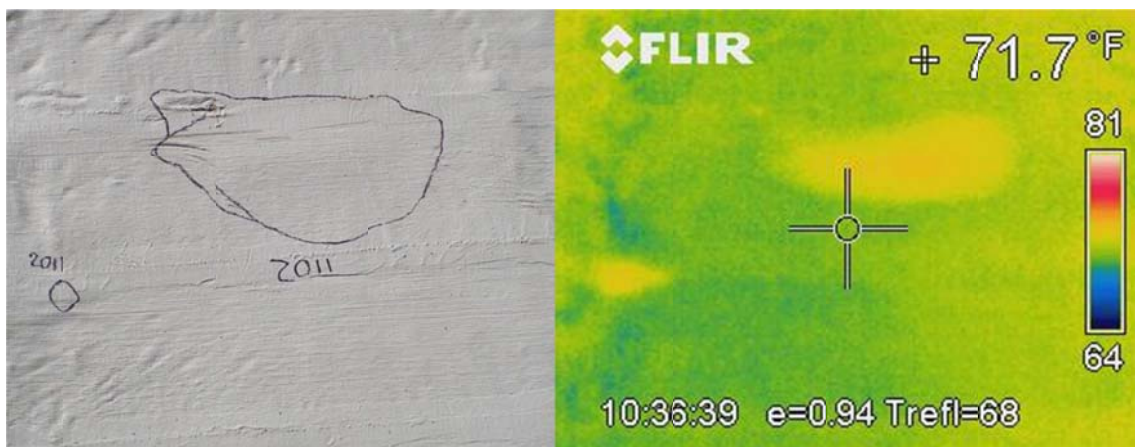
Figure A5. Photograph and thermal image of two voids in Bay 1NE

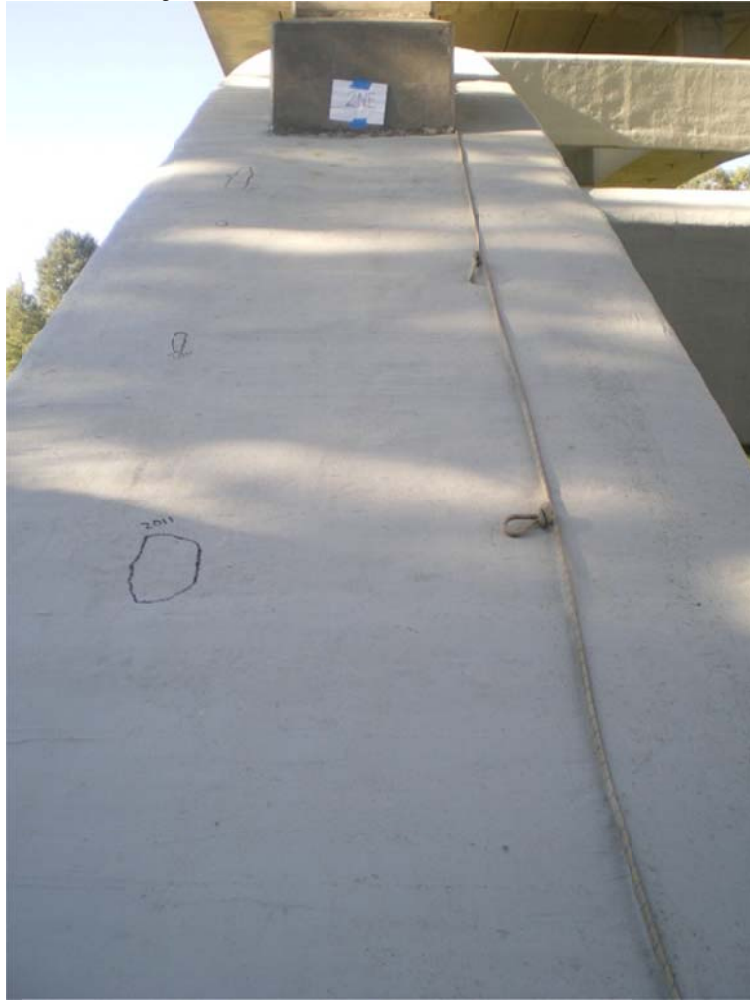
Figure A6. Bay 2NE, 3 voids

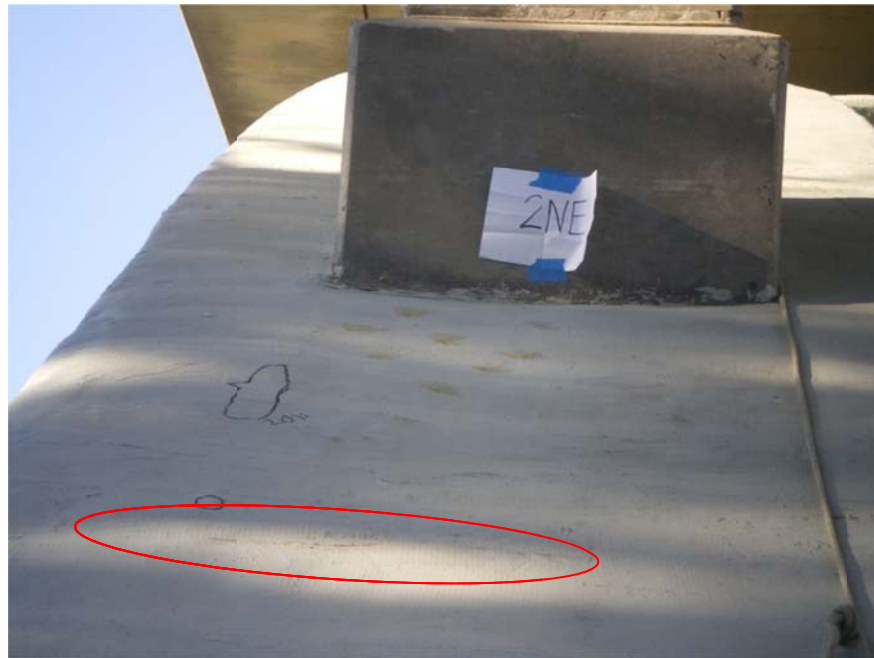
Figure A8. Previously identified in 2007, a crack enclosed in the red oval, no debonding at the location of the crack

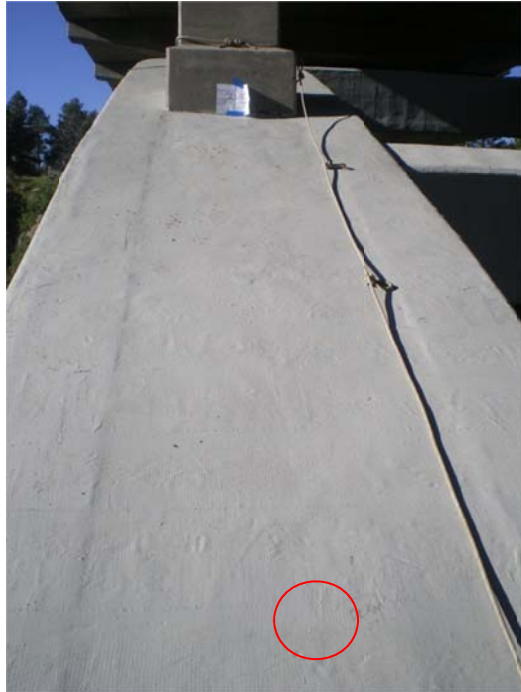
Figure A9. Bay 3NE with 1 of the 2 defects found in 2007 shown

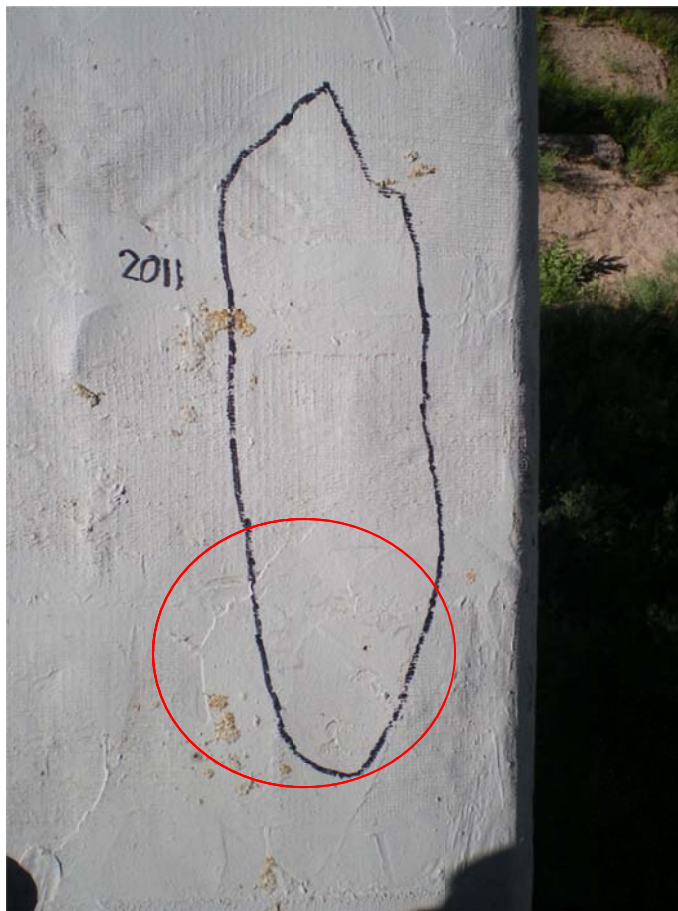
Figure A11. Enclosed in the red circle is 1 of the 2 voids found in 2007

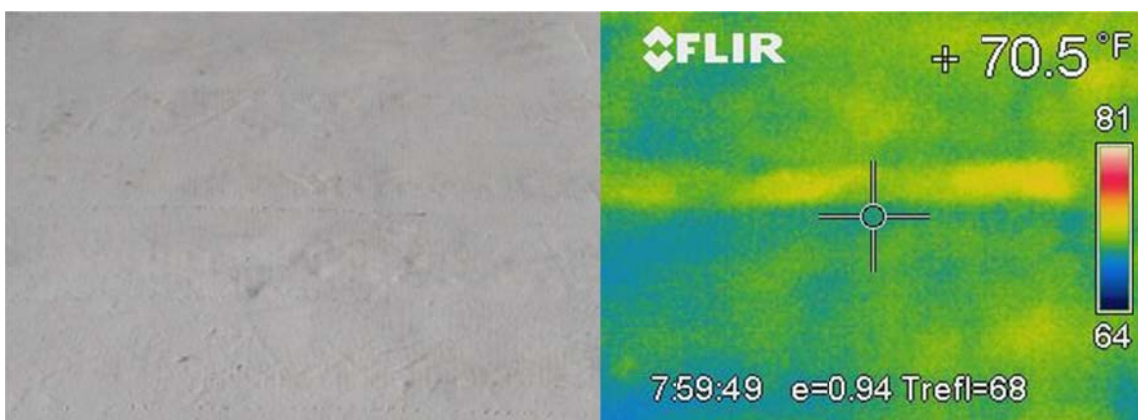
Figure A12. Photograph and thermal image of a seam in the CFRP sheets, no void present

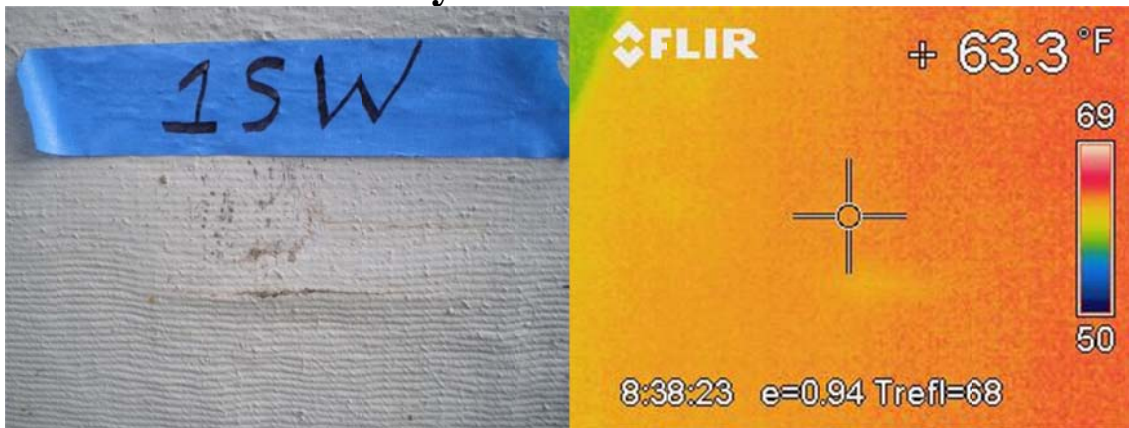
Figure A24. Photograph and thermal image of a defect found in Bay 1SW

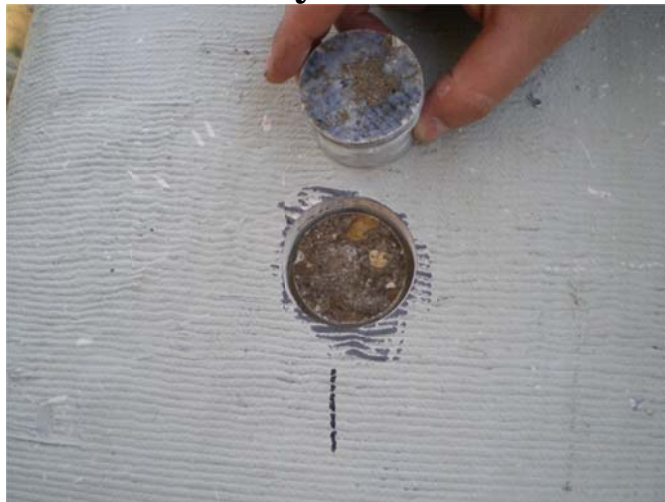
Figure B9. Test No.10, weak bond strength, and test No.11 not available, cored area failed during drilling
