WISCONSIN HIGHWAY RESEARCH PROGRAM

1. Report No. WHRP 0092-11-08	2. Government Accession No	3. Recipient's Catalog No	
4. Title and Subtitle Procedures, Cost and Effectiveness for Deteriorated Bridge Substructure Repair		5. Report Date March 2013	6. Performing Organization Code Wisconsin Highway Research Program

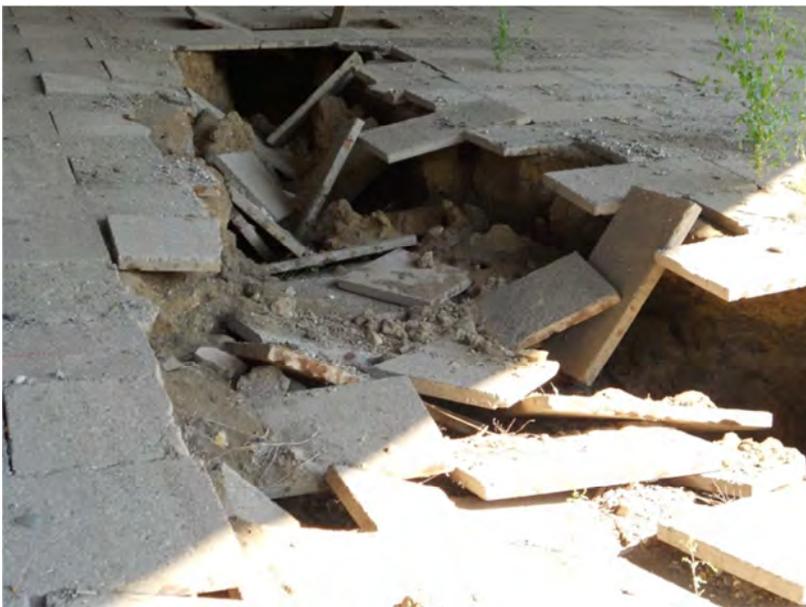
Figure 2.2 B-40-0115 Slope Embankment Failure

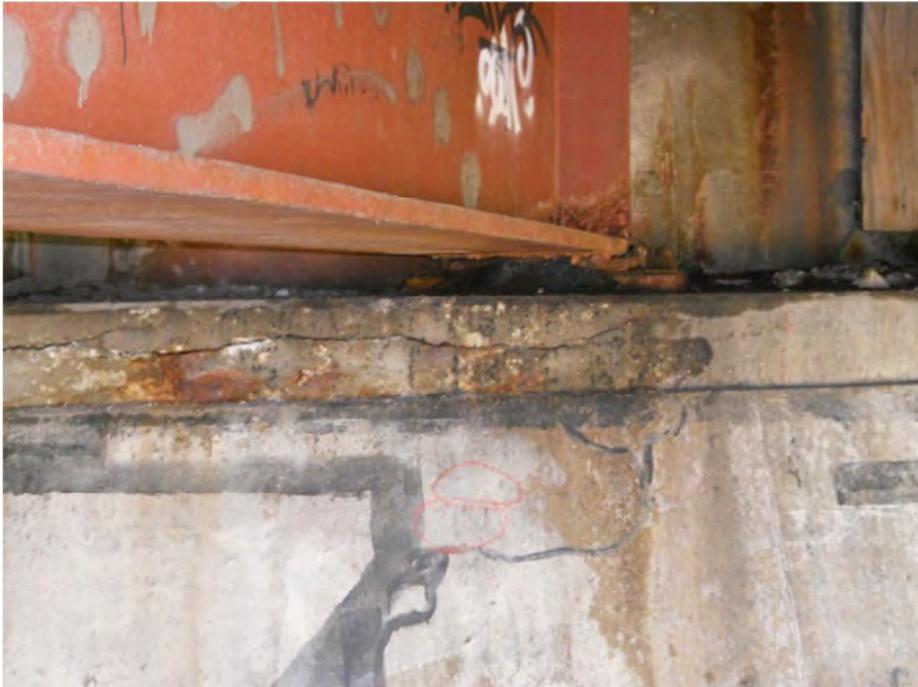
Figure 2.3 B-40-0115 Cracking of Sill Abutment

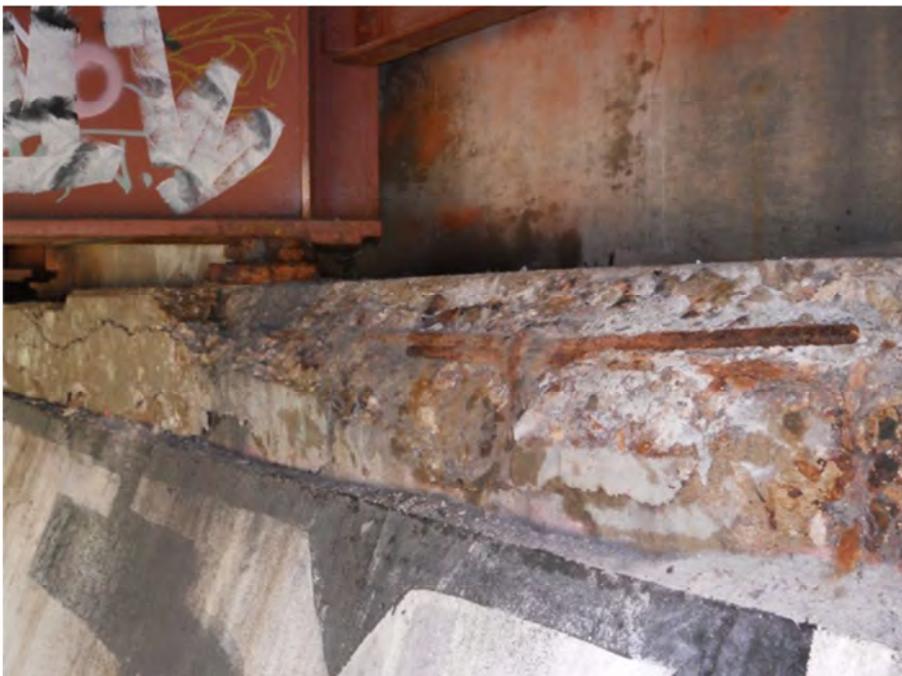
Figure 2.4 B-40-0115 Spalling of Sill Abutment

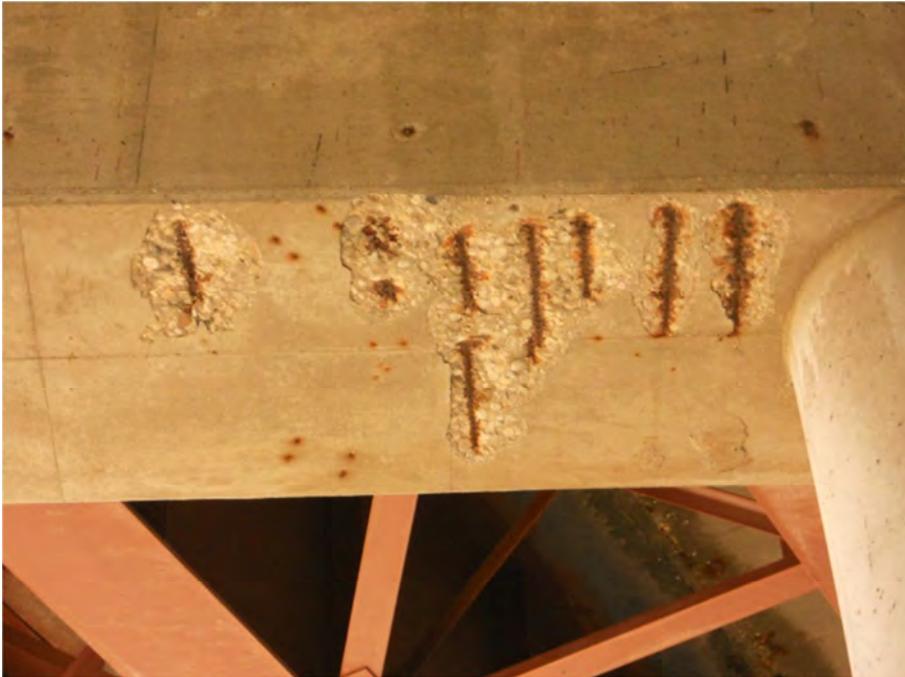
Figure 2.5 B-40-0115 Pier Cap Spalling

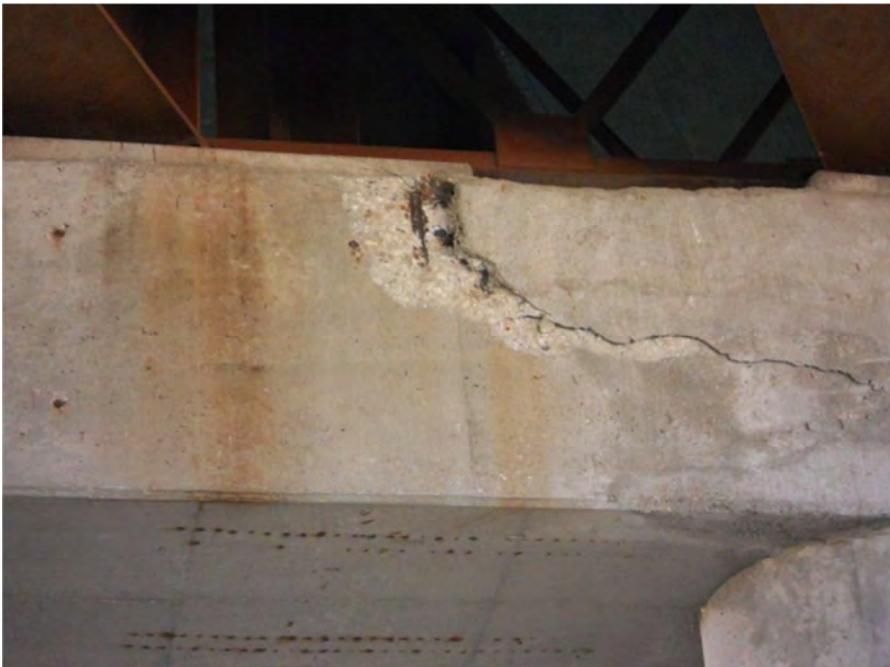
Figure 2.6 B-40-0115 Pier Cap Spalling and Cracking

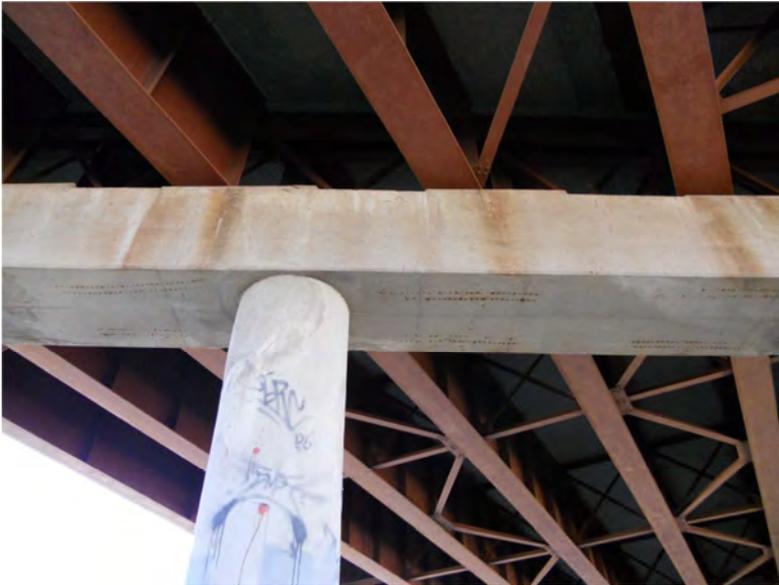
Figure 2.7 B-40-0115 Rust Staining on Pier Cap

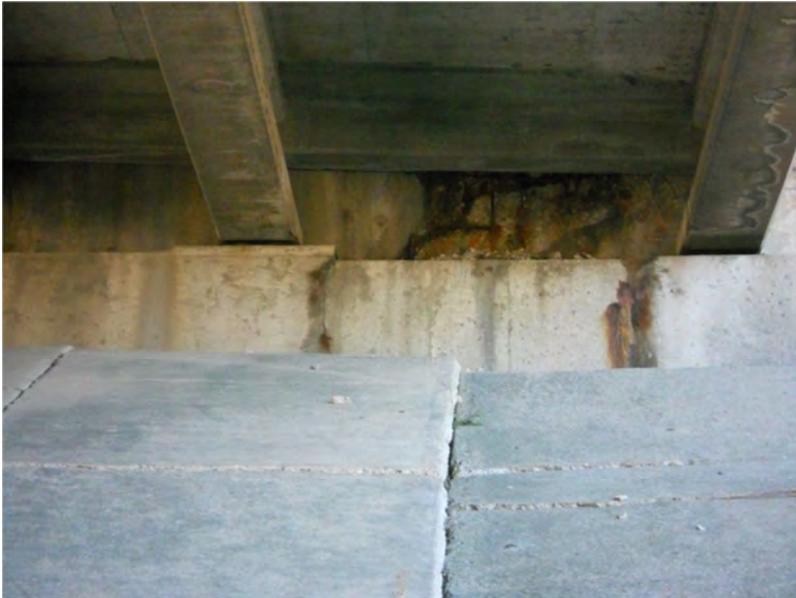
Figure 2.13 B-40-0226 Abutment Shear Failure

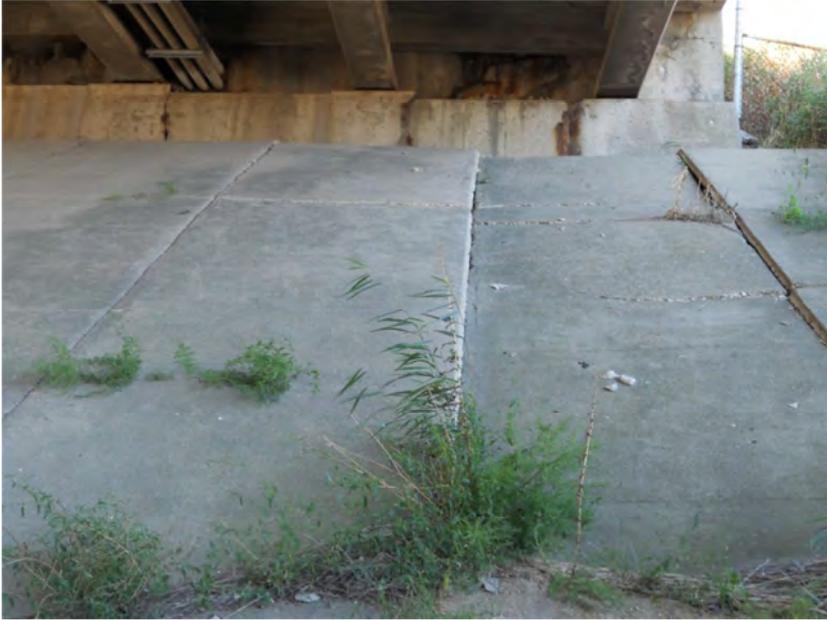
Figure 2.15 B-40-0226 Undermining of Slope Embankment

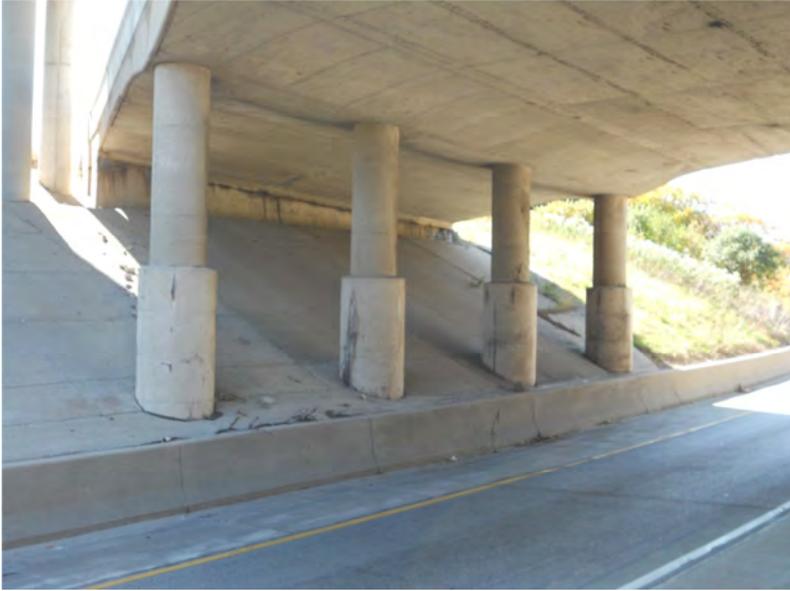
Figure 2.19 B-40-0189 Pier Column Encasement

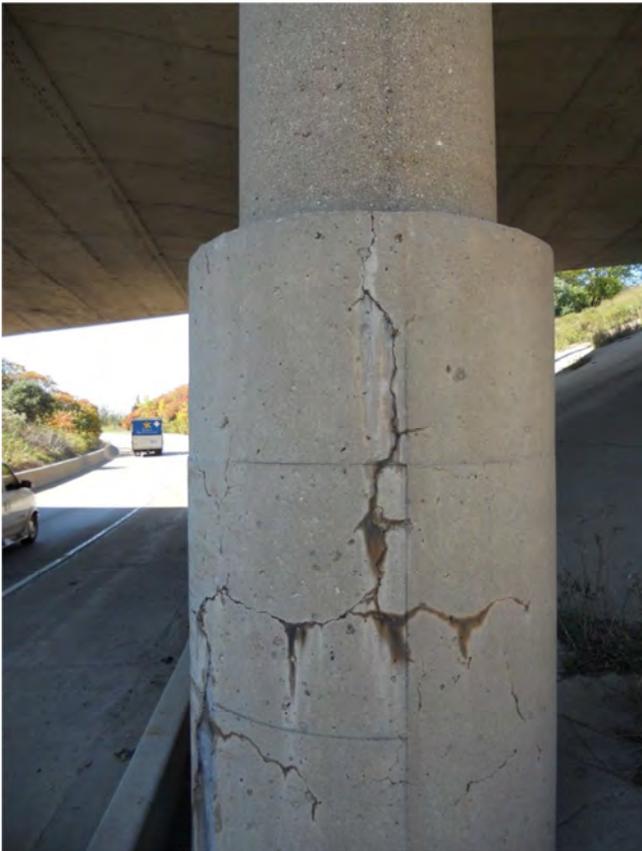
Figure 2.20 B-40-0189 Pier Column Encasement Cracking

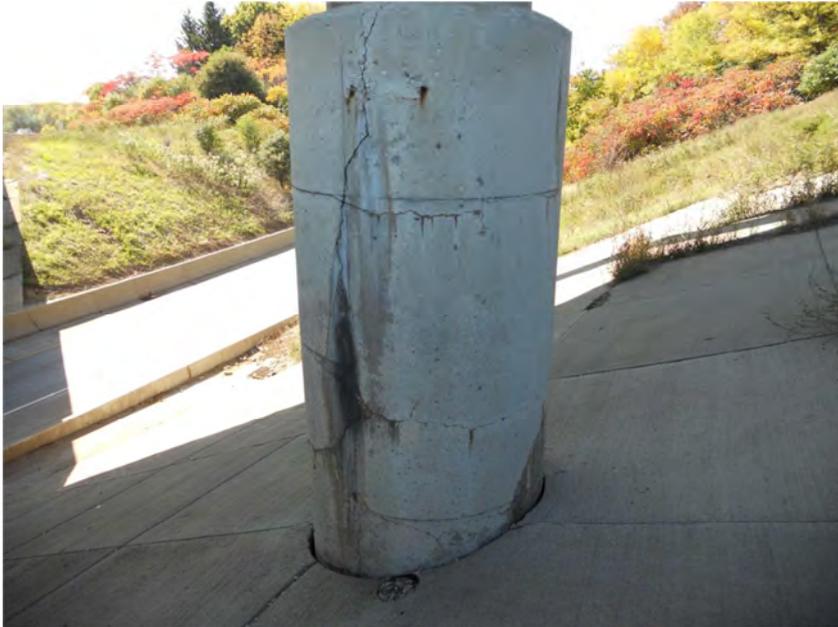
Figure 2.23 Bridge B-40-0188 Pier Column Encasement Cracking

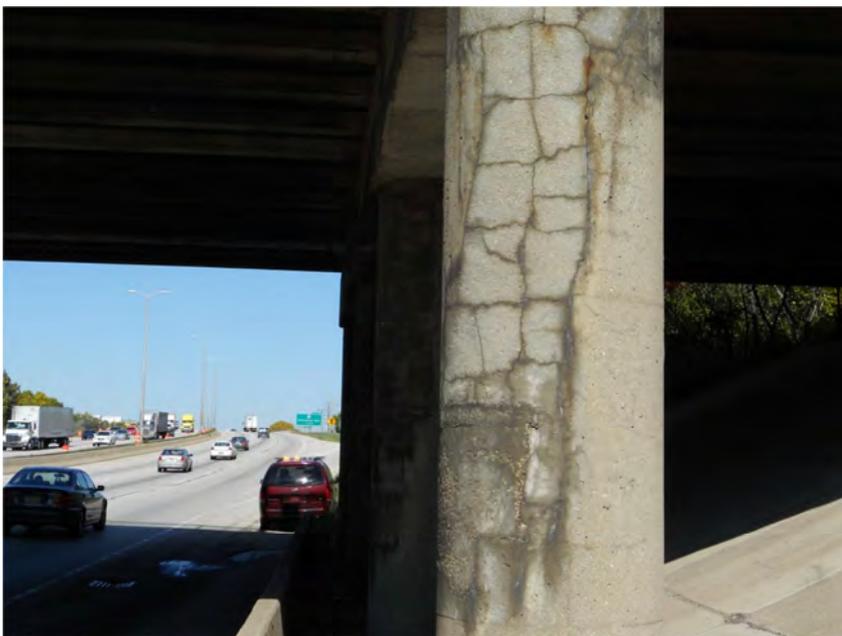
Figure 2.24 Bridge B-40-0122 Concrete Pier Column Patch Cracking

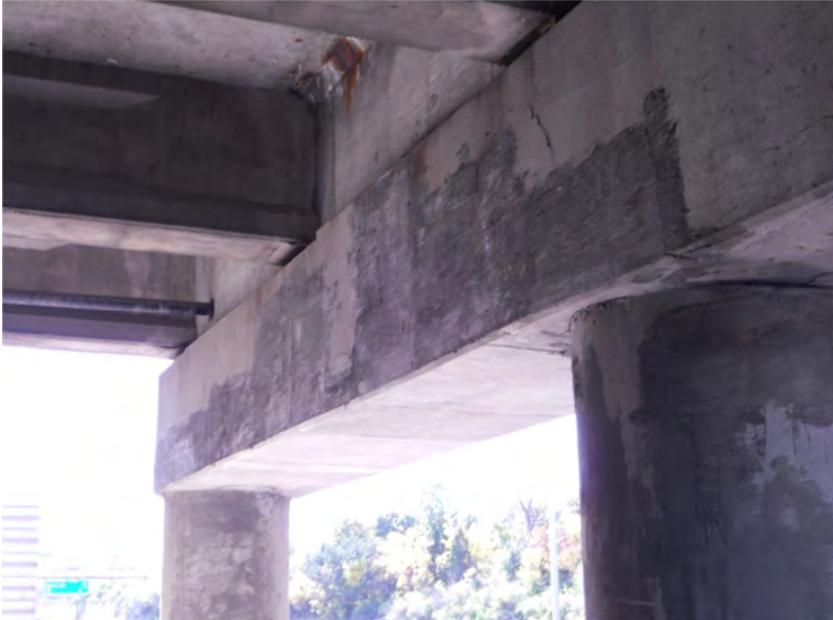
Figure 2.25 Bridge B-40-0122 Concrete Pier Cap Patch

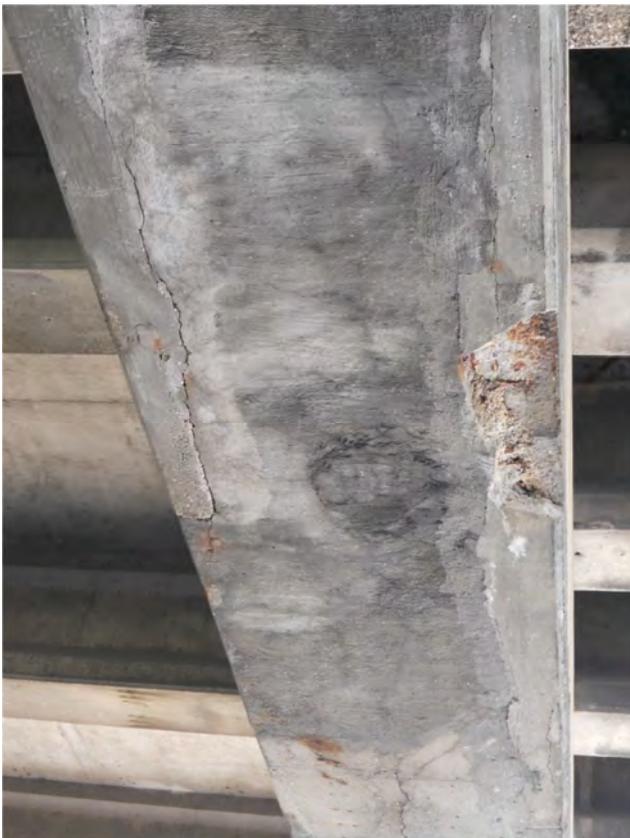
Figure 2.26 Bridge B-40-0122 Pier Cap Patch Failure

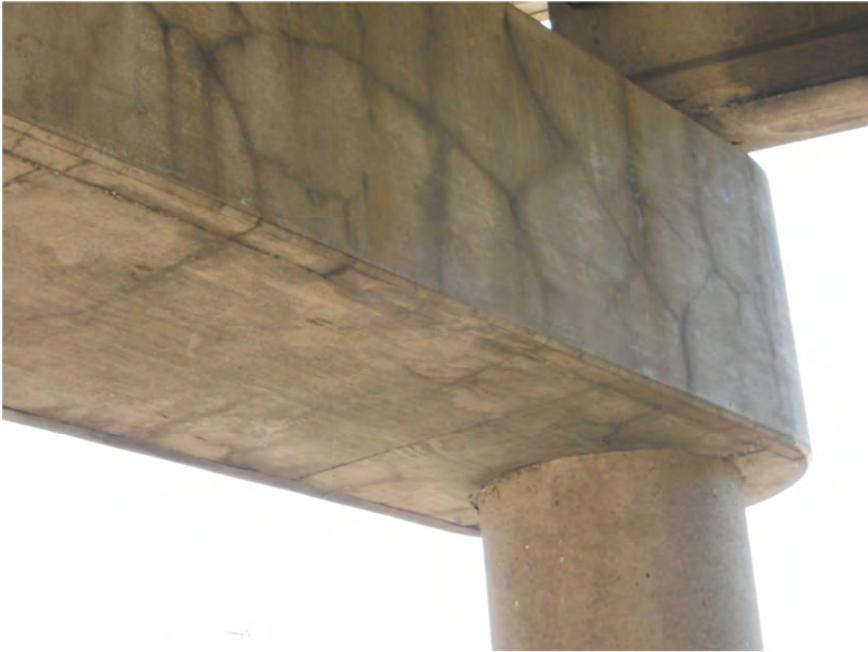
Figure 2.29 B-40-130 Cracking of Pier Cap Encasement

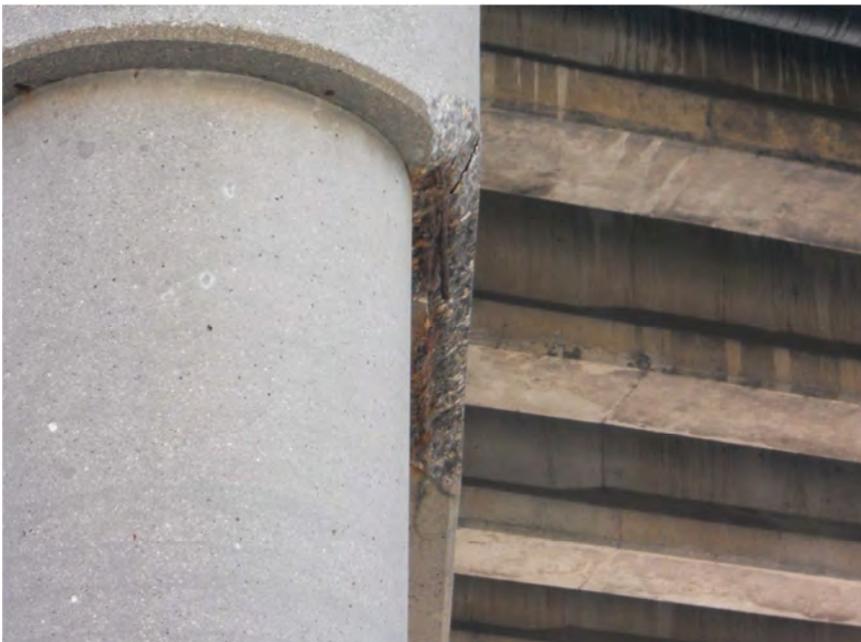
Figure 2.30 B-40-130 Spalling of Pier Cap Encasement

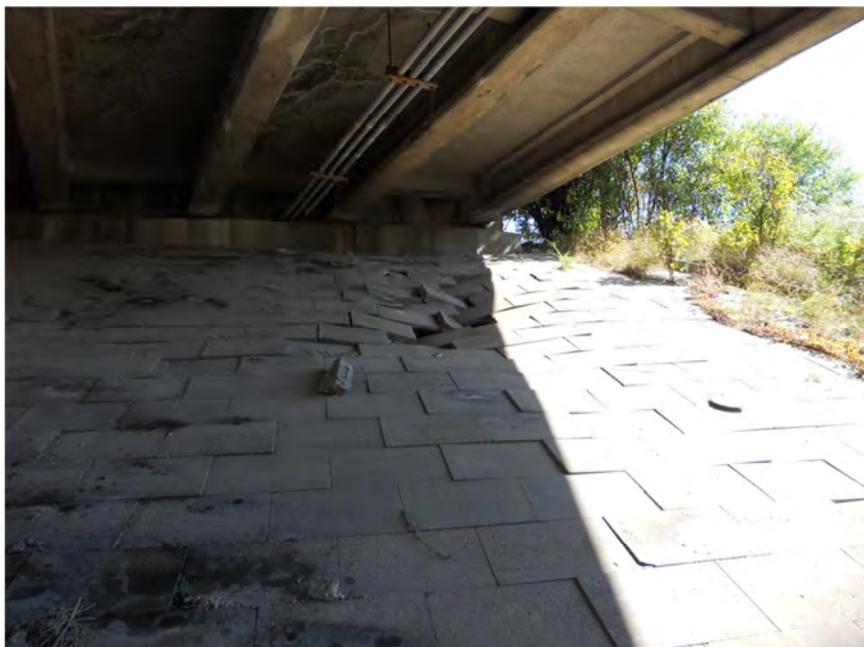
Figure 2.31 Bridge B-40-0129 Erosion of Slope Protection

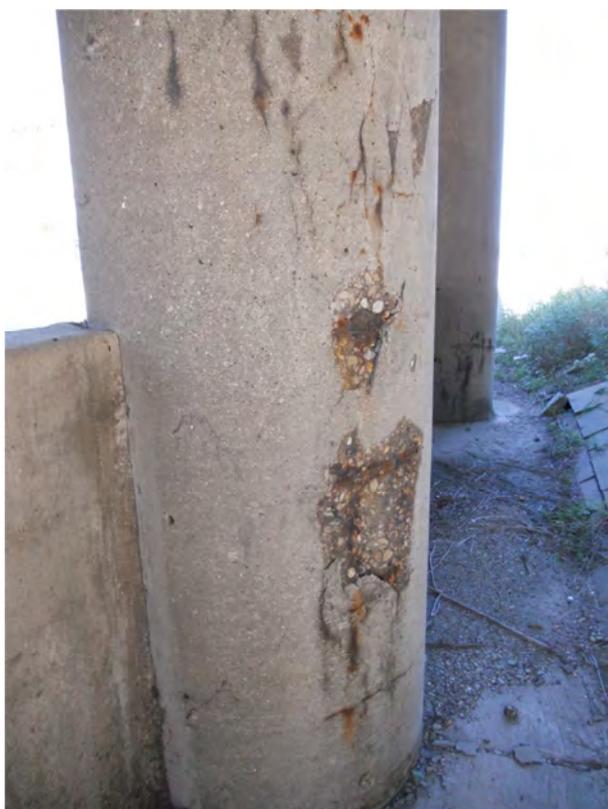
Figure 2.32 Bridge B-40-0130 Pier Column Spalling

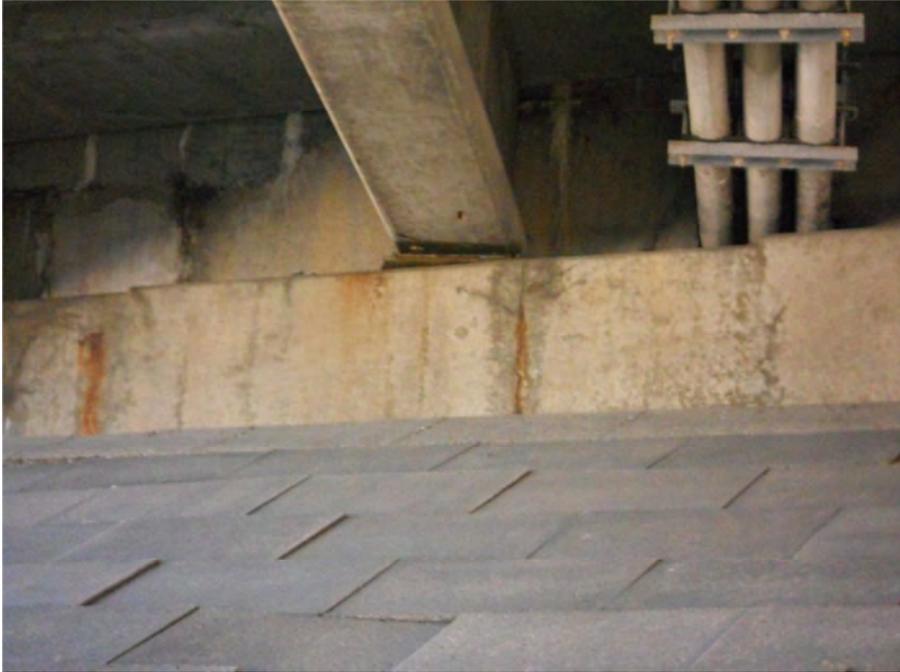
Figure 2.33 Bridge B-40-0130 Abutment Crack

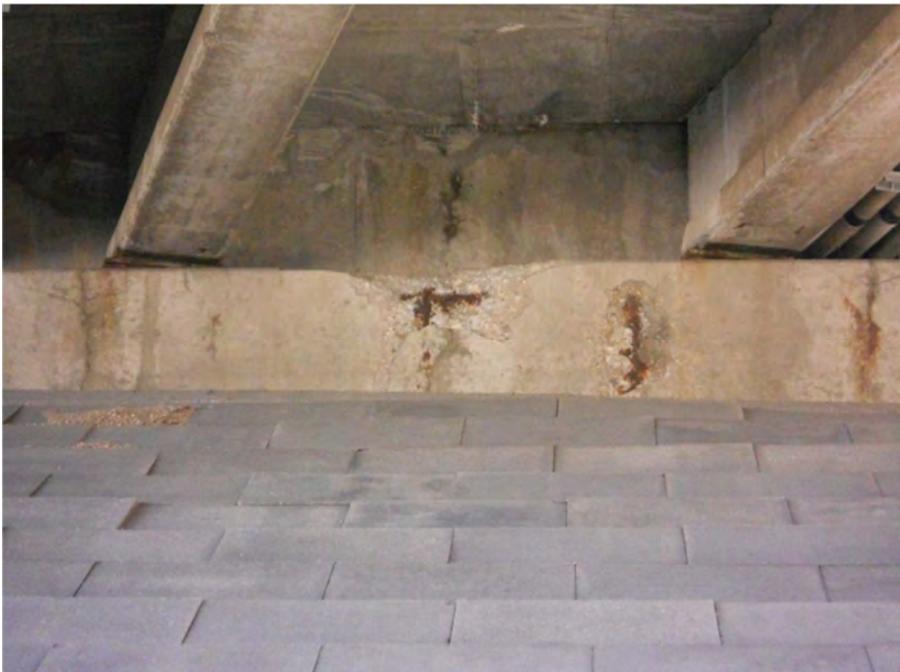
Figure 2.34 B-40-0130 Abutment Spalling
