# Laboratory and Field Testing of an Accelerated Bridge Construction Demonstration Bridge: US Highway 6 Bridge over Keg Creek

**Final Report**  
**April 2013**

**Sponsored by**  
Federal Highway Administration  
Iowa Department of Transportation  
(InTrans Project 11-411)

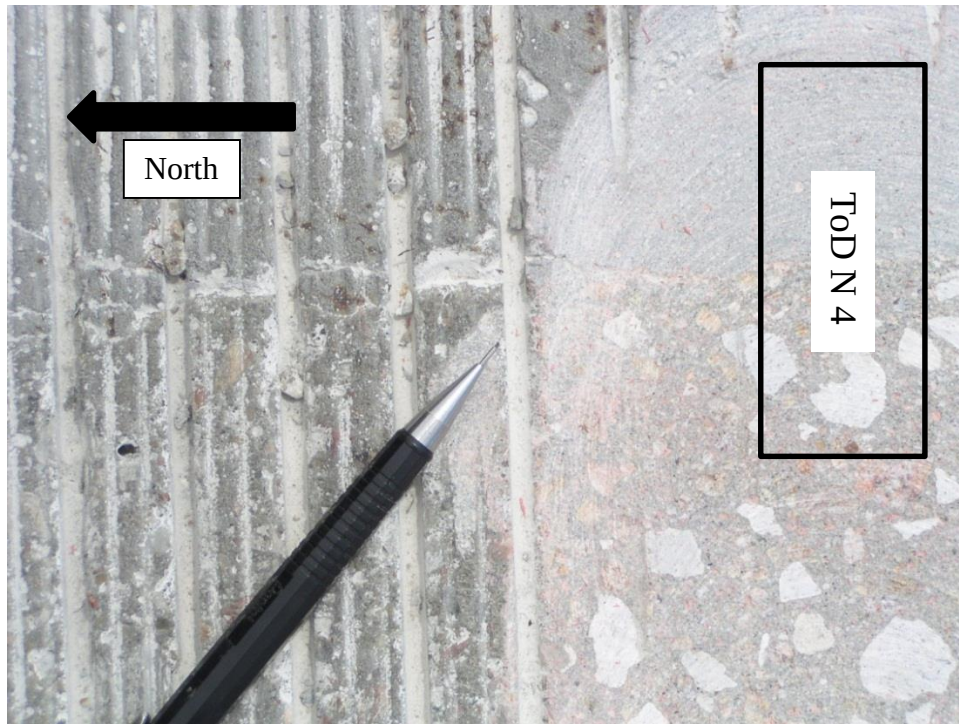
As recorded strain values have increased between the 2011 and 2012 test, the maximum tensile strains of the 2012 test ( $\sim 106 \mu\epsilon$ ) have gotten much closer to the cracking strain of the HPC ( $\sim 132 \mu\epsilon$ ). Upon visual inspection, many cracks were noticed on the top of the deck. A large majority of these cracks were noticed at the interface between the UHPC joints (both longitudinal and transverse) and the precast HPC deck modules.

The photos in Figure 4.13 through Figure 4.16 were taken at the time of the second test in May 2012 showing cracking along the joint interfaces and leakage through the bridge deck.

**Figure 4.13. Observed cracking at instrumented joint at location of ToD N 4 transducer**
