## ASSESSMENT OF WEATHERING STEEL BRIDGE PERFORMANCE IN IOWA AND DEVELOPMENT OF INSPECTION AND MAINTENANCE TECHNIQUES

**Final Report**  
**SPR 90-00-RB17-012**  
February 21, 2013  
WJE No. 2011.1671

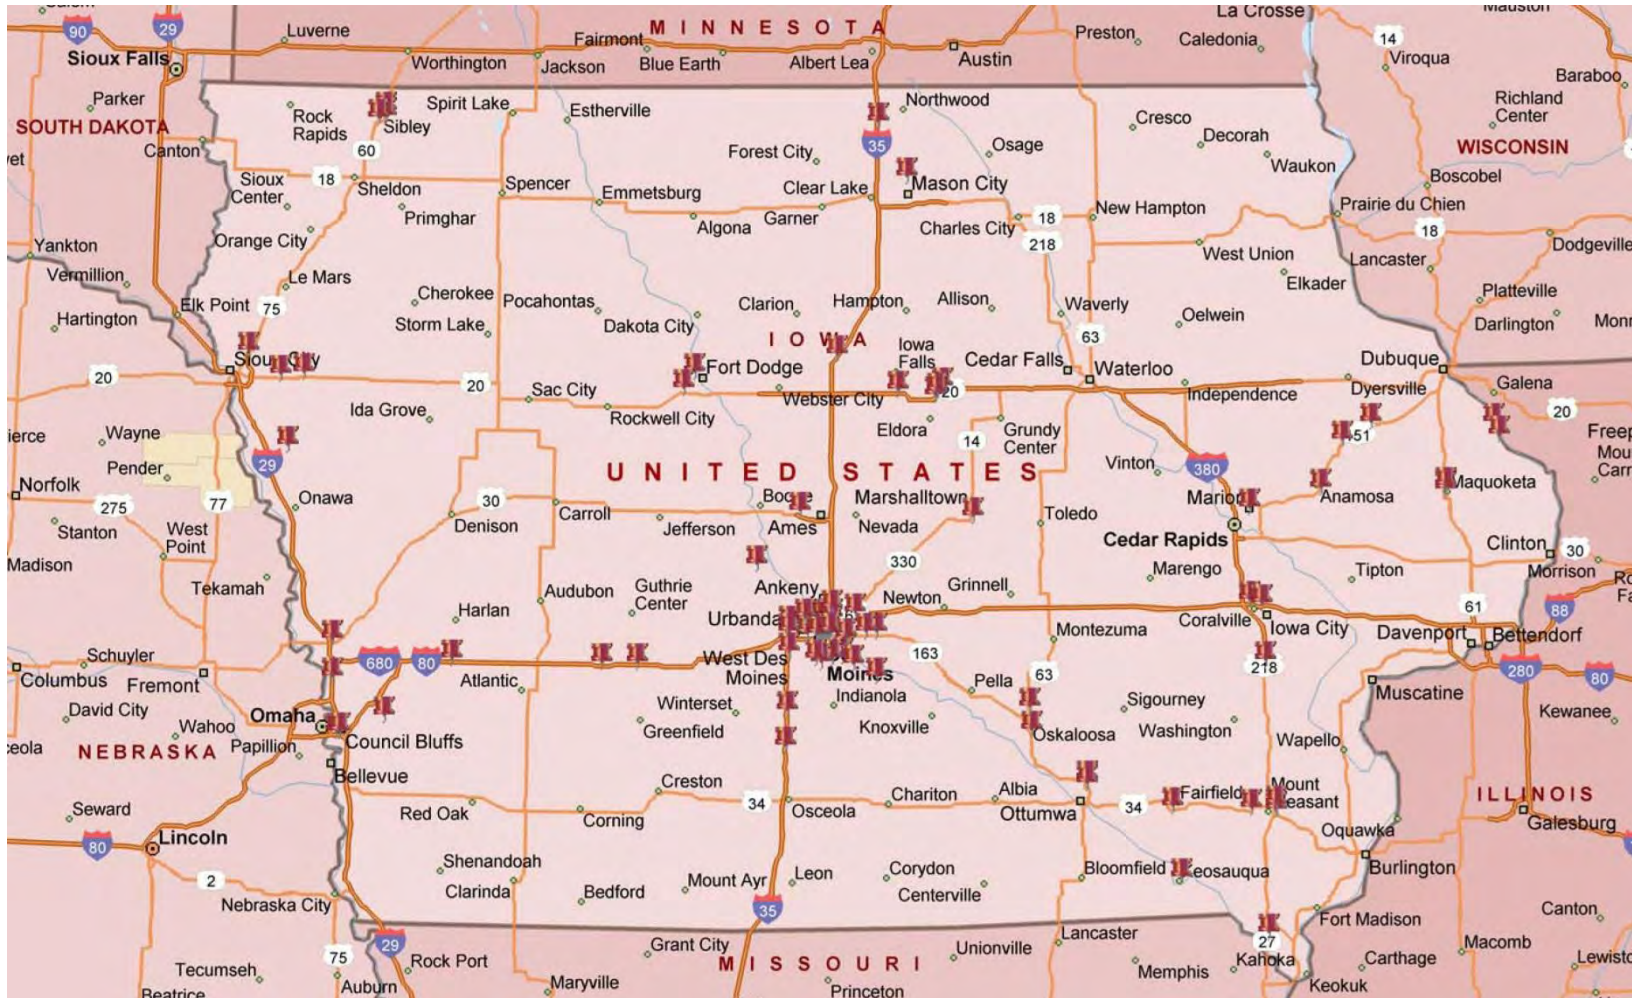
Figure 1. Map showing locations of Iowa DOT weathering steel bridge structures (each structure indicated by a thumbnail).

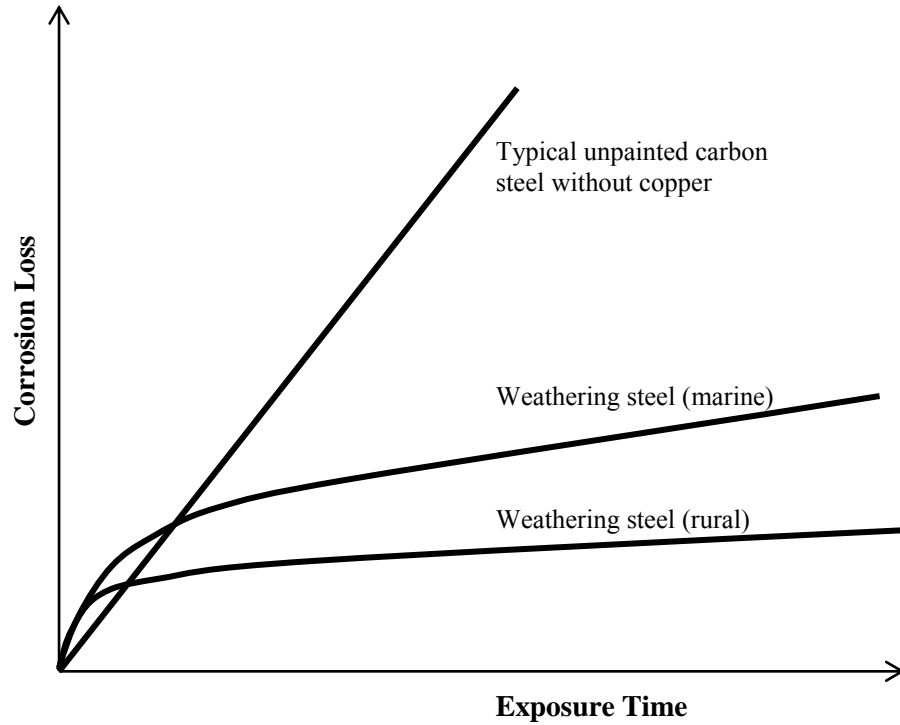
Figure 2. Schematic diagram showing the comparison between the corrosion rates for weathering steel and typical unpainted mild steel

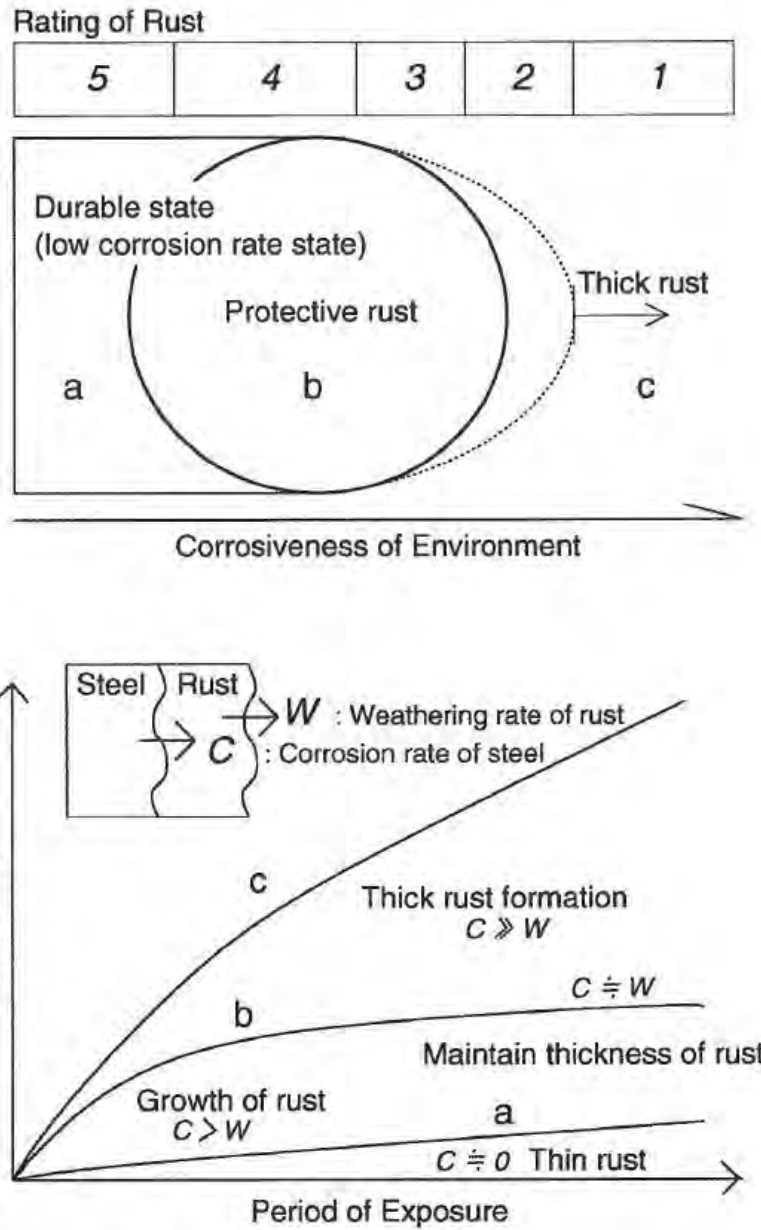
Figure 3. Schematic diagram showing the correlation between patina appearance index rating and corrosion rate.<sup>3</sup>

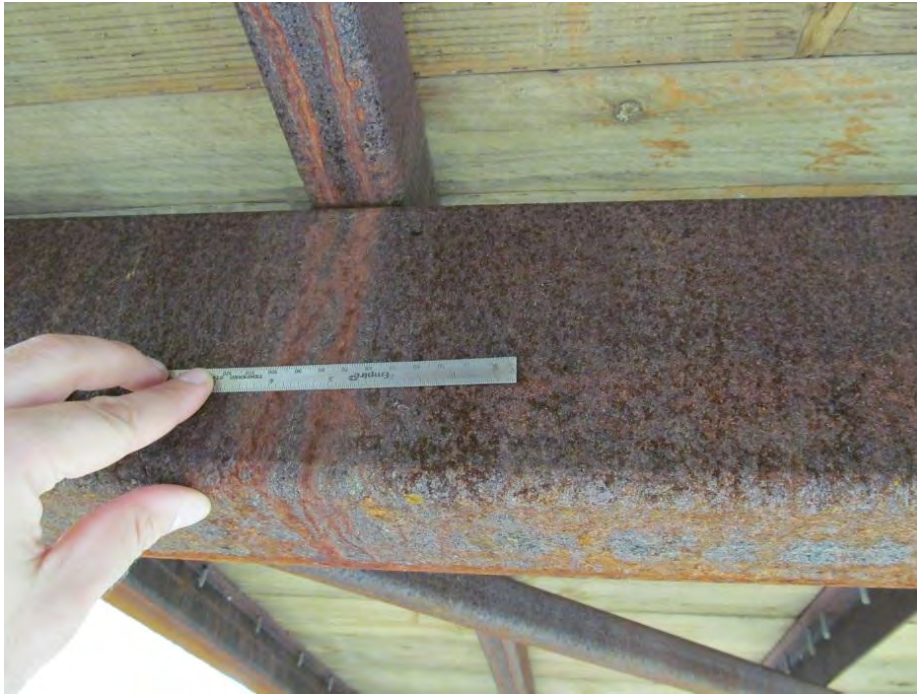
*Figure 4. Apparent nonprotective patina on the floor beams and bottom chords of this 10 month old wood-decked pedestrian bridge.*

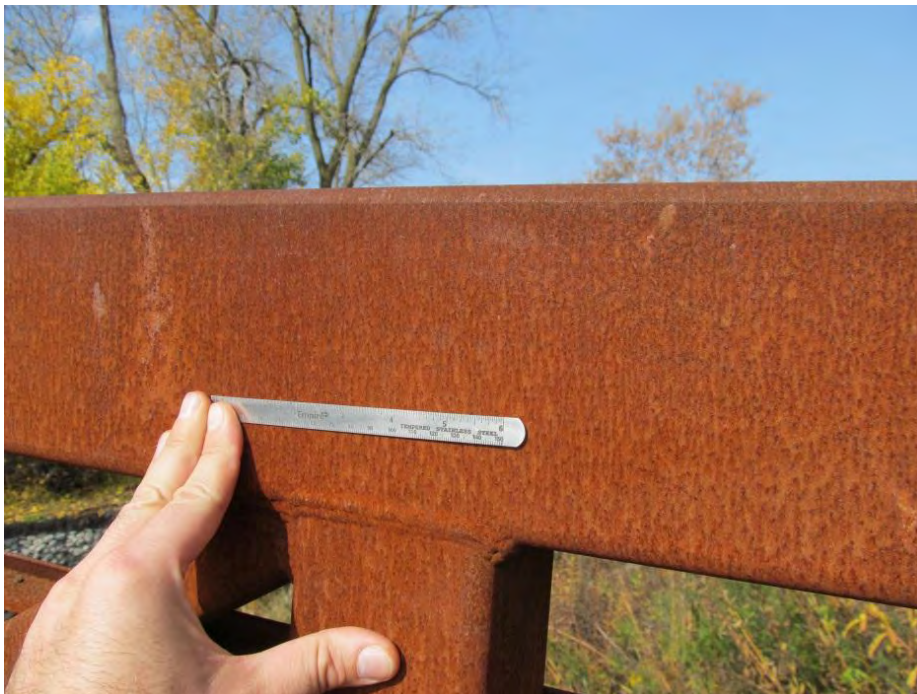
*Figure 5. Developing patina on pedestrian bridge in a suburban Illinois park. Note the adherent, small size of the patina rust particles, and the reddish coloration.*

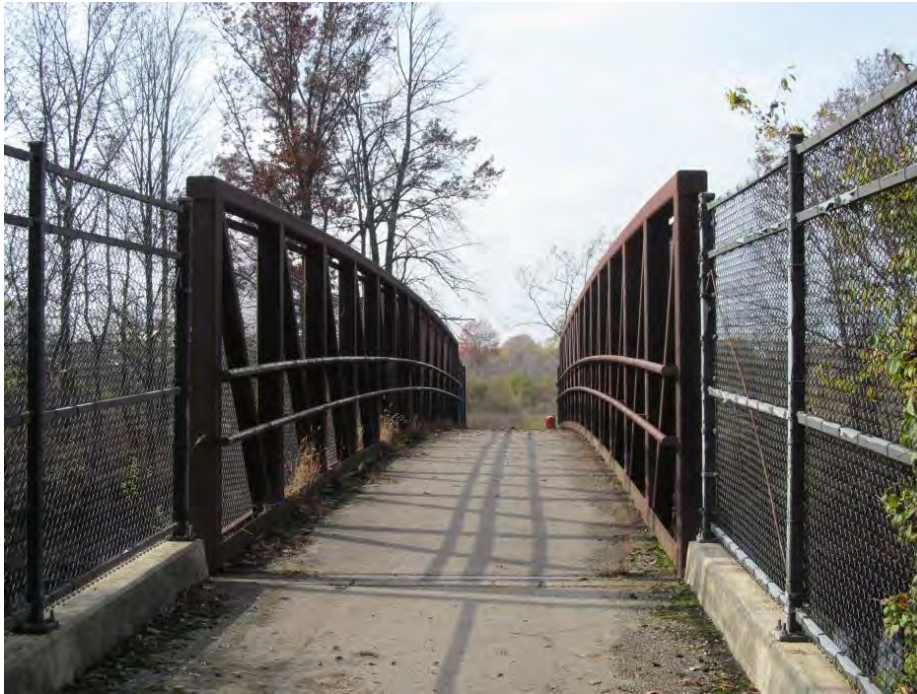
*Figure 6. Pedestrian bridge carrying a trail over the Des Plaines River in an Illinois forest preserve, with no apparent salt exposure.*

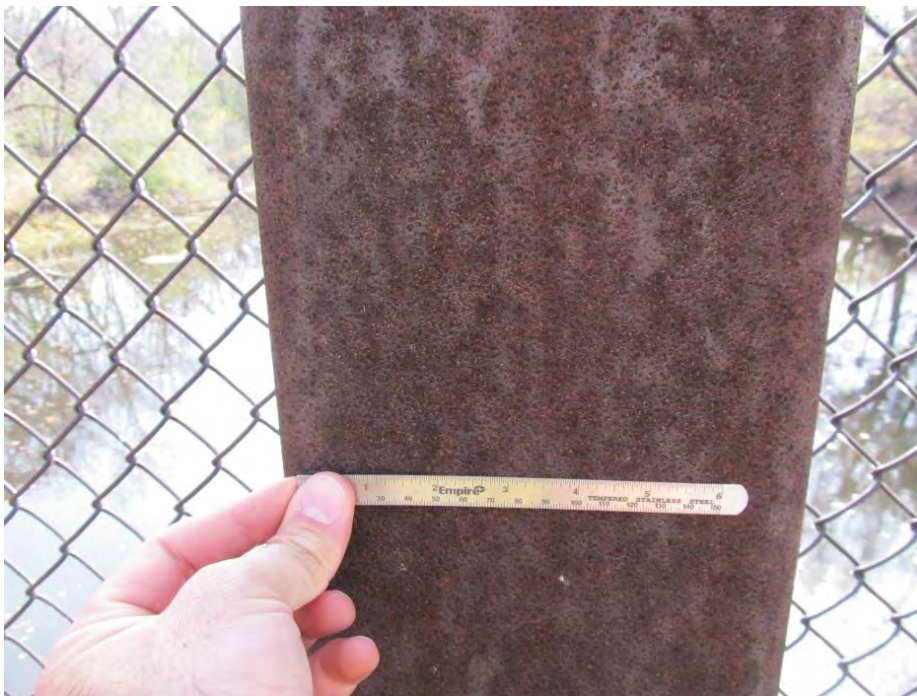
*Figure 7. Close-up photo of patina performance on the Des Plaines River pedestrian bridge; patina is dense and adherent, with small constituent rust particles.*

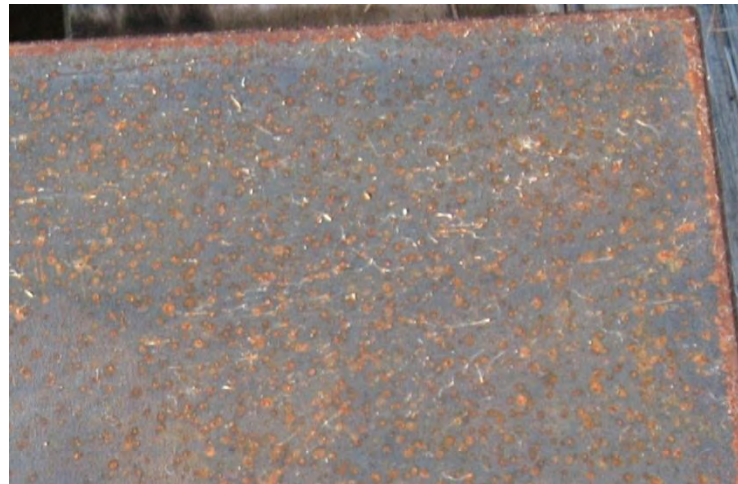
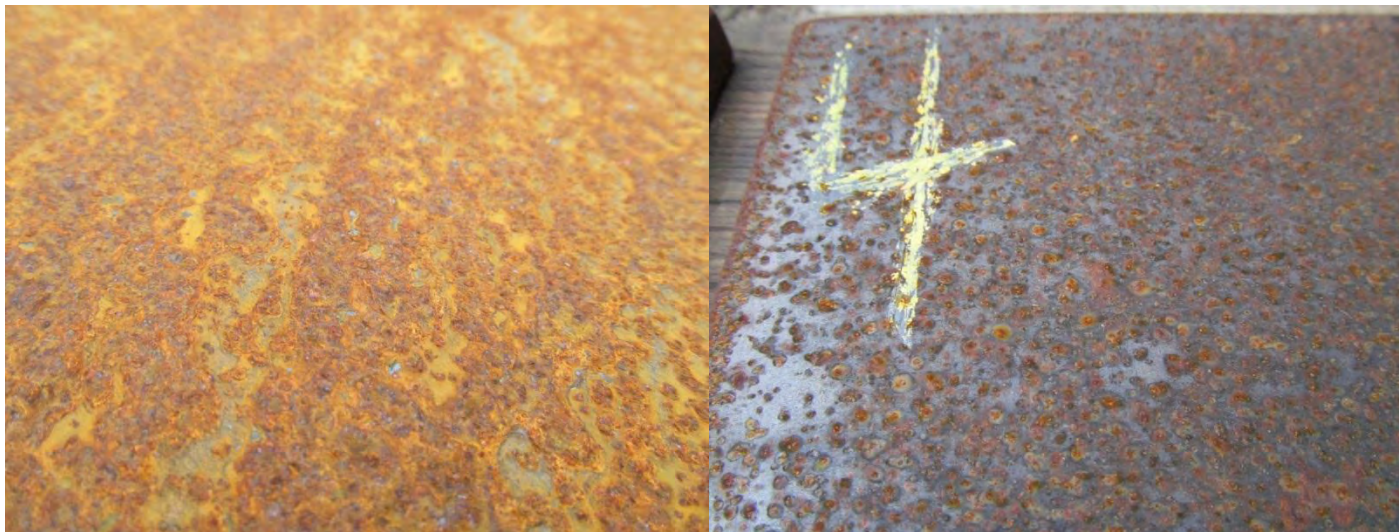
*Figure 8. Close-up photos of plate condition before testing (top center), after salt spray (bottom left), and after deionized water spray (bottom right).*

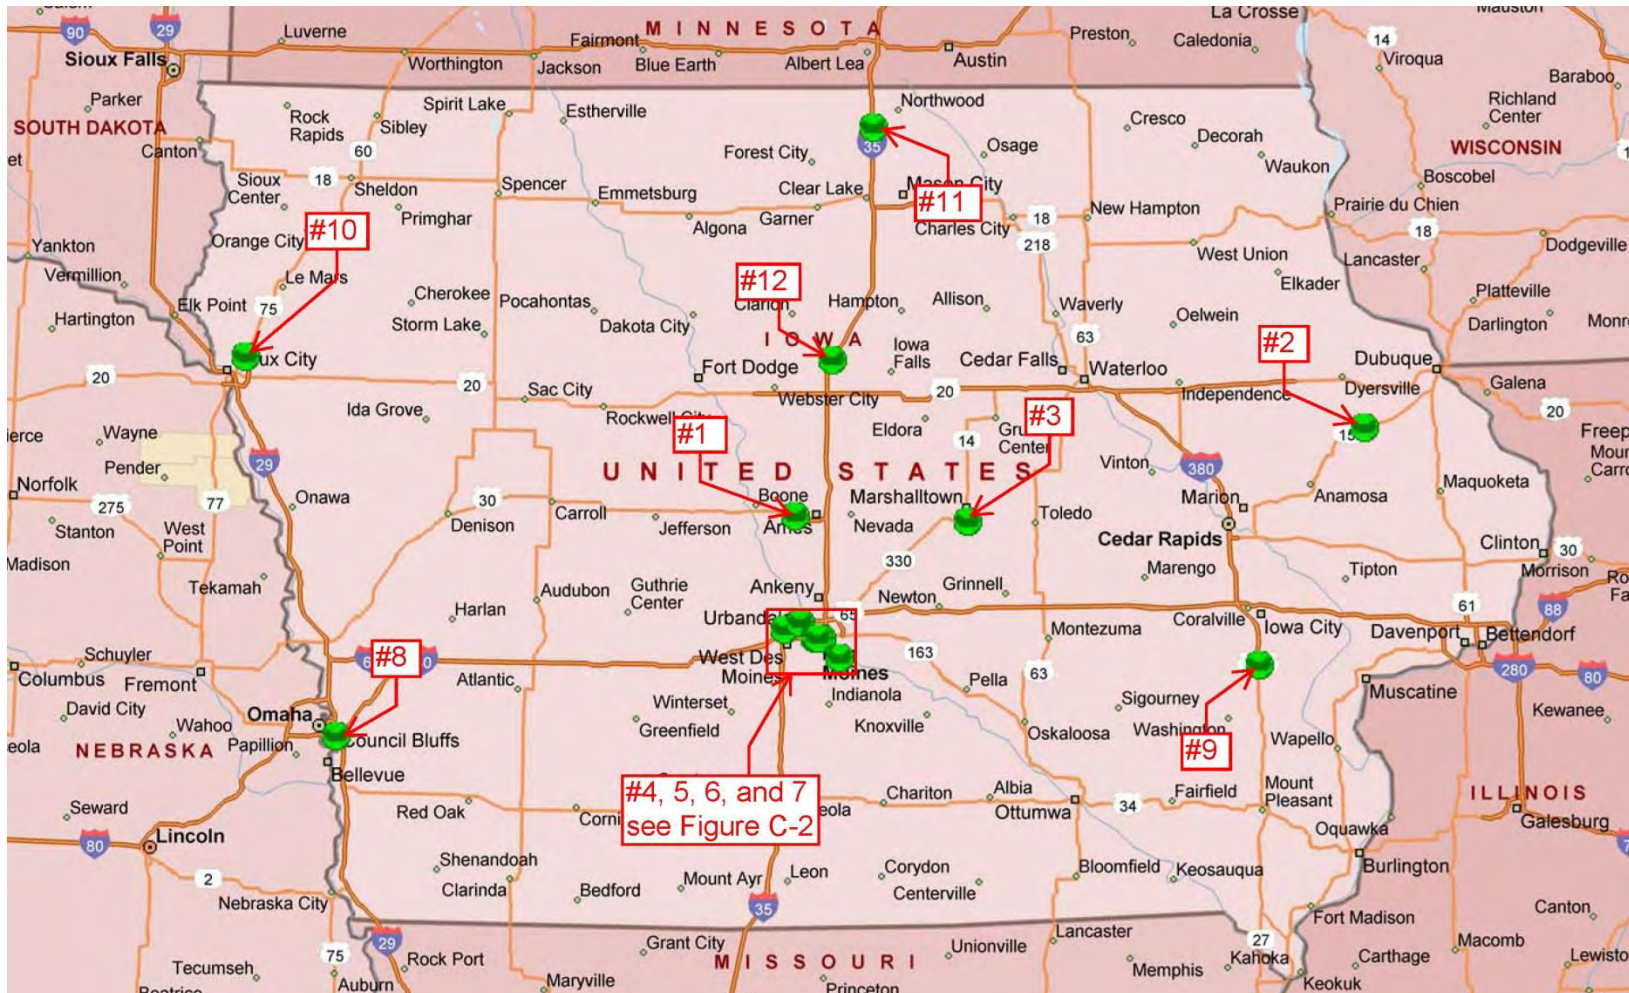
Figure 9. Map showing locations of weathering steel bridges selected for the Iowa field investigation (Field Selection number shown, refer to Appendix C).

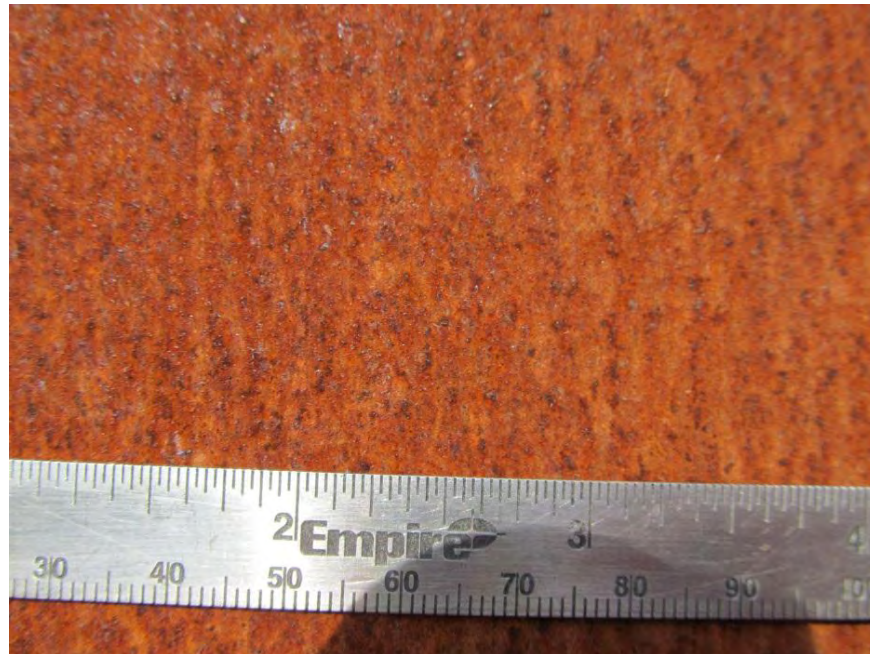
*Figure 16. Close-up photo of Category 5 patina taken from Illinois pedestrian bridge truss. Only isolated regions of Category 5 patina, likely due to mill scale, were observed on Iowa bridges.*

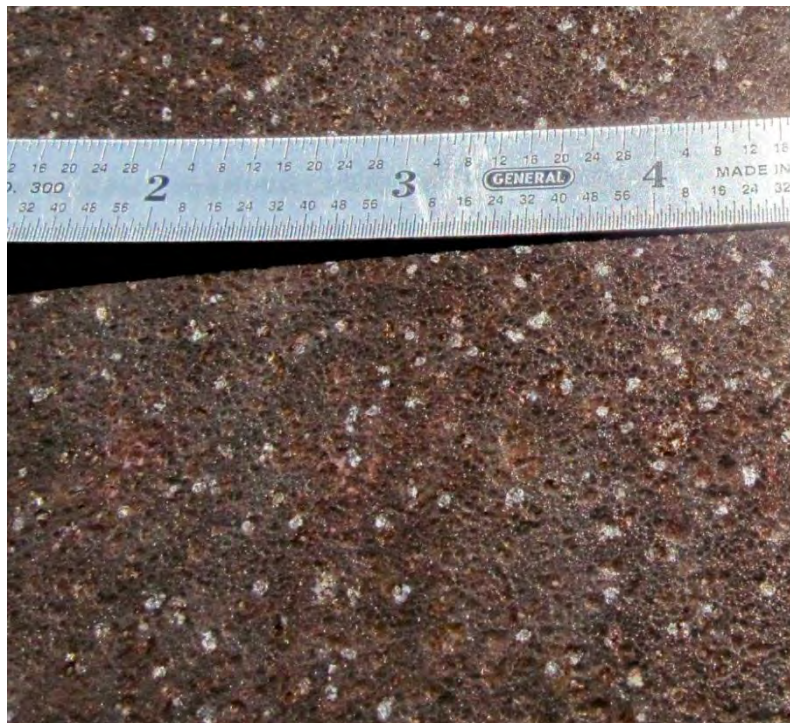
*Figure 17. Close-up photo of Category 4 patina commonly observed on exterior web of fascia girder. Surface is textured but tightly adherent, and rust formations are small. No loose flakes are present.*

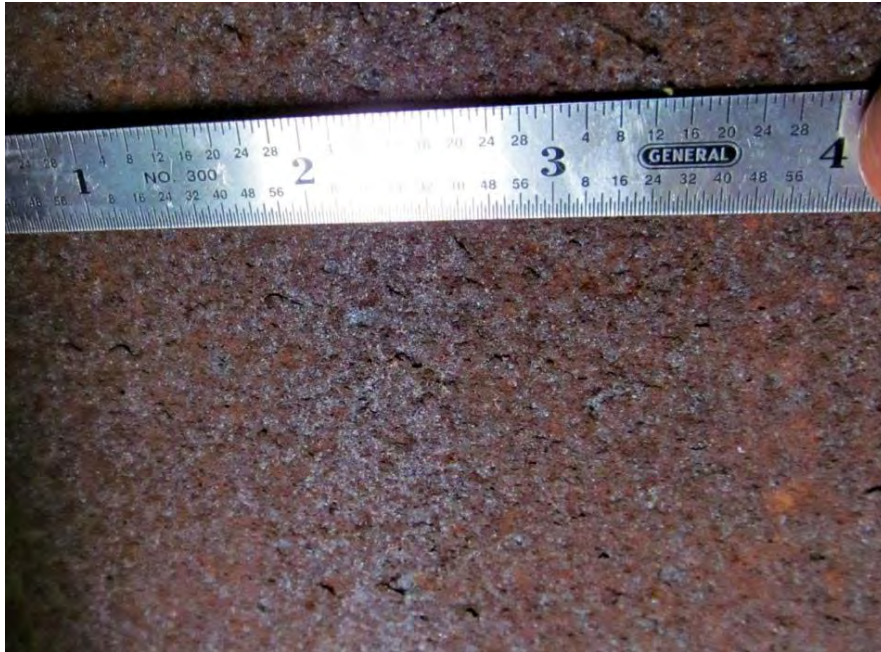
*Figure 18. Close-up photo of Category 3 patina on bottom of interior girder web. Texture is less uniform but still generally adherent, with some small loose flakes.*

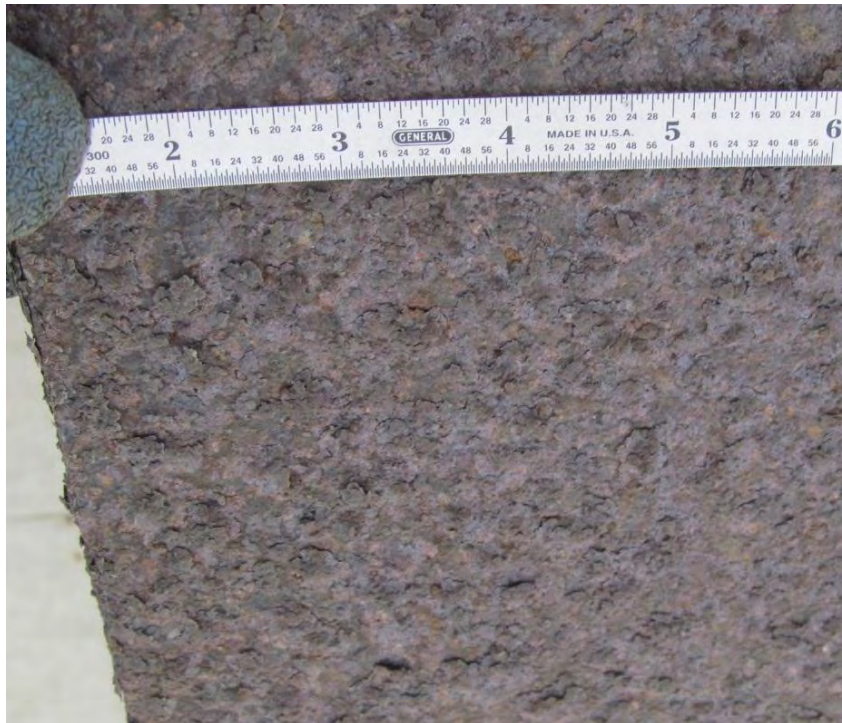
*Figure 19. Close-up photo of typical Category 2 patina on the underside of an interior girder bottom flange. Medium size flakes are easily peeled away with a fingernail.*

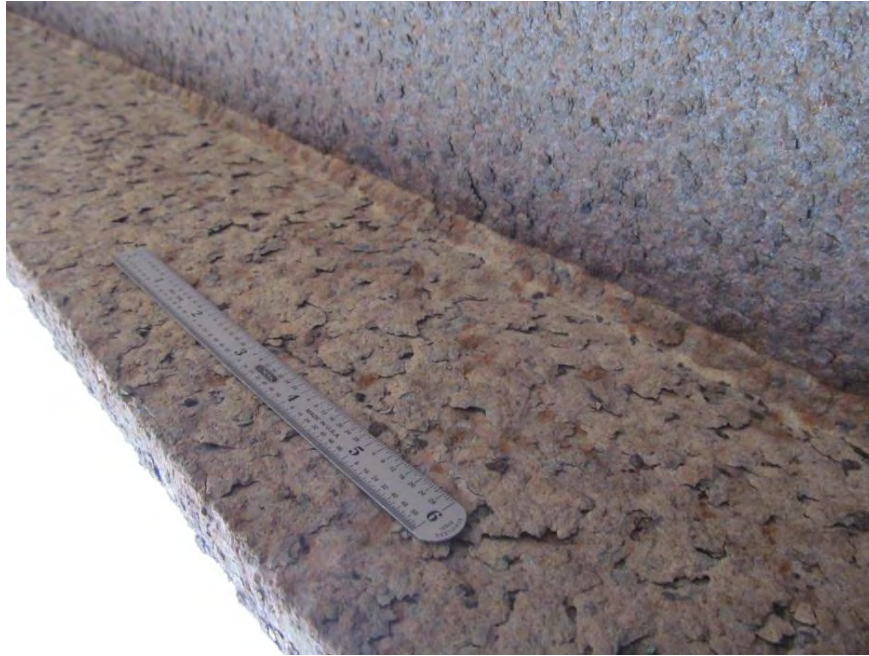
*Figure 20. Category 1 patina on top of an interior girder bottom flange; note the large, loose, thick flakes that cover virtually the entire surface. Section loss is not yet apparent in this case.*

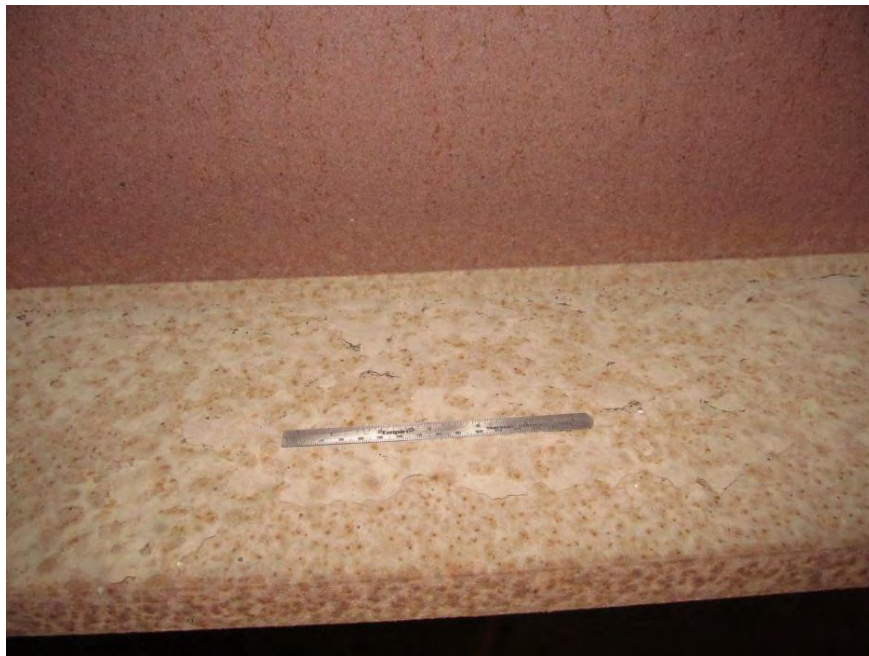
*Figure 21. Poulitice corrosion on an interior girder flange in downtown Des Moines. This is typical of conditions observed on the tops of many interior horizontal elements. Close examination and testing confirms this chalky film is primarily a mixture of dirt and salts.*

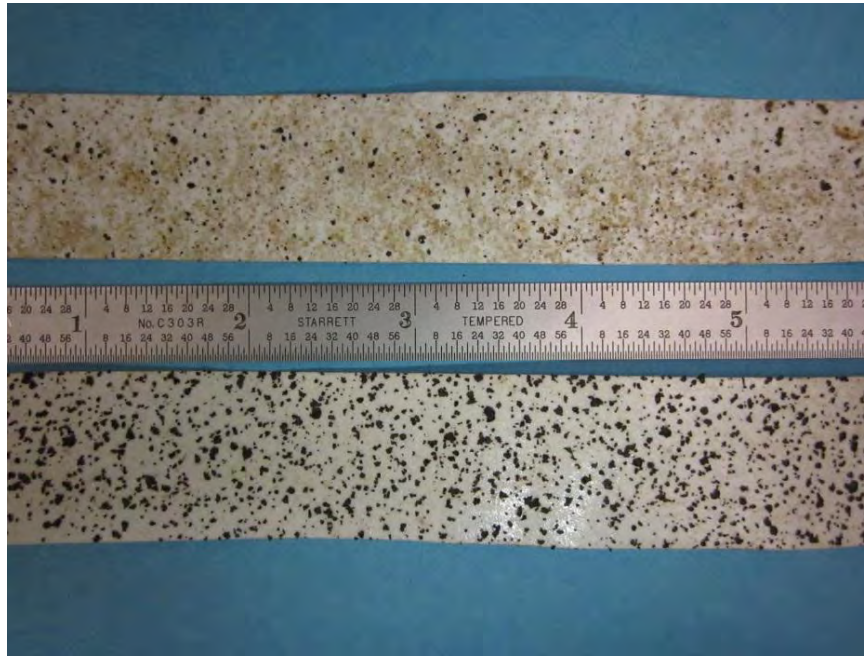
Figure 22. Tape test comparison of heavily chalked interior (top sample) and exterior (bottom sample) fascia girder bottom flange; note lighter coloration of salt and dirt deposits compared to rust flakes in poultice corrosion sample (top sample). Patina index rating for both of these specimens is 3.5.

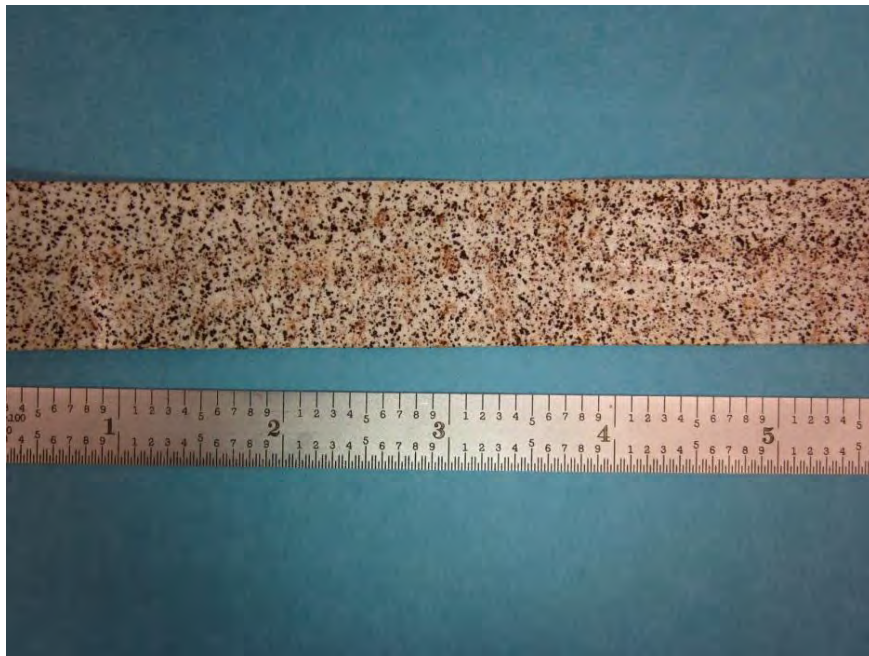
Figure 23. Category 5 tape test sample; note fine reddish rust phase particulates interspersed with more typical dark brown patina flakes.

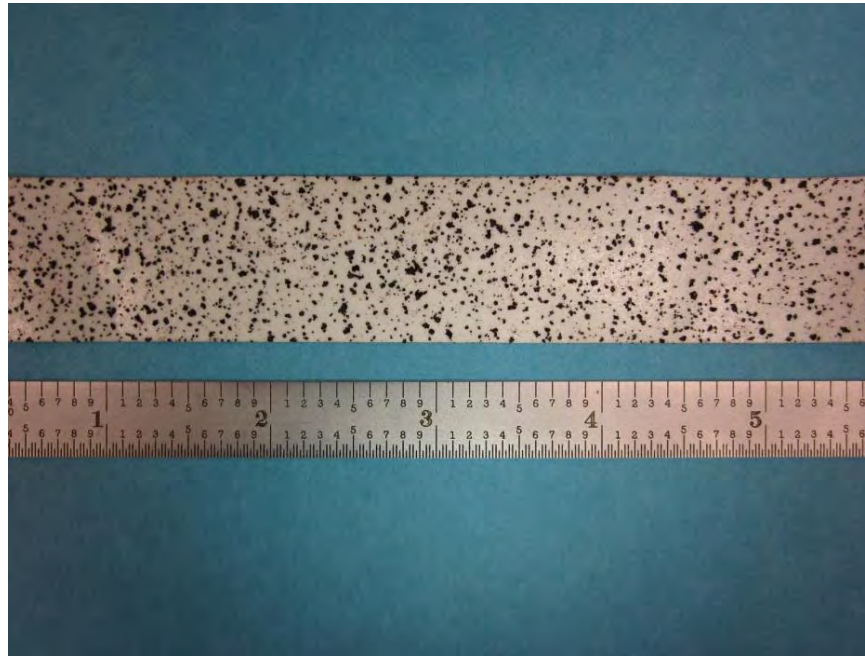
Figure 24. Category 4 tape test sample.

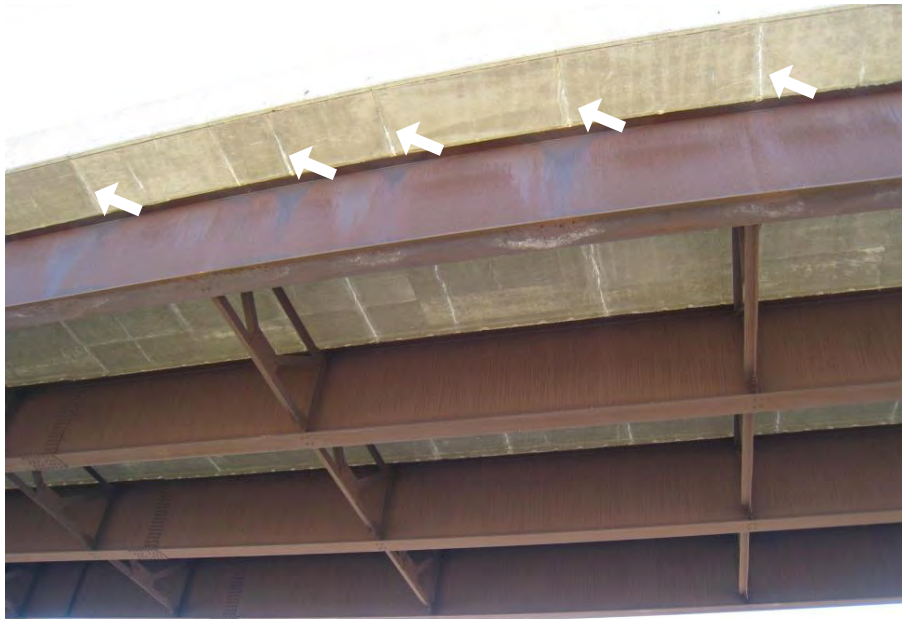
*Figure 35. Cracking with efflorescence noted in the concrete deck (arrows) at Structure 9799.5L075, Field Selection 10. Note areas of non-uniform, black weathering steel patina and salt staining on the bottom flange below each crack in the deck.*

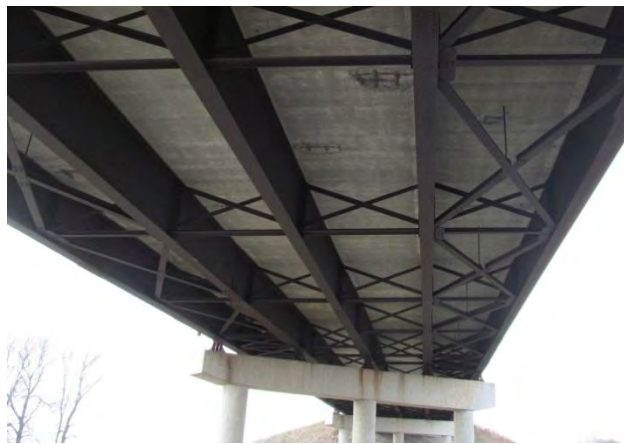
*Figure 1. North roadway span showing bracing arrangement and spall locations in the deck.*

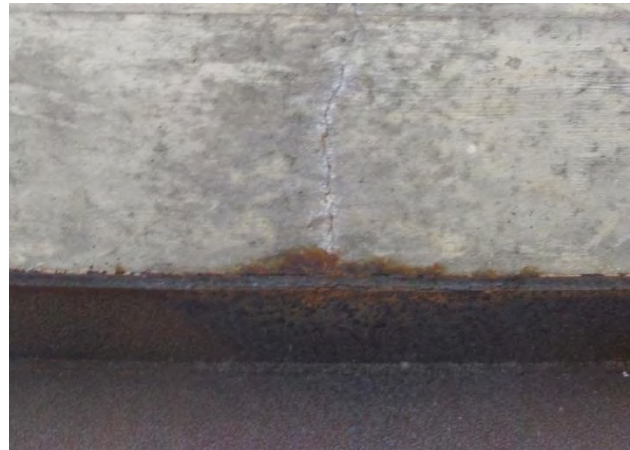
*Figure 2. Top flange deterioration beneath concrete deck crack; possibly index rating of 1 on hidden top.*

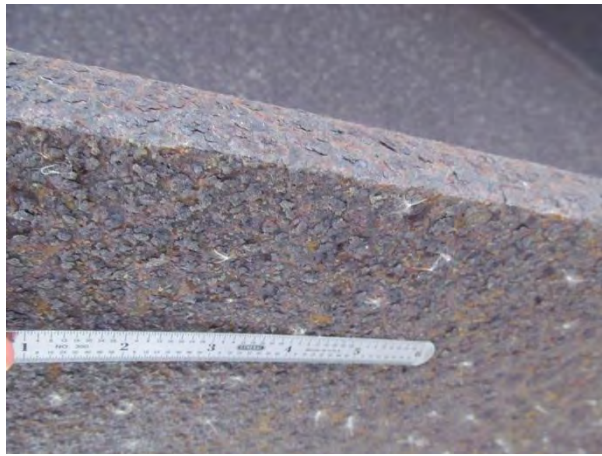
*Figure 3. Flakiness on interior bottom flange near south abutment (Index = 2.5). Worse than over traffic on north half of bridge.*

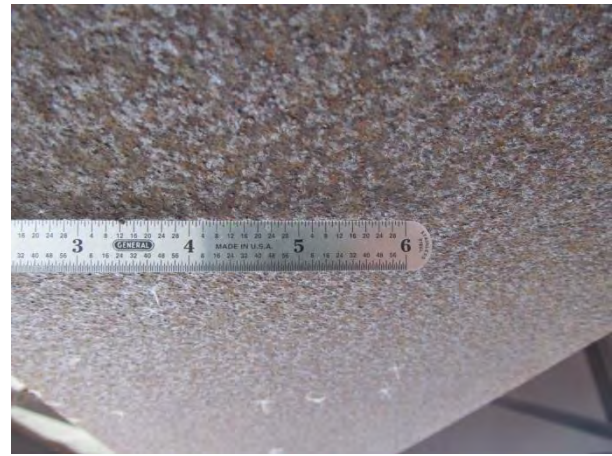
*Figure 4. Interior bottom flange condition near north abutment; index here is 3.5. Contrast with Figure 3 from identical location at south end.*

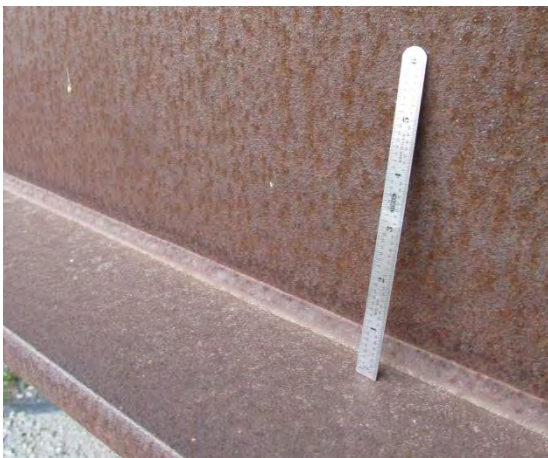
*Figure 5. Excellent patina performance on exterior fascia faces after 40 years, typical of rural bridges.*

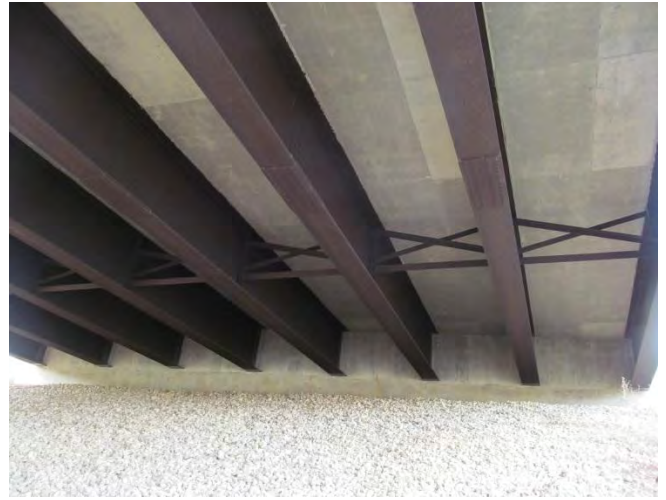
*Figure 2. Typical conditions underneath interior of both bridges. Index = 3.5 to 3 on bottom flanges. Sound deck prevents water infiltration from above.*

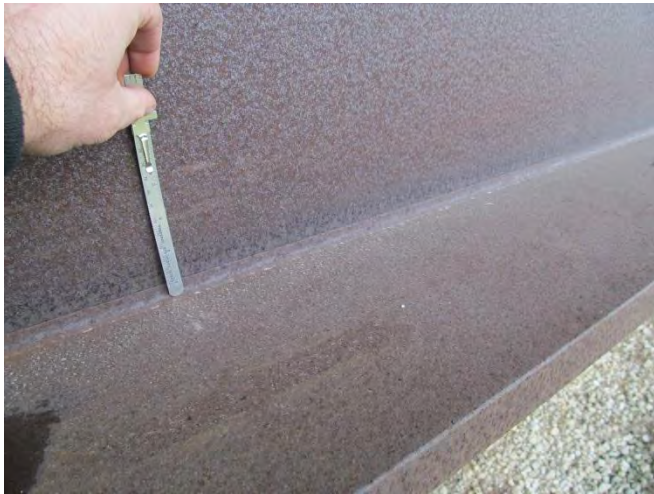
*Figure 3. Index 4 and 3 patina on web and top of bottom flange, respectively, near fascia girder tape and chloride tests on 608020.*

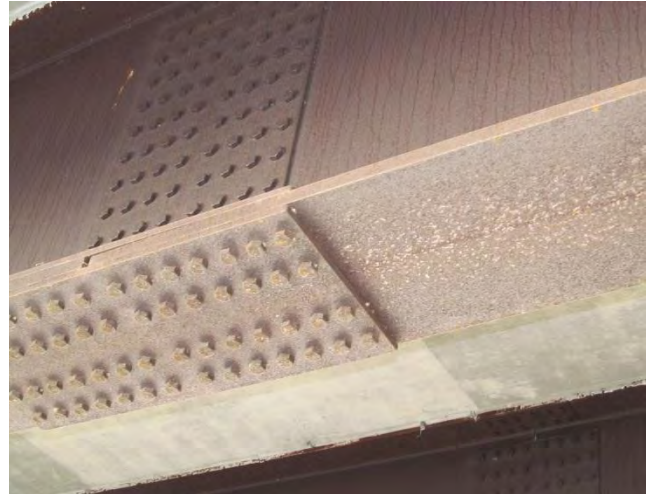
*Figure 4. Mild salty staining and flakiness visible on bottom flange near girder splices over shoulder. Patina Index = 3.*

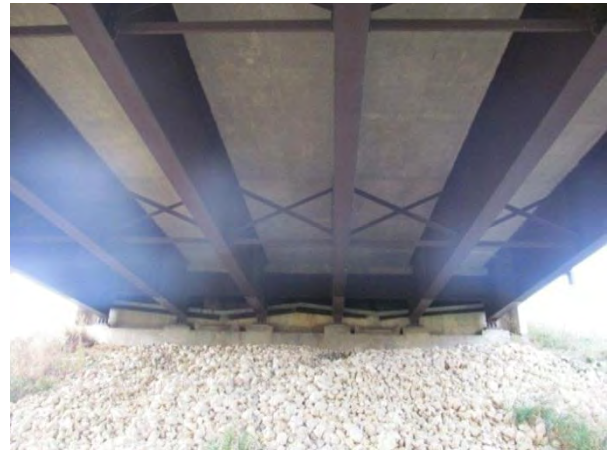
Figure 2. South abutment, showing typical cross-frames and diaphragms detailed to not stain concrete.

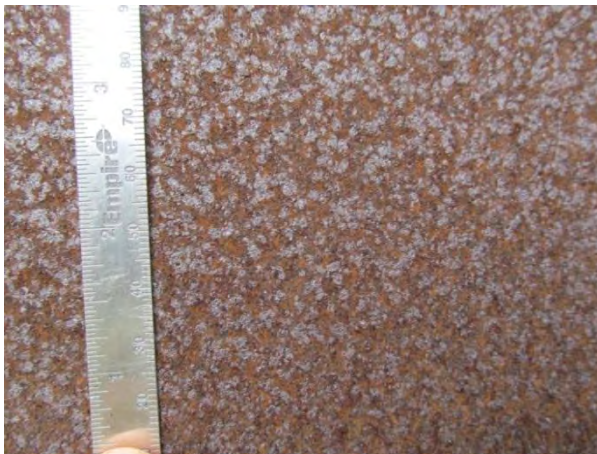
Figure 3. Typical close-up of Index 4 patina on fascia web.

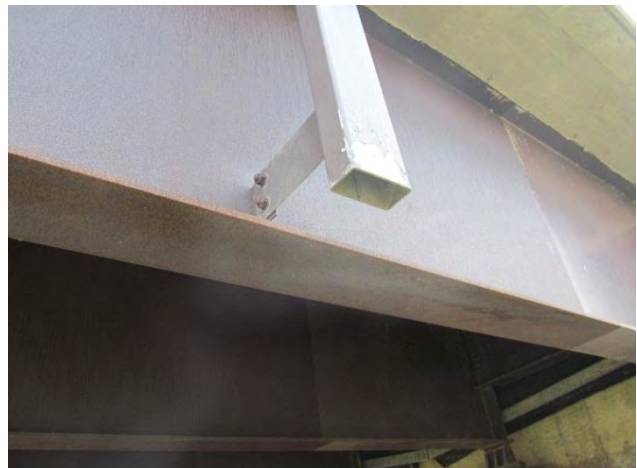
Figure 6. View of downspout; bottom flange corrosion extends away from spout, primarily in direction of girder slope.

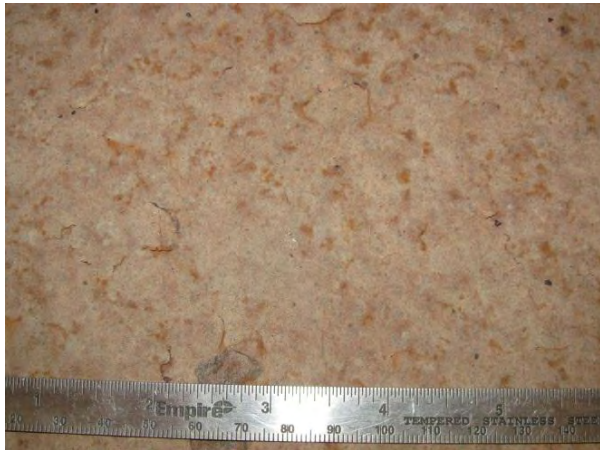
Figure 1. Top of bottom flange poutlice prior to washing; Index = 2, chlorides measured = 20 ppm.

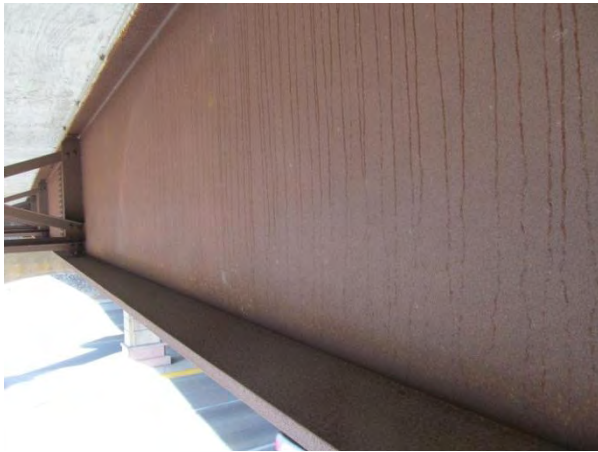
*Figure 1. Typical interior girder conditions; good patina performance on web and flange, despite flange poutlice.*

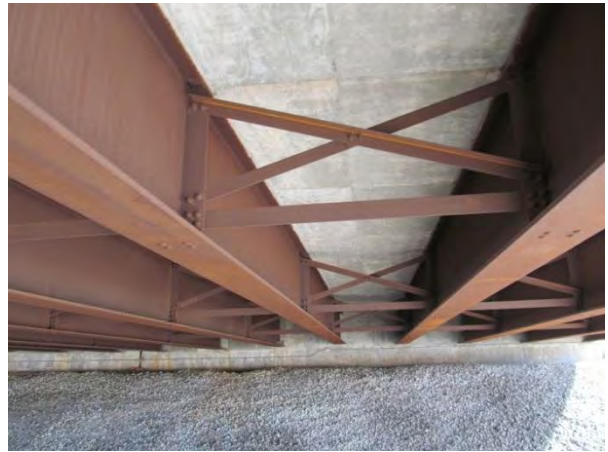
*Figure 2. Some discoloration on bottoms of flanges, but only minor flaking. Conditions near abutment similar to those over traffic.*

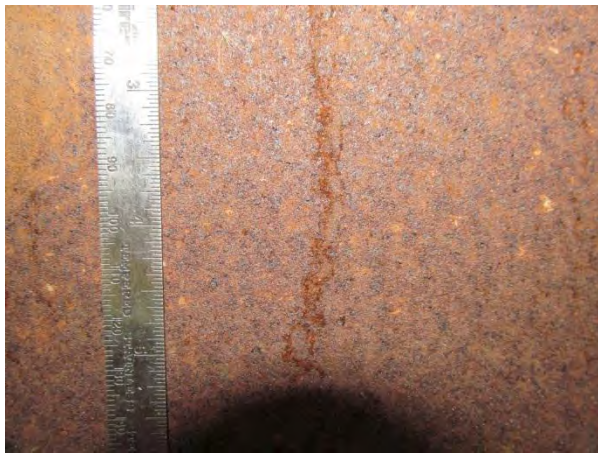
*Figure 3. Web patina performing well (Index = 3.5).*

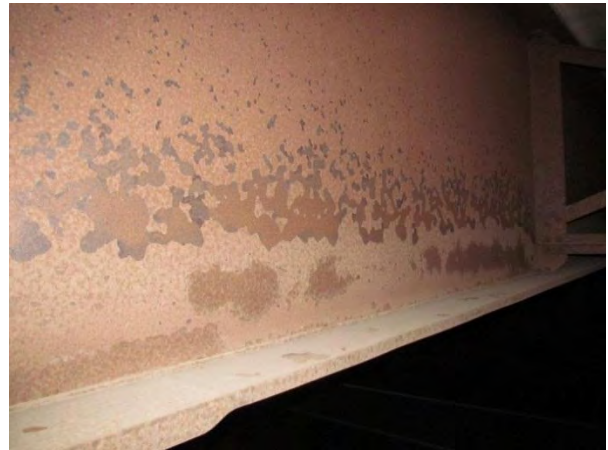
*Figure 2. Typical widespread delamination on web above traffic. Lower delaminations appear older, beginning to deteriorate again.*

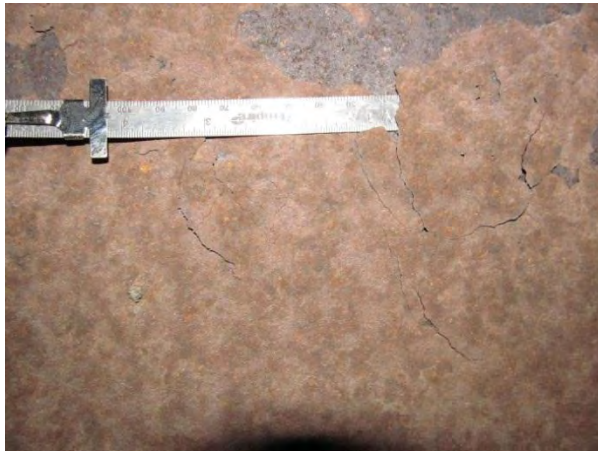
*Figure 3. Close-up of web delamination progressing with scale inserted behind loose flake*

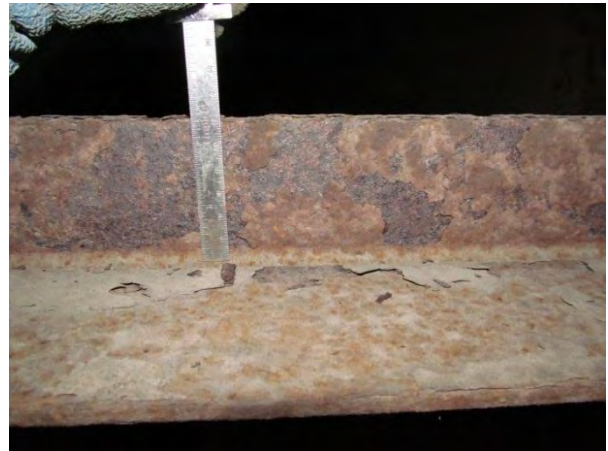
*Figure 4. Heavy deterioration typical of cross-frame members over traffic lanes.*

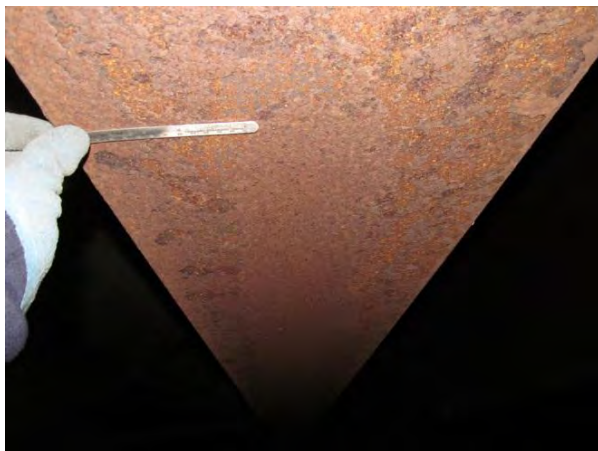
*Figure 5. Flaking and small delaminations on bottom of flanges over traffic.*

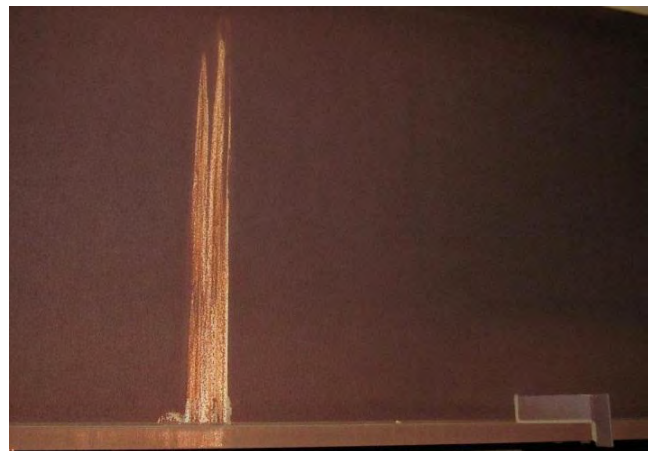
*Figure 6. Example of staining on fascia girder. Patina locally under-developed underneath.*

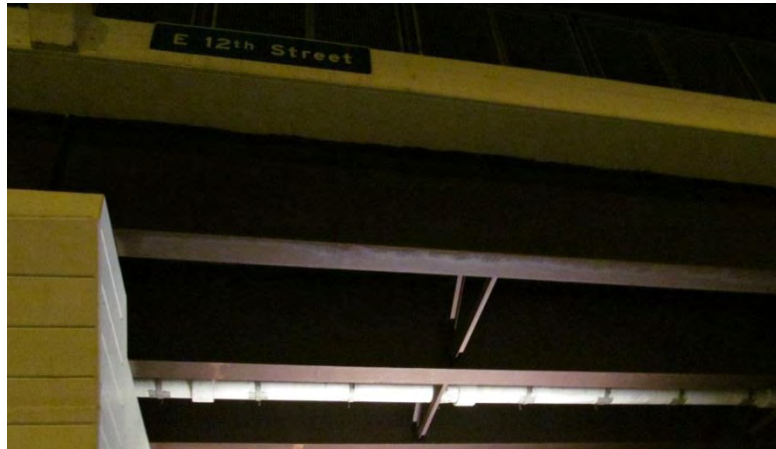
*Figure 1. White, salty staining on west fascia girder (toward oncoming traffic) bottom flange south of pier.*

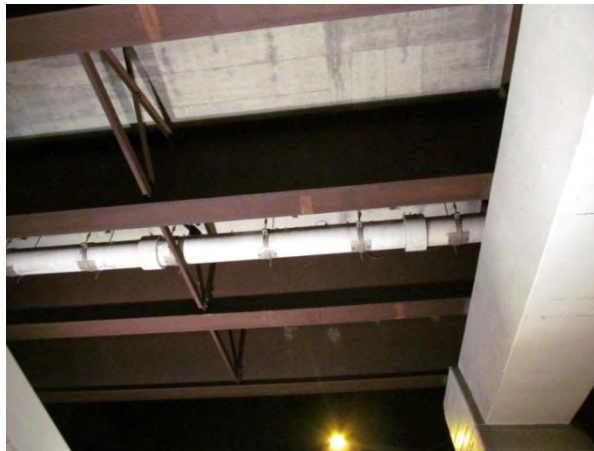
*Figure 2. Rectangular, reddish stains on bottom flanges. Also note grayish staining on interior web of fascia girder beyond. Such stains occasionally noticed throughout Field Selection 7.*

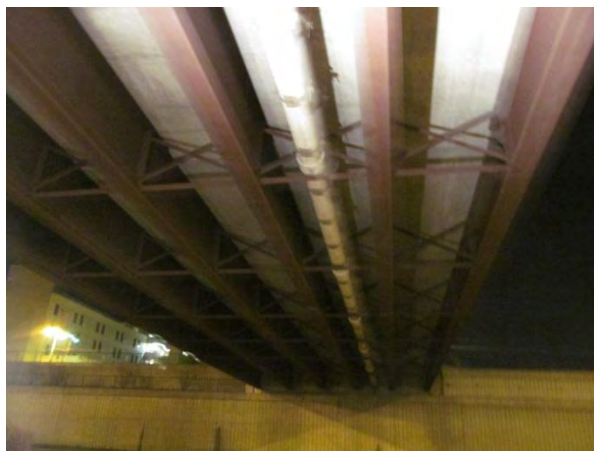
*Figure 3. Overall photo of the span over eastbound I-235.*

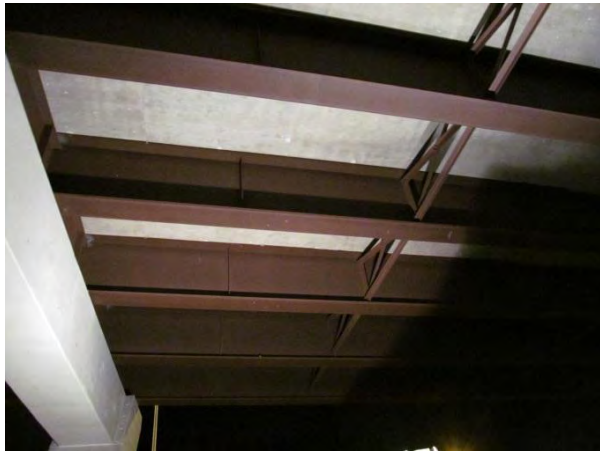
Figure 1. Overall condition of girders and bracing viewed from below, here near pier.

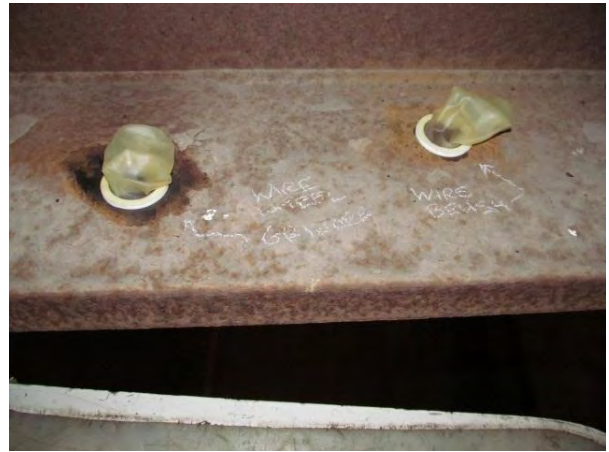
Figure 2. Chloride tests with some leaking on chalky poutlice of bottom flange before washing.
