## ASSESSMENT OF WEATHERING STEEL BRIDGE PERFORMANCE IN IOWA AND DEVELOPMENT OF INSPECTION AND MAINTENANCE TECHNIQUES

**Final Report**  
**SPR 90-00-RB17-012**  
February 21, 2013  
WJE No. 2011.1671

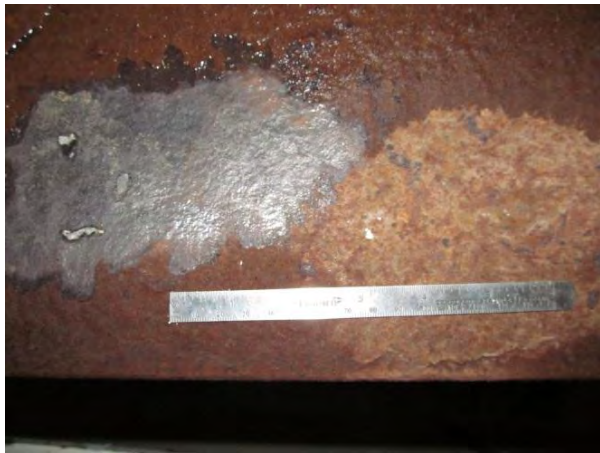
Figure 3. Close-up of wire wheel ground area and adjacent as-is poutlice after washing and drying.

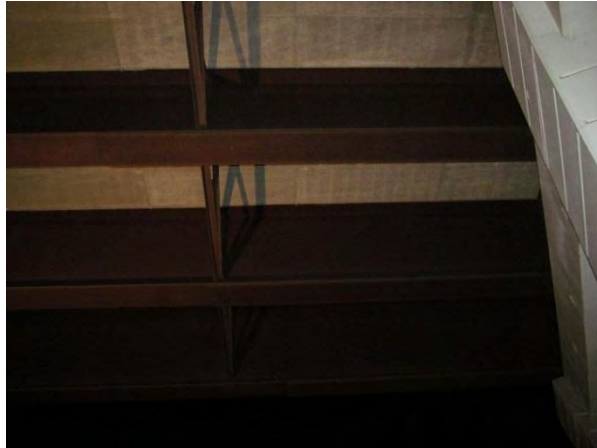
*Figure 1. Patina in good condition on all surfaces visible from ground; here near pier.*

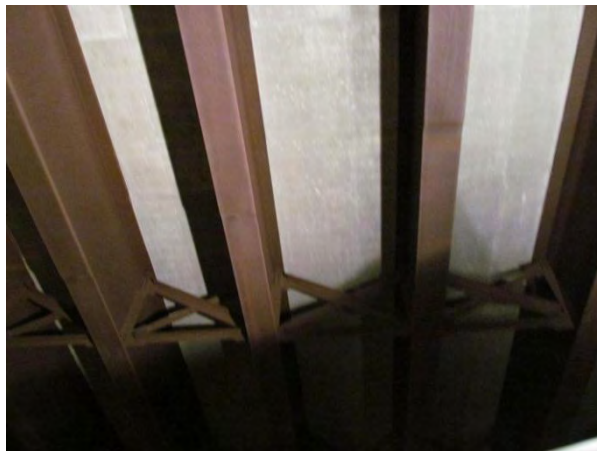
*Figure 2. Uniform, dark patina performing well near mid-span.*

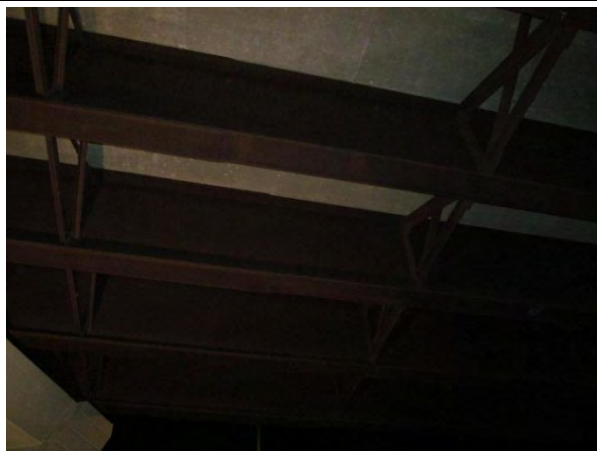
*Figure 3. Some localized blotchy stains and flaking; otherwise patina is uniform when viewed from the ground.*

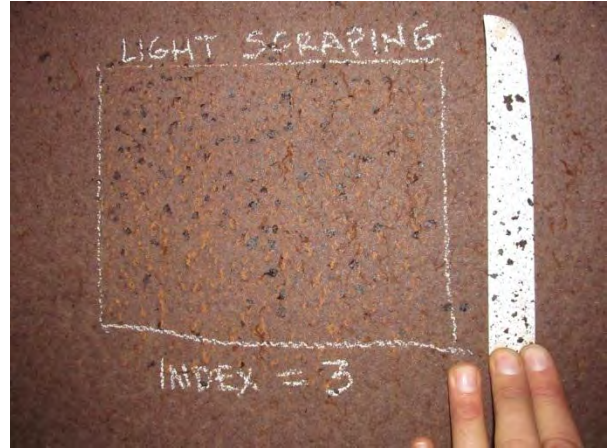
Figure 2. Interior middle of web tape test and hand scraping of loose flake (dark spots). Index later determined to be 2 based on tape flake size.

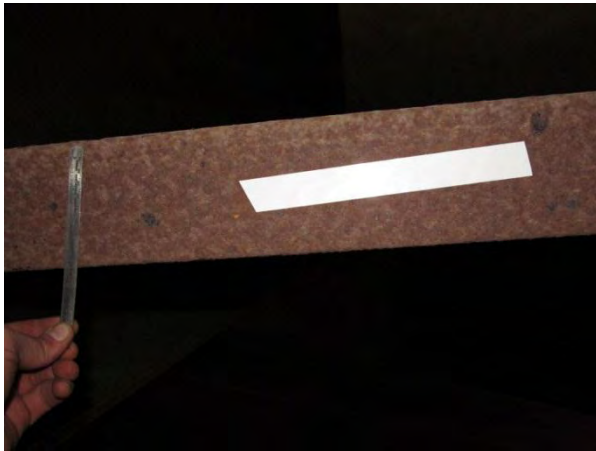
Figure 3. Index = 2 patina on vertical face of cross-brace where tape test conducted.

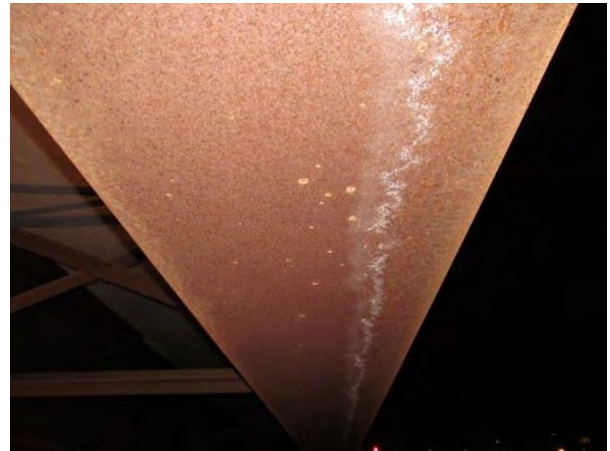
Figure 4. White staining on bottom flange of west fascia on eastbound lanes (side toward traffic).

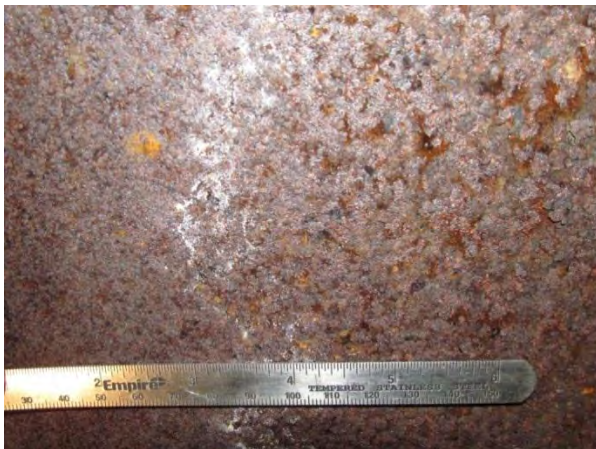
Figure 5. Close-up of discoloration and flaking on bottom flange adjacent to staining, Index = 2.

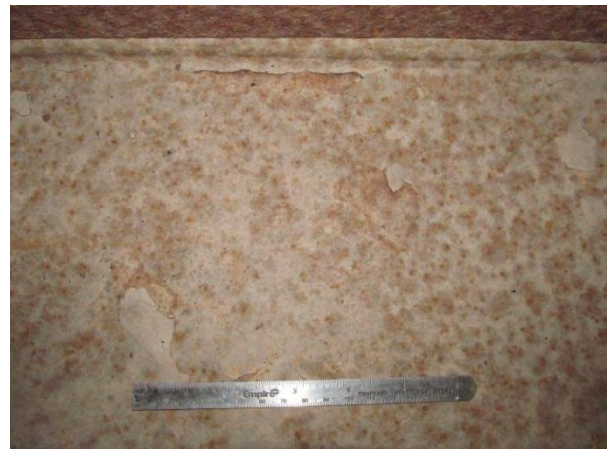
Figure 6. Delaminated, heavy pultice corrosion on interior bottom flange.

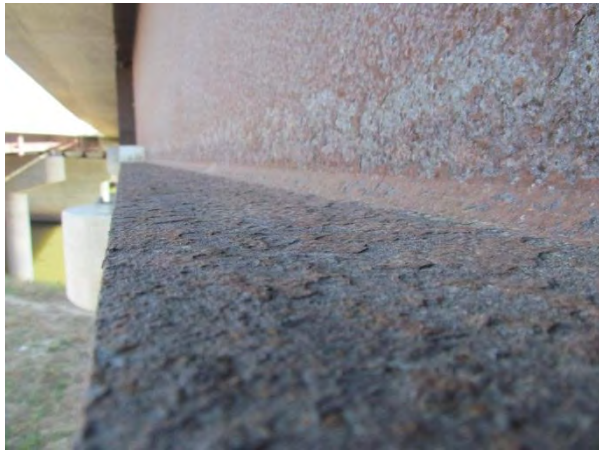
*Figure 1. Delamination of top of exterior bottom flange and web of north fascia girder on I-235 eastbound entrance ramp.*

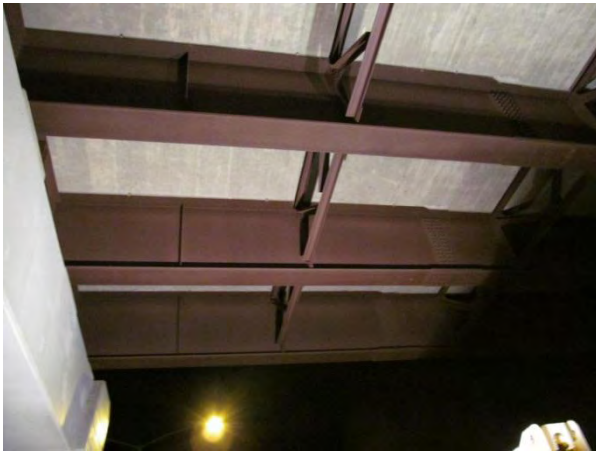
*Figure 1. East half of bridge girders near pier; generally good patina condition viewed from below.*

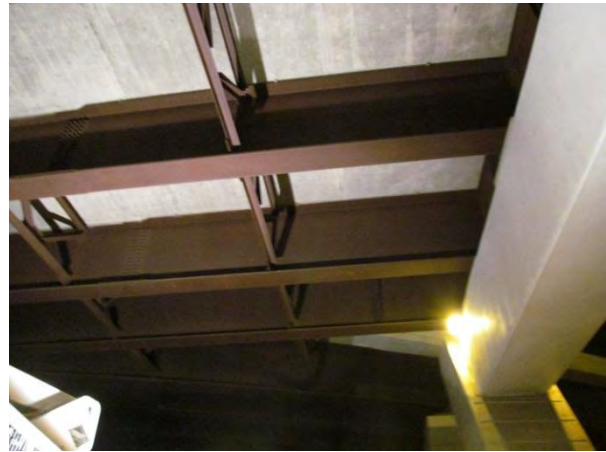
*Figure 2. West half of girders near pier, where ramp comes in (background).*

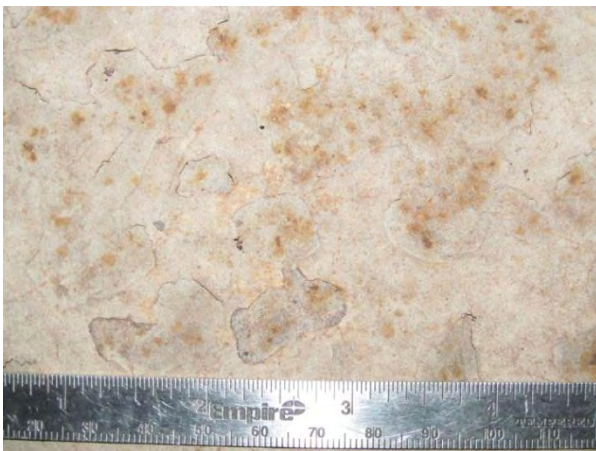
*Figure 5. Delaminating patina with heavy poultrice corrosion on interior girder bottom flange.*

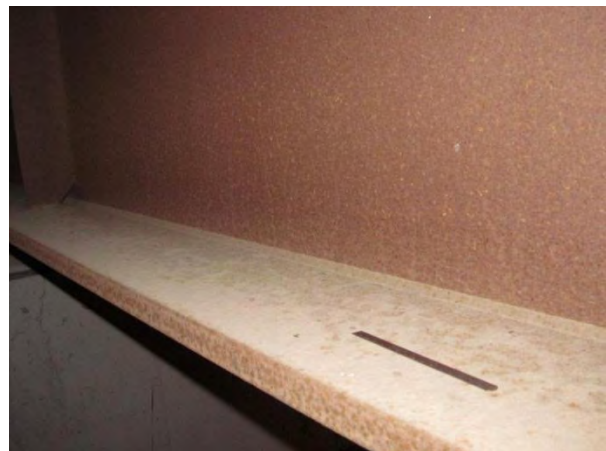
*Figure 6. Interior girder bottom flange with heavy poultrice corrosion viewed from arm's length.*

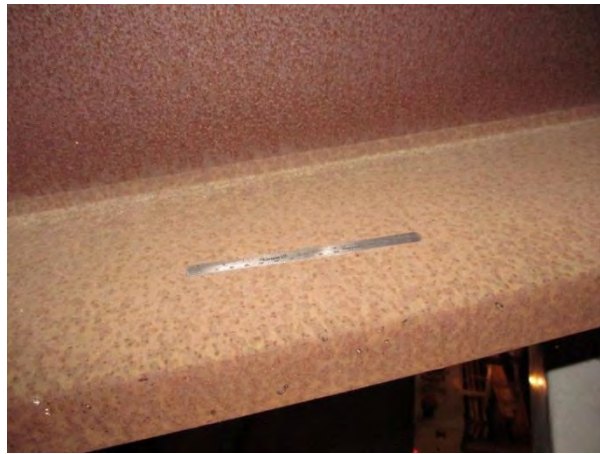
*Figure 3. Light poulitice corrosion without flaking or deterioration on fascia girder flange.*

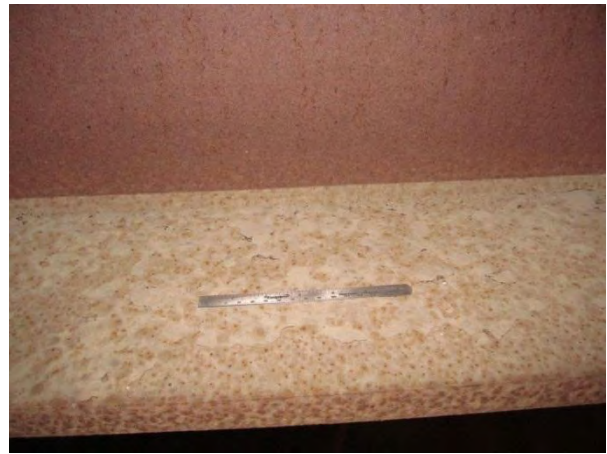
*Figure 4. Heavy poulitice corrosion with delaminated flaking on interior bottom flange.*

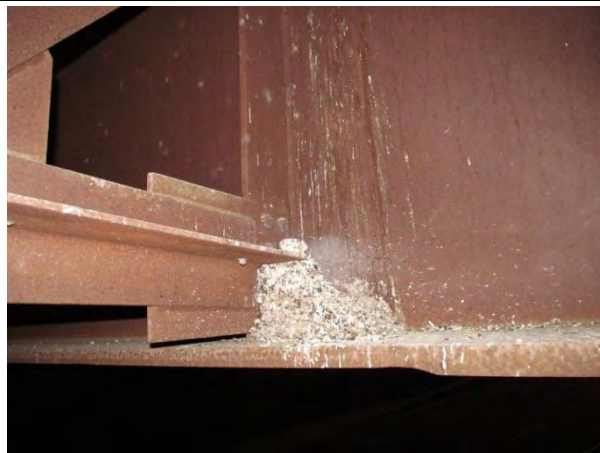
*Figure 5. Bird droppings contributing to poulitice on interior bottom flange.*

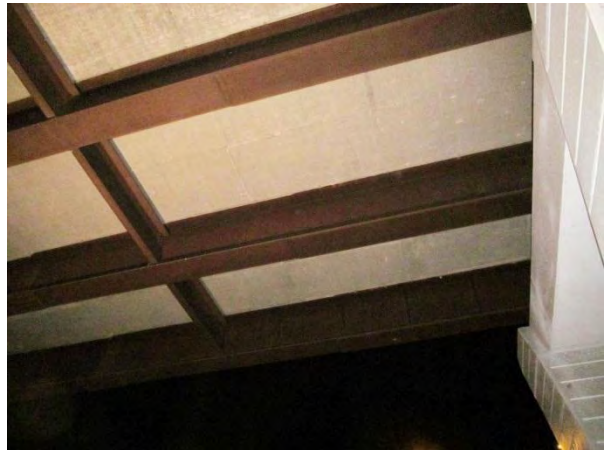
Figure 2. Girders and diaphragms near south pier; appear in good condition from below.

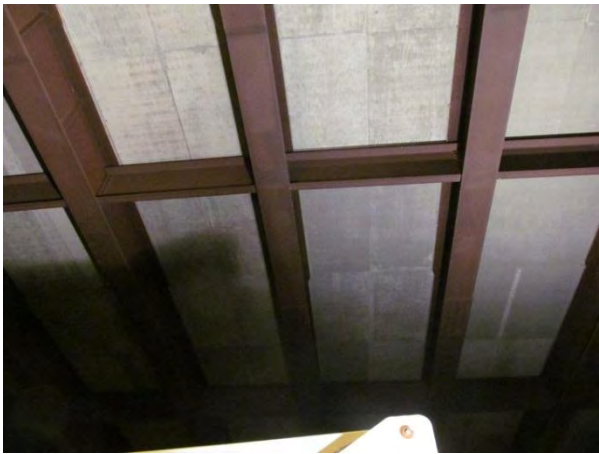
Figure 3. Middle of south span.

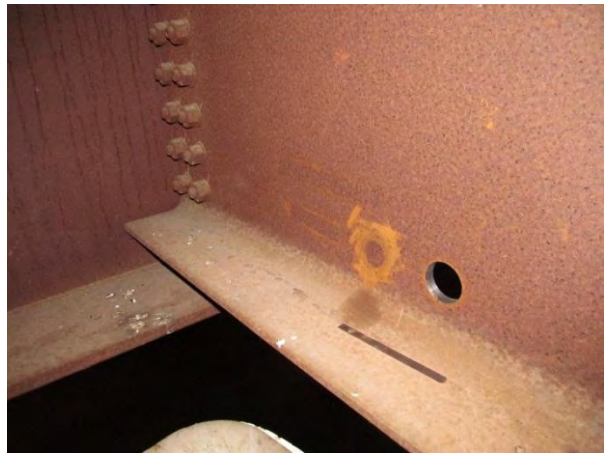
Figure 4. Heavy poutlice corrosion on diaphragm and girder flange at core location.

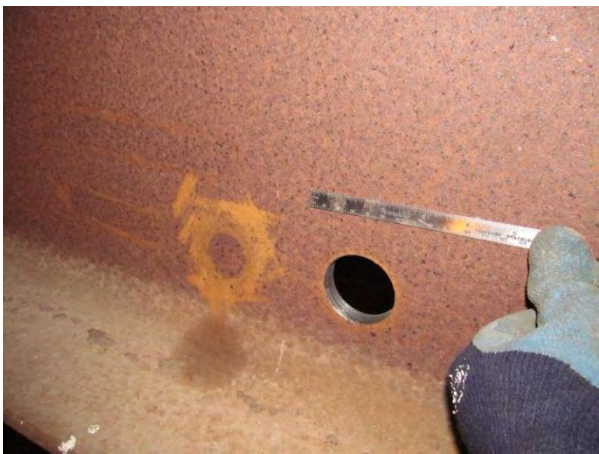
Figure 5. Tape and chloride tests also taken adjacent to core.

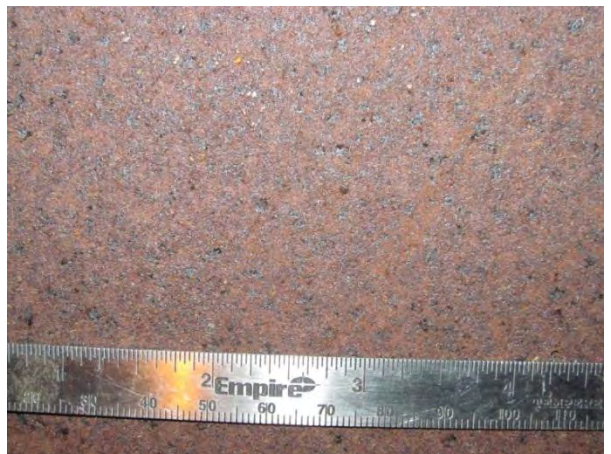
Figure 6. Detail of patina condition on diaphragm web adjacent to core. Index=3.5.

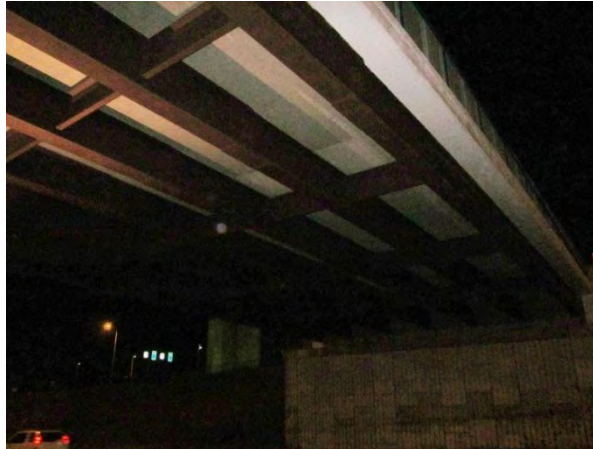
*Figure 1. South span over eastbound I-235. Some staining noted on fascia girder and 1st interior girder over the center lane, but not readily visible in this photo.*

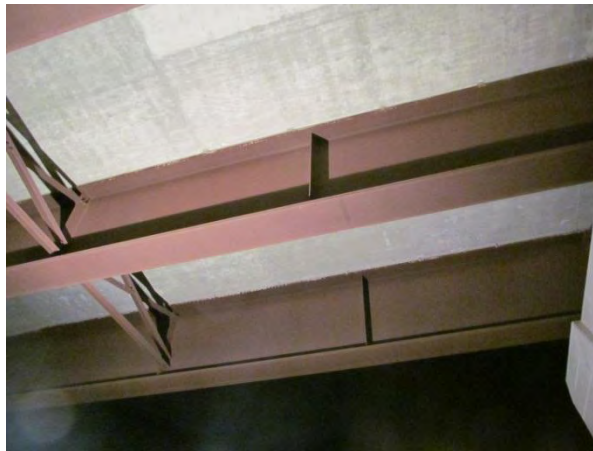
*Figure 2. Girders and cross-frames near center pier; no significant deterioration visible from below.*

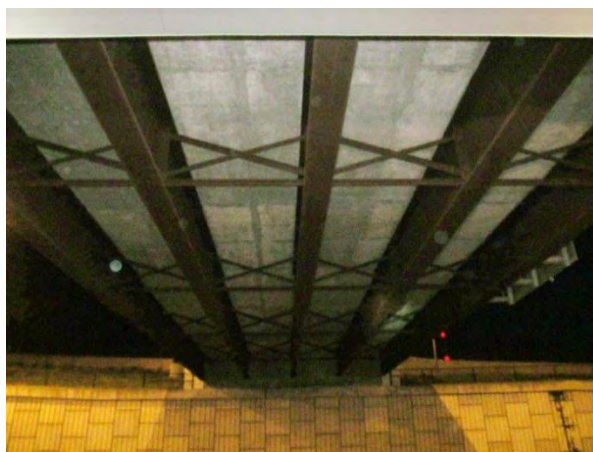
*Figure 3. North span over westbound I-235.*

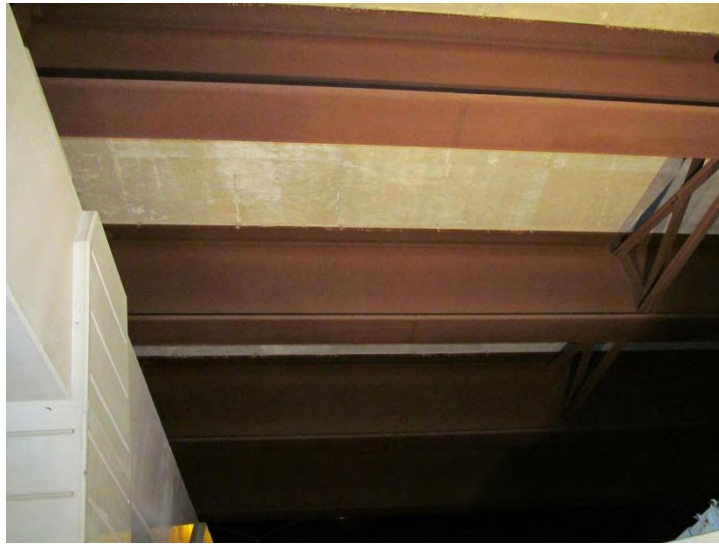
*Figure 1. Girders near the intermediate pier; no signs of significant deterioration visible.*

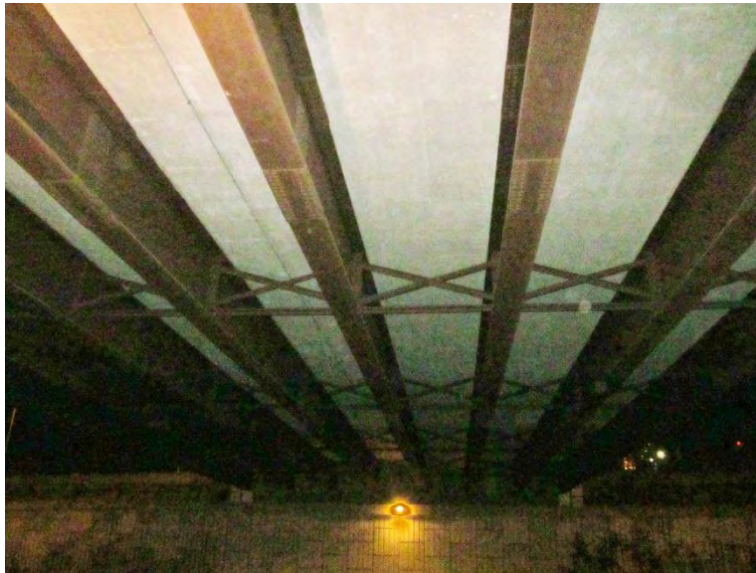
*Figure 2. Overall photo of the second span.*

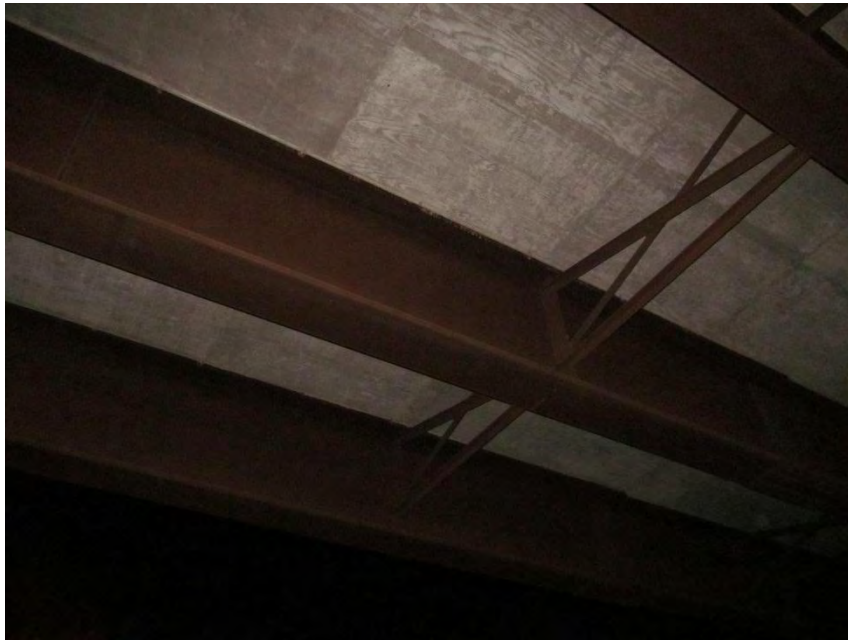
*Figure 1. Girder and cross-frames near mid-span; representative of conditions throughout the structure.*

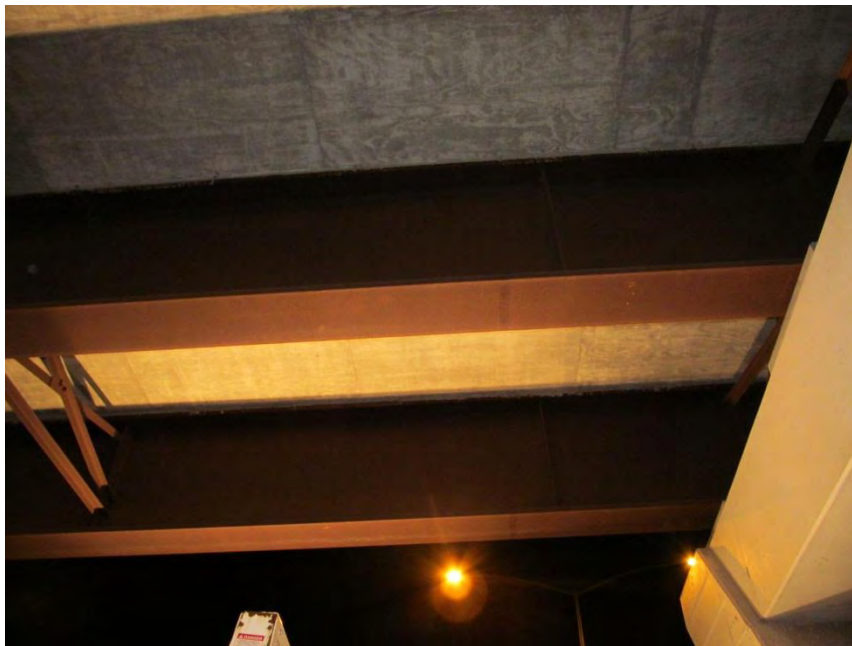
*Figure 2. Girders and cross-frames near the intermediate pier.*

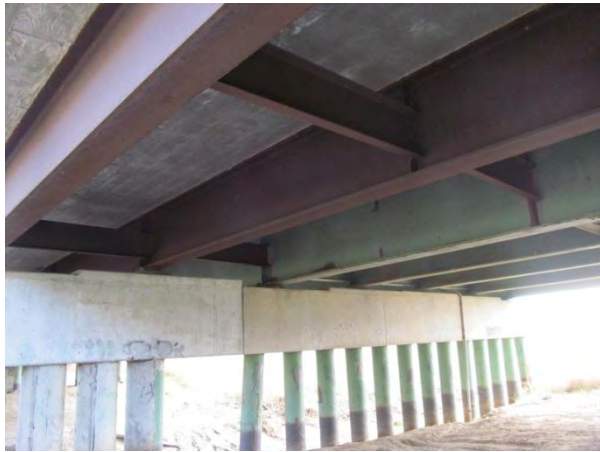
Figure 1. West pier showing framing arrangement and tie-in to original structure.

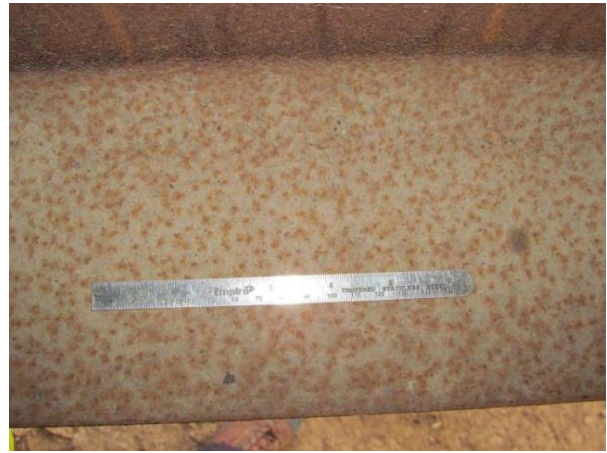
Figure 4. Interior top of bottom fascia flange with light poulitice corrosion, but minimal flakiness.

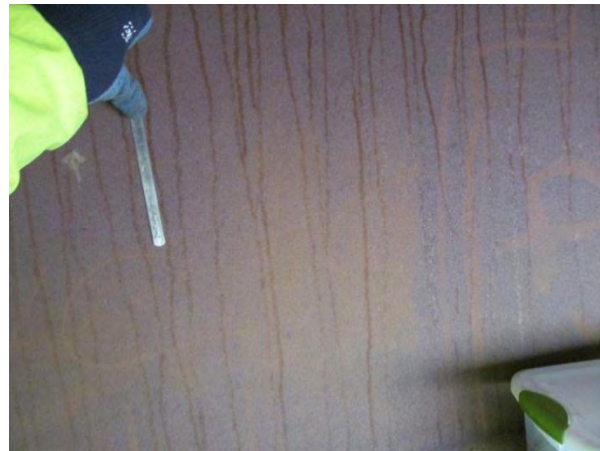
Figure 5. Interior web performing well.

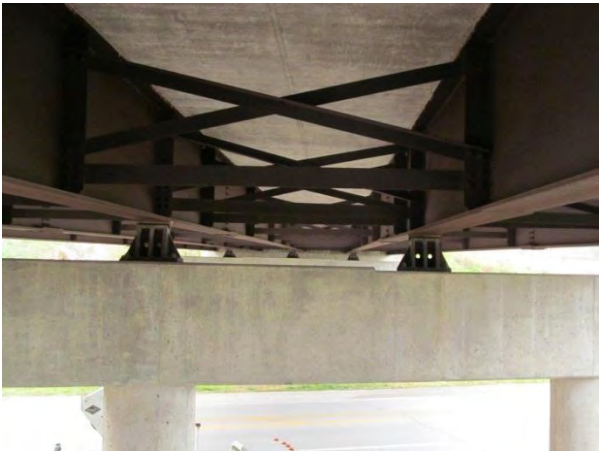
Figure 1. View of south pier looking north; note lack of drainage deflector plates on bottom flanges, typ.

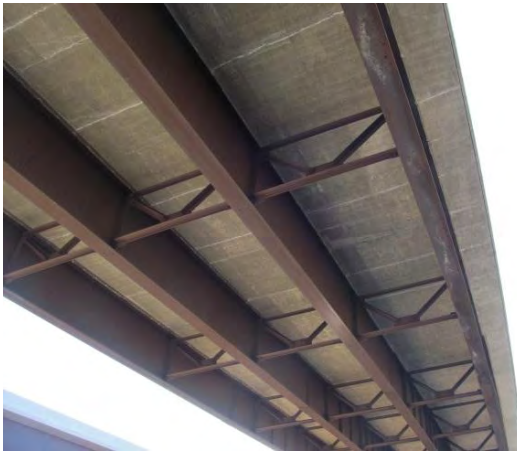
Figure 1. Typical middle bay of southbound bridge; note regular cracking with efflorescence and heavy salt staining on west fascia girder bottom flange.

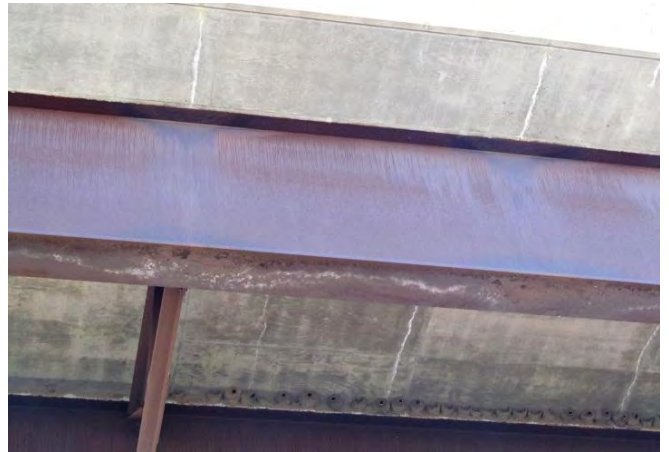
Figure 2. Exterior of west fascia girder on southbound bridge showing localized patina deterioration on all surfaces beneath cracks.

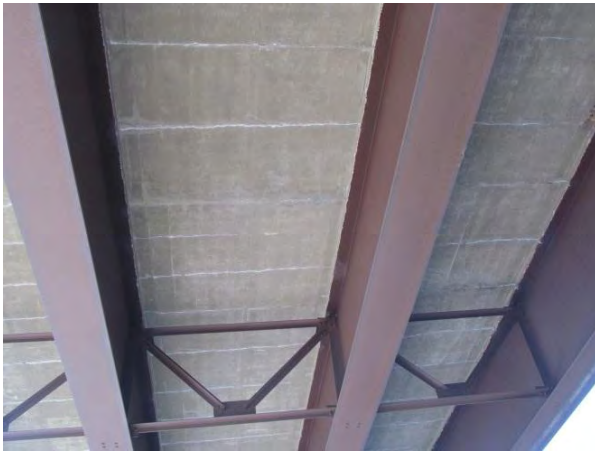
Figure 3. Other girders of southbound bridge show little change in patina condition beneath cracks.

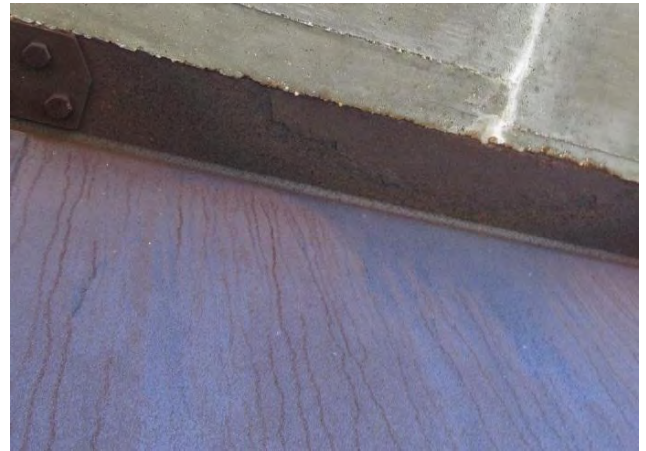
Figure 4. Heavy deterioration/delamination of west fascia girder top flange at crack, possibly Index = 1.

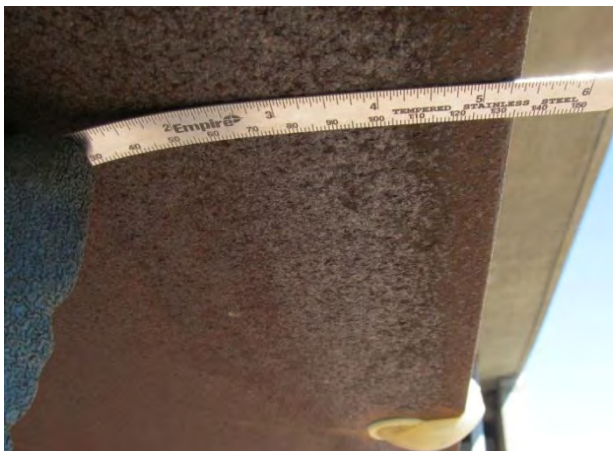
Figure 5. Condition of bottom of flange of east fascia near north abutment considerably better than west fascia (Index = 3).

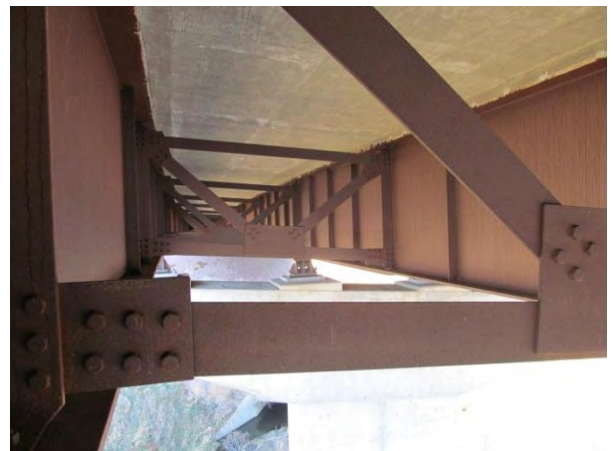
Figure 6. Typical condition of other interior surfaces away from deck cracks typically Index = 3 to 4, with little to no surface chlorides measured.

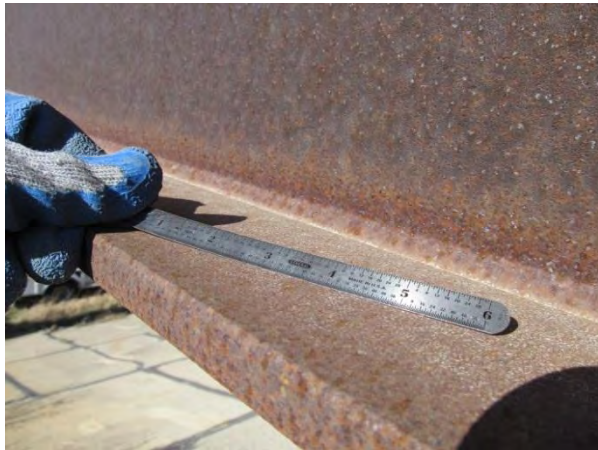
*Figure 1. Exterior surfaces over traffic in good condition after more than 40 years.*

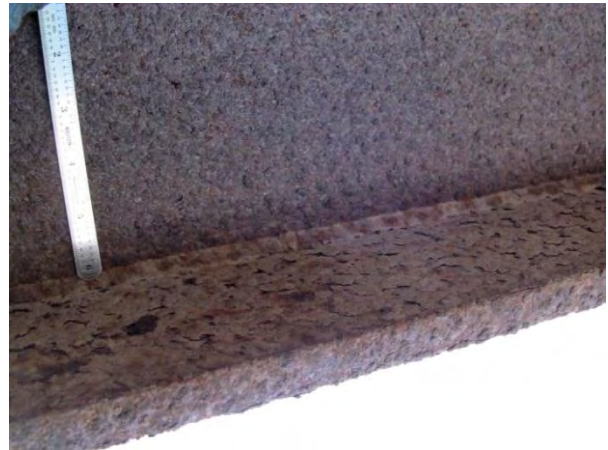
*Figure 2. Interior surfaces over traffic showing signs of long-term deterioration.*

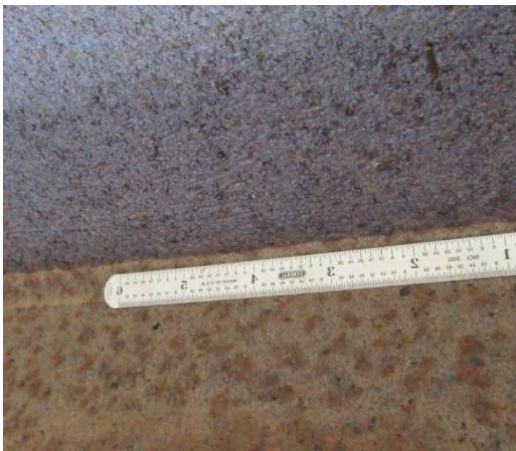
*Figure 3. Interior surfaces near east abutment with less deterioration than areas over traffic.*

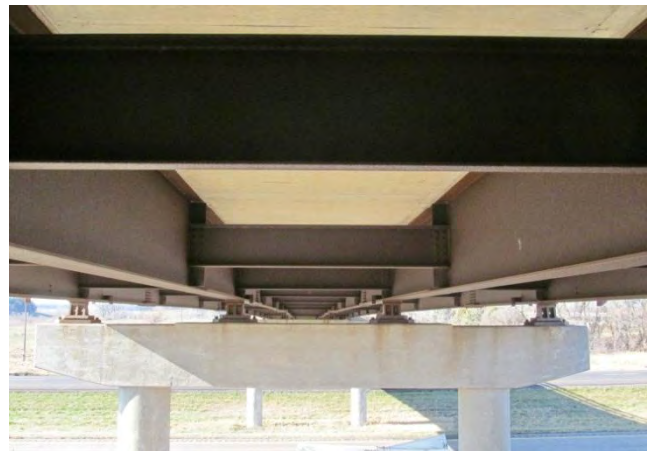
*Figure 4. East pier viewed from east abutment. Drainage deflectors separating spans effectively.*

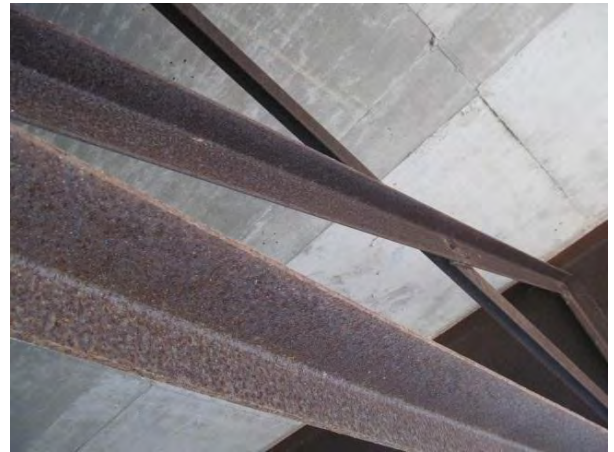
Figure 4. Typical cross frame condition near south abutment. Index = 3.

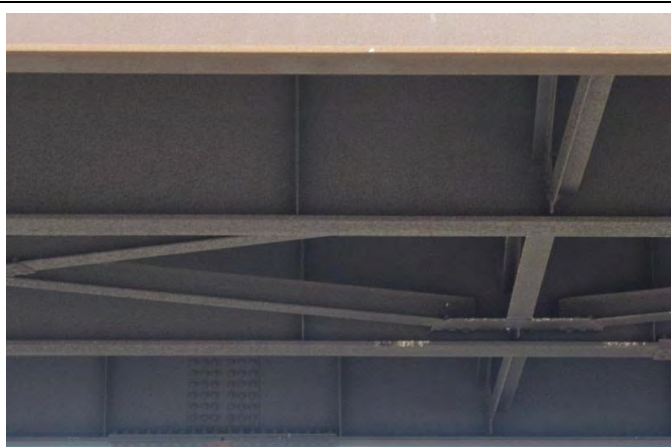
Figure 5. Heavy flaking visible from the ground on interior flanges and webs over traffic lanes; Index = 2.

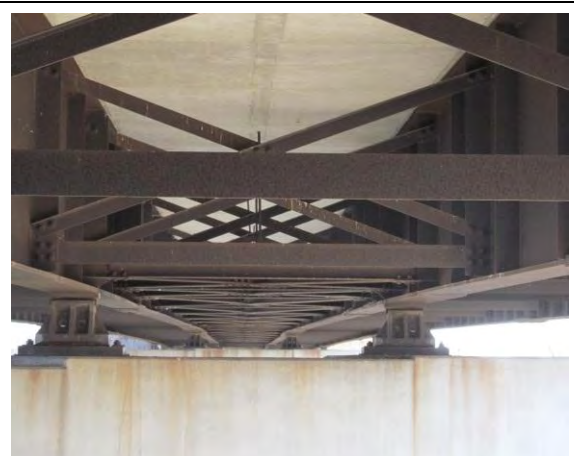
Figure 6. Center bay viewed over top of south pier; note lack of deflector plates and concrete staining.

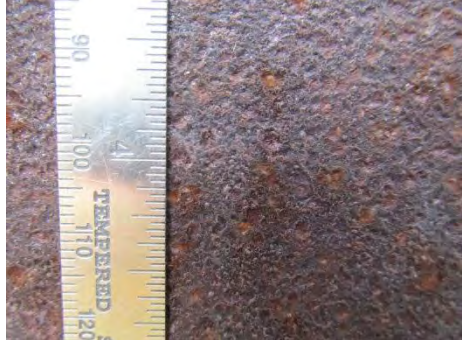
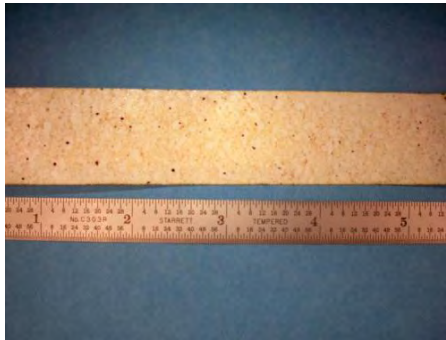
| Patina Rating | Condition Description | Example Condition in Field | Example Tape Test Specimen |
|---|---|--|---|
| 8<br>Very Good | <p>Uniform color pattern, generally dark brown with some lighter reddish-brown, metallic and purple-brown spots. May be difficult to see small rust product clusters.</p> <p>Texture may be dimpled or rough but uniform in pattern. Patina layer is thin but dense and very adherent, indicative of very good protective properties. Superior adherence; tape test sparse with only very small flakes (&lt; 1 mm).</p> | | |

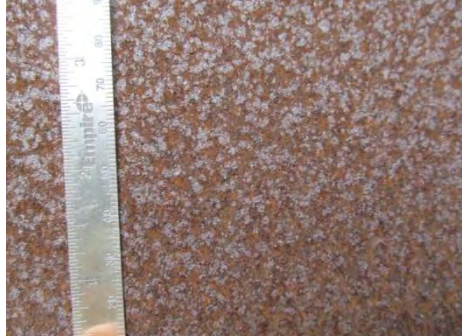
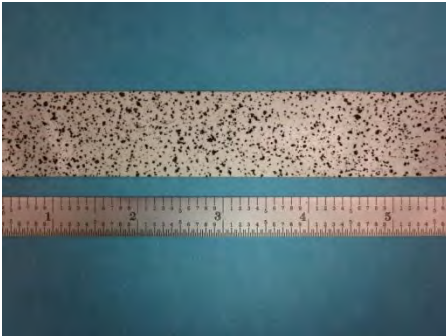
| Patina Rating | Condition Description | Example Condition in Field | Example Tape Test Specimen |
|---|---|--|---|
| 7<br>Good | <p>Uniform color pattern, generally dark brown with some lighter reddish-brown, metallic and purple-brown spots. Individual rust product clusters visible.</p> <p>Texture is dimpled or rough but uniform in pattern. Patina layer is thin but dense and adherent, indicative of good protective properties. Tape test easily removes very small (&lt; 1 mm) flakes.</p> | | |

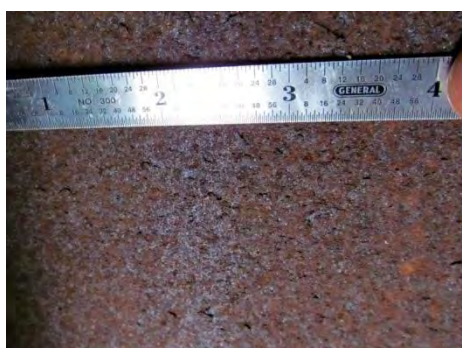
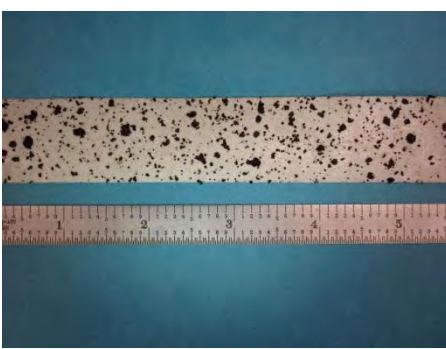
| Patina Rating | Condition Description | Example Condition in Field | Example Tape Test Specimen |
|---|---|--|---|
| 6<br>Satisfactory | <p>Dark brown coloration, but begins to show minor variation. 1-5 mm flakes loose on surface, easily removed with tape test.</p> <p>Underlying layer adherent, still relatively dense, thin and protective. Texture more granular and loose flakes may be less-protective, holding water and salts.</p> <p>Chalky poulitice layer may be present, but not significantly affecting performance (i.e., flake size).</p> | | |

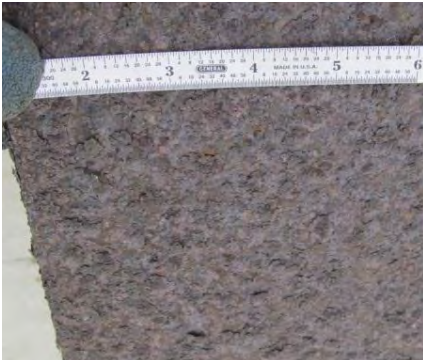
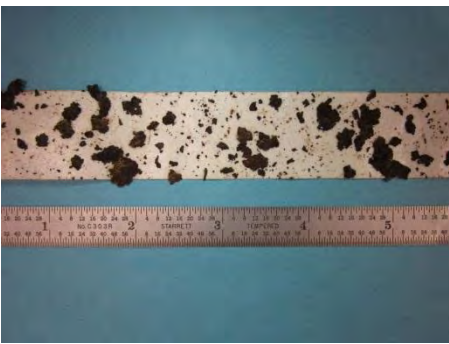
| Patina Rating | Condition Description | Example Condition in Field | Example Tape Test Specimen |
|---|--|--|---|
| 5<br>Fair | <p>Dark brown with black and some color variation. Blotchy with some salty or rusty stains. Medium (5-25 mm) flakes over most of area loose and non-protective, easily removed with tape test.</p> <p>Layer beneath flakes thicker and more permeable, with some pitting beginning. Non-protective; contaminants penetrating.</p> <p>Elements with poultice may show significant associated flaking.</p> | | |

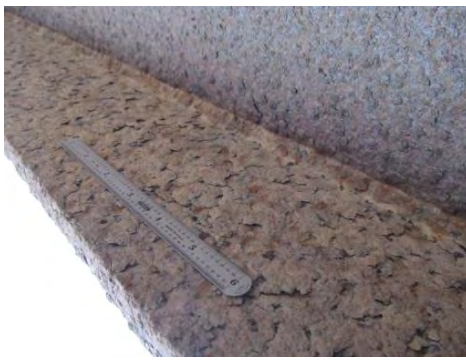
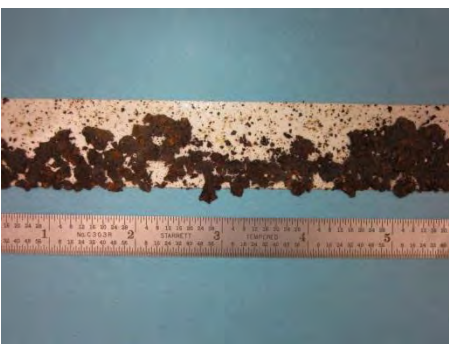
| Patina Rating | Condition Description | Example Condition in Field | Example Tape Test Specimen |
|---|--|--|---|
| 4<br>Poor | <p>Color is dark brown and black but non-uniform, with widespread blotchiness and staining. Non-protective.</p> <p>Large (&gt; 25 mm) flakes, or layered delamination beginning in some areas. Thickness/permeability of rust increased, with pitting and section loss possible.</p> <p>Poultice areas have thin delamination sheets or very large flakes. Layer below loose poultice may appear similar, but still somewhat adherent.</p> | | |

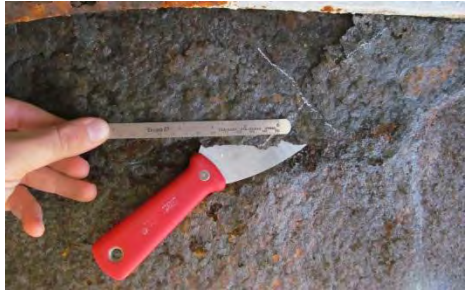
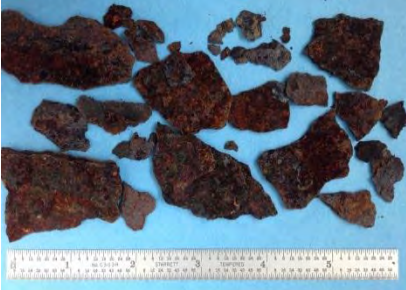
| Patina Rating | Condition Description | Example Condition in Field | Example Tape Test Specimen |
|---|--|--|---|
| 3<br>Serious | <p>Blackish, stained, blotchy appearance.</p> <p>Formation of laminar sheets with deeply pitted semi-adherent layer beneath; chunks and sheets of rust product removable by hand.</p> <p>Aggressive advancement of pitting and section loss; can be up to 50%. Complete failure of patina to protect base steel.</p> | | |
