*Midwest States Regional Pooled Fund Research Program  
Fiscal Year 2011 (Year 21)  
Research Project Number TPF-5(193) Supplemental #31  
NDOR Sponsoring Agency Code RFP-11-MGS-1*

# **MIDWEST GUARDRAIL SYSTEM (MGS) WITH SOUTHERN YELLOW PINE POSTS**

MwRSF Research Report No. TRP-03-272-13

September 4, 2013

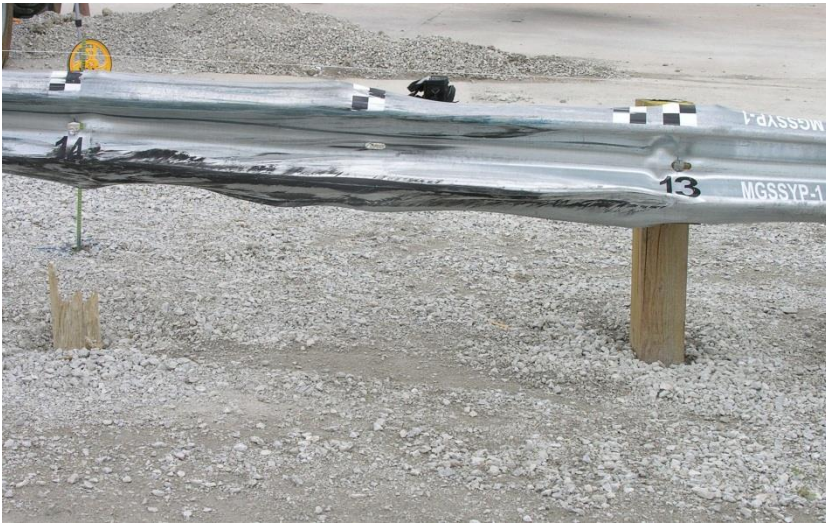
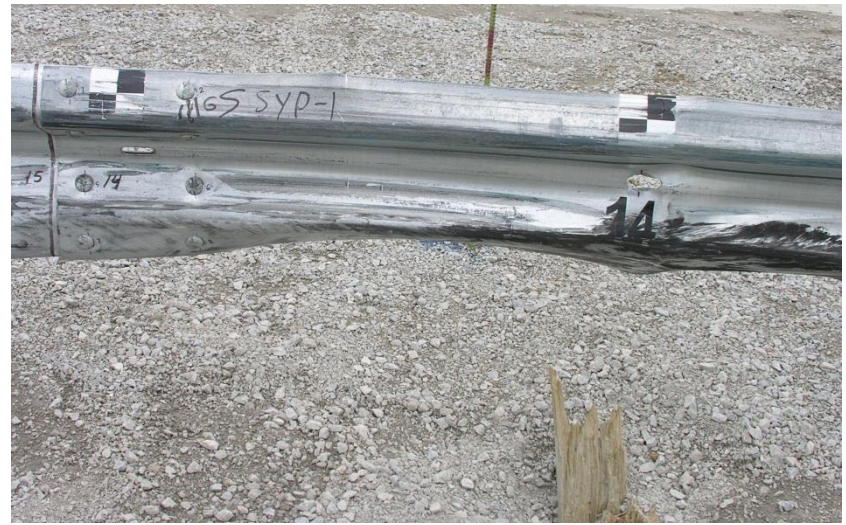
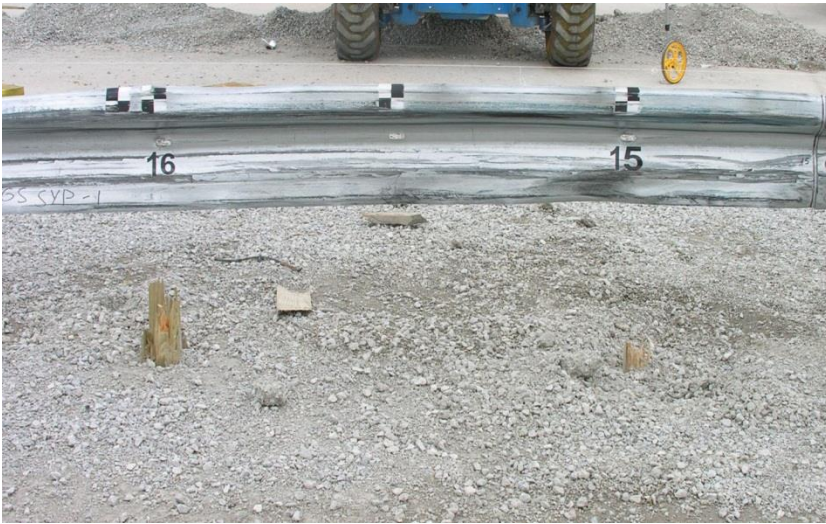
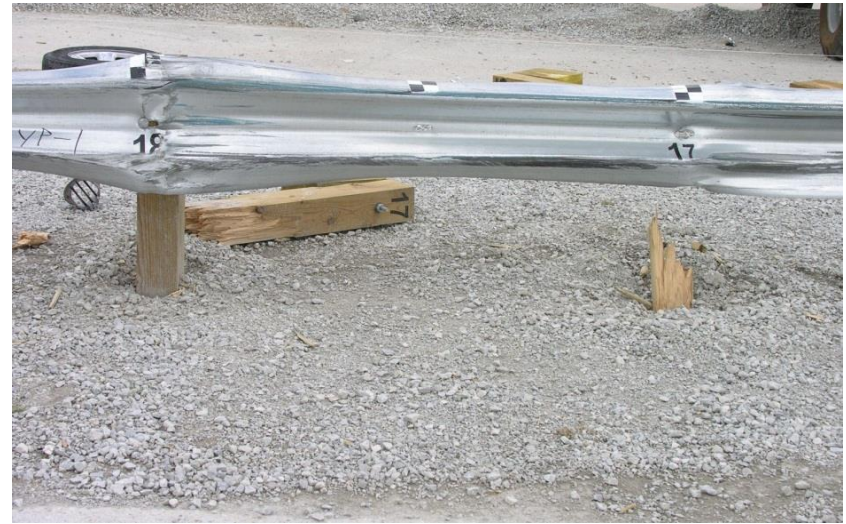
Figure 37. System Damage, Test No. MGSSYP-1

Damage to the barrier was moderate, as shown in Figures 37 through 38 . Barrier damage consisted of deformed guardrail, fractured posts, and contact marks on the front face of the W-beam guardrail. The length of vehicle contact along the barrier was approximately 34 ft – 4 in. (10.5 m) which spanned from 4 in. (102 mm) upstream of the centerline of post no. 13 and extended to 33 in. (838 mm) downstream of post no. 18.

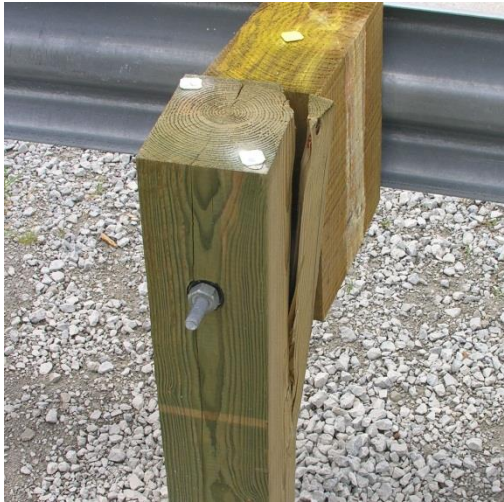
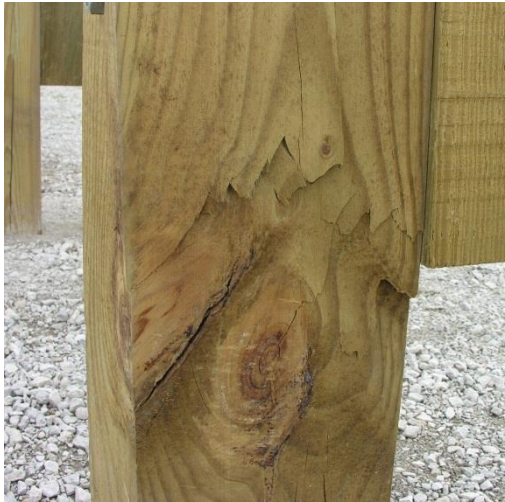
Figure 38. Rail Damage Between Post Nos. 13 and 18, Test No. MGSSYP-1

The rail disengaged from several posts both upstream and downstream of impact. The guardrail bolt pulled through the rail at post nos. 3 through 5, 7 through 9, and 14 through 17. A ¼-in. (6-mm) tear was found in the rail on the upstream end of the slot at post no 3. A ¼-in. (6-mm) tear also occurred at the bottom center of the slot at post no. 7. A ½-in. (13-mm) tear occurred on the bottom downstream edge of the slot at post no. 14.

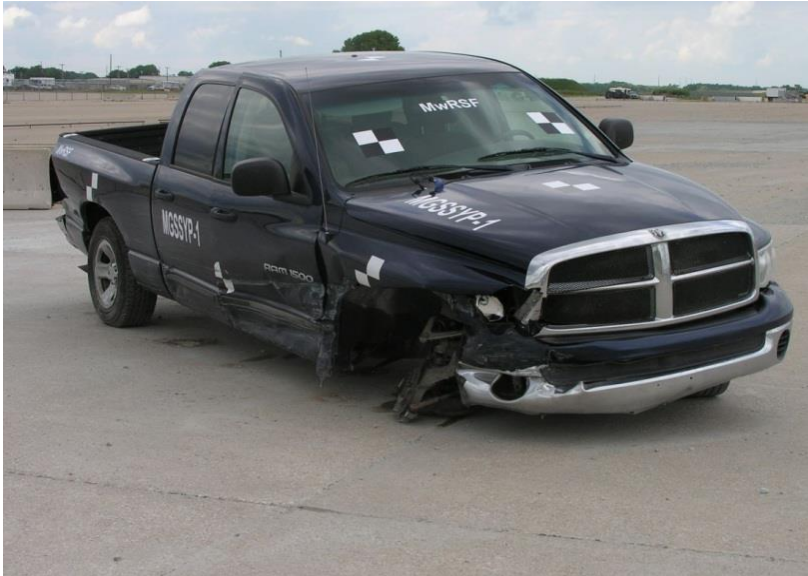
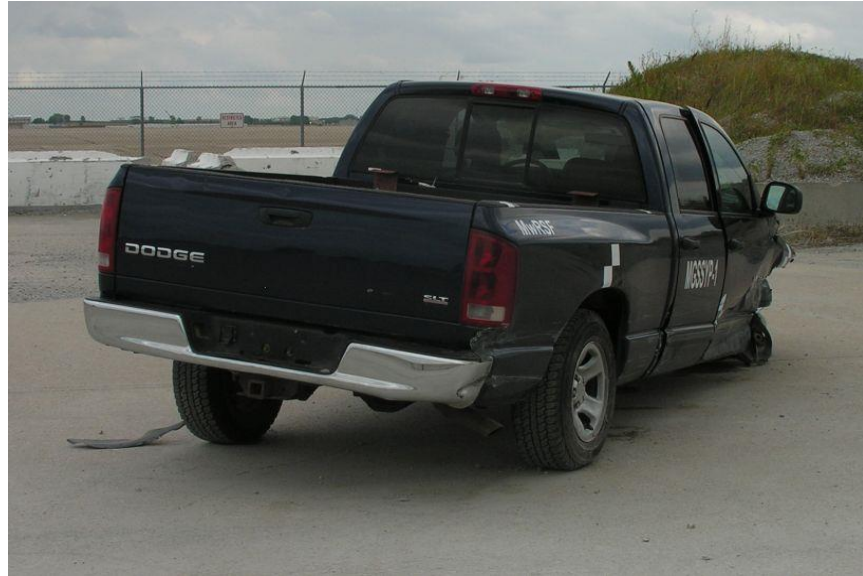
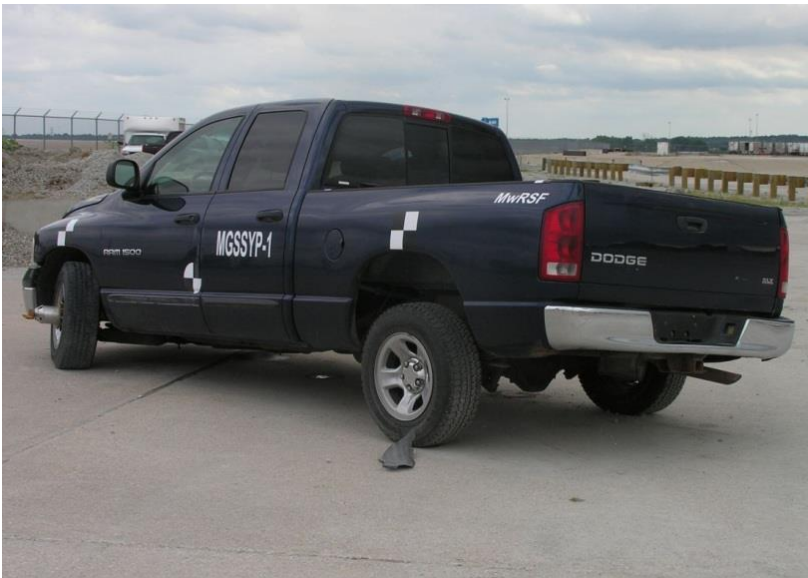
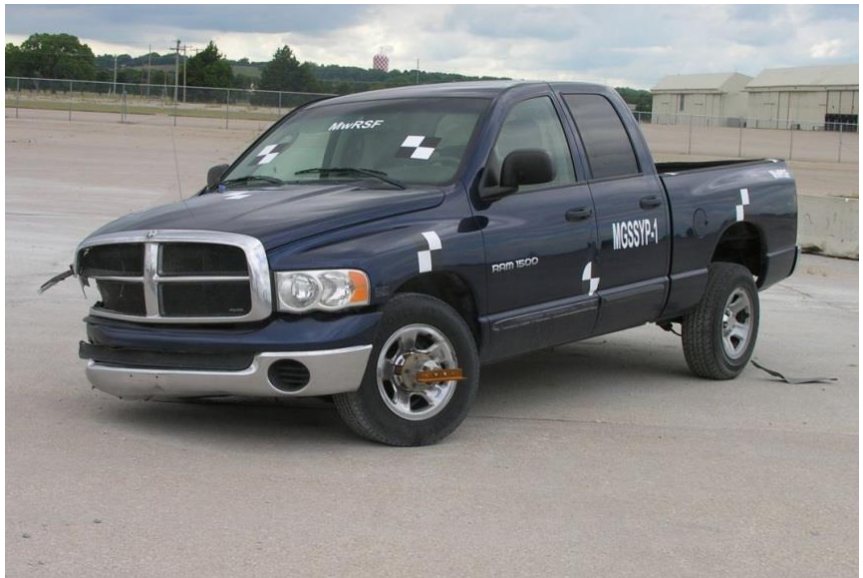
Figure 46. Downstream Anchor Damage, Test No. MGSSYP-1

The damage to the vehicle was minimal, as shown in Figures 47 and 48. The maximum occupant compartment deformations are listed in Table 6 along with the deformation limits established in MASH for various areas of the occupant compartment. Note that none of the MASH established deformation limits were violated. Complete occupant compartment and vehicle deformations and the corresponding locations are provided in Appendix D.

The majority of the damage was concentrated on the right-front corner and right side of the vehicle where the impact occurred. The front bumper was bent on the right lower side approximately 8 in. (203 mm) from the centerline of the vehicle. There was also a kink on the top of the front bumper approximately 19 in. (483 mm) from the centerline of the vehicle. There were contact marks on the right side of the front bumper cover. The front bumper cover also had a 5-in. (127-mm) tear along the right quarter panel. The grill of the vehicle was deformed backward 2½ in. (64 mm) on the bottom right side. The right quarter panel was folded inward 7 in. (178 mm). The right headlight fractured, and the right-front tire detached from the vehicle at the wheel bearing. The right-front upper control arm and disc brake assembly detached. Contact marks extended the entire length of the right side of the vehicle. Both of the doors on the right side were slightly ajar. The top of the right-front door separated 1 in. (25 mm) from the cab of the vehicle, while the bottom of the right rear door separated ¾ in. (19 mm) from the cab. The right-front door also had flattening that extended the entire length of the door 17 in. (432 mm) up from the bottom of the door. The right-rear door had contact marks that extended the length of the door. Flattening occurred at the bottom of the door and at the rear corner of the cab. The right

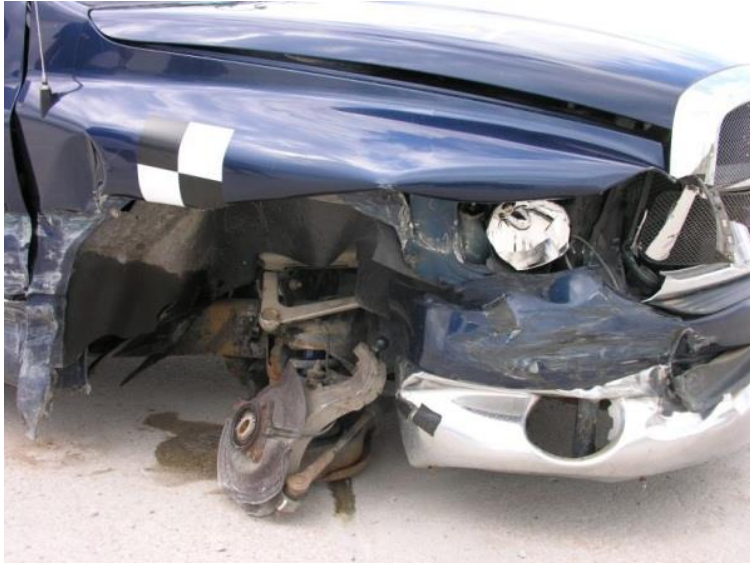
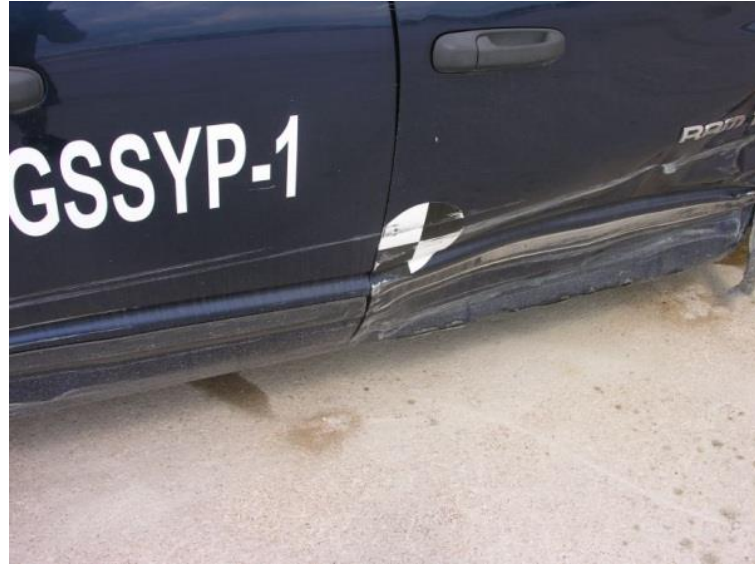
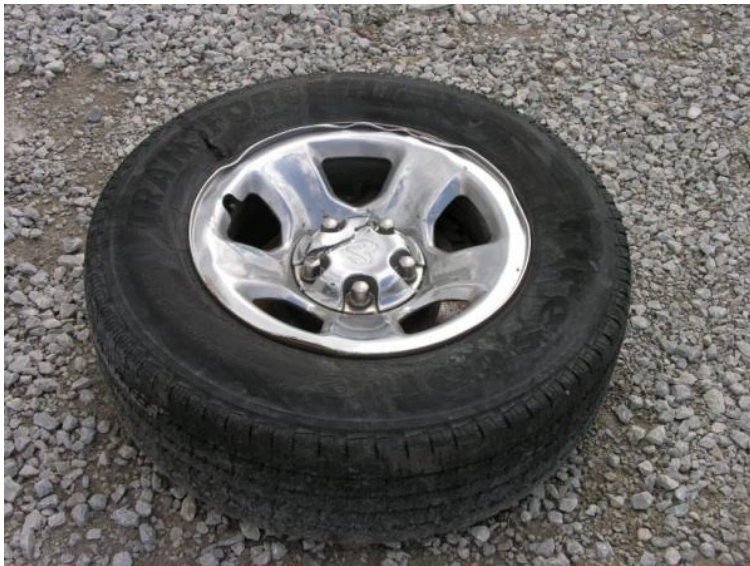
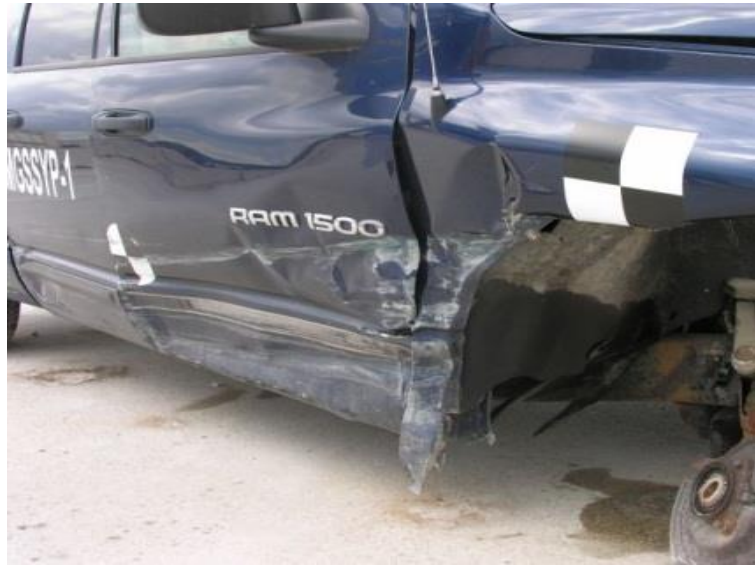
Figure 47. Vehicle Damage, Test No. MGSSYP-1

side of the rear bumper was flattened and had a kink 12 in. (305 mm) from the right fender. The right-rear taillight separated approximately 2½ in. (64) mm from the fender. A 35 in. (889 mm) long crack was found down the center of the windshield.
