Western Iowa Missouri River Flooding —  
Geo-Infrastructure Damage Assessment, Repair  
and Mitigation Strategies

# Geo-Infrastructure Post-Flood Damage Assessment, Repair and Mitigation Strategies

tech transfer summary

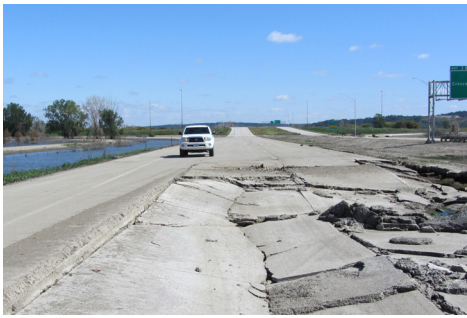
Pavement damage due to erosion

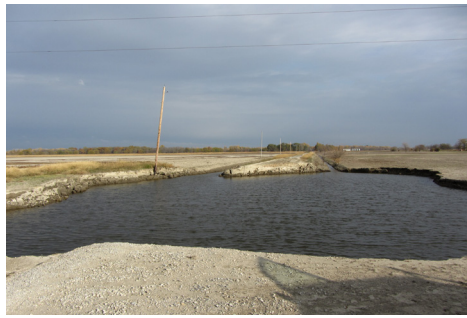
Full breach of roadway embankment

- Erosion of backfill materials around culverts was observed at several locations, which in some cases resulted in potholes and complete breach of the roadways.

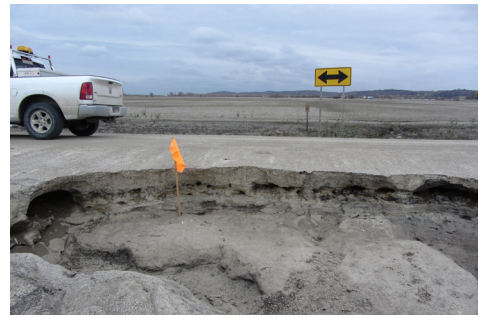
Erosion of granular shoulder

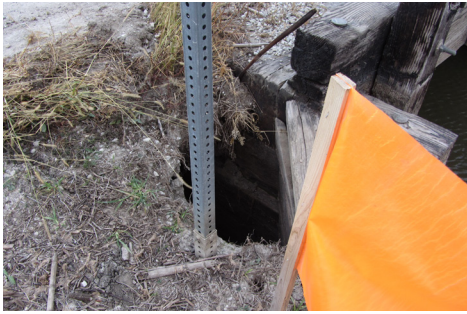
Erosion of abutment backfill

- Erosion of bridge approach backfill materials was observed at the two bridge sites assessed in this study, resulting in voids down to about 2 m (6.6 ft) below surface.

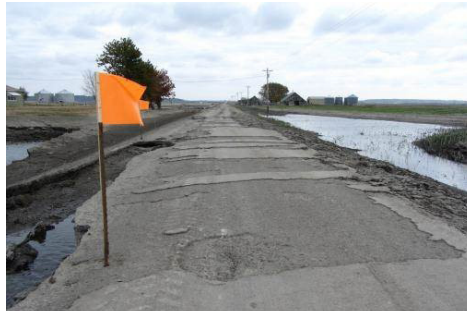
Stripping of chip seal surface

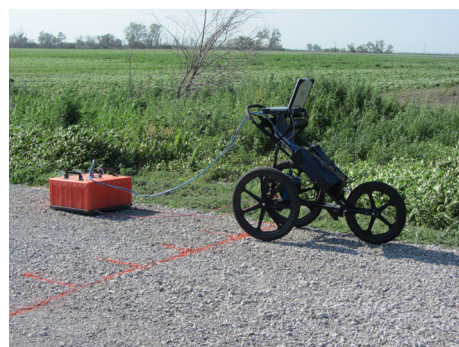
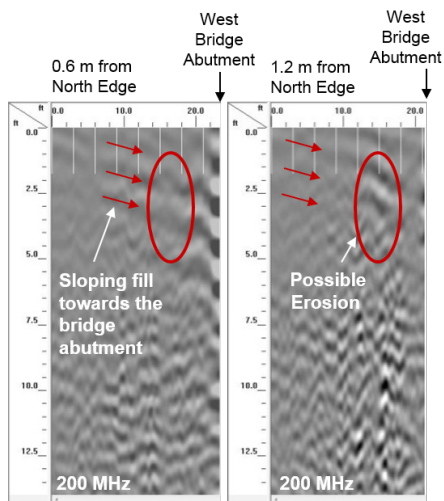
*Figure 2. Ground penetrating radar scanning at a bridge site to identify subsurface voids/erosion in approach backfill*

- Ground penetrating radar scanning identified changes in gravel layer thicknesses, culvert locations, weep holes under roadways, voids beneath pavements, and voids in bridge approach backfill materials.

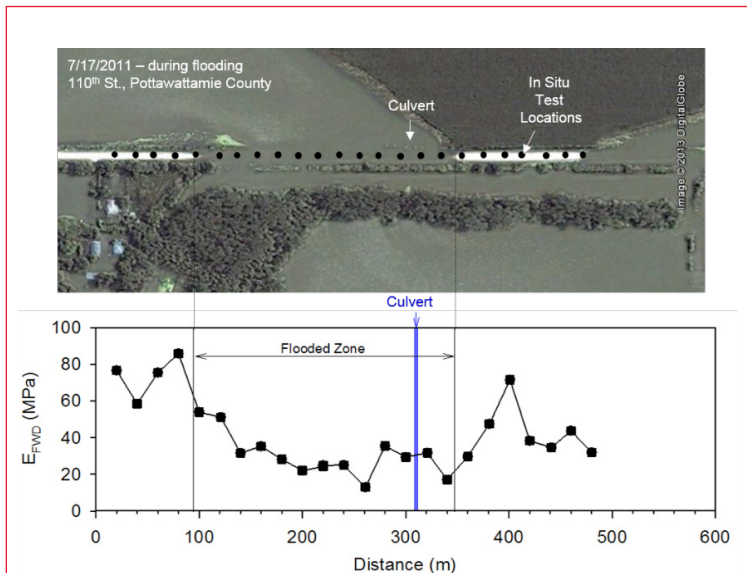
**Figure 5. Aerial imagery (from Google Earth) and falling weight deflectometer (FWD) test results in flooded and non-flooded zones on 110th Street, Pottawatomie County**

- FWD tests obtained shortly (< 30 days) after flooding indicated that the average modulus values in flooded zones were about 1.3 to 3.6 times lower than the values in non-flooded zones (see Figure 5 for example). In some areas, the foundation layers within the flooded zone gained strength over time, likely as the degree of saturation in the subgrade decreased. However, many sections did not show much improvement.
