Report No. UT-13.14

## **MONITORING OF DUROMAXX PIPES INSTALLED ON MANHEAD ROAD IN RICH COUNTY, UTAH**

Utah State University  
Buried Structures Laboratory

**Final Report  
September 2013**

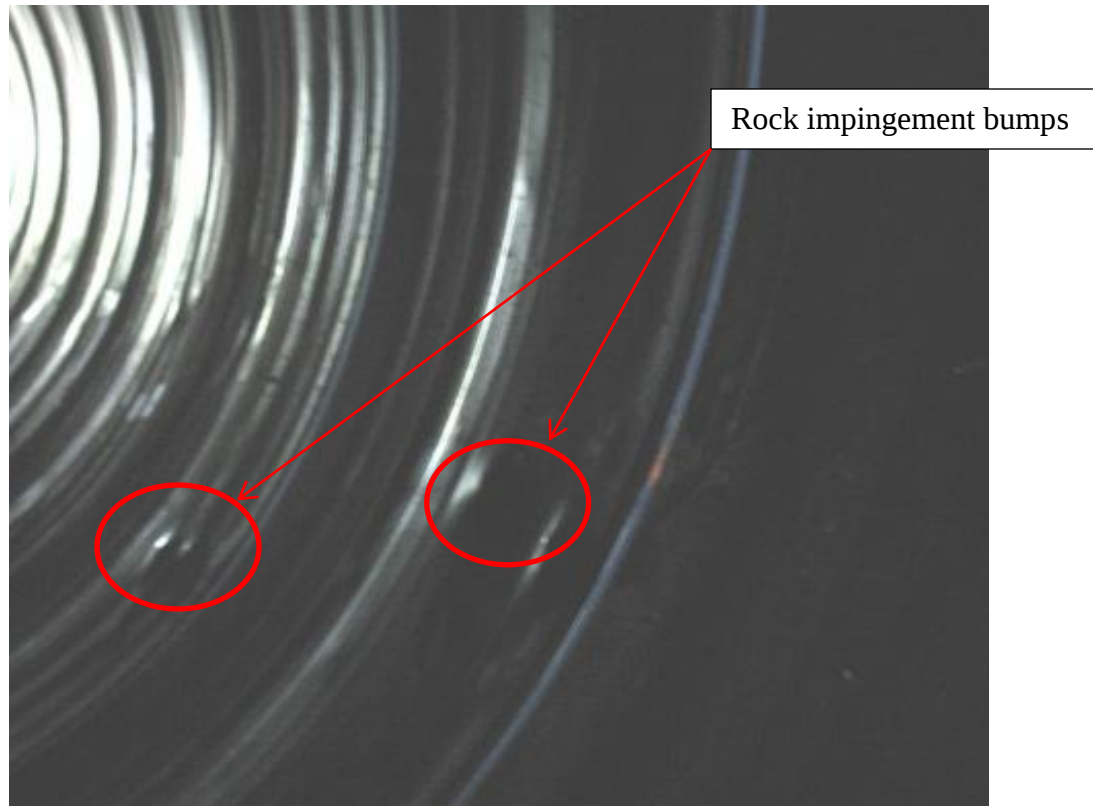
An effort was made to identify any localized deflections that could be identified visually on the interior of the pipe. No significant issues were observed during the visual inspections of the inside pipe surfaces. However, on the two-year visit, minor rock impingement bumps were observed in the haunch region of the north DuroMaxx pipe between stations 1 and 2. Figure 14 is a photo of the “bumps.” Please note that it is difficult to capture these minor bumps if the camera flash is operating. Figure 14 has the flash turned off requiring a long shutter time (causing some blurring) and the pipe exit cropped out to better highlight the bumps. These very minor bumps did not change between the year-2 and year-3 visits and likely have been present all along. Minor damage was also observed during the final inspection in the blue plastic seals that cover the spiral weld seams in the south DuroMaxx pipe. Figure 15 has a photograph of the damage. After careful inspection it was determined that the loops were pulled away from the pipe during our inspections. It is believed that in process of pushing ourselves through the pipes that our feet pulled these seals out as shown. Since these are located above the spring-line of the pipe, no leakage or soil migration issues are expected.

**Figure 14.** Rock impingement bumps in the north DuroMaxx pipe.

There were also observations of minor damage. It was noted that there are rock impingement marks in the north DuroMaxx pipe between stations 1 and 2. These marks are very small and were first observed during the year-two visit. No growth of these impingement marks was observed in the final year-three visit, and these marks were likely present during all the visits. These are of no concern at this time. The blue plastic seal at the helical weld seams was pulled out slightly at three locations in the south DuroMaxx pipe. It is believed that this damage was done during the inspection process. Again, there is no concern about this minor damage.

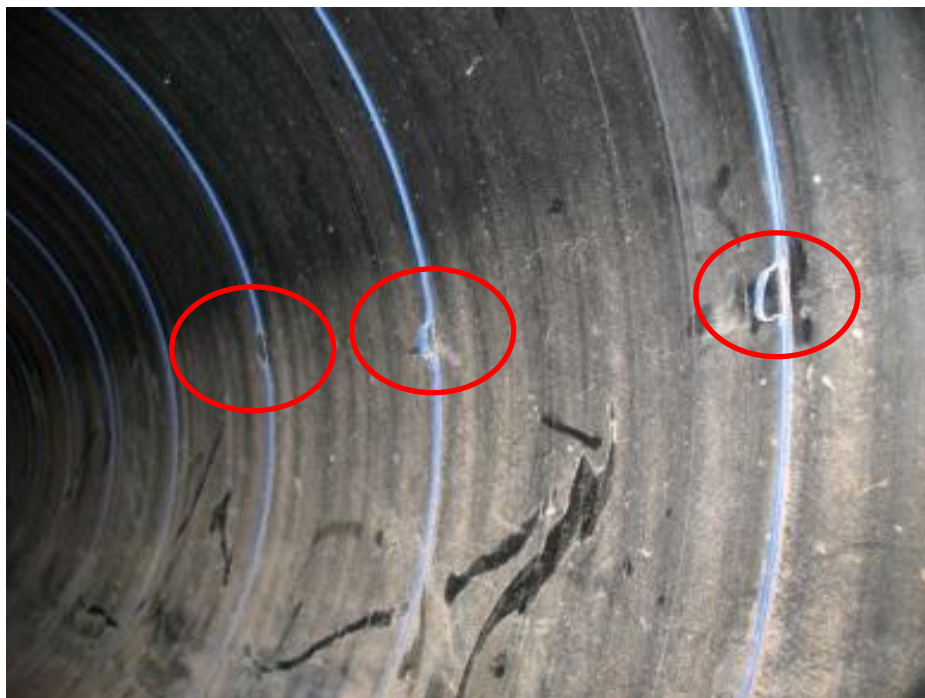
**Figure 15.** Minor damage to plastic seal at spiral weld locations.

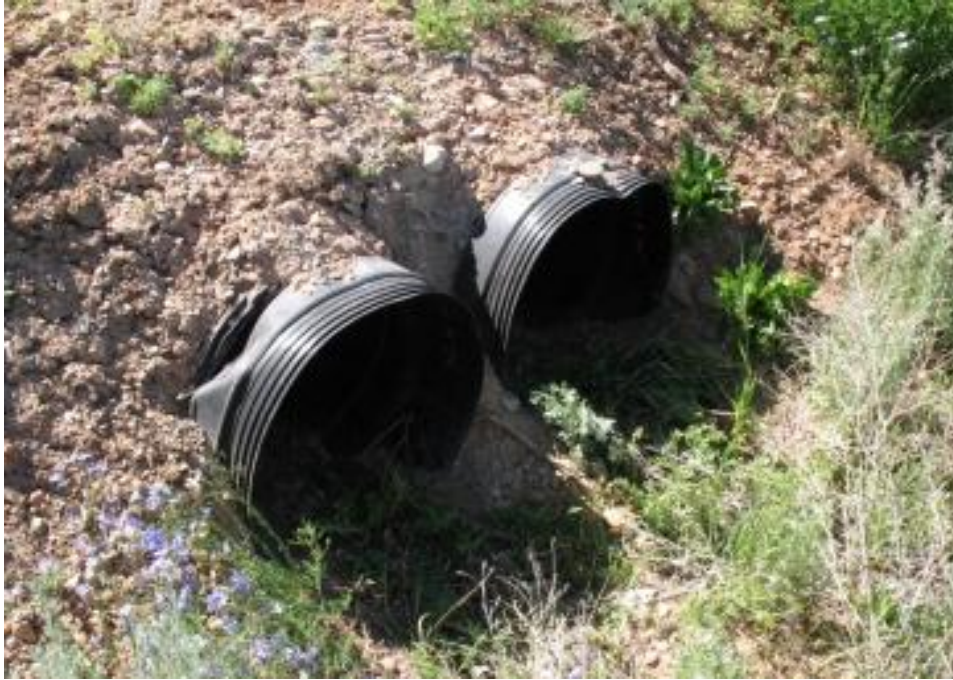
In the final inspection there was some damage observed in the DuroMaxx pipes in the west entrance to both pipes. The damage is localized to the portion extending past the soil. This may be a concern if the additional damage causes erosion of the shoulder material.

Some significant damage was observed on the final, year-3 inspection on the west entrance of the DuroMaxx pipes. Figures 16 and 17 are photographs of the pipe at the west entrance. Figure 17 shows the tear at a rib location that occurred. The soil above the pipe may

be more subject to erosion because of this. No damage was observed on the exterior of the ADS pipe. The cause of this damage is unknown.

**Figure 16.** Damage to the west entrance to the DuroMaxx pipe.

Both the ADS and DuroMaxx pipes have performed adequately to date with two exceptions. Station 1 of the south ADS pipe is at a 7% deflection, but is holding steady at that deflection. Also damage has been done on the west entrance to the DuroMaxx pipe. The cause of the damage is unknown. This damage might lead to additional erosion of the road shoulder at this location. It may be wise to consider monitoring this in the future.

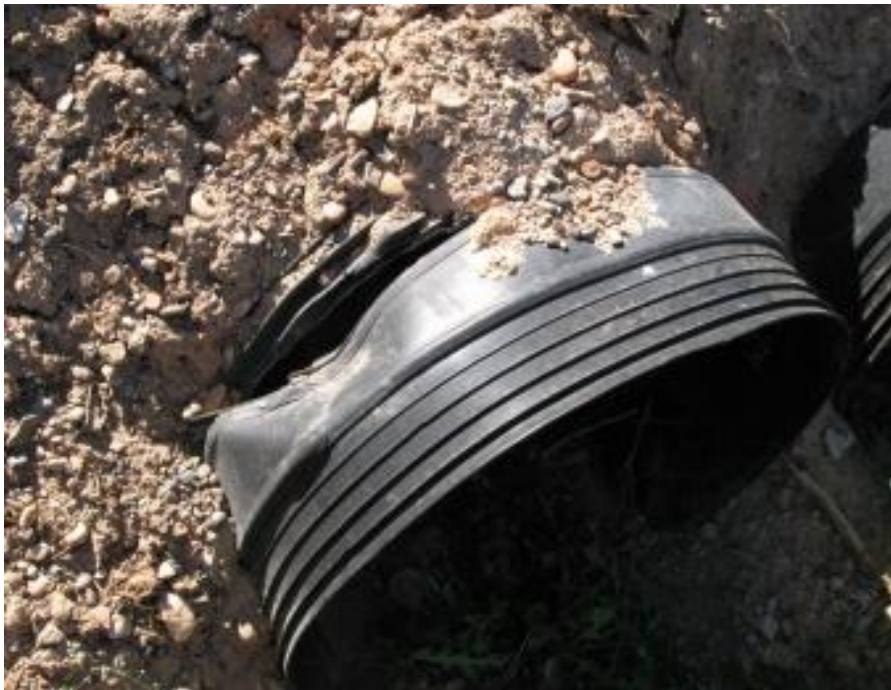
**Figure 17.** Close up view of damage to the west entrance to the north DuroMaxx pipe.

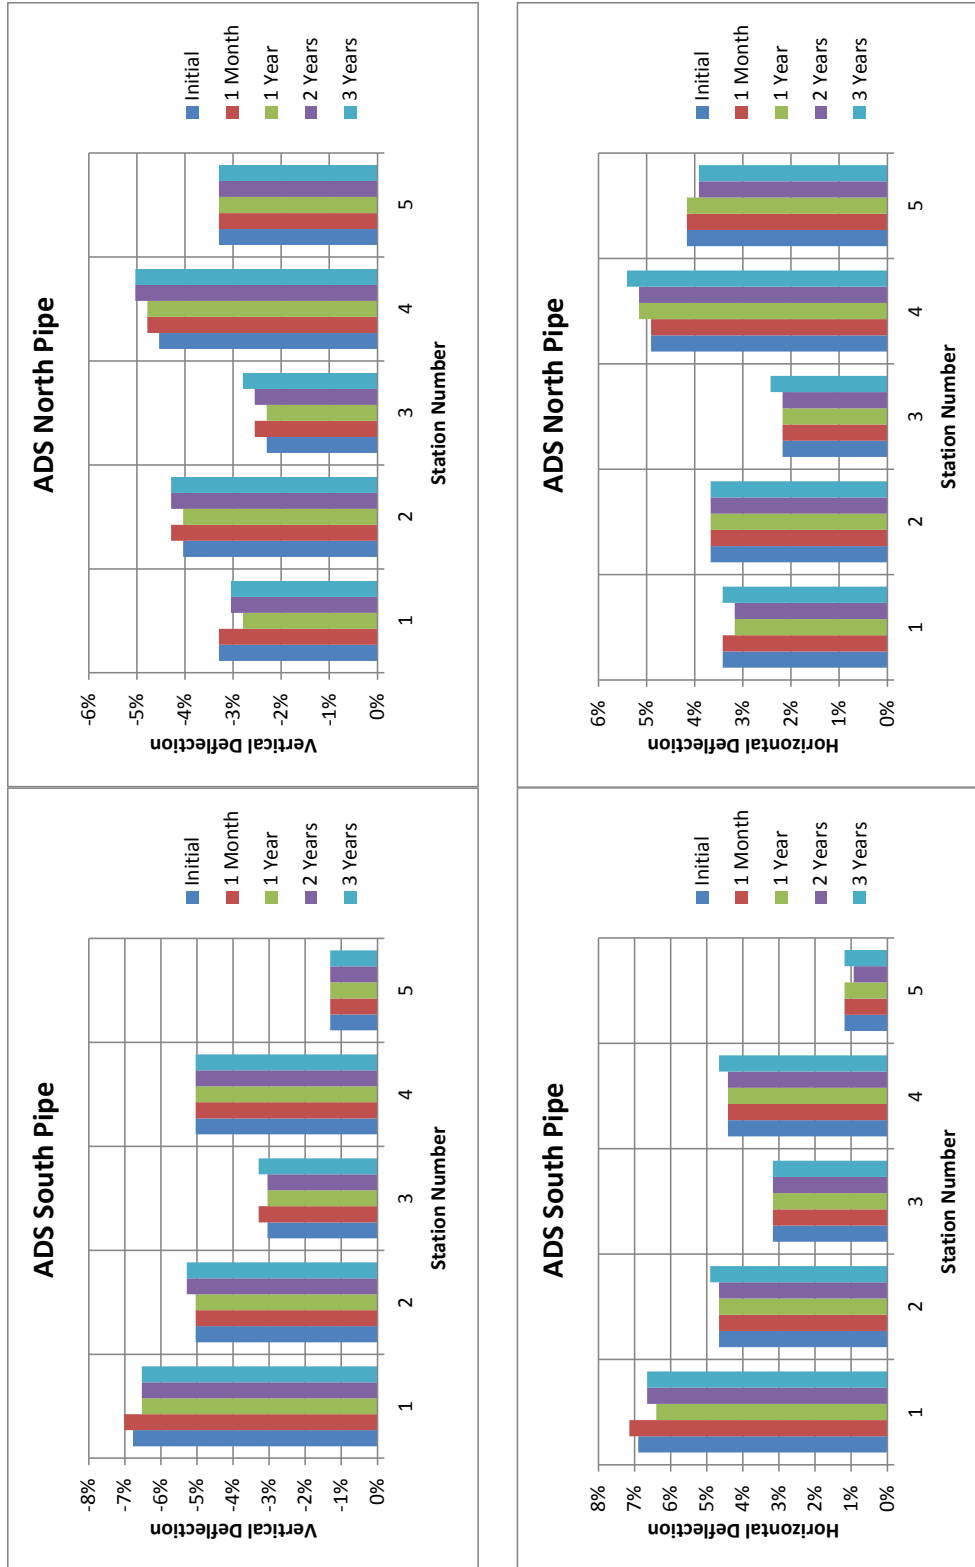
**Figure 18.** ADS pipe deflections as a function of station number and time.

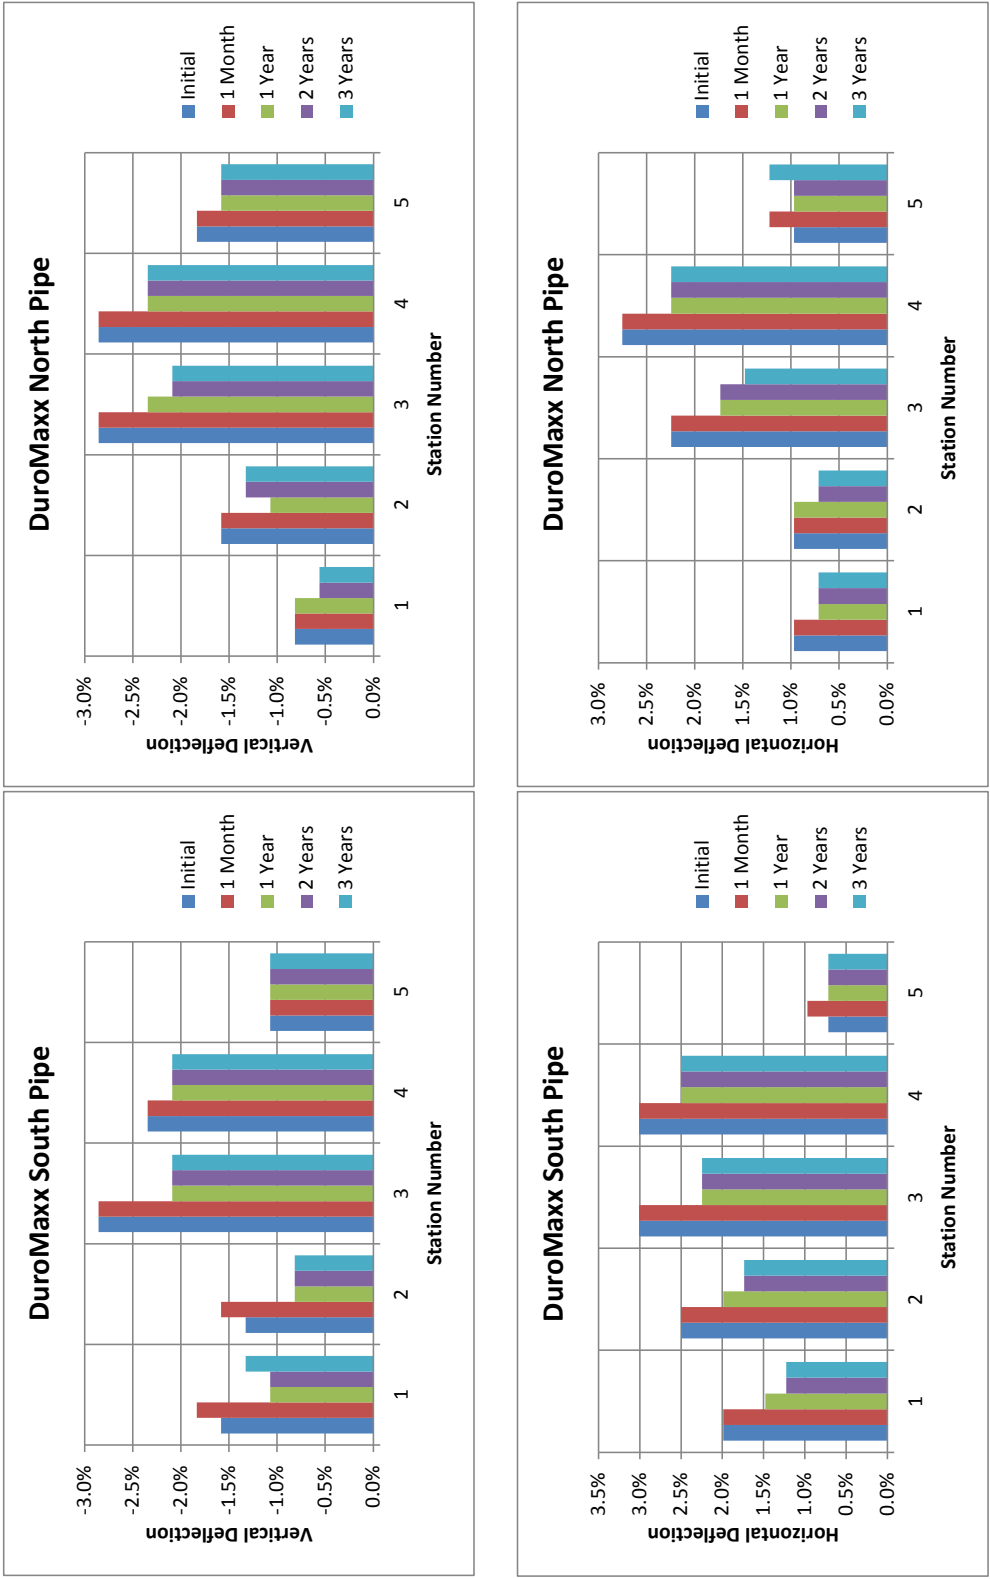
The cause of the slight re-rounding of pipe between the one-month and one-year inspections is believed to be attributed to penetration of the pipe ribs on the bottom of the pipe

**Figure 19.** DuroMaxx pipe deflections as a function of station number and time.

The reduction in deflections in the DuroMaxx pipe between the one-month and the one-year visits resulted in a slight re-rounding of the pipe. This was a real effect and not attributable to measurement error. The cause is believed to be attributed to the installation procedure used to install the pipes, the pipe rib design, and the granular backfill. The narrow trench and pipe spacing result in poor compaction of fill in the haunch areas of both the ADS and DuroMaxx pipes. The DuroMaxx pipe ribs would have incomplete penetration into the granular soil at the bottom of the pipe. The soil above the spring-line of the pipe was highly compacted forming a soil bridge. The water table clearly rises above the bottom of the pipe during the spring snow melt, lubricating the soil particles and allowing the bottom of the pipe to more deeply penetrate the soil, while the soil bridge maintained the support of the road.
