# Evaluation of the Overheight Detection System Effectiveness at Eklutna Bridge

## Final Report

March 2013

FHWA-AK-RD-13-01

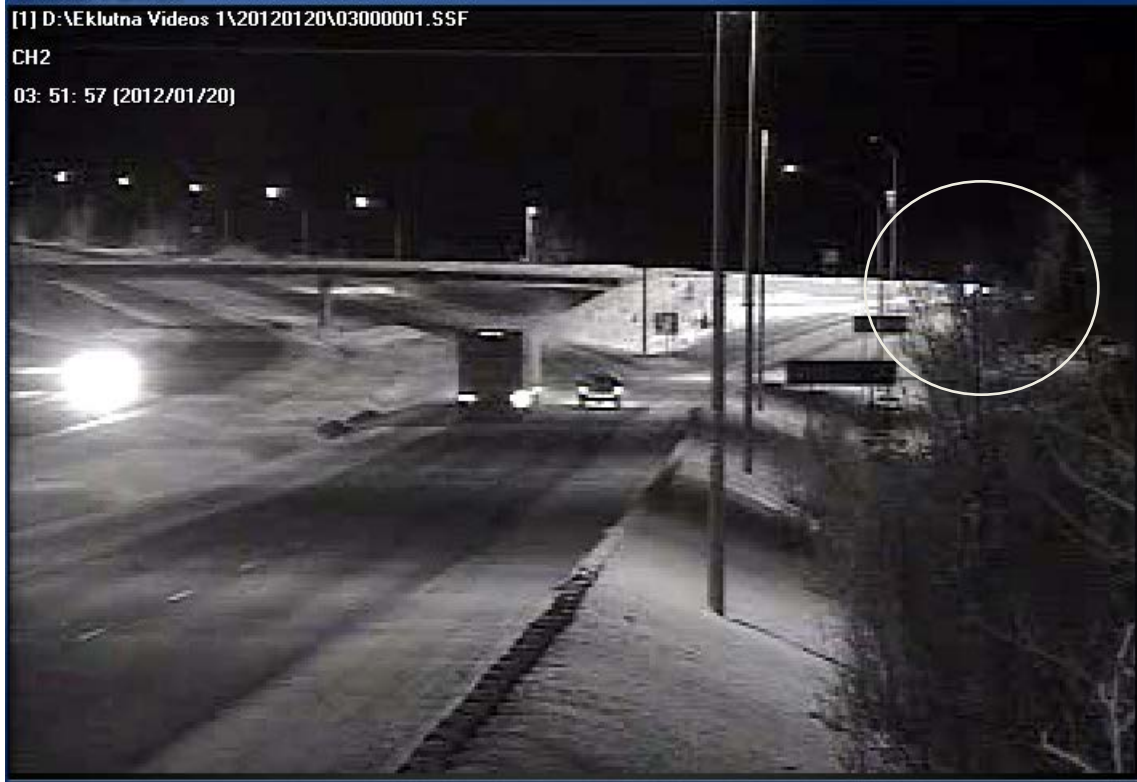
**Figure 12 The VMS during flashing (located in center of the circle area)**

During the summer months, the view to the VMS sign is blocked by leaves on trees between the camera and the VMS sign. Without the leaves in winter, the flashing of the sign is clearly visible at night as shown in the above figures, but it cannot be recognized under daylight. The flashing of the VMS sign, when exposed under sunlight, is not strong enough to produce the necessary contrast to be seen in the video images shot by camera#2 from far away.

With favorable lighting conditions in winter months, the flashing of the VMS sign was unmistakably verified in a total of 25 incidences dating between 10/24/2011 and 4/21/2012.
