# DEVELOPMENT AND EVALUATION OF A *MASH* TL-3 31-INCH W-BEAM MEDIAN BARRIER

## Test Report 9-1002-12-8

TEXAS A&M TRANSPORTATION INSTITUTE  
COLLEGE STATION, TEXAS

TEXAS DEPARTMENT OF TRANSPORTATION

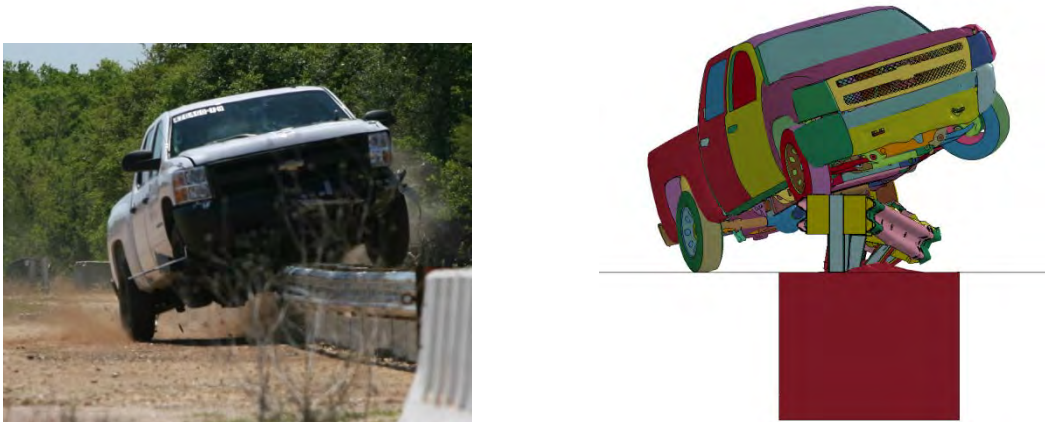
**Figure 2.3. Simulation of the *MASH* 3-11 as the 2270P Vehicle Vaults over the 27-Inch Median Barrier.**

The research team started by simulating the failed test using LS-DYNA (20) finite element code. Figure 2.3 shows the vaulting phenomena of the vehicle captured in the simulation. Hence, the model is considered corroborated with the failed *MASH* test 3-11 and can be used as a tool to investigate the system performance once modified.

Design modifications included increasing the rail height from 27 inches to 31 inches and moving the splice location from at-post to mid-span. Figure 2.4 shows the cross-section views of the new system design and the model.

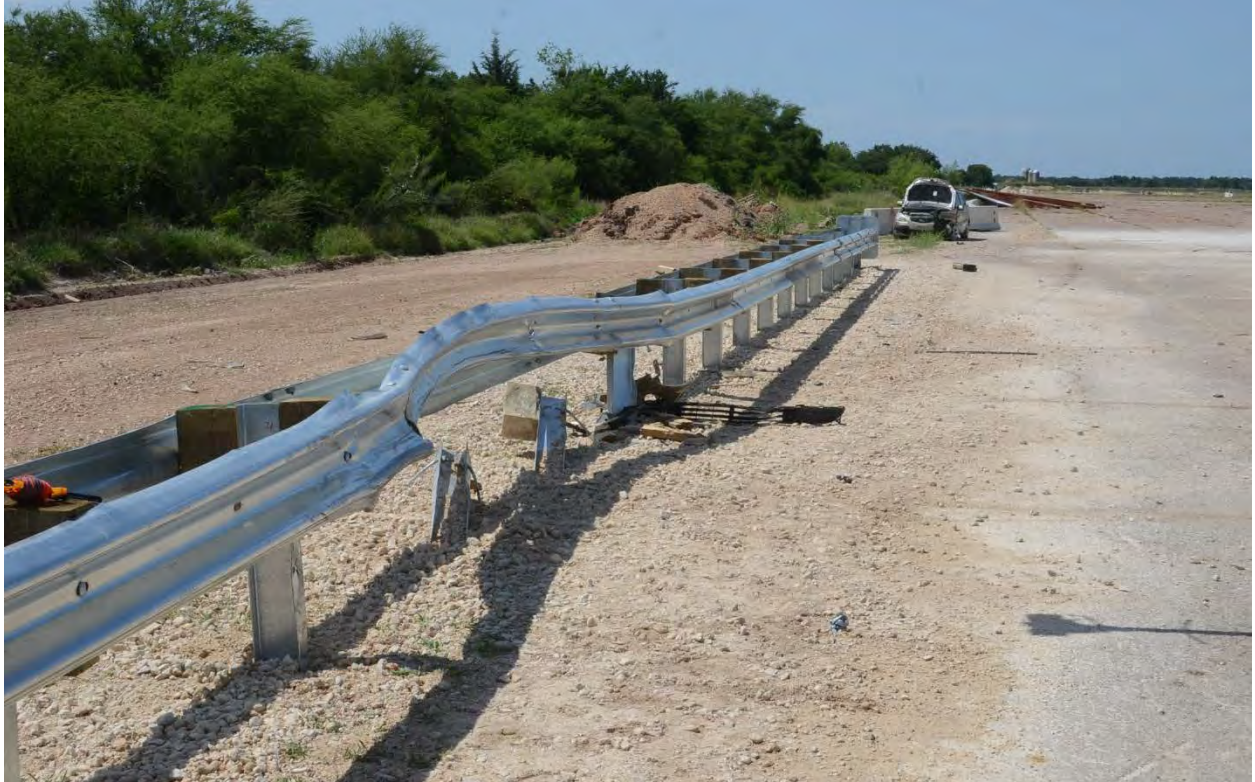
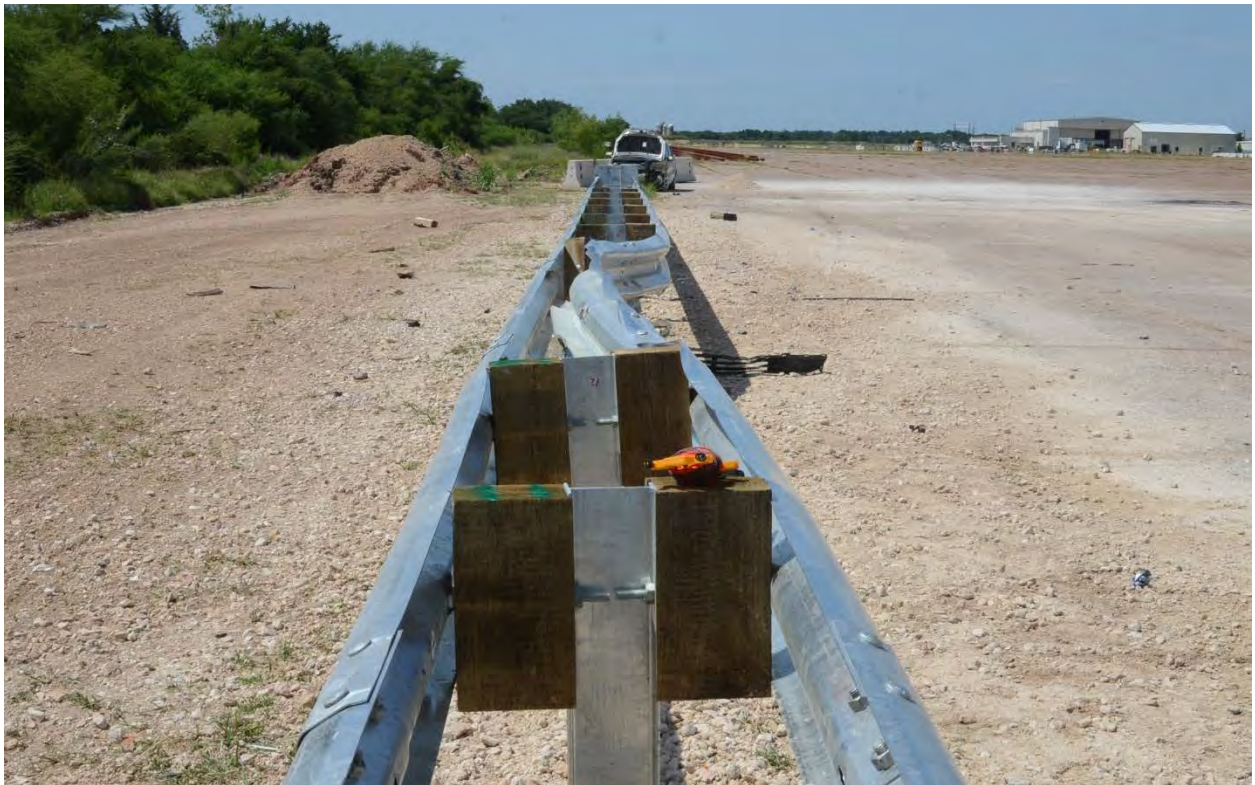
**Figure 6.3. Vehicle/Installation Positions after Test No. 490023-3.**

Figures 6.3 and 6.4 show damage to the TxDOT 31-inch W-Beam Median Barrier. No apparent movement was noted at post 1 or post 26 (the end posts). Post 11 and 12 were displaced through the soil toward the side opposite impact 0.25 inch and 1.75 inches, respectively. Posts 13 and 14 were leaning 70 degrees toward the side opposite impact and the rail element on the impact side separated from the posts. Both blockouts at post 13 separated from the post and the blockout on the side opposite impact separated from post 14. Post 15 rotated 45 degrees in the soil, the blockout on impact side separated from the post, and both rail elements separated from the post. The rail element on the impact side ruptured upward two-thirds of the width of the rail element at the upstream bolts on the splice between posts 12 and 13. The length of contact of the 1100C vehicle with the rail was 22.0 ft. Maximum permanent deformation of the rail was 20.25 inches between posts 13 and 14.

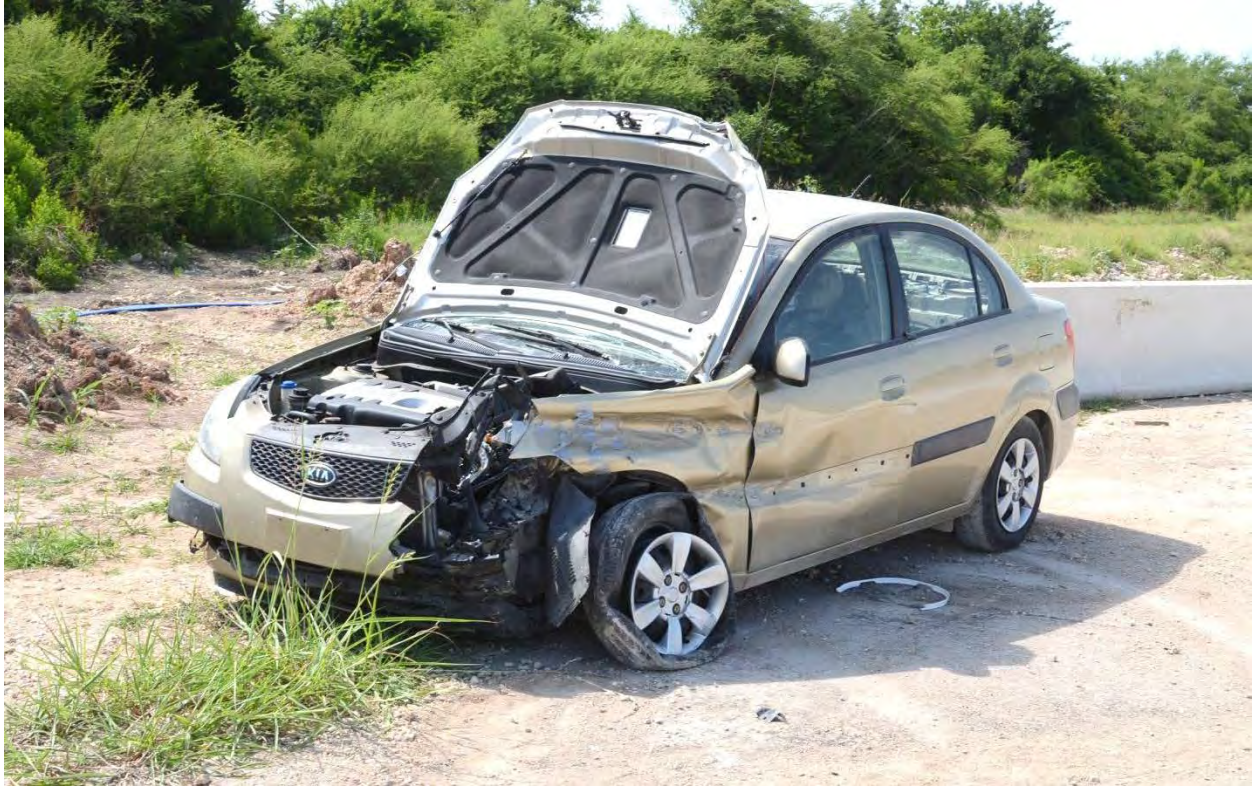
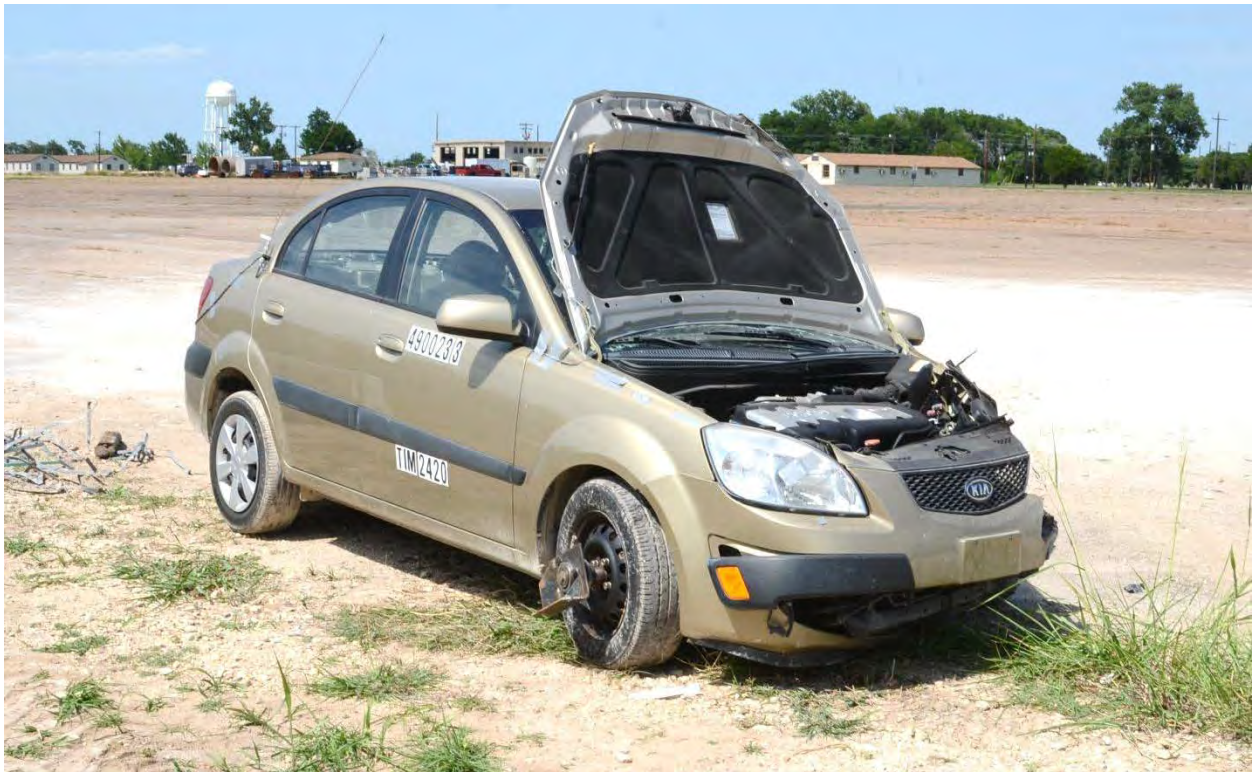
**Figure 6.5. Vehicle after Test No. 490023-3.**

Figure 6.5 shows damage to the 1100C vehicle. The front bumper, hood, radiator and support, left front strut and tower, left front tire and wheel rim, left front fender, and left front door were damaged. The hood was pushed into the windshield, which shattered the lower portion of the windshield. Maximum exterior crush to the 1100C vehicle was 13.0 inches in the side plane at the left front corner just above bumper height. No occupant compartment deformation was noted. Figure 6.6 provides photographs of the interior of the vehicle, and Tables D1 and D2 provide exterior and occupant compartment measurements.

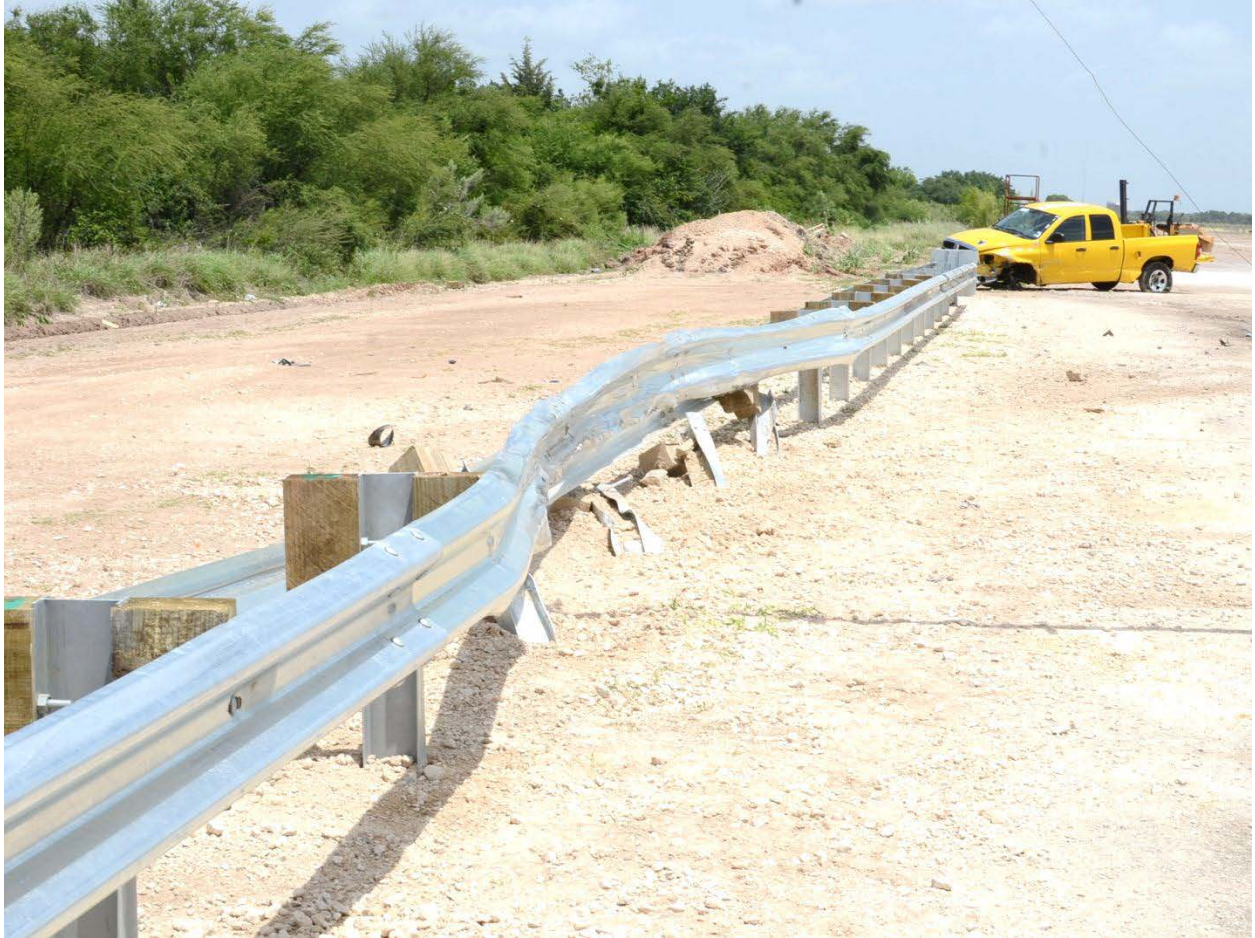
**Figure 7.3. Vehicle/Installation Positions after Test No. 490023-4.**

Figures 7.3 and 7.4 show damage to the TxDOT 31-inch W-Beam Median Barrier. Post 1 was displaced through the soil 0.5 inch at ground level on the upstream side, and no apparent movement was noted at post 26 (end posts). Posts 6 through 11 were slightly rotated, and post 11 was displaced through the soil 0.5 inch toward the side opposite impact. Post 12 was leaning downstream and toward the side opposite impact 45 degrees. Post 13 was leaning downstream 85 degrees and toward the side opposite impact 45 degrees. Posts 14 and 15 were leaning downstream 60 degrees. Post 16 was rotated slightly. The rail element on the impact side separated from posts 12 through 15, and the rail element on the side opposite impact released from posts 8 through 17. The blockouts on the impact side of posts 12 through 15 fractured and separated from the posts and rail element. The length of contact of the 2270P vehicle with the rail was 31.0 ft. Maximum permanent deformation of the rail was 29.5 inches between posts 13 and 14.

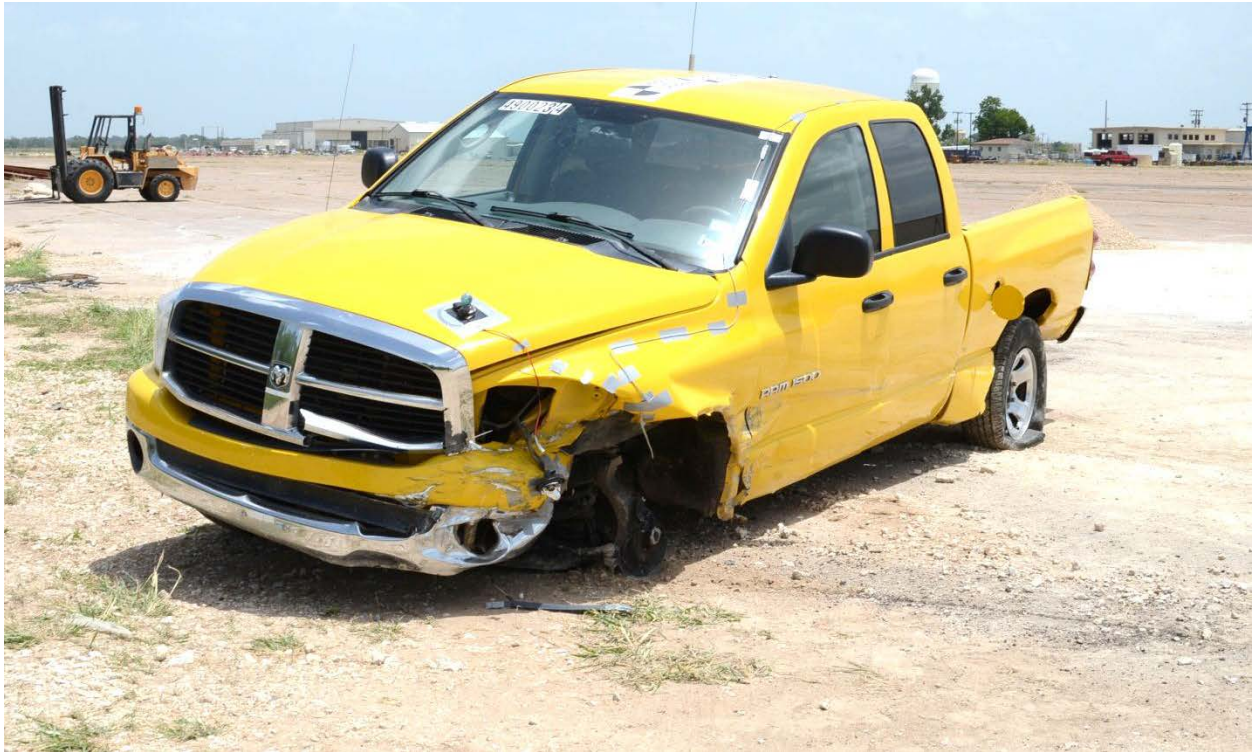
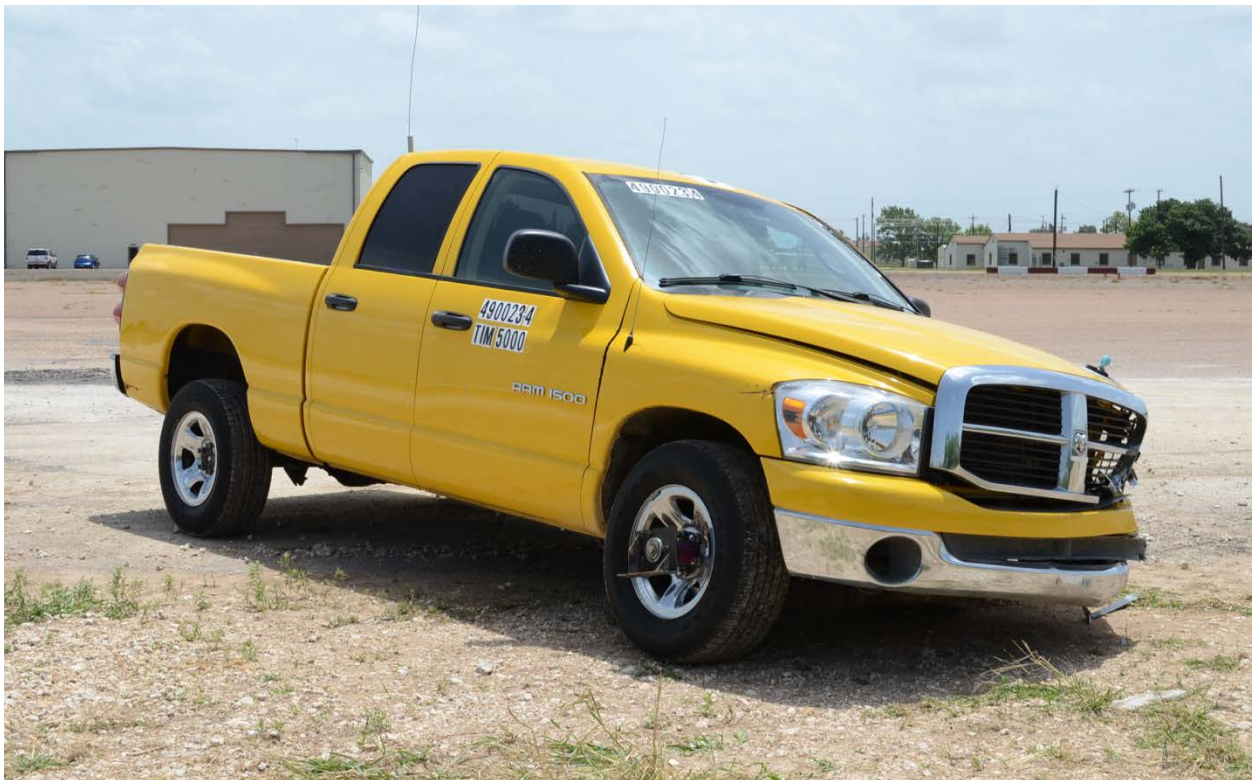
**Figure 7.5. Vehicle after Test No. 490023-4.**

Figure 7.5 shows damage to the 2270P vehicle. The left front tie rod, left front lower A-arm, left front frame rail, and left front hub assembly were deformed. Also damaged were the front bumper, grill, left front tire and wheel rim, left front fender, left front door, left rear door, left rear exterior bed, left rear tire, and rear bumper. Maximum exterior crush to the vehicle was 11.0 inches in the side plane at the left front corner just above bumper height. No occupant compartment deformation occurred. Figure 7.6 shows the interior of the vehicle before and after the test. Tables E3 and E3 in Appendix E present the measurements made on the vehicle.
