## CRASH TEST AND EVALUATION OF THE TxDOT T631 BRIDGE RAIL

**Test Report 9-1002-12-10**

# **CRASH TEST AND EVALUATION OF THE TxDOT T631 BRIDGE RAIL**

Report 9-1002-12-10  
Project 9-1002-12  
Project Title: Roadside Safety Device Crash Testing Program

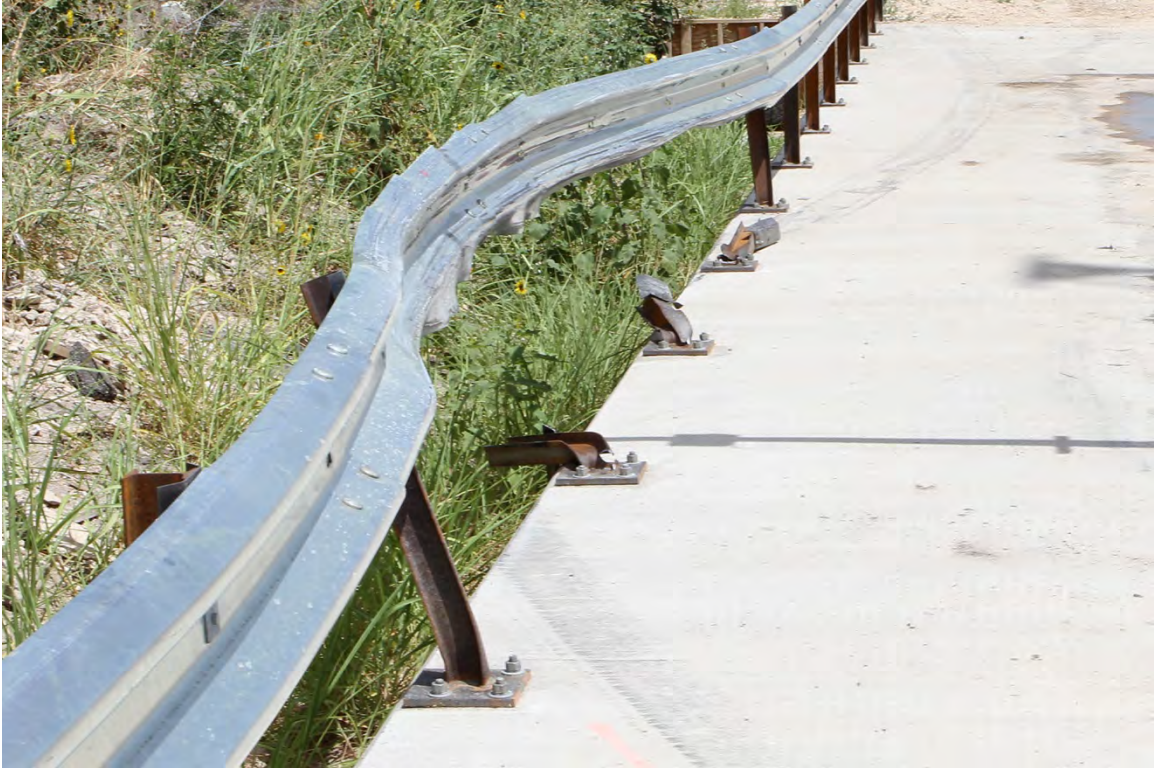
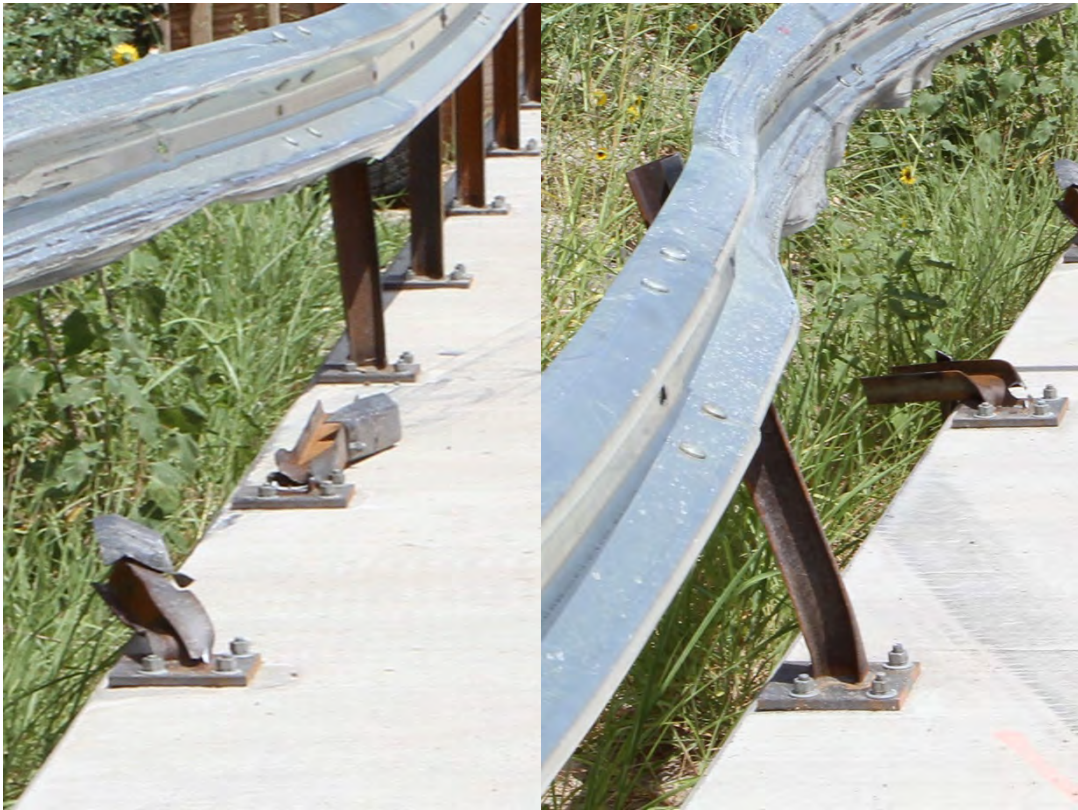
**Figure 5.4. Installation after Test No. 490023-6-1a.**

Post 1 was pulled downstream 0.25 inch, and Posts 10 and 11 were leaning toward the field side 2 degrees and 20 degrees, respectively. Posts 12 through 14 were leaning downstream 90 degrees; there was a partial tear at the base, and the rail separated from the posts. Post 15 was leaning towards the field side 5 degrees and downstream 14 degrees, and the rail separated from the post. The vehicle contacted the installation a second time at the downstream terminal post and anchor. Figures 5.3 and 5.4 show damage to the installation. The vehicle was in contact with the bridge rail 22.25 ft. Maximum dynamic deflection of the bridge rail was 25.7 inches, and permanent deformation was 21.5 inches. Working width was 30.0 inches, and vehicle intrusion was 28.8 inches.

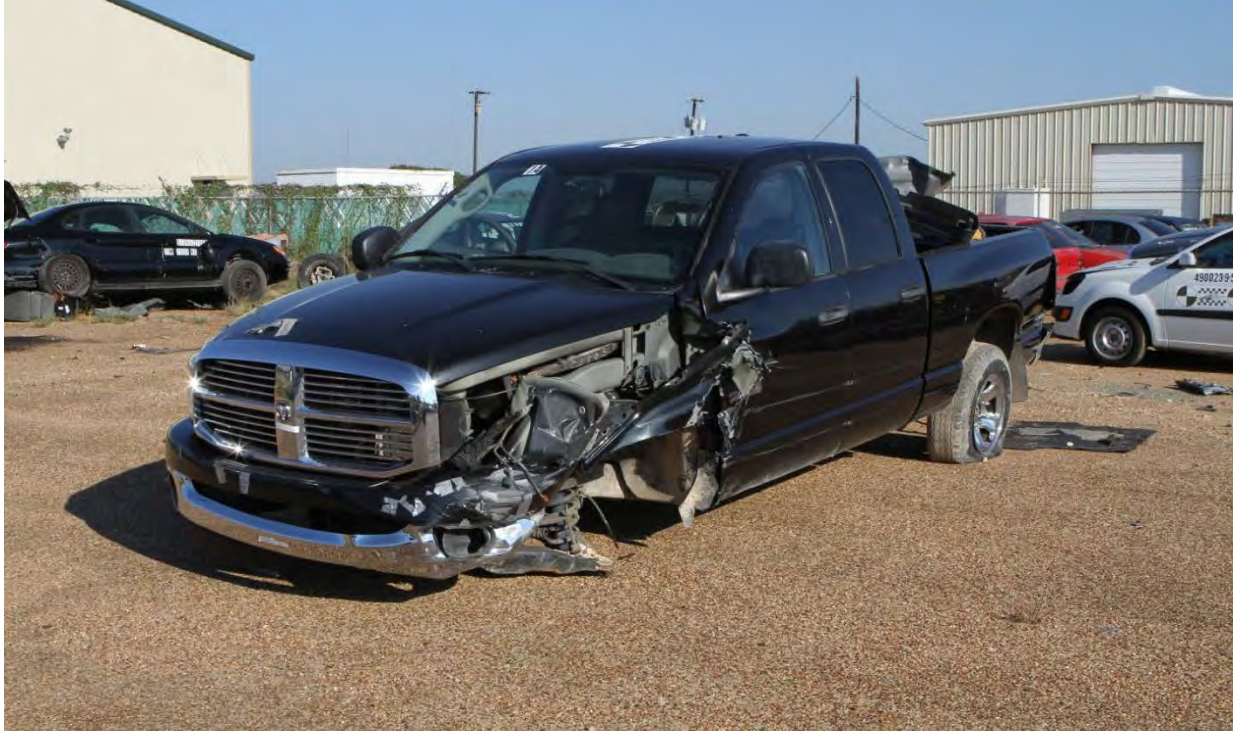
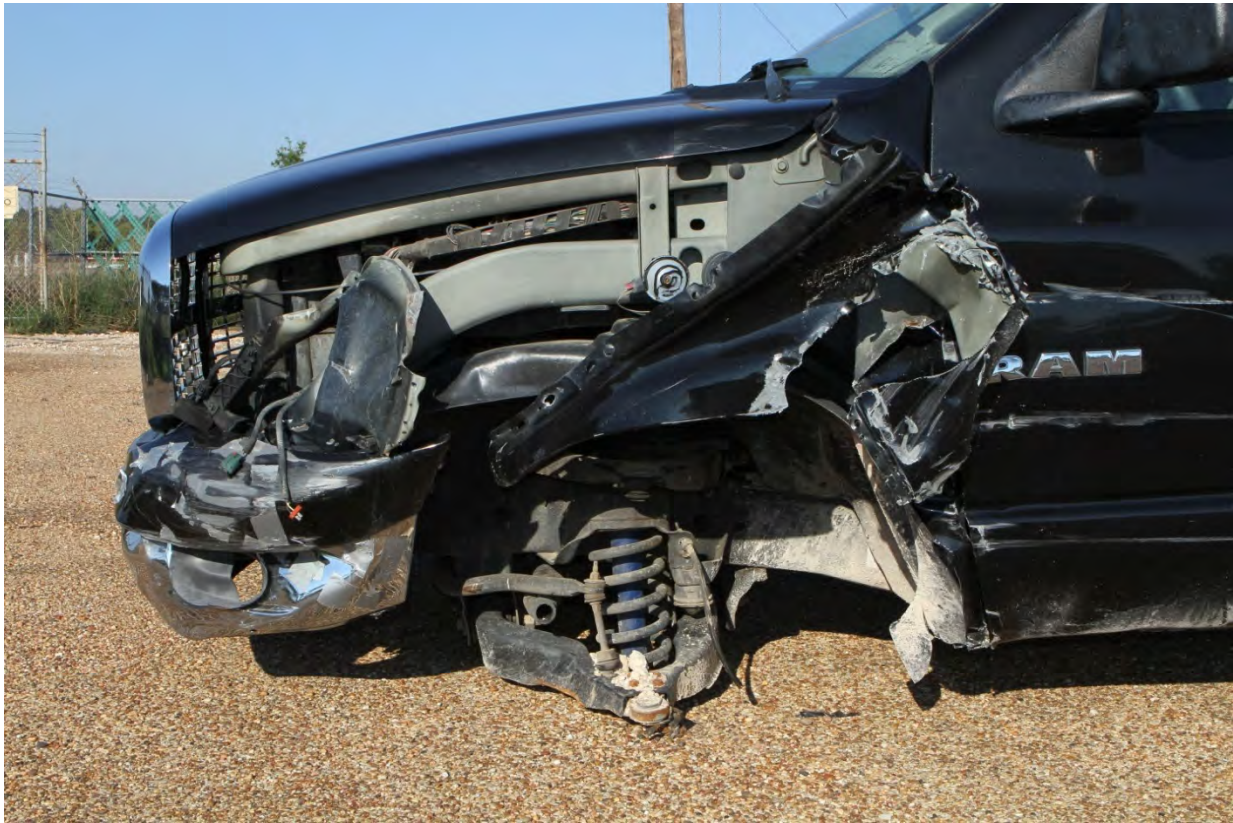
**Figure 5.5. Vehicle after Test No. 490023-6-1a.**

Figure 5.5 shows damage to the exterior of the vehicle. The left front wheel assembly broke from the upper and lower ball joints; the left upper and lower ball joints, A-arms, and left front tie rod end were deformed. Also damaged were the front bumper, left front fender, left front brake line, left front door, left front tire and wheel rim, left rear tire, left rear exterior bed, and the left rear bumper. Maximum exterior crush to the vehicle was 6 inches in the side plane at the left front corner at bumper height. No occupant compartment deformation or intrusion occurred. Figure 5.6 provides photographs of the interior of the vehicle. Tables C3 and C4 in Appendix C provide exterior crush and occupant compartment measurements.

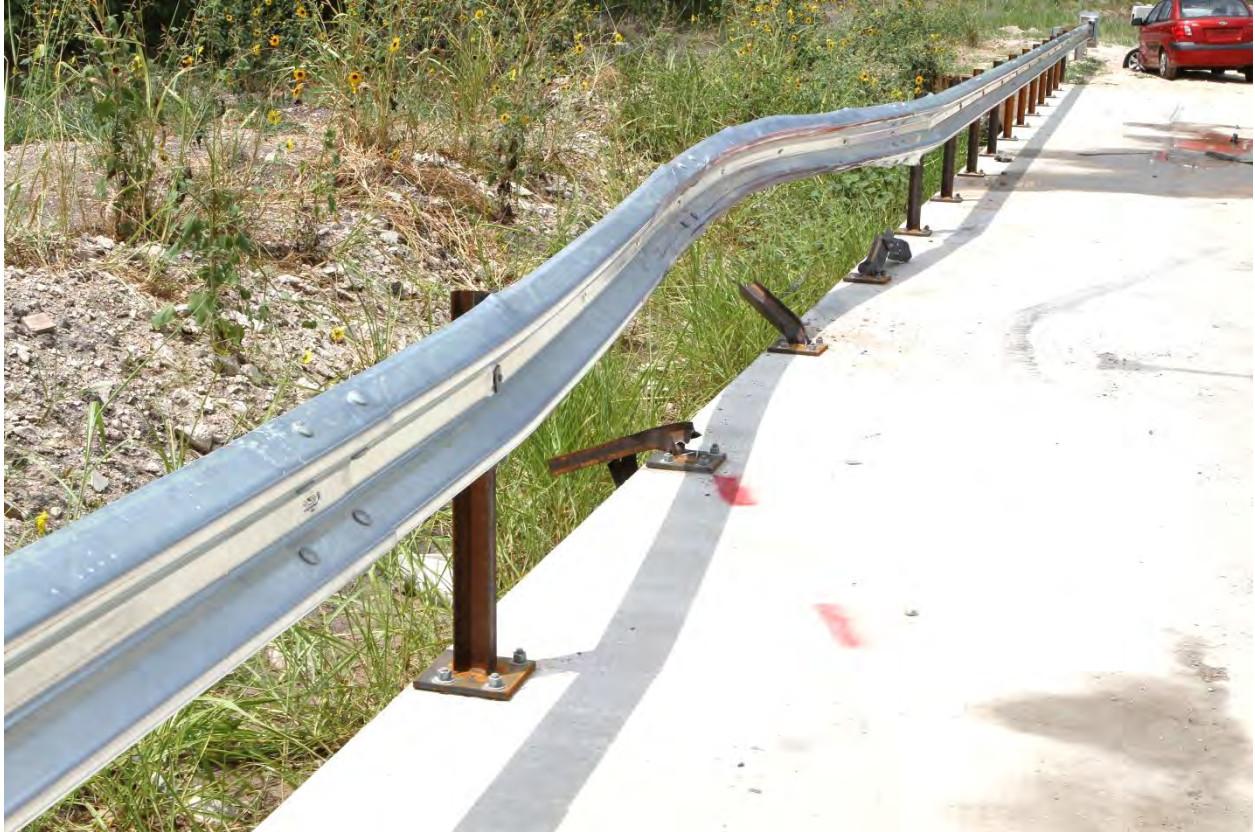
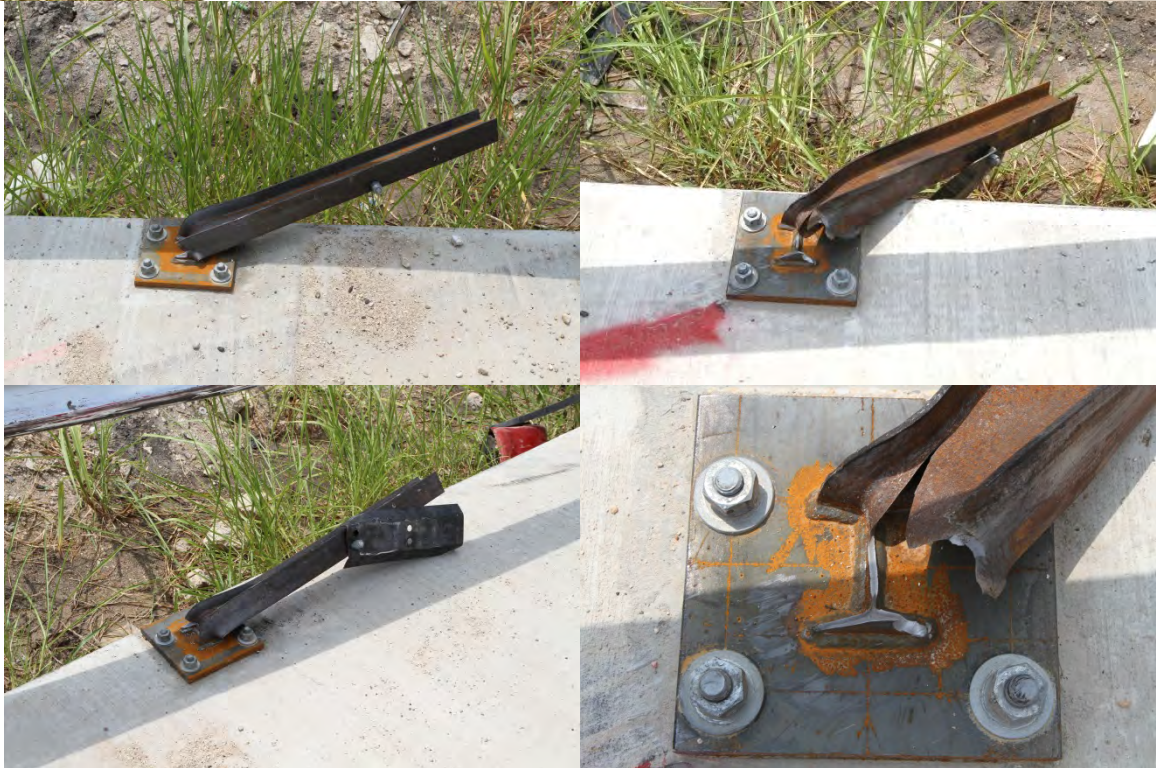
**Figure 6.4. Installation after Test No. 490023-6-2.**

Post 9 was leaning towards the field side 4 degrees. Post 10 was leaning towards the field side 95 degrees and the front flange and webbing were torn. Post 11 was leaning downstream 85 degrees and towards the field side 10 degrees; the front flange was partially torn, and the backup plate released. Post 12 was leaning downstream 85 degrees and the back flange was partially torn. Post 12 was leaning downstream 8 degrees. Figures 6.3 and 6.4 show damage to the installation. The 1100C vehicle was in contact with the bridge rail 17.8 ft. Maximum dynamic deflection of the bridge rail during the test was 22.6 inches, and maximum permanent deformation was 15.0 inches. Working width was 25.5 inches, and vehicle penetration was 30.3 inches.

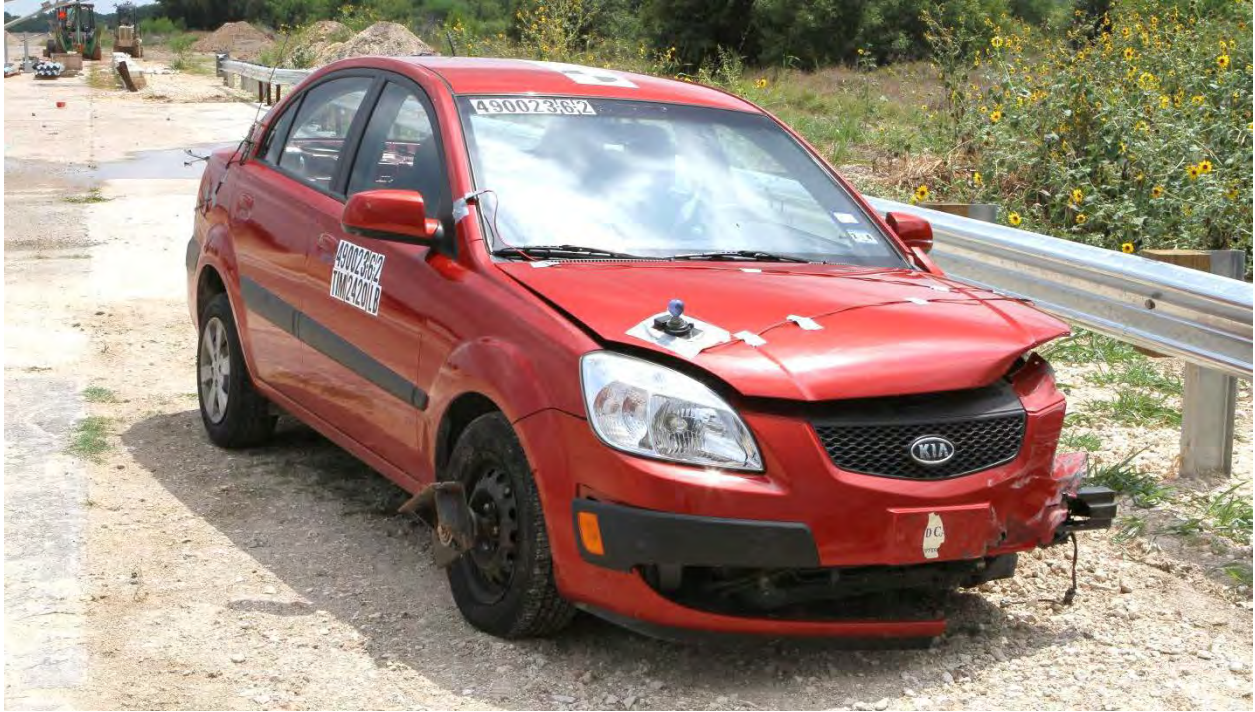
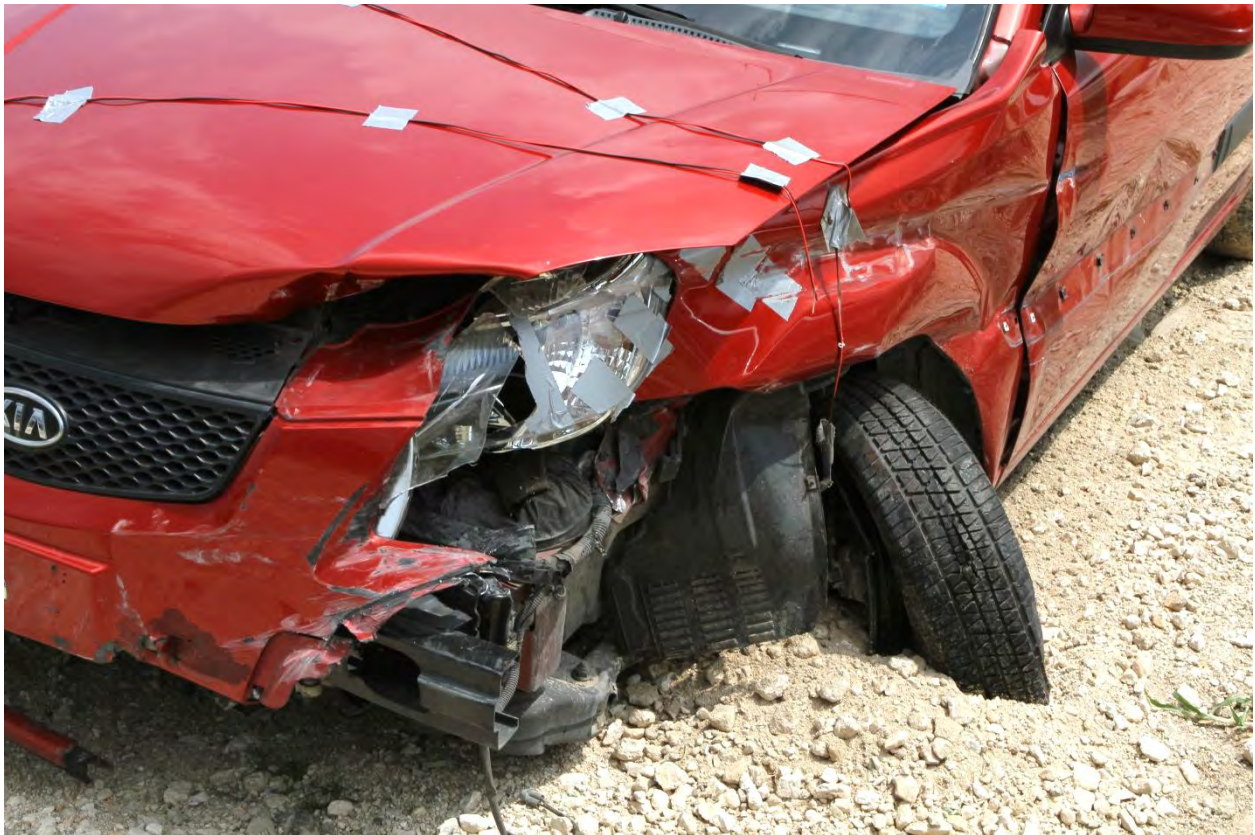
**Figure 6.5. Vehicle after Test No. 490023-6-2.**

Figure 6.5 shows damage to the 1100C vehicle. The left strut, strut tower, and left tie rod end were deformed. Also damaged were the front bumper, hood, left front fender, left front tire and wheel rim, and the left front door. Maximum exterior crush to the vehicle was 9.5 inches in the side plane at the left front corner at bumper height. No occupant compartment deformation or intrusion occurred. Figure 6.6 provides photographs of the interior of the vehicle. Tables D3 and D4 in Appendix D provide exterior crush and occupant compartment measurements.
