Evaluation of Rutting Distresses on I-20 near Mound to Delta Scales

LTRC Project No. 13-01TA-B

January 2014

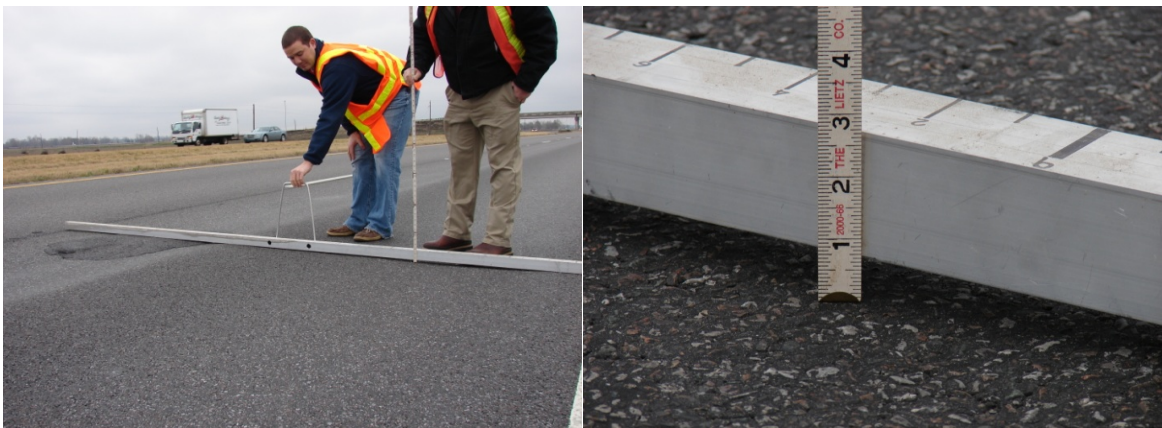
To assess the overall condition of the pavement, a visual condition survey and a nondestructive distress condition survey were conducted at first. As shown in Figure 2, rut depths were measured randomly using a traditional straight edge and measuring gauge at severely rutted areas. Afterwards, an automated laser profiler was utilized to record the rut depth for the entire length of the project. Historical records such as design details, preliminary engineering reports, and construction records were also reviewed to find the possible clues to the pavement failure. After the preliminary site investigation, 21 full depth 6-in. diameter asphaltic concrete roadway cores were taken from four strategic locations to evaluate the current in situ pavement condition. Roadway cores were sampled from sites that rutted (wheel paths) along with samples from non-distressed areas (center line). The locations of cored test sections and the schematics of coring are illustrated in Figures 3 and 4, respectively; whereas, a brief description of those cores is presented in Table 1. All cores had 4-lifts of Superpave mixture with approximately 2-in. thickness per lift in addition to the 2-in SMA. The arrangement of various lifts found in the roadway cores is illustrated in Figure 5. According to the plant production data and roadway reports, the bottom two lifts, Lift A and Lift B were deemed as the leveling courses; whereas, the top two lifts, Lift C and Lift D were the binder courses. It should be noted that all Superpave lifts were produced in accordance with the same Job Mix Formula (JMF).

Figure 2
Localized rut measurement using traditional straight edge

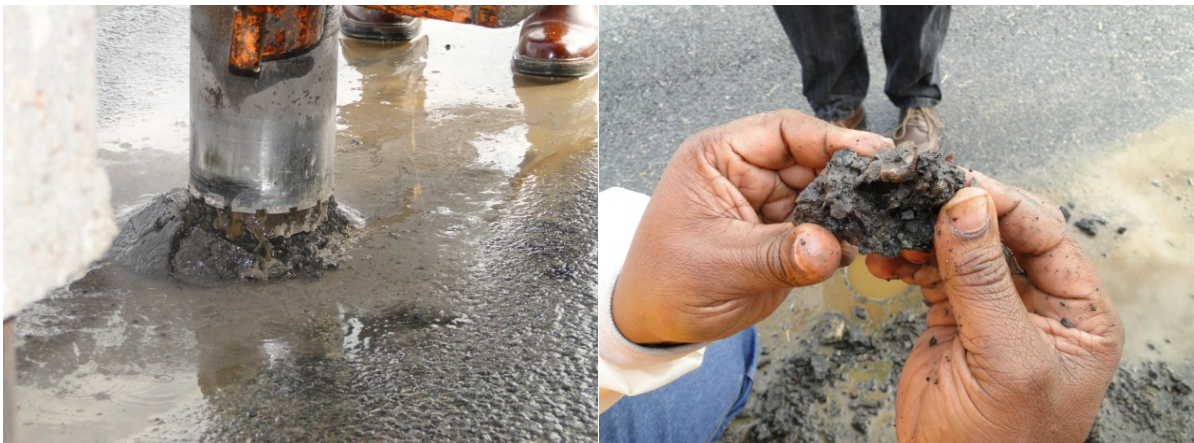
During the recent coring operation, it was noticed that the permanent deformation was only occurring at the wearing course or SMA lift. However, moisture damage was noticed at a couple of locations where the corresponding cores fell apart completely (Figure 6). The moisture damage was mainly noticed in the binder/ leveling course lifts and the mixtures of those layers seemed to be soft and lacking cohesion. It should be noted that the soil cement base underneath the CRCP is generally highly impermeable to water. It is anticipated that the water or water vapor was getting into the pavement structural system from underneath and finding no place to escape due to an inadequate subsurface drainage conditions. In addition, the differential thermal expansion of water vapor during day-night cycle and the cyclic stresses from moving traffic increases the pore water pressure which may rupture the asphalt-aggregate bond and cause stripping [3].

Figure 6
Observation of moisture damage during coring

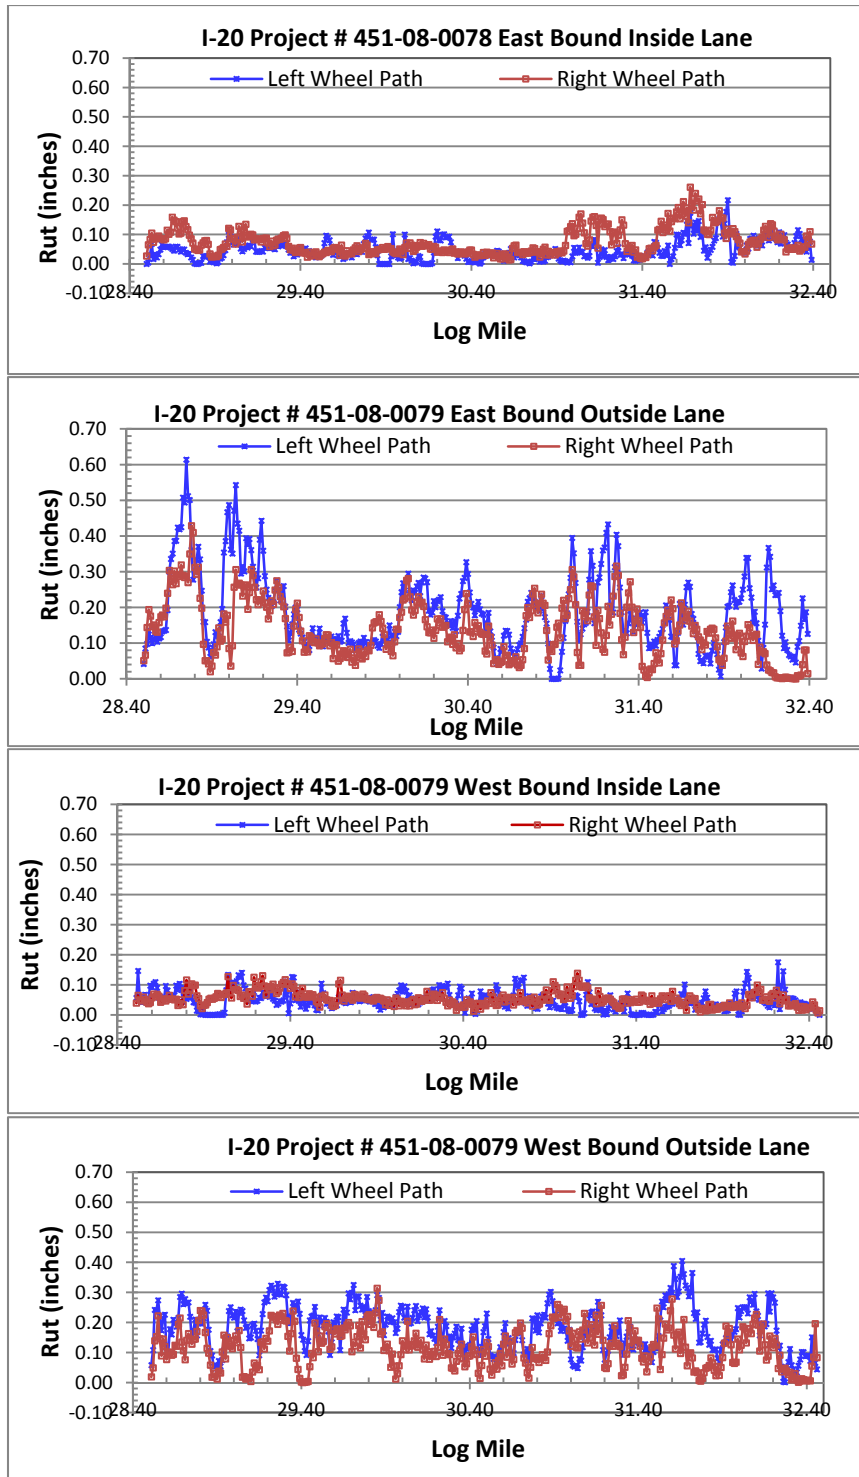
Figure 7
Rut measurements of I-20 sections

In an effort to measure the extent of premature rutting, the LTRC pavement research group collected rut measurements at every 0.10 mile interval for the entire length of the project. As shown in Figure 7, it is clear that the outside lanes in both directions rutted more than their inside counterparts. The highest rut depths of 0.61 inch and 0.41 inch were noticed in the outside lanes in the eastbound and westbound directions respectively. The outside lanes usually experience more and heavier traffic which may be the possible reason behind the higher rutting results. Interestingly, the scenario of having higher rutting in the outside lanes also supports the underneath moisture damage phenomenon. The roadway was built with a slope towards the outside lane, which may allow the moisture to flow in that direction and eventually deposit under those lanes.

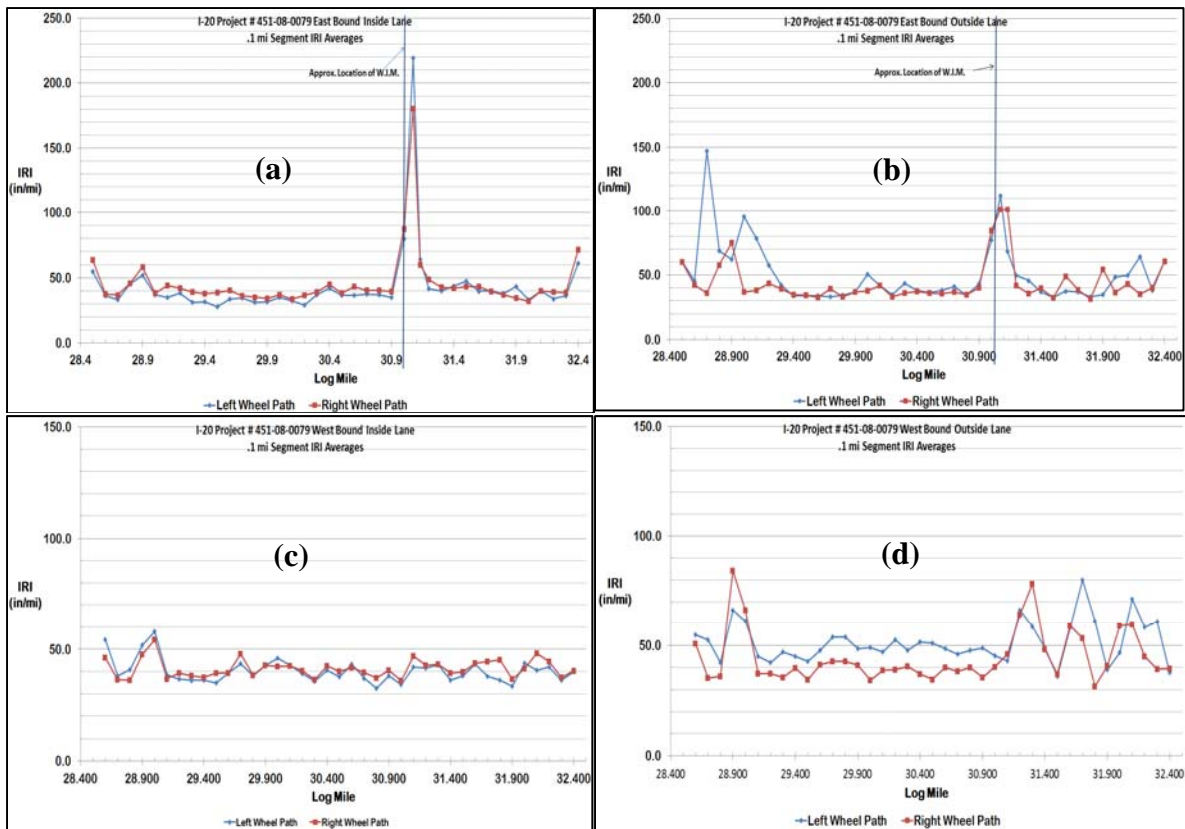
Figure 8
IRI data

The IRI values as presented in Figures 8a to 8d indicate that, for the most part, the project is smooth (IRI < 80) according to the FHWA criteria. The east bound inside lane (EBIL) had IRI values generally less than 50 except for the locations near the weigh-in-motion (WIM) station at CSLM 31 as presented in Figure 8a. The east bound outside lane (EBOL) had a similar trend to the EBIL except for the first mile of the project, which had IRI values up to 150 as presented in Figure 8b. The west bound inside lane (WBIL) had IRI values around 40 indicating a very smooth ride as presented in Figure 8c. The west bound outside lane (WBOL) had a different trend than the WBIL with more variation in IRI values and notably higher IRI values at CSLM 29 to 29.1 and CSLM 31 to 32.4.

In both the east and west bound directions, the outside lanes had rougher trends than inside lanes, though, generally, the IRI values were within FHWA's criteria for a smooth roadway.

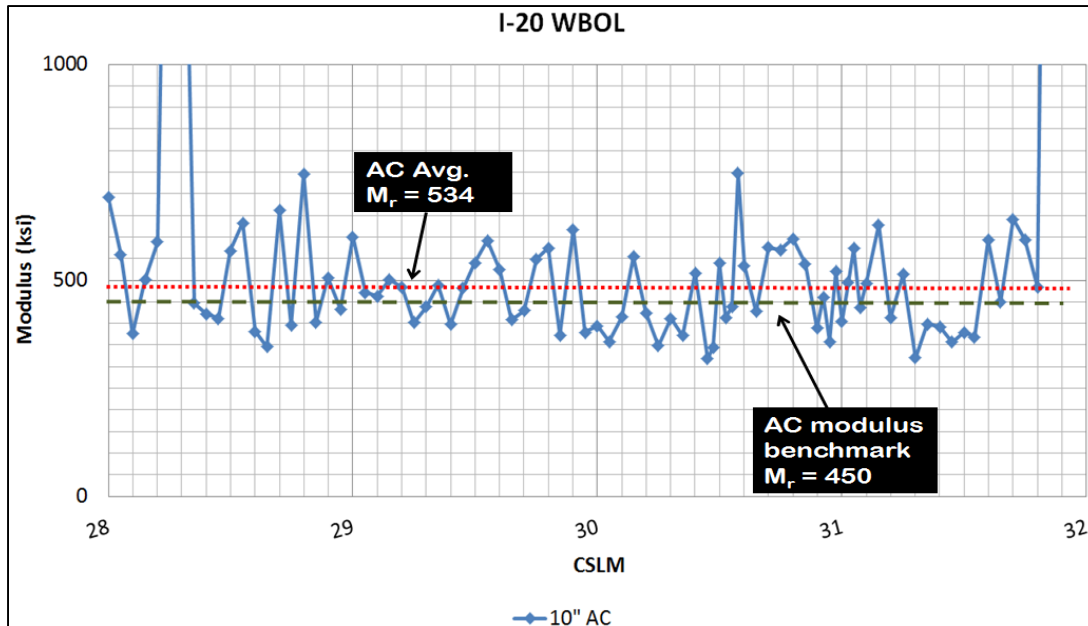
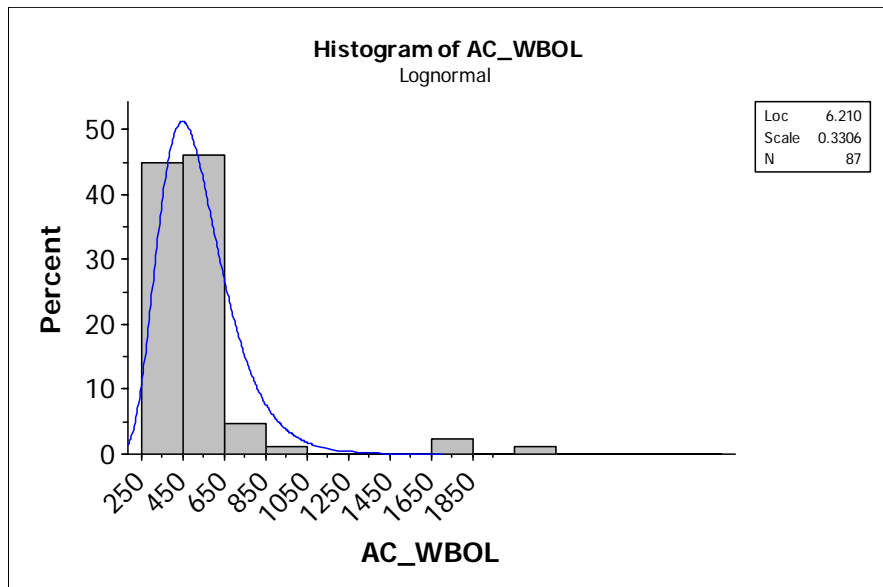
The asphalt mixture (AC) moduli values for the west bound outside (WBOL) are presented in Figures 9 to 10. Outliers, values which were far out of range, were not removed. Even though the average AC modulus was 534 ksi, which was greater than the 450 ksi benchmark, many test locations were below the 450 ksi benchmark as presented in Figure 9. Approximately 45 percent of the AC modulus values were less than 450 ksi as presented in

Figure 10. That could indicate that stiffness of the AC layer was significantly impacted by stripping at those locations.

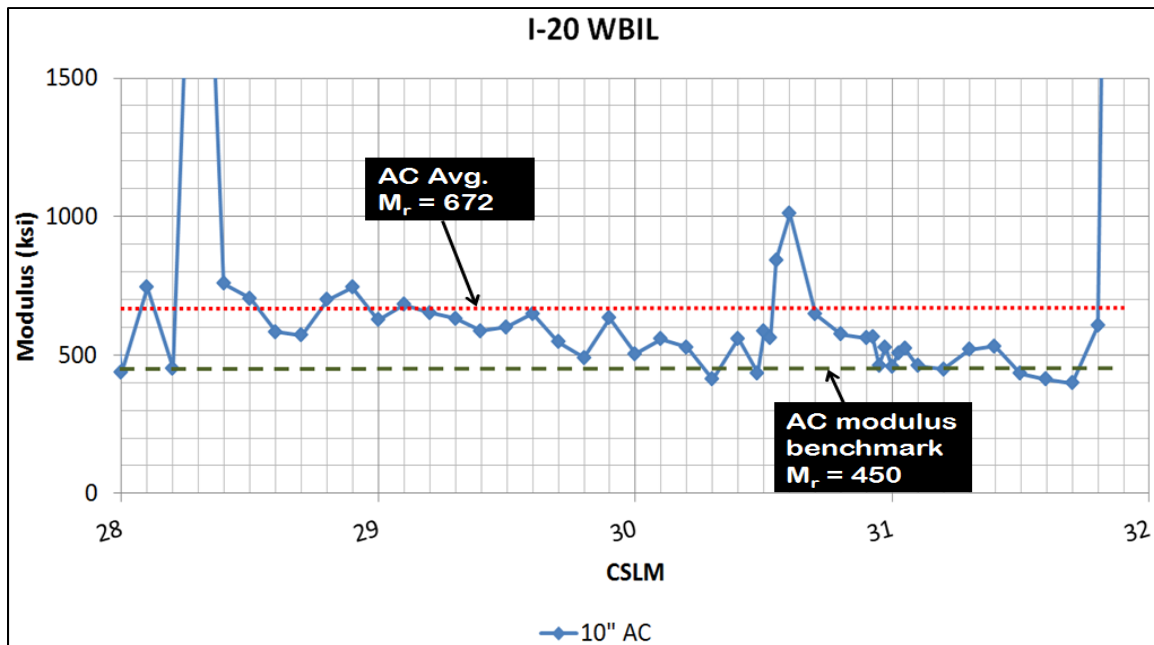
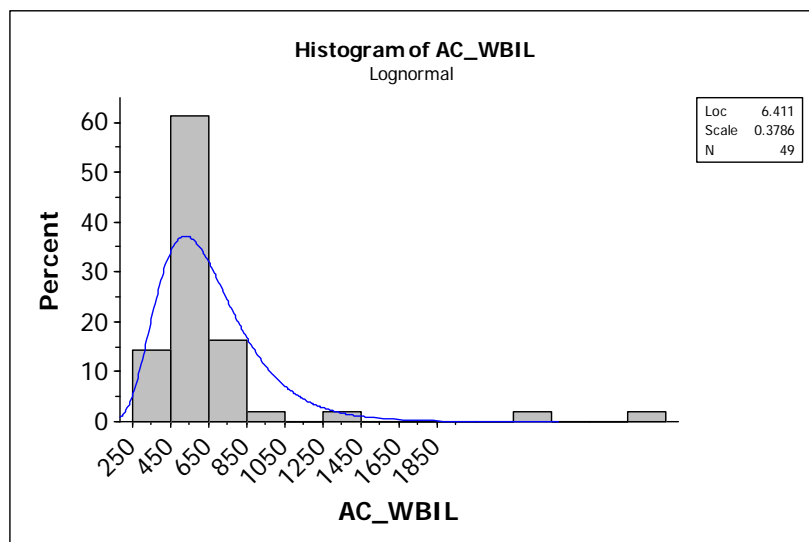
Figures 11 and 12 present the AC modulus results for the WBIL. The average AC modulus was 672 ksi as presented in Figure 11. Unlike the WBOL, only a few test locations were below the 450 ksi benchmark. The histogram for the WBIL indicated that approximately 15 percent were below the 450 ksi benchmark as presented in Figure 12.

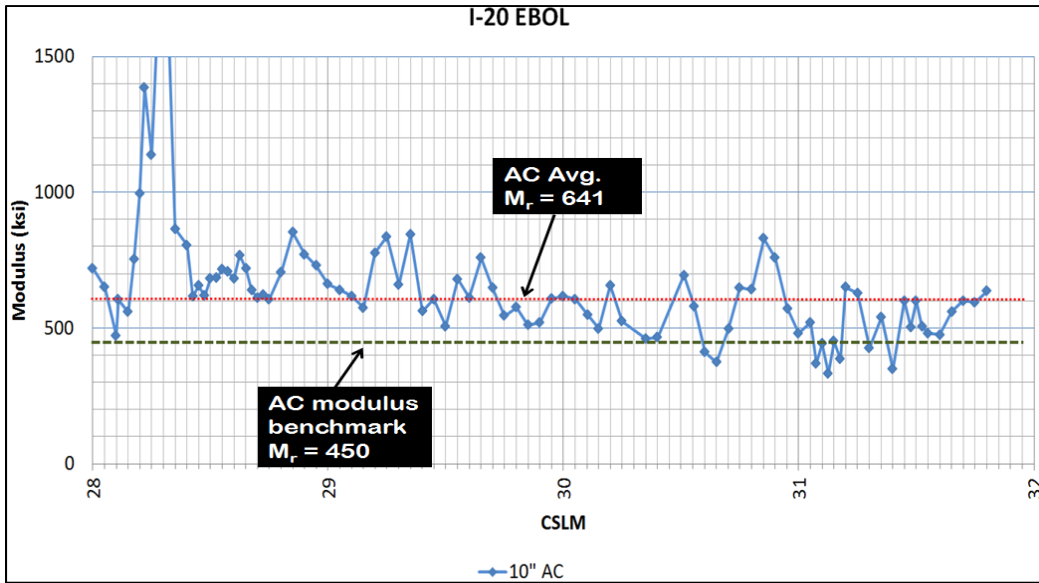
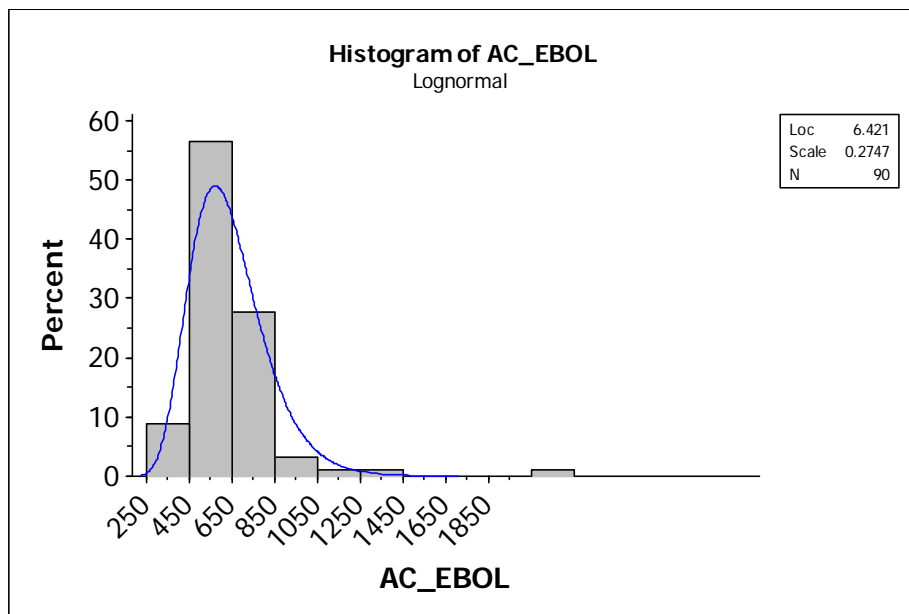
The AC moduli values for the east bound outside lane (EBOL) are presented in Figures 13 to 14. Outliers, values which were far out of range, were not removed. The results indicated that the average M_r value was 641 ksi with some points below the 450 ksi benchmark as presented in Figure 13. The histogram of the AC modulus data indicated that approximately 9 percent of the points were below the 450 ksi benchmark as presented in Figure 14. This implies that a significant portion (9 percent) of the pavement was impacted by the stripping.

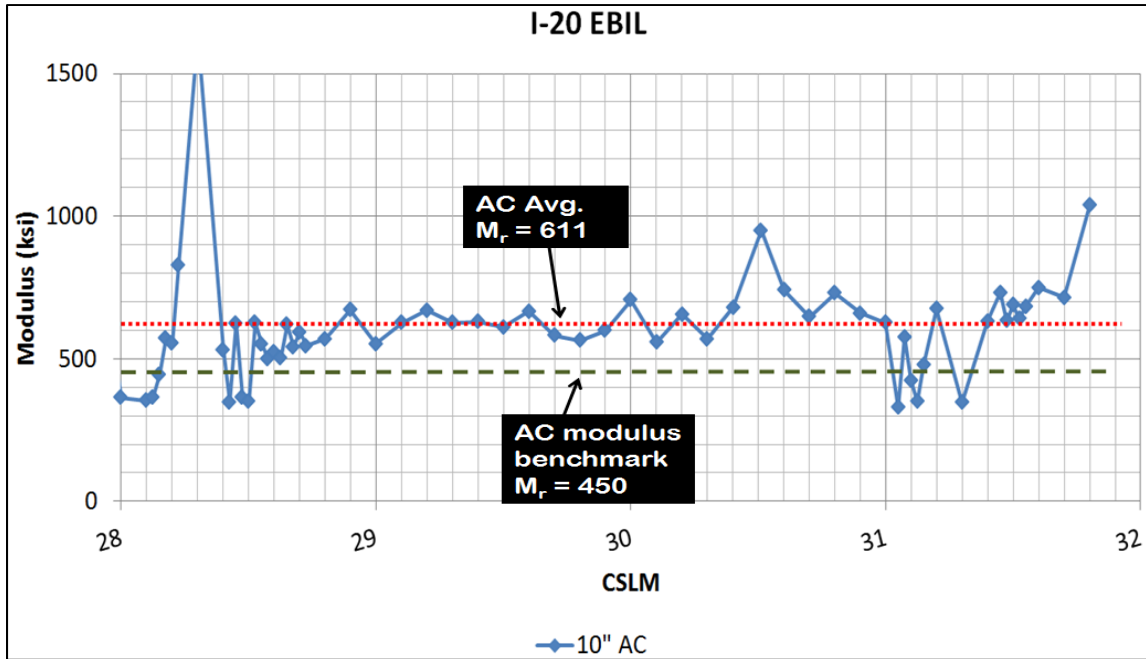
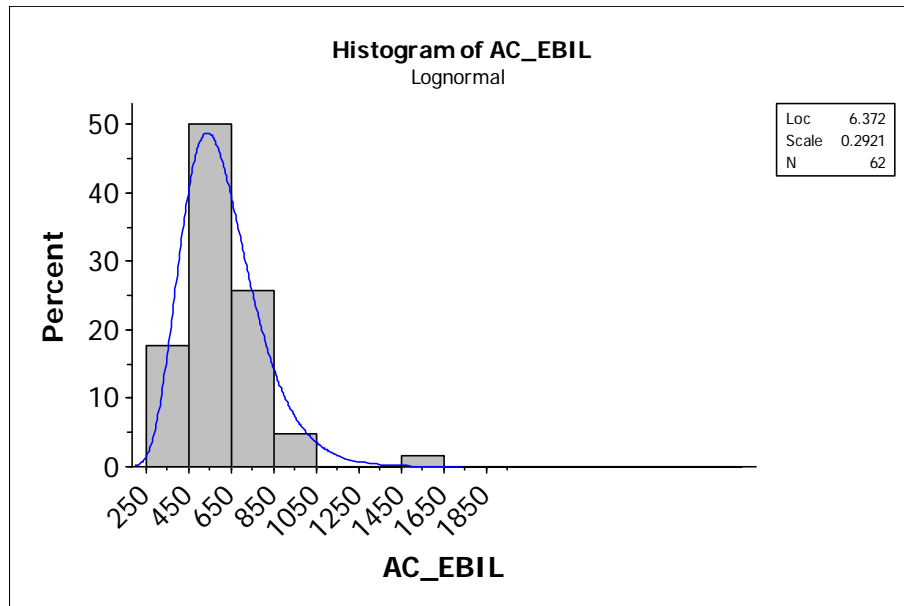
Figures 15 to 16 present the AC modulus values for the east bound inside lane (EBIL). As presented in Figure 15, the average AC modulus is 611 ksi with some points below the 450 ksi benchmark. The histogram for the AC modulus data indicated that approximately 18 percent of the points were below the 450 ksi benchmark as presented in Figure 16. This implies that a significant portion (18 percent) of the pavement was impacted by the stripping.

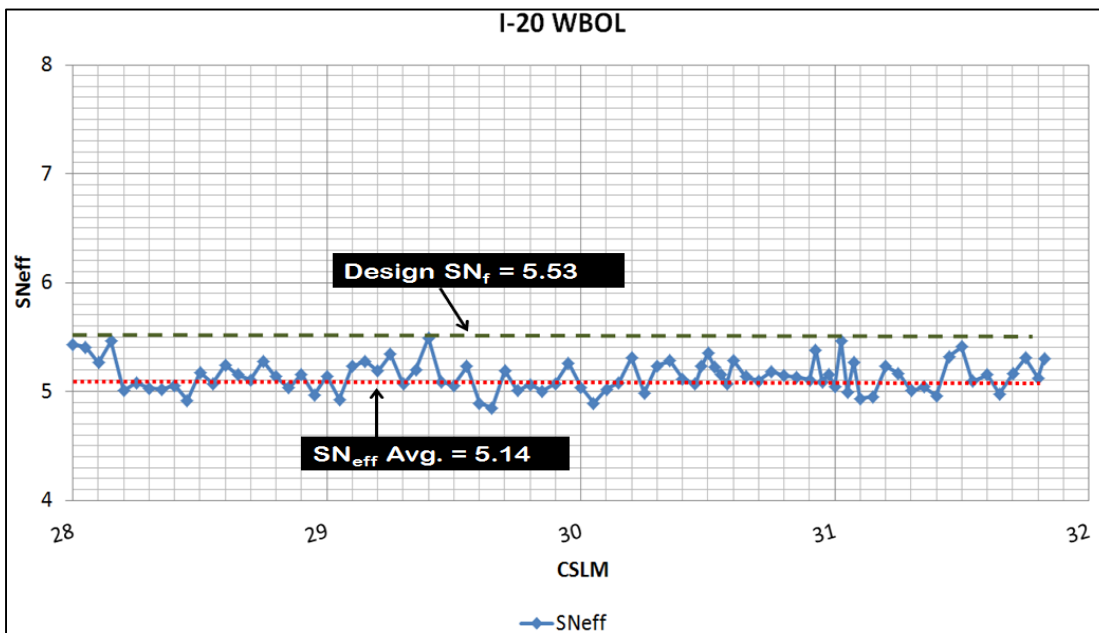
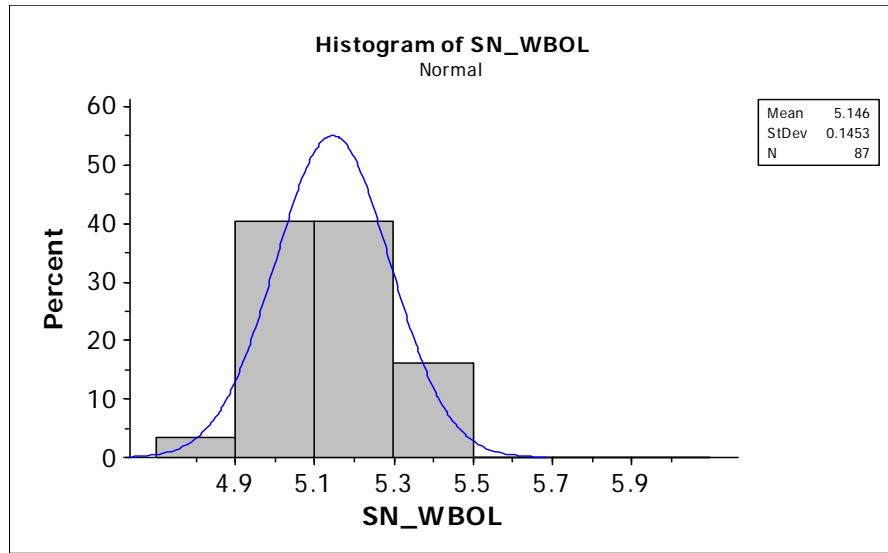
The SN_{eff} values for the west bound outside lane (WBOL) are presented in Figures 17 and 18. The results indicated that the average SN_{eff} was 5.14 and that only a few test locations were near the 5.53 benchmark as presented in Figure 17. The histogram of the SN_{eff} data indicated that all points were below the 5.53 SN_f benchmark as presented in Figure 18. The difference between the average SN_{eff} (5.14) and the benchmark SN_f (5.53) is -0.39, which equates to approximately to 1-in. of AC.

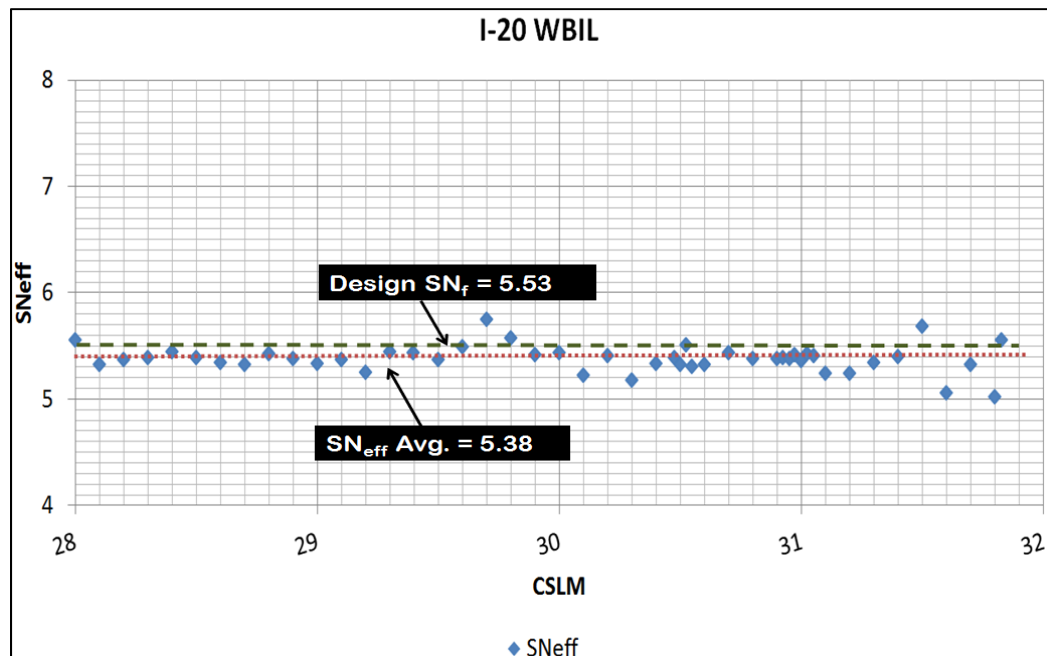
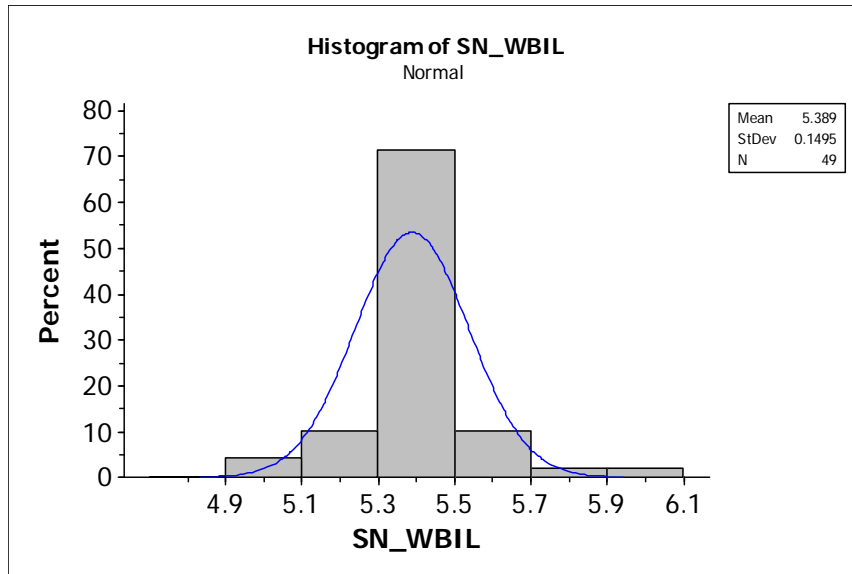
The SN_{eff} values for the west bound inside lane (WBIL) are presented in Figures 19 and 20. The results indicated that the average SN_{eff} was 5.38 and that only a few test locations were above the 5.53 benchmark as presented in Figure 19. The histogram of the SN_{eff} data indicated that approximately 86 percent of the test locations were below the 5.53 SN_f benchmark as presented in Figure 20. The difference between the average SN_{eff} (5.38) and the benchmark SN_f (5.53) is -0.15, which equates to approximately 0.34-in. of AC.

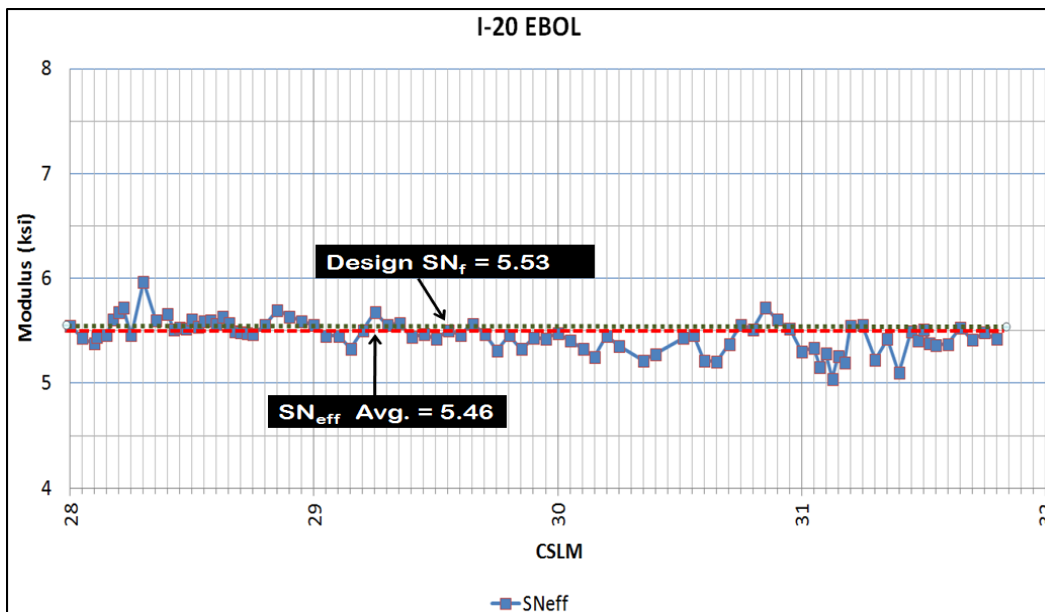
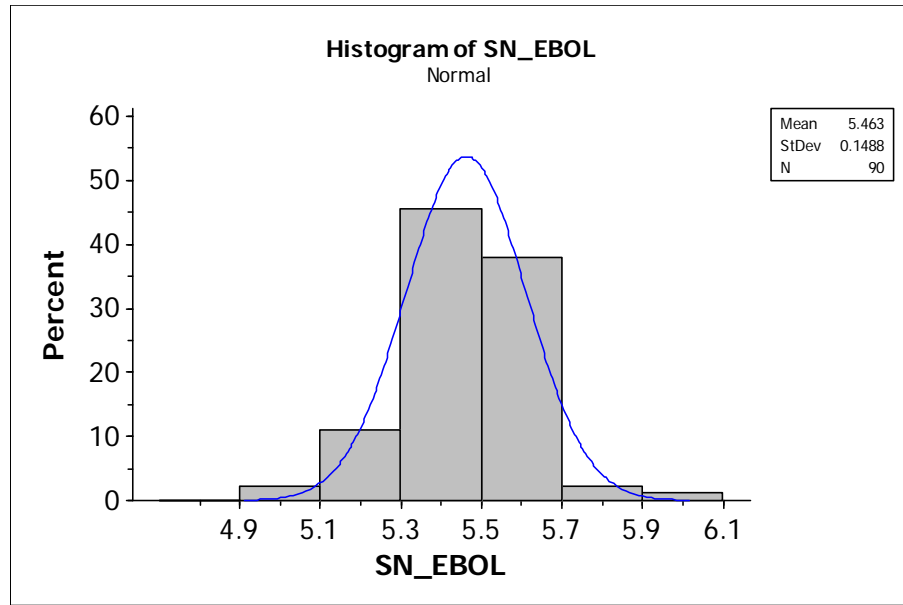
The SN_{eff} values for the east bound outside lane (EBOL) are presented in Figures 21 and 22. The results indicated that the average SN_{eff} was 5.46 and that many test locations were near the 5.53 benchmark as presented in Figure 21. The histogram of the SN_{eff} data indicated that approximately 58 percent of the test locations were below the 5.53 SN_f benchmark as presented in Figure 22. The difference between the average SN_{eff} (5.46) and the benchmark SN_f (5.53) is -0.07, which equates to approximately 0.15-in. of AC.

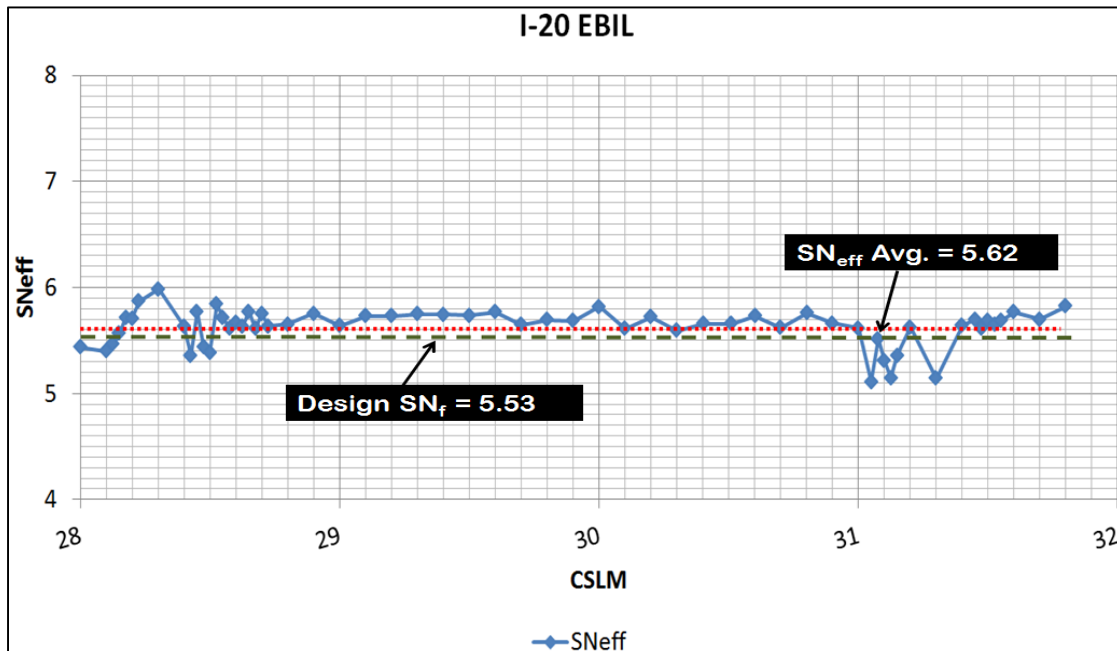
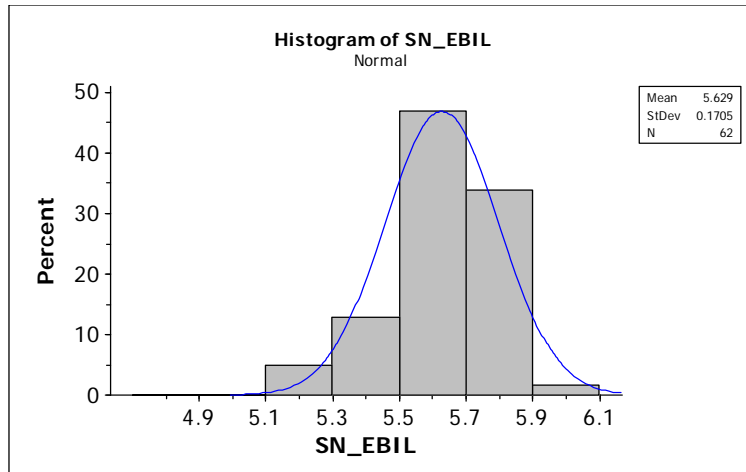
The SN_{eff} values for the east bound inside lane (EBIL) are presented in Figures 23 and 24. The results indicated that the average SN_{eff} was 5.62 and that many test locations were above the 5.53 benchmark as presented in Figure 23. The histogram of the SN_{eff} data indicated that approximately 18 percent of the test locations were below the 5.53 SN_f benchmark as presented in Figure 24. The difference between the average SN_{eff} (5.62) and the benchmark SN_f (5.53) is +0.09, which equates to approximately 0.2-in. of AC.

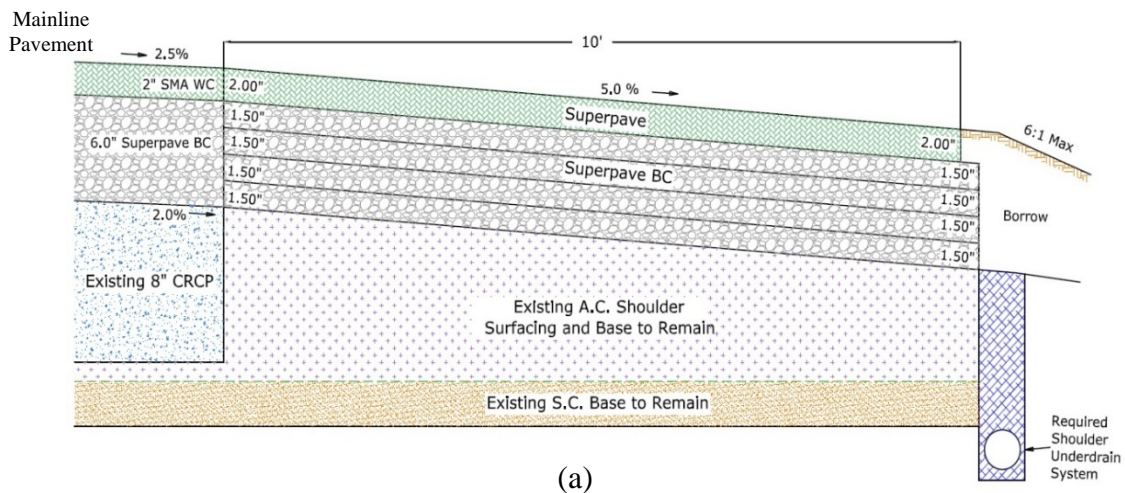
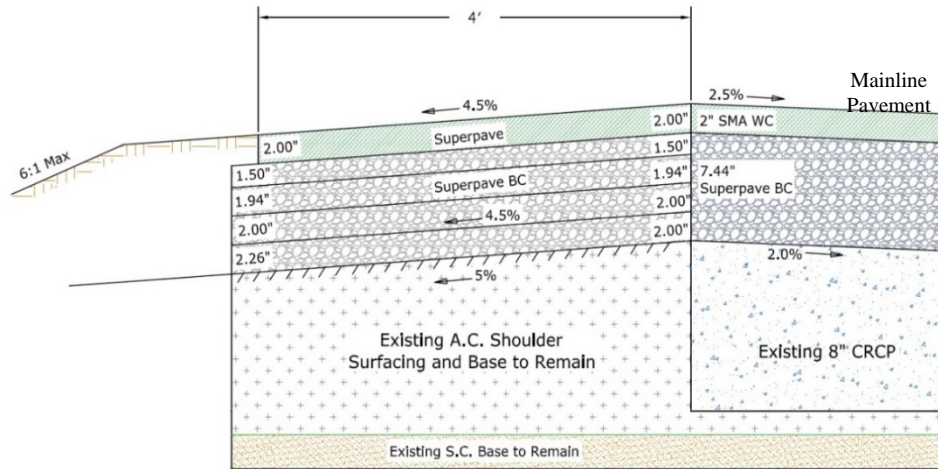
Existing shoulder cross-section: (a) outside shoulder, (b) inside shoulder

It was observed from LADOTD roadway reports that the shoulder and mainline pavements were constructed at the same time. From the typical cross-sections of inside and outside shoulders presented in Figure 25, it can be seen that the shoulders were constructed in different layers. As a regular construction practice, it is anticipated that the same layer thicknesses were maintained also for mainline roadway construction to avoid drop off and facilitate safe traffic movement during construction. However, it should also be noted that the lift thickness of asphaltic pavements is influenced by the nominal maximum aggregate size (NMAS). Generally, the minimum lift thickness is at least 2.5 to 3 times the NMAS to ensure

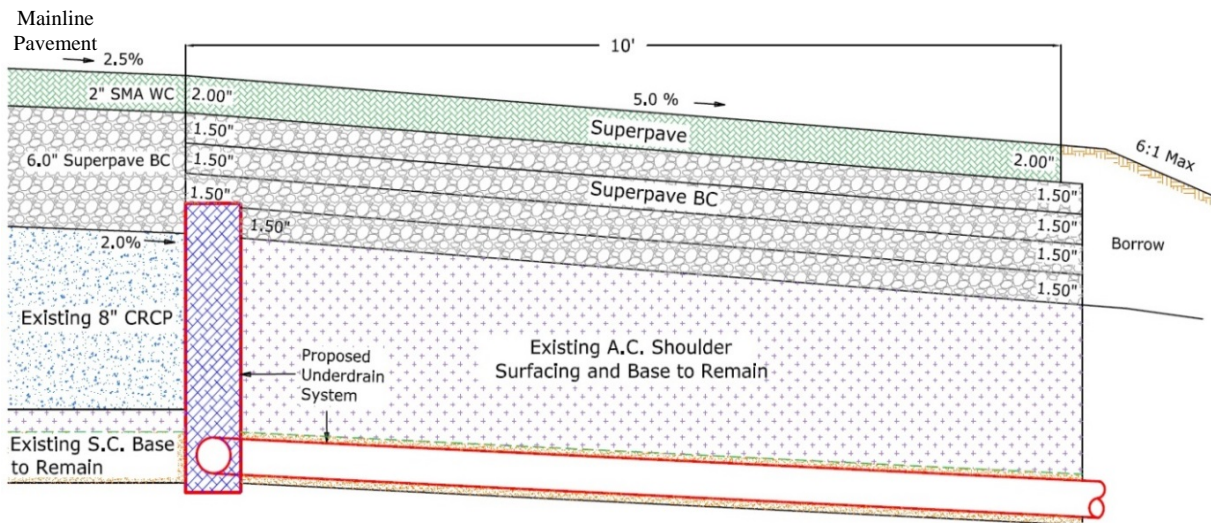
Figure 26
New proposed cross sections showing edge drain

LTRC recommends placing an underdrain system throughout the length of the project against the outside edge of the original concrete pavement to help eliminate the moisture from the existing pavement structure. Ensure the top of the underdrain system is placed at the top or slightly above the first lift of asphalt mixture. The depth of the underdrain system should be enough to go through the treated base coarse. Outlets should be placed according to the standard plan for edge drains. A full depth 8- to 10-ft wide permeable asphalt drainage mixture placed in the shoulder and day lighted through the cross slope could be utilized for the outlets.

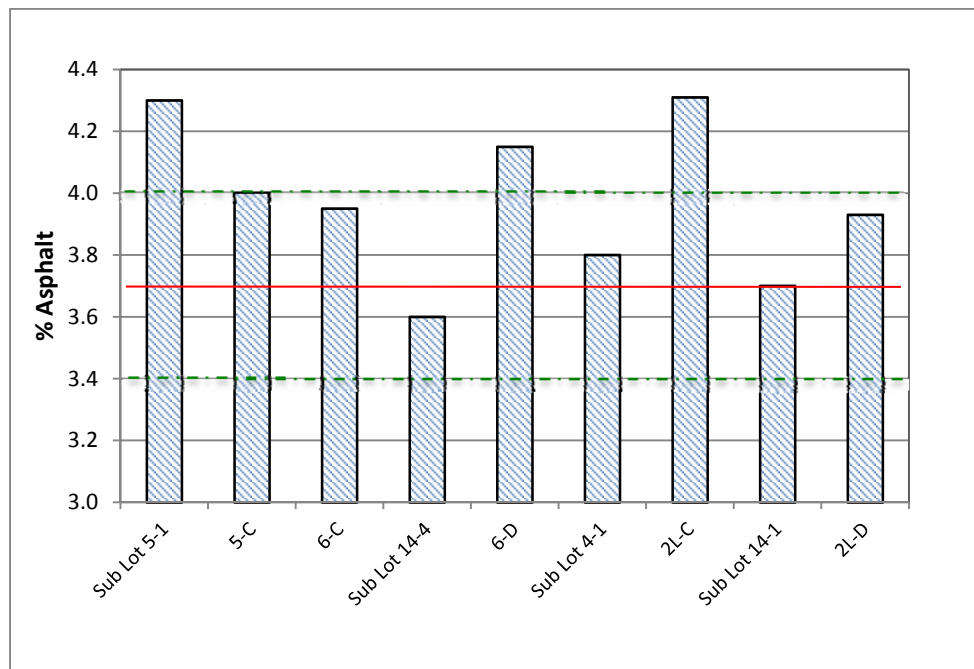
Figure 27
Comparisons of asphalt content

Figure 27 shows the percent asphalt content obtained from various cores and the corresponding Sublots respectively. Except for a couple of the specimens (Core 6: Lift D and Core 2L: Lift C), the percent asphalt for all roadway samples were within the validated JMF tolerance limits. Even though LTRC asphalt lab computed the extracted aggregate gradations and percent asphalt content for leveling course mixtures (Lift A and Lift B), a comparison between plant production data and roadway samples could not be performed due to the unavailability of plant production data at this time.

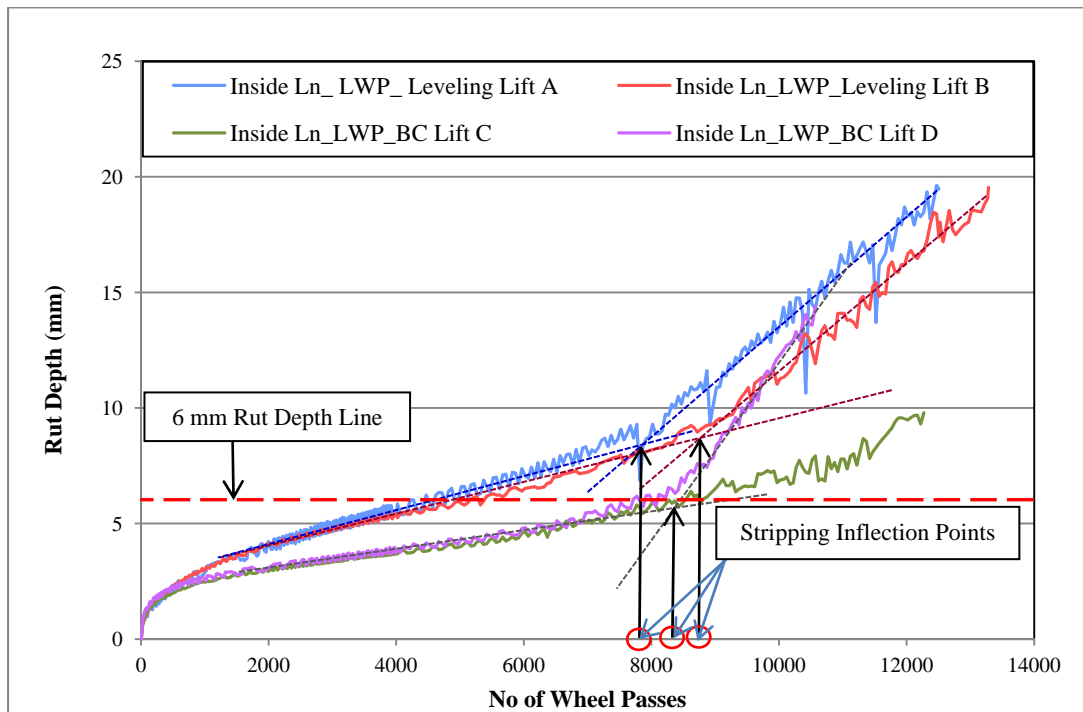
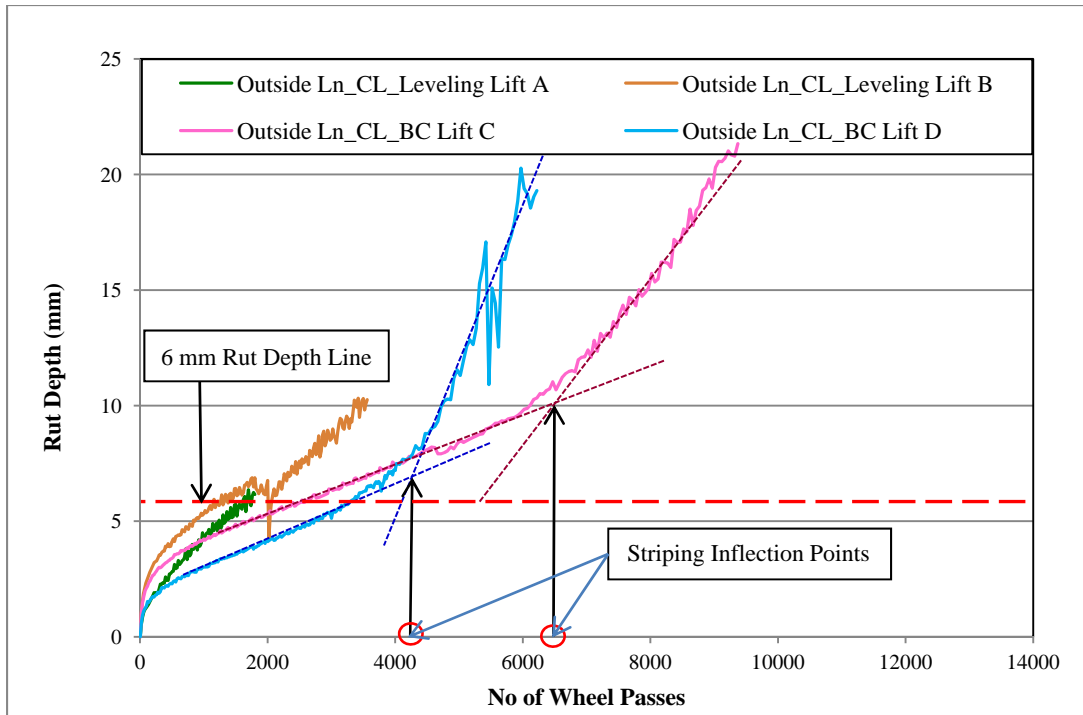
Figure 31
LWT test results

Results presented in Figure 31 clearly indicate that all roadway cores used in LWT test failed miserably and did not survive the whole 20,000 wheel passes. Regardless of the location of the cores (i.e. wheel path or centerline), none meet the current LADOTD specifications

requirement of 6.0 mm rut depth after 20,000 passes for level 2 Superpave BC mixtures. The samples also showed very high stripping potential. However, the cores taken from inside lane showed slightly better performance than the cores from outside lane. Except Lift C samples, all samples from the inside lane showed stripping inflection points around 8000 cycles whereas, the samples from Lift C and Lift D from outside lane showed stripping inflection points at 6200 and 4100 cycles respectively. Note that Colorado DOT reported that a stripping inflection point below 10,000 cycles indicated moisture susceptibility potential of that mix [13].

The graphs in Figure 31 also indicate that the lower the lift of the pavement the more moisture damage it showed. Interestingly, this also supports the underneath moisture damage phenomenon, as Lift A has the maximum potential to be exposed to the moisture. The higher traffic on the outside lane perhaps developed a pumping action of moisture in the lower lifts, which might be the reason behind the moisture damage revealed in LWT test results. The damaged samples were further investigated once the LWT test was completed. From visual inspection, the cores appeared to be completely stripped and fine sand appeared to be leaching as shown in Figure 32.

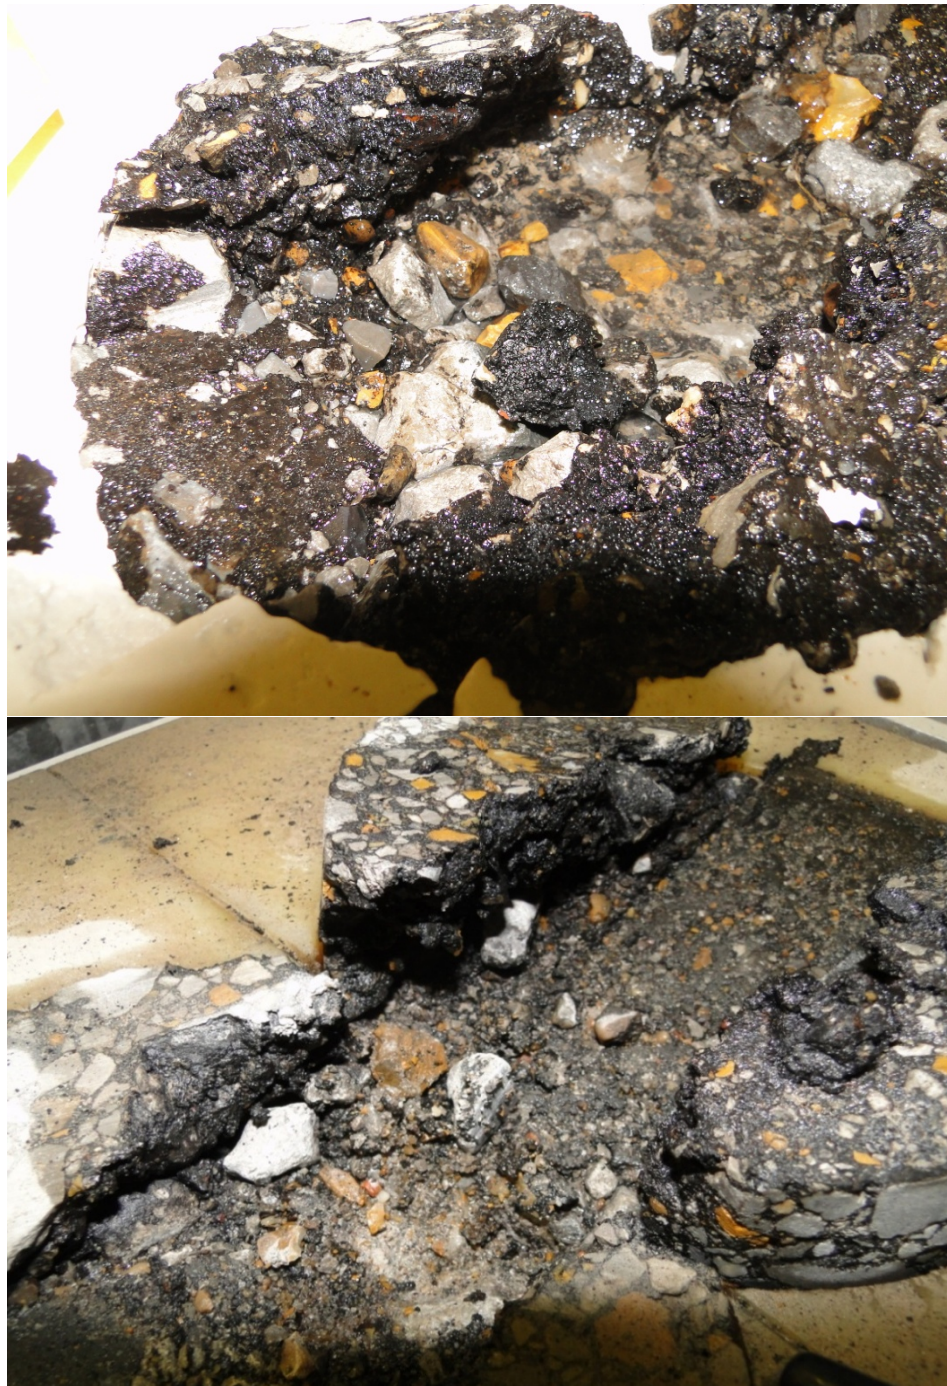
Figure 32
Moisture damage observed on cores after LWT test

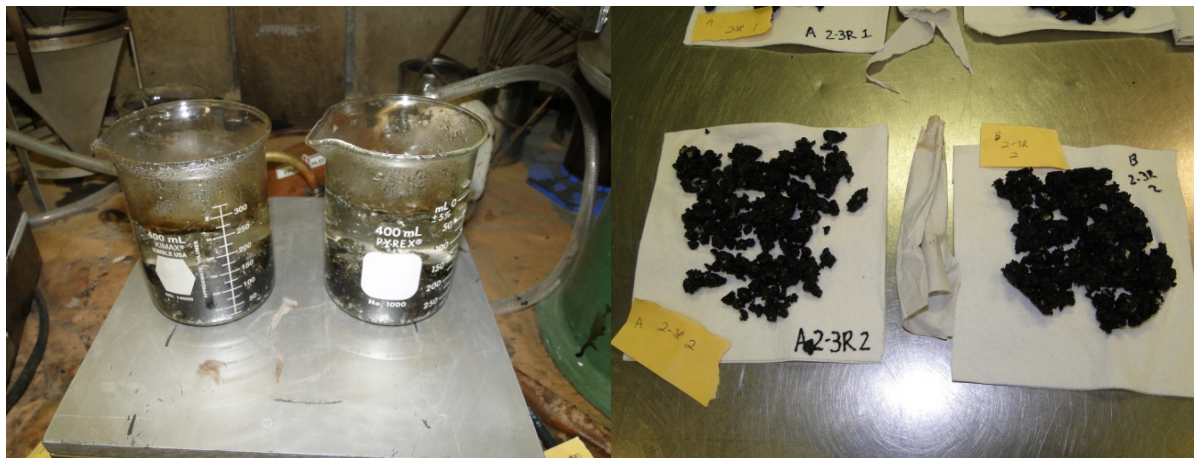
Figure 33
Boil test

As seen in Figure 33, almost no-stripping of binder was evident from the boil test. The reviewers of the test judged that, on average, 98 percent of the aggregates retained the binder coating after 10 minutes of boiling. This also indicates that there may not be any compatibility issue with the materials used in this mixture. However, it should be noted that boil test neither reflects any mechanical properties of the mixture nor accounts for the effect of traffic action. Therefore, the stripping problem noticed in the LWT test was perhaps a result of the underneath moisture and pumping action from the traffic movement rather than the compatibility of the materials.
