Evaluation of Rutting Distresses on I-20 near Mound to Delta Scales

LTRC Project No. 13-01TA-B

January 2014

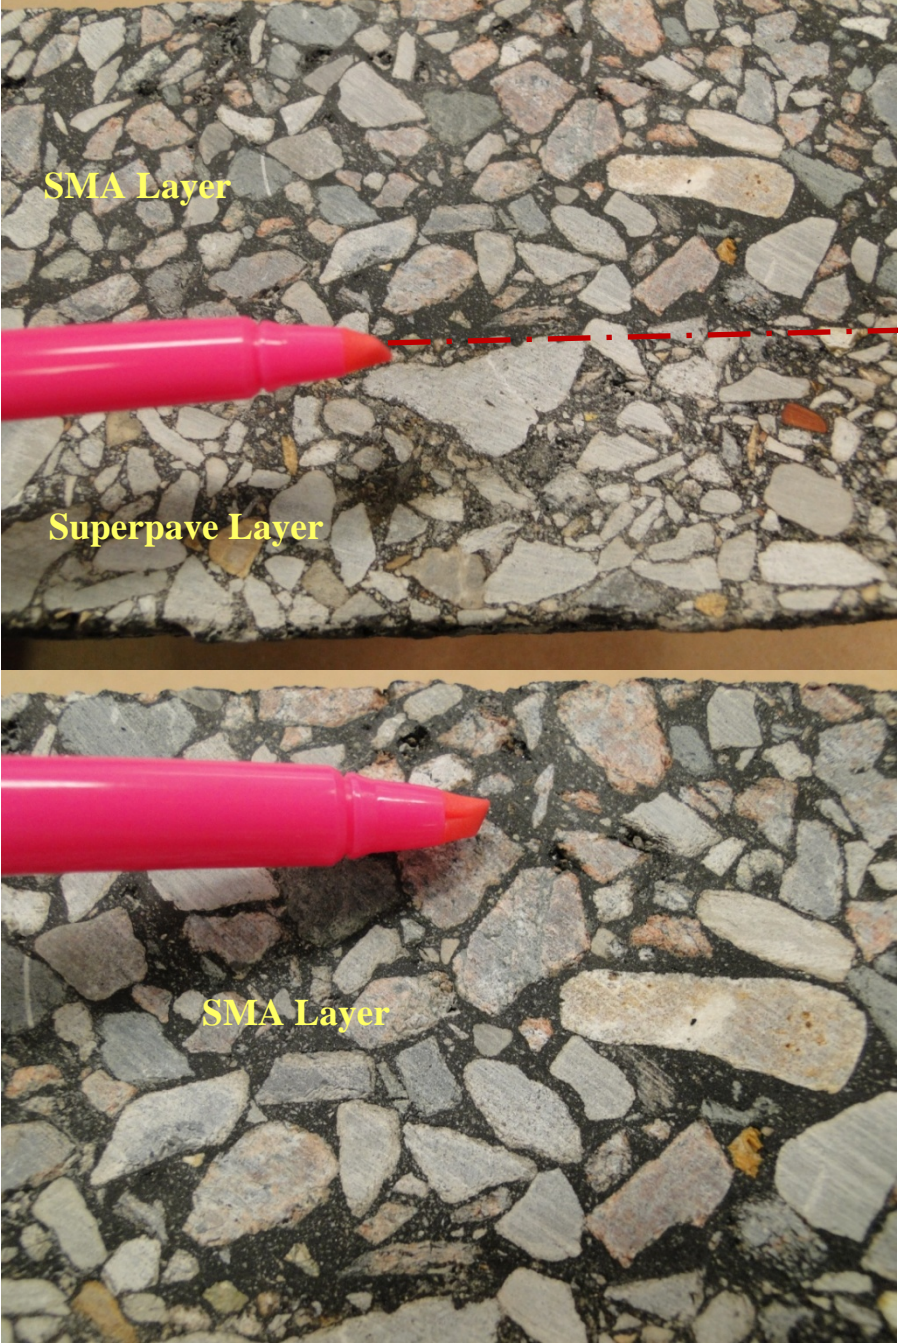
capacity relies on the stone on stone contact of the coarse aggregate skeleton. Longitudinal sectional views of a roadway core collected from a very bad section of this project are presented in Figure 35. It is evident there is lack of proper stone on stone contact for the SMA mixture used in this project.

Figure 35
Aggregate arrangements in the SMA mixture

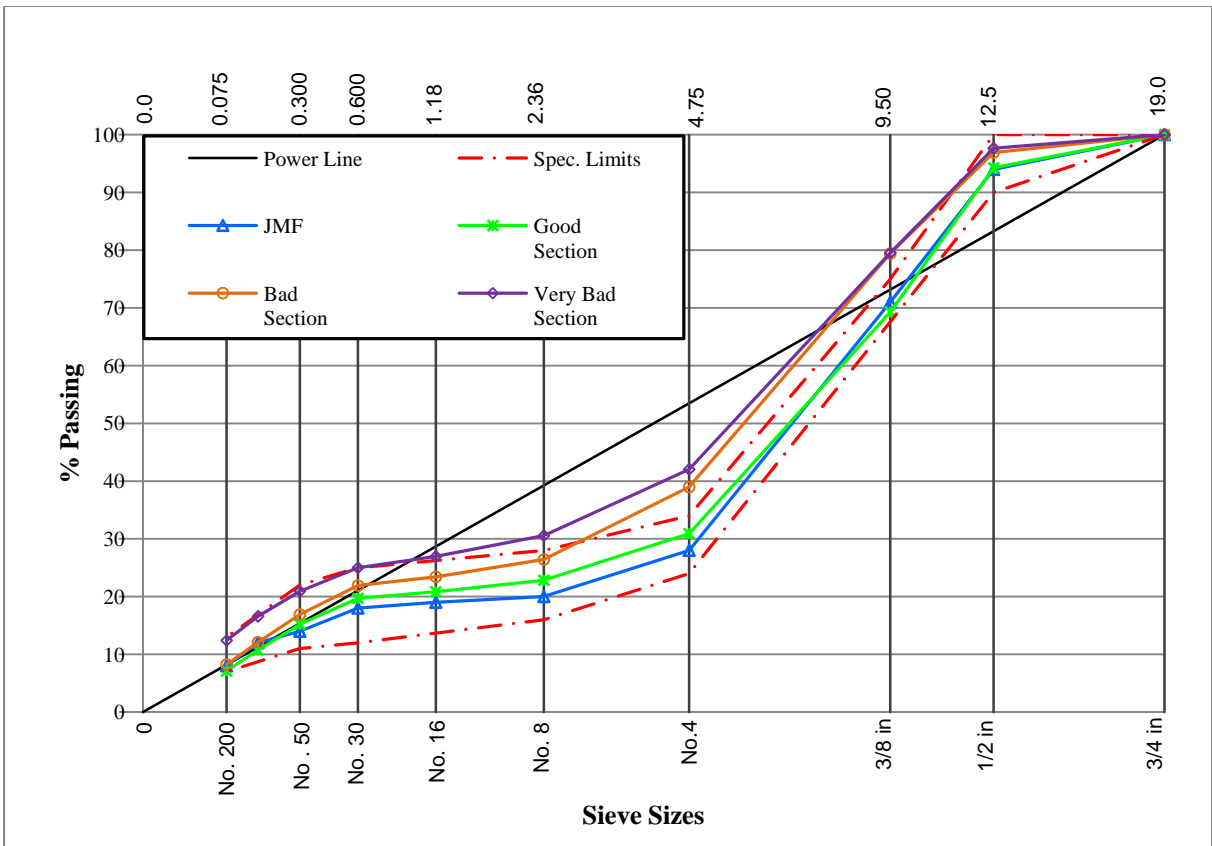
Figure 36
Aggregate blend gradations

Blended aggregate gradations and percent asphalt contents were obtained from the ignition oven method and compared with the original job mix formula (JMF) for this project and the current LADOTD specification limits for SMA mixtures. Investigation showed that the extracted aggregate gradations obtained at the LTRC Asphalt Lab were different than the approved JMF (Figure 36). Moreover, the “percent passing” values for several sieves exceeded the specification limits for mixtures representing bad and very bad sections. The use of finer graded aggregates might be the possible reason of losing stone on stone contact of aggregates as discussed previously. The percent asphalt content obtained from the roadway cores representing good, bad, and very bad sections are 6.18, 6.37, and 6.16 percent respectively, whereas the asphalt content in the approved JMF was reported to be 6.0 percent. The extracted asphalt content was within the JMF and the specifications requirement of 6.0 ± 0.4 percent.

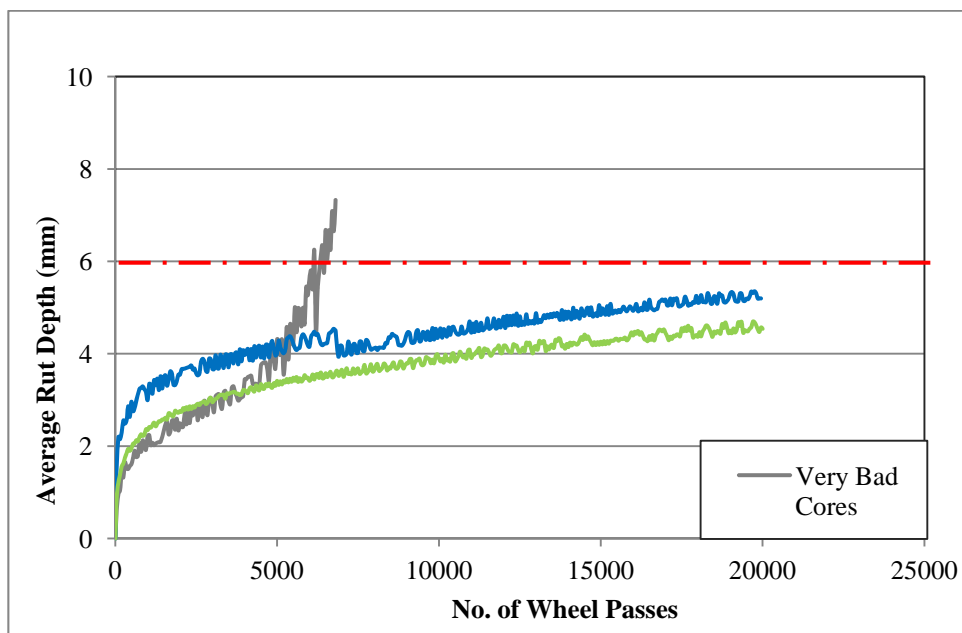
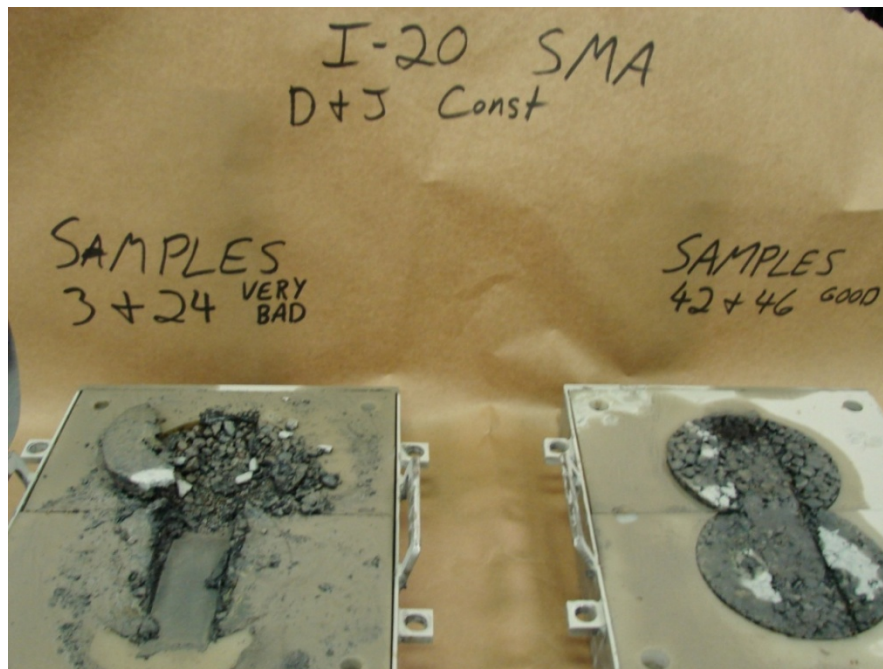
LWT (Hamburg) tests were conducted in accordance with AASHTO T 324 in an effort to evaluate the rutting potential and moisture susceptibility of SMA mixture used in this project. Roadway cores from good and very bad sections were tested in addition to laboratory fabricated superpave gyratory compacted (SGC) specimens supplied by the contractor, D & J Construction. It should be noted that the SGC specimens were prepared to replicate the plant production of the mixtures from the actual aggregate stockpiles during the construction of the project. Results presented in Figure 37 indicate that roadway cores from the good section and laboratory fabricated SGC specimens met the maximum allowable rut depth requirement of 6.0 mm after 20,000 passes. Also, no sign of stripping was observed for those specimens. Alternatively, roadway cores from the very bad section failed immediately after 6300 wheel passes and showed sign of severe stripping. As shown in Figure 38, the roadway cores from very bad section were crushed and completely destroyed after the test.

Figure 37
Roadway Core from Very Bad Section after LWT Test

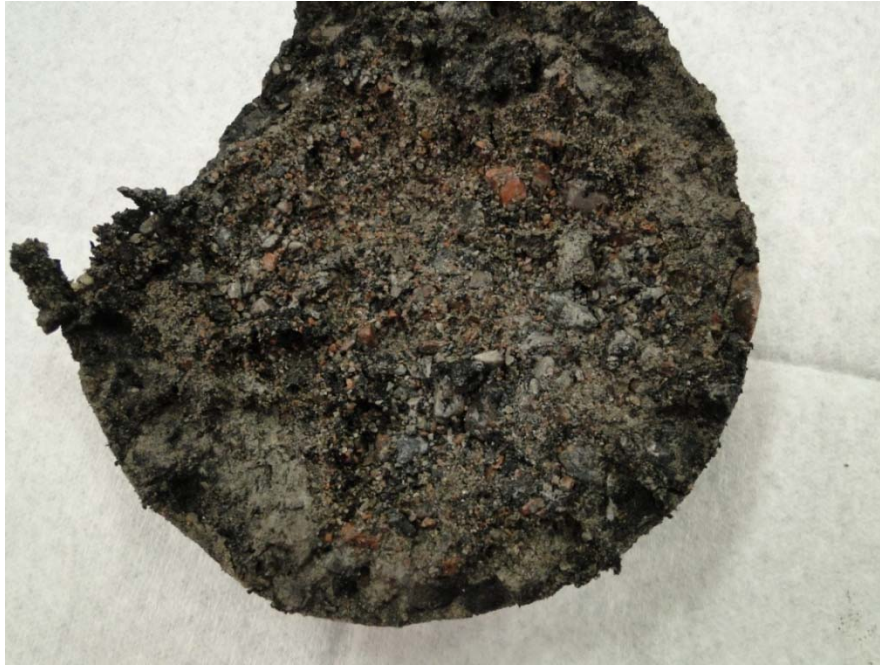
Figure 38
Condition of roadway core specimens after LWT testing

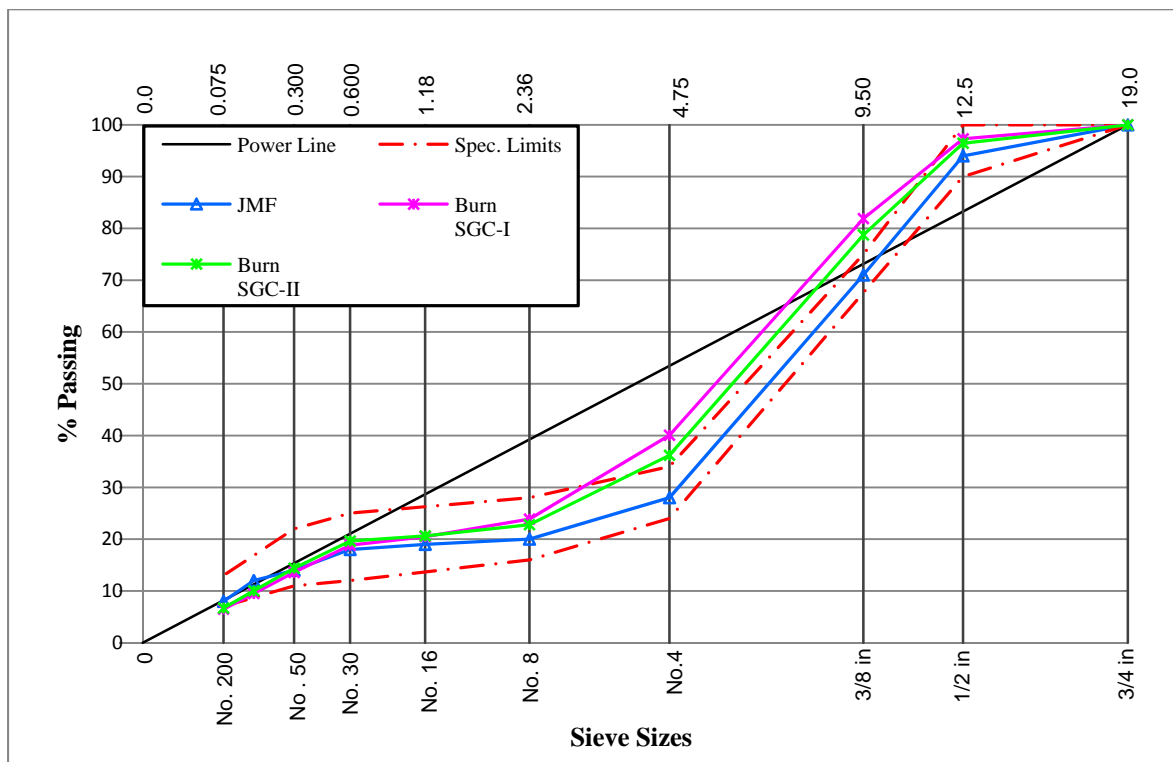
Figure 39
Aggregate blended gradations for lab-fabricated SGC specimens

Once again the ignition oven method was used to determine the blended aggregate gradations and percent asphalt contents for laboratory fabricated SGC samples supplied by the contractor. Although SGC specimens passed the LWT test, the burn gradations for that mixture failed to meet the current LADOTD aggregate blend specifications for SMA mixtures (Figure 39). Additionally, the average asphalt content for SGC samples was

found to be 5.45 percent which failed to meet the minimum asphalt content requirement of 5.6 percent for SMA mixtures.

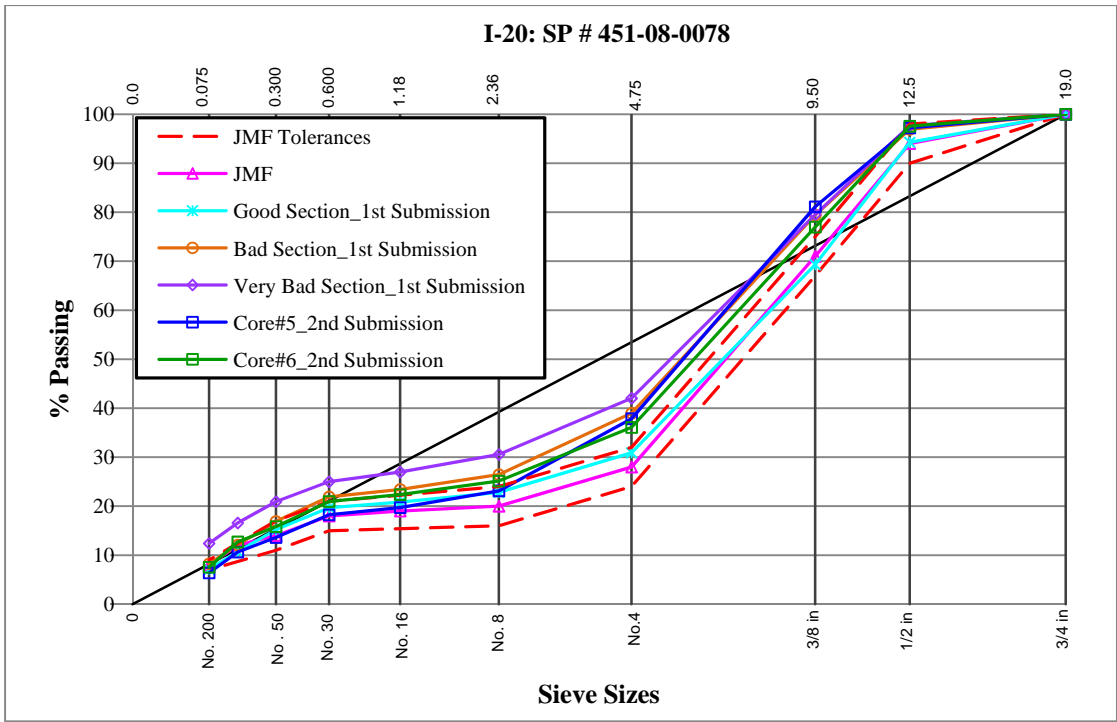
Figure 41
Aggregate blended gradations

Core # 5 and Core # 6 were used in obtaining the blended aggregate gradations and percent asphalt contents from ignition oven method. Figure 41 shows a comparison of blended gradations with the original job mix formula (JMF), specified tolerances for SMA mixtures, and the blended aggregate gradations found from the roadway cores previously submitted (roadway cores represented the good, bad, and very bad sections of the first submission). It is evident that the extracted aggregate gradations obtained at the LTRC Asphalt Lab did not match the gradations reported in the approved JMF. Also, the “percent passing” values for several sieves exceeded the tolerance limits specified in current LADOTD specifications for SMA mixtures. Interestingly, for the No. 4, 3/8 inch, and 1/2 inch sieves, the “percent passing” values from second submission of roadway cores are similar to the mixtures representing bad and very bad sections in the first submission of cores. The percent asphalt content obtained from Core # 5 and Core # 6 were 6.41 and 6.51 percent respectively whereas, the asphalt content in the approved JMF was reported to be 6.0 percent. The asphalt content for the first set of roadway cores from good, bad, and very bad sections are 6.18, 6.37, and 6.16 percent respectively. Note that the current LADOTD specifications tolerate 6.0 ± 0.4 percent of extracted asphalt in SMA mixtures.

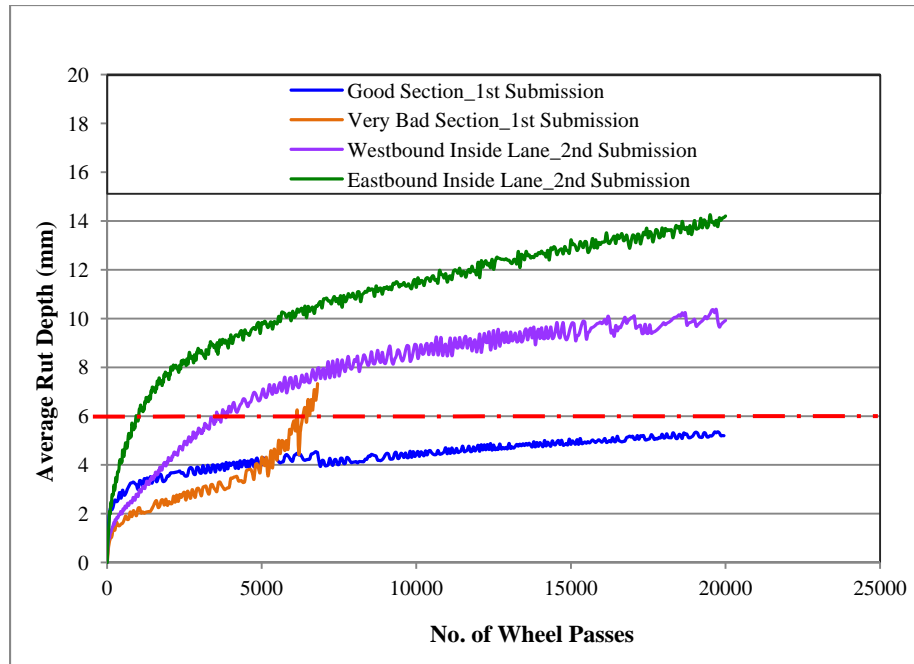
Figure 42
LWT test results

To evaluate the rutting potential and moisture susceptibility of SMA mixture used in this project, cores from Westbound (Core # 1 and 2) and Eastbound (Core # 3 and 4) lanes were used in LWT (Hamburg) tests in accordance with AASHTO T 324. Results presented in Figure 42 indicate that roadway cores from both sections exceeded the maximum suggested rut depth requirement of 6.0 mm after 20,000 passes. Also, no sign of stripping was observed for those specimens. It should be noted that the roadway cores from very bad section of first submission failed immediately after 6300 wheel passes and showed sign of severe stripping.
