Inspection of the Advanced Engineered Lumber Railroad Ties at the New Meadows Bridge

Final Report 2009

A Publication from the Maine Department of Transportation's Research Division

FINAL REPORT
Inspection of the Advanced Engineered Lumber
Railroad Ties at the New Meadows Bridge
AEWC Project 048

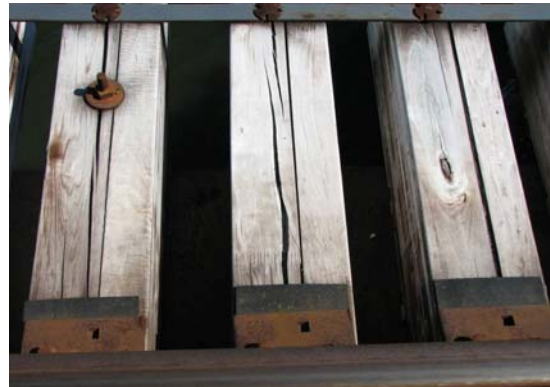
1. Approximately half the ties developed a crack that parallels edge joint of the multiple width boards, as shown in Figure 4. The location of the crack coincides with the location of a J-bolt or a lag screw that is drilled into the tie during installation, as shown in Figure 4.

Figure 4: Crack development near lifting bolt

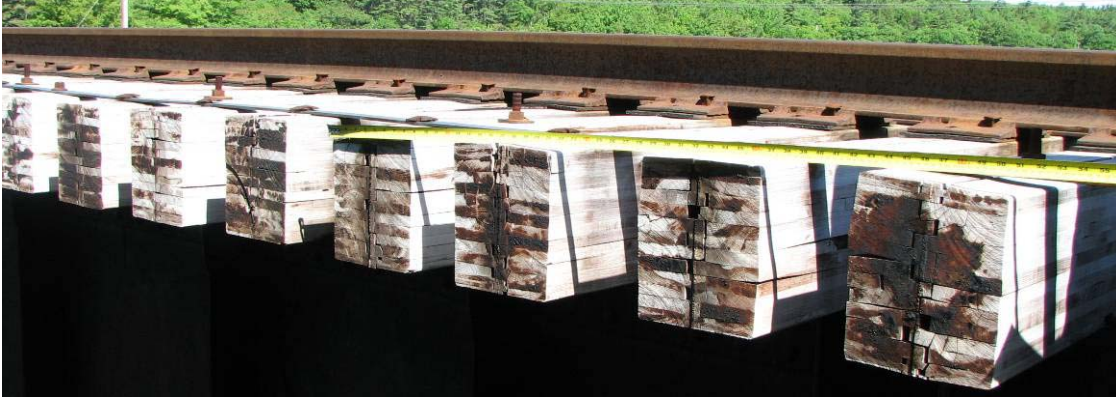
2. Delaminations were observed on the overhanging portions of the ties, as seen in Figure 5; however, there was minimal sign of delamination along the middle 6-foot long section of the ties between the rails.

Figure 5: End view of AEL ties

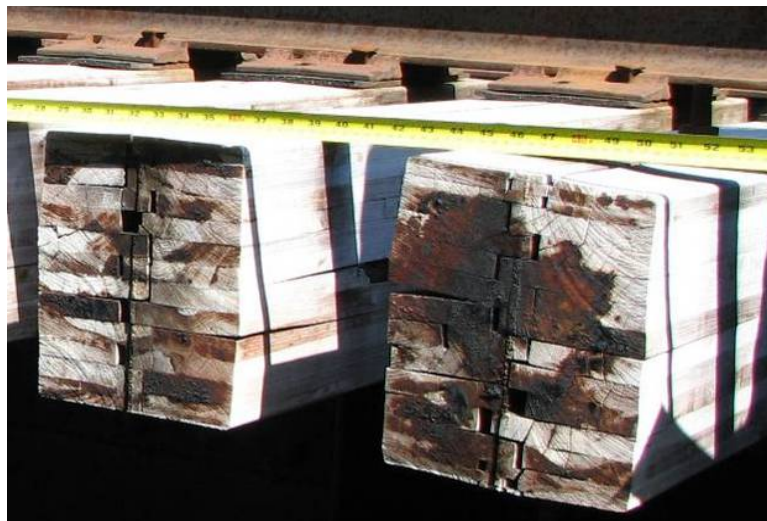
3. Based on a limited visual inspection of the overhand portion of the ties, the first three (3) ties on the east end of the bridge appear to have sustained more damage than the other ties. They have larger delaminations, both in length and depth, and there is greater separation between the edges of the boards within a lamination, as shown in Figure 6 and Figure 7. Rail road regulations require people to remain between the tracks when walking on a rail road bridge.
4. When the rail road division inspects ties, they look for tie spike pull out, movement of the ties, and plate cutting in the ties. None of these items were evident in the AEL ties during the inspection.

Figure 6: First 2 ties on east end-south overhang

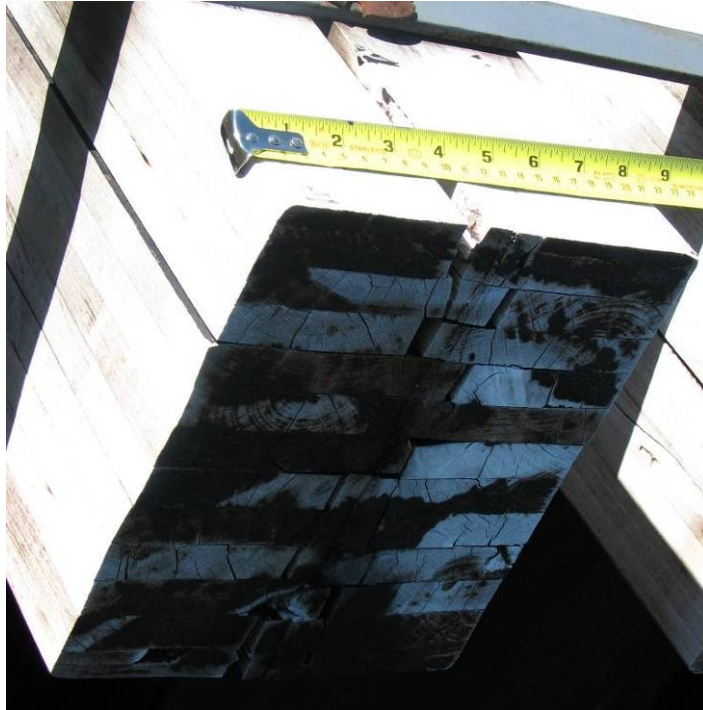
Figure 7: East end tie-north overhang
