Nondestructive Evaluation of MoDOT Bridge Decks – Pilot Study

Report cmr14-010

**NONDESTRUCTIVE EVALUATION OF MODOT BRIDGE DECKS
– PILOT STUDY**

MARCH 2014

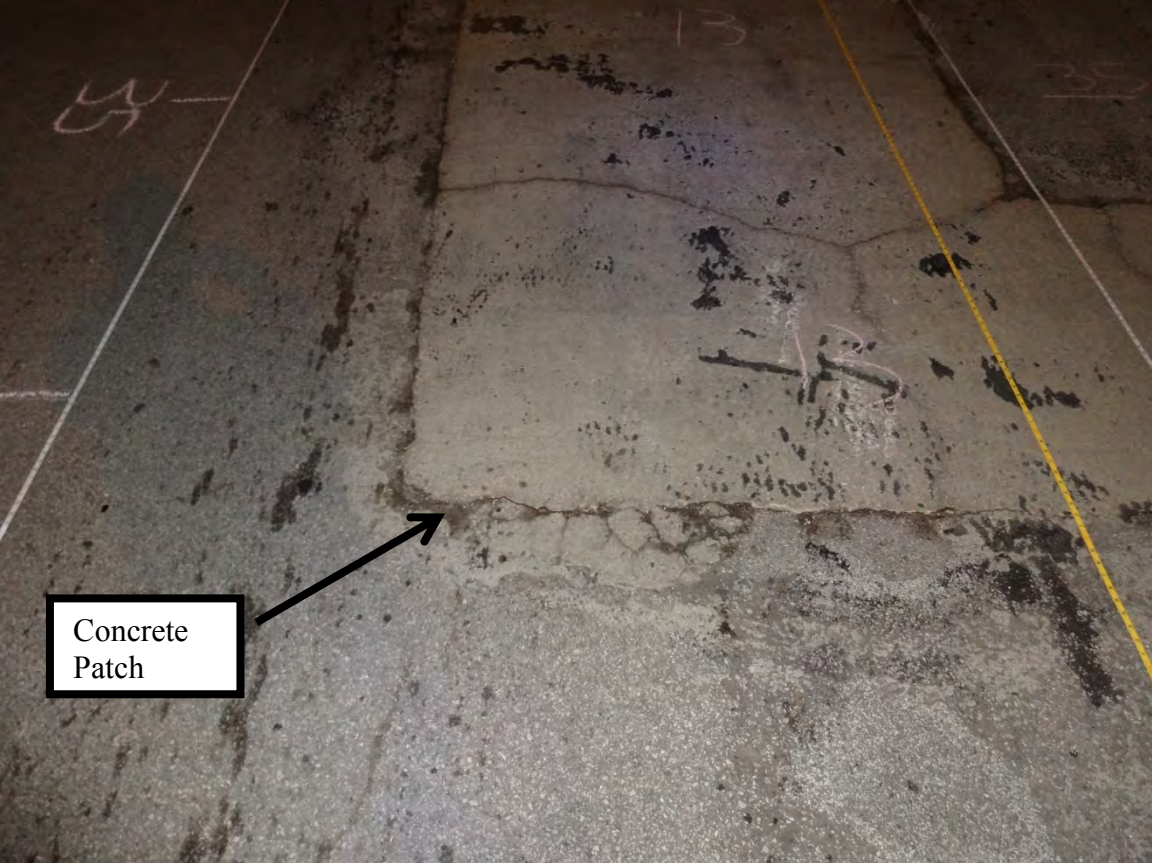
There were 20 defects documented during the field investigation of Bridge A0569. The deck contained an asphalt wearing surface that showed some signs of deterioration. Documented defects include concrete patches, asphalt rutting and shoving, and unfilled potholes in the concrete. Figure 3-1 below shows a concrete patch present on Bridge A0569, along with a deteriorated asphalt overlay around the patch.

Figure 3-1 Bridge A0569 Concrete Patch and Deteriorated Asphalt Overlay Observed During Field Investigation

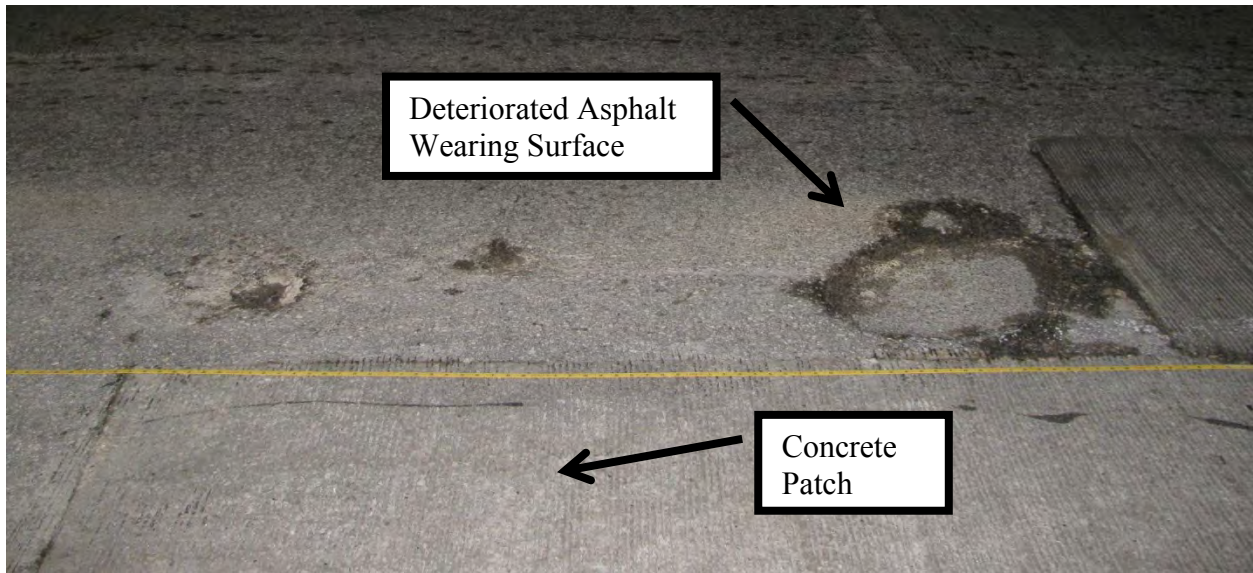
During the first investigation of Bridge A1187, the asphalt wearing surface was noted to be heavily deteriorated, and 52 individual surface defects were documented. These defects consisted mainly of concrete patches, but also included visible deterioration of the asphalt, such as rutting and shoving, as well as unfilled potholes. No defects were documented during the second visual investigation of Bridge A1187 after the wearing surface had been milled off and replaced with an approximately 1 in. thick asphalt wearing surface. Figure 3-2 shows Bridge A1187 during the first investigation. Figure 3-2 shows the deteriorated asphalt overlay and concrete patches. Figure 3-3 shows the top deck surface of the same bridge during the second investigation (approximately eight months later), with a new asphalt wearing surface.

Figure 3-2 Bridge A1187 Deteriorated Asphalt Wearing Surface Observed During First Investigation

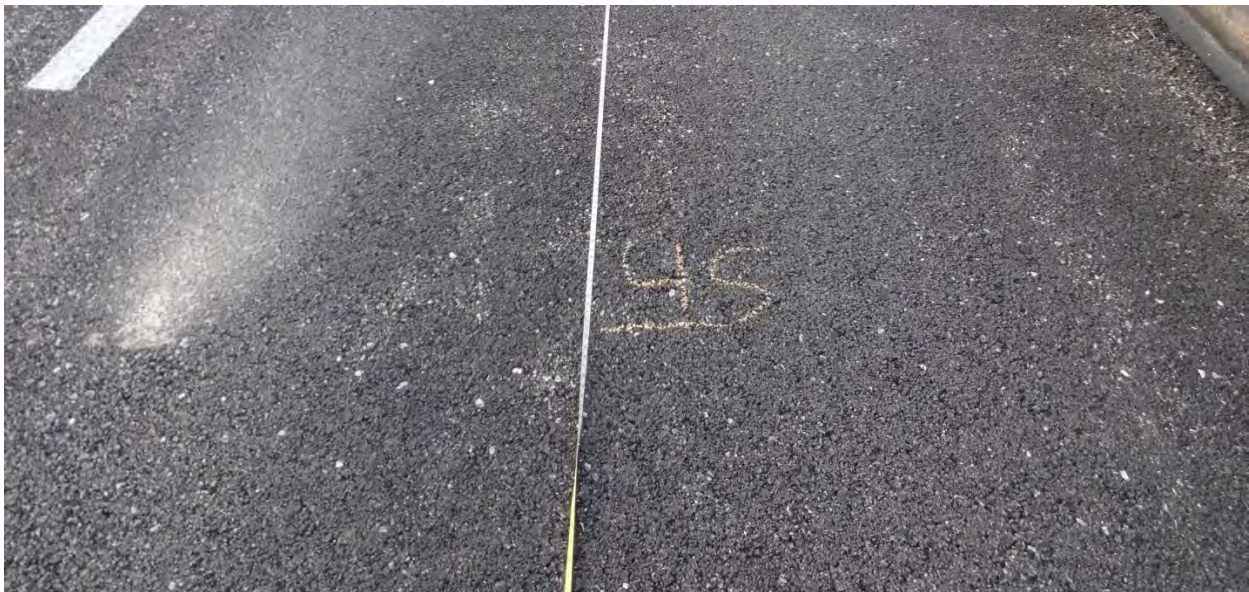
Figure 3-3 Bridge A1187 Deck Surface Observed During Second Investigation

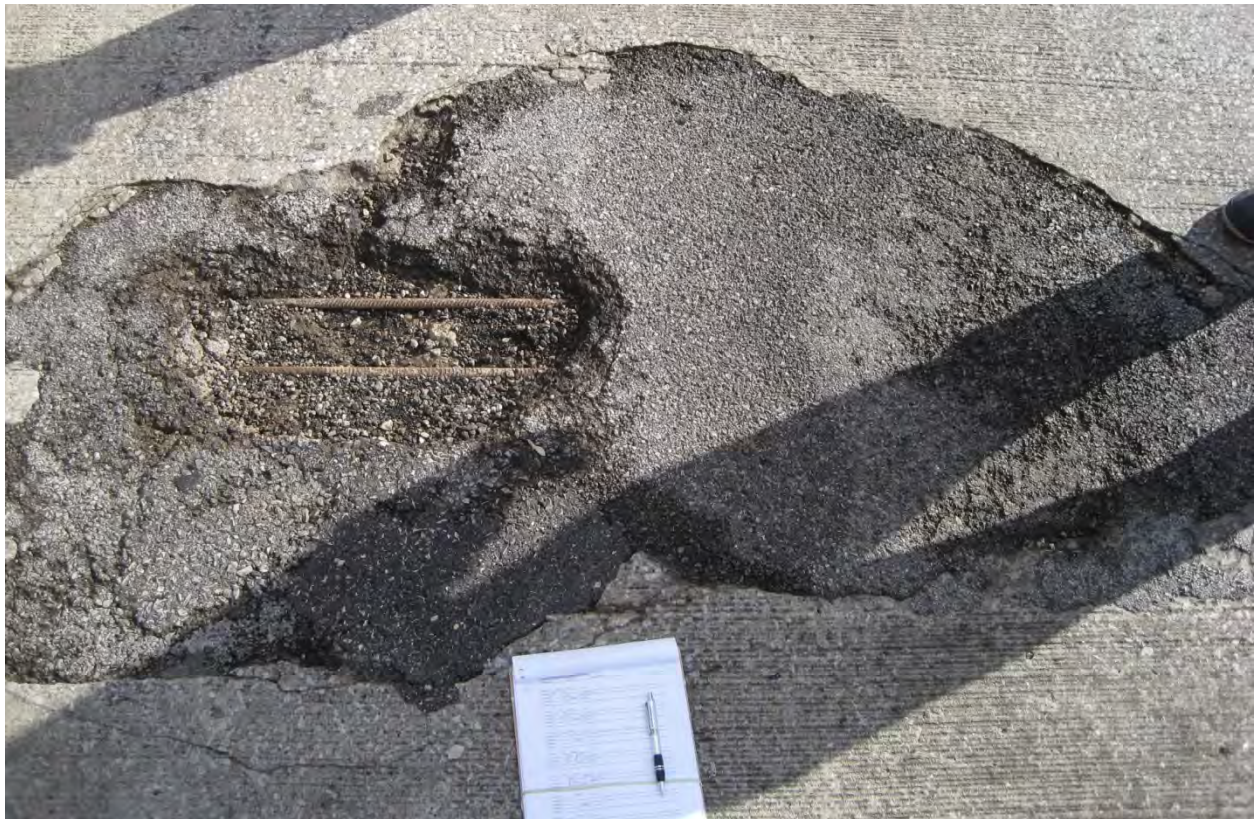
There were 81 defects documented during the field investigation of Bridge A1193. Due to time constraints of the time on site, the shoulders were not examined. The bridge deck surface did not appear to be heavily deteriorated. Most of the visible defects were asphalt filled potholes, and some unfilled potholes in the concrete were noted. Figure 3-4 shows a typical asphalt filled pothole found on the deck surface of Bridge A1193. This region also had exposed reinforcing steel.

Figure 3-4 Bridge A1193 Typical Asphalt Filled Pothole Observed During Field Investigation

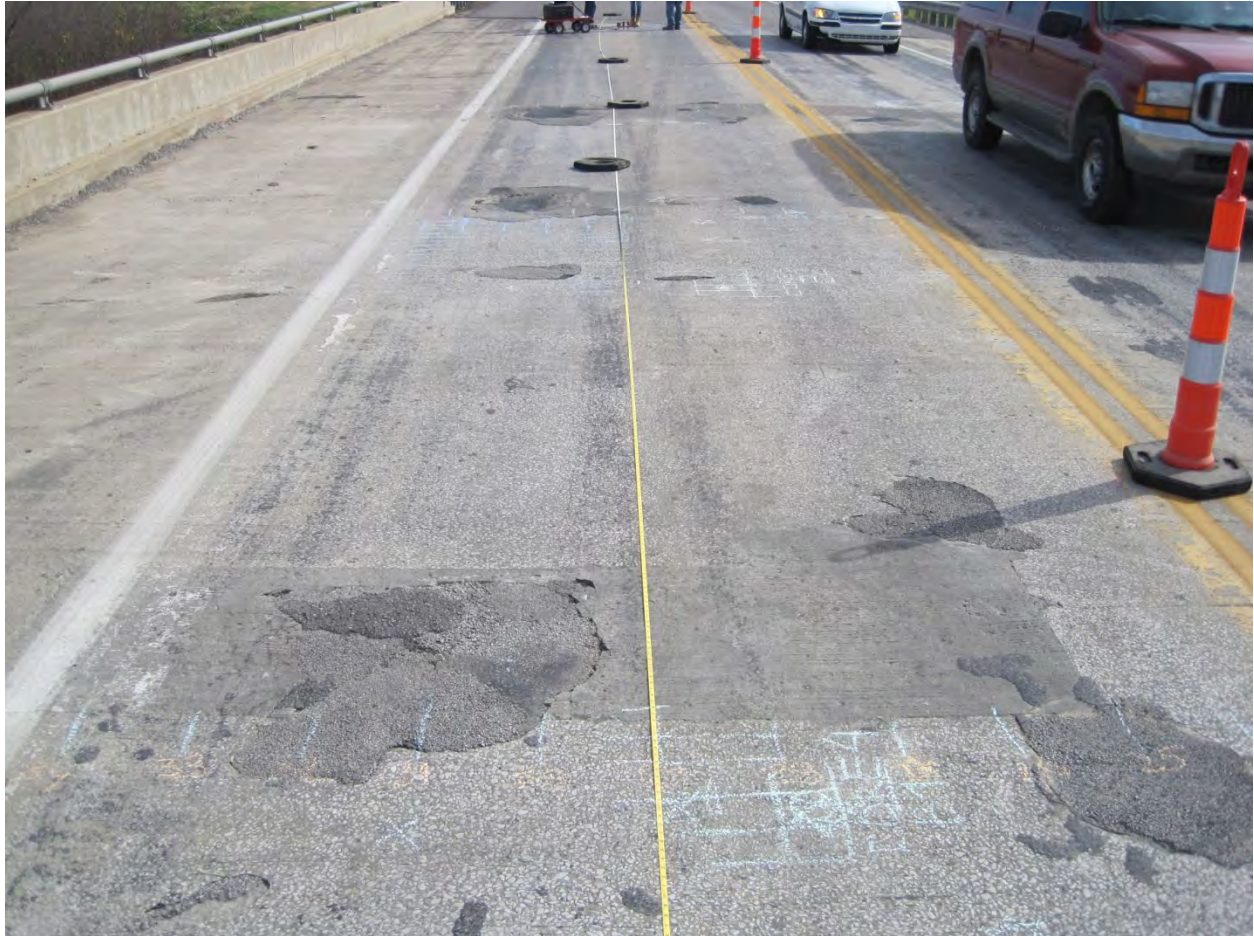
There were 69 defects documented during the field investigation of Bridge A1297. The deck had many traverse cracks, concrete patches, asphalt filled potholes, and unfilled potholes in the concrete. Figure 3-5 shows typical deterioration located during the field investigation of Bridge A1297.

Figure 3-5 Bridge A1297 Typical Deck Condition Observed During Field Investigation

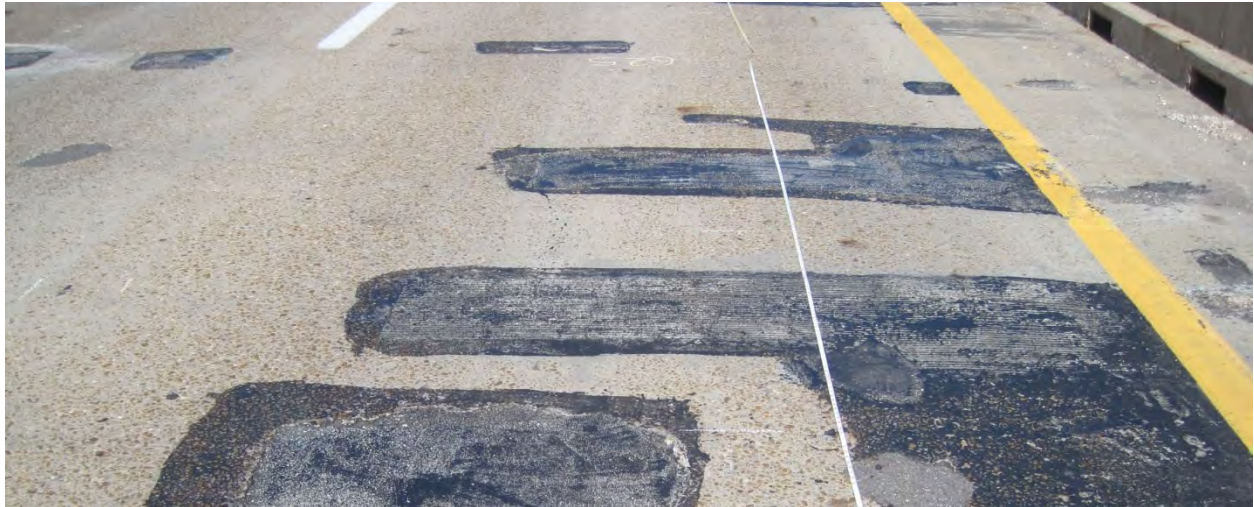
There were 161 defects documented during the field investigation of Bridge A1479. The deck surface appeared heavily deteriorated near the middle of the beam spans. Deterioration levels appeared to be much lower near the bent supports. The researchers noticed a lot of vibration of the bridge during the investigation as large trucks passed over the bridge. The deck curb drains were also severely deteriorated with reinforcing steel visible in several areas, especially along the soffit of the deck. Documented deterioration includes concrete patches, unfilled concrete potholes, asphalt filled potholes, and transverse cracks. Figure 3-6 shows an area of the deck with multiple concrete patches and asphalt filled potholes.

Figure 3-6 Bridge A1479 Typical Deck Condition Observed During Field Investigation

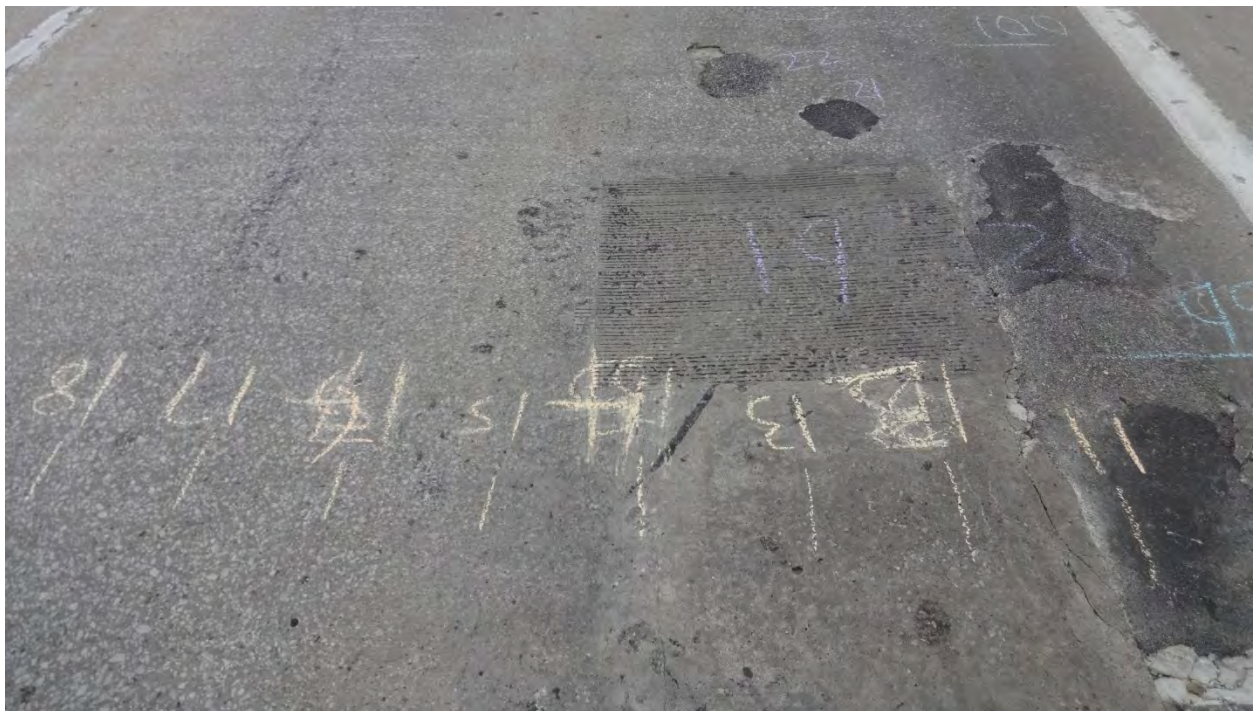
There were 50 defects documented during the field investigation of Bridge A2111. The deck contained several concrete patches, asphalt filled potholes, and unfilled potholes. There were several areas of the deck where delaminations were suspected because tapping on the concrete surface generated a “hollow” sound. Figure 3-7 shows typical deterioration that was observed on Bridge A2111, including concrete patches and asphalt filled potholes.

Figure 3-7 Bridge A2111 Typical Deck Condition Observed During Field Investigation

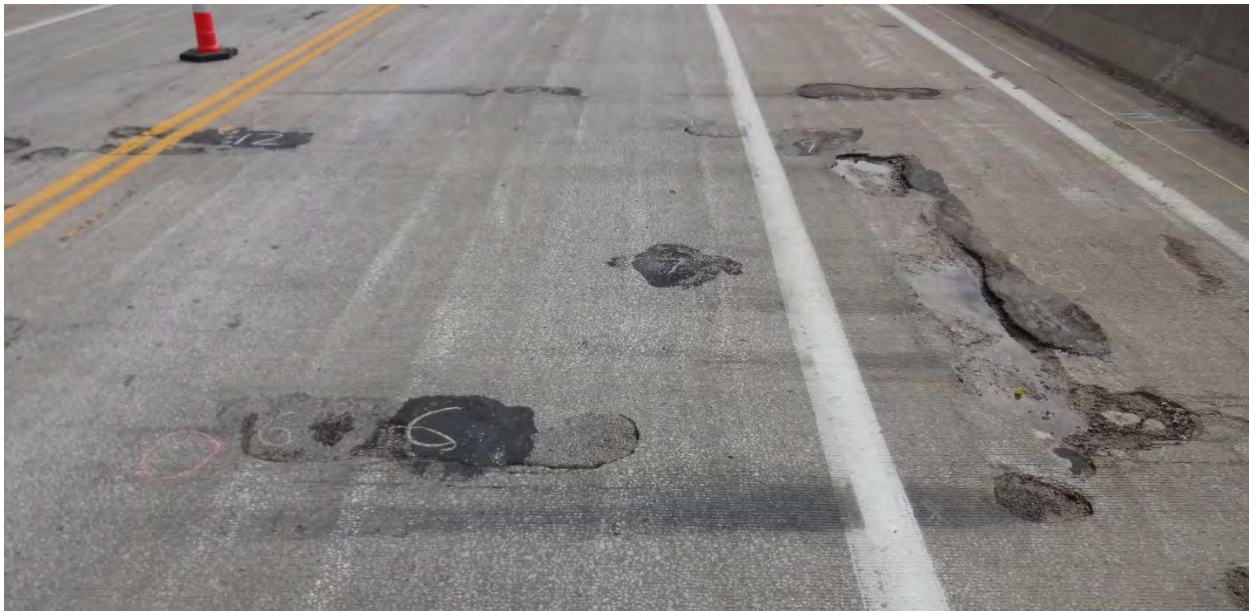
Figure 3-9 Bridge A3017 Typical Deck Deterioration Observed During Field Investigation

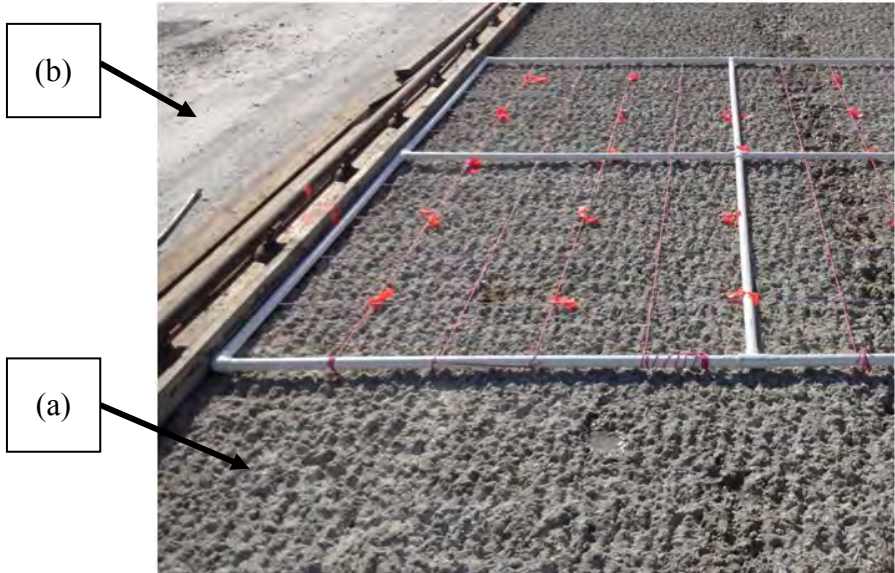
Figure 6-1 Rough Grooved Concrete Surface Caused by Milling (a) and Original As-Built Concrete Surface (b)

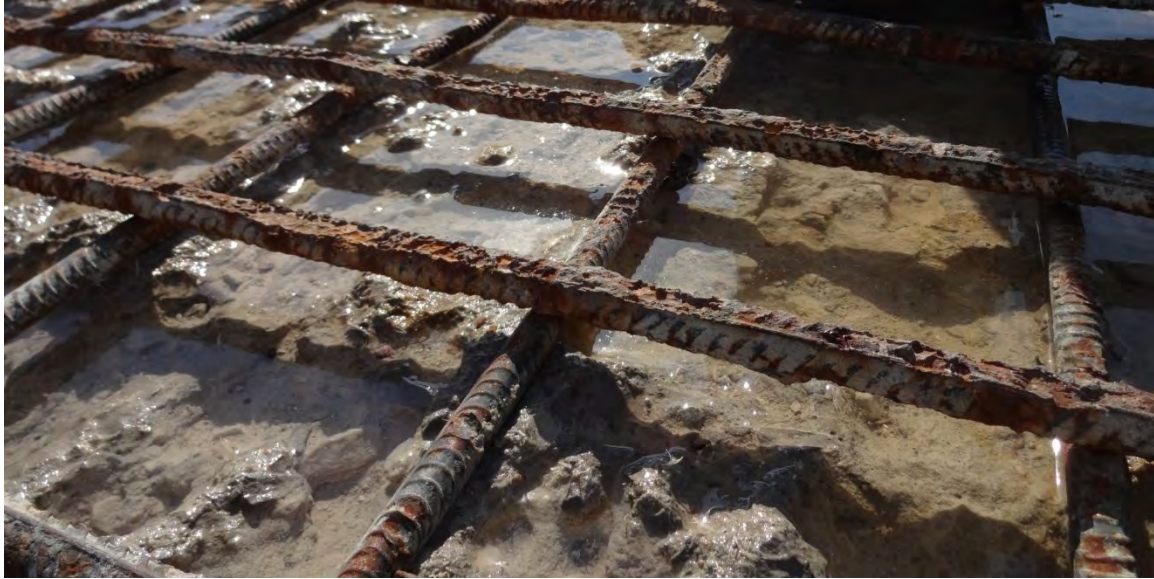
Figure 6-2 Corroded Rebar Exposed After Removal of Loose and Deteriorated Concrete by Hydro Demolition

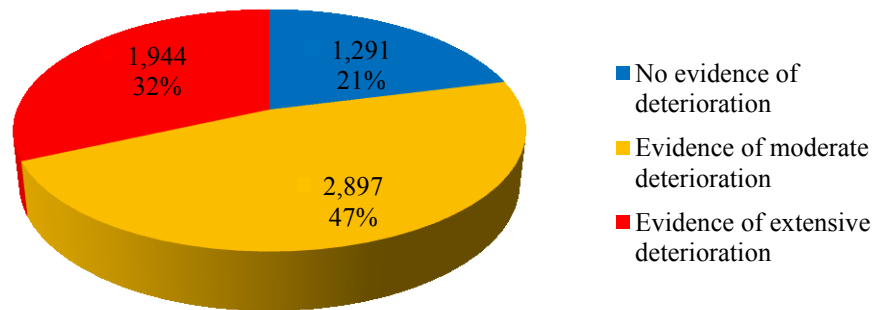
Figure 7-7 Graph Showing Predicted Distribution of Deterioration of the Bridge Deck for Bridge A0569 (investigated area) in Each Category (Based on Amplitude of the Reflection From the Top Layer of Rebar). Total Area Investigated - 6,132 ft²; No Evidence of Deterioration - 1,291 ft²; Evidence of Moderate Deterioration - 2,897 ft²; Evidence of Extensive Deterioration 1,944 ft².

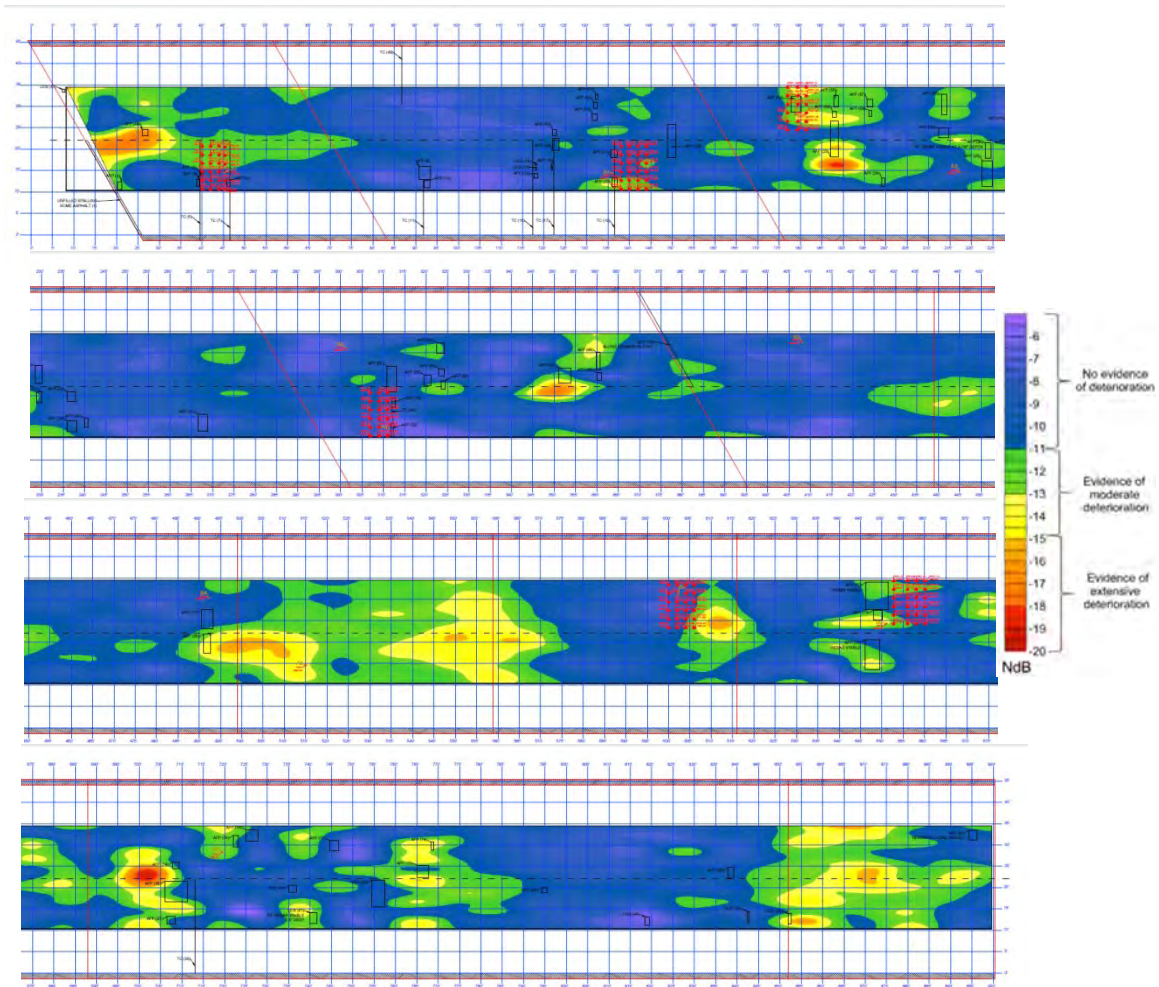
Figure 7-12 GPR Amplitude Map Based on Top Bar Reflection for Bridge Deck A1193 with Superposed Core Locations and Visual Surface Condition Features. Map Sections are Illustrated from Top to Bottom: 0-225 ft., 225-450 ft., 450-675 ft., 675-900 ft.

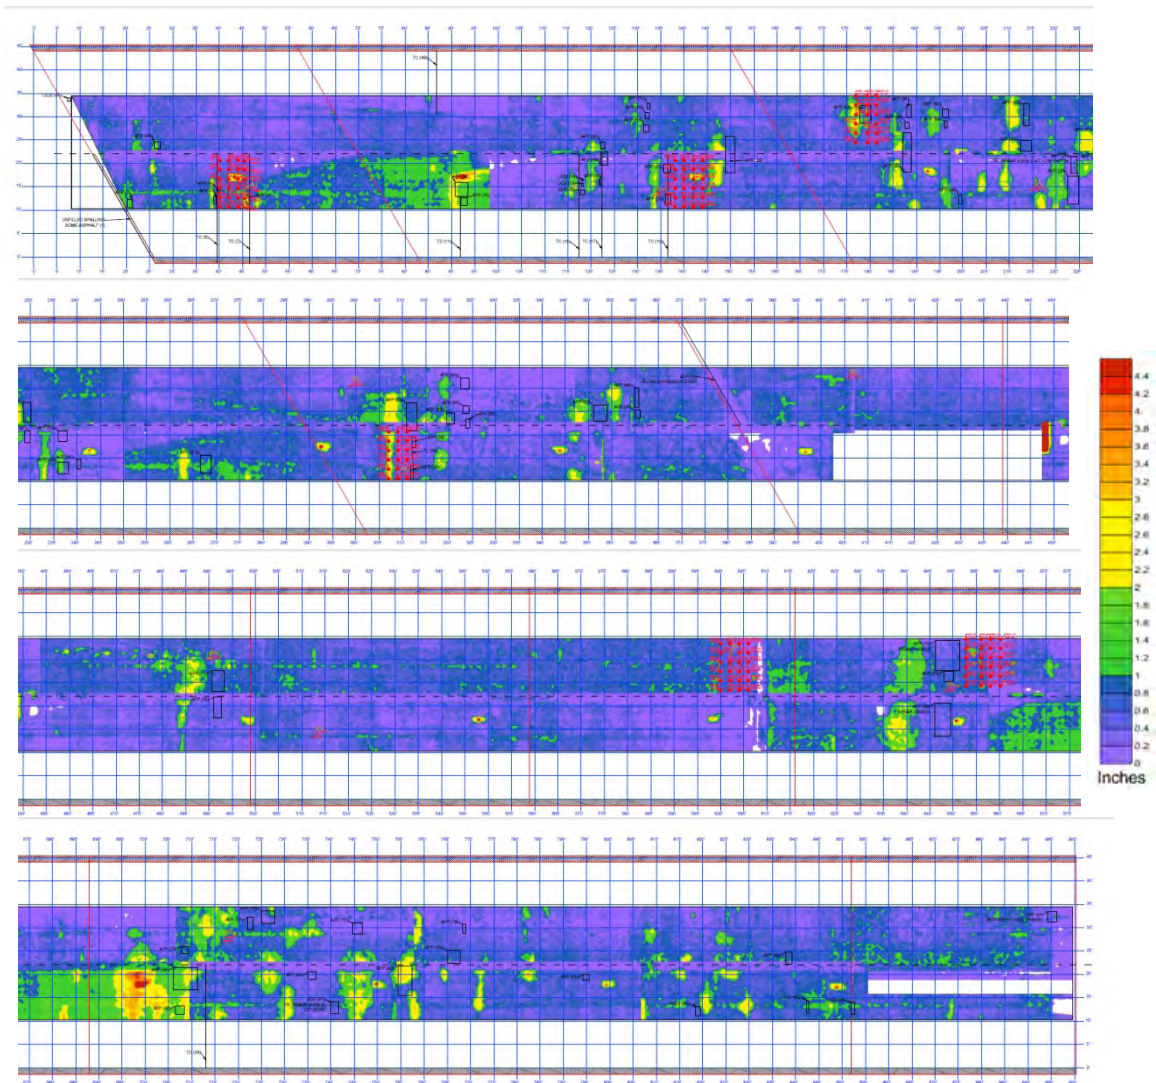
Figure 7-13 Lidar Map Showing Depth of Material Removed After the Hydro Demolition on Bridge Deck A1193. Depth Difference Between Lidar Scan Prior to Hydrodemolition and After Hydrodemolition is Shown in Inches. Map Sections are Illustrated from Top to Bottom: 0-225 ft., 225-450 ft., 450-675 ft., 675-900 ft.

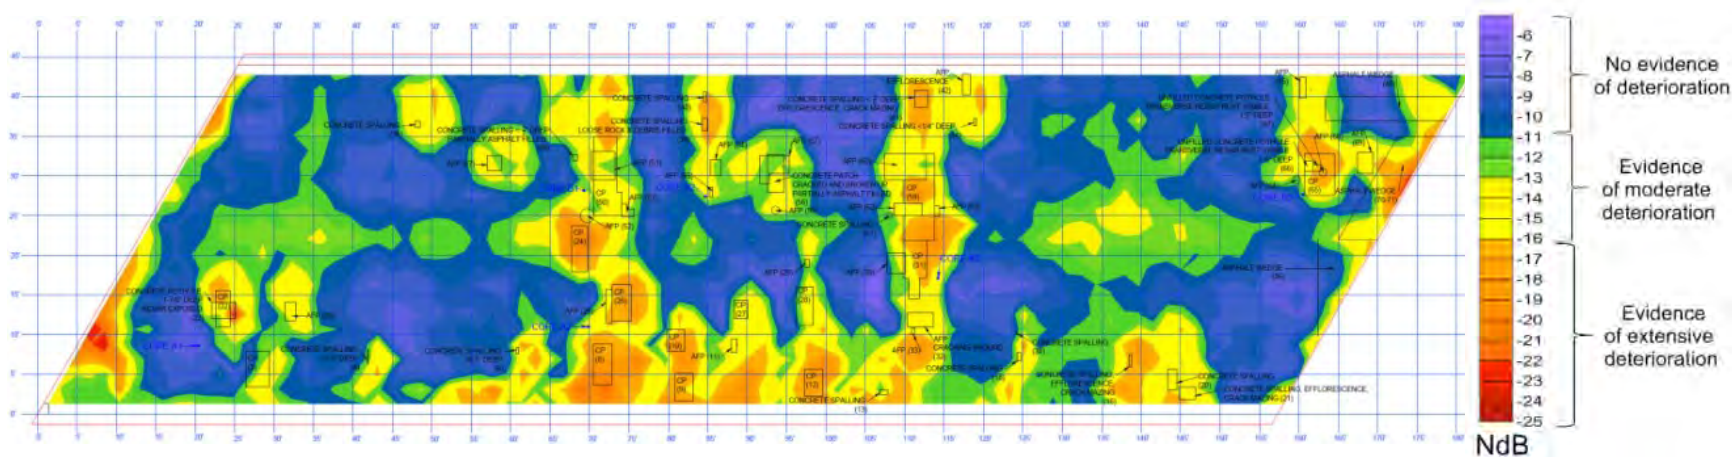
Figure 7-16 GPR Amplitude Map Based on Top Bar Reflection for Bridge Deck A1297 with Superposed Core Locations and Visual Surface Condition Features

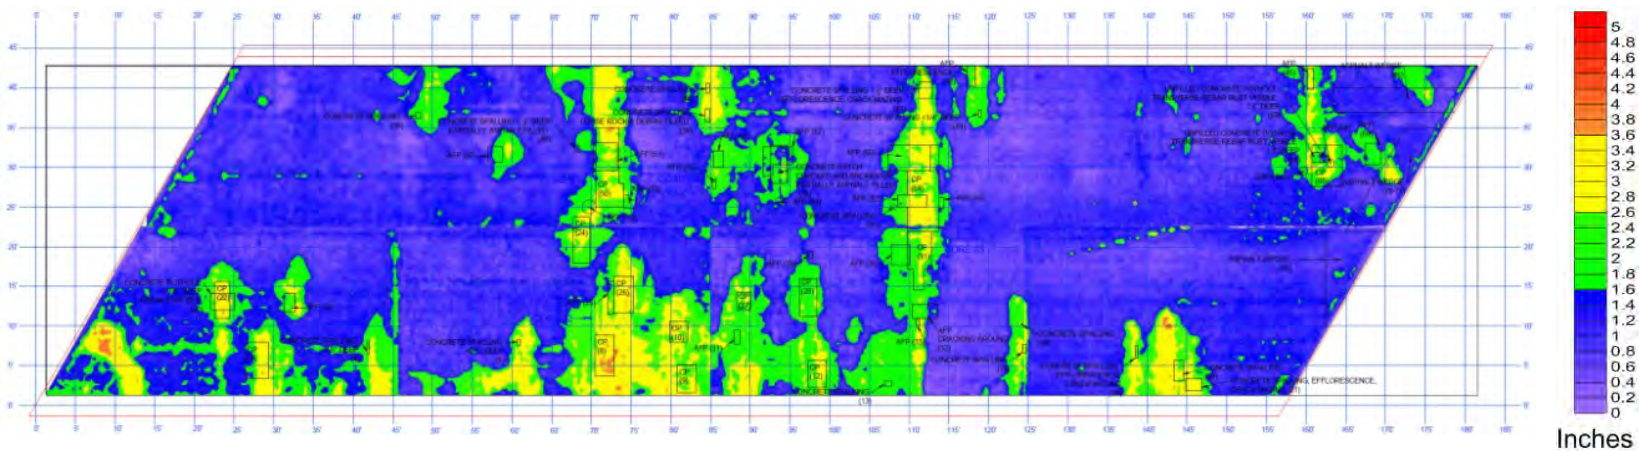
Figure 7-17 Lidar Map Showing Depth of Material Removed After the Hydro Demolition on Bridge Deck A1297. Depth Difference Between Lidar Scan Prior to Hydrodemolition and After Hydrodemolition is Shown in Inches.

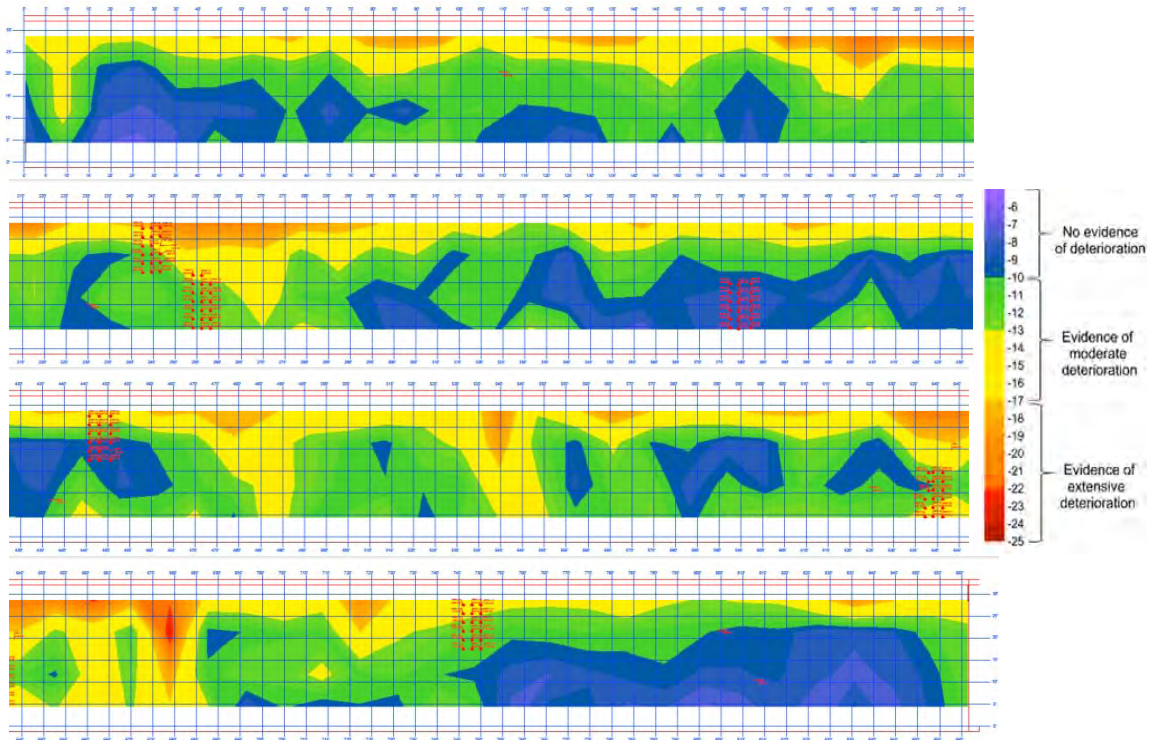
Figure 7-20 GPR Amplitude Map Based on Top Bar Reflection for Bridge Deck A1479 with Superposed Core Locations and Visual Surface Condition Features. Map Sections are Illustrated from Top to Bottom: 0-215 ft., 215-430 ft., 430-645 ft., 645-862 ft.

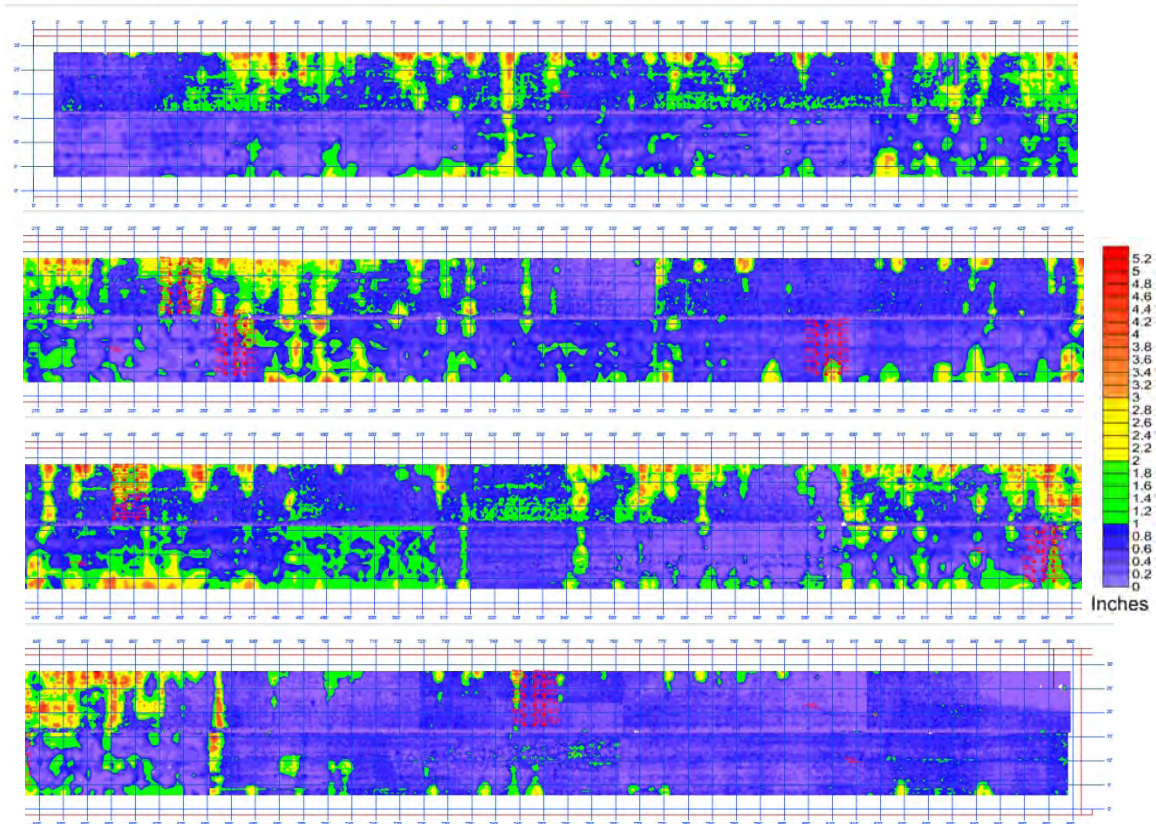
Figure 7-21 Lidar Map Showing Depth of Material Removed After the Hydro Demolition on Bridge Deck A1479. Depth Difference Between Lidar Scan Prior to Hydrodemolition and After Hydrodemolition is Shown in Inches. Map Sections are Illustrated from Top to Bottom: 0-215 ft., 215-430 ft., 430-645 ft., 645-862 ft.

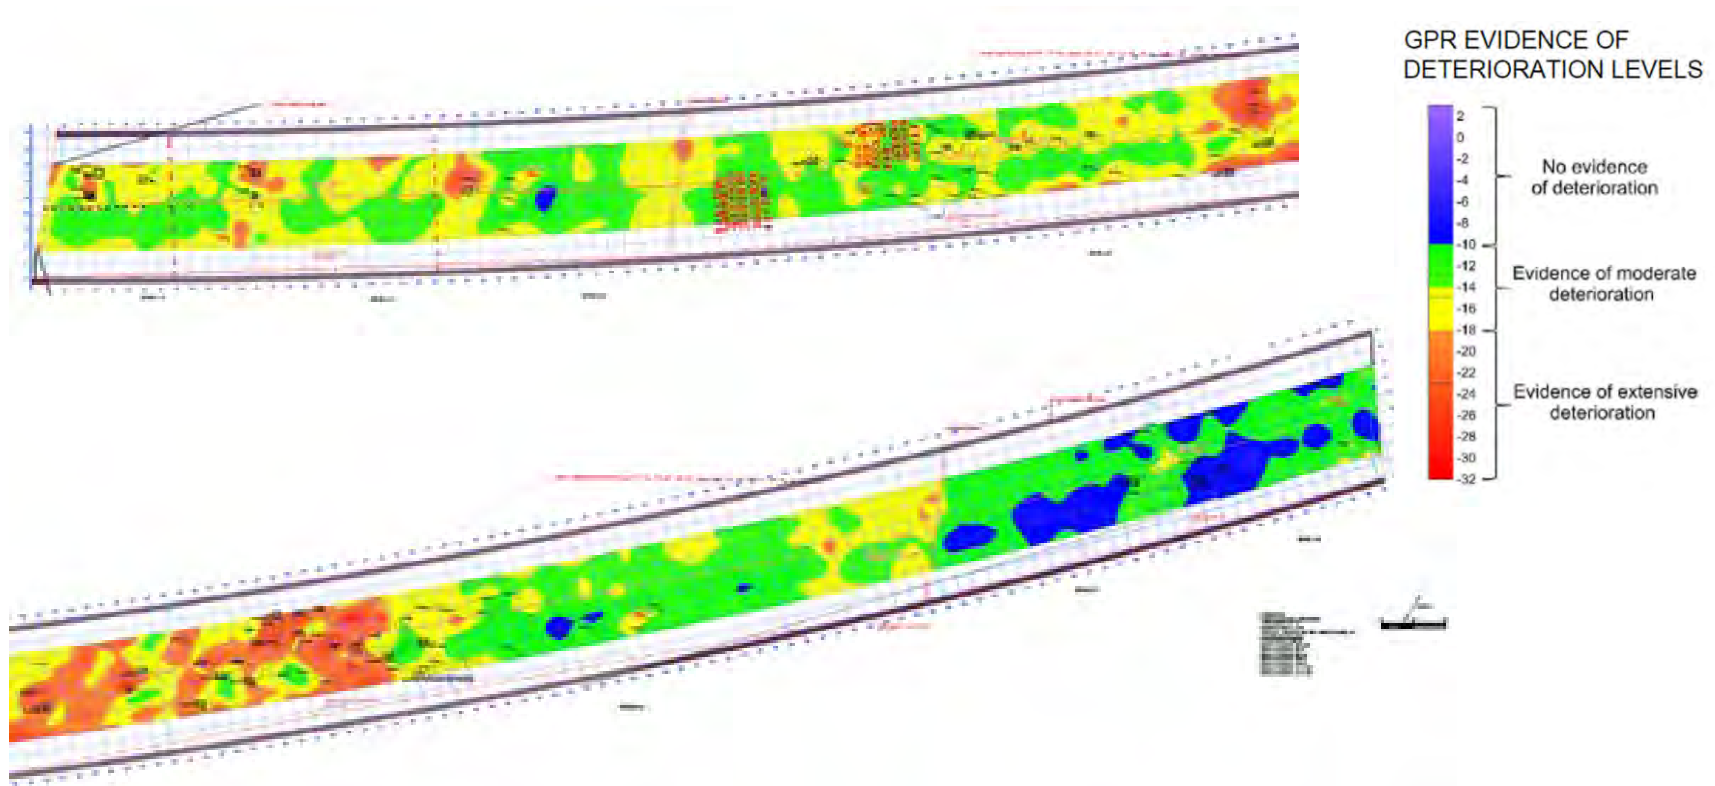
Figure 7-28 GPR Amplitude Map Based on Top Bar Reflection for Bridge Deck A3017 with Superposed Core Locations and Visual Surface Condition Features
