**CRASHWORTHINESS TESTING OF A PORTABLE
MAINTENANCE WORK-ZONE BARRIER**

TECHNICAL REPORT STANDARD TITLE PAGE

1. REPORT NO. FHWA/CA08-0277	2. GOVERNMENT ACCESSION NO.	3. RECIPIENTS CATALOG NO.	
4. TITLE AND SUBTITLE CRASHWORTHINESS TESTING OF A PORTABLE MAINTENANCE WORK-ZONE BARRIER		5. REPORT DATE December 2008

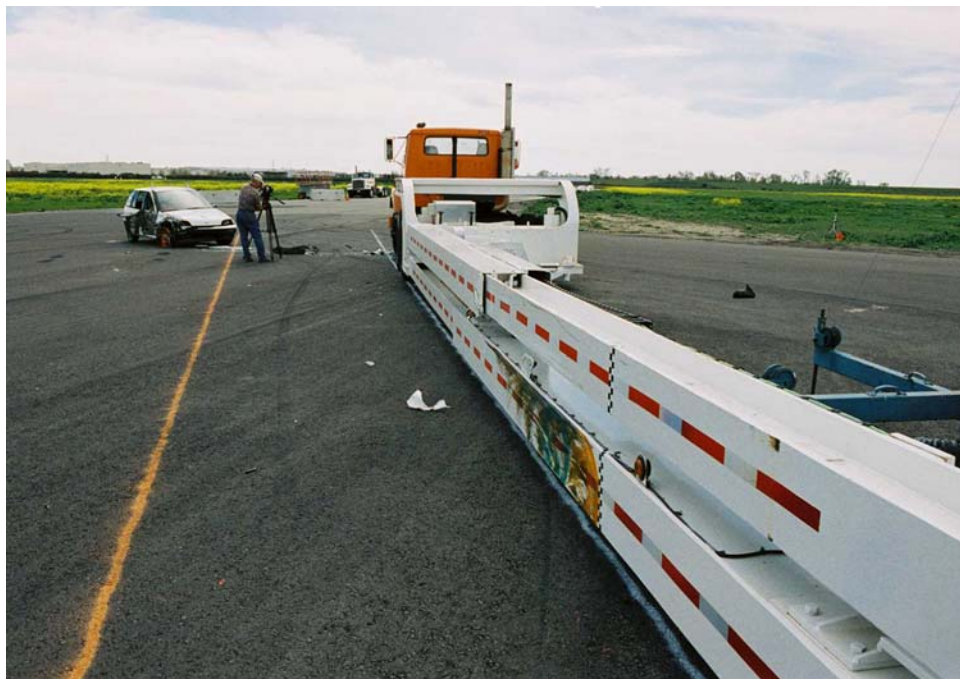
Figure 2-13 Impact Area After Test 641

The barrier suffered minor scrapes and scratches from the impact with the vehicle. Sheet metal from the vehicle was lodged in-between the overlapping in the beams. During the impact with the vehicle, the barrier deflected dynamically by 100 mm (3.94 in) and had a final static deflection of 23-mm (0.91-in). The PMWB did not move from its initial location. The tractor truck had minor damage to the left side. The front bumper was push forward away from the truck slightly.

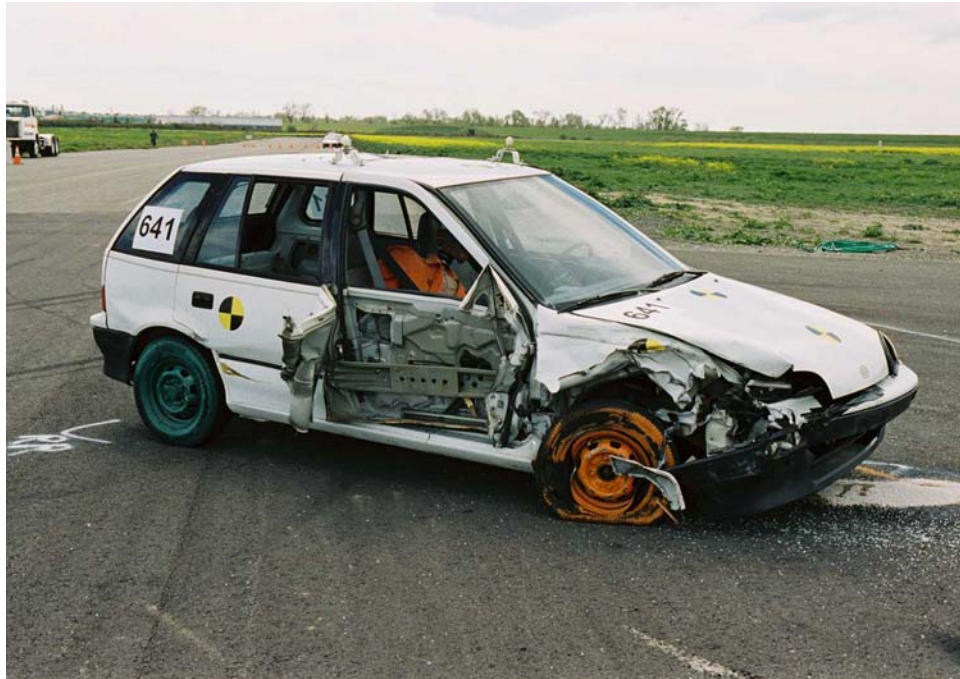
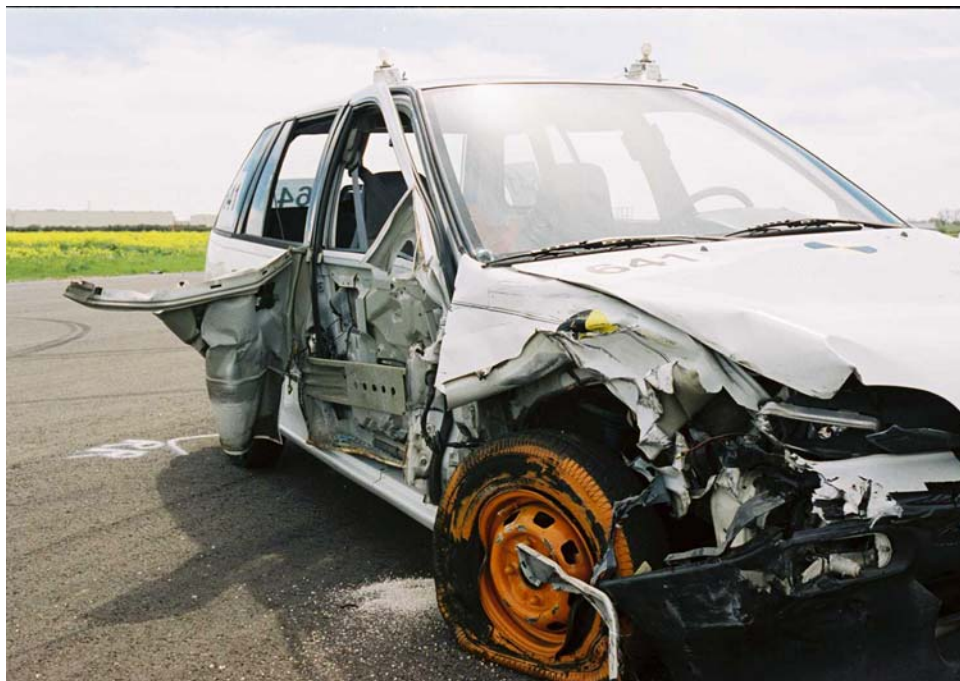
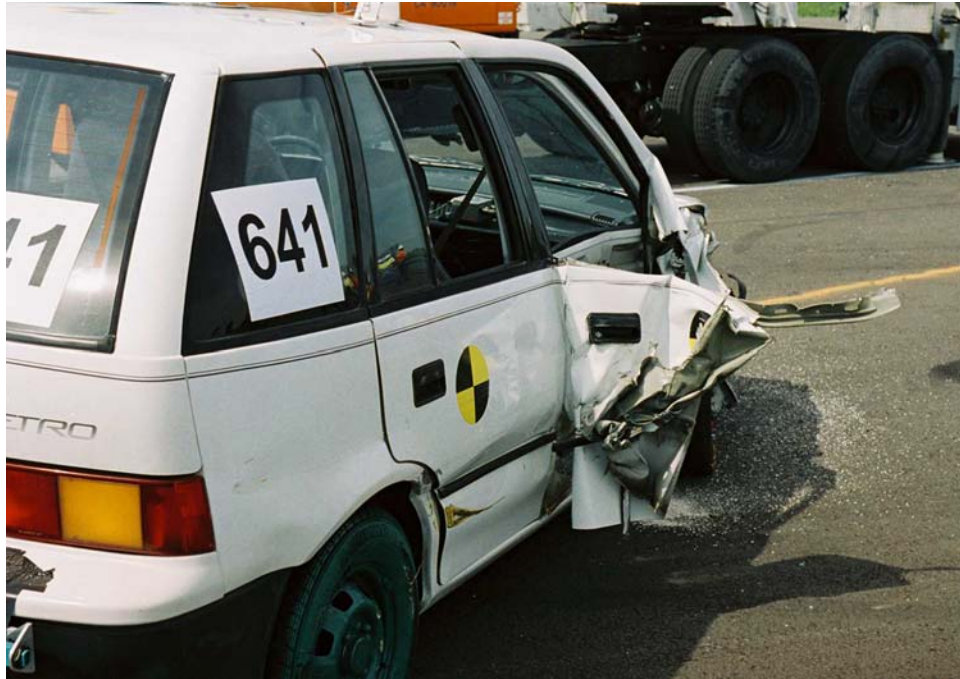
The right front corner of the vehicle sustained minor damage from the initial impact with the barrier. The amount of damage increased as the vehicle impacted the point where the box beams overlap each other. The sheet metal over the right front tire was crumpled inward and the tire deflated. The sheet metal over the passenger door was completely pulled away and the internal portion of the door was pushed inward. The final impact with the bumper on the tractor truck pushed the right front bumper of the test vehicle backward. The right front tire was also pushed back in the wheel well. Inspection of the occupant compartment revealed that there had been little to no deformation to the floorboard and firewall.

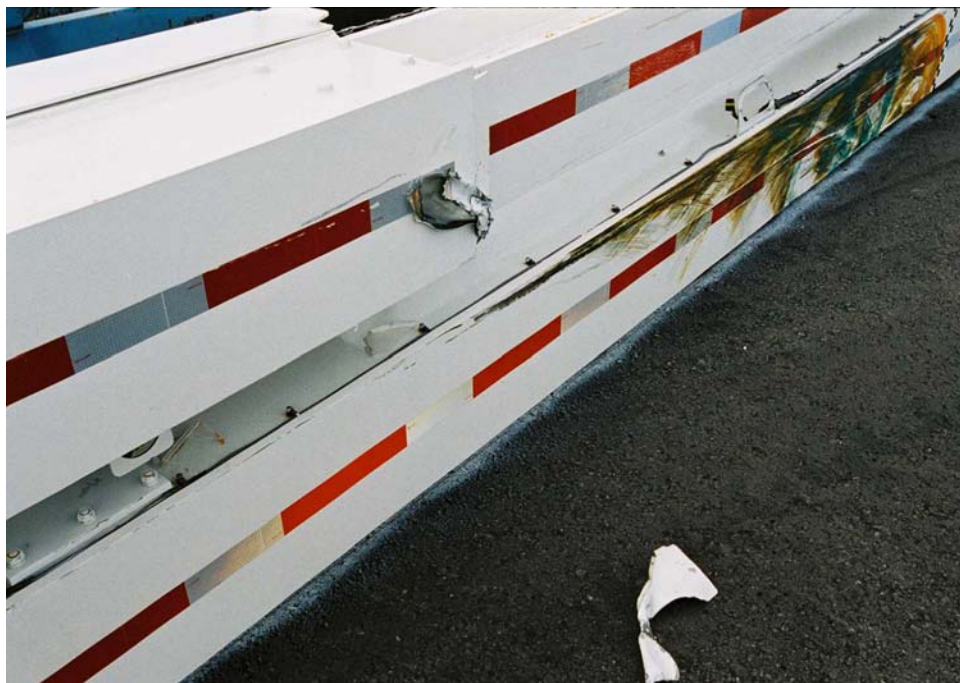
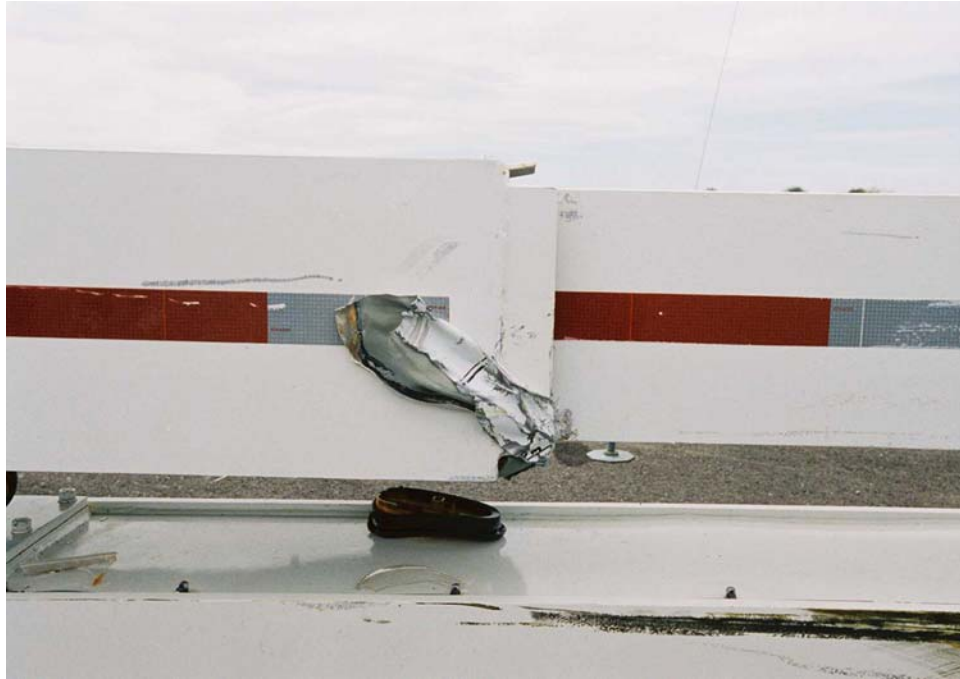
The barrier had minor scratches from the impact. A piece of the Metro's sheet metal was lodged in the area where the box beams overlap. The tractor truck had minor damage to the front end due to a secondary impact with the vehicle.

Each of the two tests conducted involved significant sheet metal damage. This was expected considering the reversed lap connection in the barrier elements for the top beam. The snagging of the sheet metal can probably be lessened if each of the beam elements were made to lap in the appropriate direction. However, this change would make a reverse hit even more damaging to the impacting vehicle.

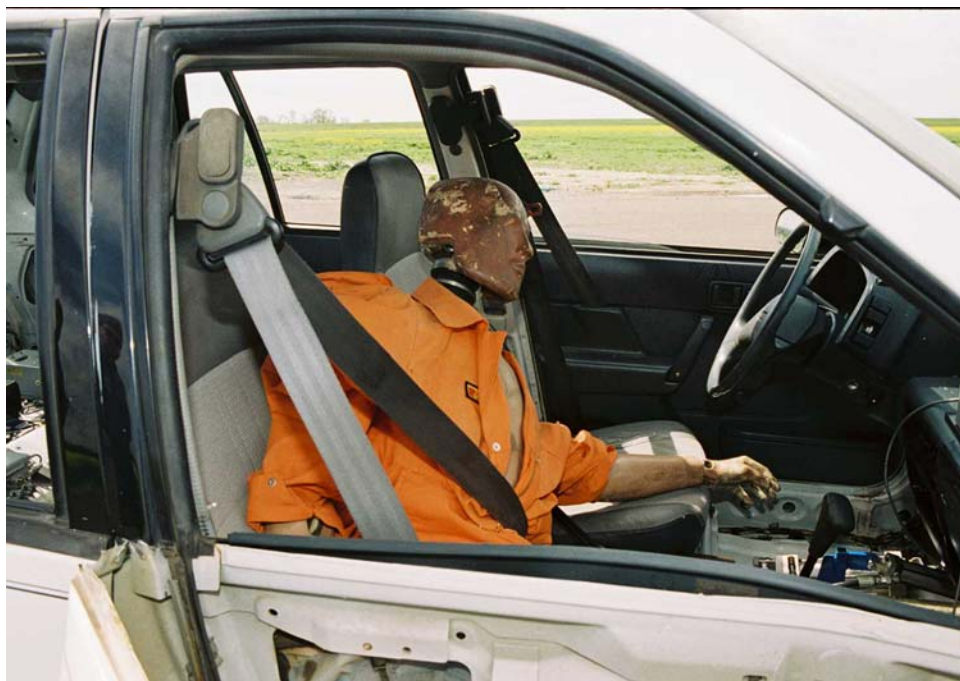
The test dummy was strapped into the right front seat with both a lap and shoulder belt. The dummy's head never moved out of the passenger's side window. There was no contact between the dummy and the face of the barrier. The dummy remained upright and secure during the test. The final resting position of the dummy was leaning slightly to the left, but was still belted into the passenger's seat.

Figure 2-19 Final Resting Place of Test Dummy

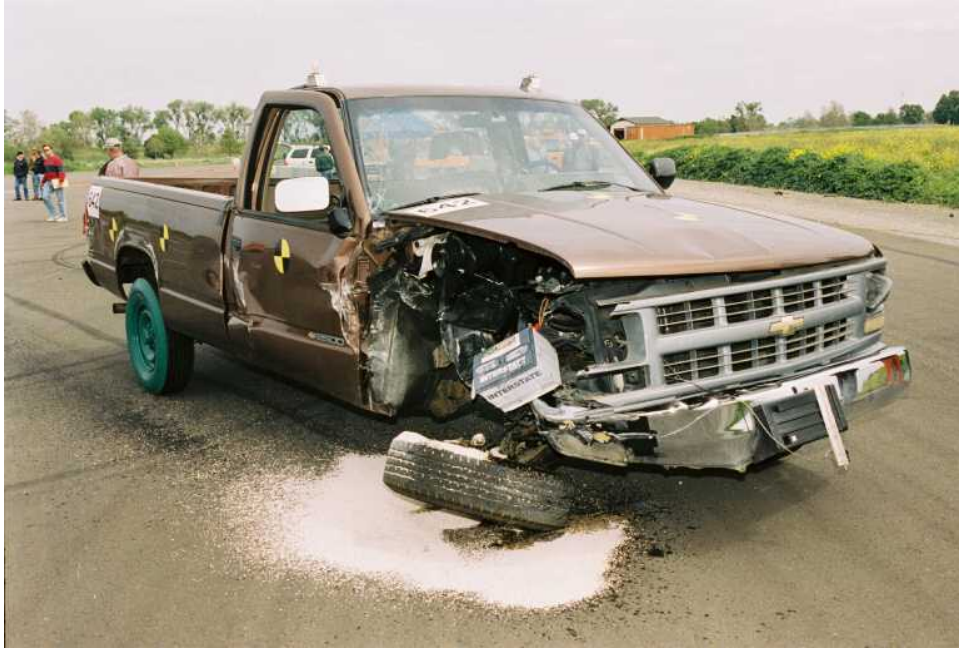
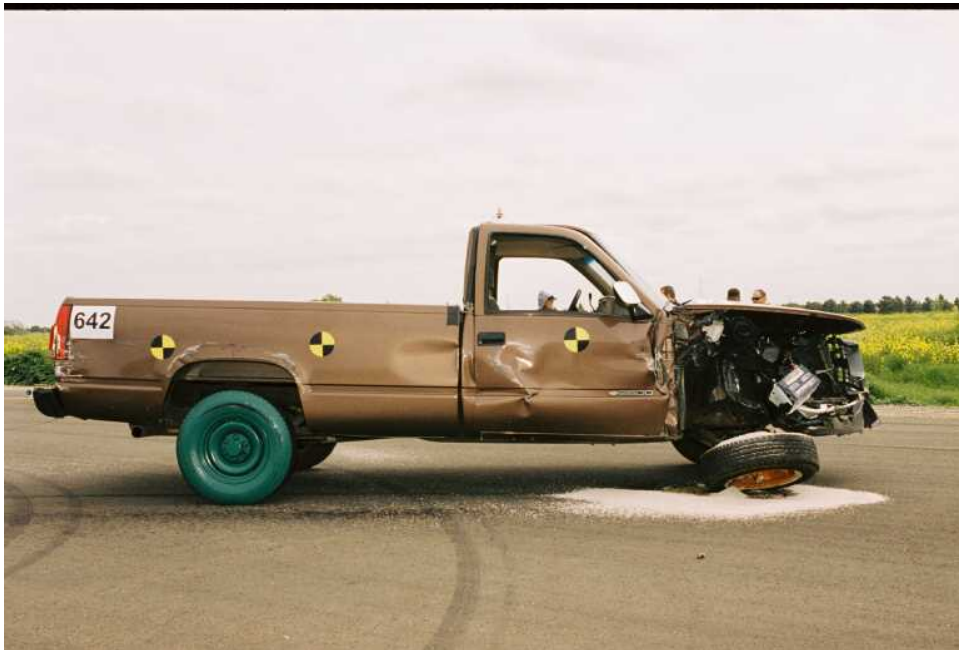
The right front corner of the vehicle sustained significant damage due to the impact with the box beam overlap. Only the lower control arm was still attached to the front wheel hub assembly. All of the sheet metal that covered the right corner of the vehicle was torn away. The battery was exposed and only supported by its wiring. The right half of the front bumper was folded backward. The top of the passenger door was bent outward and the steel metal was crumpled inward.

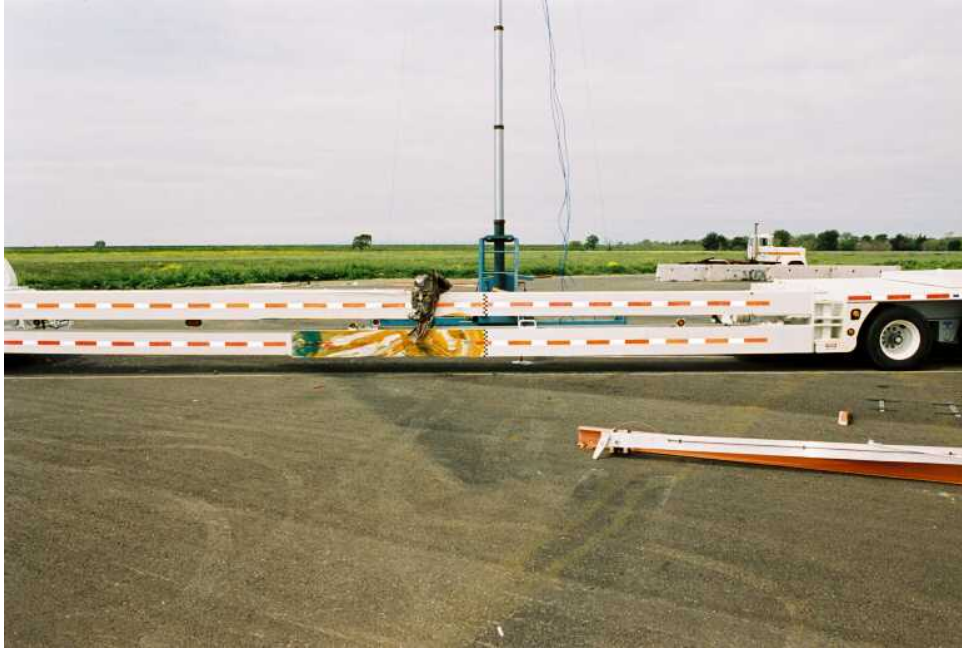
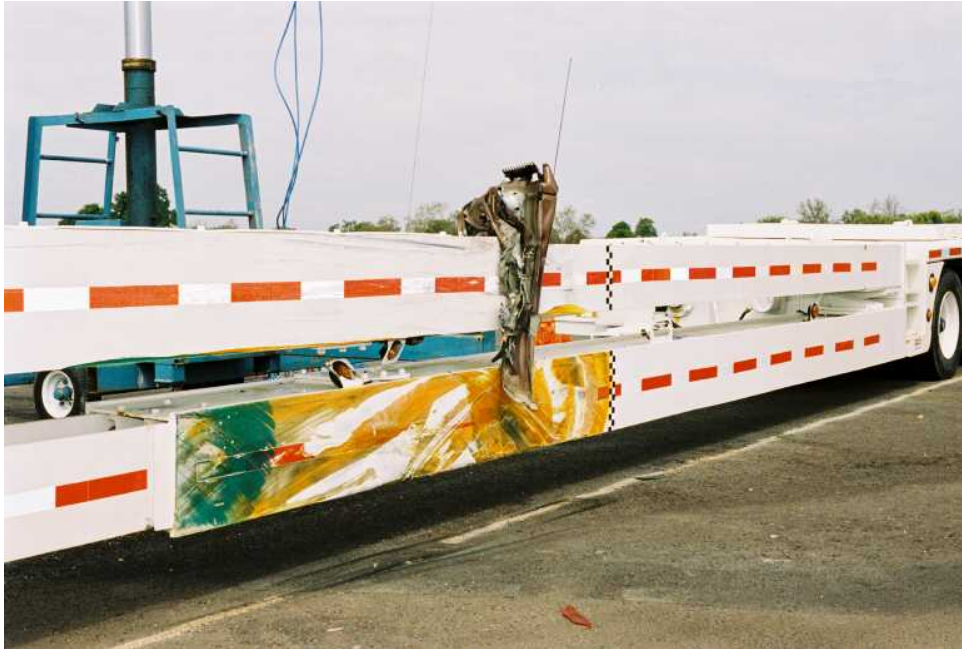
The barrier appears to have suffered only minor damage and scraping. There was a large amount of the test vehicle's sheet metal lodged into the overlapping joint of the barrier's box beams.

During the impact with the vehicle, the barrier had a lateral dynamical deflection of 200 mm (7.87 in) and had a final static deflection of 142 mm (5.59 in). Both the tractor truck and trailer were pushed away from the impact area (to the right/passenger side of the tractor truck and trailer). Figure 2-21 shows the amount of displacement of the tractor truck tires, trailer tires, and trailer brace.

The barrier suffered minor scratches caused by the vehicle. The tractor-trailer was pushed backwards slightly. A large section of sheet metal from the vehicle was wedged in-between the overlap in the box beams.

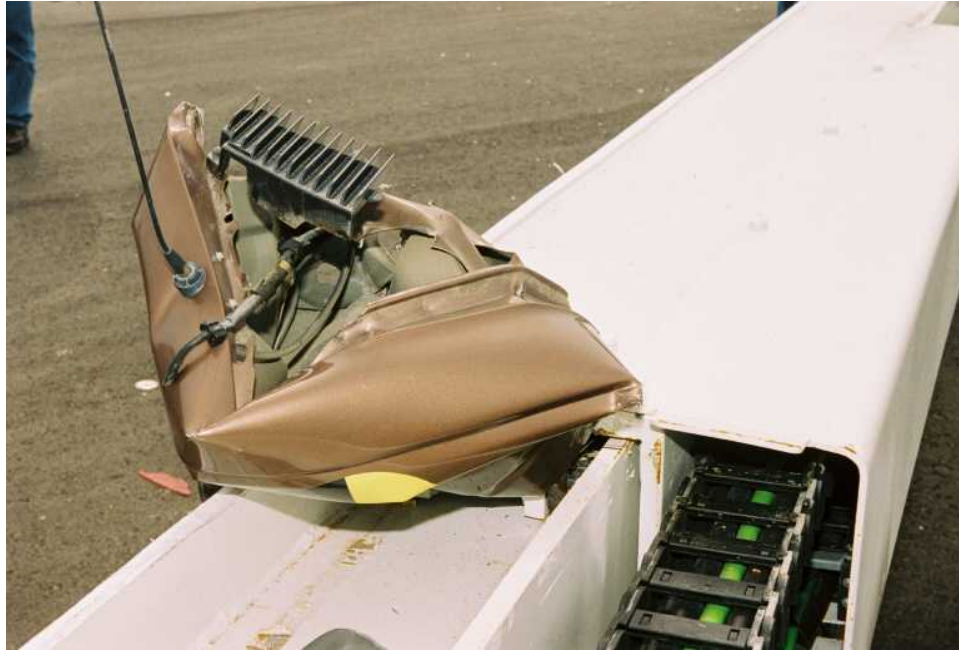
Figure 2-31 Close-up of the Vehicle's Sheet Metal in Test 642

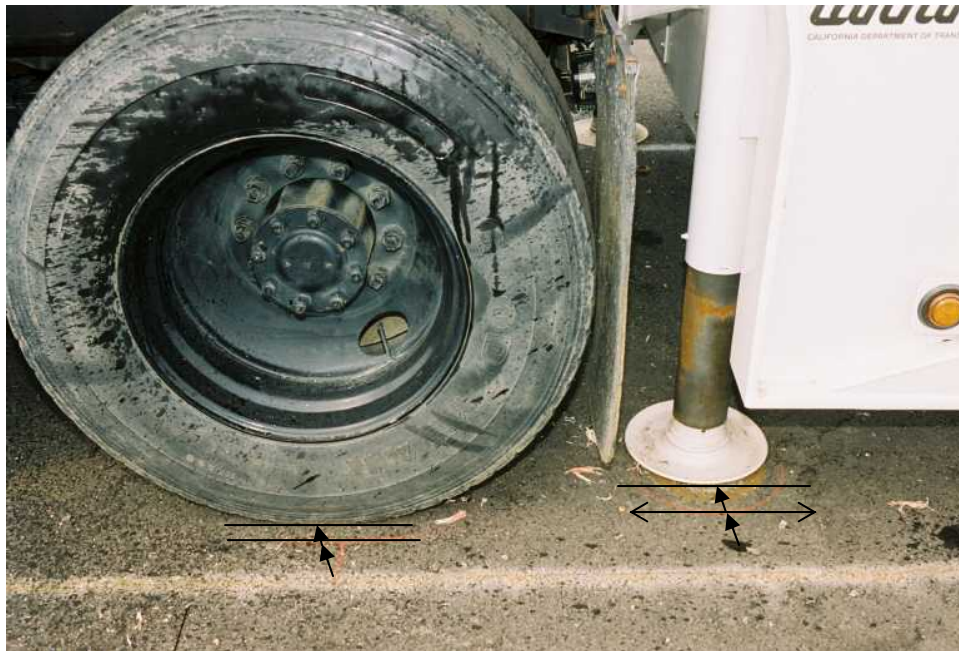
Figure 2-32 Trailer Tire and Brace Displacement in Test 642
