Assessment and Evaluation of Timber Piles Used in Nebraska for Retrofit and Rating

Sponsored By
Nebraska Department of Roads

April, 2014

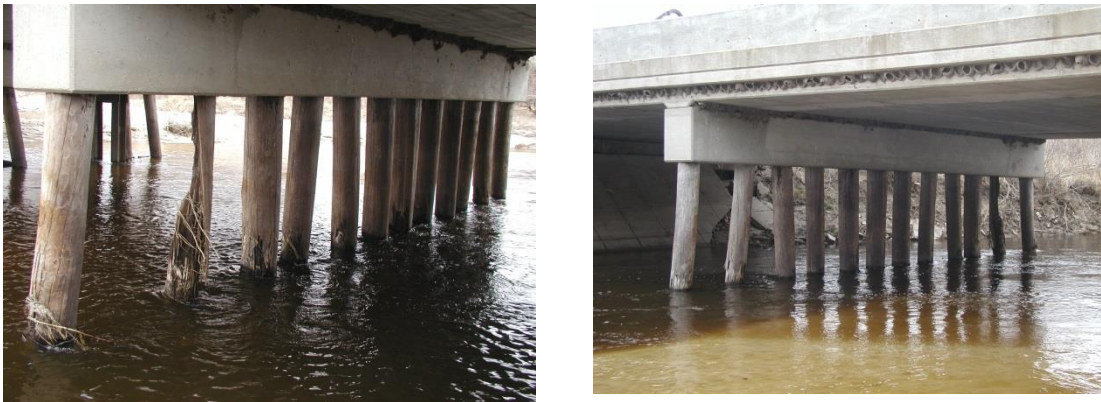
Many timber piles used in the substructure of bridges throughout Nebraska have different types and extent of damage. The damaged area is typically located immediately beneath ground level or in the splash zone, which is defined as a boundary between the top surface of the water and the air. Below the water level there is water, but not enough oxygen. Above water level, there is oxygen, but not enough water. In the splash zone, partly due to changes in water levels, the sub-structure elements are subject to both water and oxygen, the two elements needed to cause deterioration. Figure 1.1 show some typical damages observed in Timber piles in Nebraska.

Figure 1.1: Examples of observed damages in Timber Piles in Nebraska

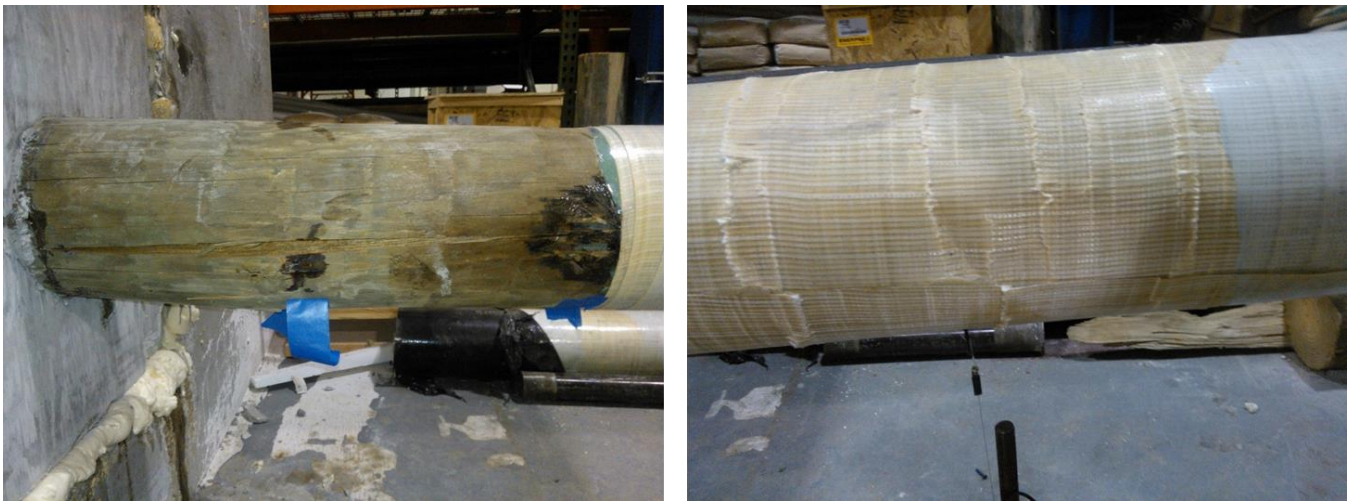
Specimen 1, with one inch deep damage filled by resin, showed the highest ultimate load capacity among the five specimens tested as part of this study. The specimen failed at approximately 177 kips axial load with rapid cracking. Major damage was observed at two locations after the failure of the specimen. Damage was observed near the fixed end where the pile had a big longitudinal crack splitting the pile into two halves. Damage was also observed at the repair location resulting in ripping and delamination of FRP jacket. Note these damages occurred at failure and were not progressive in nature.

Figure 5.7: Failure of specimen 1 (1 inch deep damage filled with resin)

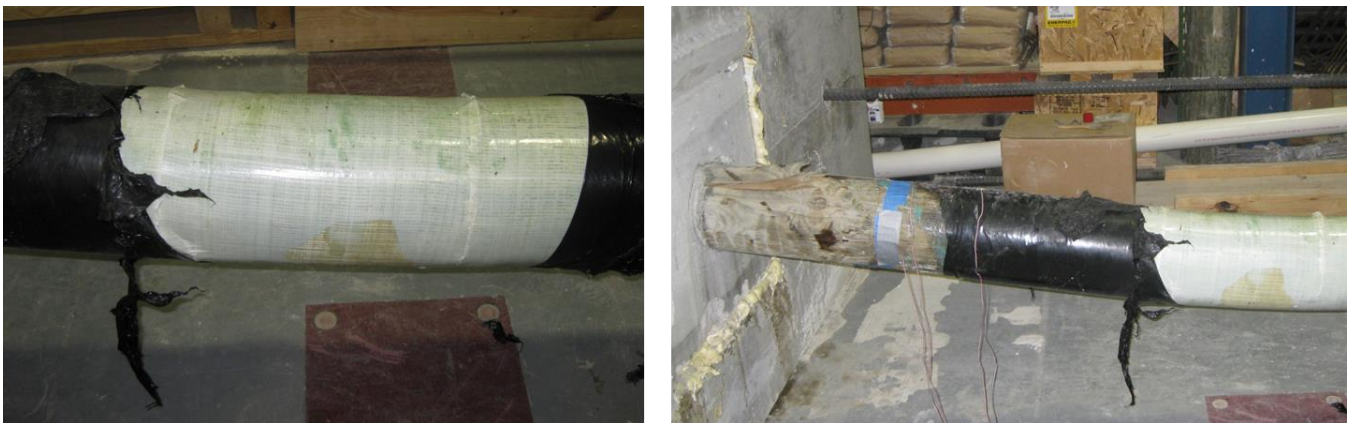
Specimen 2, with 1.5 inch deep damage filled with resin, showed the lowest ultimate load capacity (95 kips) among the five specimens tested as part of this study. This specimen failed mainly due to large gradual deflection at the repair location. FRP jacket was damaged at the two ends of the 14 inch long damaged region. The test was continued even after the large downward deflection of the repaired region that resulted in cracking of the fixed end of the pile.

Figure 5.8: Failure of specimen 2 (1.5 inch deep damage filled with resin)

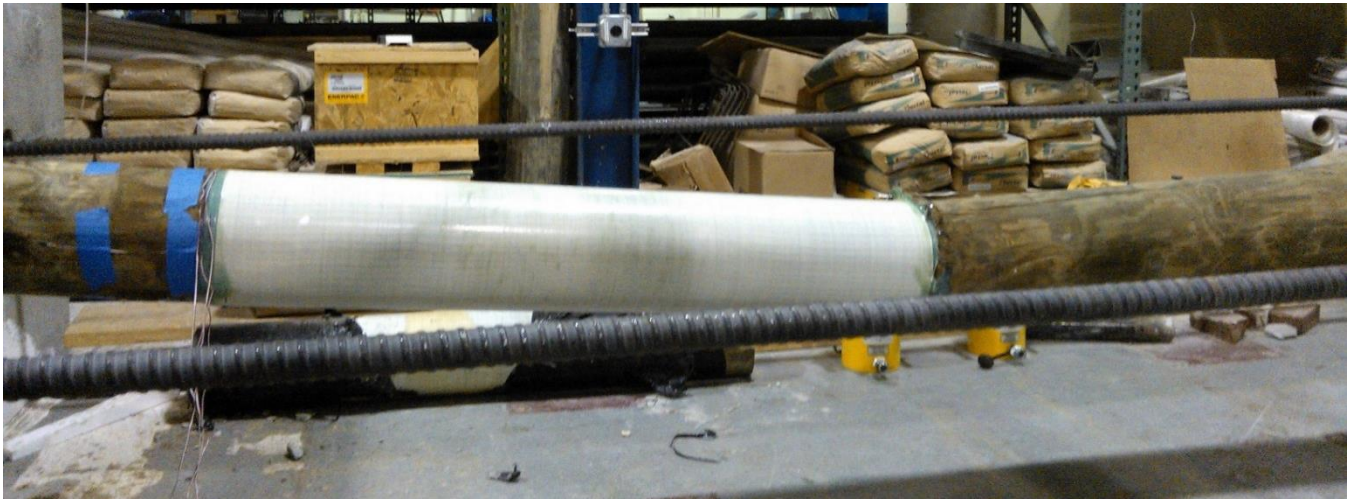
failed specimen indicated bending type failure resulting in crumpling top fibers and splintering bottom fibers. No damage of FRP wrap was observed during this test.

Figure 5.9: Failure of specimen 3 (2 inch deep damage filled with grout)

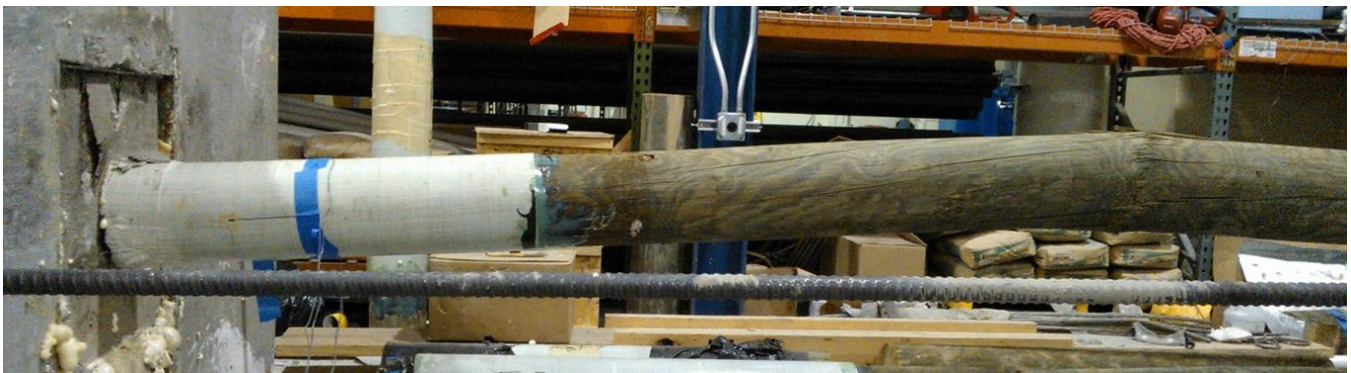
Specimen 4 also had 2 inch deep damage filled with grout similar to specimen 3 however; the location of damaged region was different from specimen 3. In specimen 4, the damaged region was placed at the most critical location (fixed end) in an attempt to fail the specimen in damaged region. The failure of this specimen however appeared away from the damaged region during the test. The specimen took approximately 170 kip maximum axial load before failure.

Figure 5.10: Failure of specimen 4 (2 inch deep damage filled with grout)

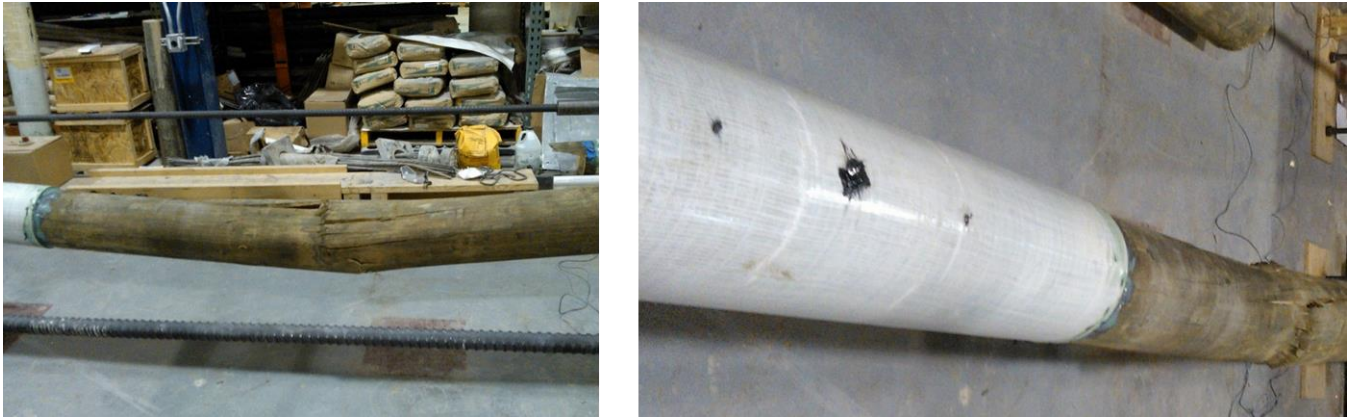
Specimen 5, with two inch deep damage filled with resin gravel, failed at approximately 115 kips axial load. The failure took place away from the repaired section. Insignificant damage was observed in the FRP jacket on the repaired section.

Figure 5.11: Failure of specimen 5 (2 inch deep damage filled with resin + gravel)

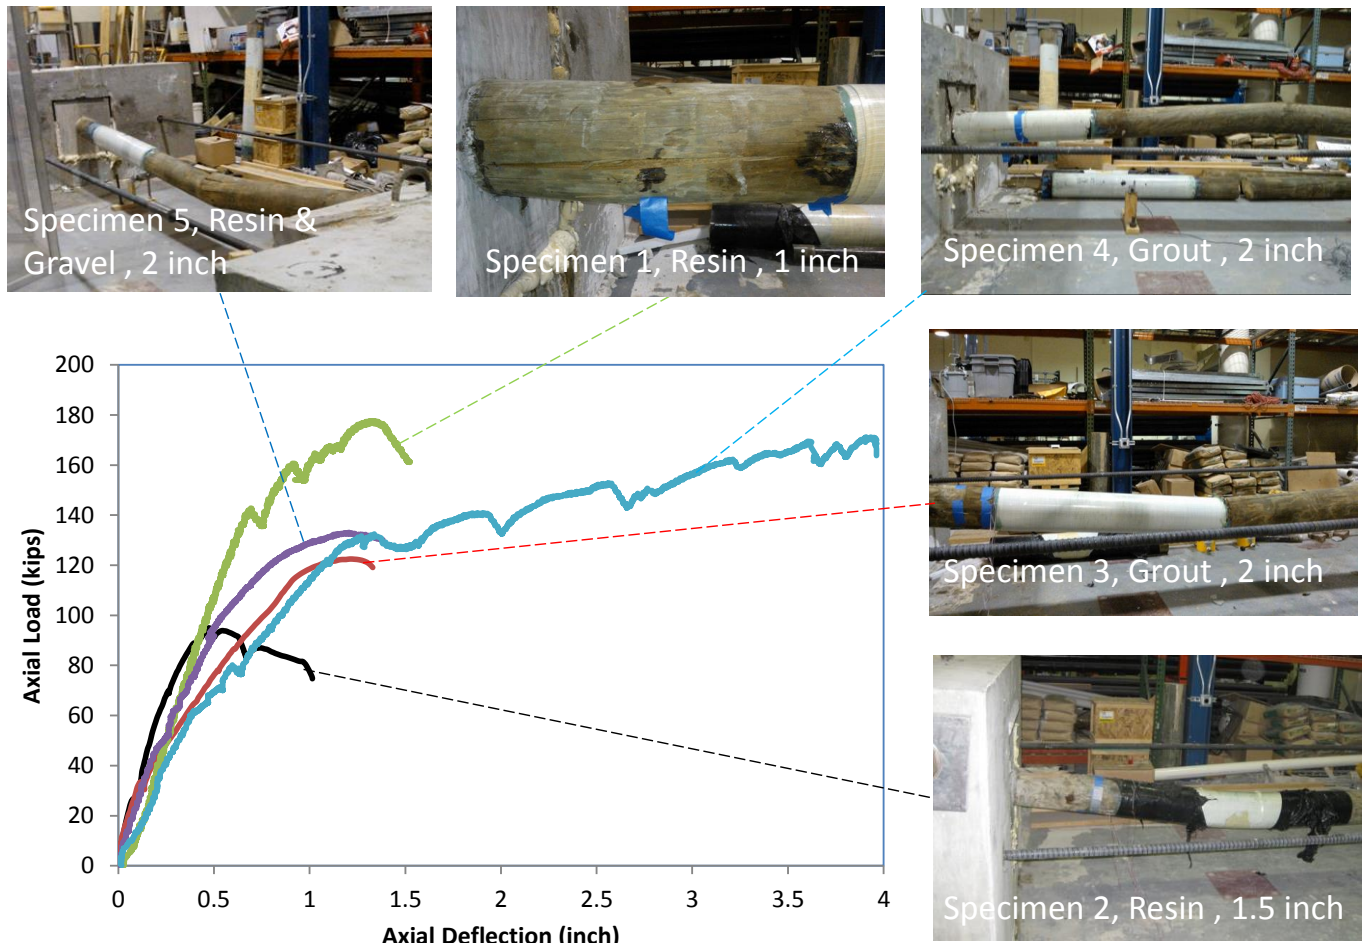
load drops can be observed in load deflection curve of specimen 1 at approximately 140 kips and 160 kips load. These load drops correspond to cracking of the wood during the test. Whenever wood cracking sound was heard, the load was put to hold to allow the failure to take place by progressive wood cracking. However, if the cracking sound stops and failure did not take place, the load was increased again until the next cracking sound or complete failure of the test specimen.

Figure 5.12: Load deflection curve and failure mode of specimens
