## **SAFETY PERFORMANCE EVALUATION OF THE NON-BLOCKED MIDWEST GUARDRAIL SYSTEM (MGS)**

### **MIDWEST ROADSIDE SAFETY FACILITY**

MwRSF Research Report No. TRP-03-262-12

January 24, 2013

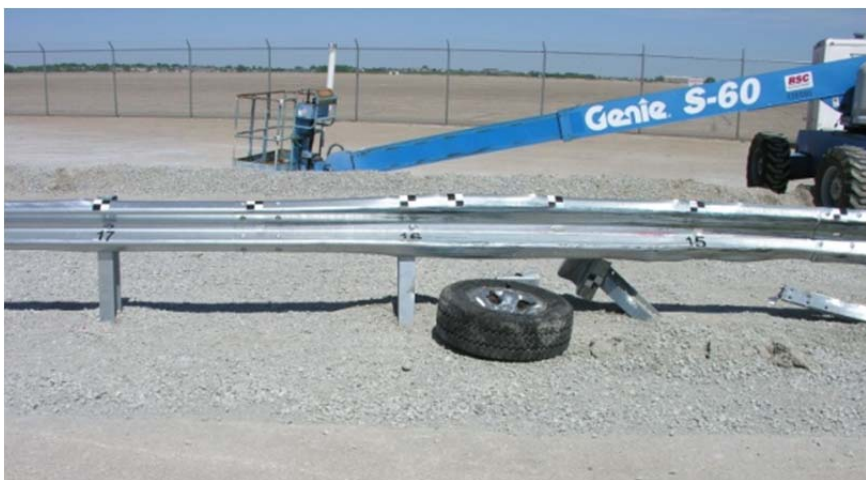
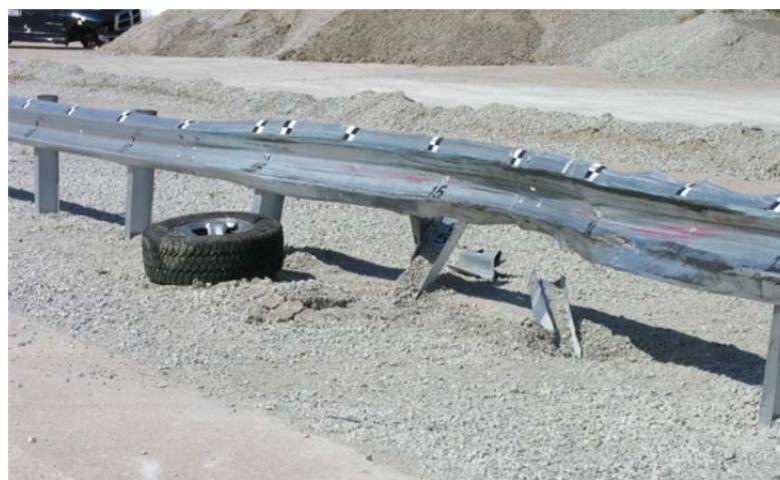
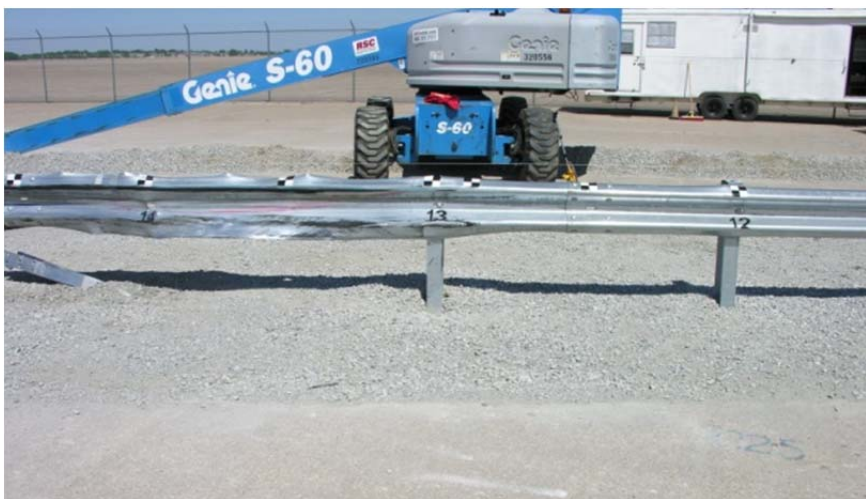
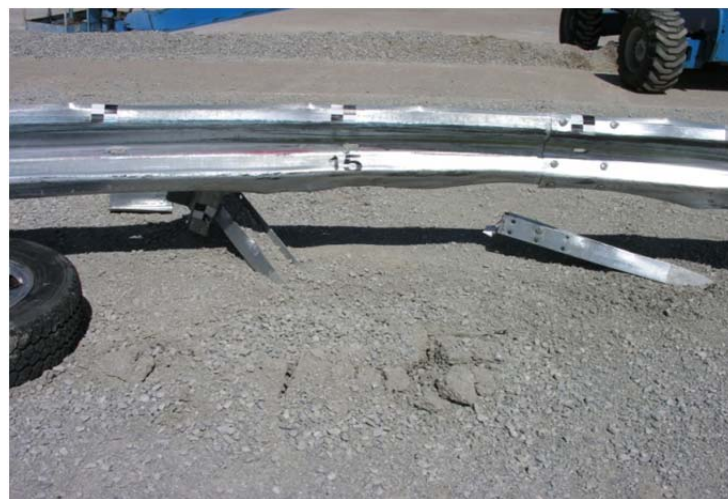
Figure 40. Guardrail Damage between Post Nos. 13 and 17, Test No. MGSNB-1

The W-beam backup plate at post no. 14 disengaged and the top corrugation was deformed. The bottom corrugation of the W-beam backup plate at post no. 15 was buckled. A 1 $\frac{1}{4}$ -in. (32-mm) gap between the top of the backup plate and the rail section was formed at post no. 16. A  $\frac{1}{2}$ -in (13-mm) gap between the backup plate and the top of the rail section was found at post no. 17.

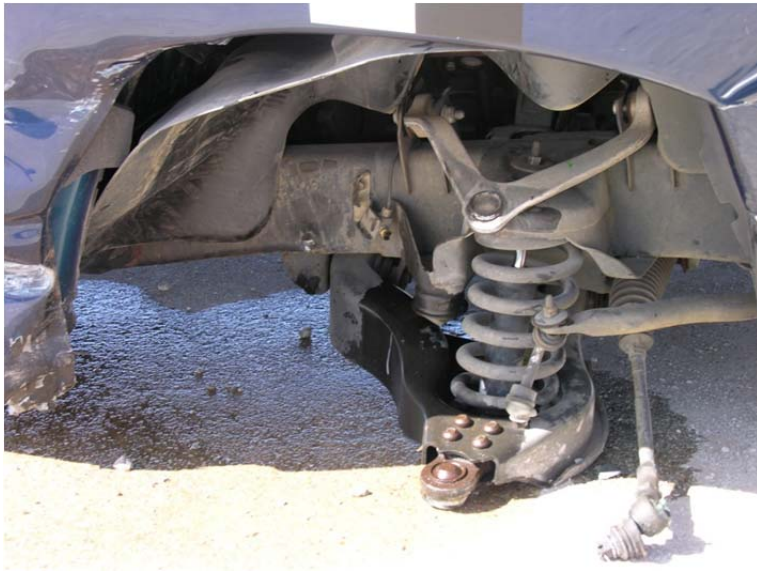
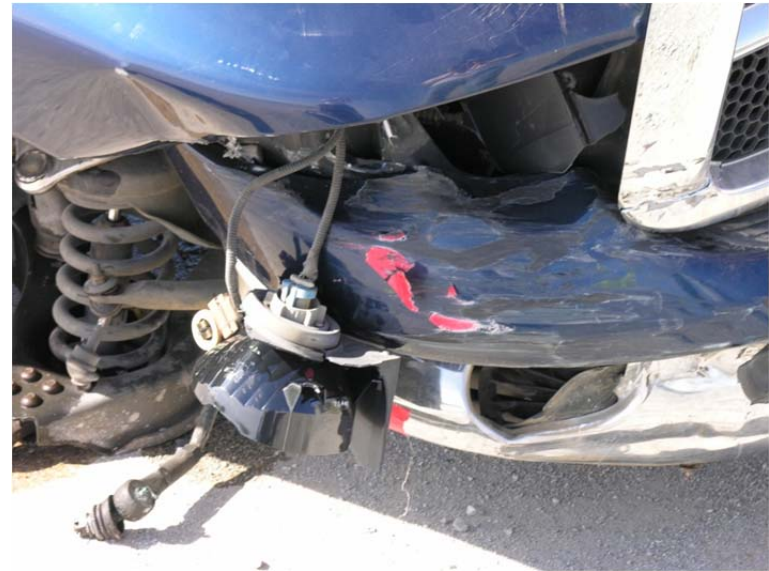
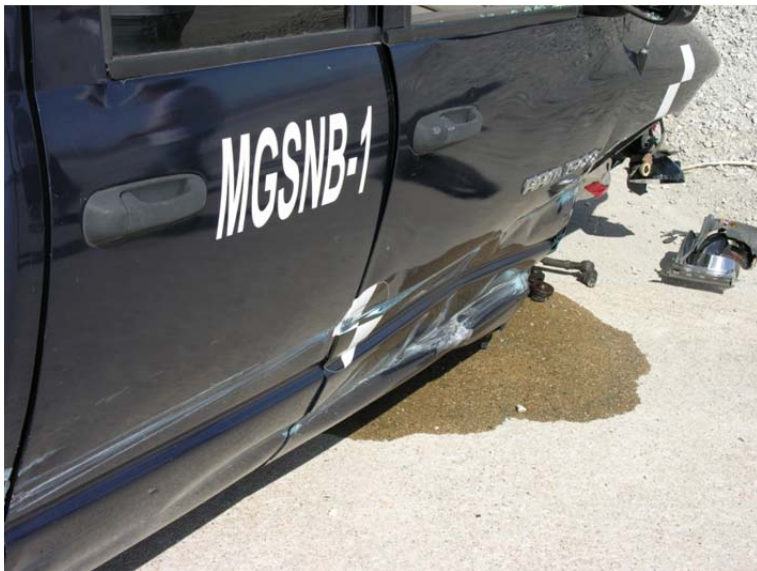
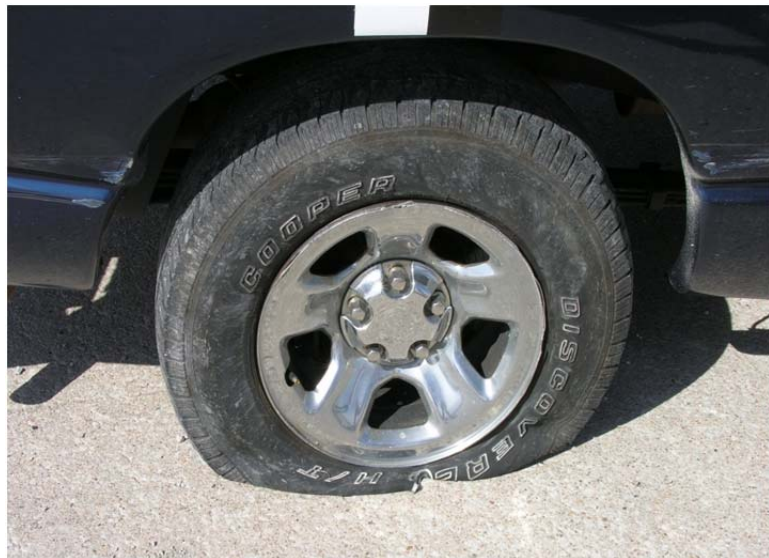
Figure 44. Vehicle Damage, Test No. MGSNB-1

Damage to the vehicle was moderate, as shown in Figures 44 and 45. The maximum occupant compartment deformations are listed in Table 5 along with the deformation limits established in MASH for various areas of the occupant compartment. None of the MASH

The majority of the damage was concentrated on the right-front corner and right side of the vehicle. The right-front tire was detached from the vehicle at the ball joint. The right-front tire was torn, and the steel rim was scratched and deformed. The right-front lower control arm fractured at the tie rod. The right-front tie rod and sway bar linkage were bent. The right-front wheel well was deformed inward and downward, and the right-front fender was bent inward. The right-side headlight was disengaged from the vehicle and fractured. The right-side of the front bumper was deformed inward toward the engine compartment. The left side of the front bumper was scraped, and a  $1\frac{3}{4}$ -in. (44-mm) gap was found between the front bumper and the left-side headlight. The lower portion of the center of the grill was fractured. The left side of the hood was ajar 1 in. (25 mm). The left-front wheel well was torn. The right side of the rear bumper was deformed and deflected downward  $3\frac{1}{2}$  in. (89 mm). The right side of the box rotated outward at the top and crushed inward at the bottom. The right-rear tire was torn and deflated. Deformations and contact marks extended along the entire right side of the vehicle. Both right-side doors were

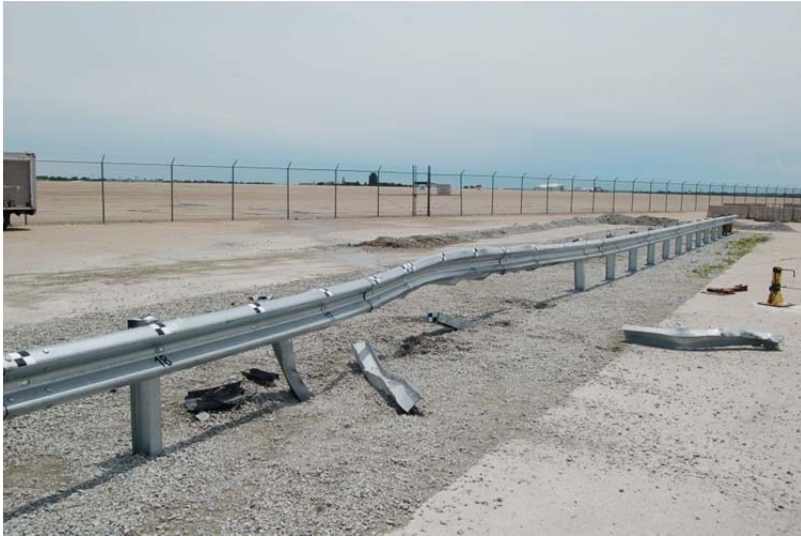
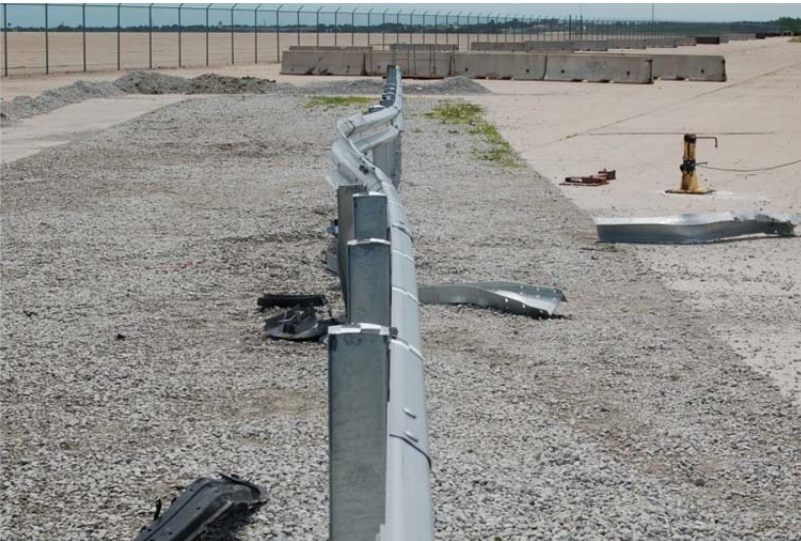
Figure 54. System Barrier Damage, Test No. MGSNB-2

Damage to the barrier was moderate, as shown in Figures 54 through 56. Barrier damage consisted of deformed W-beam rail, deformed posts, and contact marks on sections of guardrail and posts. The length of vehicle contact along the barrier was approximately 20 ft – 7¼ in. (6.3 m) which spanned from 2 ft – 8¼ in. (0.8 m) upstream from the center of post no. 14 to 10 in. (254 mm) upstream from the center of post no. 17. Secondary vehicle contact was 9 ft – 10 in.

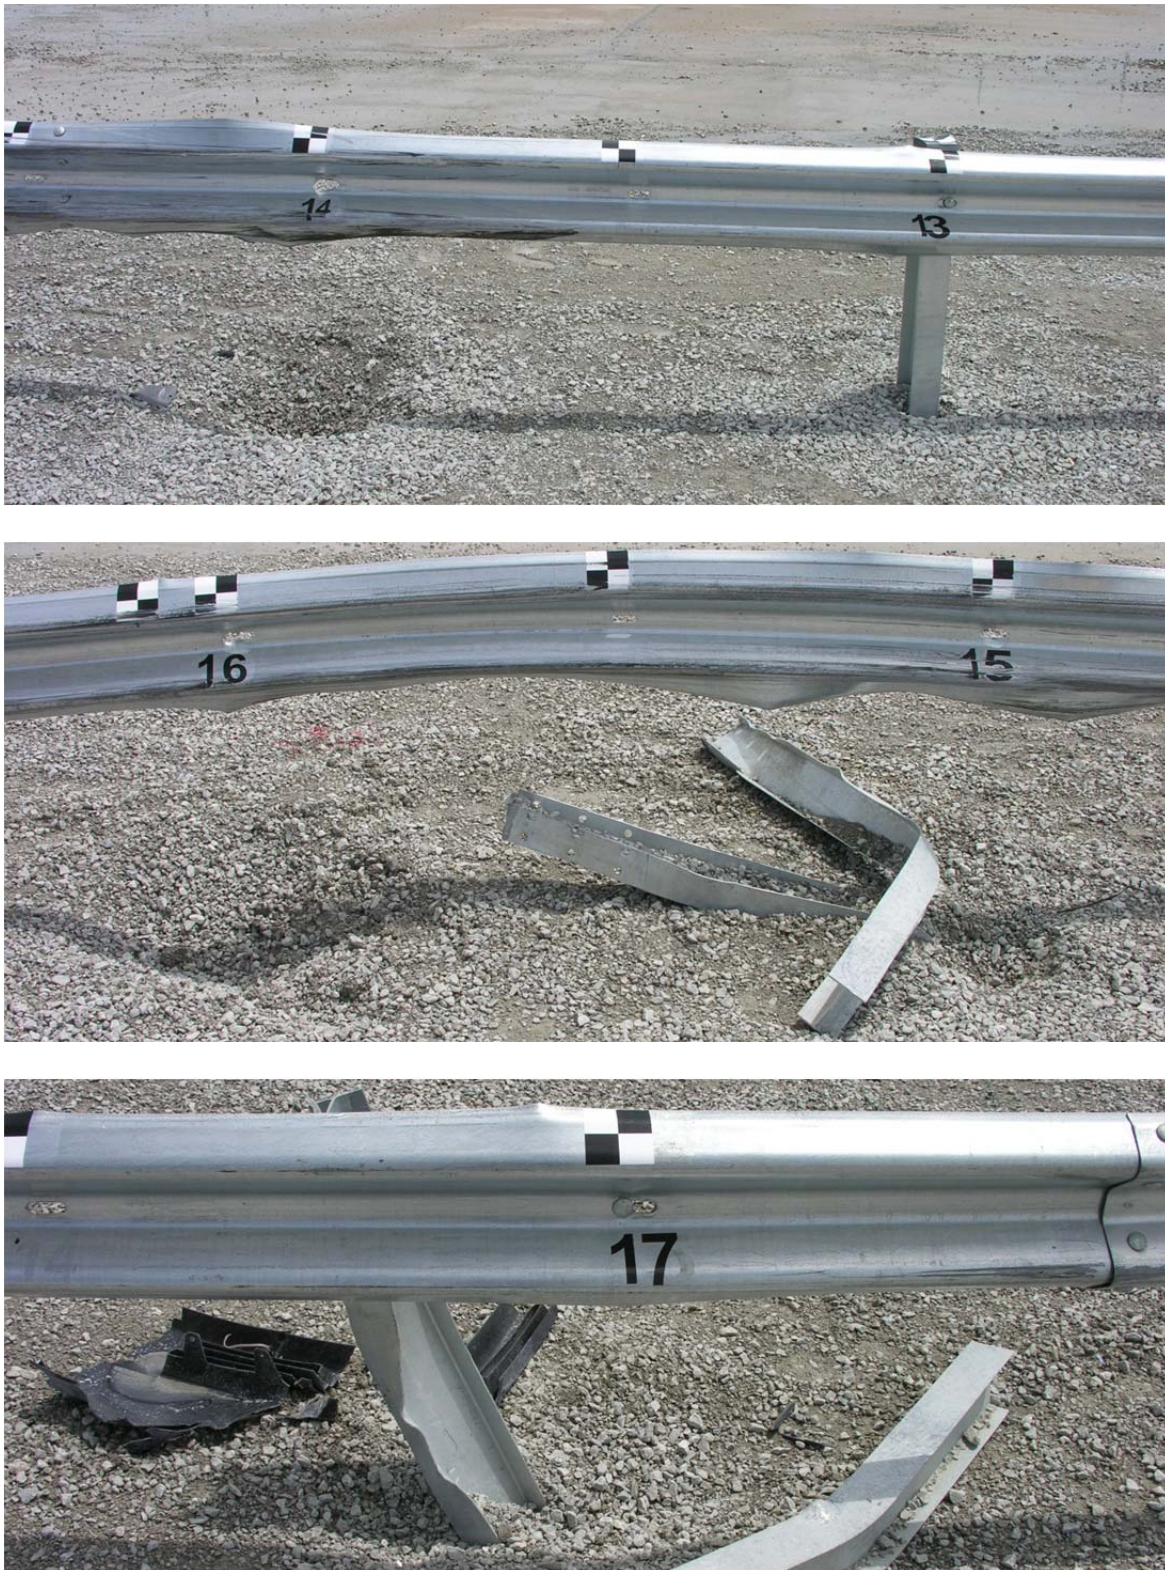
Figure 55. Guardrail Damage between Posts 13 and 17, Test No. MGSNB-2

The W-beam backup plate at post nos. 14 through 16 disengaged from the system. The W-beam backup plate from post no. 14 was deformed about the middle of the corrugations. The W-beam backup plate from post no. 15 twisted. The bottom corrugation of the W-beam backup plate from post no. 16 was deformed and buckled. The W-beam backup plate at post no. 17 remained attached to the rail with the bottom corrugation buckled. The flange of post no. 17 tore and was found between the guardrail bolt head and the W-beam backup plate.

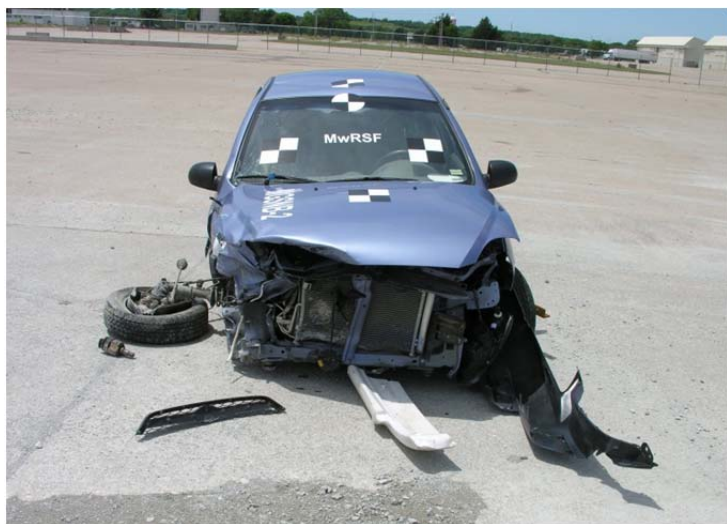
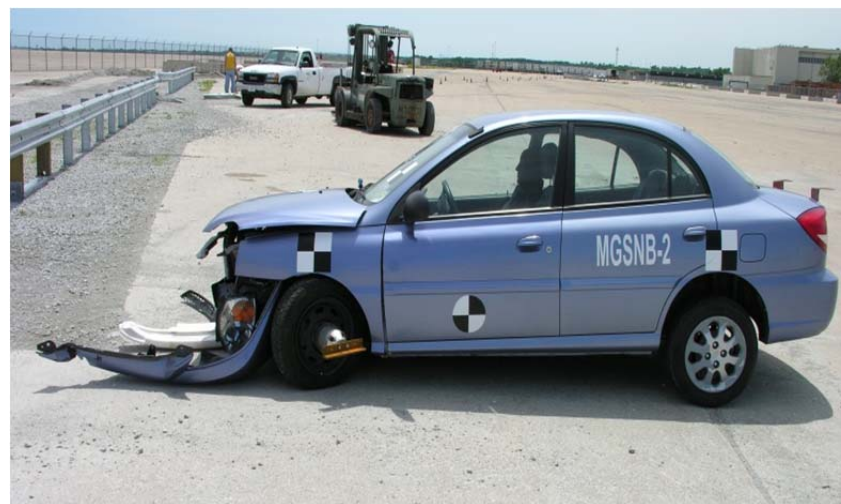
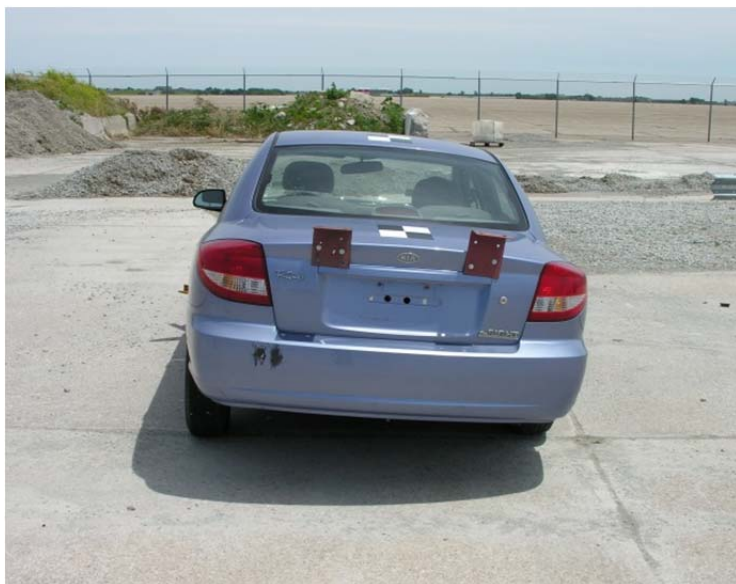
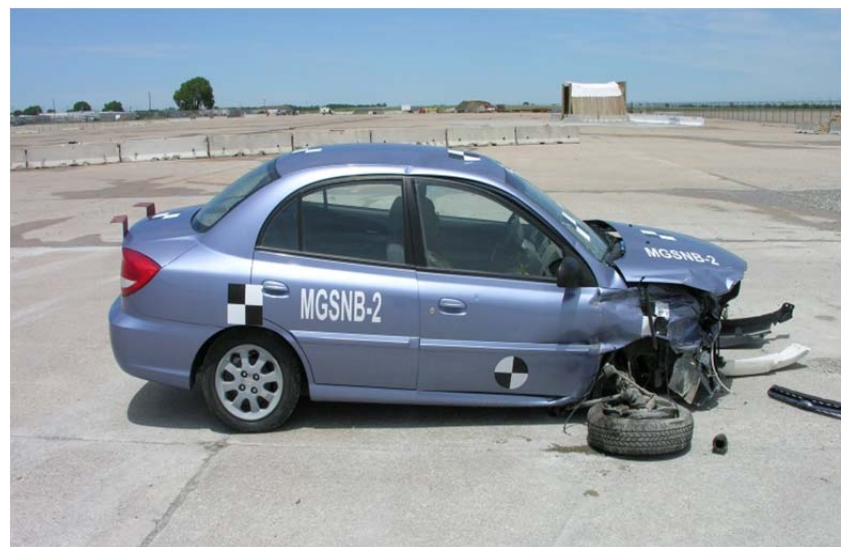
Figure 57. Vehicle Damage, Test No. MGSNB-2

Damage to the vehicle was moderate, as shown in Figures 57 and 58. The maximum occupant compartment deformations are listed in Table 9 along with the deformation limits established in MASH for various areas of the occupant compartment. None of the MASH established deformation limits were violated. Complete occupant compartment and vehicle deformations and the corresponding locations are provided in Appendix D.

The majority of the damage was concentrated on the right-front corner and right side of the vehicle. The right-front wheel assembly remained attached by only the brake line. The right-front steel rim was dented and encountered a 5-in. (127-mm) long tear on the inside. The right-

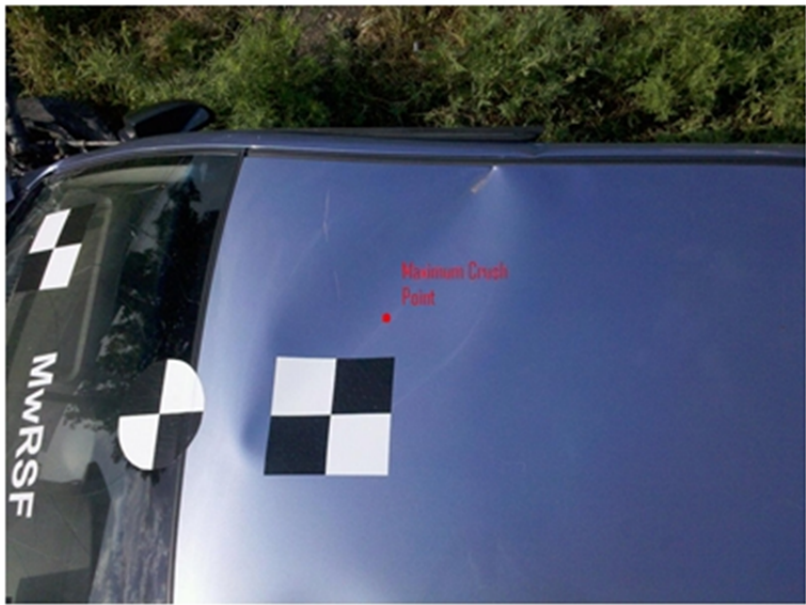
MGSNB-2 roof damage was located at one point on the right front quarter of the roof panel.
