Technical Report 07-3

*Utilizing Snap-Tite Slip Line Pipe
as a Direct Burial Cross Pipe*

Construction and First Interim Report, October, 2007

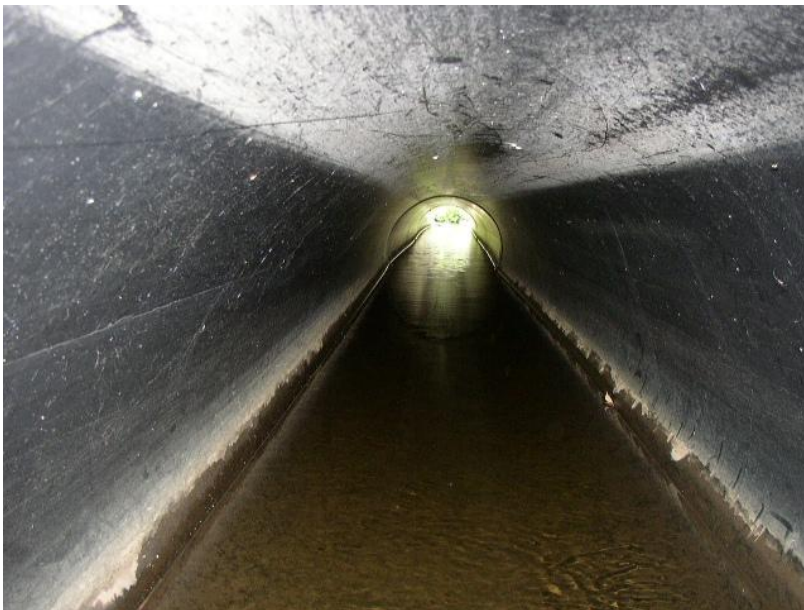
Figure 1 Downstream view of Snap-Tite pipe at Oakfield one year after construction. Center elevation is 4 inches below inlet and outlet.

Condition of the pipe after one year reveals very little distortion. There is a 4 to 5 inch elevation drop at the center of

the pipe however the pipe joints appear to be well sealed and water tight. The roadway surface elevation has dropped 1.5 inches where the pipes cross the road.

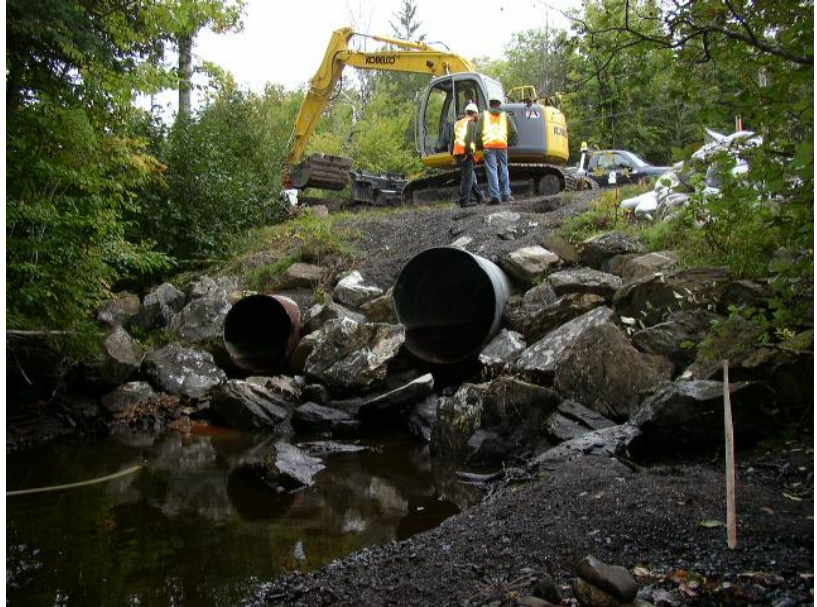
This area has two corrugated metal cross pipes that are corroded from the water line to the bottom of the pipe. The existing pipes could have been slip lined however the pipe elevation was too high for proper drainage and fish migration.

Figure 2 Pre-construction view of cross pipe at Benedicta. New pipe will be installed one foot lower.

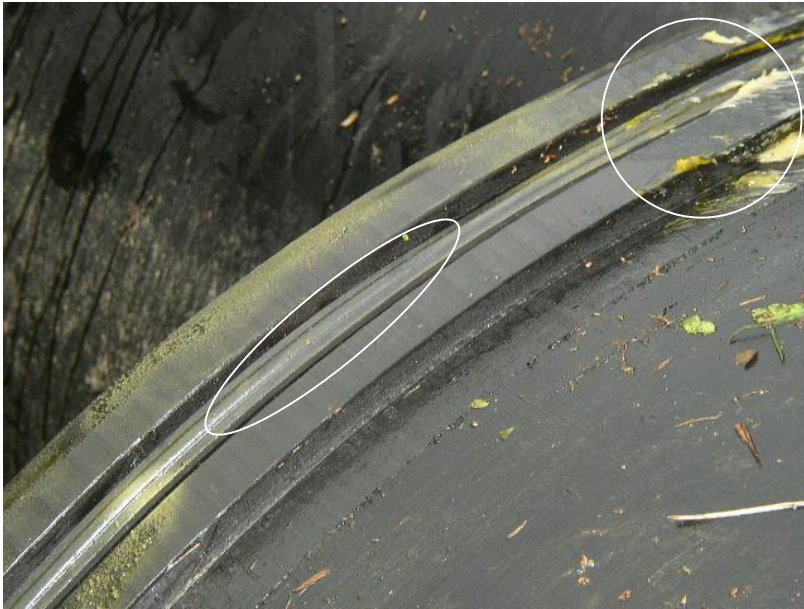
Figure 3 O Ring seal on male end of Snap-Tite Pipe. A small amount of pipe lubricant can be seen in the upper right corner.

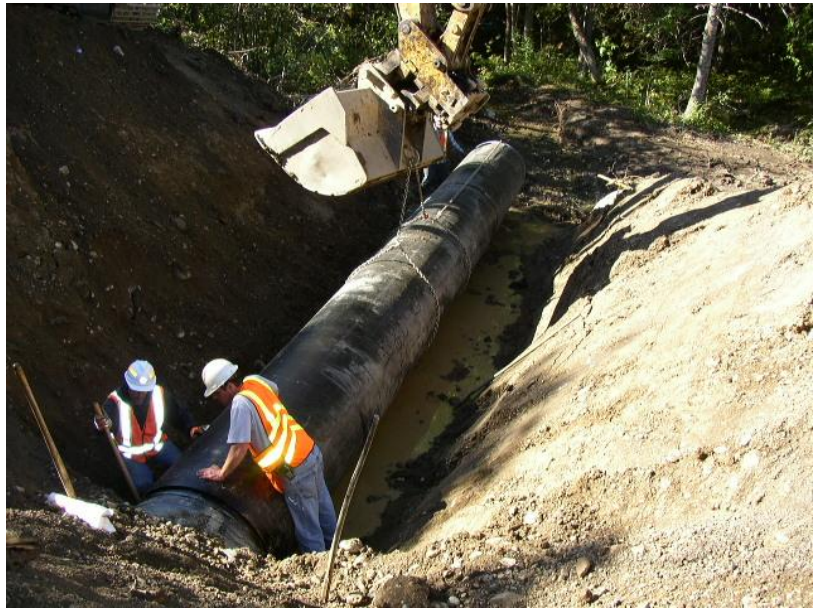
Figure 4 Placing inlet half of overflow pipe in Benedicta.

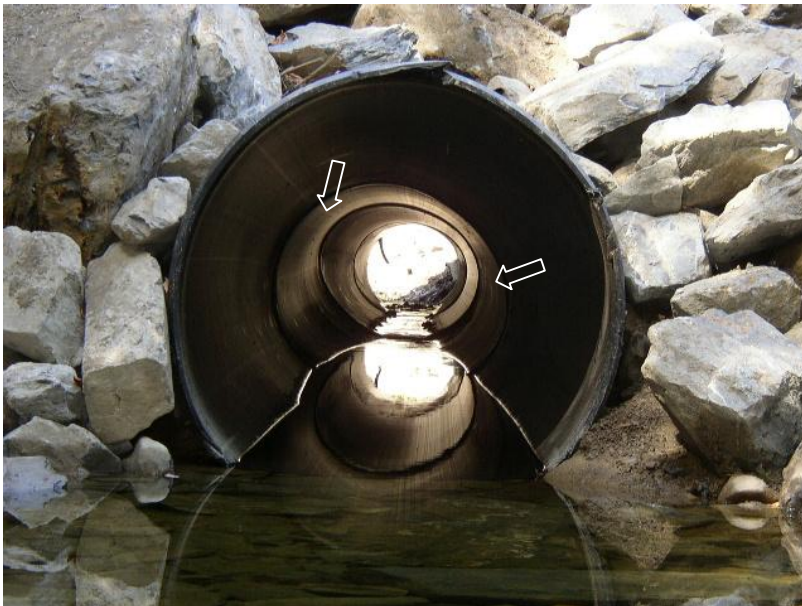
Figure 5 Upstream view of Main Pipe in Benedicta. Pipe is deformed from weight of gravel backfill.

The completed pipe had tight joints however the pipe was deformed from the quantity of backfill used at this location. To monitor the condition of the pipe the Department will inspect the pipes on a yearly basis.

The Snap-Tite pipe that was used for this project was stored in an open field for a period of four years. While exposed to the elements the pipe settled and took on an oval shape. This shape change made it difficult to join the pipes unless the shape of the pipe is closely matched prior to joining.
