# Maine Department of Transportation Transportation Research Division

## **Technical Report 00-19**

*Comparison of "Saw and Seal" Procedure and  
Performance Grade Binder to Minimize Thermal  
Cracking*

*Interim Report - Third Year, December 2004*

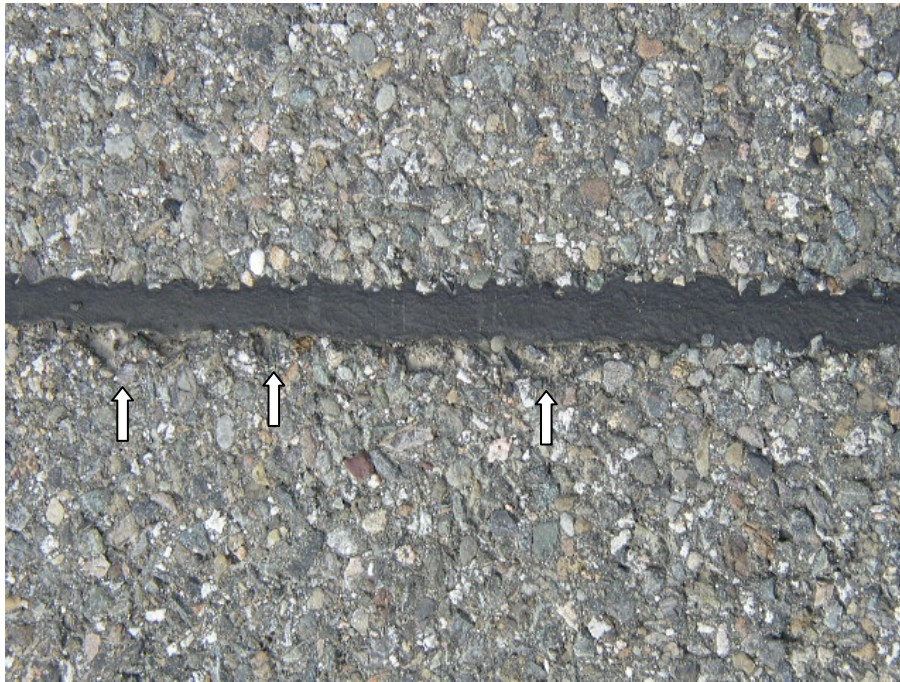
Overall pavement condition is good and the average wheel rut depth is less than 6 mm (0.25 in). The Centerline joint has separated throughout the entire section. Saw joint sealant is pliable, level with the roadway, and well adhered to the sidewalls. Photo 1 illustrates pavement ravel on the trailing edge of three saw joints. Ravel is located between wheel paths and appears to be caused by winter snow removal. There is a total of 78 meters (256 feet) of longitudinal cracking, 63 meters (207 feet) in the north lane and 15 meters (49 feet) in the south lane. A total of 40 meters (131 feet) of initial load cracking was observed in the outer wheel path of the north lane. There were only two transverse cracks in this section. As seen in Photo 2 the cracks originate at centerline, are located 152 mm (6 in) on each side of a joint and extend 0.3 meters (1 foot) into the roadway.

Photo 1. Saw joint edge ravel

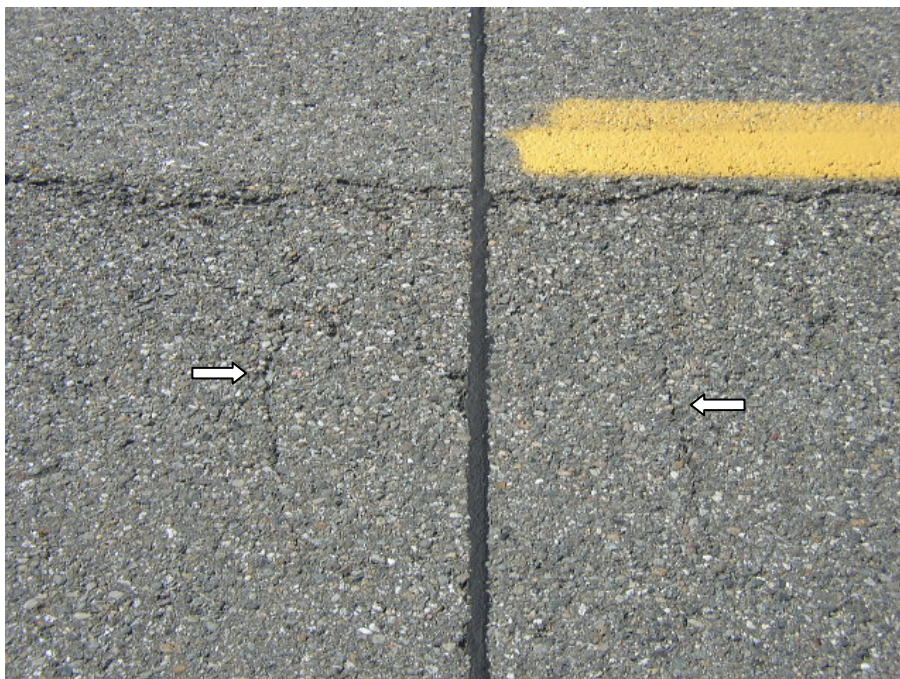
Photo 2. Transverse cracking on Saw and Seal section

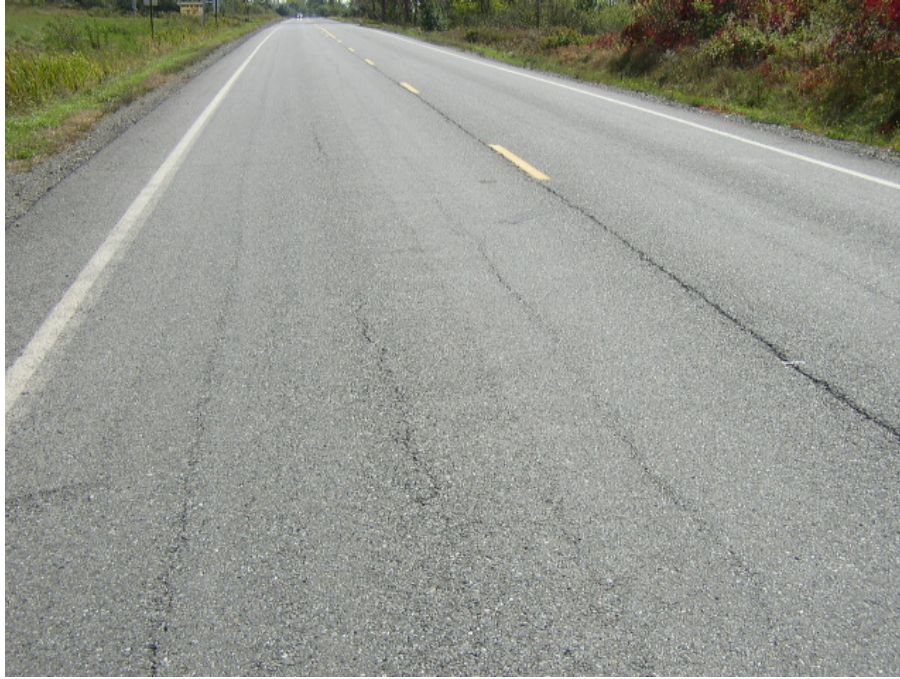
Pavement looks very good and the average rut depth is less than 6 mm (0.2 in). Centerline joint separation is evident throughout the entire section. There is a total of 18 meters (59 feet) of longitudinal cracking and a total of 96 meters (315 feet) of initial load cracking, 41 meters (135 feet) in the north lane and 55 meters (180 feet) in the south lane. There are two transverse cracks; one at station 20+560 and another at station 20+750. Both cracks are located over cross culverts and appear to be the result of horizontal movement of the culverts. A poorly constructed butt joint at station 20+562 has separated and formed a transverse crack. This crack is the result of poor construction and will not be considered a transverse crack. Photo 3 reveals typical cracking for this section.

Photo 3. Control section typical cracking

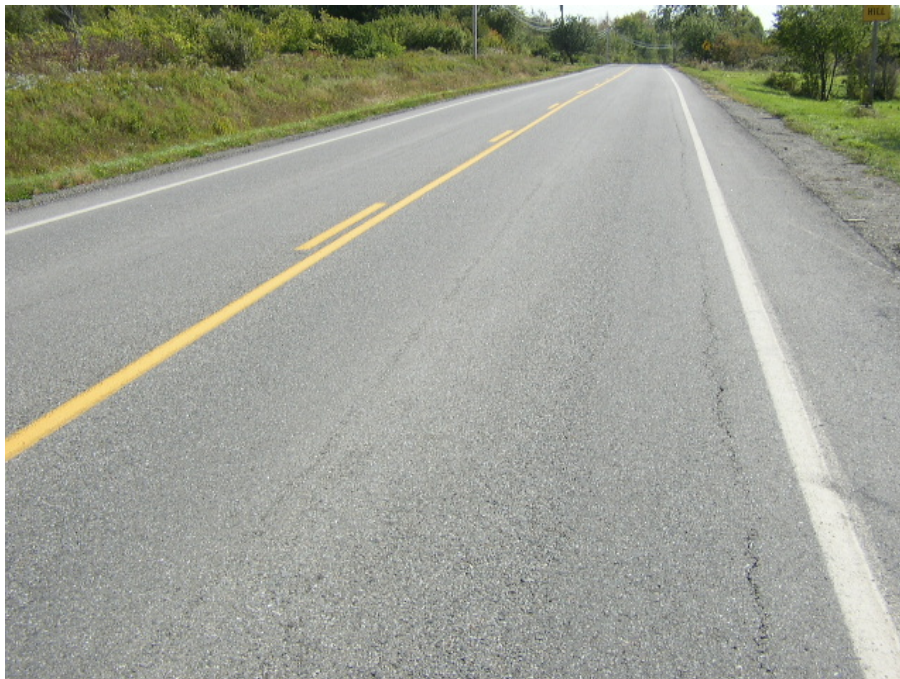
A total of 96 meters (315 feet) or 33 percent of centerline has separated. Rutting is slightly greater with an average rut depth between 6 and 13 mm (0.25 and 0.5 inches). There is a total of 54 meters (177 feet) of longitudinal cracking and a total of 48 meters (157 feet) of initial load cracking. No transverse cracks were observed even at a cross culvert location. Photo 4 shows typical cracking of this section.

Photo 4. PG Binder section typical cracking
