**WVDOT/DOH Report**

## **Evaluation of Weathering Steel Overhead Sign Structures in West Virginia**

June 2014

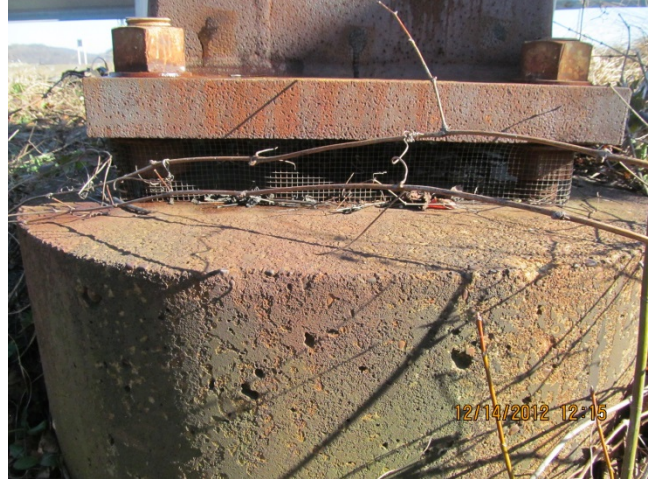
<p>No deficiencies were found in the foundation. This element was rated as 1 (Structure #01-20-64-55.45 - type 1.2).</p>

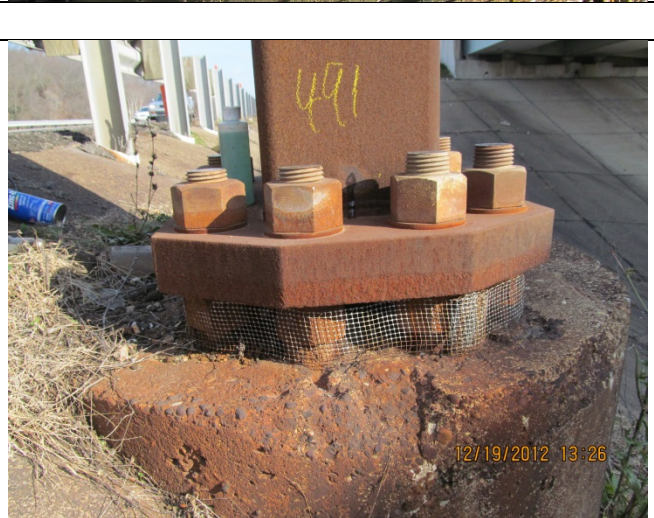
<p>Concrete spalling of the foundation under the left vertical column was observed. This element was rated as 2 (Structure #01-20-77-100.98 - type 3.1).</p>

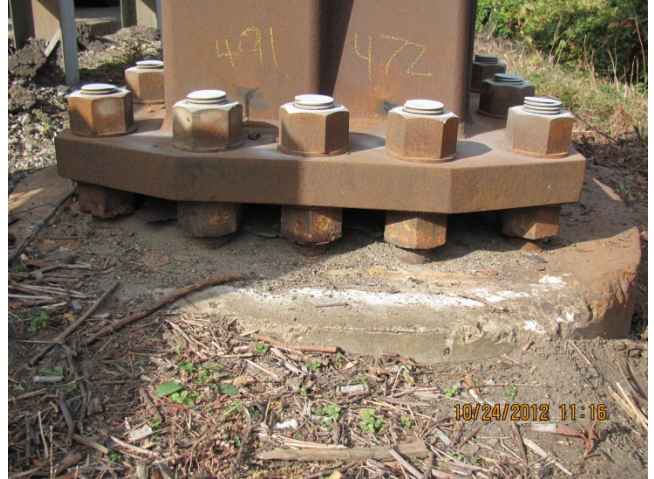
<p>No grout pad was present under the base plate. This element was rated as 1 (Structure #01-20-64-55.85 - type 1.1).</p>

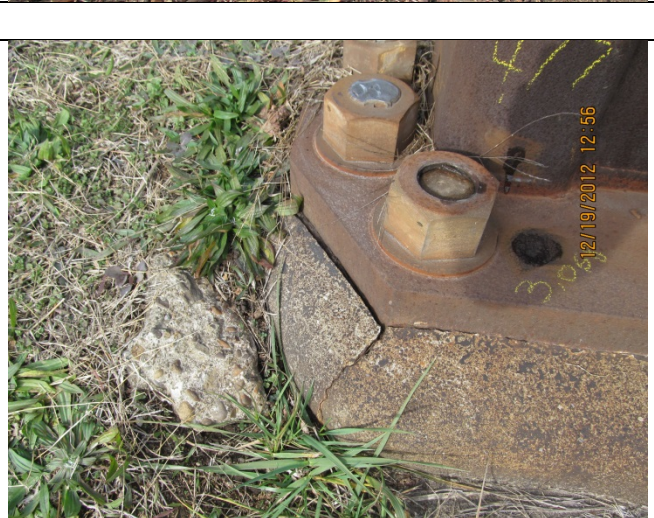
<p>Mortar cracking of the grout pad under the base plate at the left vertical column was observed. This element was rated as 2 (Structure #01-20-77-101.23 - type 3.1).</p>

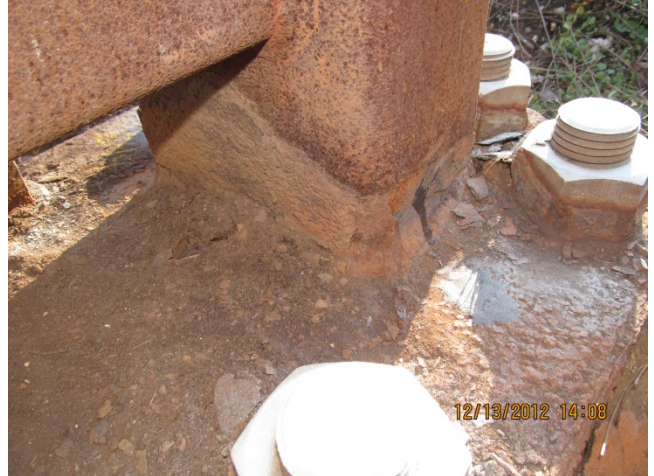
<p>Moderate section loss and deterioration/corrosion of the base plate at the shoulder vertical column were observed. Severe surface pitting of the base plate was reported. This element was rated as 4 (Structure #01-20-64-57.52 - type 4).</p>

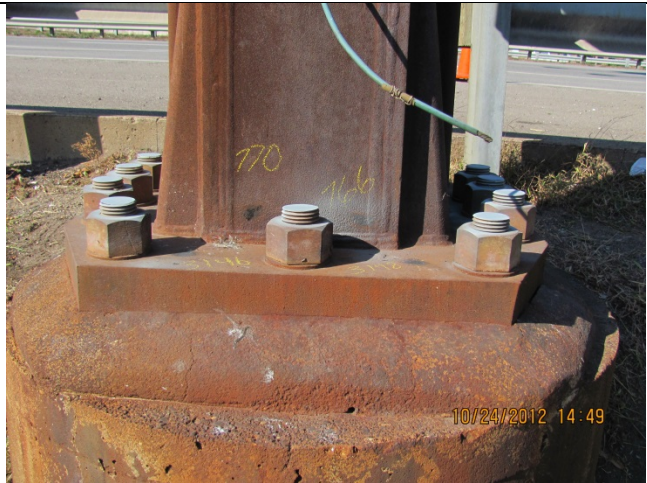
<p>No deficiencies of the anchor bolts, nuts, and washers were found. This element was rated as 1 (Structure #01-20-77-101.24 - type 1.1).</p>

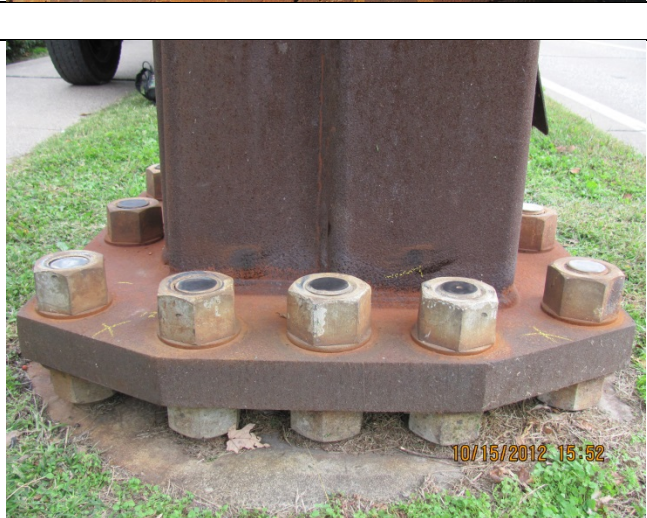
<p>Two anchor bolts were slightly cut short. Minor corrosion of two anchor bolts and leveling nuts/washers was observed. This element was rated as 2 (Structure #01-20-64-57.83 - type 1.1).</p>

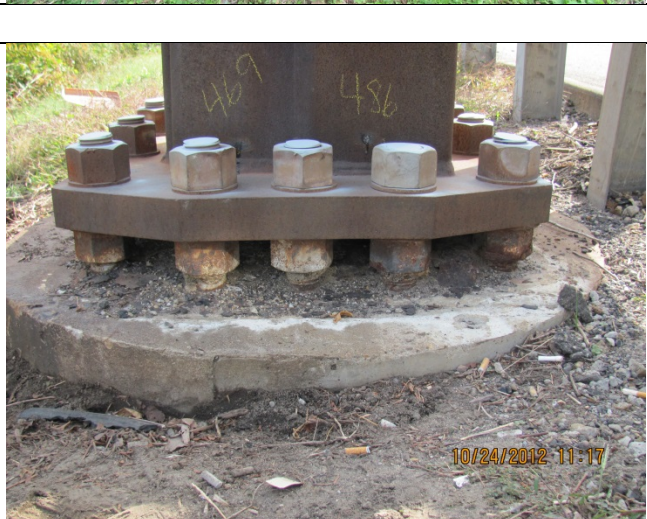
<p>Minor to moderate corrosion and deterioration of leveling nuts/washers was observed. This element was rated as 3 (Structure #01-20-64-55.85 - type 1.1).</p>

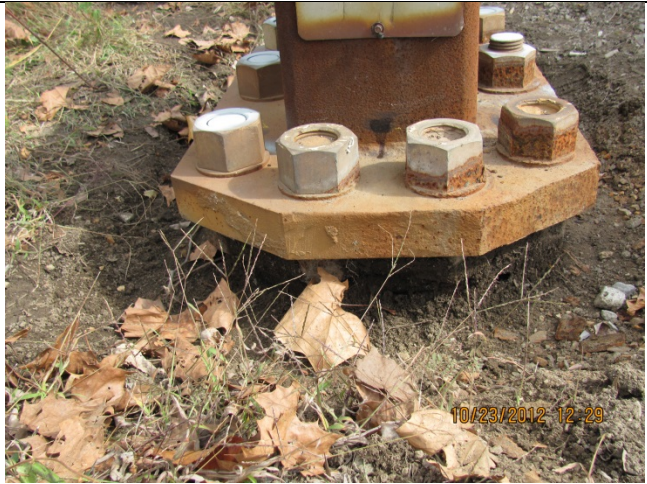
<p>Nine anchor bolts on the shoulder vertical column were cut short. Minor corrosion of top nuts/washers was observed. Minor to moderate corrosion of leveling nuts/washers was reported. This element was rated as 4 (Structure #01-20-79-01.12 - type 4).</p>

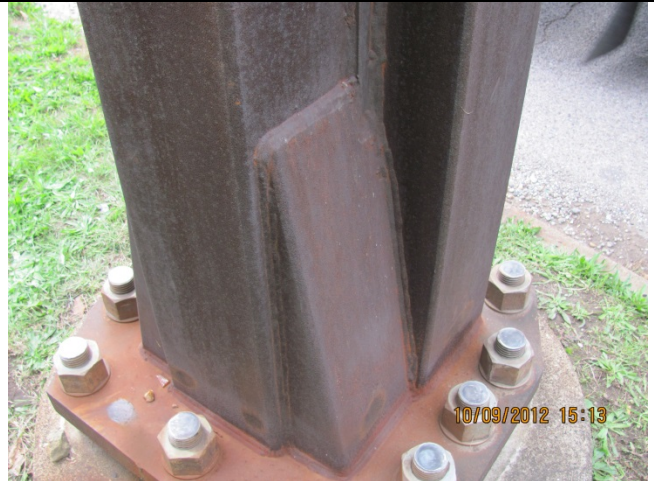
<p>No deficiencies of the connection between the base plate and the vertical column were found. This element was rated as 1 (Structure #01-20-64-52.40 - type 1.1).</p>

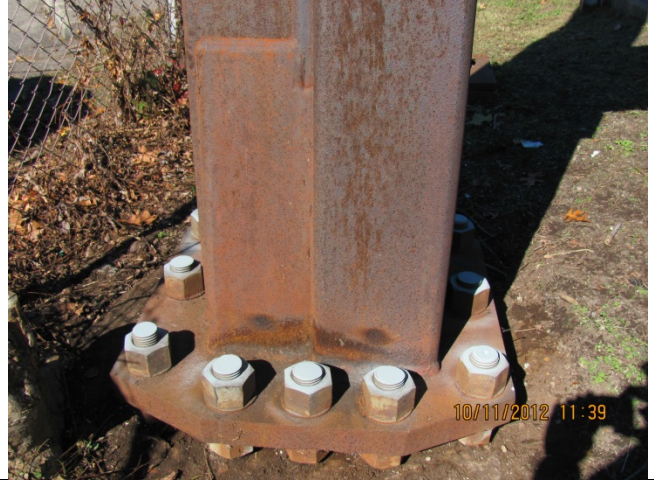
<p>Minor corrosion of weld line 1 connected between the base plate and the vertical column was observed. Weld reinforcement had been starting to deteriorate. This element was rated as 2 (Structure #01-20-77-97.32 - type 1.1).</p>

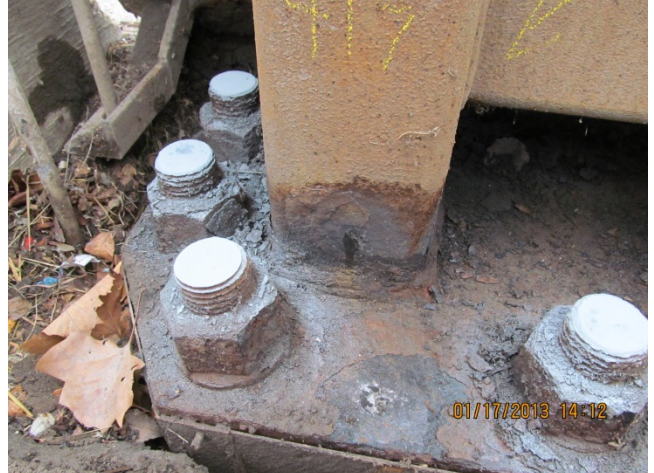
<p>Minor to moderate corrosion of weld lines 1 and 2 connected between the base plate and the median vertical column was observed. This element was rated as 3 (Structure #01-20-79-01.12 - type 4).</p>

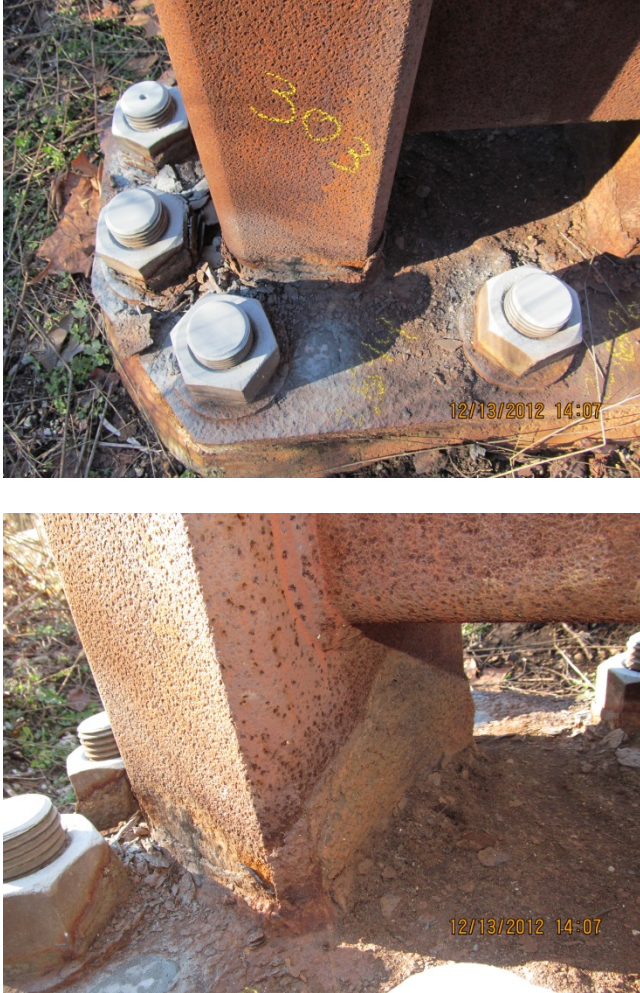
<p>Severe corrosion of weld lines connected between the base plate and the shoulder vertical column was observed. This element was rated as 4 (Structure #01-20-64-57.52 - type 4).</p>

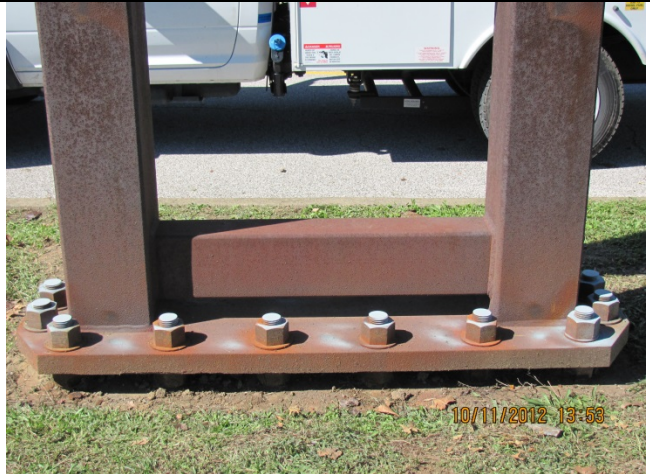
<p>No deficiencies of the weld lines between the column vertical members and the supplemental bracing were found. This element was rated as 1 (Structure #01-20-60-11.44 - type 3.3.1).</p>

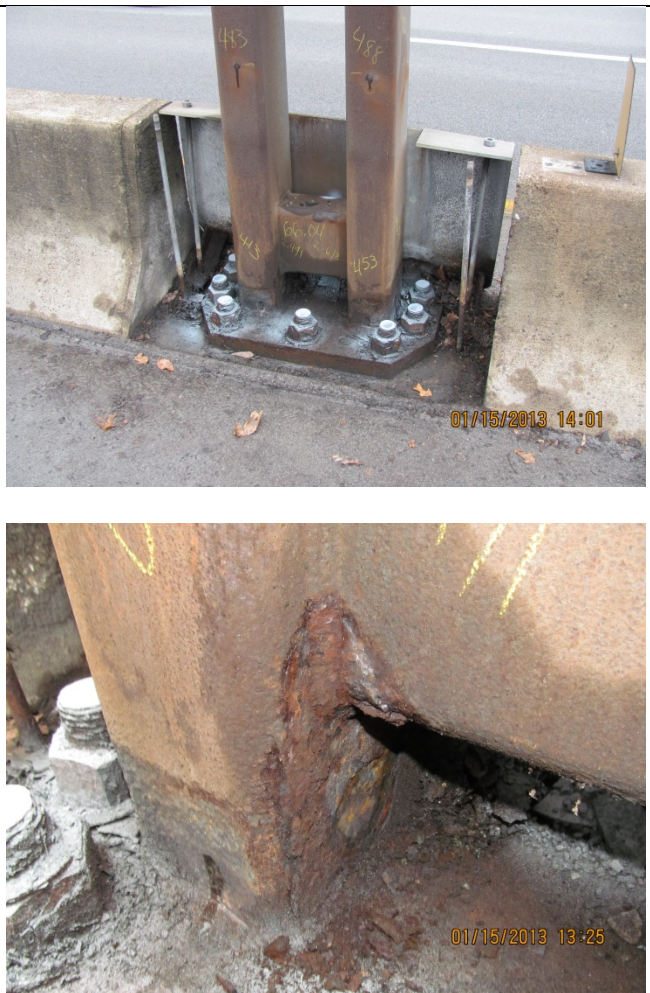
<p>Corrosion on bottom of the weld lines connected between the median vertical column and the supplemental bracing was observed. This element was rated as 2 (Structure #01-20-64-57.52 - type 4).</p>

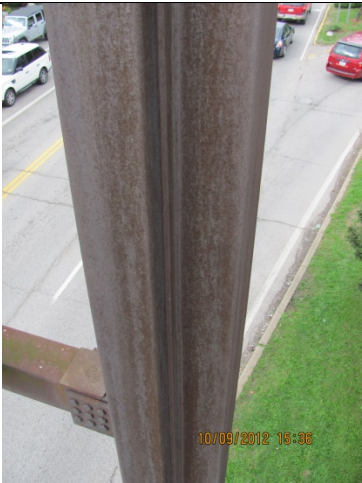
<p>Minor corrosion of the vertical column was observed. This element was rated as 2 (Structure #01-20-64-52.40 - type 1.1).</p>

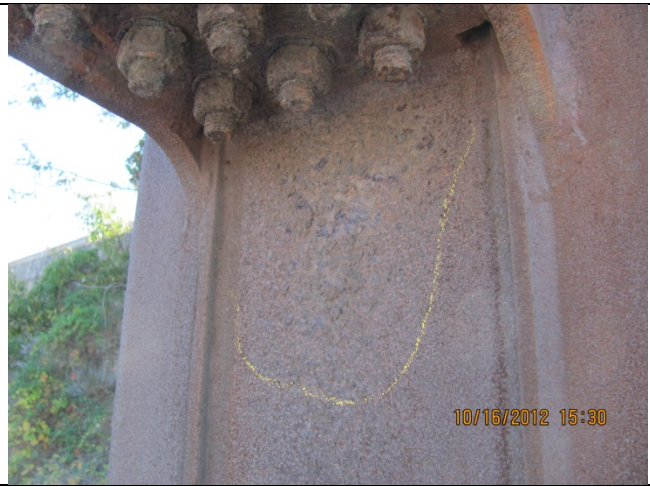
<p>Moderate corrosion of the vertical column under the bottom splice plate was observed. This element was rated as 3 (Structure #01-20-64-56.04 - type 1.1).</p>

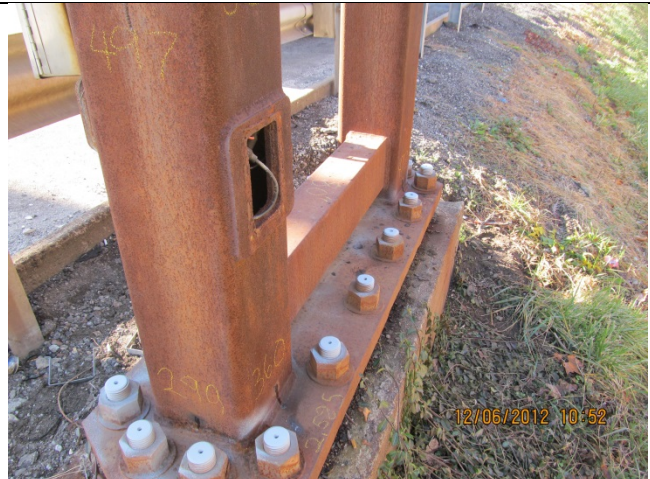
<p>Handhole cover at the shoulder vertical column was not in place. Minor to very severe corrosion of the shoulder column was observed. This element was rated as 4 (Structure #01-20-77-101.84 - type 3.3.2).</p>

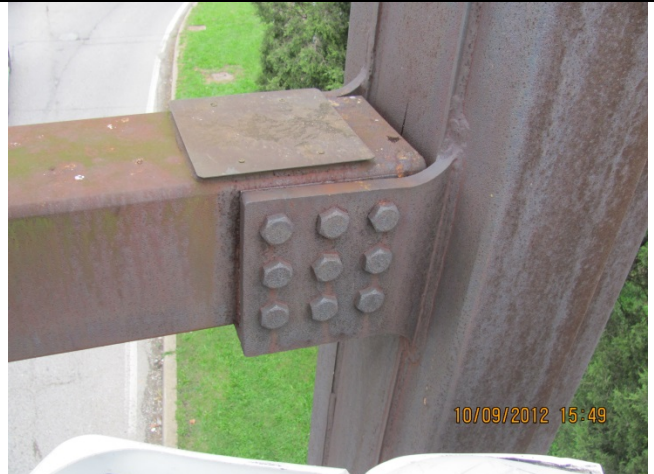
<p>No deficiencies of the connections between the vertical column and the horizontal chord were found. This element was rated as 1 (Structure #01-20-64-52.40 - type 1.1).</p>

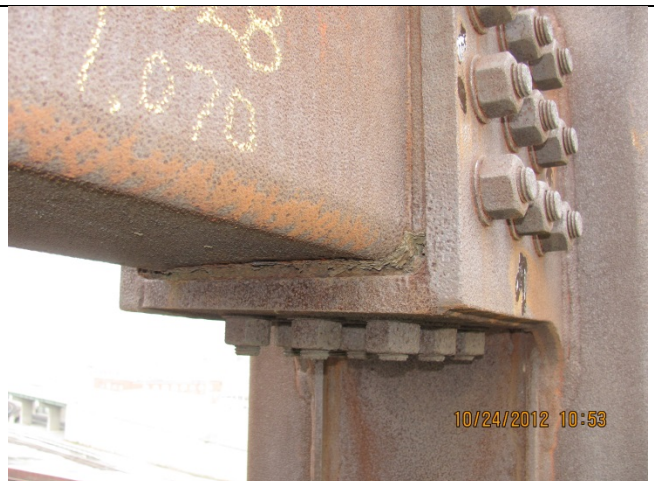
<p>Minor corrosion of bolts connected between the lower chord and the vertical column was observed. Pack rust between plates/members was reported. This element was rated as 2 (Structure #01-20-64-55.85 - type 1.1).</p>

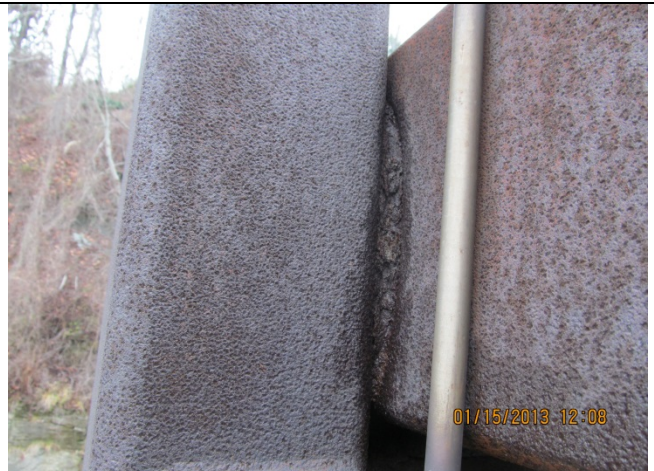
<p>Pack rust between plates/members was observed. One U-bolt connected the shoulder vertical column and the upper chord was loose. This element was rated as 3 (Structure #01-20-64-57.53 - type 4).</p>

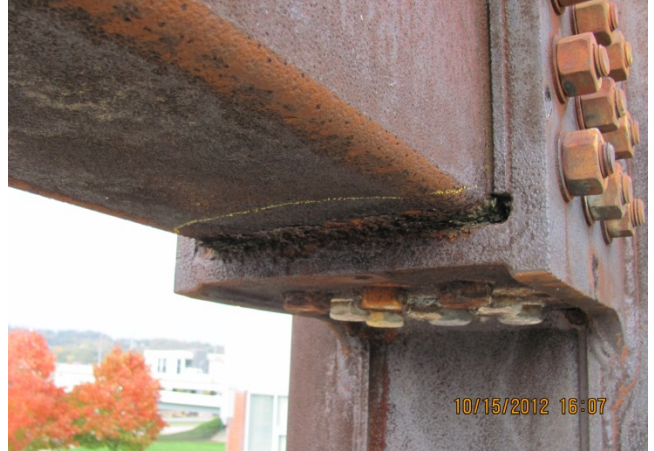
<p>Minor corrosion of bolts connected between the vertical column and the lower chord was observed. Severe pack rust between plates/members in the lower chord was reported. One bolt was completely loose and the rest were somewhat loose. This element was rated as 4 (Structure #01-20-64-57.83 - type 1.1).</p>

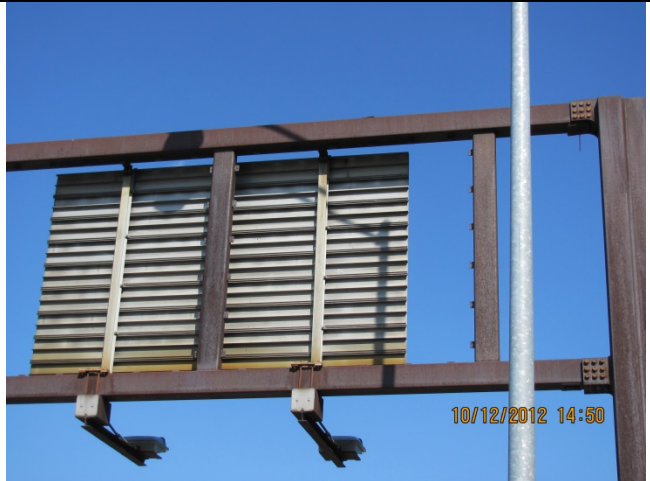
<p>No deficiencies of the horizontal chords and secondary vertical posts were found. This element was rated as 1 (Structure #01-20-64-57.88 - type 1.1).</p>

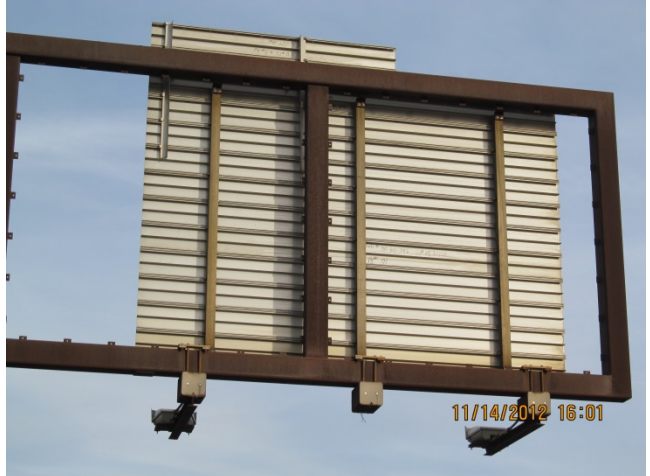
<p>Minor corrosion of horizontal chords and secondary vertical posts was observed. This element was rated as 2 (Structure #01-20-64-58.54 - type 1.1).</p>

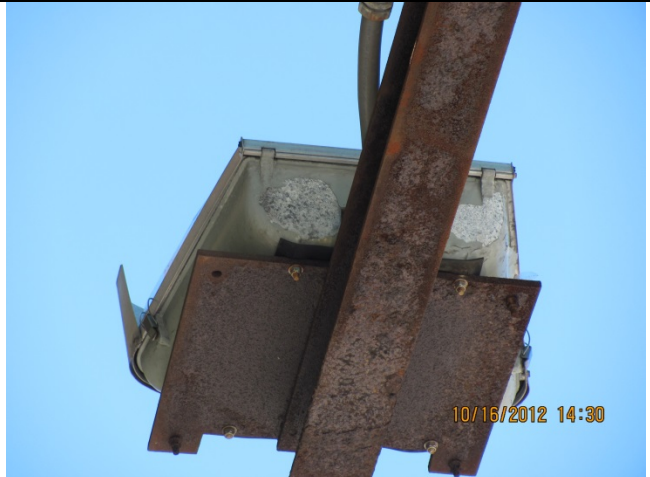
<p>Minor to moderate corrosion of the lower chord was observed. This element was rated as 3 (Structure #01-20-77-102.49 - type 1.1).</p>

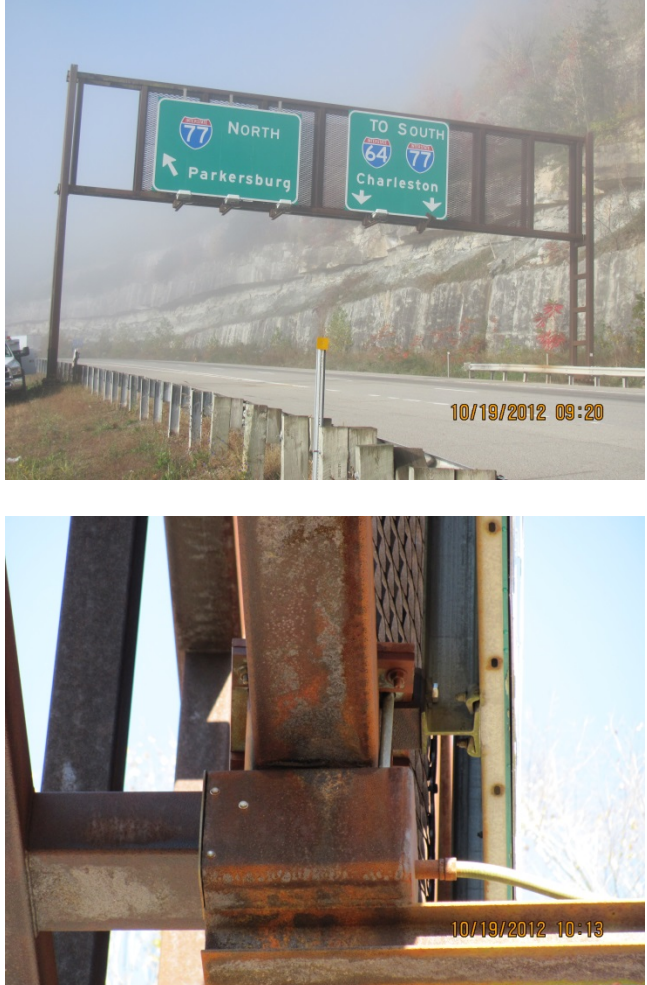
<p>The top photograph shows a highway interchange with overhead signs. The left sign is green with white text, indicating 'I-77 NORTH' and 'Parkersburg' with a left-turn arrow. The right sign is green with white text, indicating 'TO SOUTH' and 'I-64 I-77 Charleston' with a right-turn arrow. The background shows a steep, rocky hillside. A timestamp '10/19/2012 09:20' is visible in the bottom right corner of the photo.</p> <p>The bottom photograph is a close-up of the steel structure supporting the signs. It shows a horizontal steel arm and vertical posts. There is significant rust and corrosion on the steel, particularly on the horizontal arm. A timestamp '10/19/2012 10:13' is visible in the bottom right corner of the photo.</p>	<p>Right horizontal light arm had impact damage. Pack rust between light arm JB's and the lower chord was observed. L-brackets connecting the supports and the chords had a minor corrosion. Steel mesh was partially detached from secondary vertical posts. Some deformation and damage to other areas were reported. This element was rated as 4 (Structure #01-20-79-00.68 - type 3.3.1).</p>
