*Experimental Construction Project ME 00-20
Third Year Interim Report on Experimental
Utilization of Tire Shreds to Enhance Highway
Drainage
April 2003*

Third Year Interim Report on Experimental Utilization of Tire Shreds to Enhance Highway Drainage

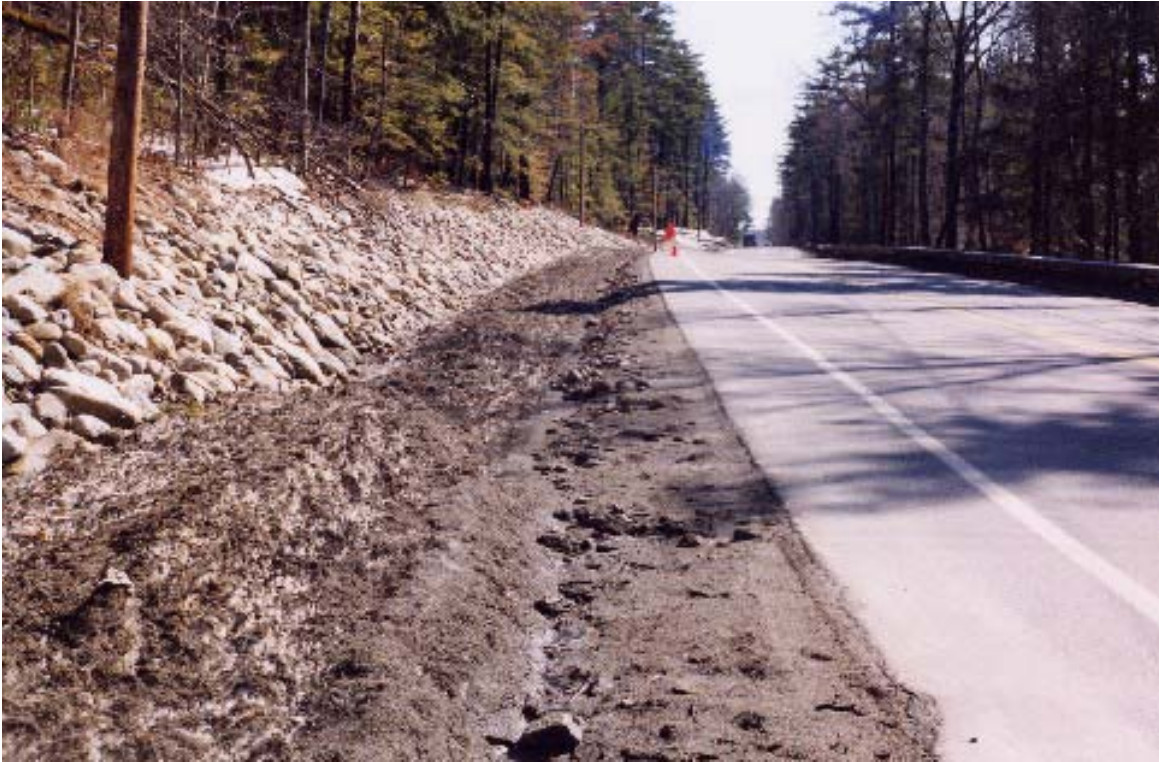
Figure 2. Ice & Snow Remain in the Ditch Long After Other Areas Have Melted

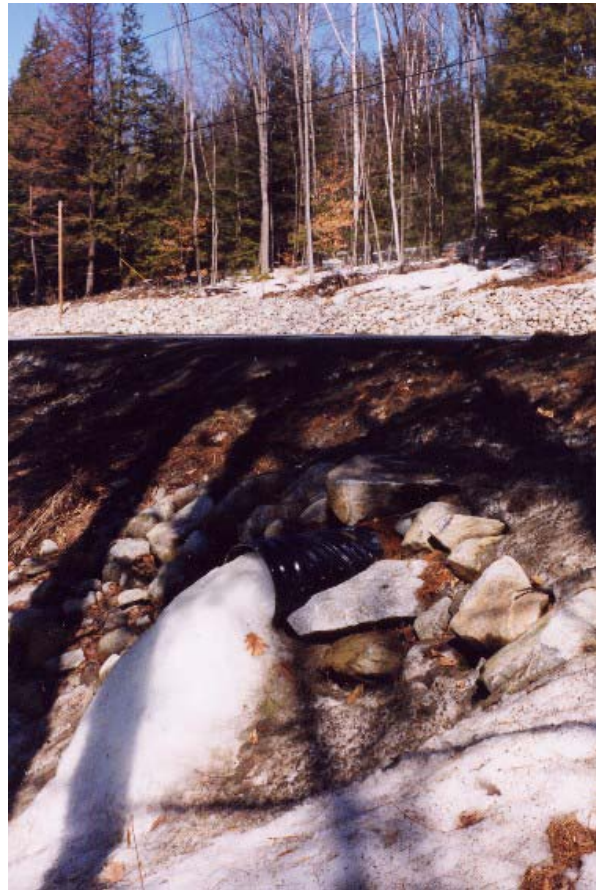
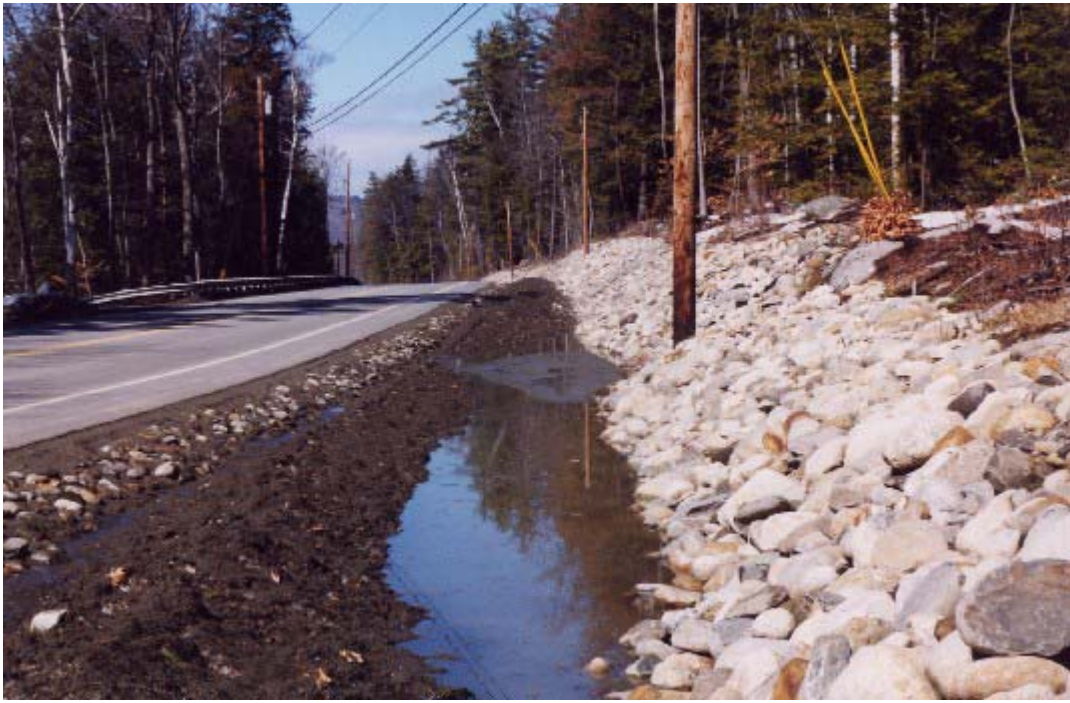
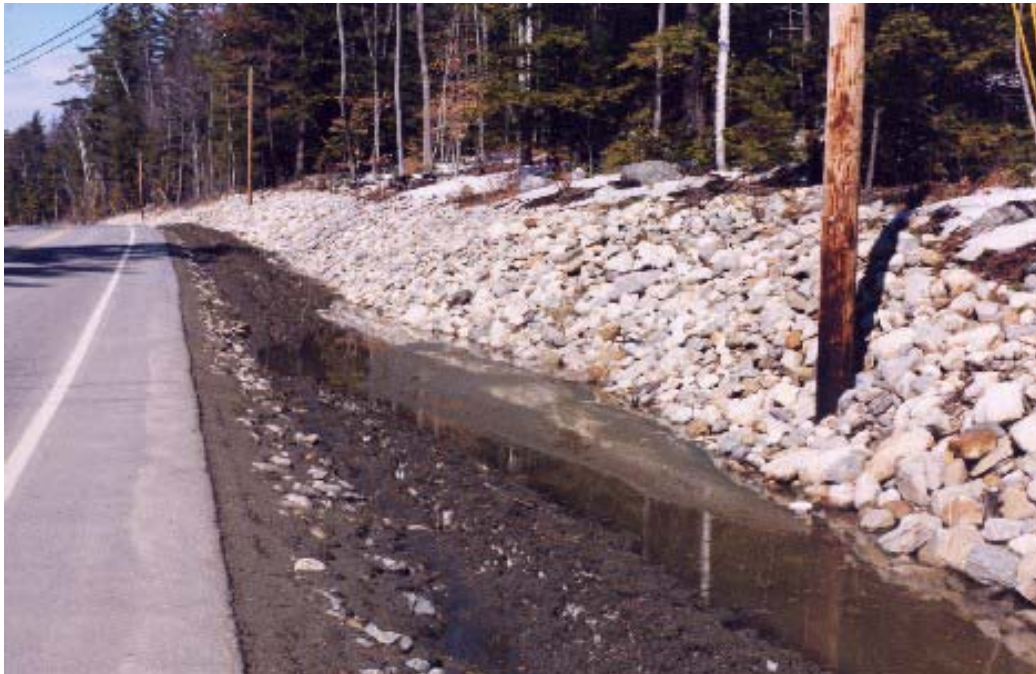
One notable problem occurred at station 14 +330 where some ponding occurred in the ditch. A culvert plugged with ice prevented cross drainage. This problem does not appear to be related to the subsurface drain or the tire shreds, since all other adjacent drainage structures were functioning properly.

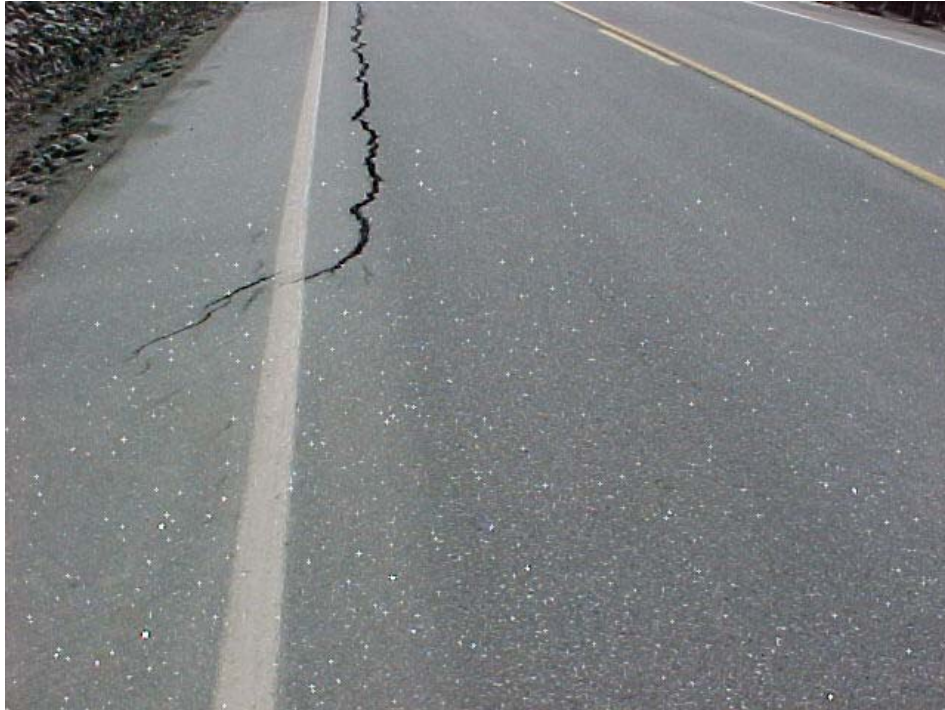
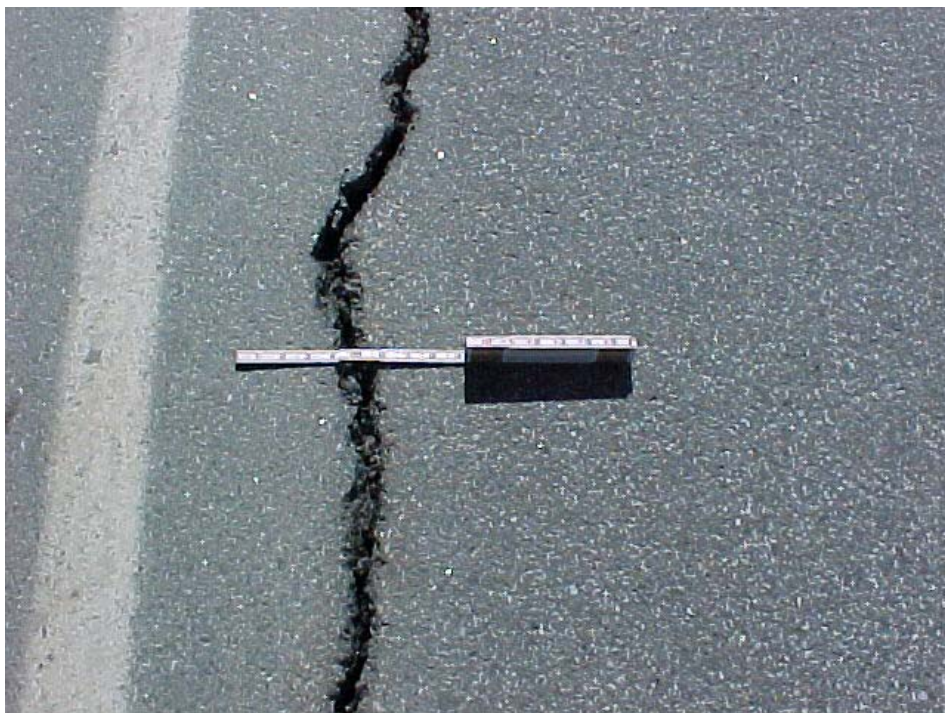
A severe crack has developed in one lane adjacent to the experimental area. It is not known if this crack is directly related to the subsurface drain, since the drain was not underneath the travel way. It may be that it is related to post construction settling adjacent to the drain.

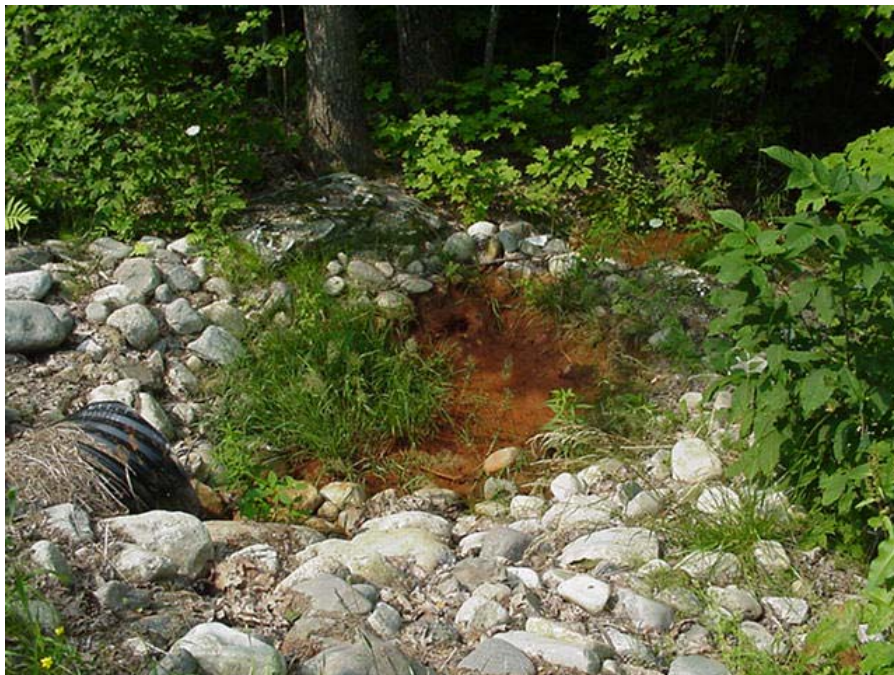
Another problem that is of concern is the discoloration in the culvert discharge areas. The photos below show this phenomena. It is believed that it is due to iron bacteria or rust from the steel belts in the shredded tires. While this is not a water quality issue, it is an esthetic consideration. Although the discoloration does not appear to pose any hazard, MDOT staff feel this will limit the locations where tire shreds can be utilized in the future.

Figure 20. Rust Discoloration Visible on Soil & Rocks

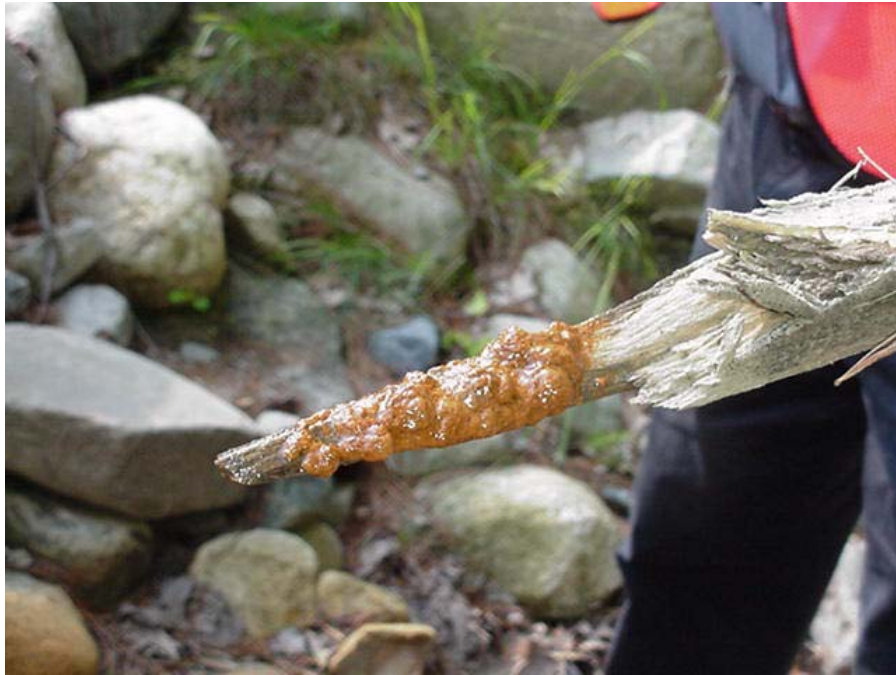
Figure 21. Surface Deposits Caused by Iron Bacteria
