**STATE OF MAINE**  
**DEPARTMENT OF TRANSPORTATION**

**EXPERIMENTAL CONSTRUCTION PROJECT ME 01-3**

**EXPERIMENTAL INSTALLATION OF GEOSYNTHETIC PAVEMENT  
REINFORCEMENT TO REDUCE REFLECTIVE CRACKING**

**RUNWAY 17-35 OVERLAY, AUBURN/LEWISTON MUNICIPAL AIRPORT  
SAIP11.7001(33)**

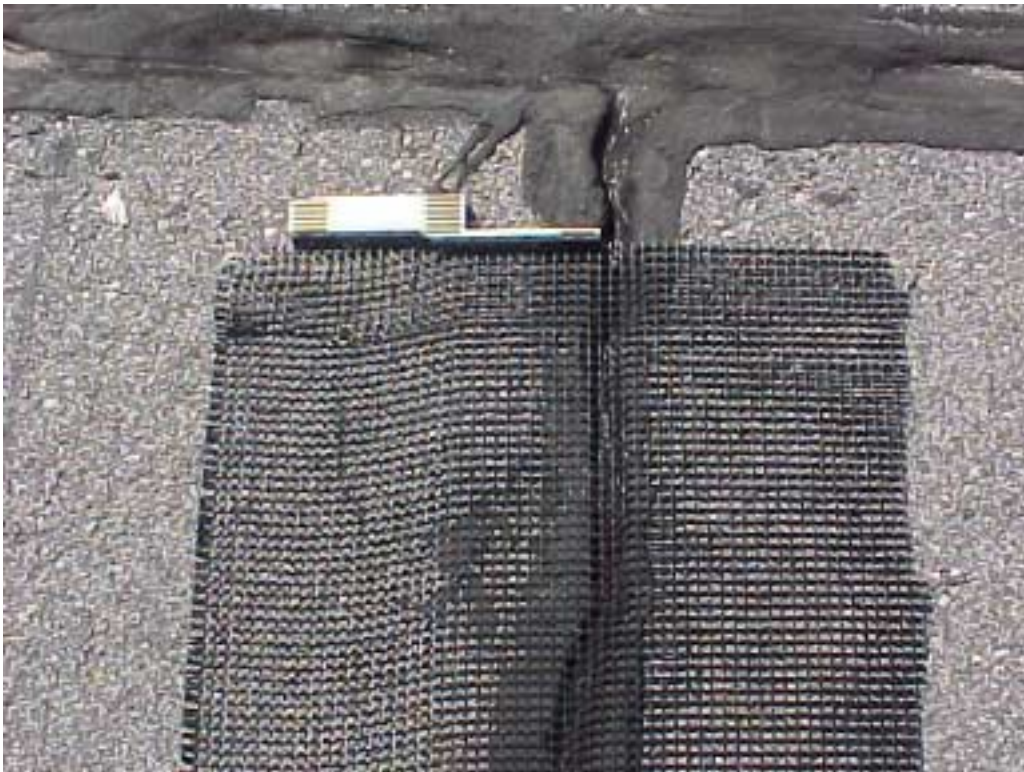
Figure 3

Figure 3. Close-Up View of Geosynthetic over a Deep Transverse Crack

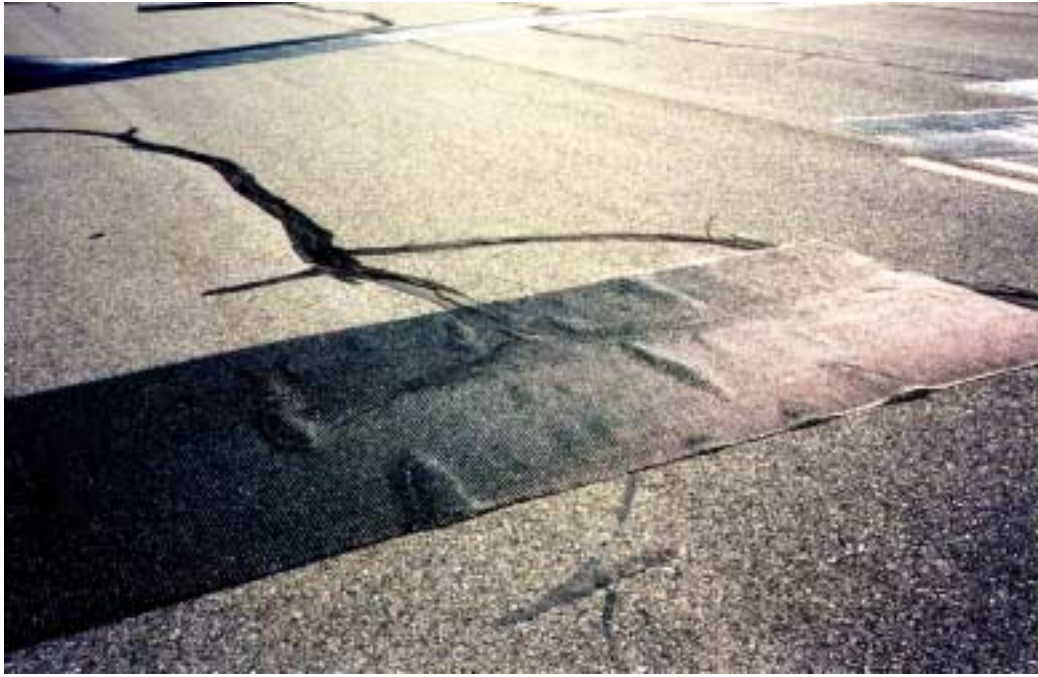
**Figure 5**

A problem was encountered with fabric adhesion in a few areas. The contractor made a few passes with a rubber tire roller after placing the fabric, but apparently did not roll it enough to fully activate the “glue” intended to make the material stick to the surface. A more thorough job of rolling might have prevented these problems, but even as applied the fabric only lifted in

a few areas, and adhesion was only a minor problem. Construction techniques are shown in the series of photos on the next pages.

Figure 5. Apparent Air Pockets in Fabric

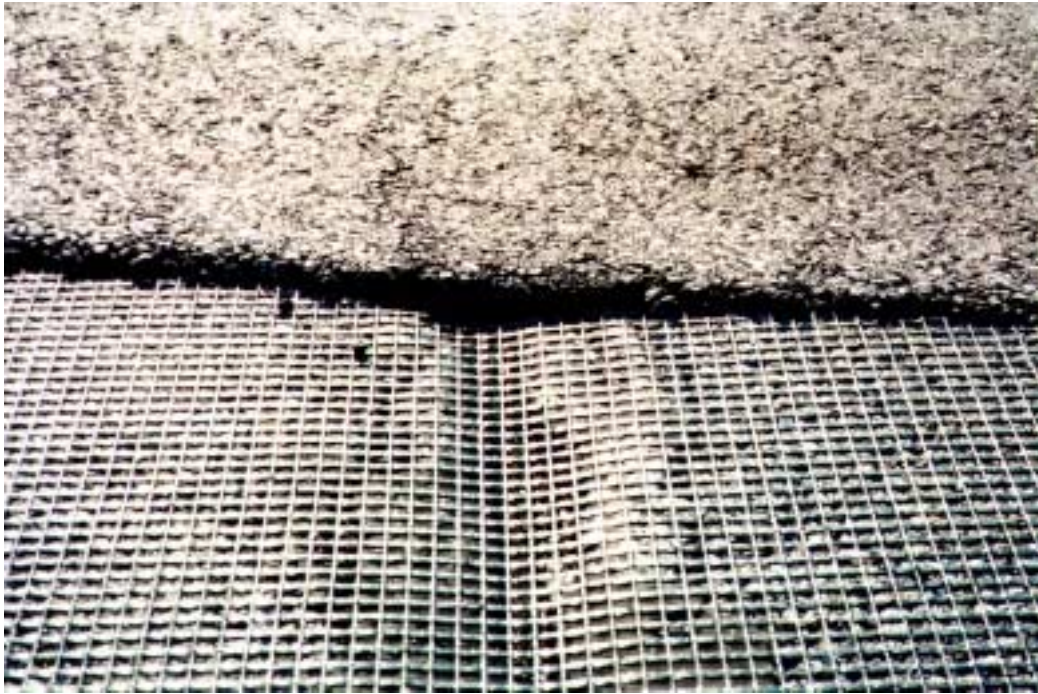
Figure 15

Figure 15. Close-up showing Extremely Deep Crack

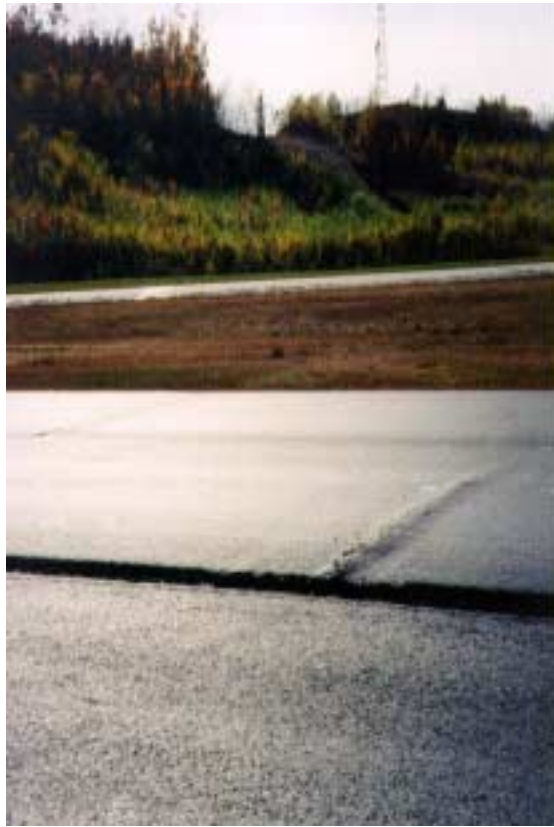
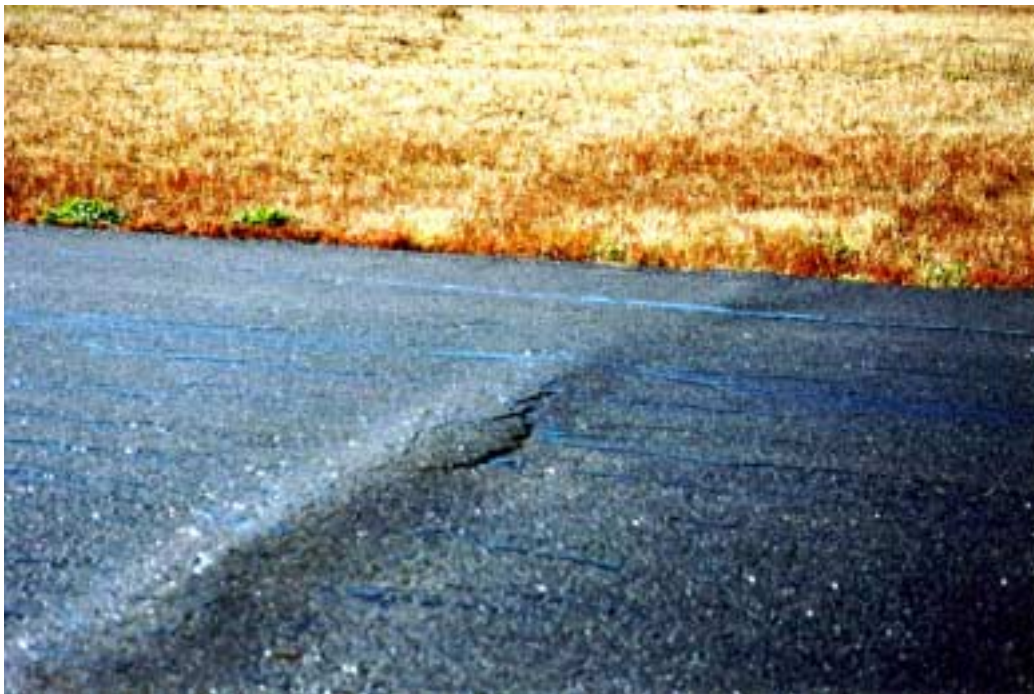
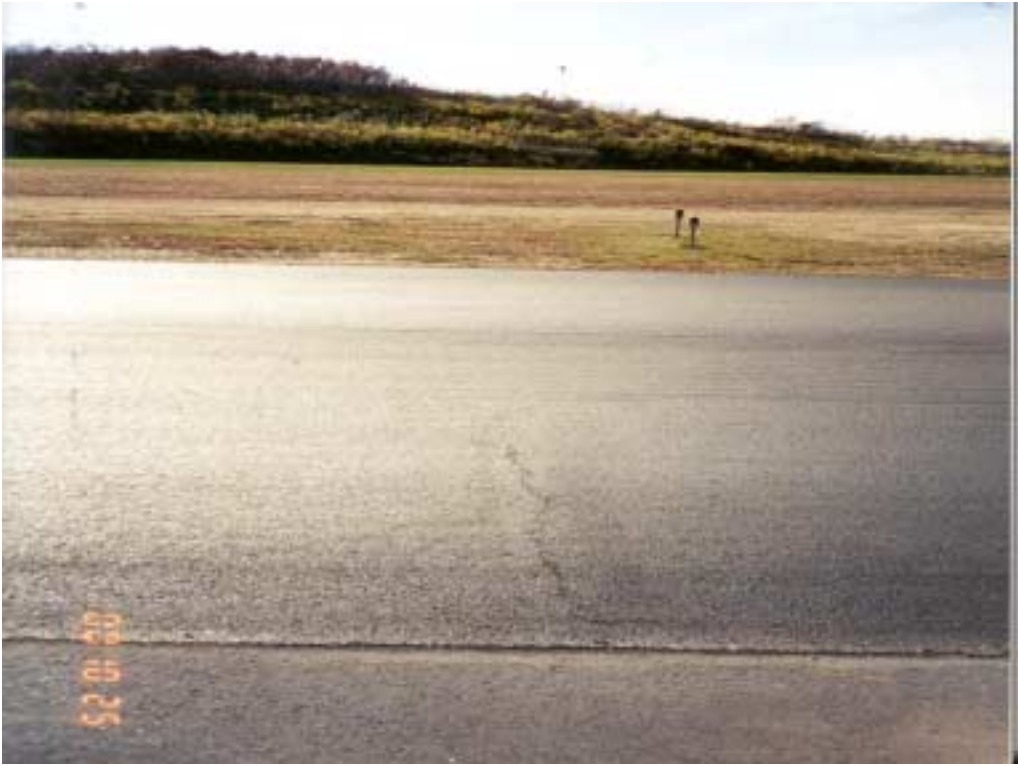
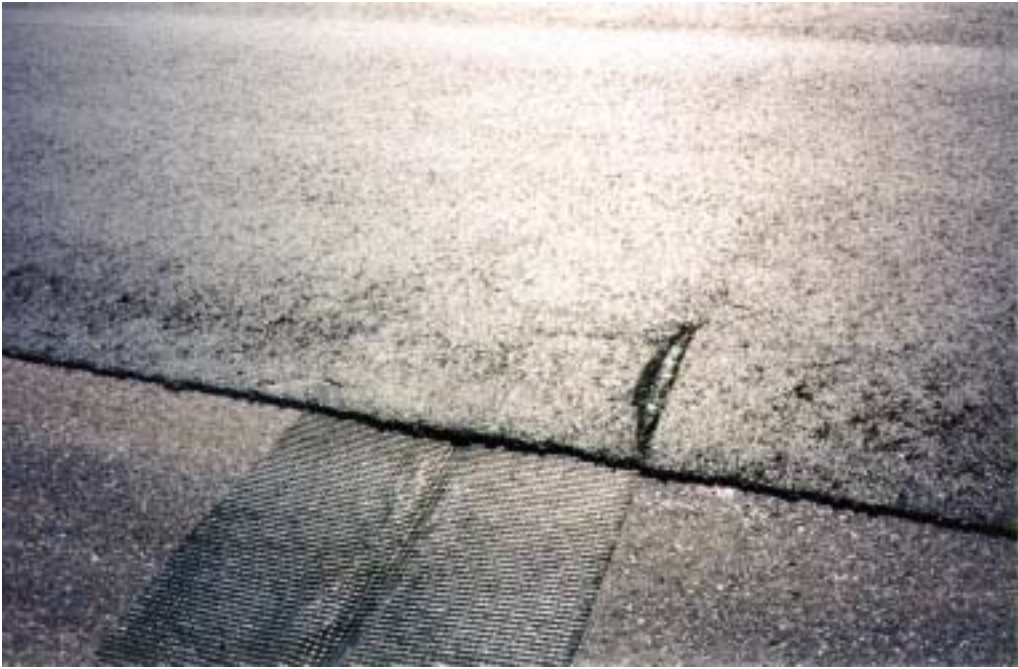
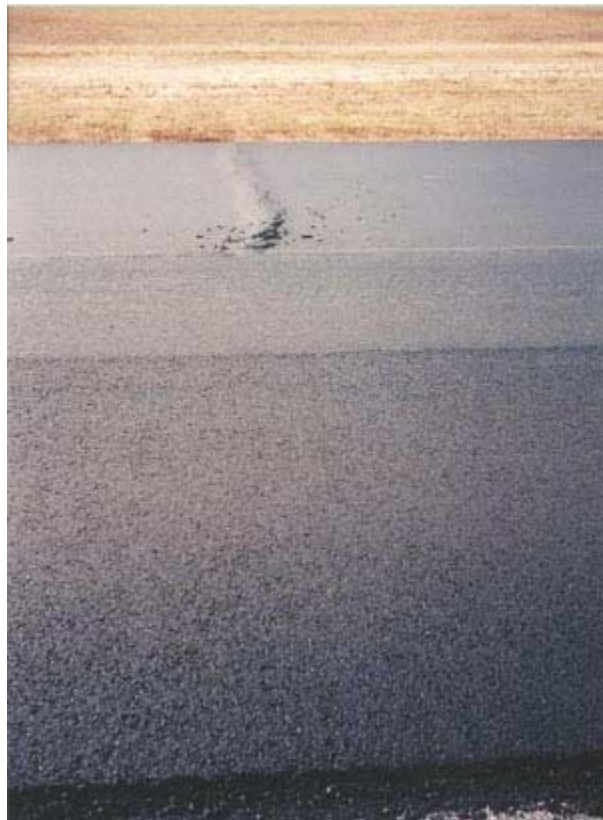
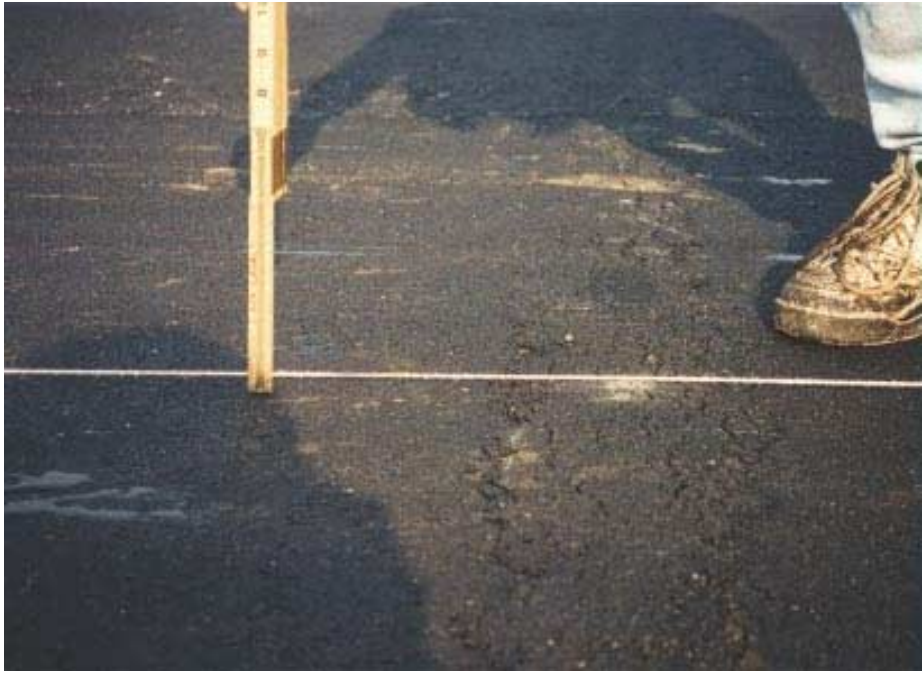
The original plan was to place a single 40 mm lift of HMA, but as the first paving lane was placed problems surfaced. It appeared that the crack sealant reacted with the HMA as it was compacted, liquefying and holding heat, so that a “bubble” was formed above the crack. This led to shoving or creeping as the HMA compaction continued. Two paving lanes were placed with the full depth overlay, as the contractor tried various compaction techniques to alleviate the problems. However, none of the techniques worked, and in the end a 15 mm shim lift was placed on the remainder of the runway width. Also, the contractor was directed to mill the two lanes placed full depth back to 15 mm in preparation for placing a 30 mm wearing course of HMA over the entire width of the runway. After placement of the shim the remainder of the project went smoothly. The milled area extended over the westerly 24 foot portion of the test area, from the south end to the intersection with the main runway.

Figure 16. - Figure 21. Ripples in the Full Depth Layer (prior to Milling and Placement of 30 mm Wearing Course)

MDOT has occasionally encountered similar problems on highway overlays. The problem seems to occur most frequently where a wide overband of sealant covers the crack area. In these cases a shim lift has been used effectively, and it appears that allowing the shim to cool before placing the wearing surface stabilizes the sealant material. Another option would be to mill 6-7 mm off the surface of the cracks, thus removing the sealant overband.

Because of the construction problems, the effectiveness of this test will be somewhat compromised, especially on the two westernmost paving lanes. However, the test area will be monitored along with the control. In the future airport overlays will be accomplished with a 15mm shim and a 30 mm wearing surface where large cracks with extensive sealing are present.

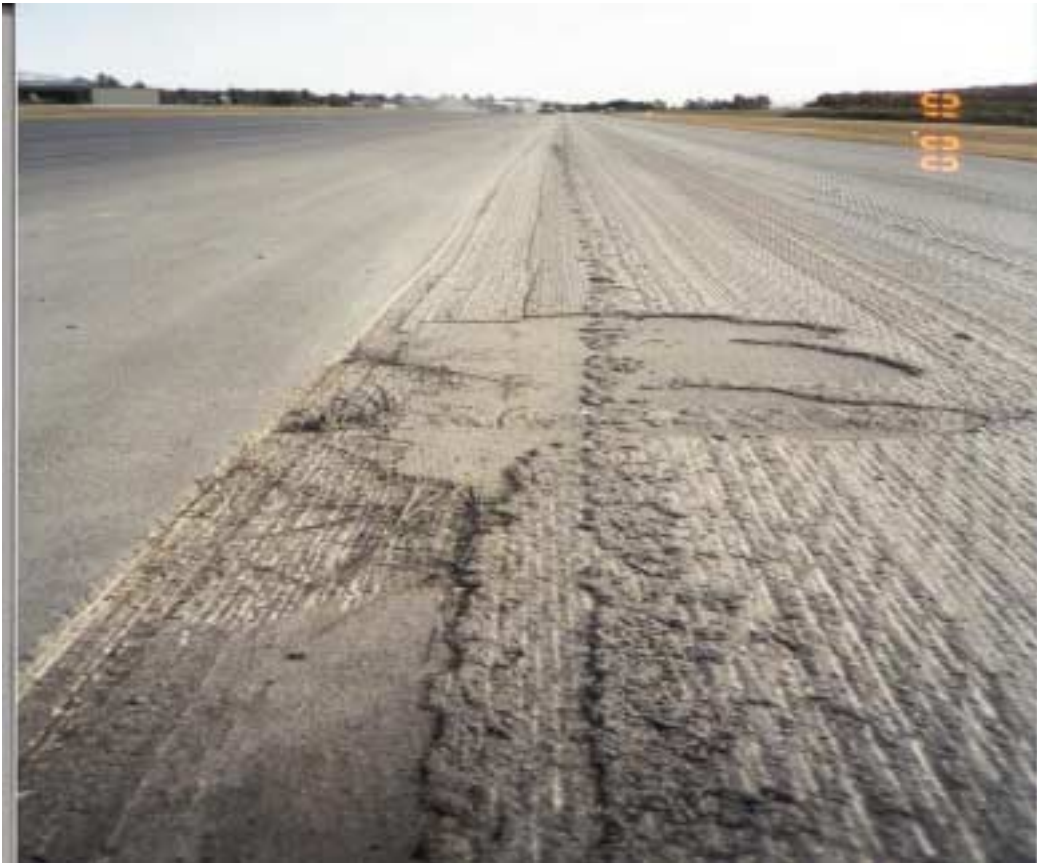
**Figure 22**

Figure 22. Milled Portion of Runway
