CRASH TEST AND EVALUATION OF LOCKING ARCHITECTURAL MAILBOXES

Test Report No. 9-1002-12-9

**TEXAS A&M TRANSPORTATION INSTITUTE
COLLEGE STATION, TEXAS**

TEXAS DEPARTMENT OF TRANSPORTATION

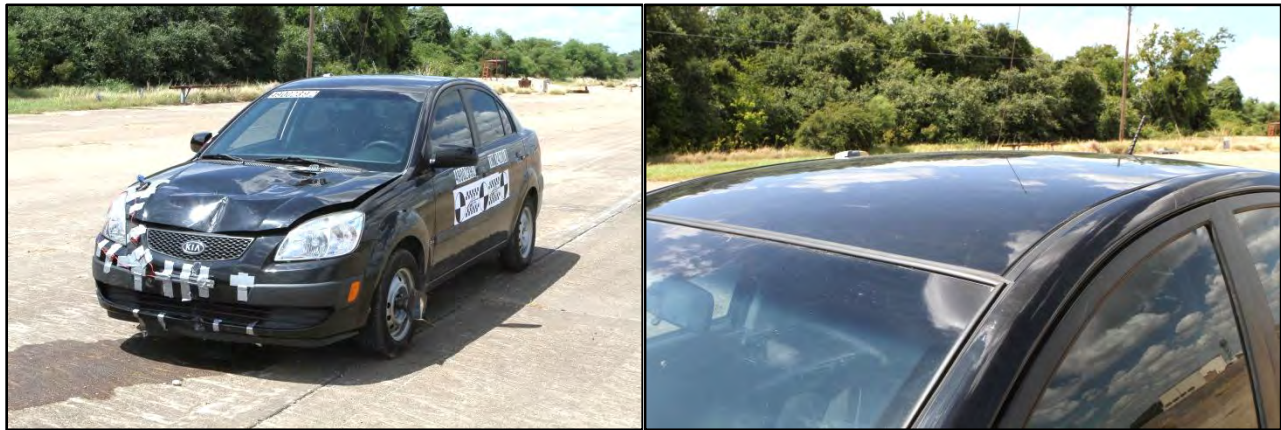
Figure 4.15. Vehicle after Test No. 490023-9-2.

Figure 4.15 shows damage to the exterior of the vehicle, and Figure 4.16 shows the interior of the vehicle. The vehicle sustained a small cut on the hood, and the hood was

deformed inward 1.25 inches. There was no contact of any components of the mailbox system with the windshield. Tables B2 and B3 in Appendix B provide exterior crush and occupant compartment measurements.

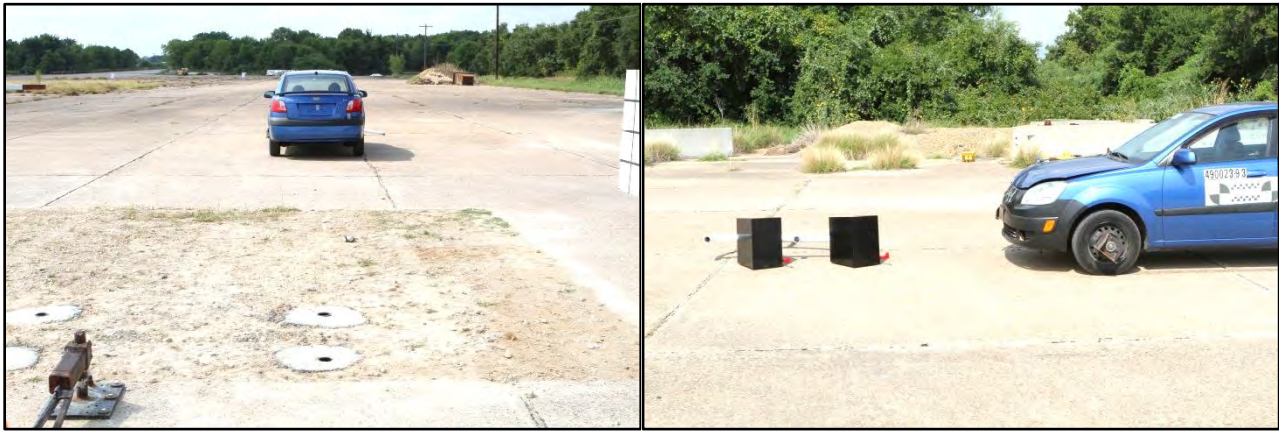
Figure 5.6. Vehicle/Installation Positions after Test No. 490023-9-3.

Figures 5.6 and 5.7 show damage to the locking architectural mailbox installation. The support post lifted out of the socket and was carried in front of the vehicle. The support post was deformed as well as the bracket attaching the mailboxes to the support post. The mailboxes remained attached to the support post and the assembly came to rest in front of the vehicle 58 ft downstream of impact.

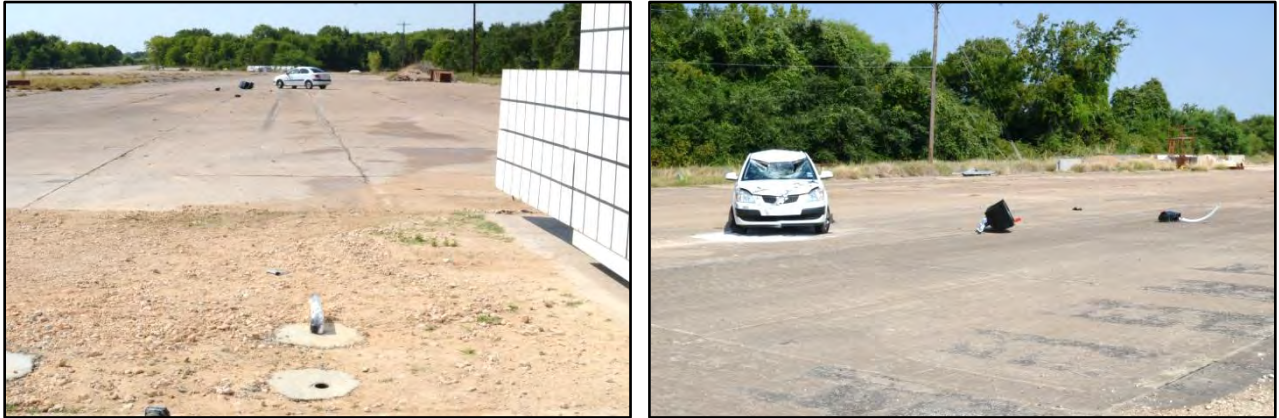
Figure 6.7. Vehicle/Installation Positions after Test No. 490023-9-5.

standard mailbox, and a section of the support post came to rest 192 ft downstream of impact and 10 ft to the left of centerline of the vehicle path.
