An Evaluation of TYFO S Fibrwrap

Final Report

Report 2013 – 05

Reporting on Work Plan 1994-R-7

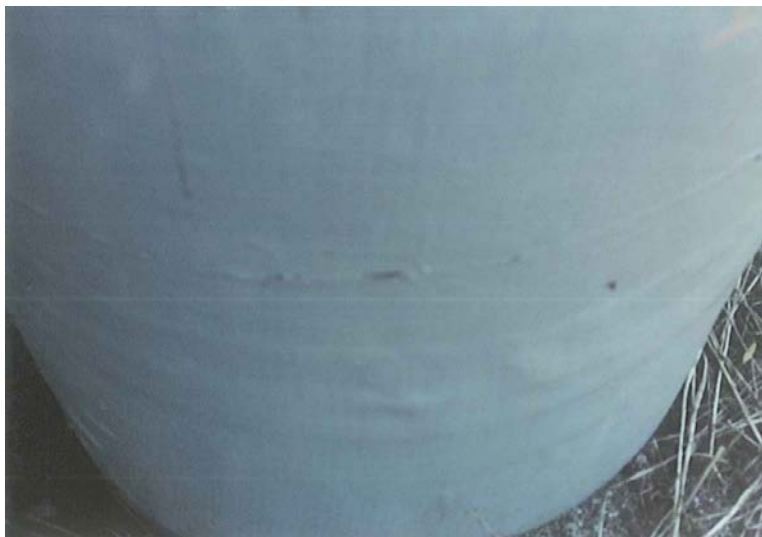
During an inspection in August 1997, apparent bubbles or small bulges in the FRP wrap were discovered, ranging from approximately one to three inches in diameter. A July 1998 inspection showed no change in the size or shape of the air pockets, indicating that they are a result of air being trapped between the Fibrwrap and the concrete at the time of installation and not a result of subsurface activity in the concrete. The status of the bulges was unchanged in the final May 2013 site visit. In June 1999, a separation, approximately one inch wide appeared along a horizontal seam of the bottom wrap of column #1 (Figure 6). This separation had no substantial depth and since the installation of this material involves overlap, there is little concern for salt intrusion. In the final 2013 inspection, the separation did not exhibit any advancement, and appeared to be more of a fray in the FRP fabric that was not smoothed out during installation.

Figure 6 Slight Separation, not substantial in length or depth (1999).

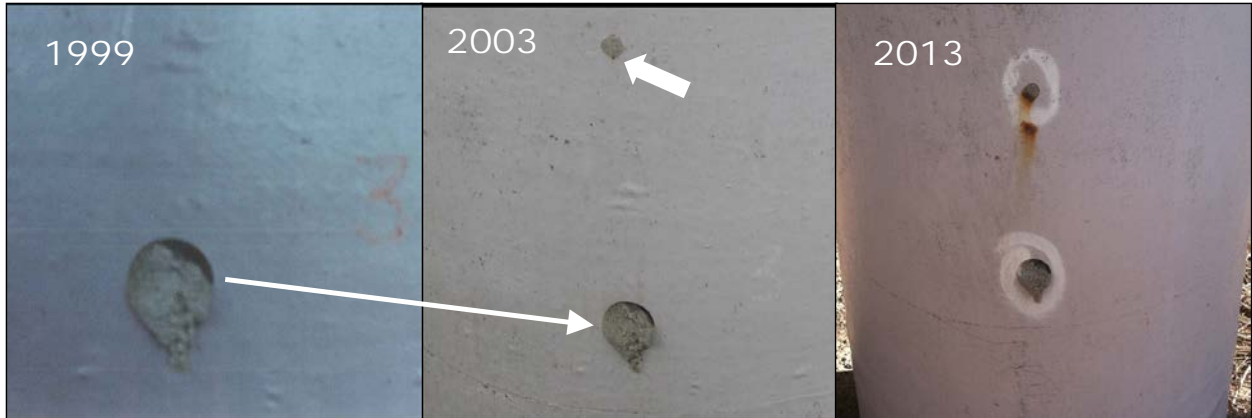
In 1997, core samples turned up no signs of distress in the concrete. During the June 1999 inspection, it was discovered that one of the cored holes in column #2 was inadequately filled resulting in a small void in the top section of the hole. By 2013, no distress has resulted from the void. However, as shown in Figure 7, the core hole above is exhibiting leaching rust, which was originally detected in the 2003 inspection. This leaching has advanced by 2013. A core hole location in column #1 showed some signs of rust leaching out around the perimeter of the former hole in 1999. There may have been some moisture trapped within the hole when it was filled, shown in Figure 8.

Figure 7 Core hole in Column #2 under pier #1 over 14 years.

The leaching rust is likely originating from reinforcing in the column the core cut through, and is slowly bleeding between the in situ concrete and the core filler concrete. As it makes its way out the column, it exits the core hole, but also seems to be seeping between the column concrete and the TYFO wrap in an outward spreading pattern. As shown in the previous figures, the core hole in Column #1 shows a lateral leaching pattern, where the Column #2 core

hole exhibits a downward leaching pattern. The leaching pattern seems to be confined within a three to four inch radius of the core hole.

Future installations of an FRP wrap should be inspected using non-destructive evaluation processes such as Infrared Thermography to check for areas of unbonded or debonded FRP wrap and areas of delaminating concrete. From observations made from the repairs made after taking core samples, it is clear that destructive testing methods put the structure at risk of advanced deterioration.

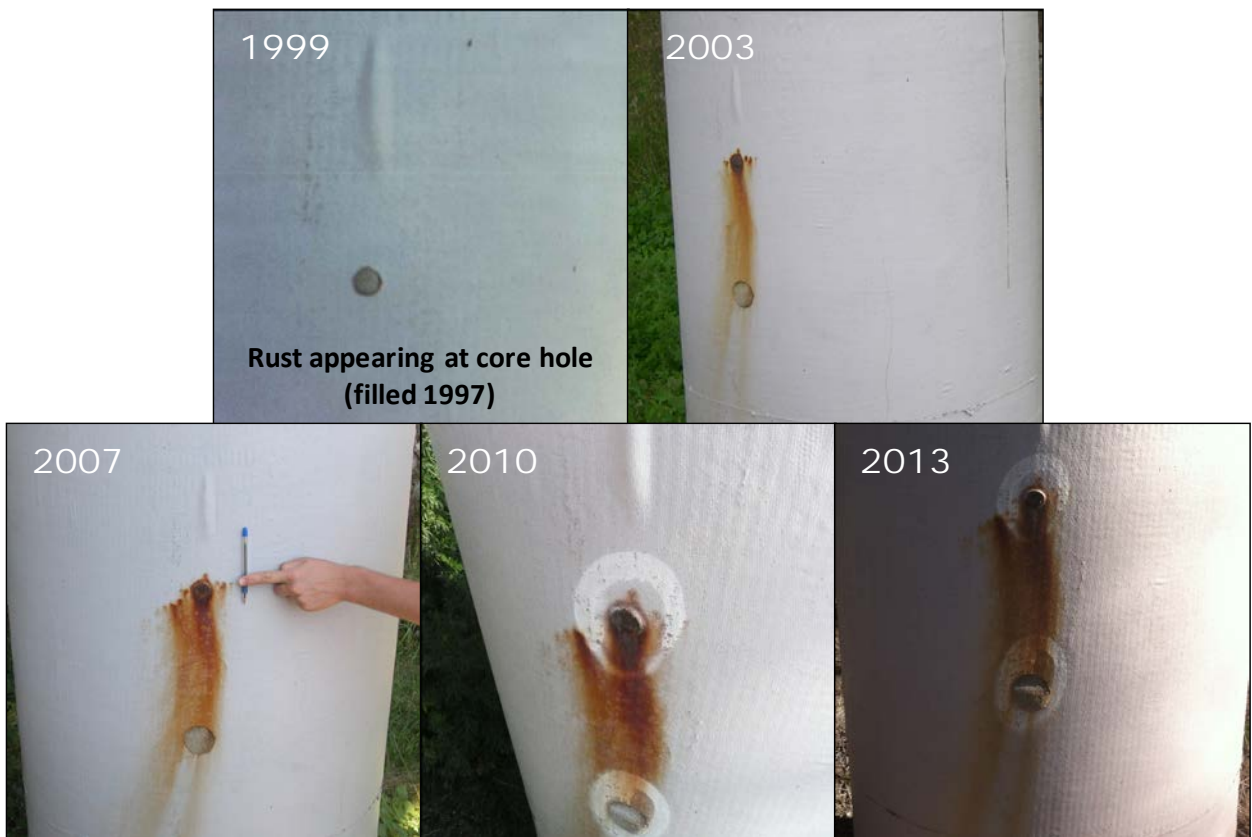
Figure 8 Core hole (filled in 1997) in Column #1 under pier #1, over time.

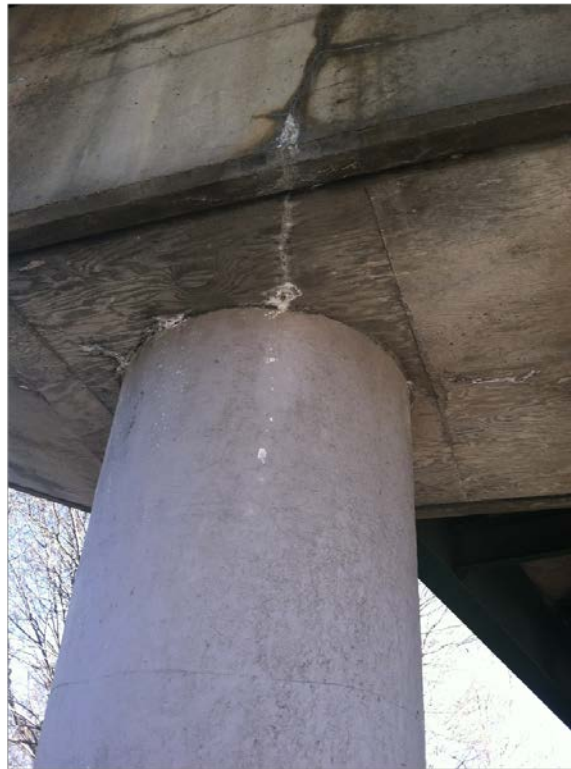
An observation made in 2013 was with chlorides that were leaching out of the pier cap adjacent to the top of Column #3. The chlorides seem to make the customary route to the column via cracks. Rather than remain and build up on the column as what typically happens with concrete, the chlorides seems to be washing, blowing or flaking off the column with typical environmental diffusion of rain, or air, shown in Figure 9.

Figure 9 Chlorides leaching onto column.

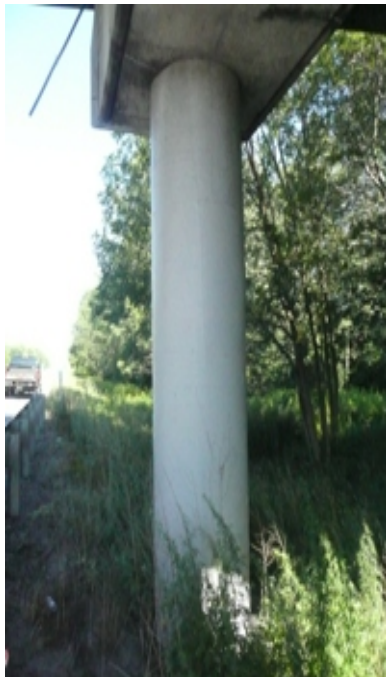
spalling. The control columns are overall in worse condition than the experimental columns. At this point, nearly nineteen years after installation, the TYFO S Fibrwrap material remains aesthetically pleasing as well as structurally sound. A comparison of a wrapped and unwrapped column is shown in Figure 10 and Figure 11.

Figure 10: Column #3 under pier #1, 2010 treated with TYFO S Fibrwrap

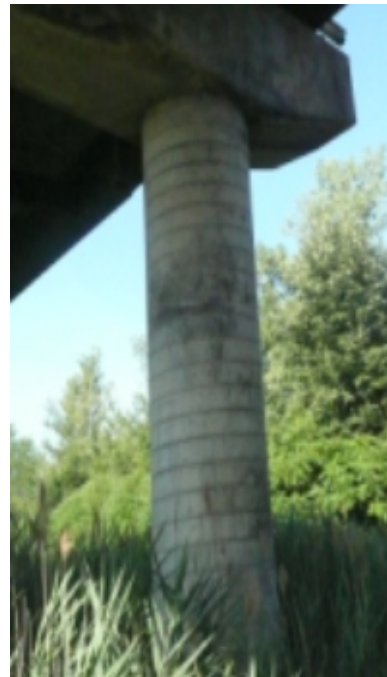
Figure 11: Column #3 under pier #2, 2010 not treated with TYFO S Fibrwrap
