**VERMONT AGENCY OF TRANSPORTATION**

**An Evaluation of Brifen Wire Rope Safety Fence**

**Final Report**

**Report 2013 – 06**

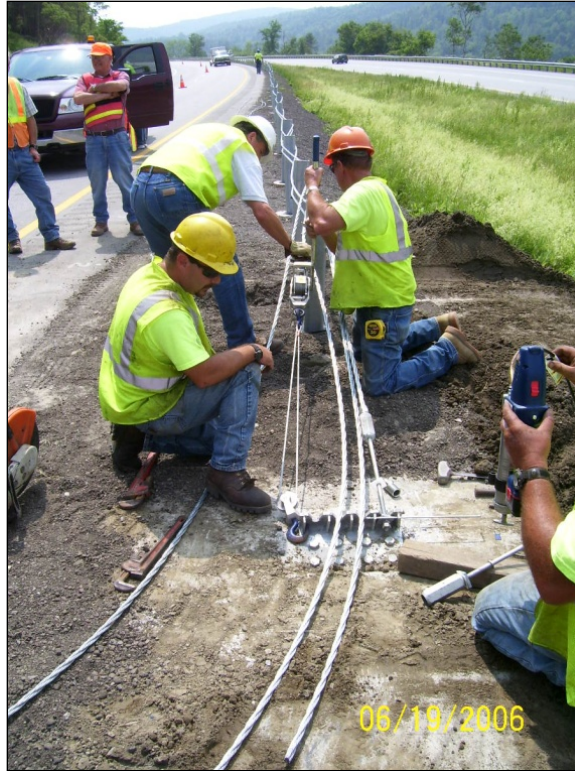
The Brifen Wire Rope Safety Fence was installed on the shoulder of the northbound passing lane of I-89 from mile marker 56.545 to mile marker 56.860. Construction activities took place from May 30, 2006 to June 19, 2006. Installation of the Brifen Wire Safety Fence is shown in Figure 1.

**Figure 1: Fence installation**

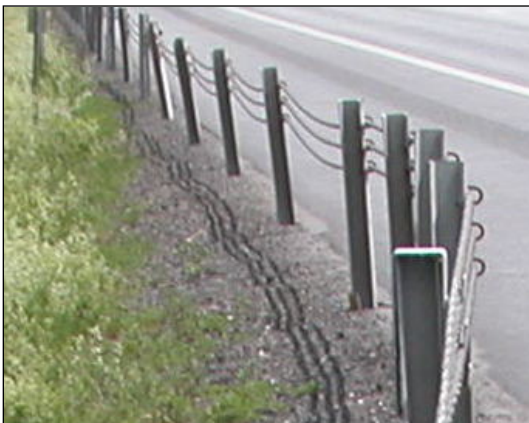
During the initial post installation site visit conducted on June 21st, 2006, the fence appeared to be very highly tensioned and visibly stronger than the standard three rope safety fence which seemed to sag in the middle between posts (See Figures 2 and 3). The referenced three-cable barrier is located on the shoulder of the break down lane of I-89 northbound diagonally across from the Brifen test site and end at MM 56.53. It was also observed that all four wire ropes were secured at the end terminals. While the three-cable wire fence is hung on the front face of the post, the Brifen system weaves two wires around both sides of the posts as shown in Figure 2 and Figure 3.

**Figure 2: Traditional Three-Rope Fence**

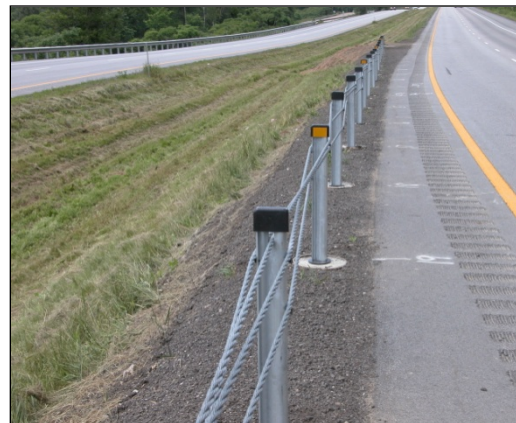
**Figure 3: Brifen Wire Rope Fence Showing Interwoven Wire Ropes**

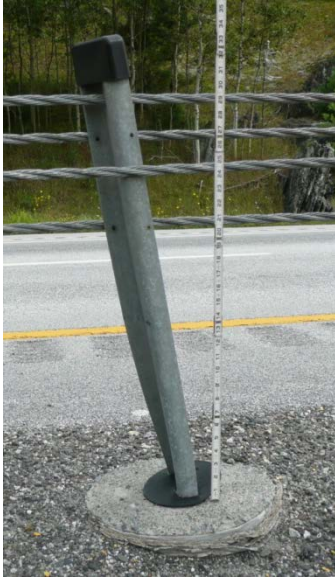
**Figure 4**

During an inspection on August 25, 2008, it was noted that eight of the posts were leaning, twisted, or bent. It appeared that an impact or some kind of torque and tension caused the force/damage to the posts. Some of the wires appeared to be not as tight as other sections on the fence. This might have been caused from the previously mentioned posts that are under torque and are twisting and bending from the force. These defects are illustrated in Figure 4, Figure 5 and Figure 6, which are all examples of posts in tension.

Through site observations it appears that the safety fence is faring considerably well, however the posts under torque is causing concern of how well the fence will continue to work when vehicles make contact with it. The excluder caps, post caps, and locator pegs should be replaced with a more durable material due to excessive cracking and breaking. This fence might not be an ideal choice for Vermont due to the inclement weather and the involved tasks of repairing the fence after accidents. Operations have stated that the repair process is quite extensive, especially in winter months. (4) Shown in Table 2 above, although half as many posts needed replacement over the course of the evaluation the labor costs in the winter months were far more expensive due to the increased effort of extracting the damaged post and replacing and setting the new posts, and tensioning the fence due to cold, inclement temperatures. Labor costs during the winter months, totaled \$2394.34 and during the summer months, totaled \$2099.54. It was reported that 24 posts were replaced during winter months at \$99.76 per post. The cost per post during the summer months was \$42.85. The post replacement costs in the summer months proved less than half of what post replacement costs were during wintertime.

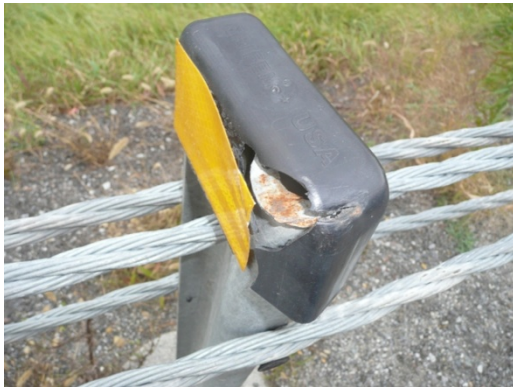
During an inspection on September 30, 2009, it was noted that the post caps and excluders did not appear to be very durable. Many of the caps were cracked, broken, or missing (Figure 7). Many of the excluders were broken. The damage was assumed to be caused by snowplow damage. Almost all excluders were allowing debris and water to build up inside the base (Figure 8). This is a cause of concern due to freeze/thaw and repairing the posts in the winter months. (2)

**Figure 7: Cracked post cap**

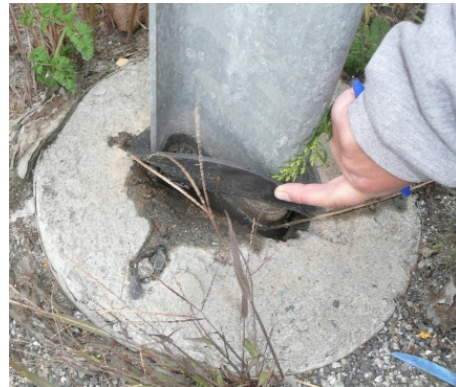
**Figure 8: Debris and water build-up in and around the posts**

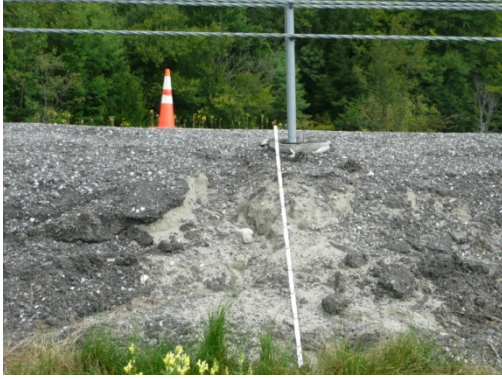
Upon inspection of the Brifen Wire Rope Safety Fence on Monday, August 25, 2008, a considerable amount of erosion was noted. Erosion was evident along the bank of the northbound passing lane, and around the concrete anchors for fence posts, shown in Figure 9 and Figure 10. (4)

**Figure 9: Erosion of the bank - median side**

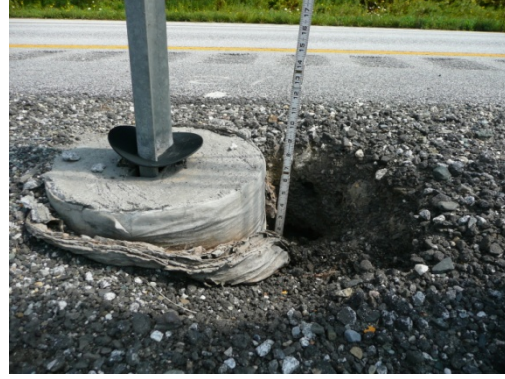
**Figure 10: Erosion around the post foundation**
