**ASSESSMENT OF TECHCRETE A CONCRETE REPAIR
MATERIAL AND JOINT SEALANT**

Report 2013 – 11

December 2013

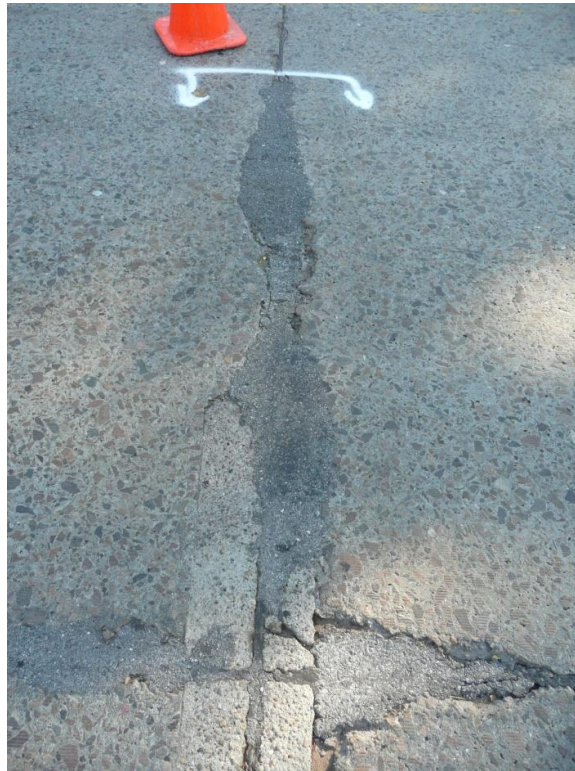
Figure 4 Typical concrete joint deterioration prior to repair

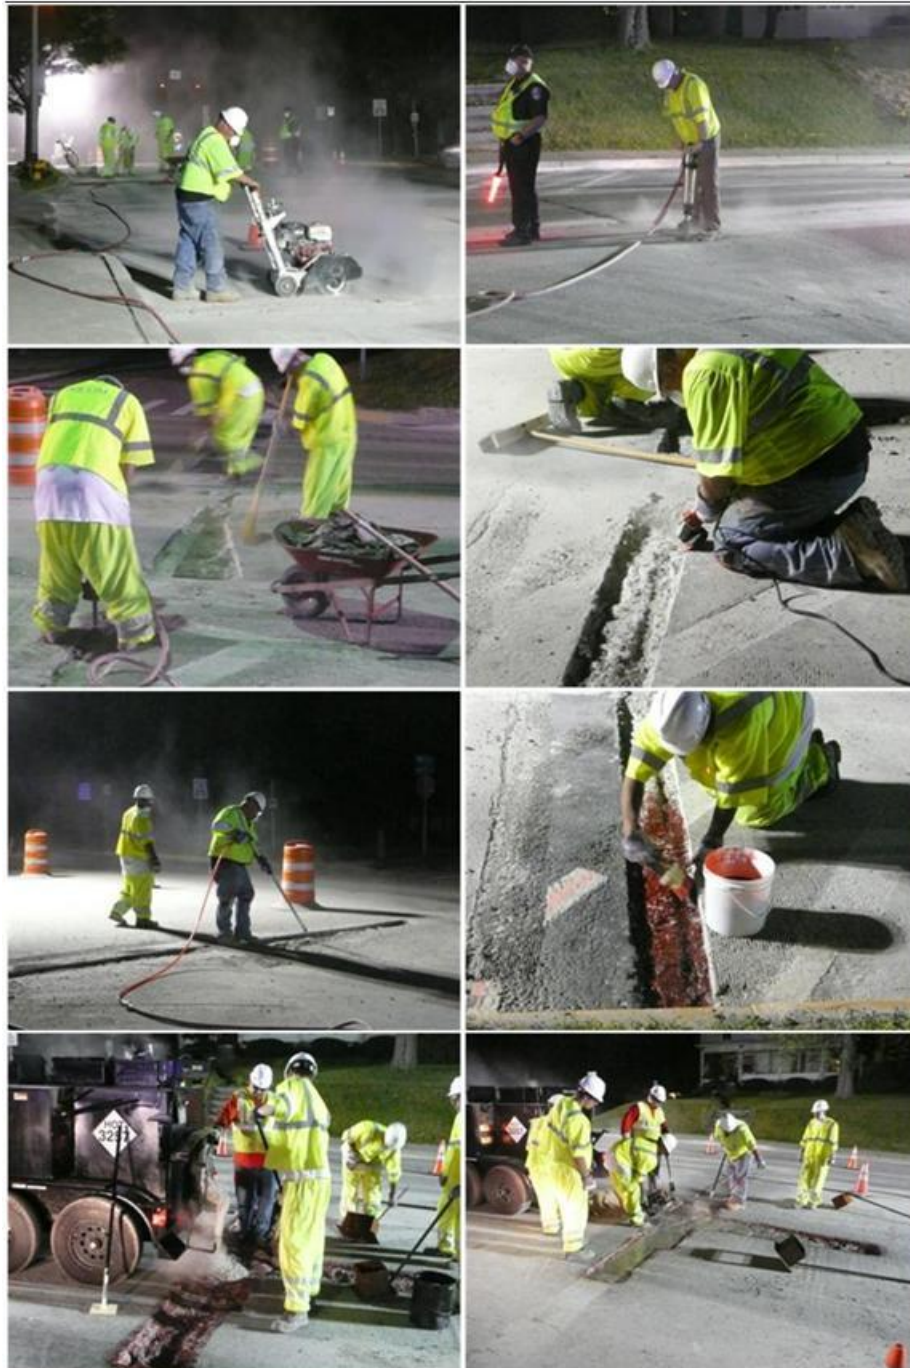
Figure 5 Typical construction sequencing for concrete joint repair with TechCrete

Once repair limits were identified, the damaged portions of concrete and joint filler from previous repairs were removed. This was accomplished by first cutting around the edges with a saw. This can be seen in Figure 5, along with the rest of the process.

The damaged concrete was broken apart using a 60 lb. jackhammer. Pieces were removed by shovel and hand, and then any dust was swept away with a broom. High points continued to be broken up with the jackhammer. After the depth of removed damaged concrete was deemed satisfactory, the edges of the repair joints were beveled. Pressurized air was used to aid in the cleaning of surfaces. After the repair sections were blasted with pressurized air, any

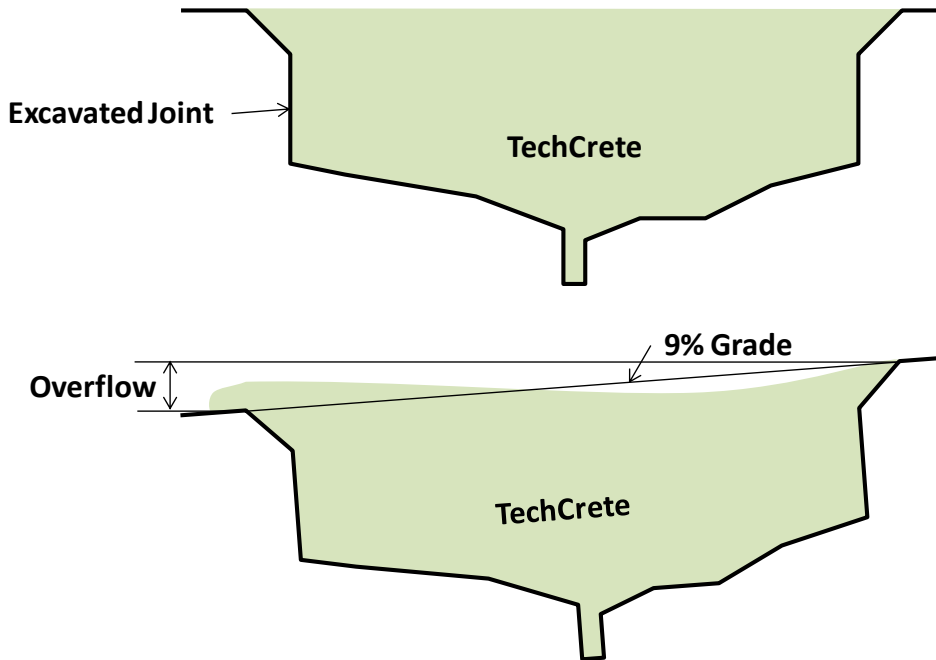
The Winooski portion on US 7 poses a large problem for the installation of a flowable material: the steep grade that encompasses a large portion of the PCC roadway. In conjunction with the chamfer on the upper edges of each joint, the repairs on the steepest section of road (approximately 9.0%) allowed the TechCrete to slowly ooze out of the joints and down the sloping concrete surface, giving an appearance of cooling lava. Additional material had to be placed into the upper elevations of each joint to ensure the higher part of the repair section was adequately filled, while at the same time allowing the material to cool enough to solidify at the lower part to keep the material overflow to a minimum. The chamfer further decreased the height of the 'berm' that would hold the TechCrete in place. The schematic shown in Figure 6 attempts to depict this phenomenon, while Figure 7 shows a picture of an overfilled joint after cooling.

Figure 6 Schematic of difficulty when placing TechCrete on a large grade

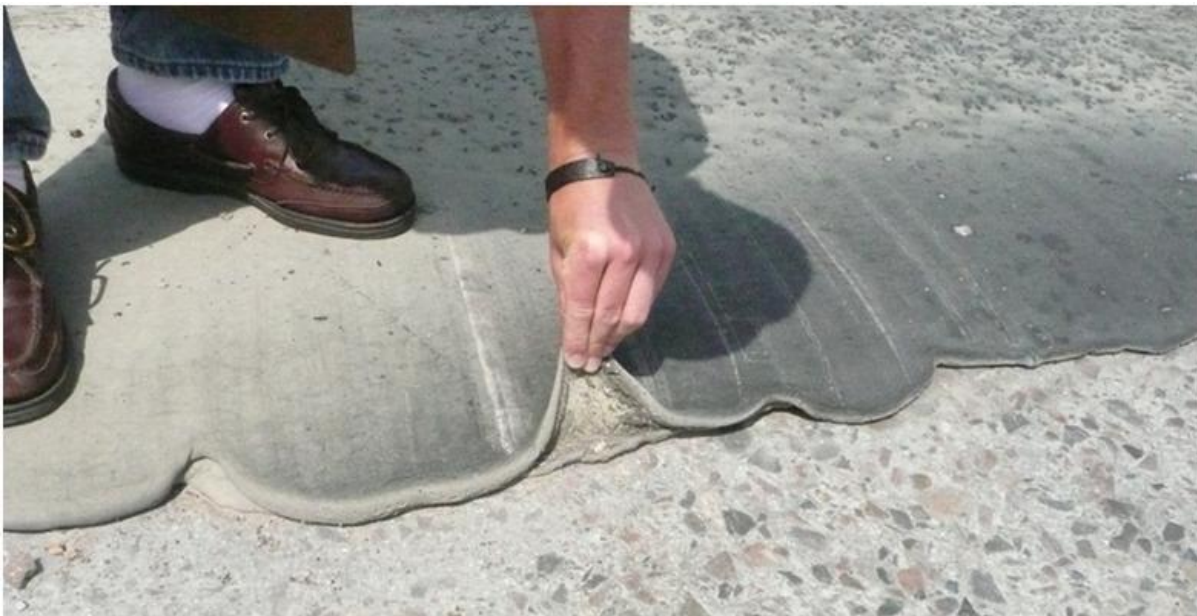
Figure 7 Excessive placement of TechCrete on an inclined joint

As can be seen in the figure, the TechCrete in this joint repair was overfilled and had begun to flow down the grade before cooling and solidifying. Once cooled, the excess material can easily be picked up as demonstrated. All joints that exhibited this overfilling had to be repaired afterward to prevent damage to the material itself and the concrete. A snowplow hitting the material could have damaged one or all of the repair material, the surrounding concrete, or the snow plow itself.

In an effort to repair the worst of the joint repairs on the steepest grade, Nicom, attempted three techniques. The first method was to cut the excess material away with a knife/blade. This method was quickly determined to be ineffective. The second method was to use a grader to plane the material away flush with the concrete pavement. This method was slightly more effective, however the TechCrete material proved to be too tough in most cases for the grader to plane the material effectively; it was a very uneven plane even when the grader was able to remove material. According to the daily work report:

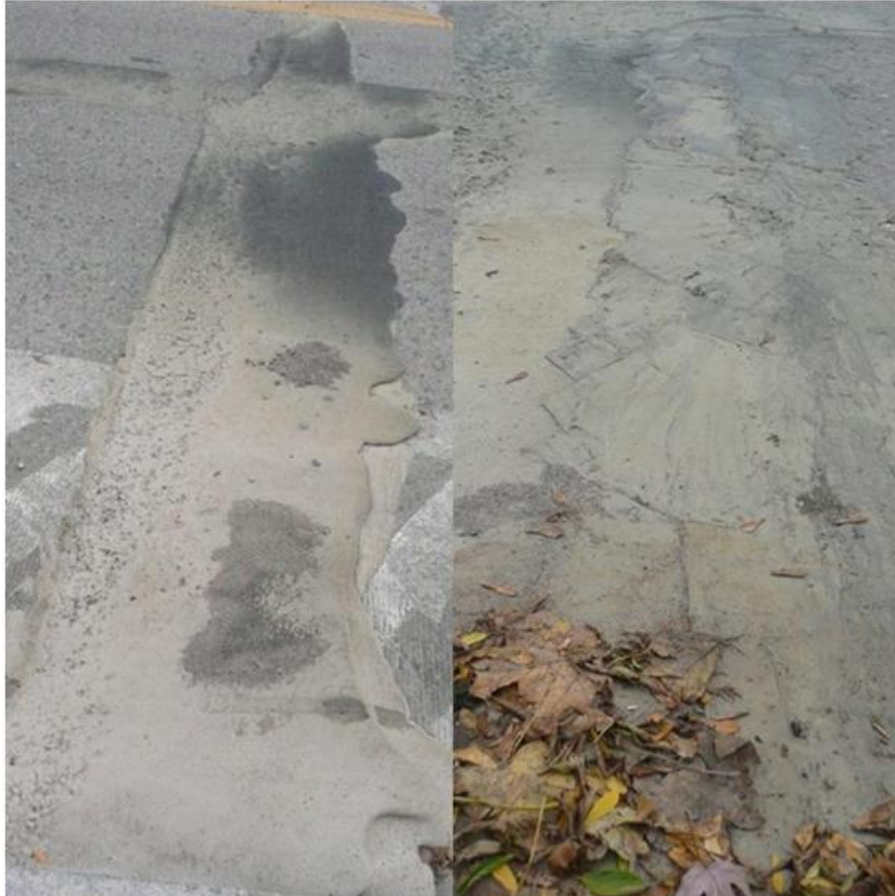
Figure 8 Side by side comparison of an overfilled joint (left) and the same joint after removal of material (right)

The image on the left of Figure 8 is a joint prior to repair, with a considerable amount of extra TechCrete having been placed into the joint. The right-hand side shows the same joint after a heated iron had been used to remove material and smooth out the remainder. The joint is virtually non-distinguishable as being the same one; its appearance is far different after repair. The extra material has been removed as well as possible and the markings from the iron are still visible. The joint is now much more effective, as it does not act as a speed bump as traffic moves across it, nor is it an obstacle for a snowplow.

The third method attempted was to heat up the material and a scraper with a propane torch and scrape the material off, as described above for October 5th. This was very similar to the method of applying the material at installation, where a hot iron was used to apply and

smooth out the TechCrete. The actual use of a hot iron was the repair method suggested by CrafcO. Once the three methods were attempted the third alternative was chosen as the preferred method, numerous joints were repaired once again, most of them being located adjacent and around the Key Bank area. Figure 8 shows a before and after comparison of one of the joints.

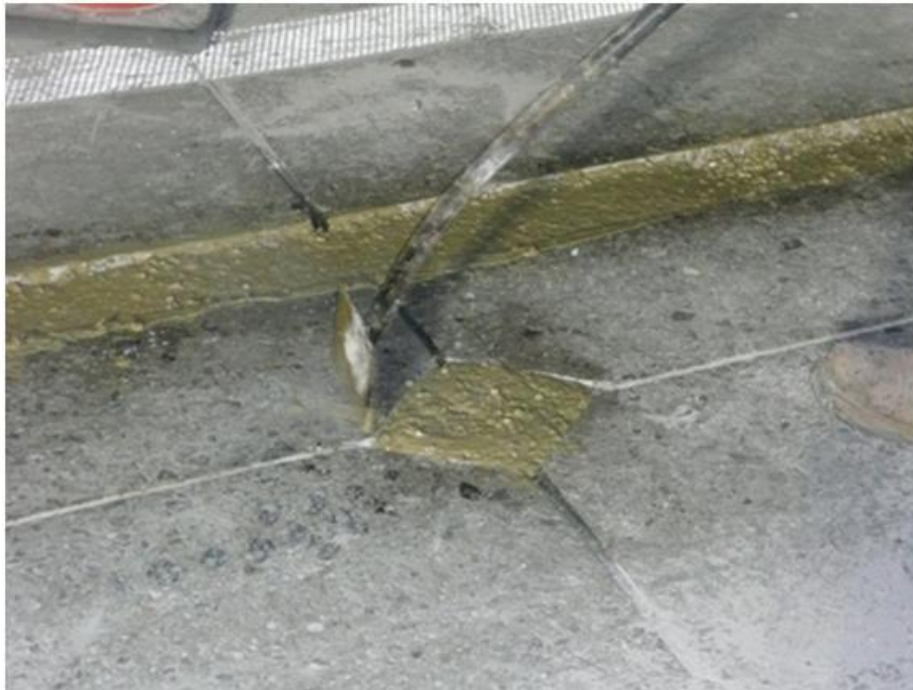
Figure 9 Hot iron used during TechCrete placement for leveling

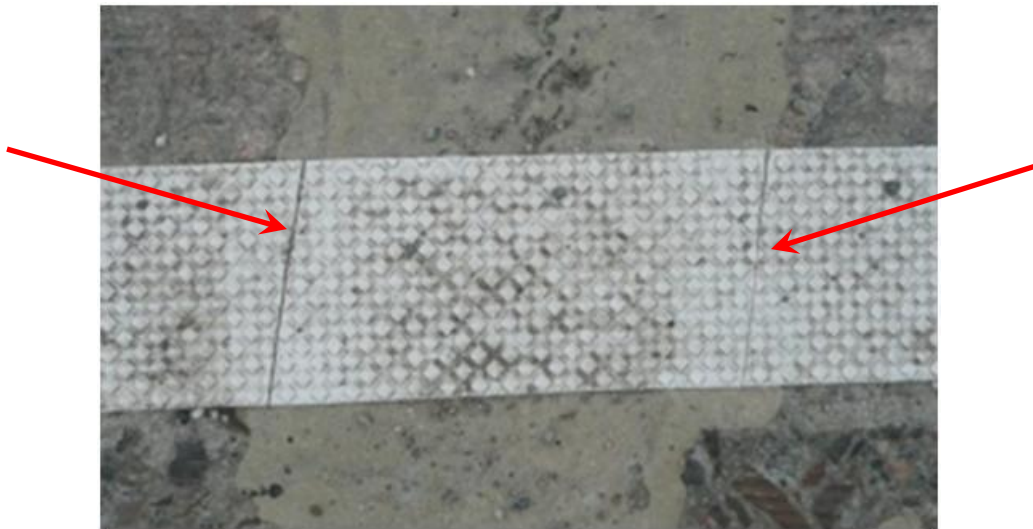
Figure 10: Durable pavement marking tape laid over both PCC and TechCrete. Please note the knife cuts on either side of the TechCrete

The solution that was decided upon was to grind the concrete, but not the TechCrete. Where in contact with the TechCrete, the tape would have a much higher profile, thus creating a spot much more susceptible to traffic wear and snowplow damage. It was decided that the tape would be cut on both sides of the TechCrete repairs. If damage or delamination were to occur over the repair material and tape was pulled off, only a foot or two of tape would be lost (between cuts) rather than losing a much longer strip of tape measuring in the tens of feet. Pictures of both the cuts and profile views of the tape can be seen in Figure 10 and Figure 11.

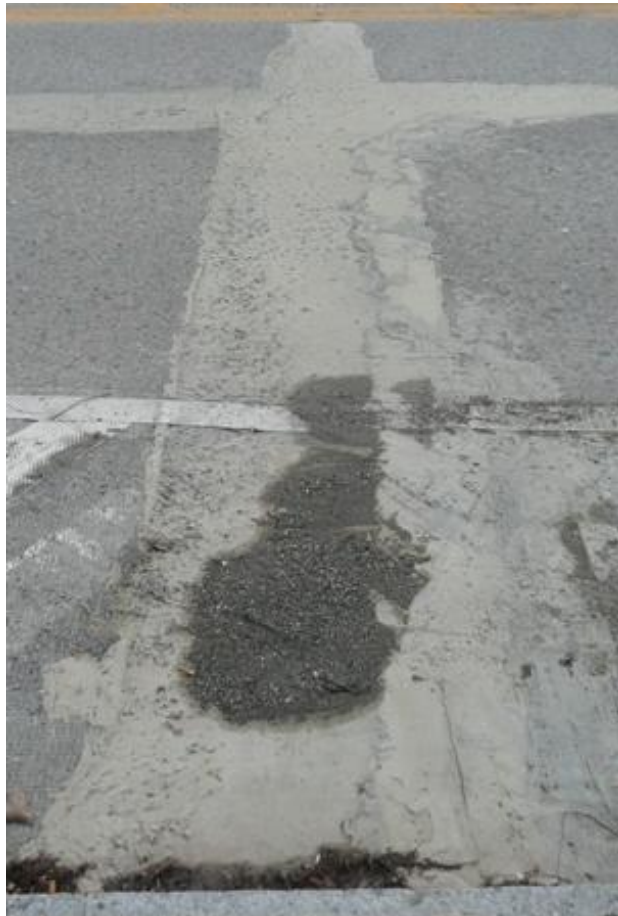
Prior to the 2008 pilot project with TechCrete, the concrete repair of 2002 had deteriorated significantly; with lengths of the concrete joint repair being fragmented. Figure 4 in this report gives an example of the state of that repair. Over the years since the repair, Winooski used asphalt patching material to seal the joints in places. In comparison, TechCrete has maintained a monolithic longitudinal integrity, and has maintained its position within the joint.

Figure 12: Condition of joint following first winter season

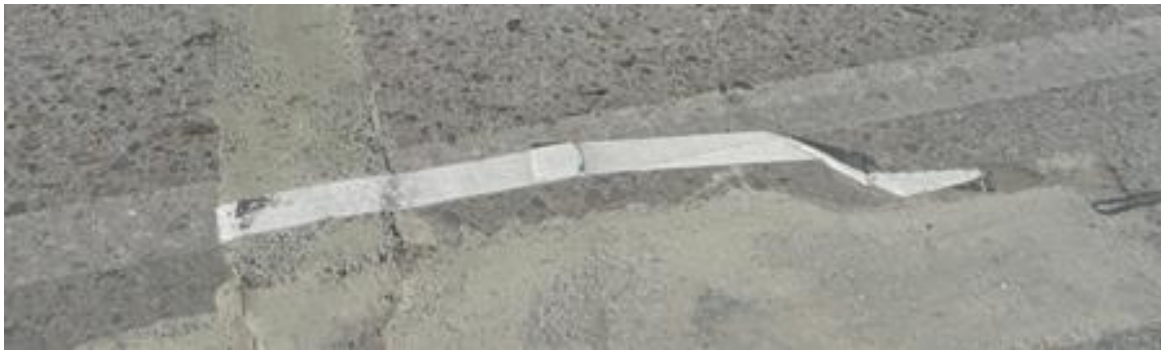
The traffic marking tape on the project has not performed as well as the TechCrete material has. As previously stated, it was assumed that the portions of tape that were placed on the TechCrete would be the most susceptible to plow and traffic damage because of their higher profile when compared with the recessed tape on the concrete surface. Countering these assumptions, what was discovered was that most of the tape damage resulted from delamination from the concrete surface. Several long and short lengths of tape detached from the concrete. The reasons for this are unknown, but should not be completely due to snow plowing as the tape was recessed. The plow would only be able to catch and edge or corner of the tape and pull it up, if it had not been initially adhered to the concrete. Images of the tape deficiencies can be seen in Figure 13 and Figure 14. Figure 13 shows a portion of tape soundly adhered to the TechCrete, but completely missing up and down station from the repair, with only a short segment of the tape detached from the concrete. Most marking damage was present at the Winooski portion of the project, with little damage on US 7 in Burlington.

Figure 13: Tape markings adhered to TechCrete but not to the concrete

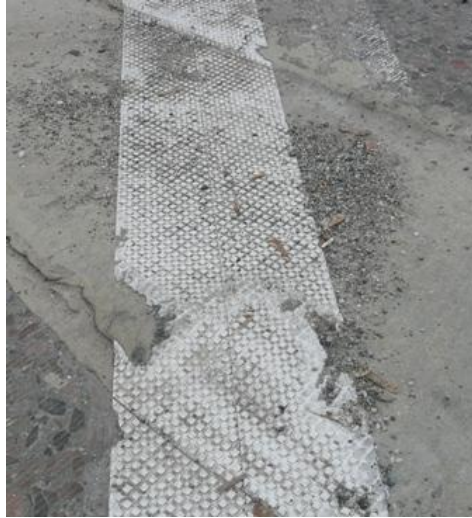
The tape markings on the TechCrete were slightly worn. In all locations where tape was placed on TechCrete, the tape remained in place; no tape has delaminated from TechCrete. What has happened is that the tape has worn down, especially on the highest spots, due to plow and traffic wear. Figure 14 below shows tape wear on the TechCrete, with the highest portion of the repair being at the bottom of the picture.

Figure 14: Tape wear over the higher points on the TechCrete repair

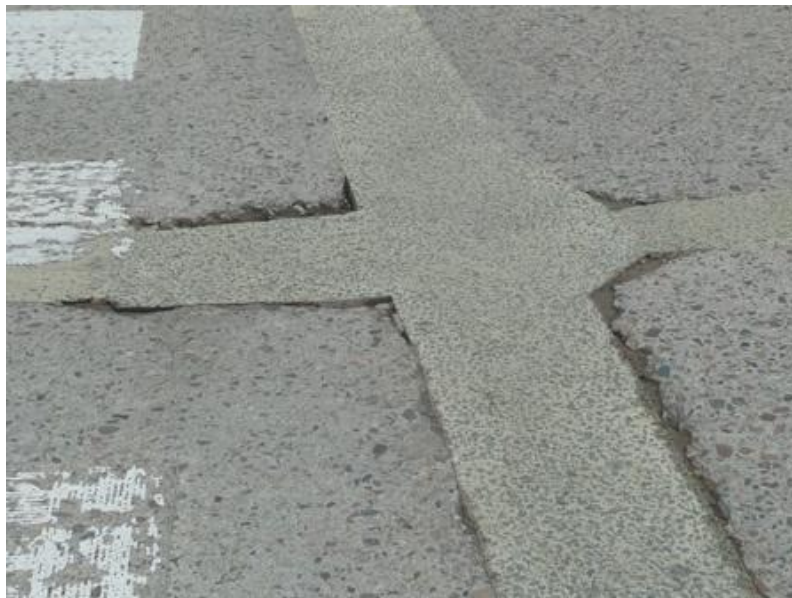
Site visits have been made following each passing winter. Each site visit showed that the TechCrete repair material was performing well and was intact in all locations as of early 2013. The quality of the concrete around the TechCrete repairs, however, has deteriorated drastically in some areas, as can be seen in Figure 15 below, from 2011, and Figure 16 from 2013. Some corner areas have spalled considerably around the TechCrete; the TechCrete shows no signs of damage or deterioration in these areas. The reason for such rapid deterioration of these corner areas of the concrete has not been determined.

Figure 15 Condition of some repair areas following the second winter of service life (2011).

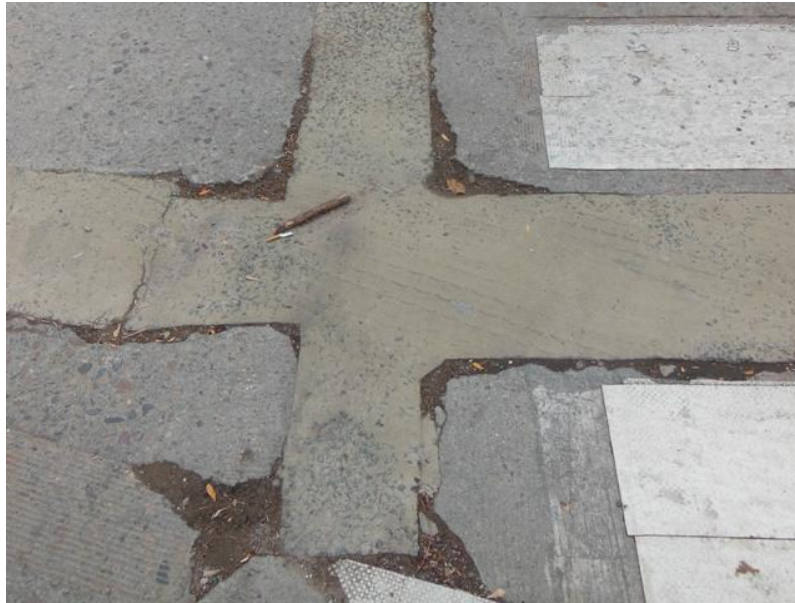
Figure 16 Condition of some repair areas following the fourth winter of service life (2013).

The concrete repair of 2002 in Winooski proved to extend the life of the concrete pavement by 5 or 6 years. In 2008, the City of Winooski began seeking means to repair the deteriorated repair of the joints. In 2009, the Agency worked with Winooski in repairing the joints with TechCrete. By 2013, 4 years later, the joint repair material is maintaining its integrity, though the supporting in situ concrete is continuing to deteriorate.
