VERMONT AGENCY OF TRANSPORTATION

Materials & Research Section
Research Report

CARGILL SAFELANE® HDX OVERLAY

Report 2014 – 04

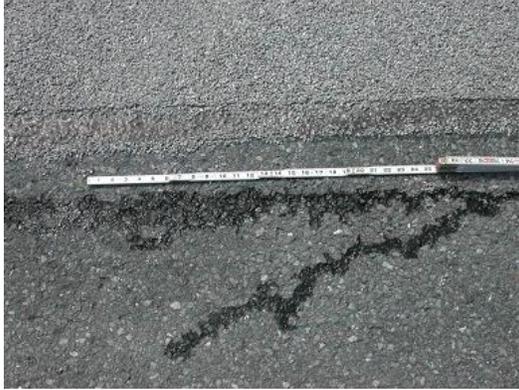
On the second day of the installation, water seepage along the centerline joint was noted in the travel lane and was attributed to the heavy rainstorms the night before. Table 6 summarizes the water seepage locations. The water seeped through the first lift of the overlay as can be seen in Figures 10 and 11 below.

Approximately four months following installation, these areas began exhibiting distress in the form of “pop-outs” where presumably the hydrostatic pressure of the groundwater within the steep incline caused the portions of the treated area to essentially lift from the layers below resulting in “pop-out” or pothole areas. In most cases, these uplifted areas were not merely the overlay but portions of the underlying pavement as well. These areas are summarized in Table 7. Some of the pop-out or pothole areas are near the water seepage locations noted during the application. Figure 12 shows one of the potholes. As such, many pop-outs were failures of the underlying pavement and not the overly itself.

Figure 12: Water leaking from the centerline joint

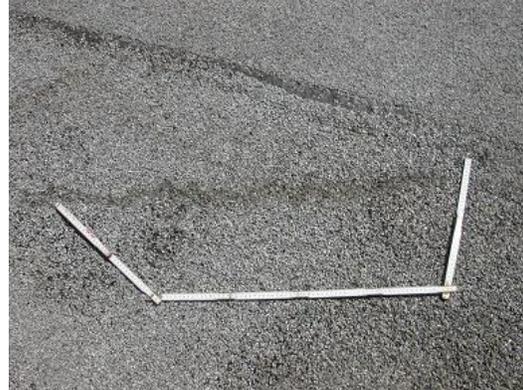
Figure 13: Water seeping through 1st lift of overlay

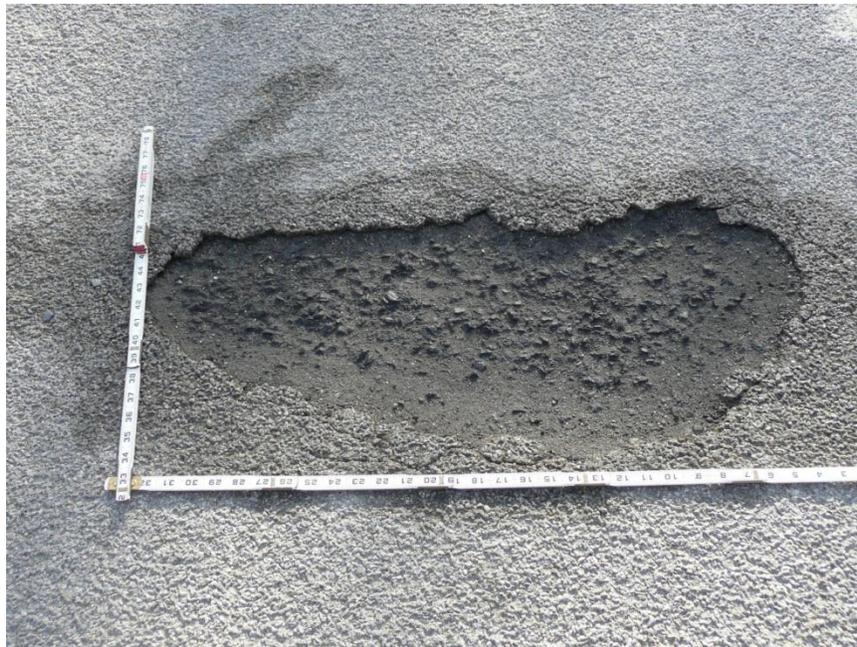
Figure 14 An example of a pothole. The underlying pavement was lifted out with the overlay.

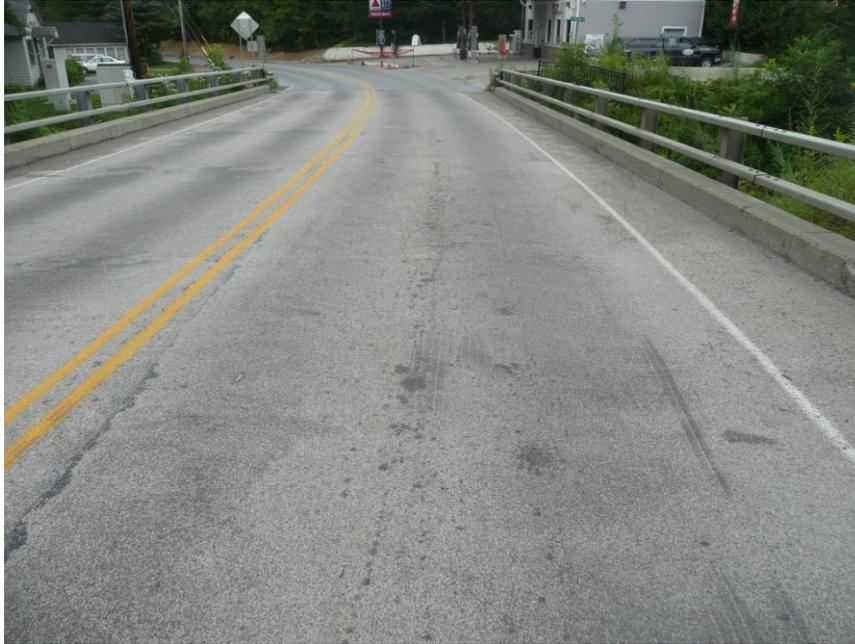
noted that the wheelpaths of the overlay were slippery. The surface was damp due to precipitation during morning hours. Upon furtherer examination, it was noted that within the wheelpaths, little aggregate remained on the surface of the experimental overlay. Instead, as shown in Figure 18, exposed epoxy was present in the majority of the surface of the overlay.

Cargill representatives were contacted and an onsite meeting to collect material and determine possible causes was conducted in September 2010. Attending were representatives from District 5, Cargill, and Materials and Research personnel. Ten cores of the overlay material were extracted to examine the current condition of the overlay and probable causes. Cargill personnel examined the cores at their central laboratory. They believed the loss of aggregate was due to studded tires. An earlier hypothesis was that the epoxy set up too quickly which did not allow enough time for the aggregate to bond properly to the epoxy. The analysis rebutted the earlier hypothesis. See Figure 19.

Figure 18 The darken wheel paths show where the aggregate has been stripped, exposing the underlying epoxy (2010).

Because of the premature failure in the wheelpaths, Cargill agreed to repair the overlay with a harder aggregate, which was projected to resist the wear of studded tire use more effectively. Due to time and weather constraints, the repair did not take place until August 2nd and 3rd, 2011. Research, District 5, Cargill, and Parent Construction representatives were onsite.

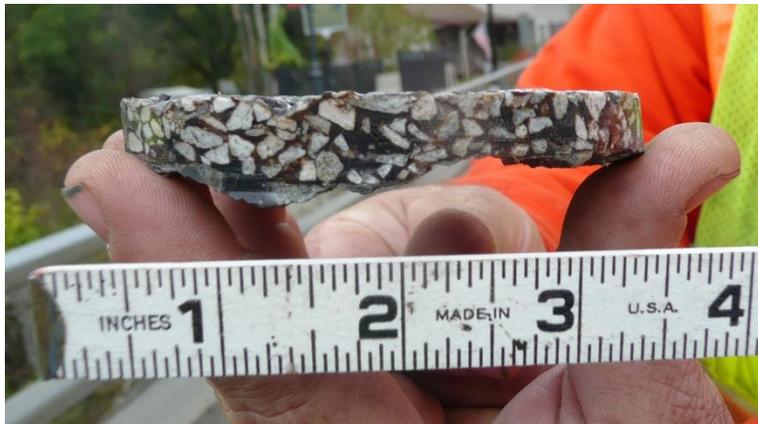
Figure 19 Core of the overlay.

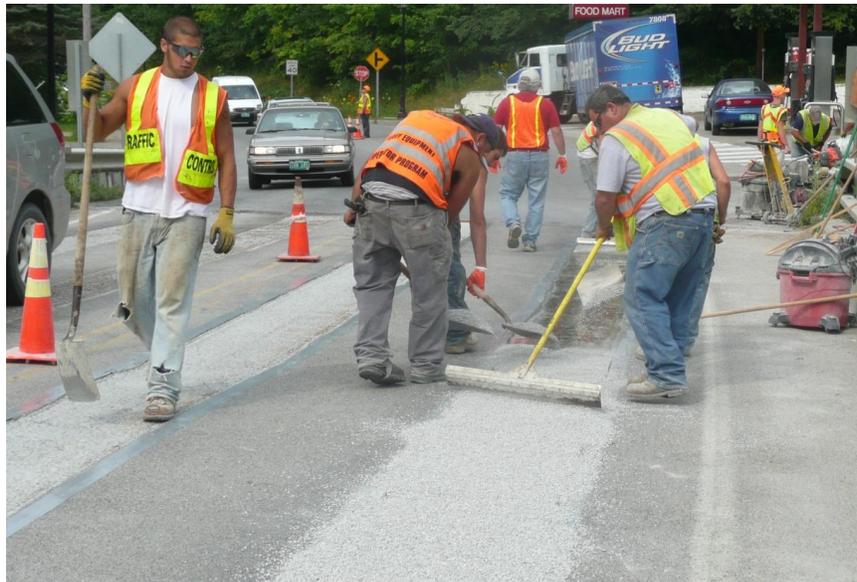
Figure 20 Repairing the wheel paths.

To prepare the surface the wheelpaths were milled to remove any remaining epoxy or aggregate from the original overlay. One lift of the epoxy and aggregate was then placed. Once cured, traffic was switched to the other side and the wheelpaths in the other lane were completed. As of the summer of 2012 the overlay appeared to be in good condition with no reports of crashes or incidents at the location.

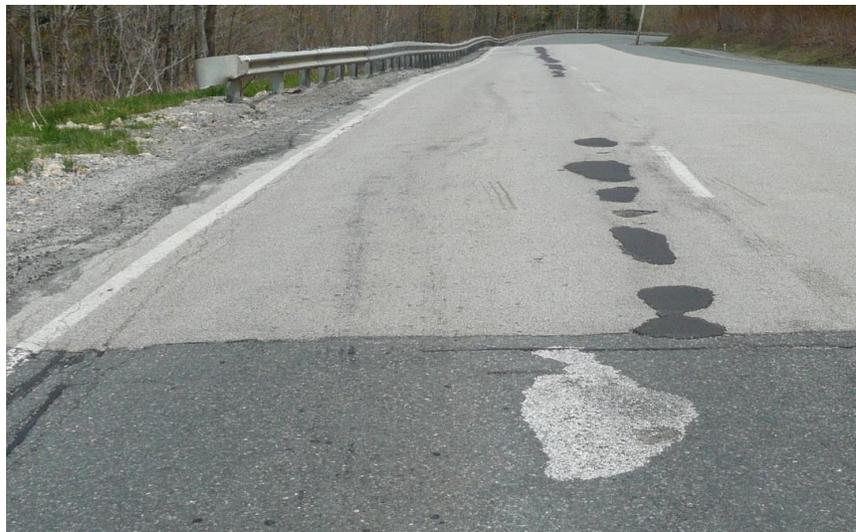
Figure 21 Pothole repair less than a year after application.
