1. Report No. FHWA/LA.14/526		2. Government Accession No.		3. Recipient's Catalog No.	
4. Title and Subtitle Data Collection and Evaluation of Continuity Detail for John James Audubon Bridge No. 61390613004101		5. Report Date October 2014

16. Abstract This report summarizes findings from monitoring data that was collected over a two-year period from Bridge No. 61390613004101 in the John James Audubon Project, which was formerly designated as Bridge #2 prior to construction completion. The bridge was instrumented as part of an earlier project (LTRC Project No. 08-1ST). Results from the first monitoring project warranted resuming data collection to monitor the performance of Bridge No. 61390613004101 over a longer period of time. The focus of the monitoring effort for both projects is on the employed continuity detail, which is based on the recommendation of the National Cooperative Highway Research Program (NCHRP) Final Report 519. Continuity details are typically used to eliminate the needs for high-maintenance joints that often lead to the acceleration of element deterioration near the joints. The employed positive moment continuity detail transfers forces between adjacent girder

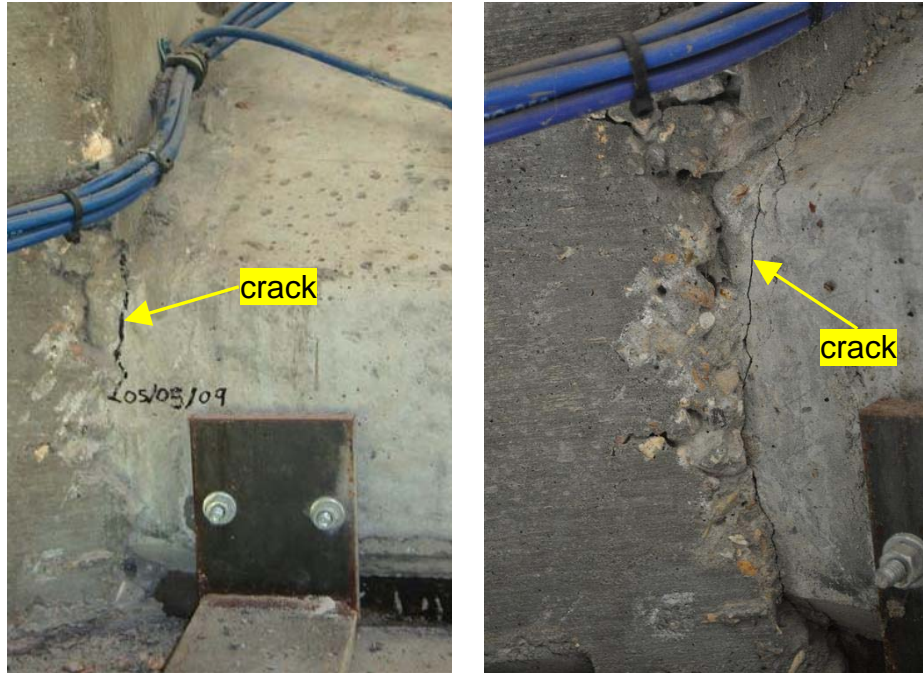
Figure 3
Observed crack at bottom flange of Girder G3 – Span 24 – Bent 24

The main crack that was observed in Girder G3 can be seen in Figure 3. It was first observed during a site visit in May 2009. At that time, the crack could only be seen extending from the top of the bottom flange to its mid-height [see Figure 3(a)]. During another visit in October 2010, it was clear that the crack propagated and could be seen extending all the way to the soffit of the girder [see Figure 3(b)]. Other than this girder (G3), no other cracks were observed in the remaining girders except for a small crack at the other end of Girder G3 in Span 24 at Bent 25. The growth of the crack was attributed to additional creep deformation, which caused additional positive moments that lead to an increase in tension forces in the hairpin bars. Positive moments that develop due to the combined effects of creep and thermal gradient can cause tensile stresses at girder ends in excess of the tensile strength of concrete, hence the observed cracking. While no cracking was observed in other girders, it was hypothesized that there is a potential for cracking of other girders with time as more creep deformation takes place in addition to the inevitable thermal gradient effects, the most dominant cause of positive moment in the monitored segment.

(a) May 5, 2009

(b) October 22, 2010

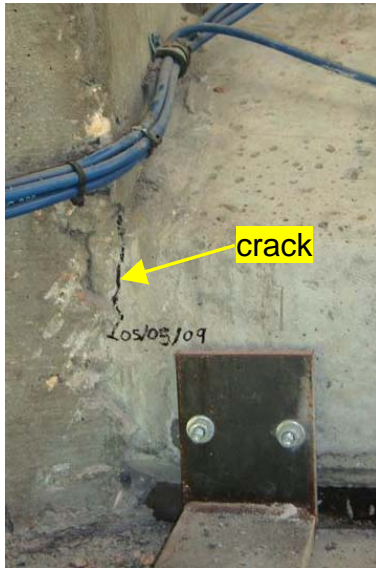
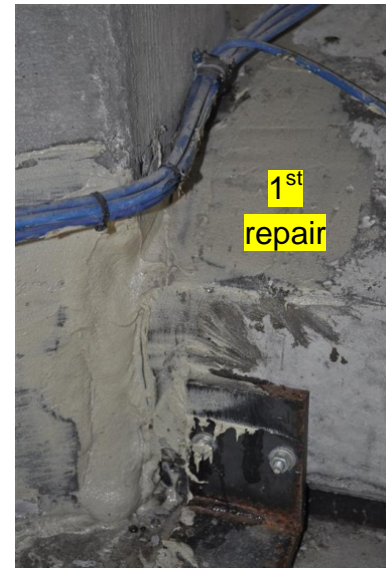
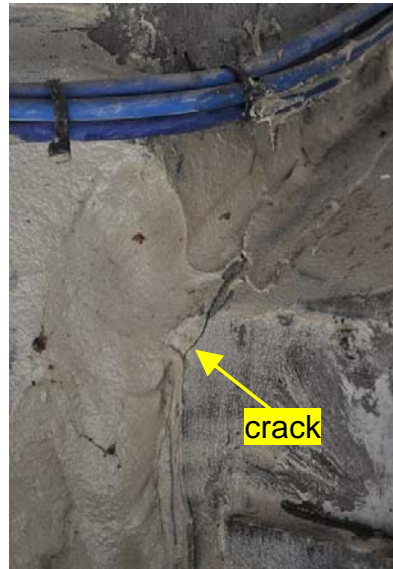
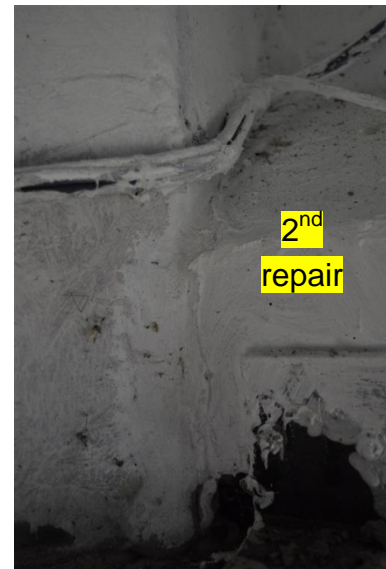
Figure 14
Observed crack at bottom flange of Girder G3 at Bent 24 – Span 24

Figure 14 shows the bottom flange of Girder G3 at six different times since bridge construction completion. Figure 14(a) and (b) show the crack as it was observed and documented in LTRC Final Report 477. It can be seen that the initial crack appeared about 6 months after establishing continuity, which coincides with the bridge getting exposed to hot weather conditions. The crack initially did not extend all the way to the soffit of the girder, but rather extended to only half the bottom flange height. In August 2012, it was clear that the crack grew and that the bottom flange was completely cracked. This crack helped explain the high strain readings in hairpin bars for Girder G3.

This crack triggered the first attempt to seal the crack to avoid accelerated deterioration of the girder end. When the current project started in January 2012, the research team visited the bridge site on February 24, 2012. At that time, the crack was sealed using an epoxy-like material that entirely covered the crack, which could not be seen [Figure 14(c)]. Six months later, on August 6, 2012, the second visit to the bridge site took place. Figure 14(d) shows the conditions at that time, which revealed that the epoxy-like sealant has cracked along the same path of the original crack. This was not a surprise to the research team as the used sealant was brittle and could not withstand the large strains at this location due to the thermal gradient induced restraining moment that was discussed earlier. In other words, the brittle sealant failed after less than a year once the bridge was subjected to the first cycle of hot summer weather. On March 13, 2013, the research team visited the bridge site for the third time and the same crack could still be seen [see Figure 14(e)]. In between the third and fourth site visits (around June 2013), the second attempt to seal the crack was made. The sealant for this attempt was an elastomeric, crack-bridging coating (Sikagard[®] Elastic Base Coat + Sikagard[®] 550W Elastocolor), which can accommodate strains in excess of 300% [11, 12]. This product was chosen primarily because of its ability to elongate to these levels without rupture, which would definitely be needed as the thermal cycles opened and closed the crack. Figure 14(f) shows the same crack location on August 22, 2013, after applying the elastomeric coating. The crack could not be seen as it was completely covered by the new coating. Although only two months had passed since applying the new coating till the time of the last site visit, those two months (July and August) are when the most severe thermal cycles take place. Therefore, it can be said that the new coating had been exposed to the most demanding conditions that caused the crack to develop initially in May 2009, and the first epoxy like sealant to crack in August 2012. In both case, the crack developed after the bridge was exposed to the first hot thermal cycle. Therefore, the research team believes that the current conditions will last for an extended period of time. Therefore, it is recommended that

(a) May 5, 2009

(c) February 24, 2012

(e) March 13, 2013

(f) August 22, 2013

the bridge be entered into a regular inspection routine (every two years), i.e., no special inspections need to be scheduled for Bridge No. 61390613004101.

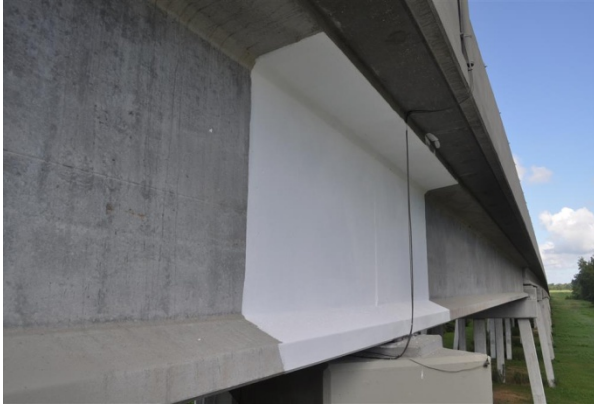
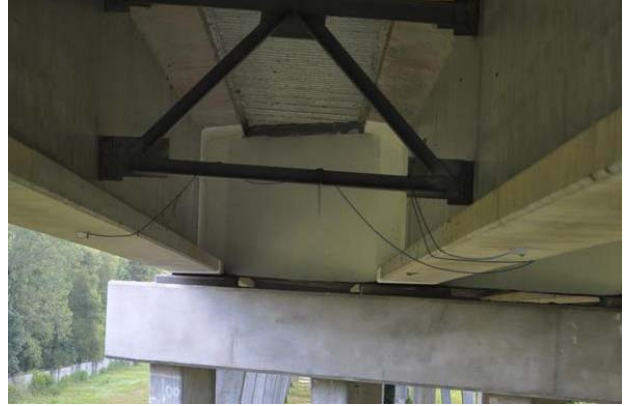
Figure 15

It should be noted that the elastomeric coating was applied to the diaphragms and girder ends up to a distance of about 5 ft. on both sides of the diaphragm as can be seen in Figure 15.

(a) Girder G1 at Bent 24

(b) Diaphragm between G1 and G2 at Bent 25

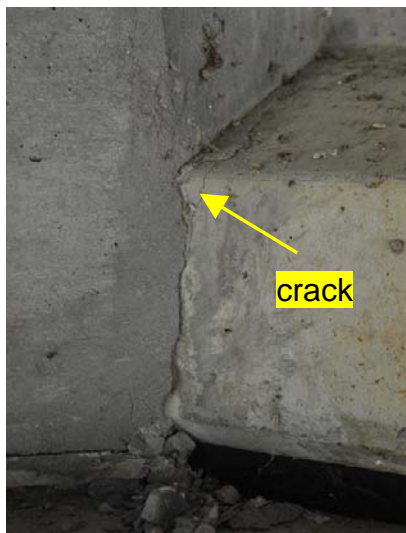
In addition to the old crack in Girder G3, the research team observed new cracks in Girder G4. The cracks can be seen in Figure 16. The crack features (location, width, and extents) were similar to those observed in Girder G3. This means that all girders are vulnerable to cracking like Girder G3 and G4. The crack in Girder G4 could not be correlated to any recorded strain readings as no sensors were installed at these locations.

(a) Girder G4 – Span 23 - Bent 24

New cracks observed in Girder G4

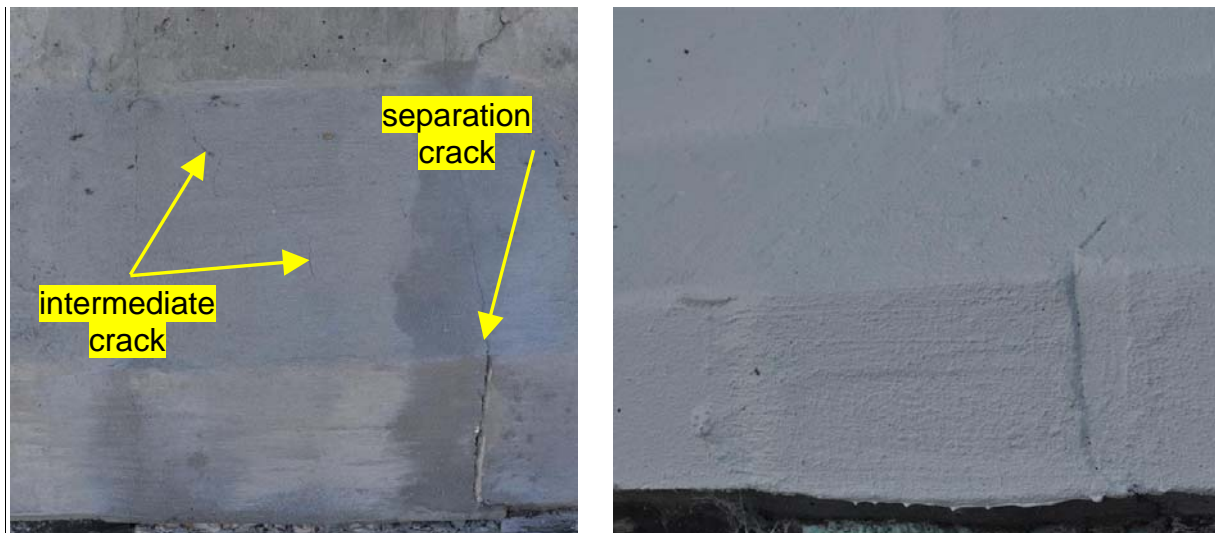
Figure 17
Diaphragm cracking (Girder G1)

Diaphragm cracking was also observed at exterior girders. This type of cracking is expected in light of the fact that the diaphragm is not prestressed and is responsible for transferring the tension force between adjacent girder ends. In addition to the intermediate diaphragm crack that can be seen in Figure 17, separation cracks can also be observed at the cold joint interface. Both crack types are inevitable in this type of construction. However, they are not detrimental to the prestressed girder, but can lead to spalling of diaphragm concrete if excessive. Also, cracking reduces the diaphragm stiffness, which is known to influence the level of continuity for the superstructure.

(a) Before coating (March 13, 2013)

(b) After coating (August 22, 2013)

All observed cracks could not be seen after applying the elastomeric coating to girder ends.
