Maine Department of  
Transportation  
**Transportation Research  
Division**

**Technical Report 02-3**  
*The Use of Micro-Surfacing for Pavement  
Preservation*

*Interim Report - First Year, May 2004*

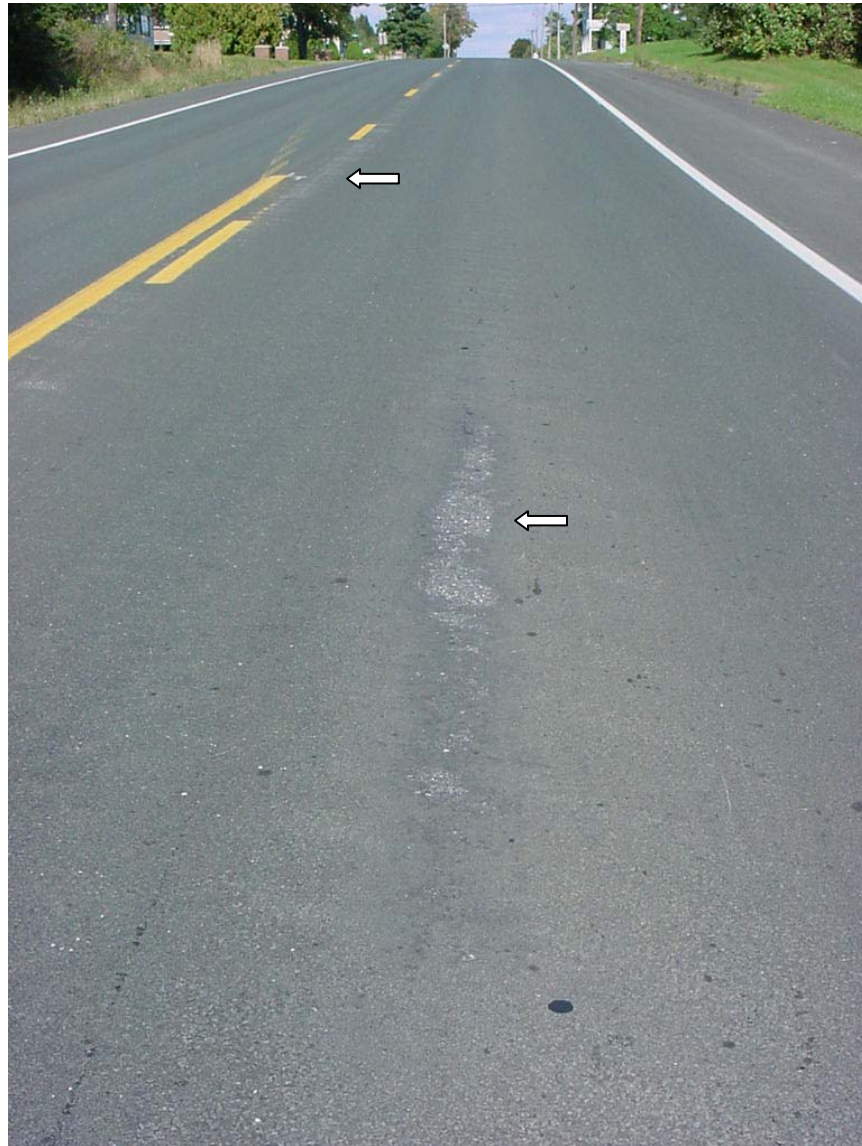
project are showing signs of snow plow abrasion at centerline, mid-point between wheel paths, and shoulder joint areas. Figure 2 displays the severity of wear at centerline and between wheel-path on the Limestone Route 1A project. Abrasion at centerline is primarily loss of the stone matrix whereas the wear between wheel-paths is down to the original Hot Mix Asphalt. The amount and severity of plow wear will be summarized for each test section later in the report.

Wheel path areas are also showing signs of wear. Much of the stone matrix has been abraded.

Figure 2: Between Wheel-Path and Centerline Plow Wear, Limestone Project.

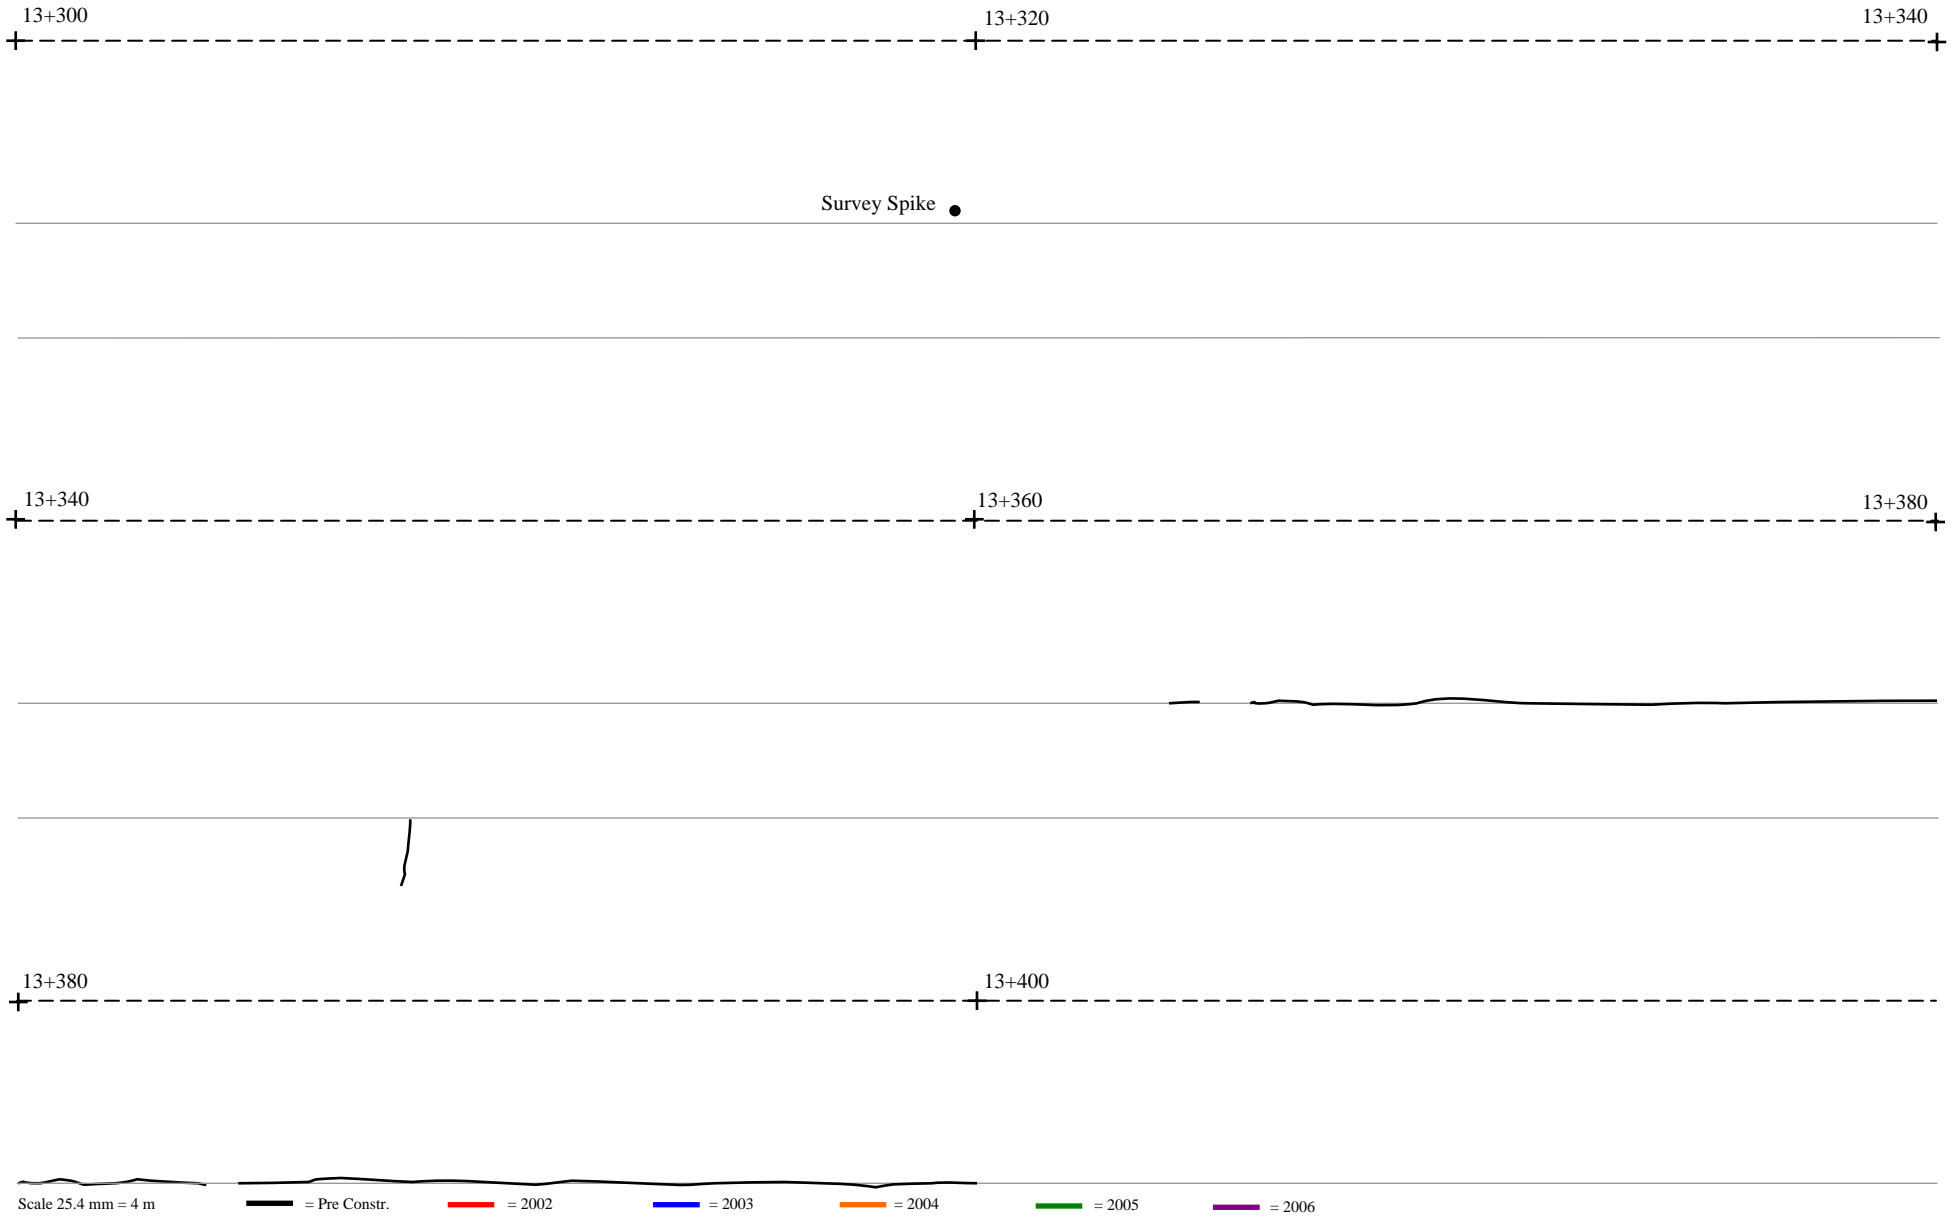
Figure 9  
PIN 9051.00 Crack Survey Section 1 Micro-Surfacing

A crack survey of Section 1 with Micro-Surfacing is depicted in Figure 9. This section had the lowest amount of preconstruction longitudinal cracking and only one partial transverse crack. There were no visible cracks observed in 2002. Snow plow wear was observed at centerline and is displayed in Figure 15. It appears that the plow bounced on the surface, gouging the Micro-Surfaced treatment. Similar plow wear was mentioned in the Construction Report on the I-95 Oakfield project after one winter season.

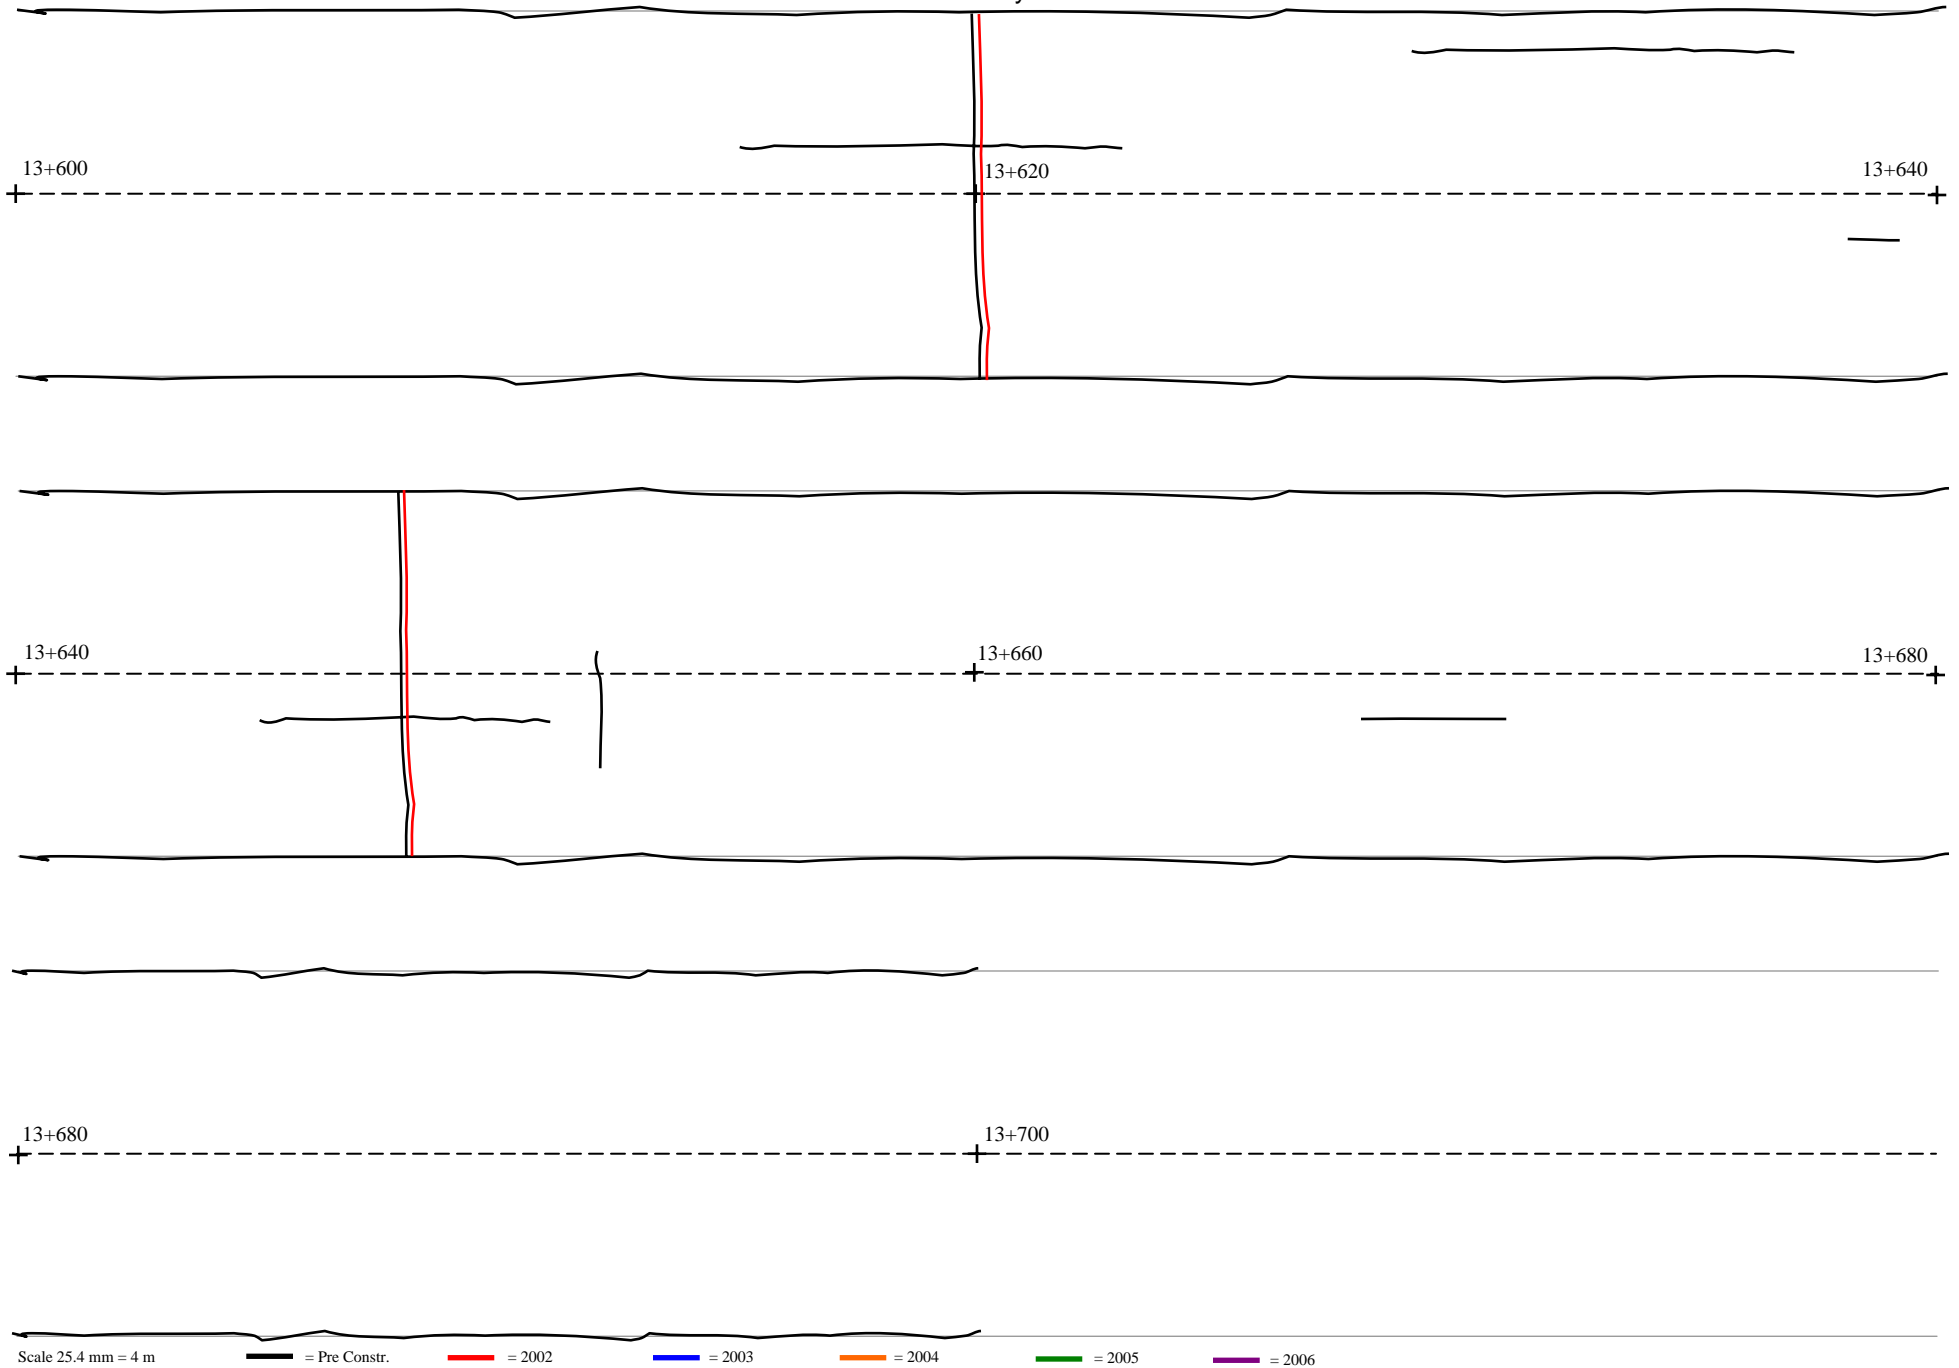
Figure 10  
PIN 9051.00 Crack Survey Section 2 Control

Figure 10 contains a crack survey of Control Section 2. Two transverse cracks have reflected thru at stations 13+620 and 13+650. No longitudinal cracking was observed. Figure 16 contains a photo of the transverse crack at station 13+620.

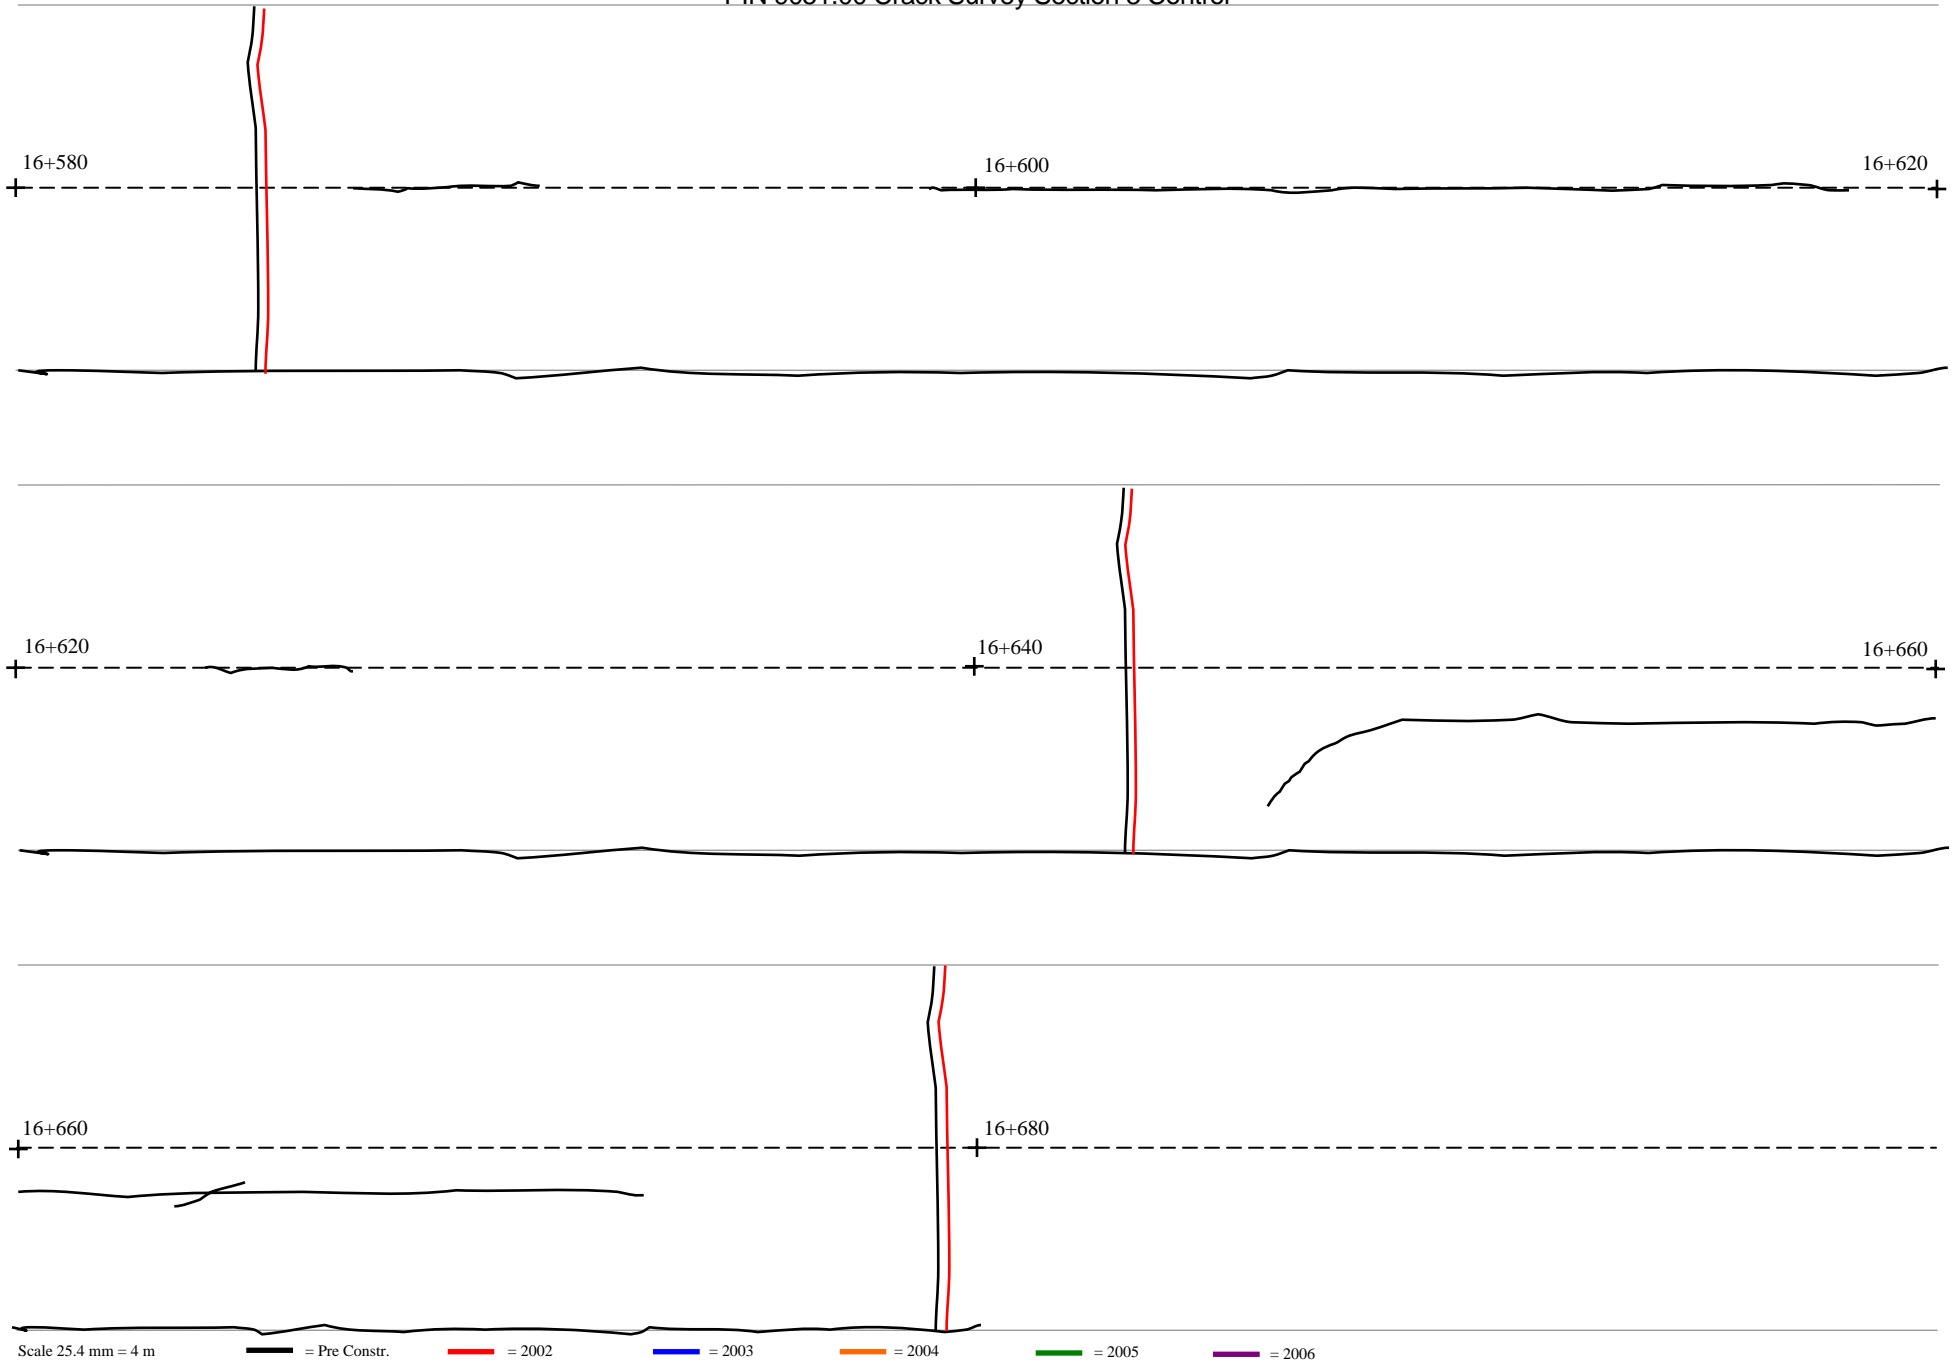
Figure 11  
PIN 9051.00 Crack Survey Section 3 Control

Figure 11 displays the amount of cracking on Control Section 3. All three transverse cracks have reflected thru with no longitudinal cracking. A transverse crack is pictured in Figure 17.

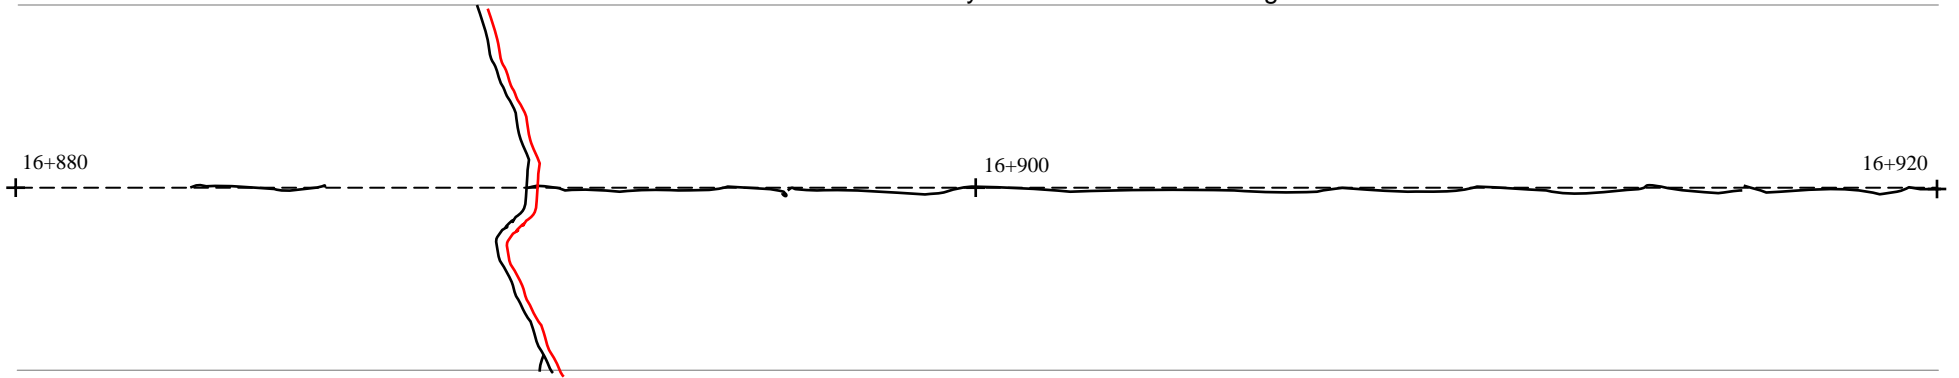
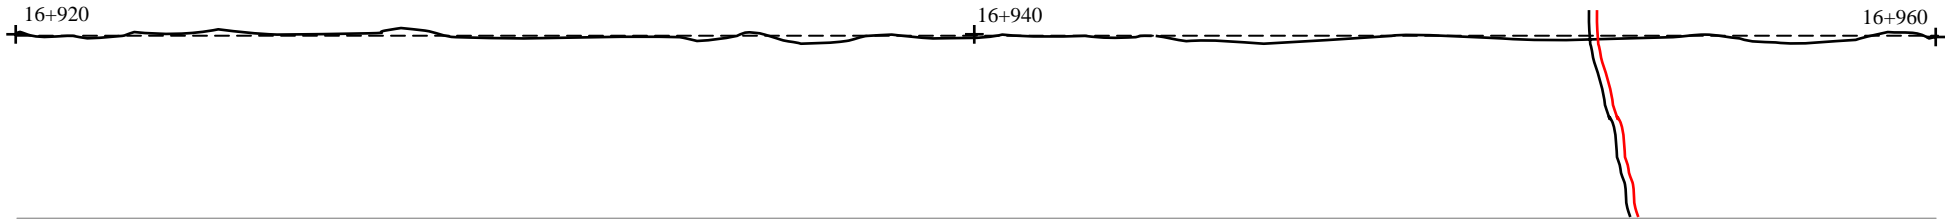
Figure 12  
PIN 9051.00 Crack Survey Section 4 Micro-Surfacing

Micro-Surfaced Section 4 in Figure 12 had no longitudinal cracking but both transverse cracks have reflected thru. The centerline is experiencing snow plow wear as displayed in Figure 18.

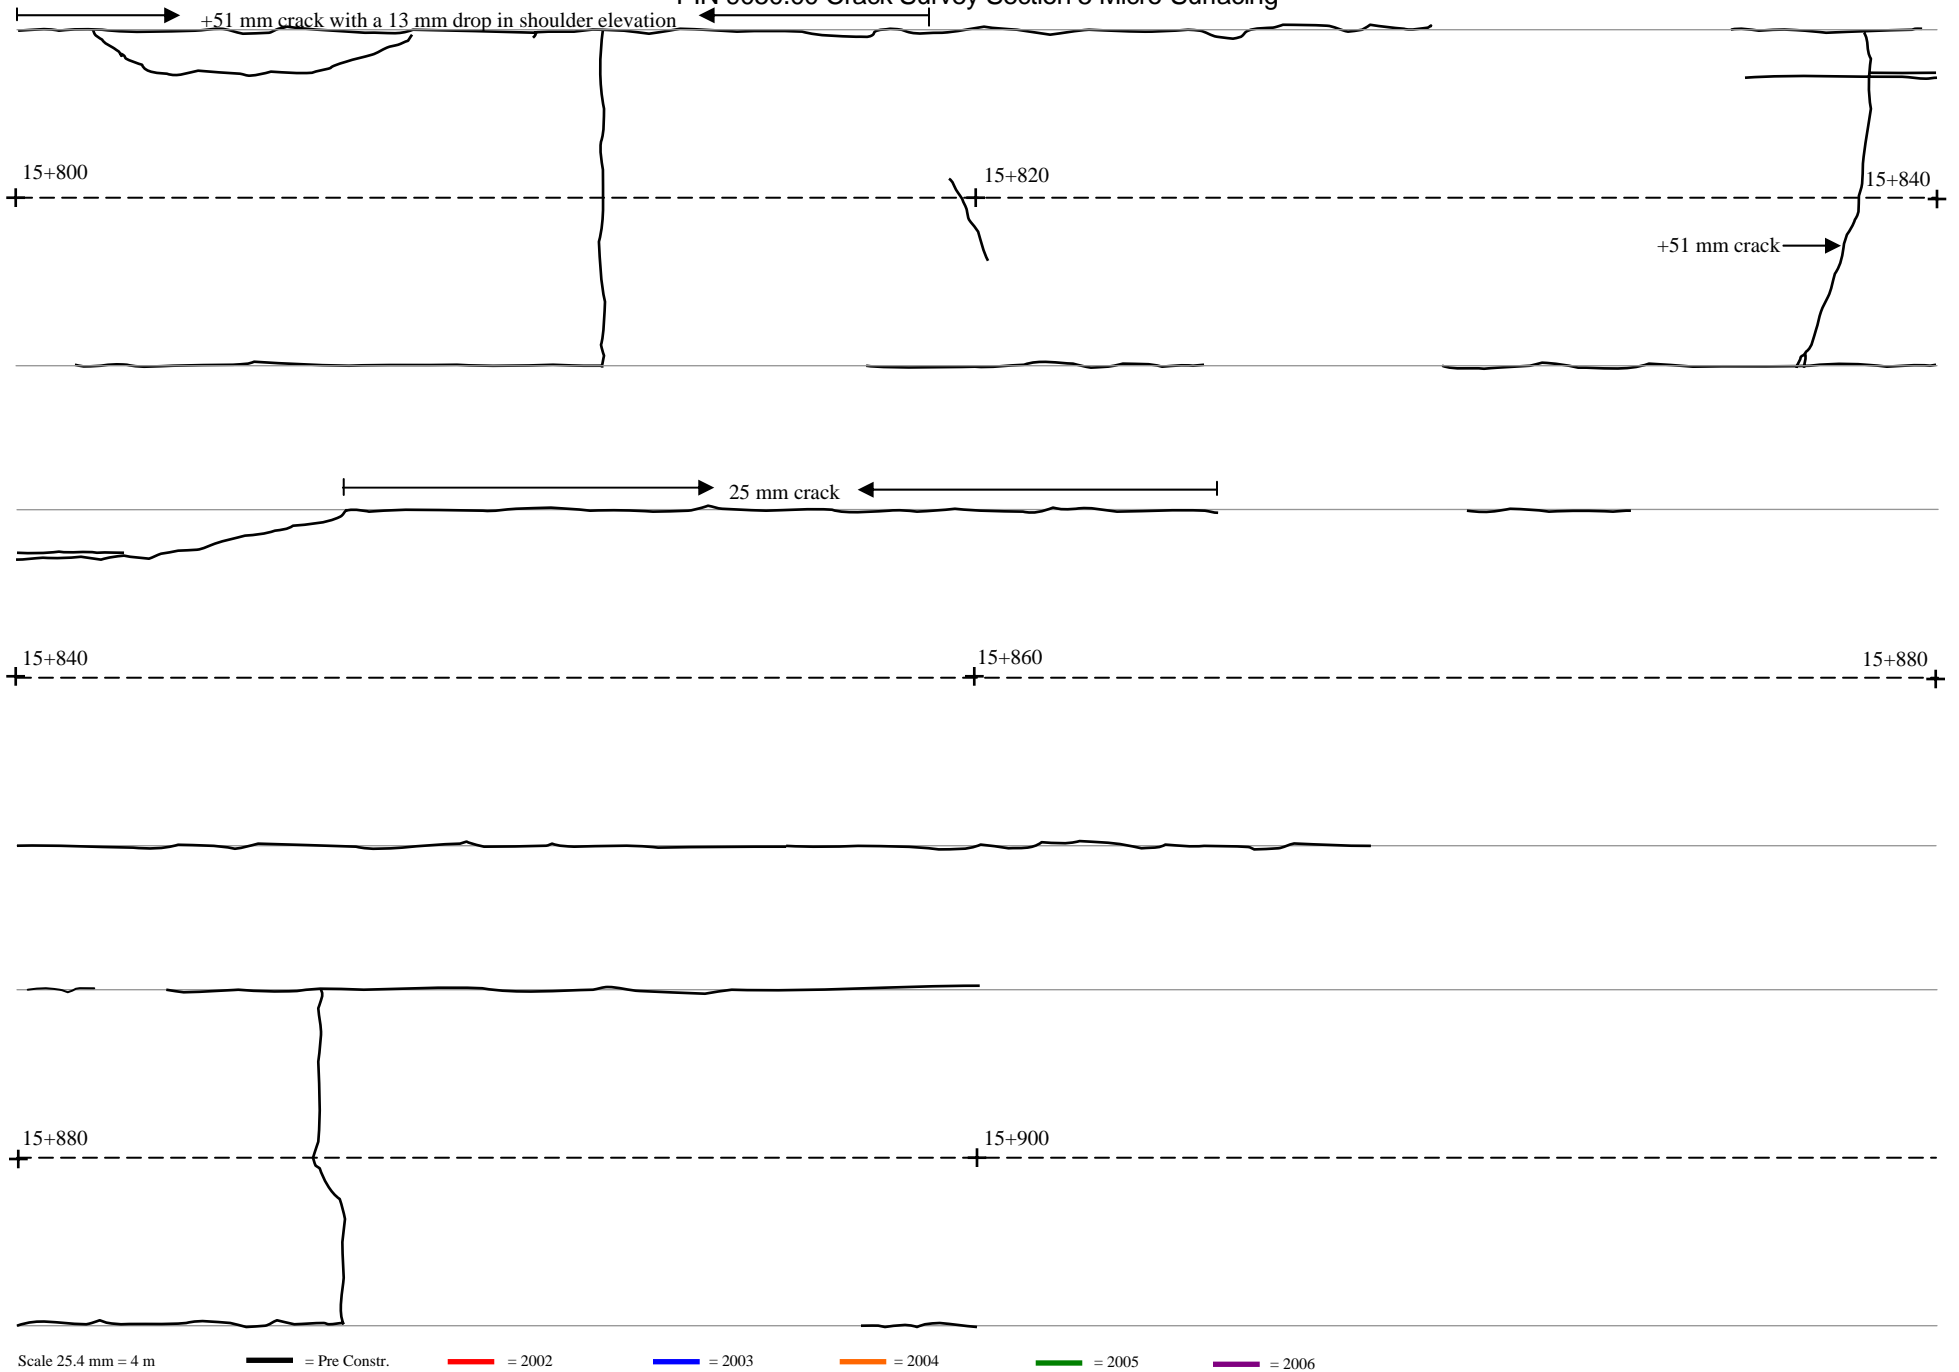
PIN 9050.00 Crack Survey Section 5 Micro-Surfacing

Micro-Surfaced Section 5 is displayed in Figure 13. There were no visible cracks after one year's exposure to traffic. As mentioned earlier, and displayed in Figure 2, plow wear was visible on most of the centerline and a few small areas between wheel paths.

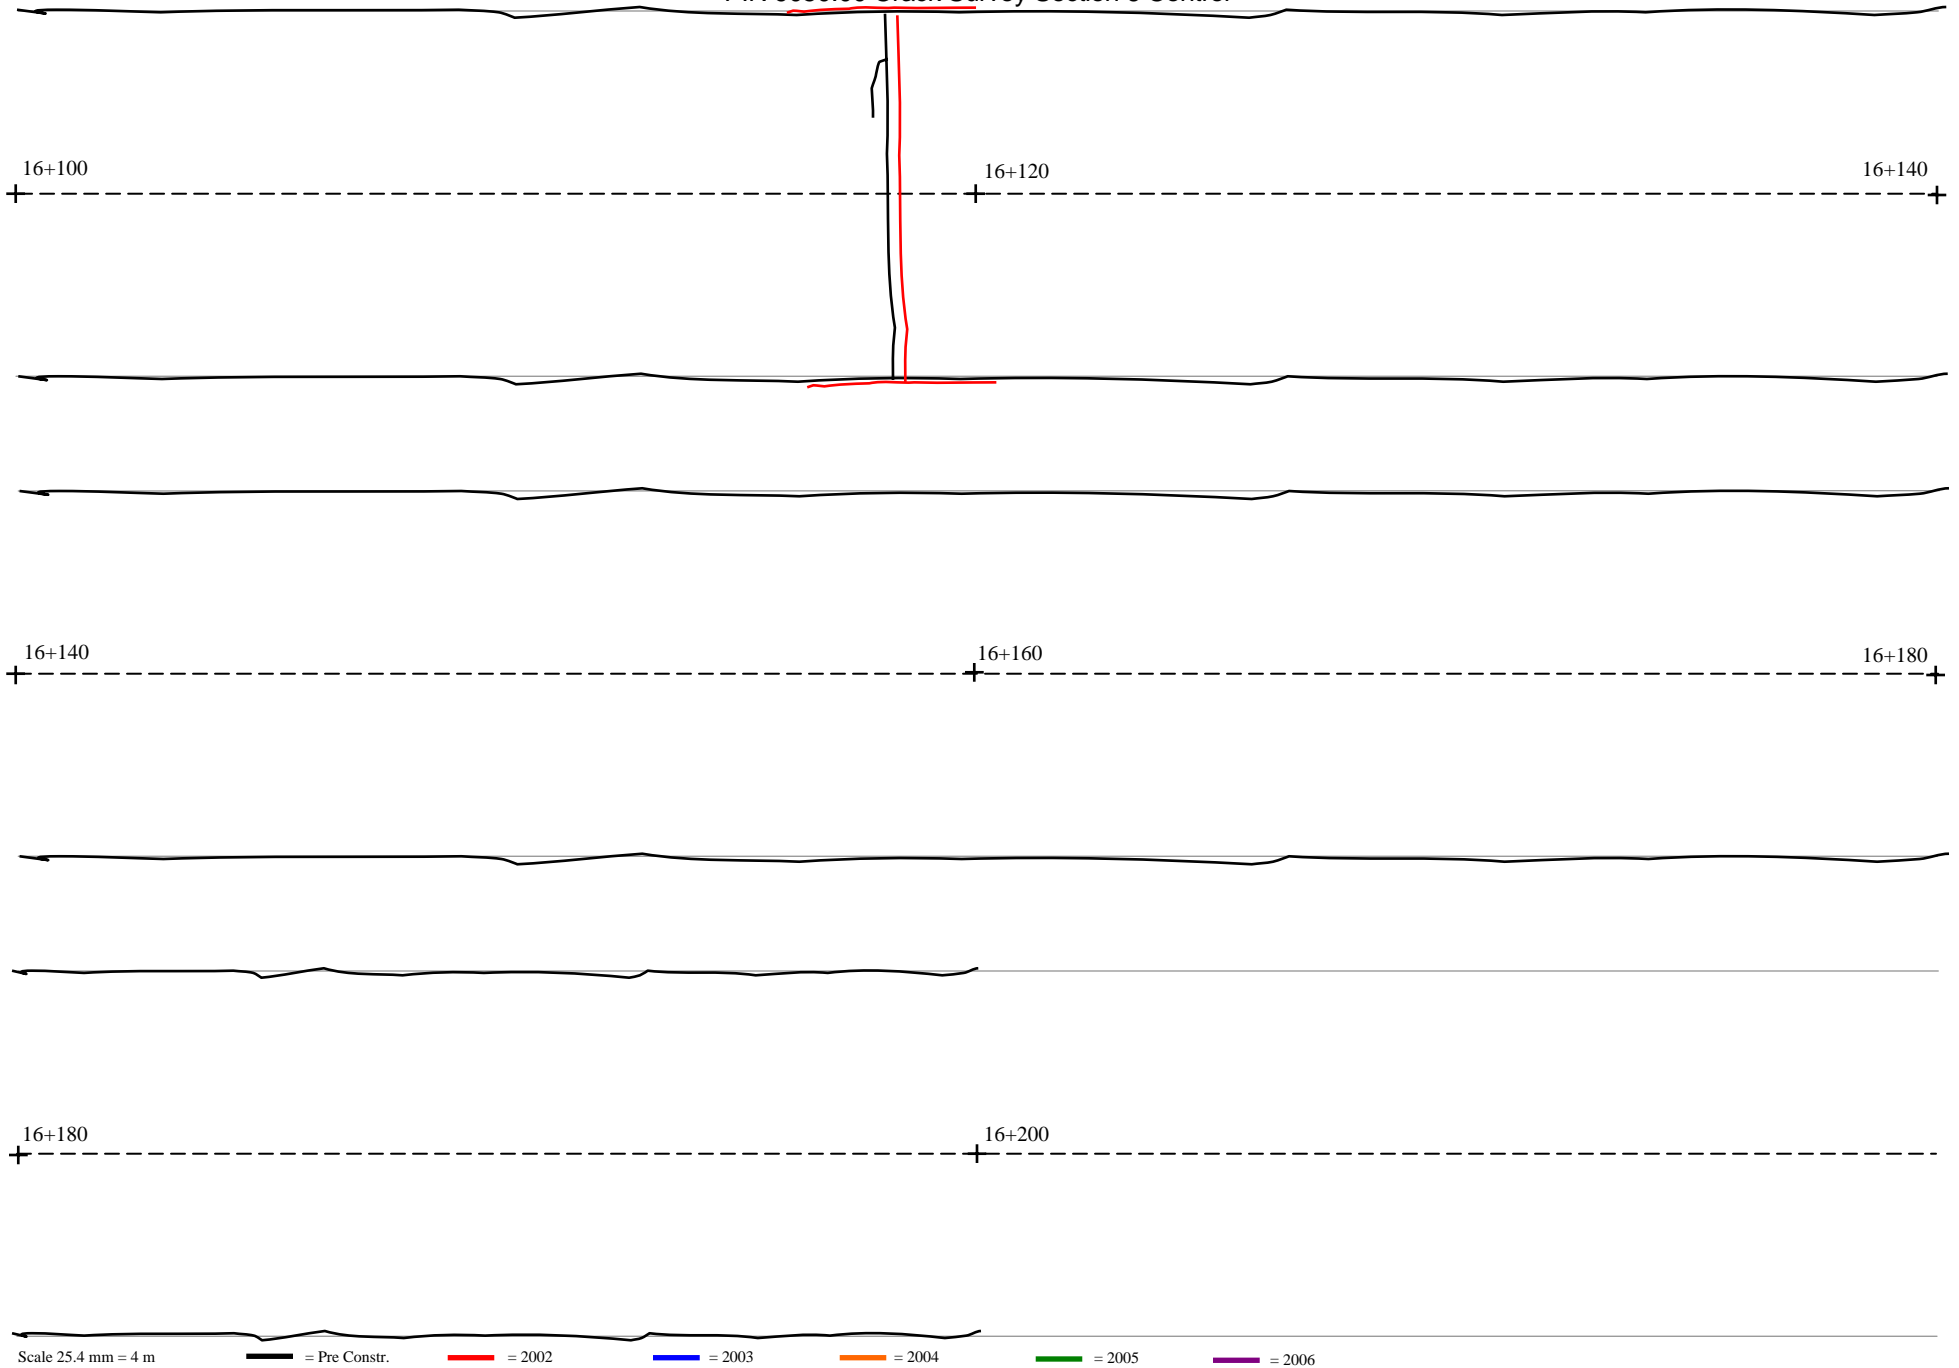
Figure 14  
PIN 9050.00 Crack Survey Section 6 Control

A crack survey for Control Section 6 is exhibited in Figure 14. A transverse crack and a portion of edge cracking on either side has reflected thru. Figure 19 contains a photo of the transverse crack.

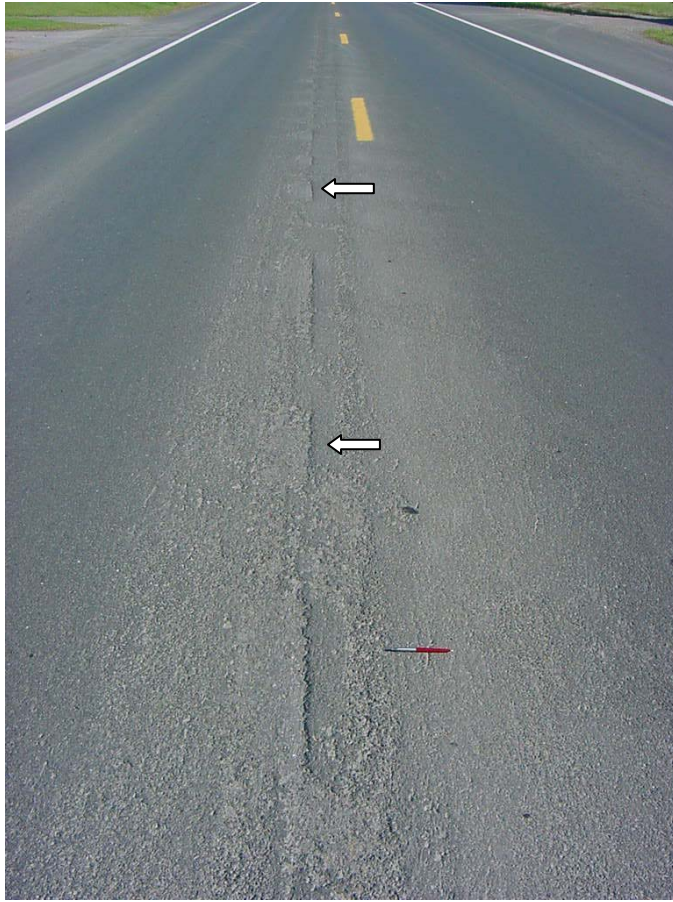
Figure 15: Micro-Surface Section 1 snow plow wear

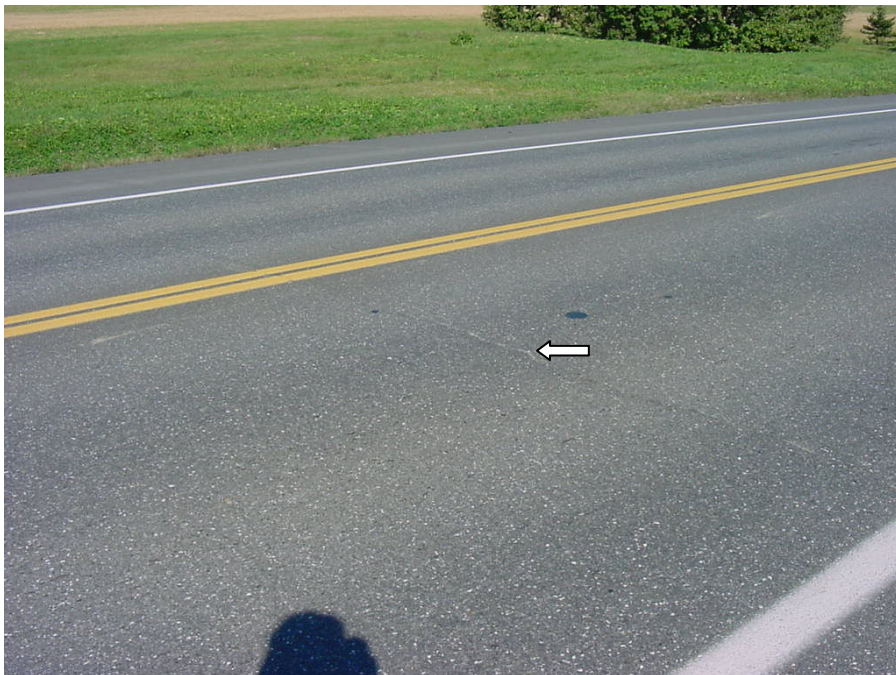
Figure 16: Control Section 2 transverse crack

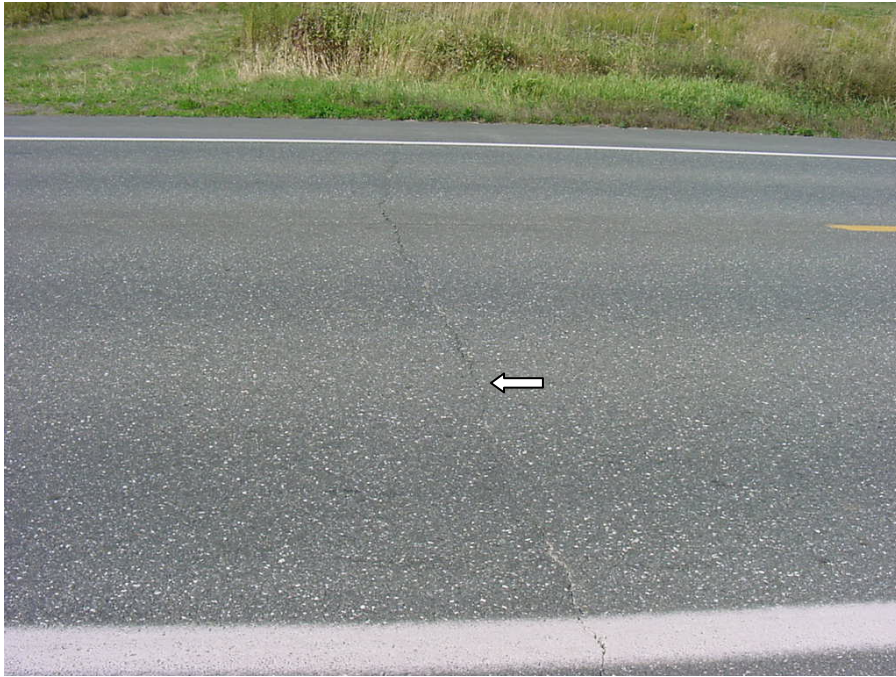
Figure 17: Control Section 3 transverse crack.

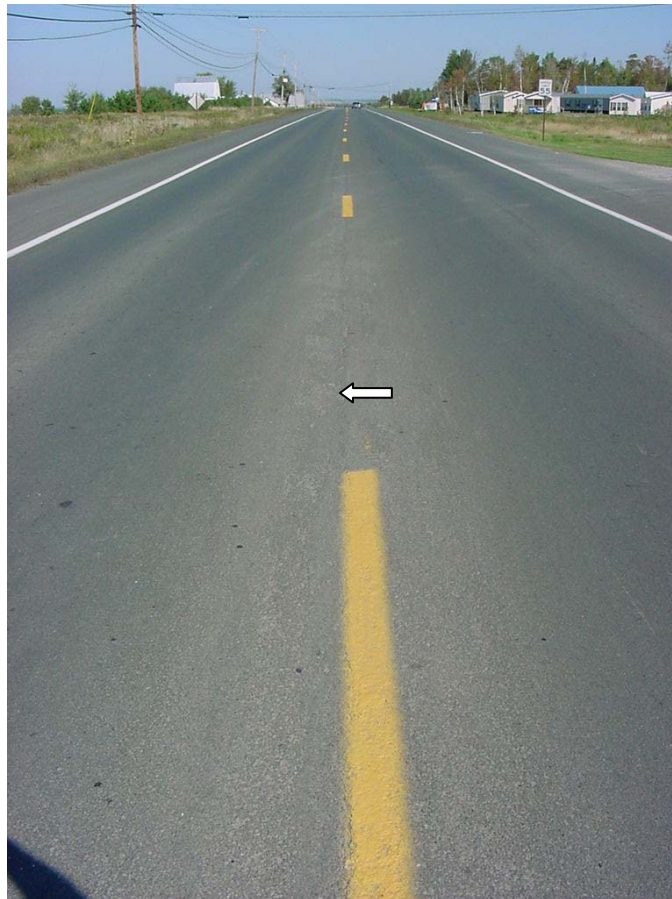
Figure 18: Micro-Surface Section 4 centerline plow wear

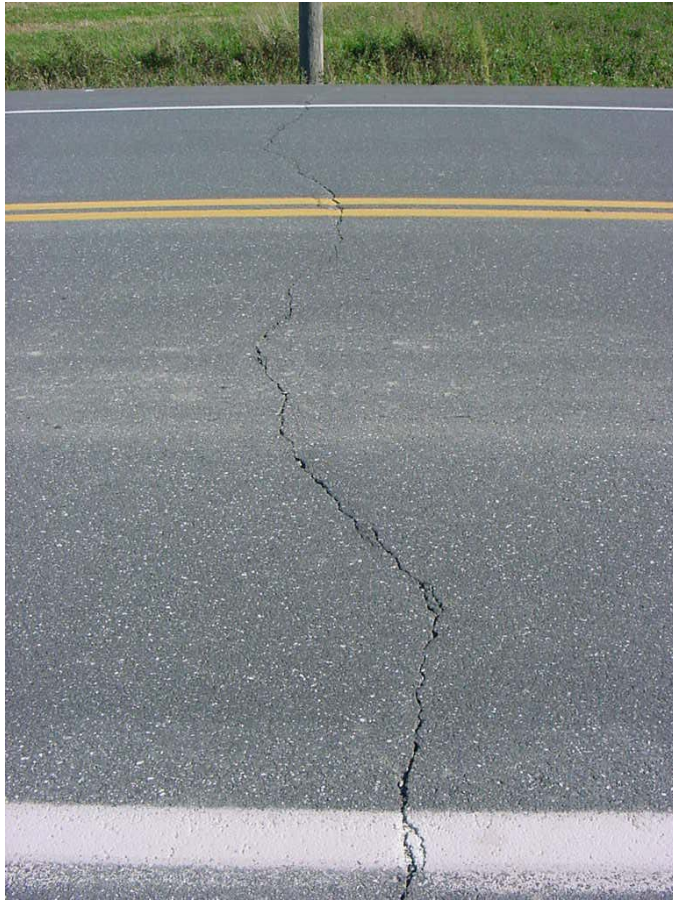
Figure 19: Control Section 6 transverse crack
