Maine Department of  
Transportation  
**Transportation Research  
Division**

**Technical Report 02-3**  
*The Use of Micro-Surfacing for Pavement  
Preservation*

*Interim Report - Second, Third, Fourth Year, December, 2005*

## *The Use of Micro-Surfacing for Pavement Preservation*

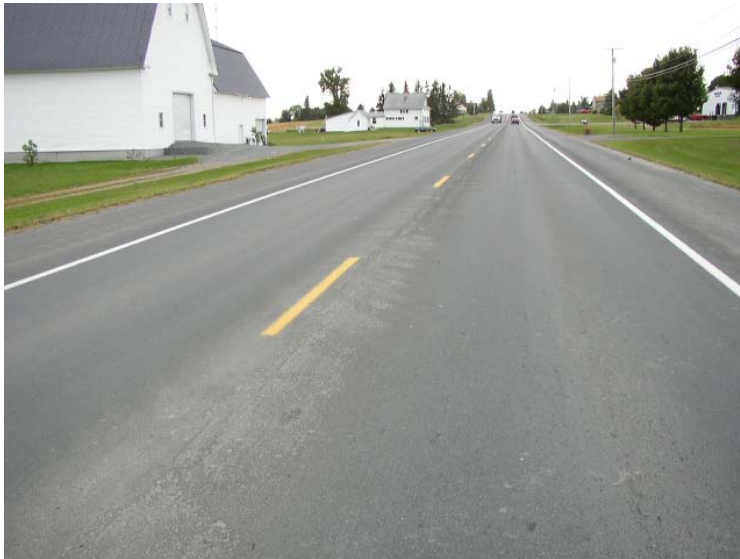
Photos 1, 2, and 3 are of Micro-Surface Section 1 taken in 2003, 2004, and 2005 respectively. It is apparent that the amount of centerline and quarter point plow abrasion has increased each year. Photo 2 displays areas in Section 1 where Micro-Surfacing has worn down to the original HMA surface. Another interesting observation is the herring bone plow wear pattern at centerline, a result of the plow skipping on the roadway during snow removal. By 2005 the quarter point has worn down to the original surface as displayed in Photo 3. Section 4, displayed as Photo 4, has similar wear patterns.

Photo 1: Section 1 Micro-Surface Centerline Plow Abrasion; September, 2003.

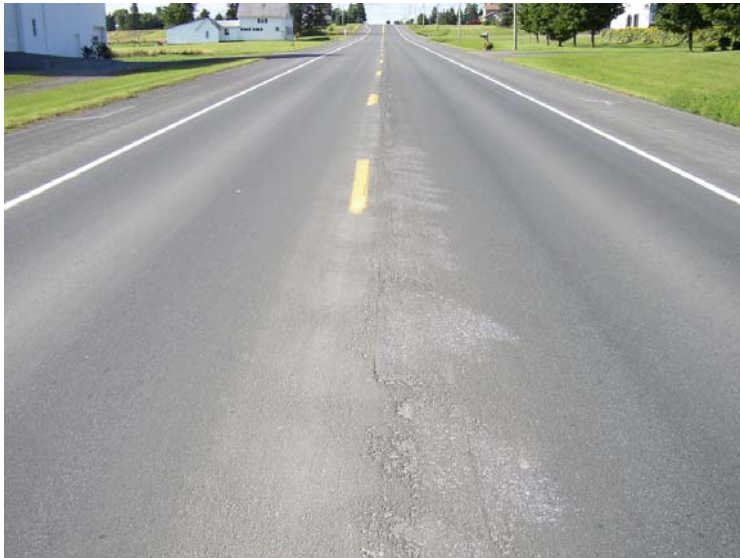
Photo 2: Section 1 Micro-Surface Centerline Plow Abrasion; August, 2004.

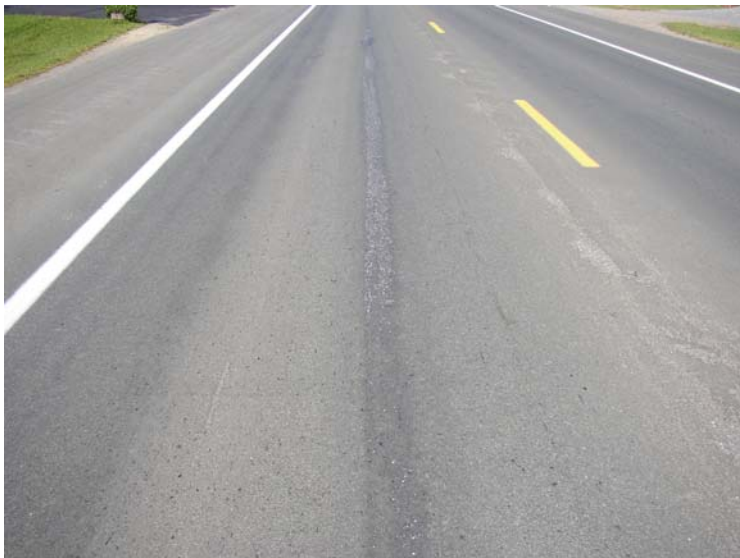
Photo 3: Section 1 Micro-Surface Centerline and Quarter Point Plow Abrasion; September, 2005.

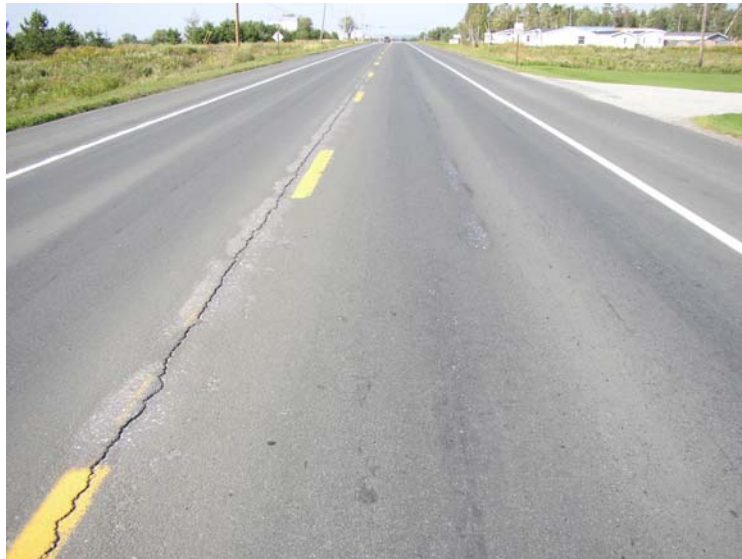
Photo 4: Section 4 Micro-Surface Centerline and Quarter Point Plow Abrasion; September, 2005.

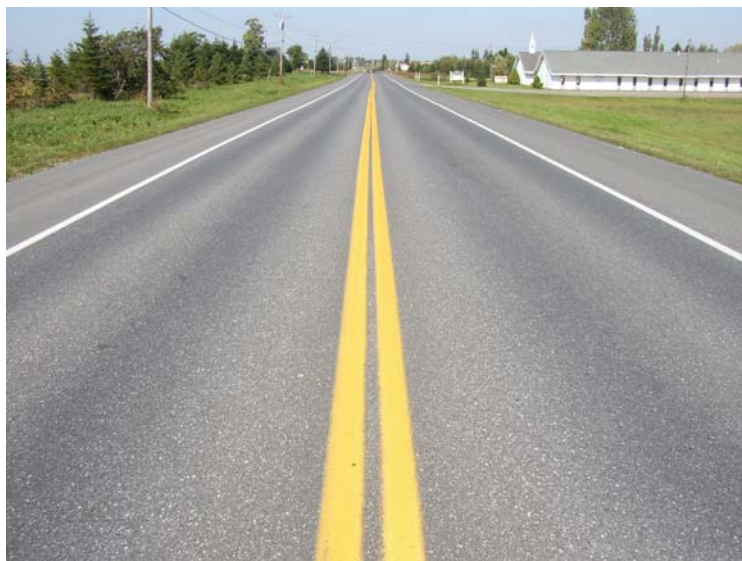
Photos 5 and 6 are of Control Sections 2 and 3 respectively. The surface looks very good and both sections have very little plow wear.

Photo 5: Section 2 Control Pavement Condition; September, 2005.

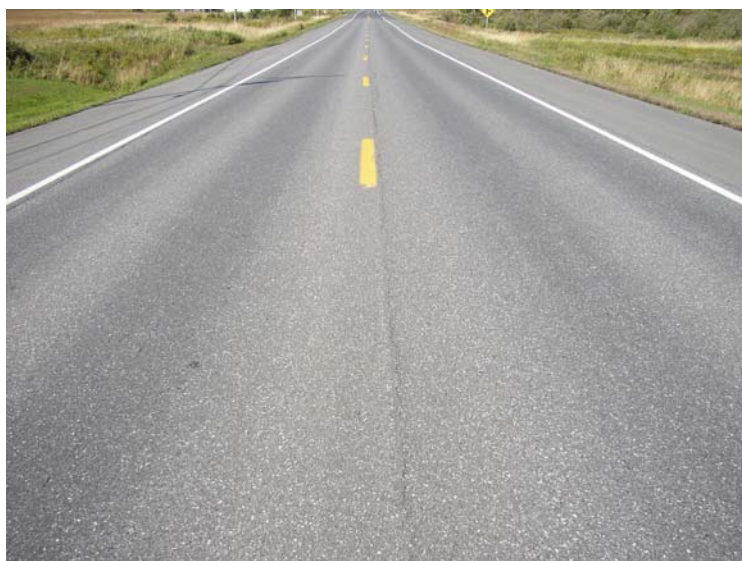
Photo 6: Section 3 Control Pavement Condition; September, 2005.

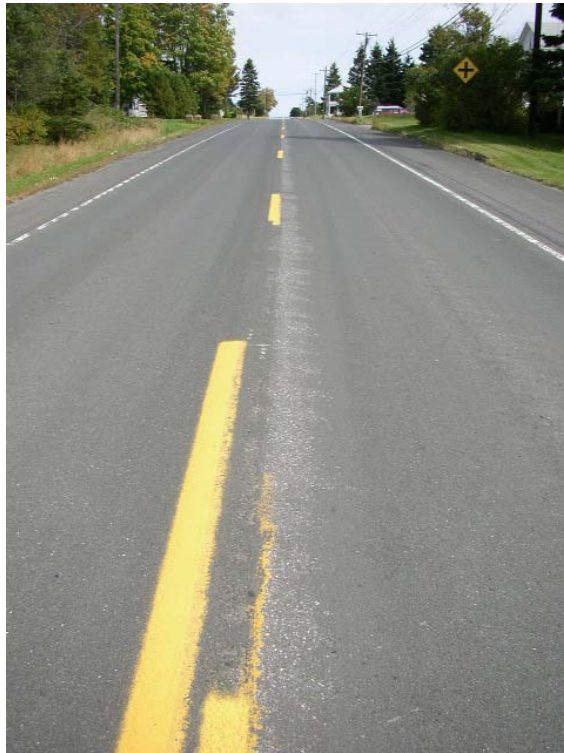
Plow abrasion on Section 5 of the Limestone – Caswell project is displayed in Photo 7 and 8. Abrasion at centerline has increased each year from 2003 to 2005. Photo 7 displays the amount of wear in 2003. In 2005 Micro-Surfacing has completely worn away exposing HMA surface the entire length of the section as displayed in Photo 8. Quarter point and shoulder joint abrasion is not as severe as compared to Sections 1 and 4.

Photo 7: Section 5 Micro-Surface Pavement Condition; September, 2003.

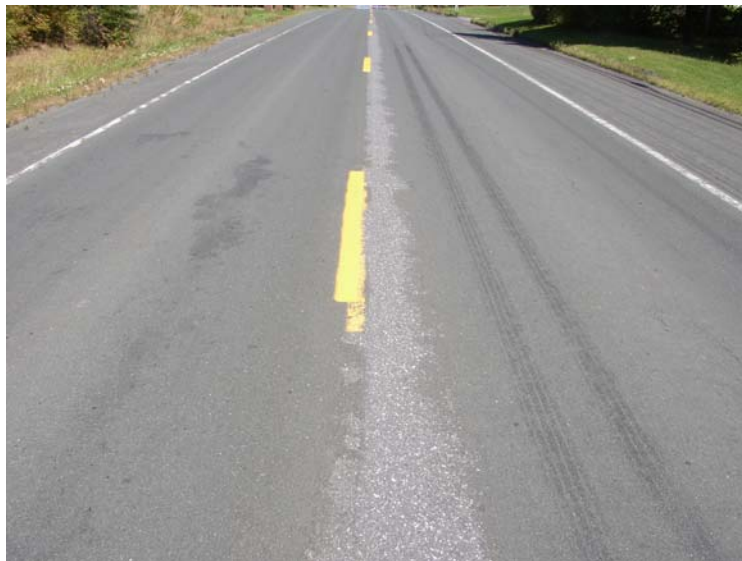
Photo 8: Section 5 Micro-Surface Pavement Condition; September, 2005.

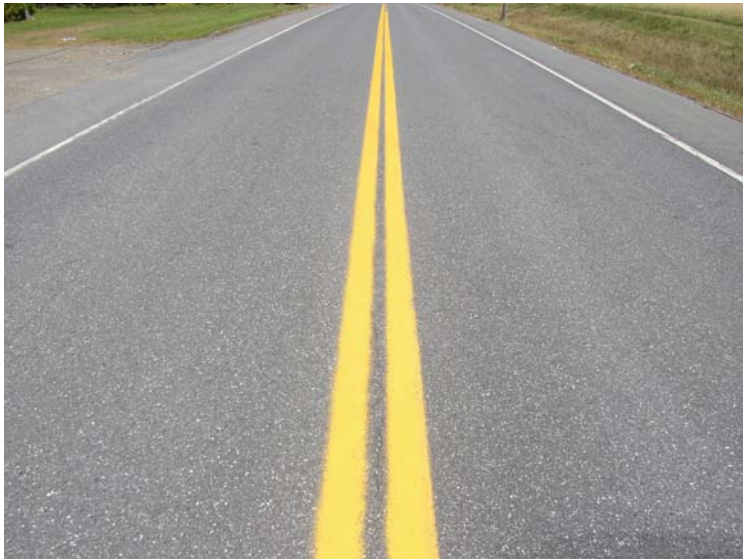
Control Section 6 has very little plow abrasion and looks very good as depicted in Photo 9.

Photo 9: Section 6 Control Pavement Condition; September, 2005.

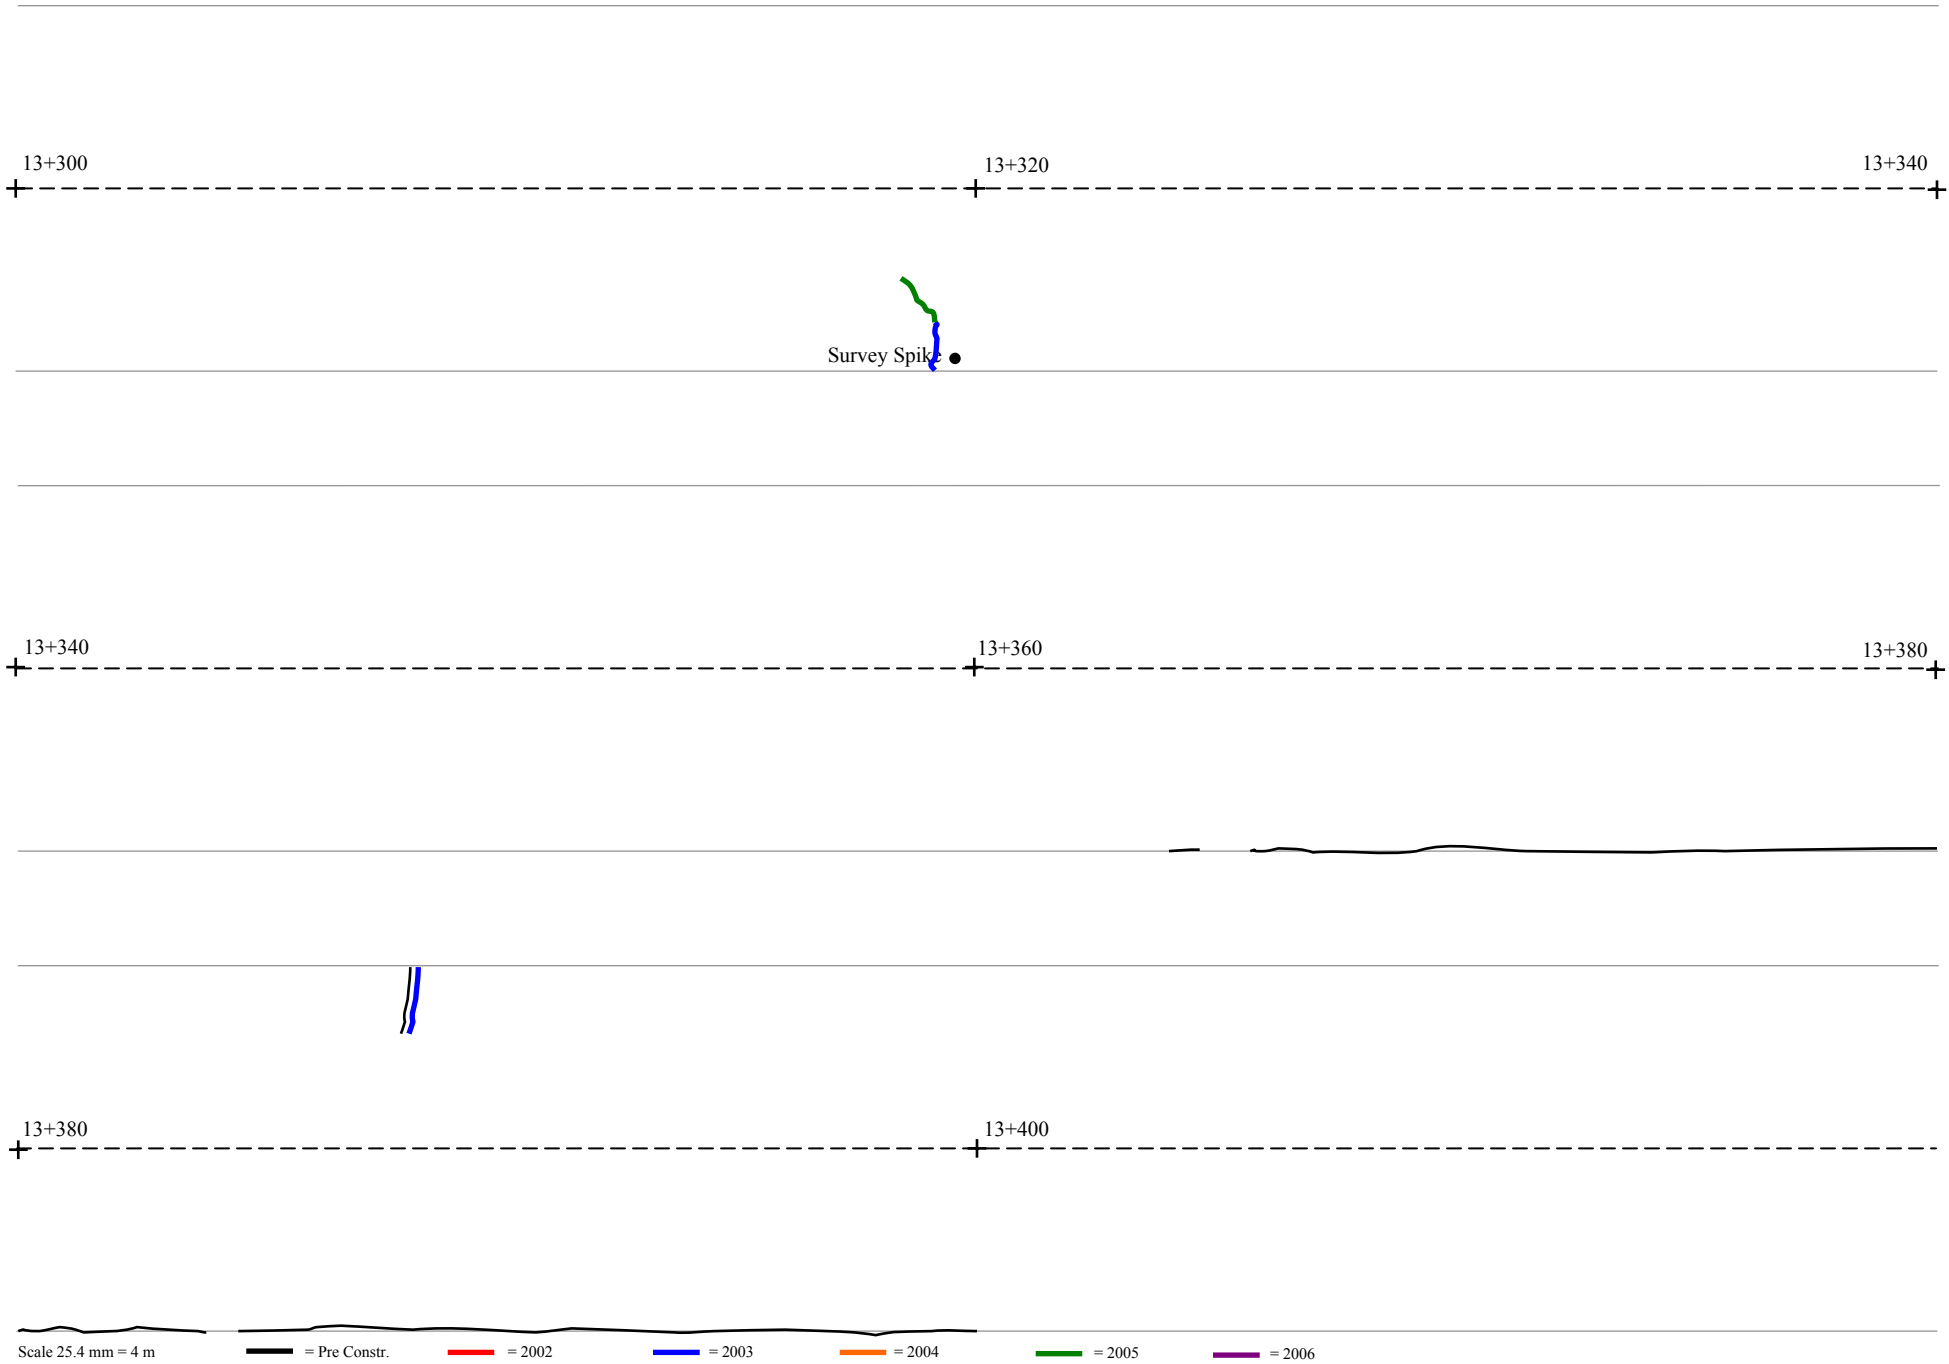
Figure 12. Section 1 Micro-Surface Crack Survey

Figure 12 contains a crack survey of Micro-Surface Section 1. This section had the lowest amount of preconstruction longitudinal cracking and only one partial transverse crack. The partial transverse crack reflected through and a new transverse crack appeared in 2003. No additional cracking was observed in 2004. In 2005 the new transverse crack at station 13+320 extended into the roadway to about midway across the lane.

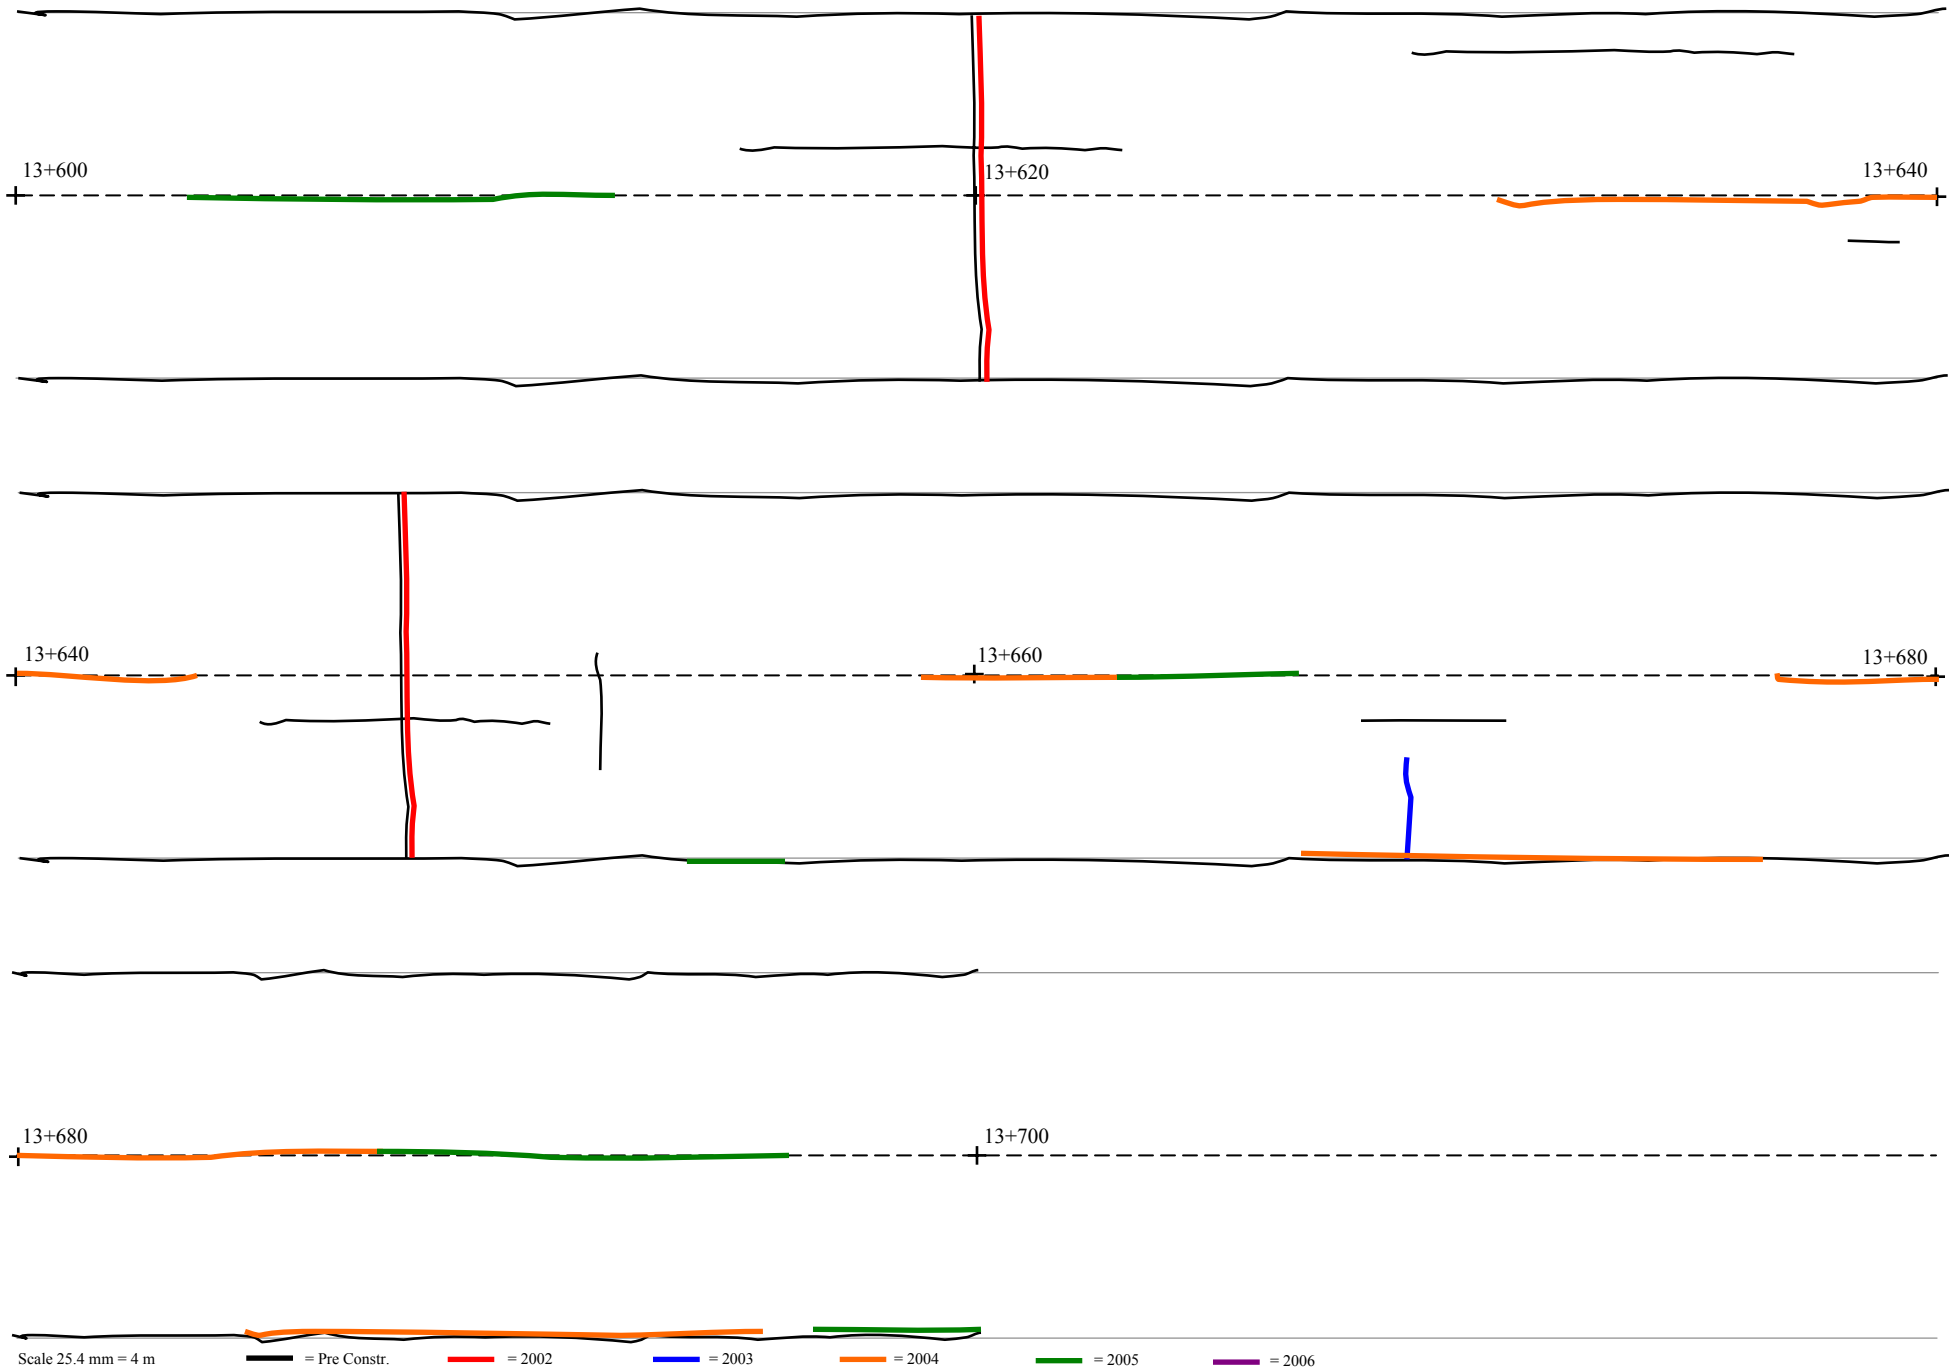
Figure 13. Section 2 Control Crack Survey

Figure 13 contains a crack survey of Control Section 2. A new transverse crack at station 13+670 was observed in 2003. In 2004 a portion of the shoulder joint had reflected through and new longitudinal cracking was noticed in much of the centerline. Additional centerline and shoulder cracking was noticed in 2005.

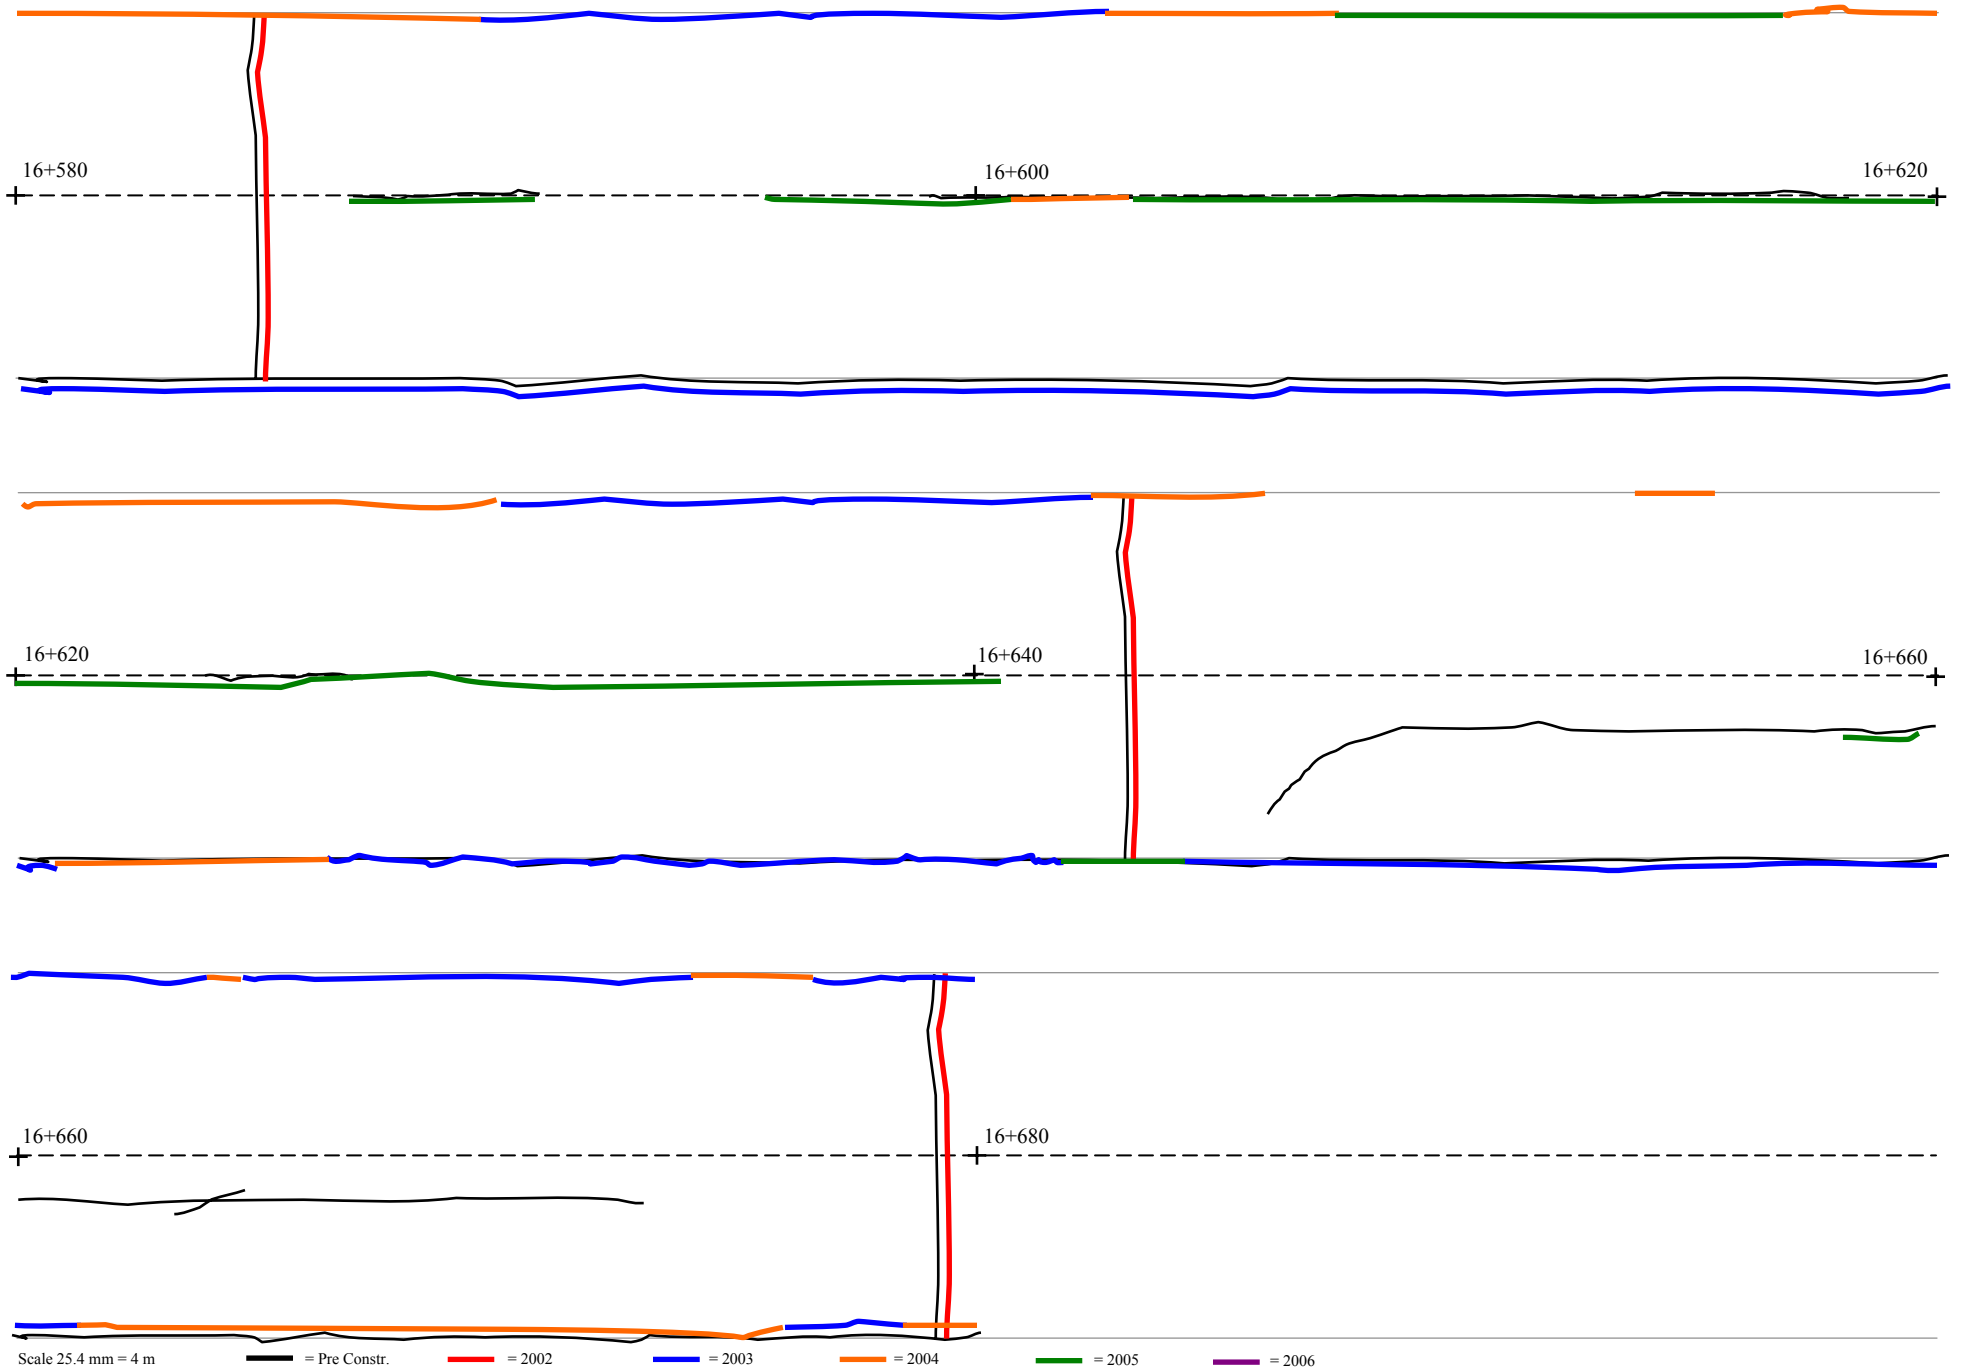
Figure 14. Section 3 Control Crack Survey

Figure 14 displays the amount of cracking on Control Section 3. No additional transverse cracking has been observed. Much of the shoulder joint has reflected through and a considerable amount of new shoulder joint cracking was observed in 2003. New and reflected shoulder joint cracking continued in 2004. By 2005 nearly all of the shoulder joint has cracked and all of the original centerline cracking has reflected through. New centerline cracking was observed on a third of the section. A small amount of longitudinal cracking in the wheel path is beginning to reflect through in 2005.

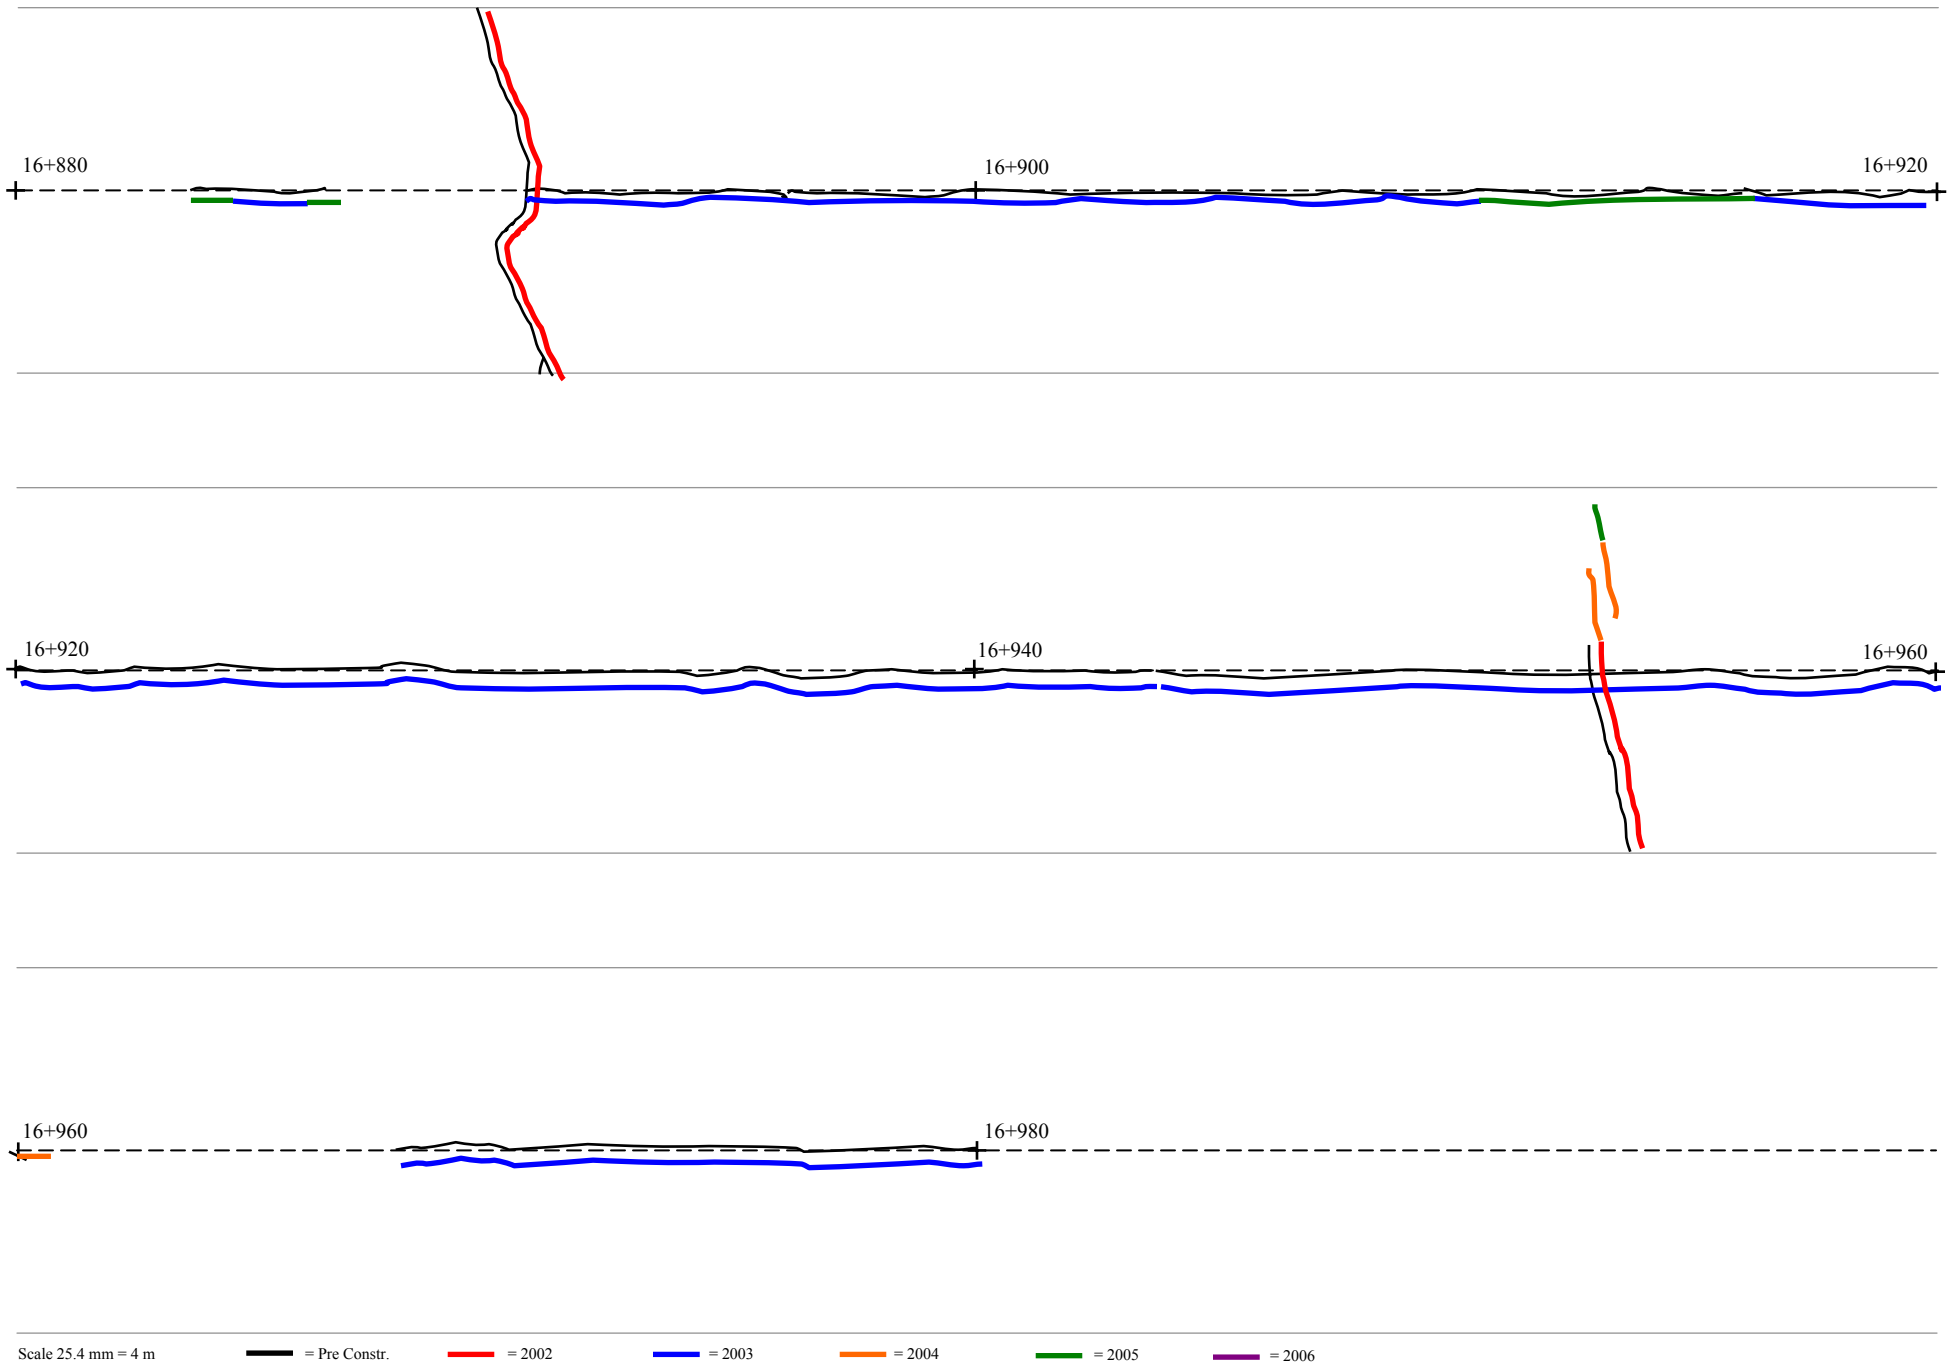
Figure 15. Section 4 Micro-Surface Crack Survey

Figure 15 contains a diagram of Micro-Surfaced Section 4. Most of the original cracks have reflected through in 2003. In 2004 only a small portion of new transverse cracking was observed at station 16+953. By 2005 all of the original cracks have reflected through.

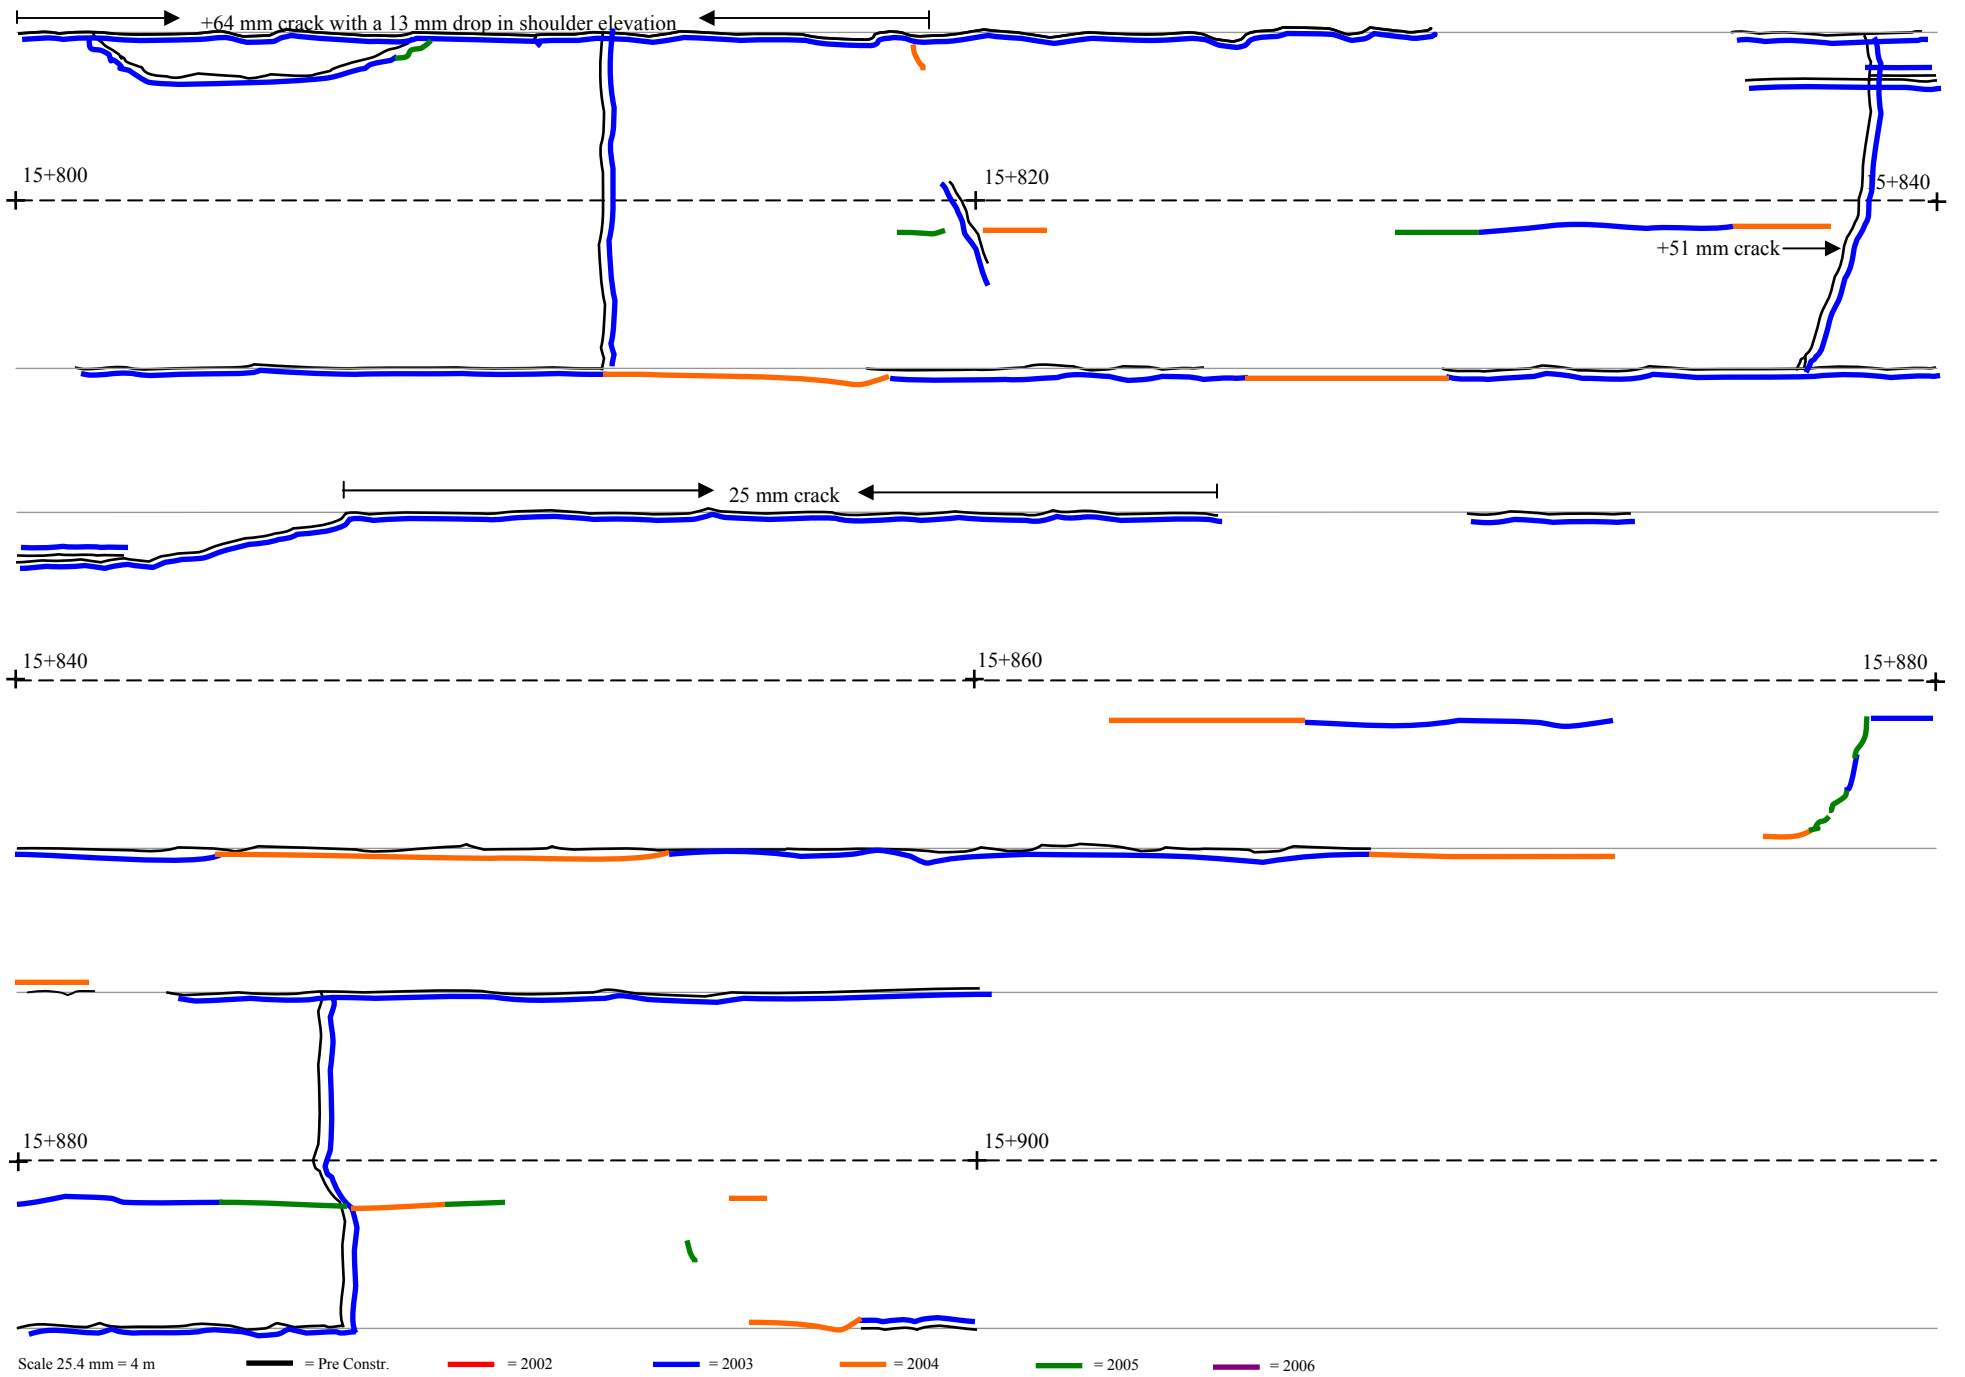
Figure 16. Section 5 Micro-Surface Crack Survey

Micro-Surfaced Section 5 is displayed in Figure 16. A majority of the original cracks have reflected through in 2003 with a number of small areas of longitudinal wheel path cracking. By 2004 nearly all of the original cracks were visible and the longitudinal wheel path cracks were increasing. A few small areas of longitudinal and transverse cracks were observed in 2005.

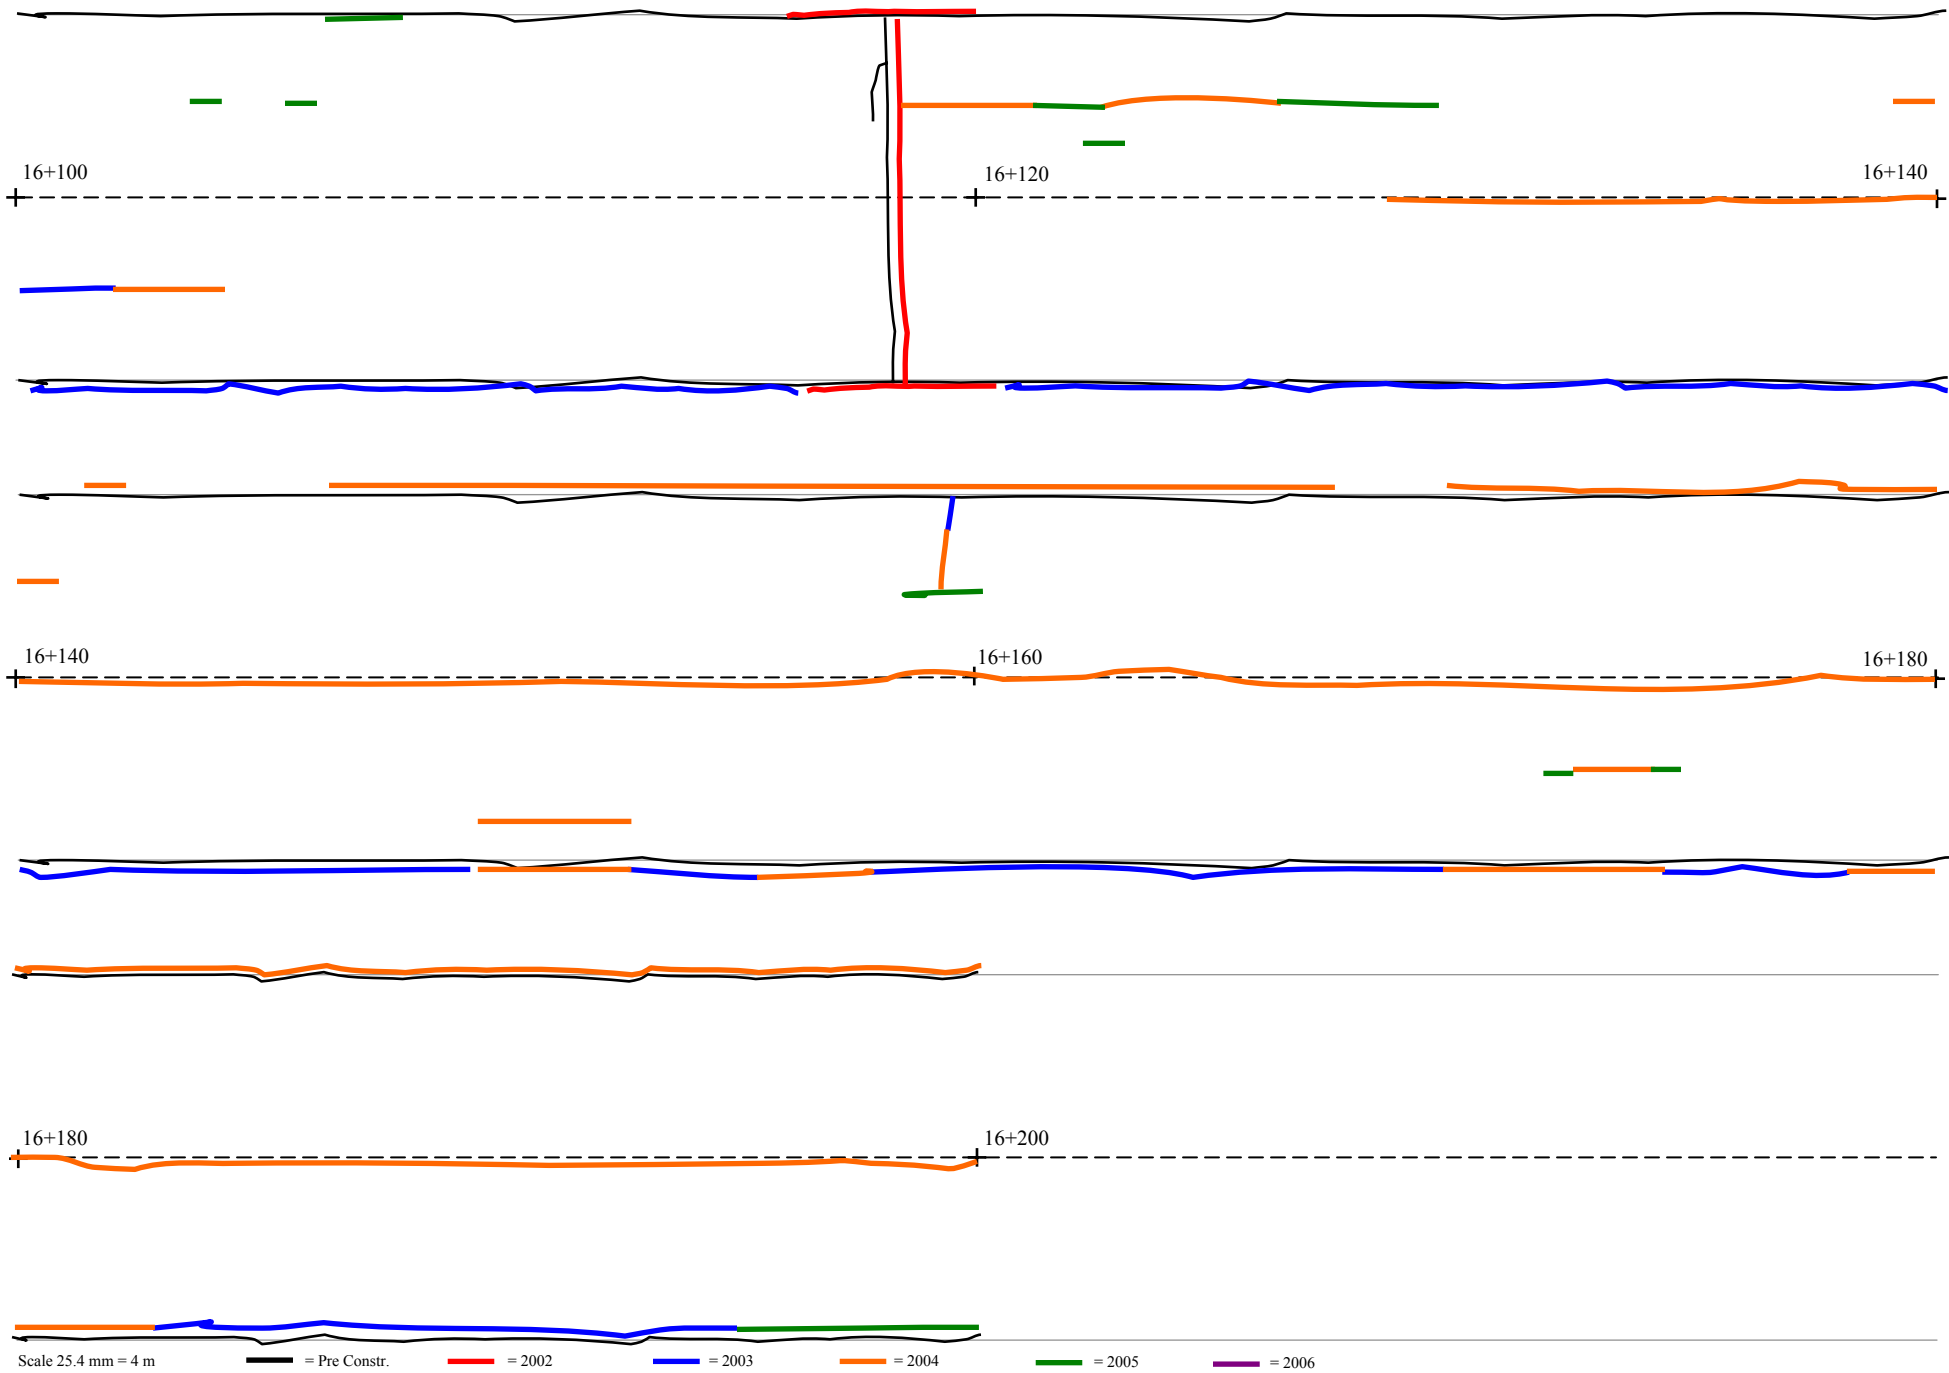
Figure 17. Section 6 Control Crack Survey

A crack survey for Control Section 6 is exhibited in Figure 17. In 2003 roughly a third of the shoulder joint has cracked and a transverse crack has begun to cross the roadway at station 16+159. By 2004 nearly three quarters of the shoulder and centerline joint has cracked and a few small areas of longitudinal cracking were observed between wheel paths and in the outer wheel path. The transverse crack at station 16+159 has extended to the quarter point. In 2005 there was a small increase of cracking at the shoulder joint and additional cracking between wheel paths and in the wheel path.
