**Technical Report (09 – 2)**  
*Evaluation of the Assaloni Plow and  
Material Spreader*  
*May, 2009*

## *Evaluation of the Assaloni Plow and Material Spreader*

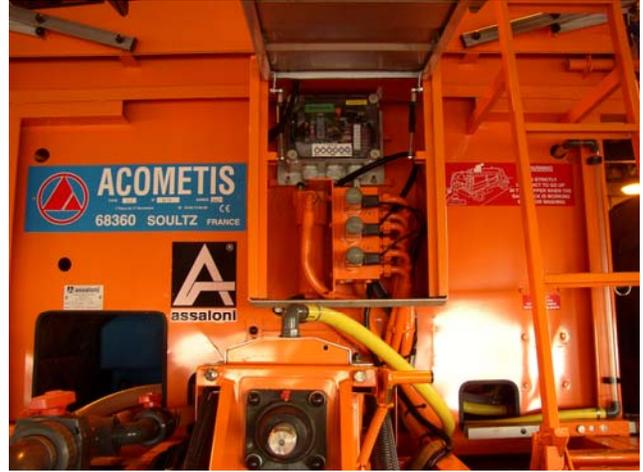
**Photo 2: Control Box at Rear of Hopper**

The Mog Implements technician returned and once again completed a series of checks on the electrical system. At this point, the technician concluded that the problem was most likely in the computer control at the rear of the hopper (see Photo 2 above). The intermittency of the problem made trouble shooting very difficult. It is theorized that any damage that may have occurred to the computer control may have been caused by the initial failure to include the relay or switch discussed above.

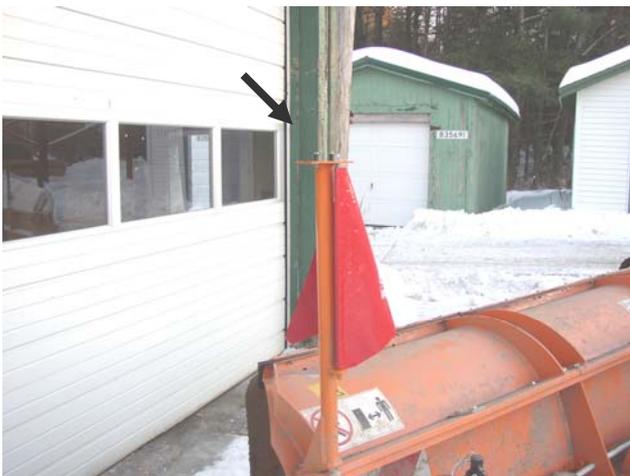
Another light storm dropped 1 to 3 inches of snow beginning December 13<sup>th</sup>. For this event, the marker light attached to the driver's side of the plow broke away (see Photo 5). The telescoping portion of the plow also "froze" in the extended position. This was corrected by simply washing the packed snow from around the extension piece.

**Photo 5: Missing Plow Marker Light**

The marker light and crank handle were also replaced. The bend at the bottom of the plow was straightened by Fleet Services Technicians.

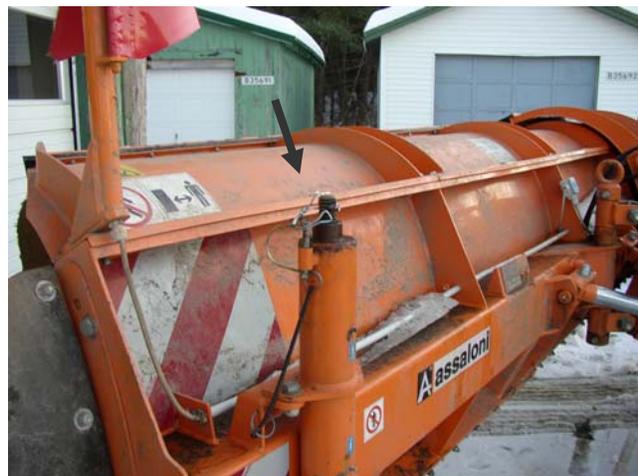
**Photo 6: Missing Wheel Lift Crank Handle**

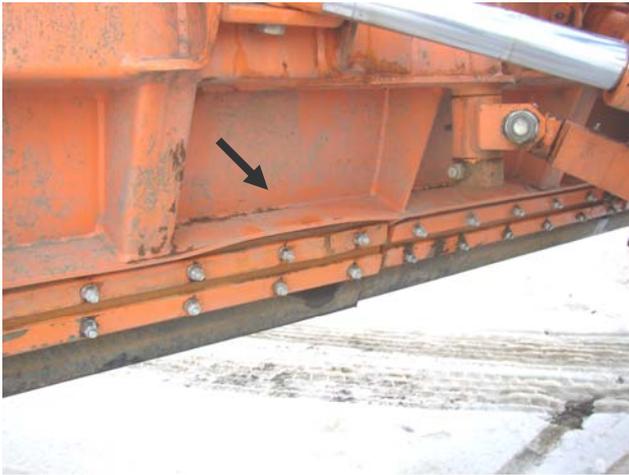
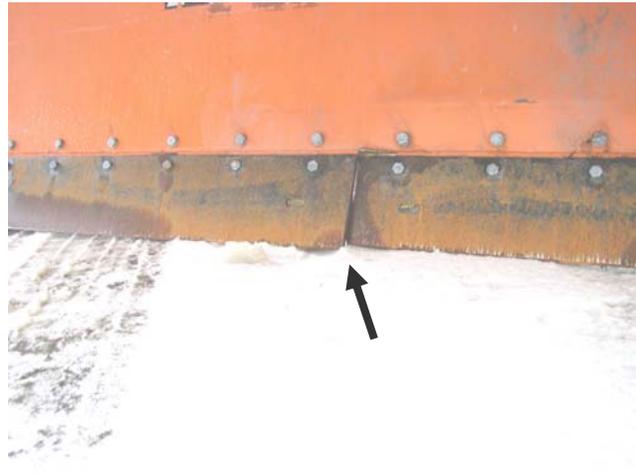
A more significant storm began Sunday morning, December 16<sup>th</sup> and dropped 6 to 8 inches of heavy, wet snow. The snow changed to rain late Sunday evening and after several hours of rain, the temperatures dropped to well below freezing. This sudden change in temperatures, coupled with the wet, heavy snow, caused most the roads to be coated in approximately 1 inch of packed ice and snow. The plow route serviced by the Assaloni was no exception. The operator reported that the Telescoping plow did not cut, or scrape the packed snow as well as his conventional plow. In addition, a crank handle, used to adjust the lift wheel on the drivers side became dislodged and was lost (see Photo 6). A direct impact with a bridge joint also bent the plow at the mold board, near its center (see Photos 7 and 8). Significant vibrating was reported when the extension portion is positioned on the gravel shoulder at the south-easterly end of Coldbrook road.

**Photo 7: Plow Damage – Rear View**

**Photo 8: Plow Damage – Front View**

For this winter season, a new driver operated the equipment. The plow was used for approximately 8 storm events. The plow was removed from service in late February because of damage to the moldboard caused by an impact to a bridge joint while the plow was operating using the down pressure feature. This damage occurred at the same position on the plow as during the 2007-2008 evaluation (see Photos 7 and 8 above). This damage caused a windrow of snow to be left on the roadway.

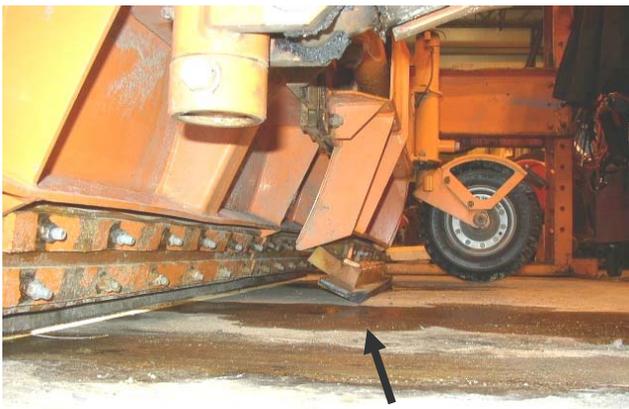
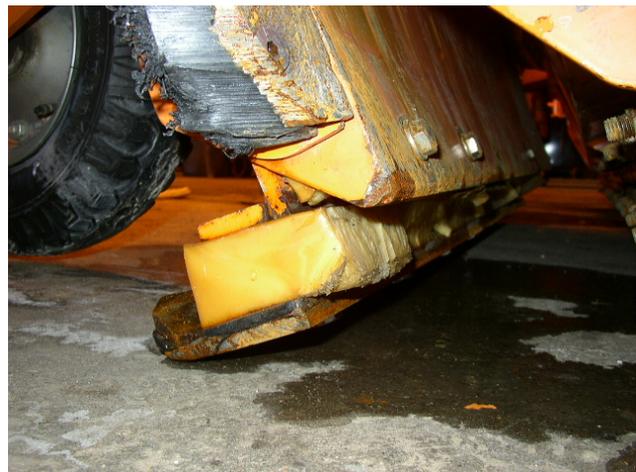
From this date until February 29<sup>th</sup>, the plow was used for 14 winter storm events. On February 29, the plow was removed from service because the plow blades had worn to termination. The polyurethane block on the extension to which the plow blades attach was also severely damaged from impact to a large pot hole associated with a catch basin (see Photos 9 and 10). This damage occurred while the plow was being operated using the down pressure option.

**Photo 9: Damage to Poly Block - Rear View**

**Photo 10: Damage to Poly Block – End View**

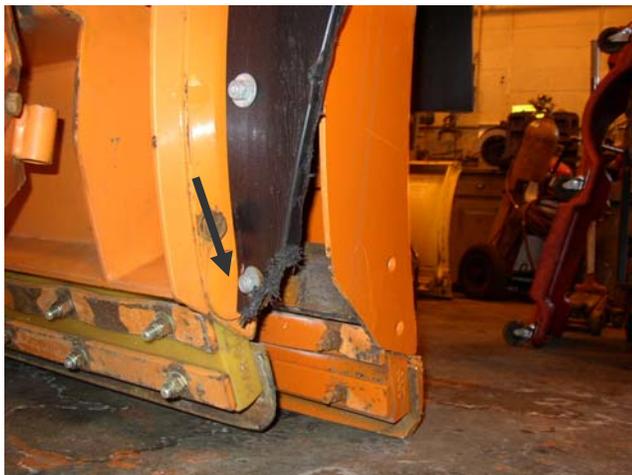
**Photo 11: Repaired Poly Block**

Before the plow was re-installed for the 2008-2009 winter, repairs to some of the damage incurred during the previous winter were completed. This work was performed by Viking-Cives USA at its Harrisville, New York facility. These repairs included the replacement of the poly block attached to the extension and straightening and “full length” reinforcement of the moldboard (see Photos 11 and 12).

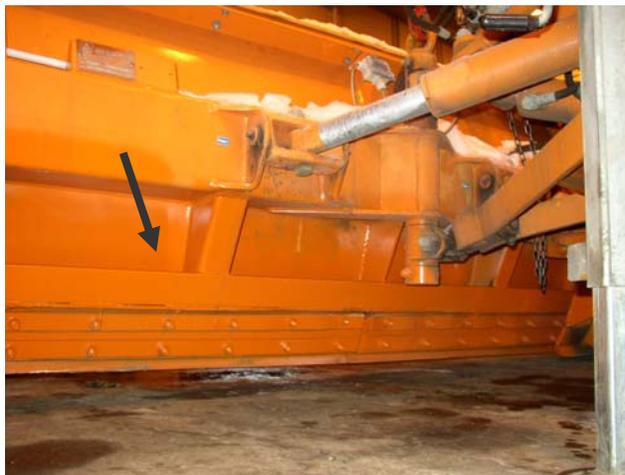
**Photo 12: Straightened/Reinforced Moldboard**
