Technical Report 96-25 and 97-19 *Experimental Use of Sawed and Sealed Joints to Minimize Thermal Cracking*

Final Report - August 2004

Experimental Use of Sawed and Sealed Joints to Minimize Thermal Cracking

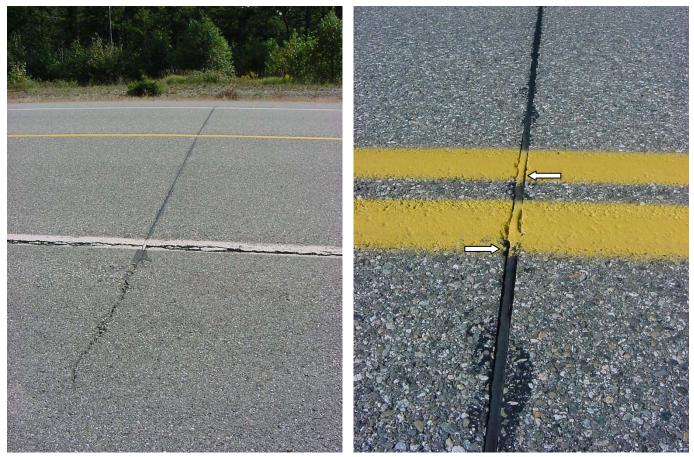
Twenty nine of the thirty three sawed joints have cracks extending from the end of the joint halfway across the shoulder. Photo 11 shows a typical crack at the end of a joint.

Sealant is pliable and adherence is good except at the roadway centerline on six of the joints where it has separated from the sidewall (Photo 12).

Photo 11: Typical shoulder crack

Photo 12: Sealant delaminating

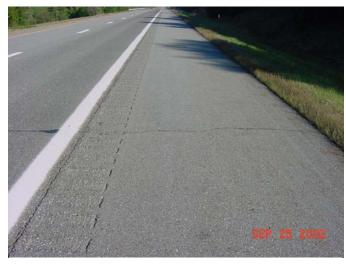
There are no transverse cracks. Centerline and shoulder longitudinal joints have separated the entire length of the section. There are isolated areas of initial load cracking in the passing lane only and longitudinal cracks between wheel paths on both lanes. Cracks are extending from the ends of each sawed joint into the left shoulder and break down lane (Photo 13).

Photo 13: Crack extension into shoulder

The T1R6 project has a number of transverse cracks, all in the control section. It appears the saw and sealed joints has eliminated or delayed the formation of transverse cracks. Shoulder cracking at the joint ends are more severe on this project than in Beddington. The cracks extend across the entire shoulder. This could be attributed to thinner HMA.

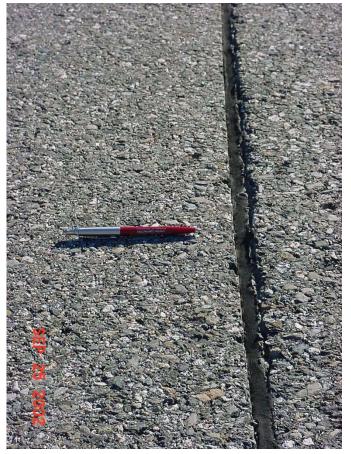
Sealant is pliable and adherence is good in most of the joints. Sealant has dropped approximately one inch or more below the pavement surface in eight of the sixty six joints. This could be attributed to the exclusion of Bond Breaker tape to seal the bottom of the reservoir. The joint edge has raveled in these areas due to winter snow removal (Photo 14). Two joints had missing sealant between wheel paths (Photo 15).

Photo 14: HMA ravel at joint edge

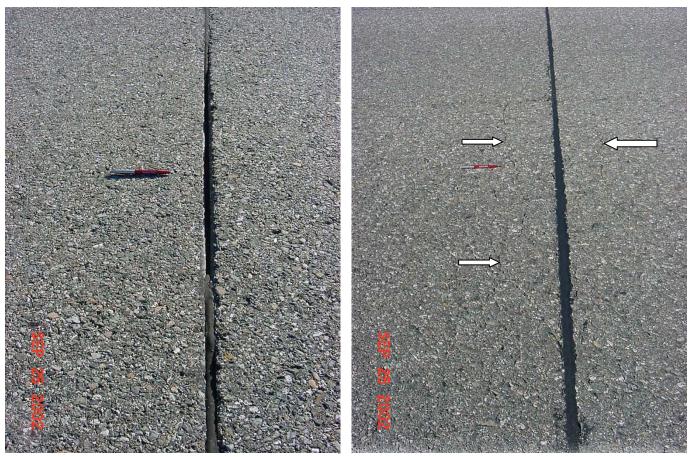
Twenty five joints have initial cracking parallel to the joint in each travel lane wheel path (Photo 16). This type of cracking was reported in the Fourth Interim report and severity has remained the same after one

Photo 15: Missing sealant

Photo 16: Parallel cracking

A number of joints experienced sealant failure. Types of failure include sealant delaminated from the sidewall, sagging into the joint, or missing sealant. Bond breaker tape was not utilized on this project and may be the cause of many sealant failures. Construction temperatures below 50 degrees Fahrenheit may also contribute to poor sidewall adhesion.

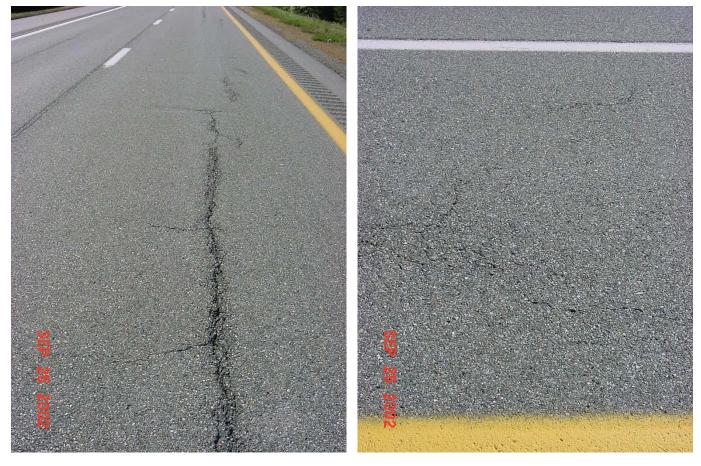
Centerline and shoulder joints have separated the entire length of this section. There is a small amount of longitudinal cracking between wheel paths in both lanes and a small amount of initial load cracking in the passing lane. Eleven transverse cracks, ranging in length from 1 to 2 feet, are located between wheel paths in both lanes. A number of them are originating from longitudinal and load cracking mentioned earlier (Photo 17 and 18). There are a total of six transverse cracks that are crossing from either centerline to quarter point or from shoulder to quarter point in both lanes (Photo 19).

Photo 17: Migrating transverse cracks

Photo 18: Transverse crack from load cracking

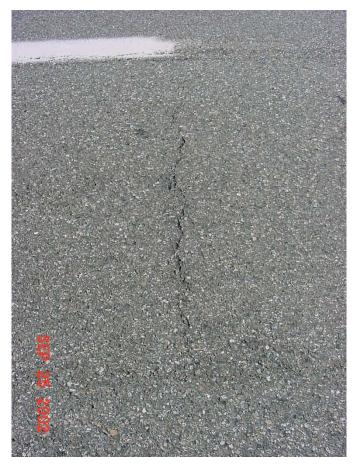
Photo 19: Control section transverse crack
