VERMONT AGENCY OF TRANSPORTATION

**COLD IN-PLACE RECYCLED BITUMINOUS PAVEMENT
DORSET-DANBY, VT**

Report 2015 – 04

January 2015

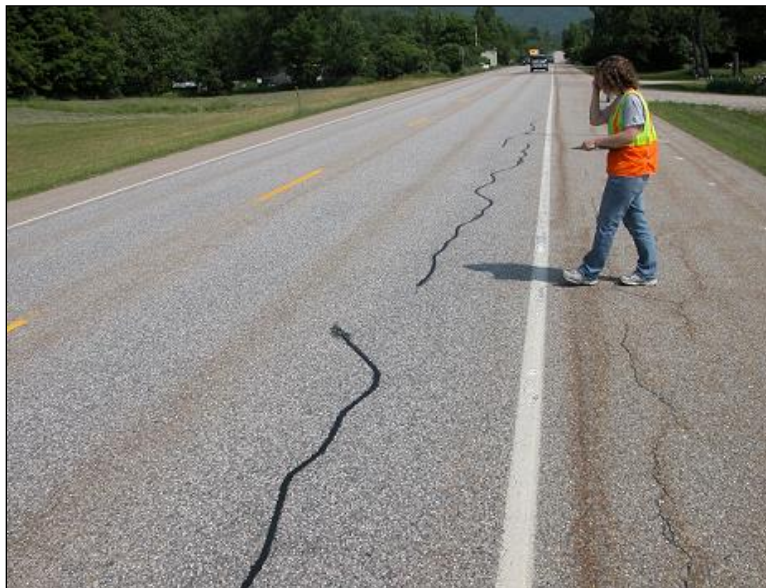
As indicated by the Distress Identification Manual, fatigue cracking occurs in areas subjected to repeated traffic loading, most notably the wheelpaths, and may be a series of interconnected cracks in early stages of development that progresses into a series of chicken wire/alligator cracks in the later stages. For this investigation, the wheelpaths were determined to be 3 feet in width with the center of the left wheel path 3 feet from the centerline and the right wheel path 8 feet from the centerline for both sides of the roadway. An example of fatigue cracking within test site 2 is provided in Figure 6.

Figure 6 Fatigue cracking (Test Site 2, year 10)

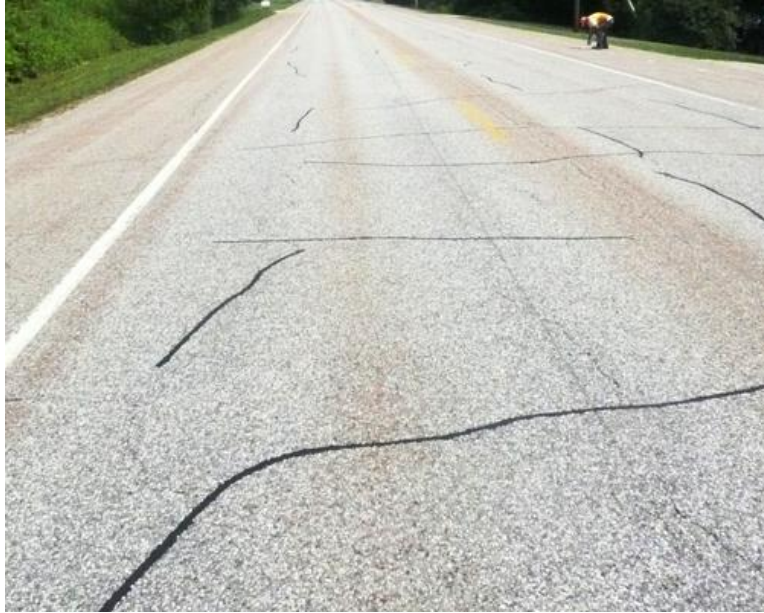
Figure 8 Example of transverse cracking (among others), within test site 1.
