Development, Field Testing, and Implementation of Improved Bridge Parapet Designs

Amy Kalabon, Lauren Hedges, Norbert Delatte

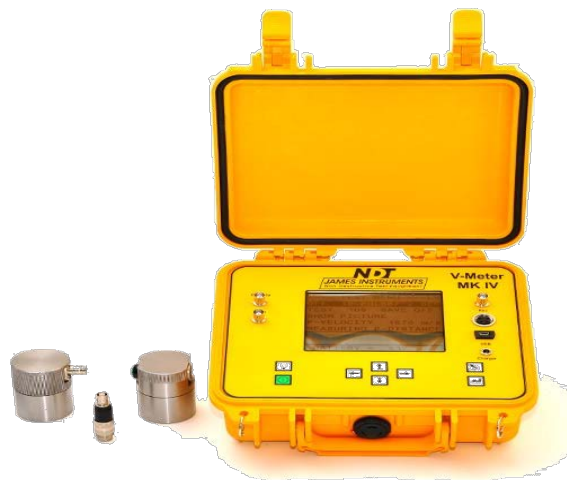
Figure 1: James Ultrasonic Pulse Velocity Meter

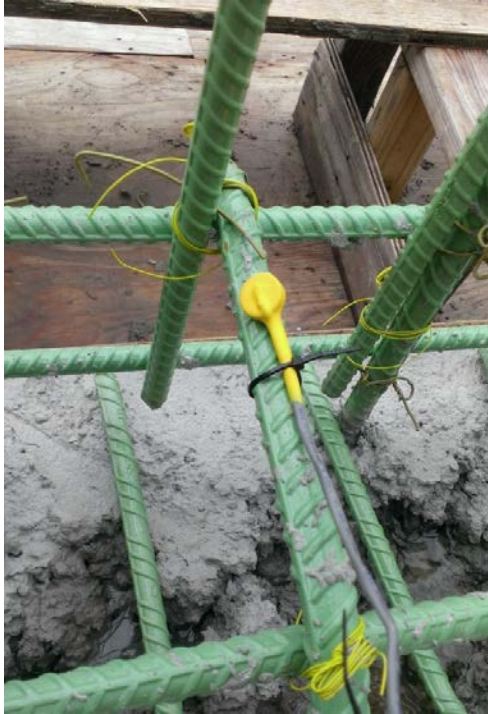
Figure 2: Maturity Sensor Attached to Reinforcement (Photograph by Amy Kalabon)

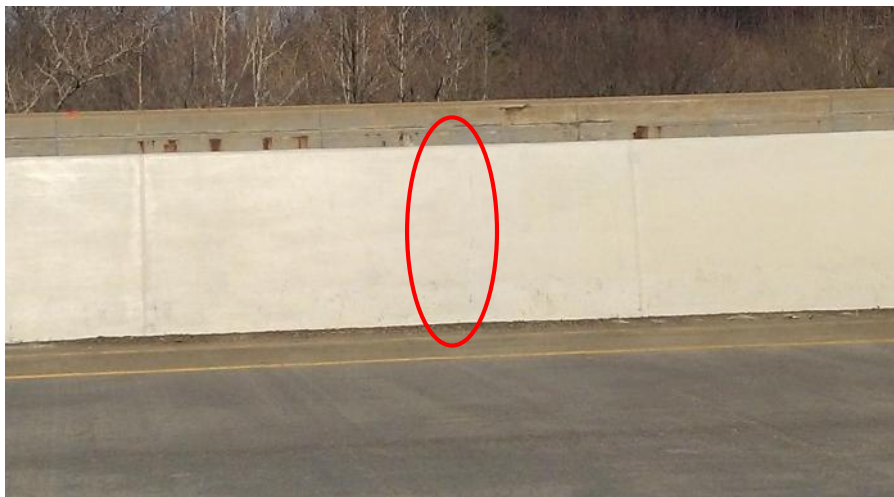
Figure 26: EB Big Creek Bridge North Parapet Crack (Photograph by Lauren Hedges)

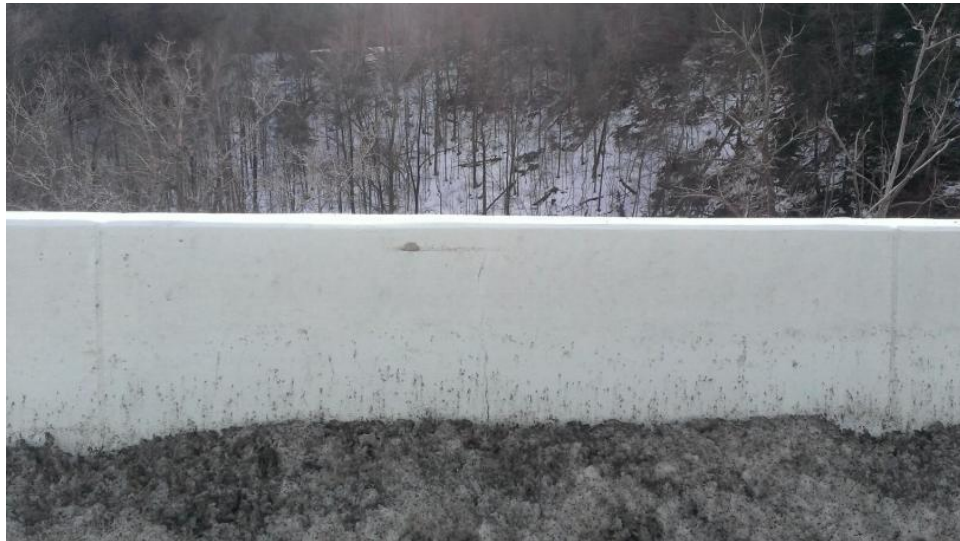
Figure 27: EB Big Creek south parapet crack (Photograph by Lauren Hedges)

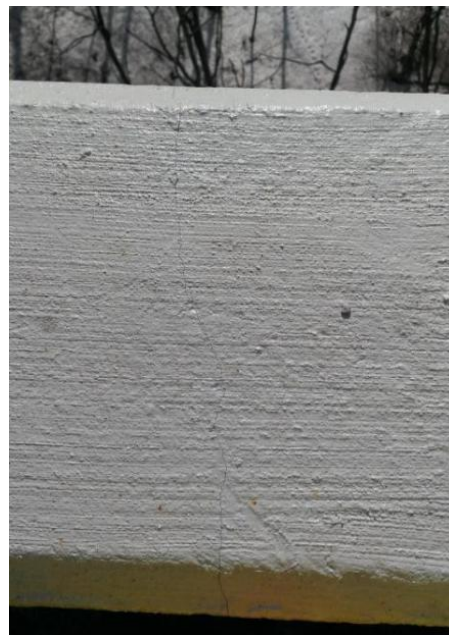
Figure 28: Crack along top of parapet (Photograph by Lauren Hedges)

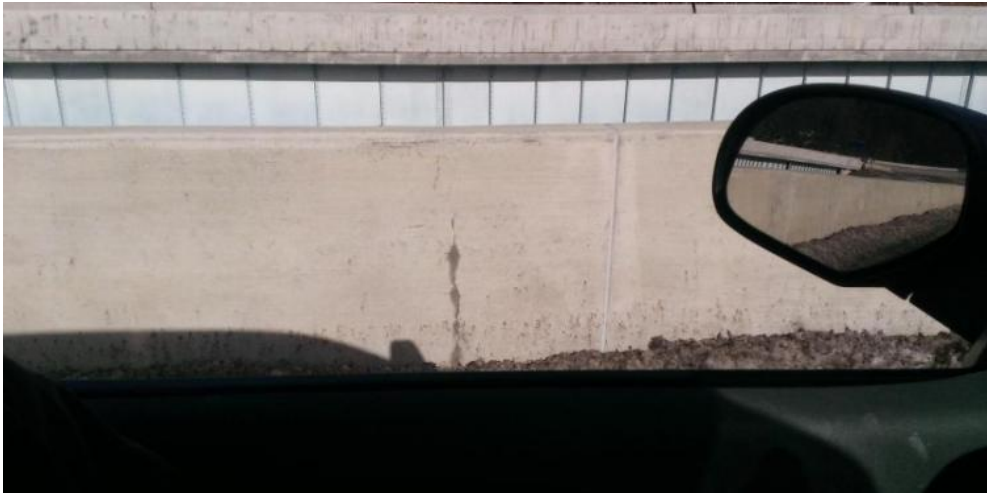
Figure 29: EB Paine Creek north parapet crack near control joint (Photograph by Lauren Hedges)

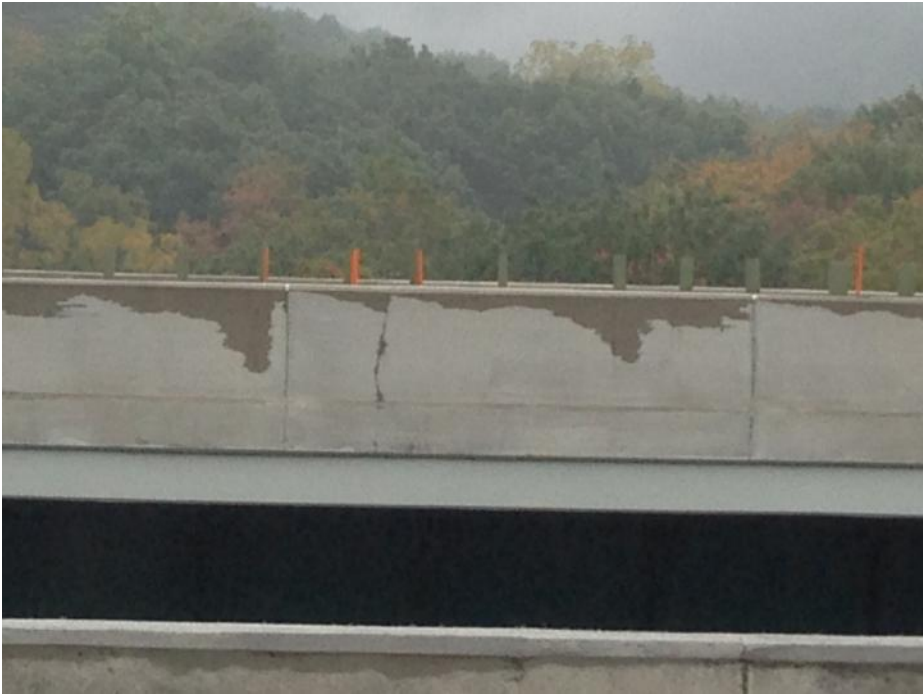
Figure 30: Looking at EB Paine Creek north parapet crack from adjacent bridge (Photograph by Lauren Hedges)

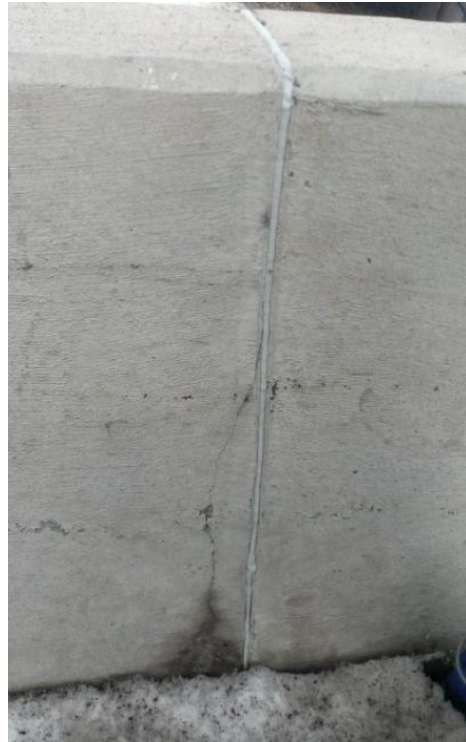
Figure 31: EB Paine Road north parapet crack propagating out of control joint (Photograph by Lauren Hedges)

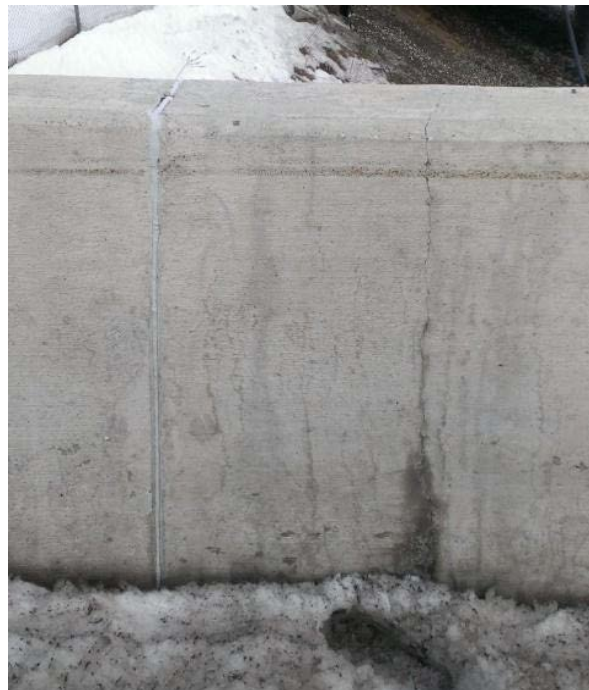
Figure 32: EB Paine Road 2nd crack found between joints (Photograph by Lauren Hedges)

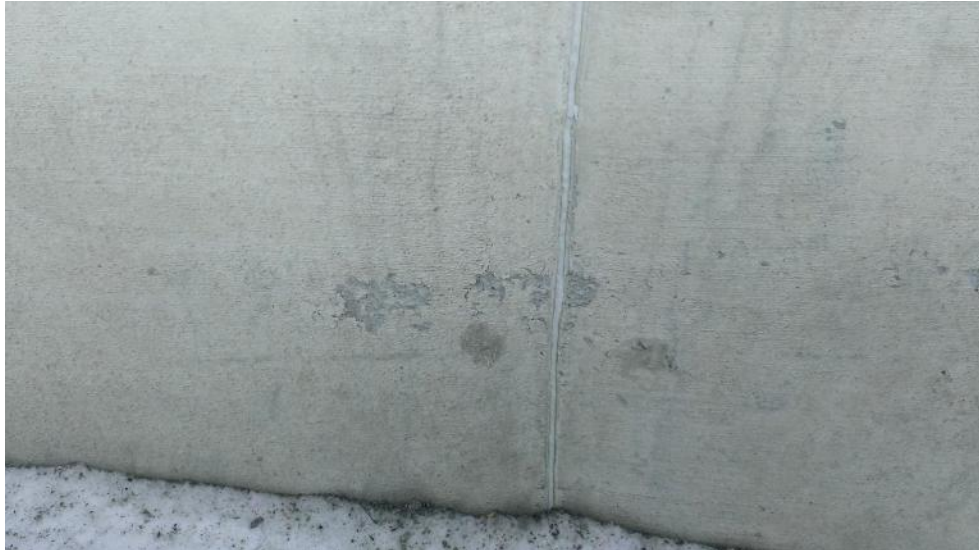
**Figure 33: Spalling on EB Paine Road north parapet along location of horizontal reinforcement
(Photograph by Lauren Hedges)**

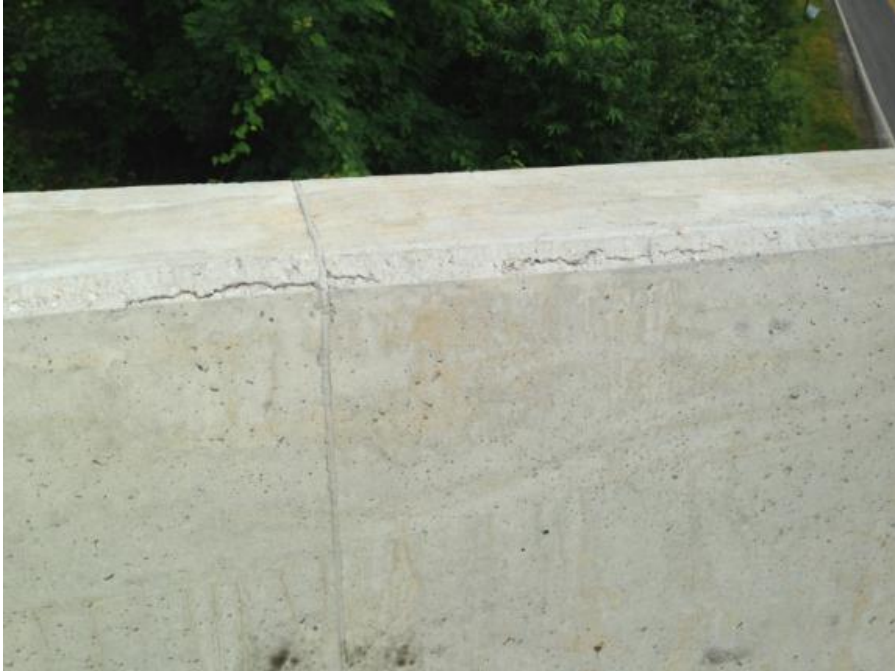
Figure 34: EB Hermitage Road north parapet surface cracks (Photograph by Amy Kalabon)

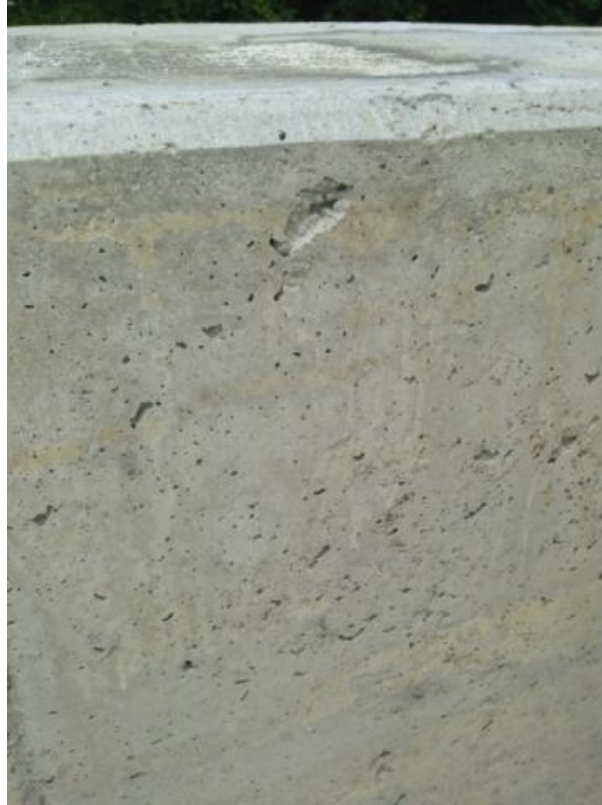
Figure 35: EB Hermitage Road north parapet typical bug holes (Photograph by Amy Kalabon)

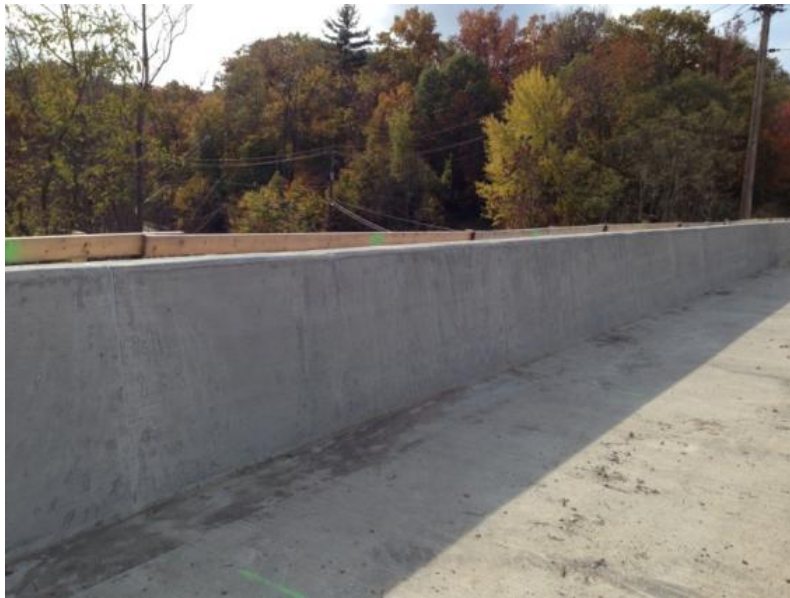
Figure 36: EB Hermitage south parapet condition (Photograph by Amy Kalabon)

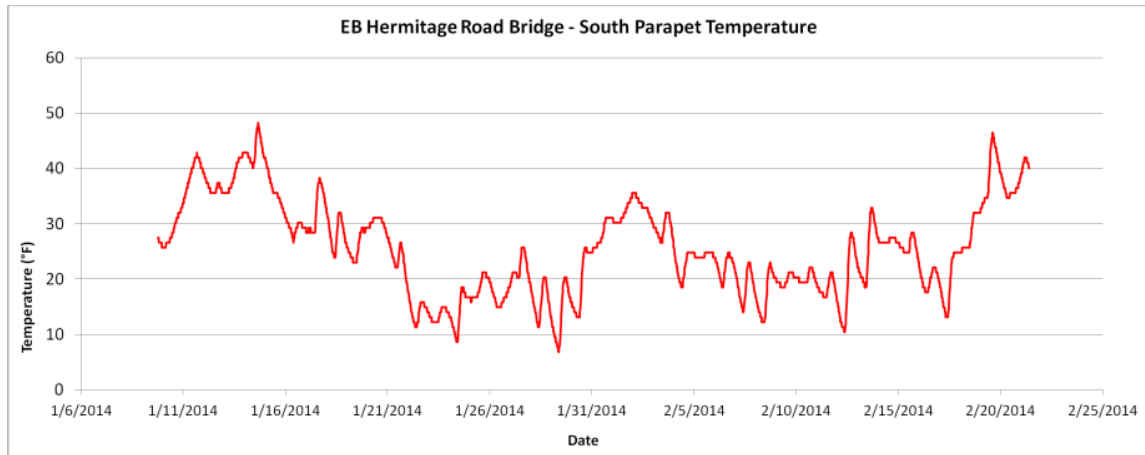
Figure 37: EB Hermitage south parapet winter temperature fluctuations

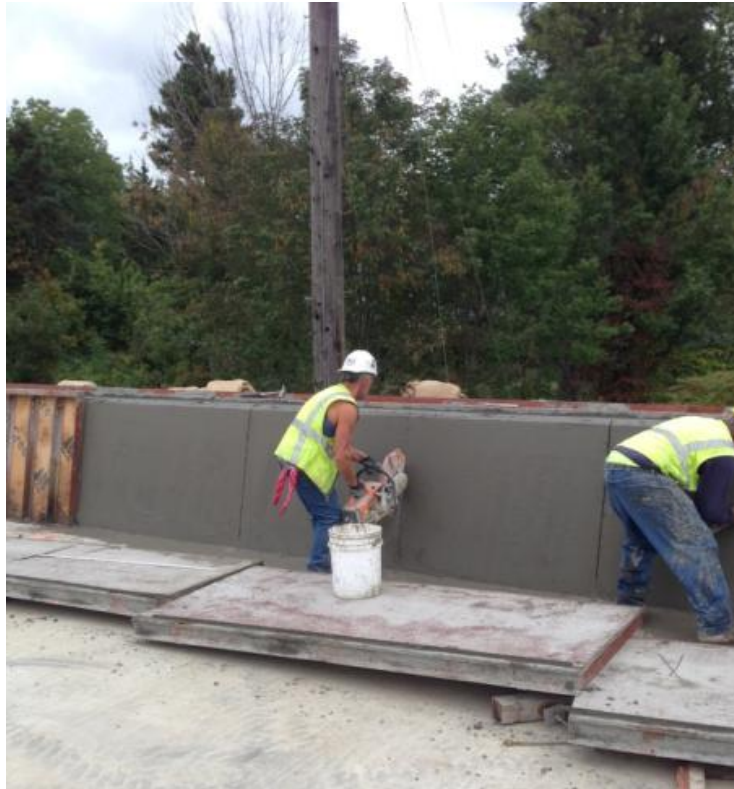
Figure 38: WB Paine Road north parapet performance of saw cuts (Photograph by Amy Kalabon)

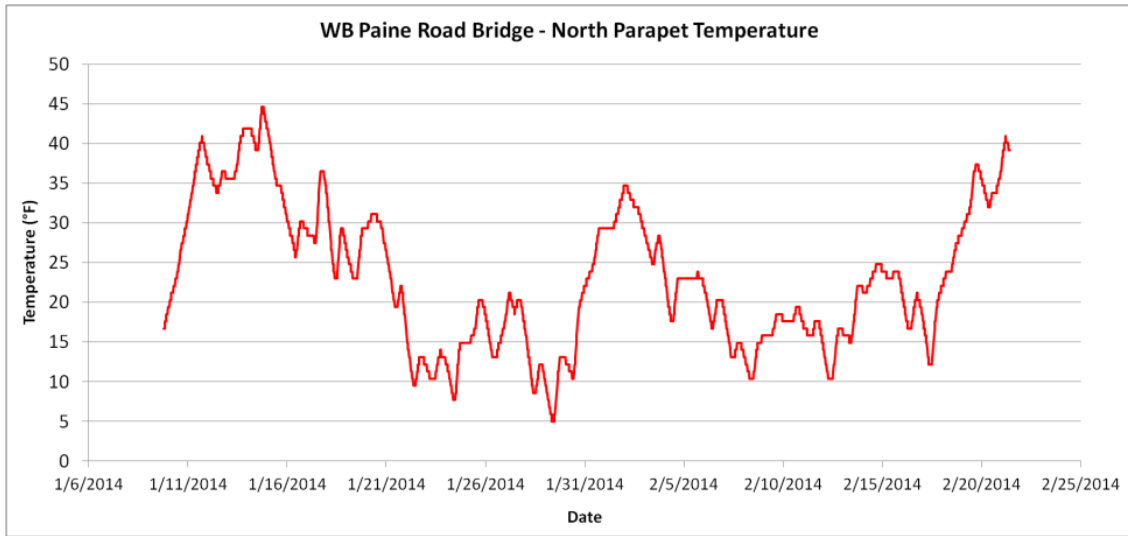
Figure 40: WB Paine Road north parapet winter temperature fluctuations

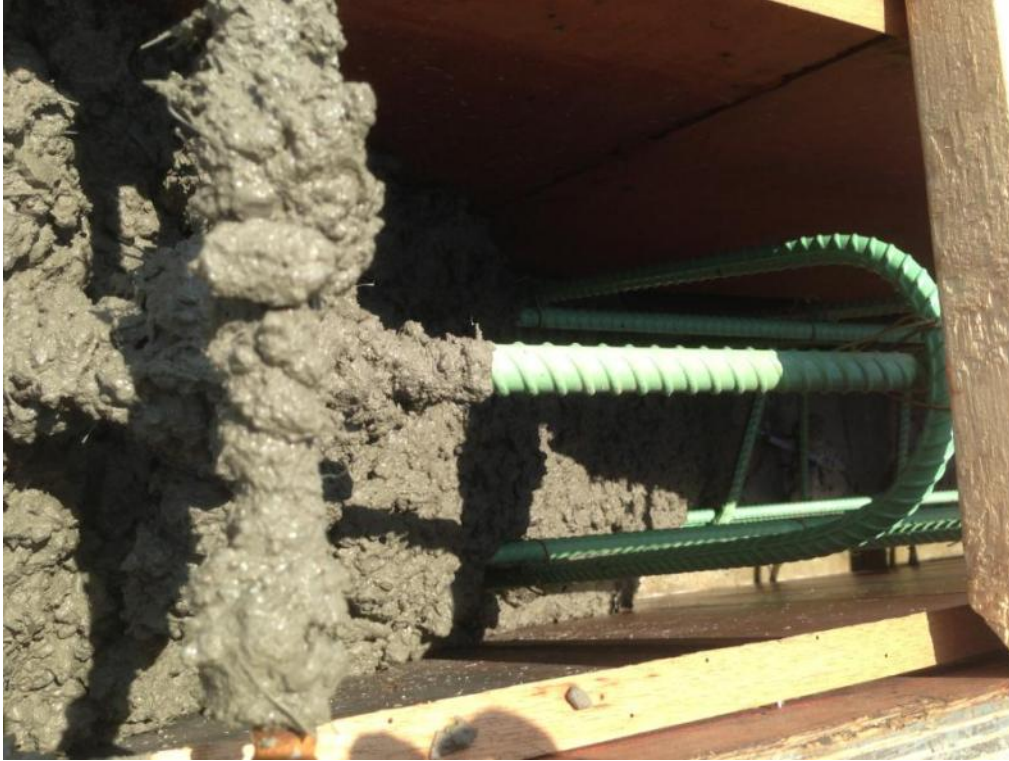
Figure 41: Consolidation of the concrete on WB Paine Road south parapet (Photograph by Amy Kalabon)

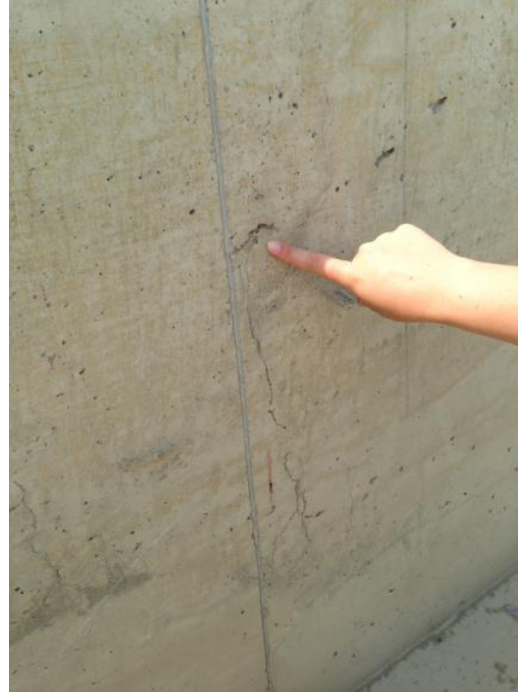
Figure 43: Surface cracks found on WB Paine Road south parapet (Photograph by Amy Kalabon)

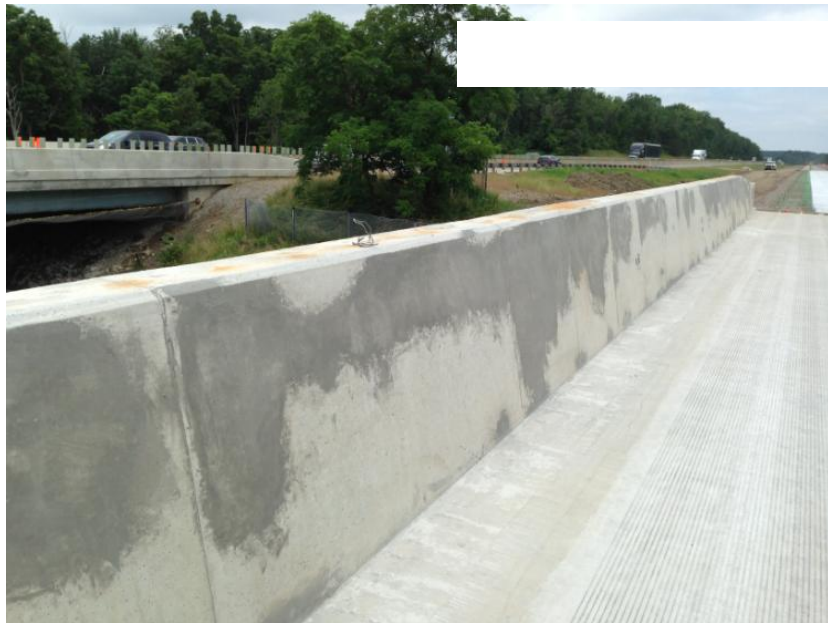
Figure 44: WB Paine Road rubbed south parapet (Photograph by Amy Kalabon)

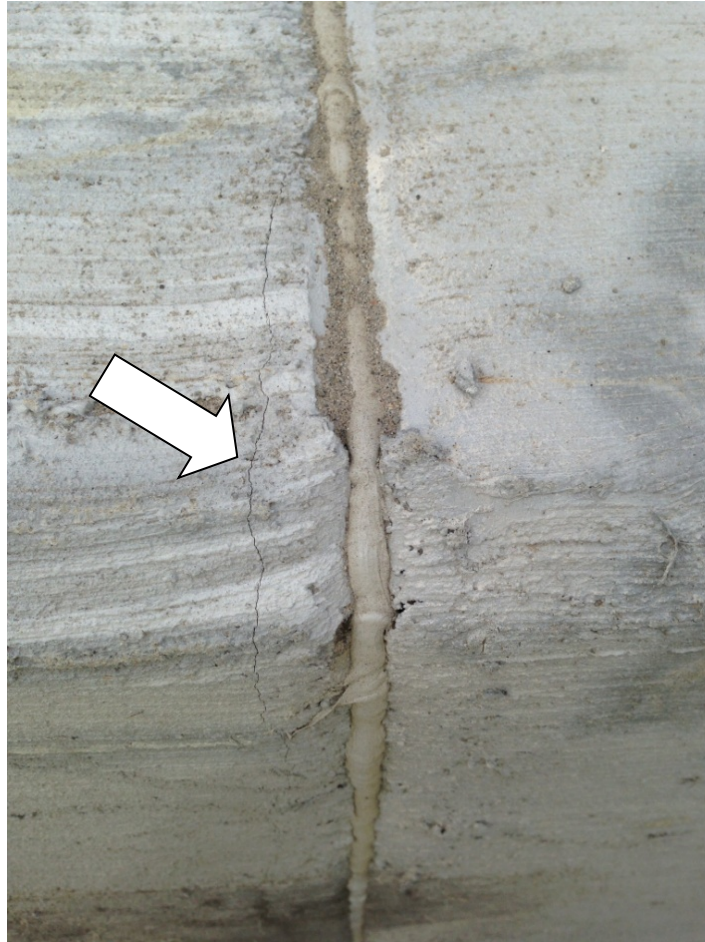
**Figure 45: WB Paine Creek north parapet crack looking down from top of parapet
(Photograph by Amy Kalabon)**

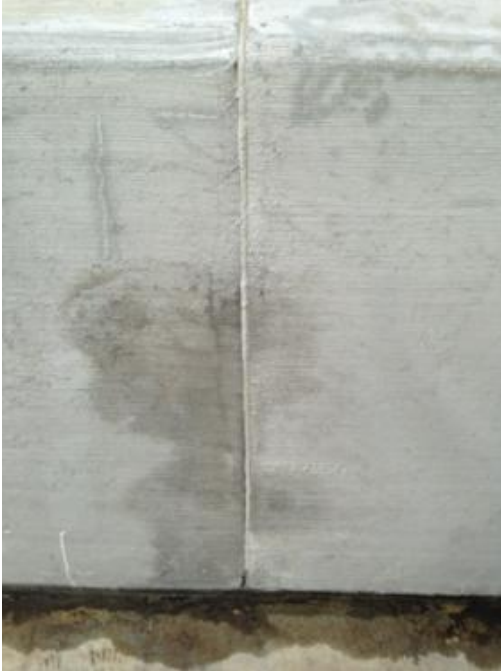
Figure 46: WB Paine Creek north parapet crack (Photograph by Amy Kalabon)

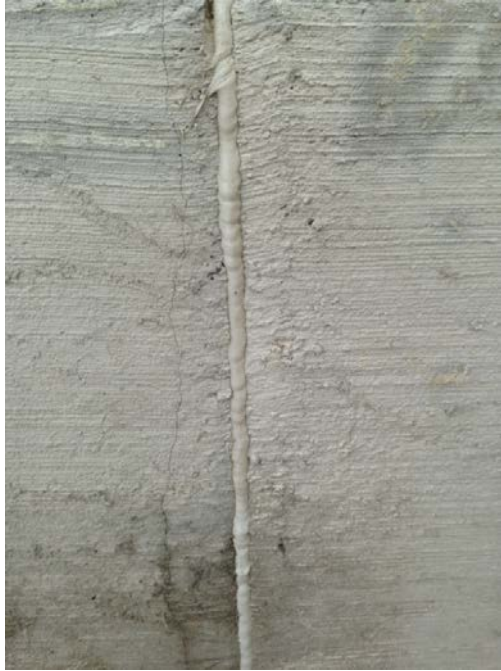
Figure 47: WB Paine Creek north parapet crack zoomed in view (Photograph by Amy Kalabon)

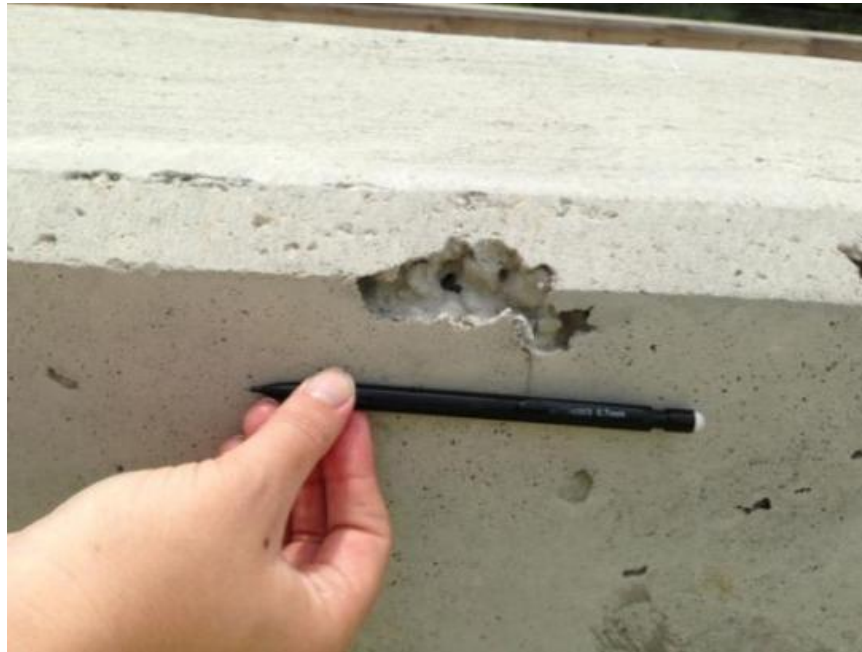
Figure 48: WB Paine Creek south parapet poor consolidation at the surface (Photograph by Amy Kalabon)

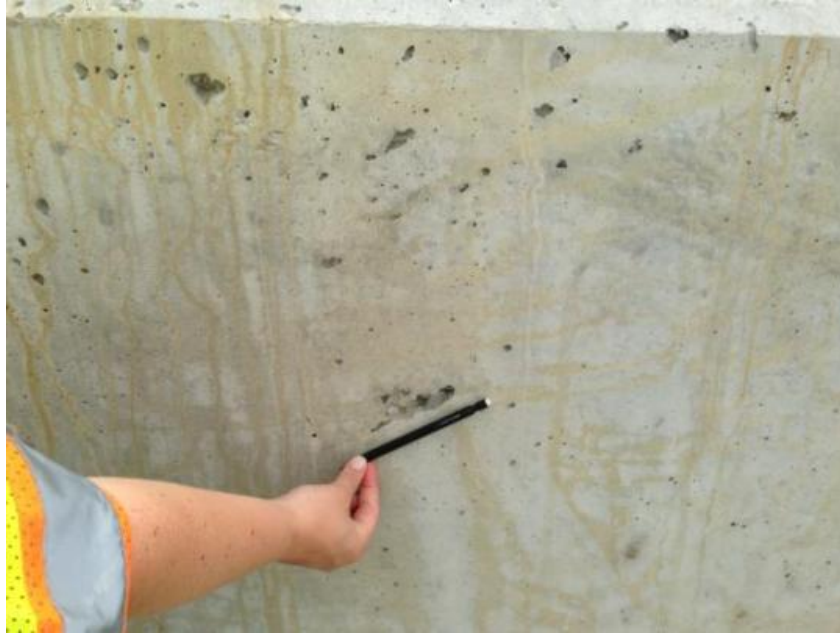
Figure 49: WB Paine Creek south parapet holes on the surface (Photograph by Amy Kalabon)

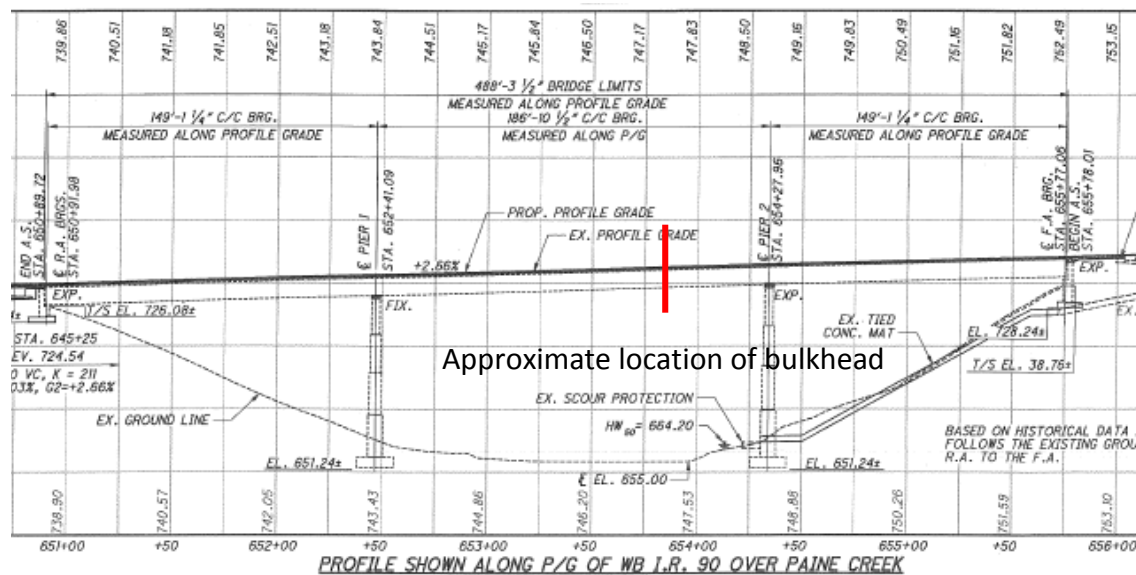
Figure 50: WB Paine Creek Bridge Profile

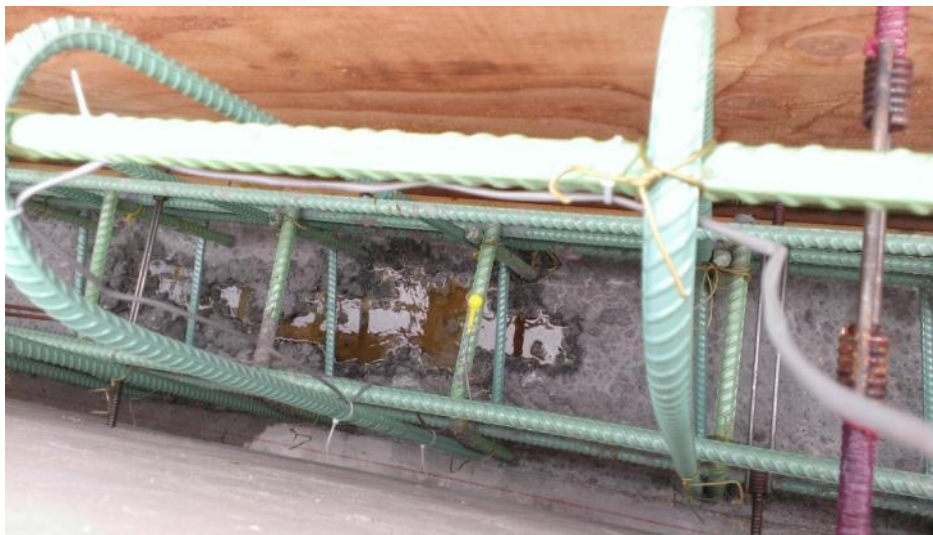
Figure 52: Placement of maturity sensors (Photograph by Amy Kalabon)

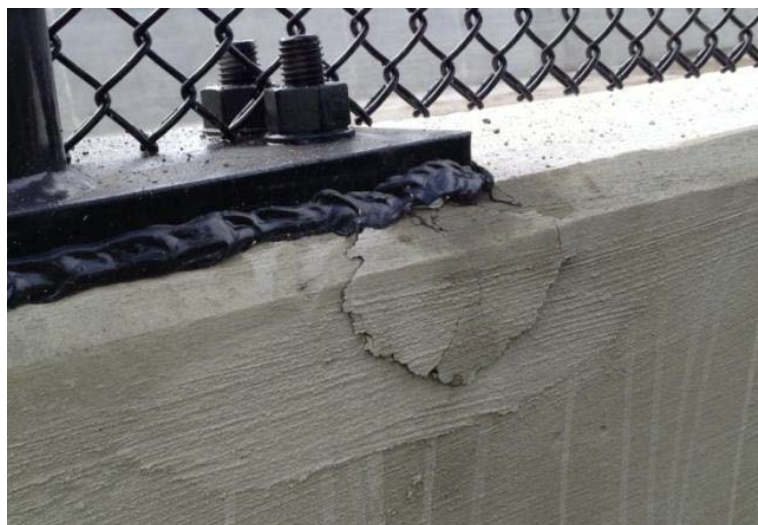
Figure 53: South Marginal north parapet crack at VPF post base plate (Photograph by Amy Kalabon)

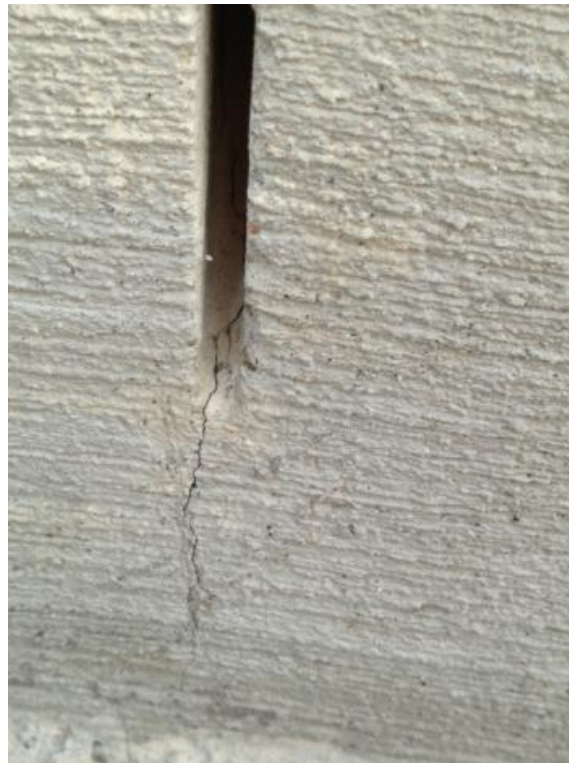
Figure 54: South Marginal north parapet cracks where control joint terminates (Photograph by Amy Kalabon)

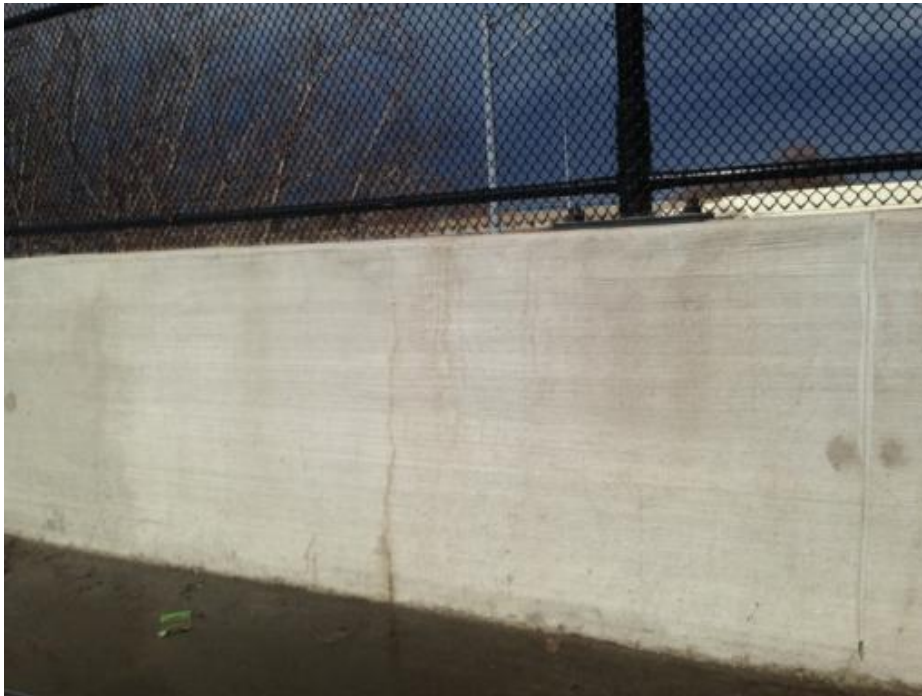
Figure 55: South Marginal north parapet mid-panel cracking (Photograph by Amy Kalabon)

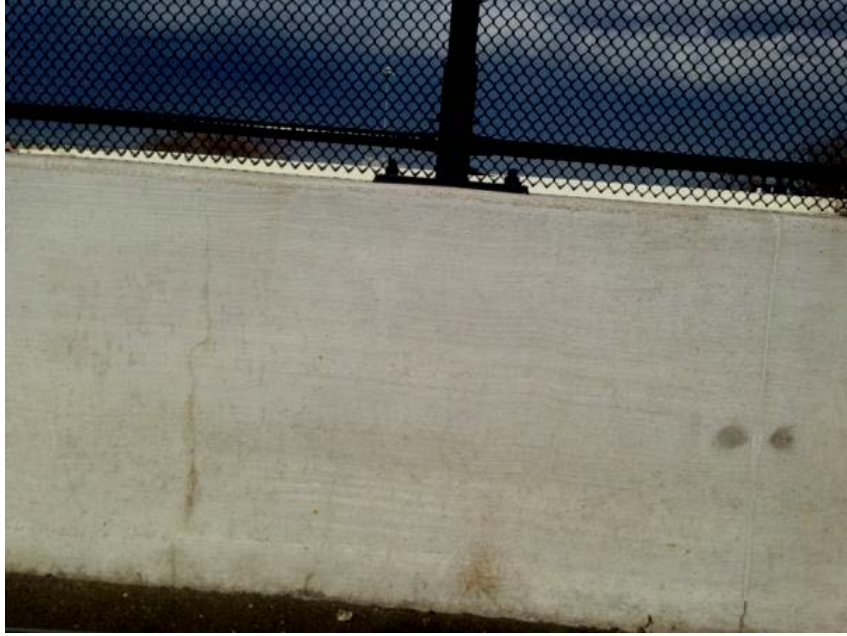
Figure 56: South Marginal north parapet mid-panel cracking (Photograph by Amy Kalabon)

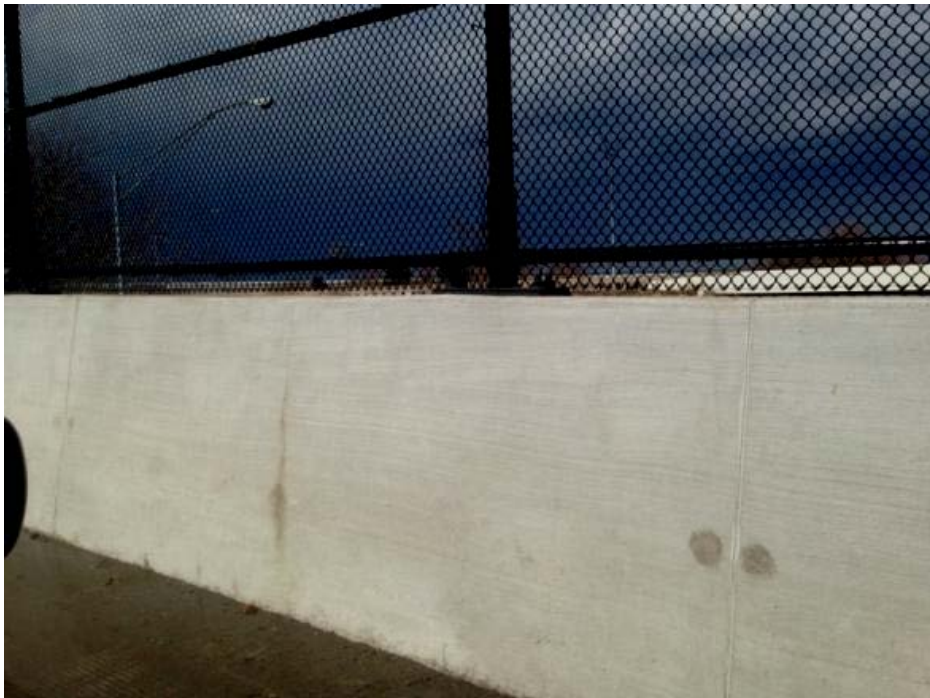
Figure 57: South Marginal north parapet mid-panel cracking (Photograph by Amy Kalabon)

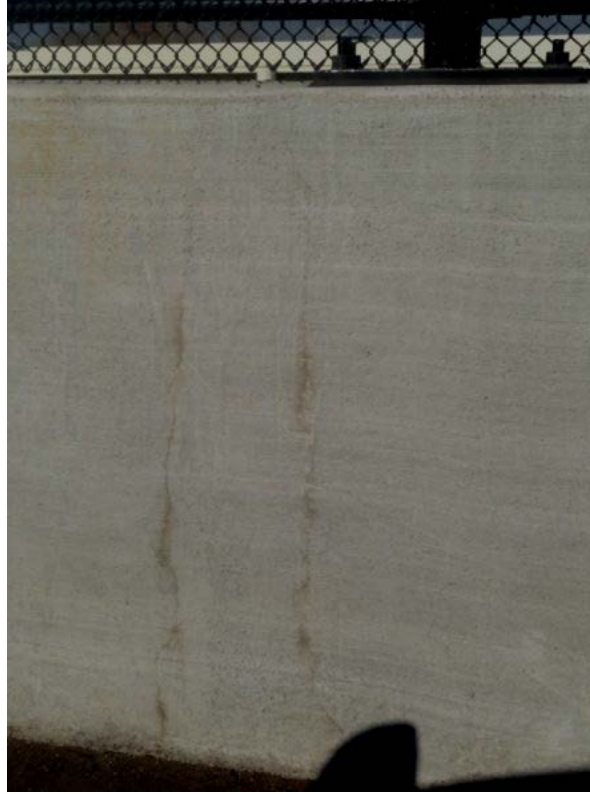
Figure 58: South Marginal north parapet mid-panel cracking (Photograph by Amy Kalabon)

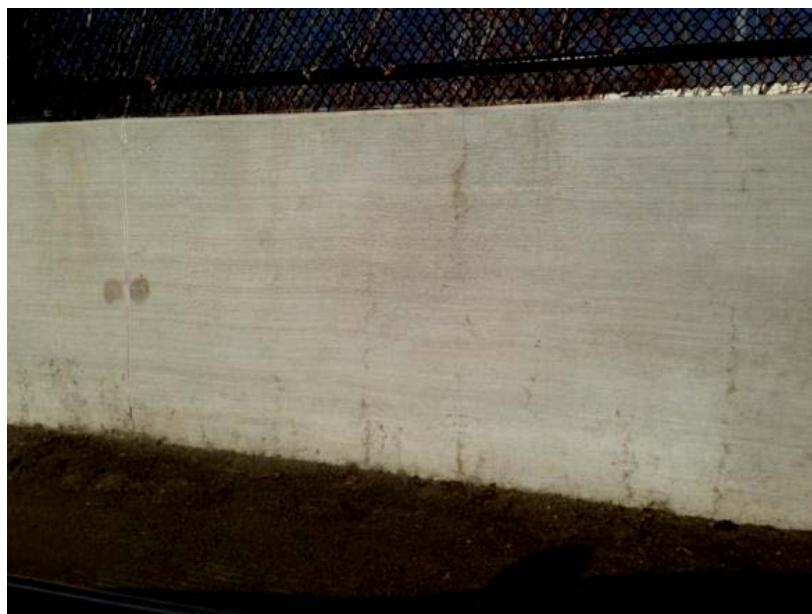
Figure 59: South Marginal north parapet small cracking (Photograph by Amy Kalabon)

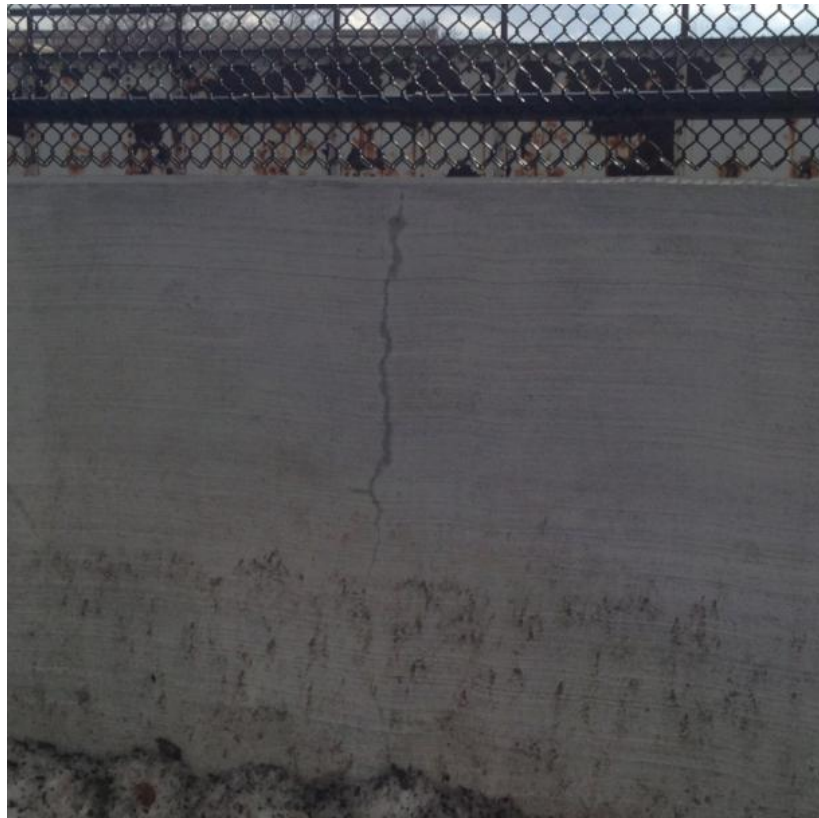
Figure 60: South Marginal south parapet mid-panel crack (Photograph by Amy Kalabon)

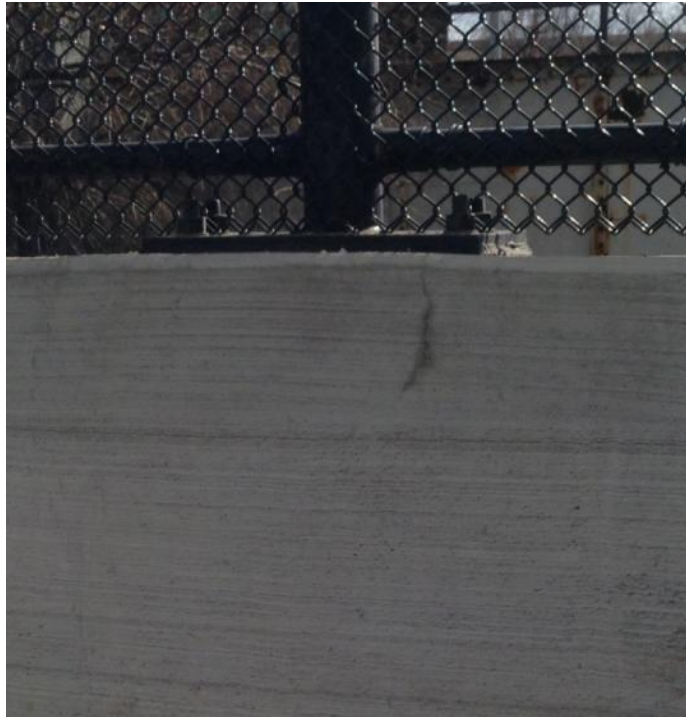
Figure 61: South Marginal south parapet VPF post base plate crack (Photograph by Amy Kalabon)

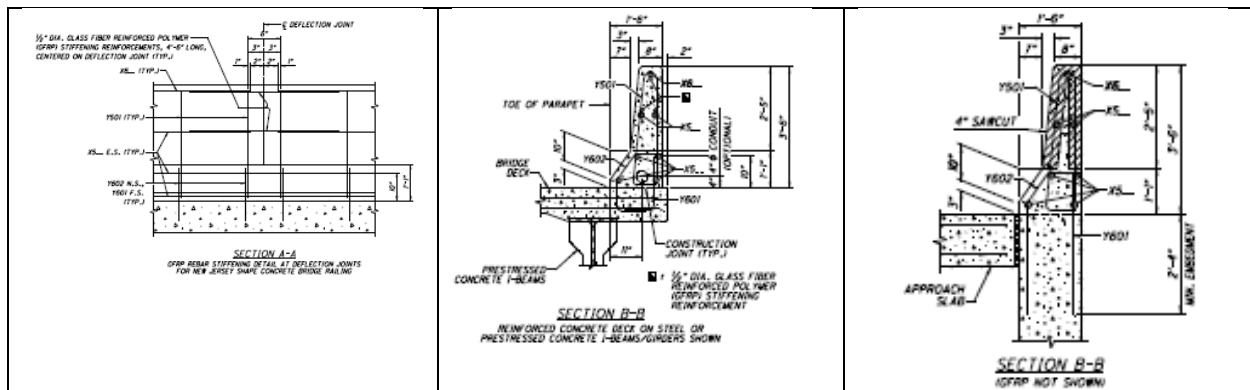
Figure 62: New ODOT Parapet BR-1-13 January 17, 2014 (ODOT 2014b)
