Evaluating Roadway Subsurface Drainage Practices – Phase II

Final Report
April 2015

IOWA STATE UNIVERSITY
Institute for Transportation

Sponsored by
Iowa Highway Research Board
(IHRB Project TR-662)
Iowa Department of Transportation
(InTrans Project 13-473)

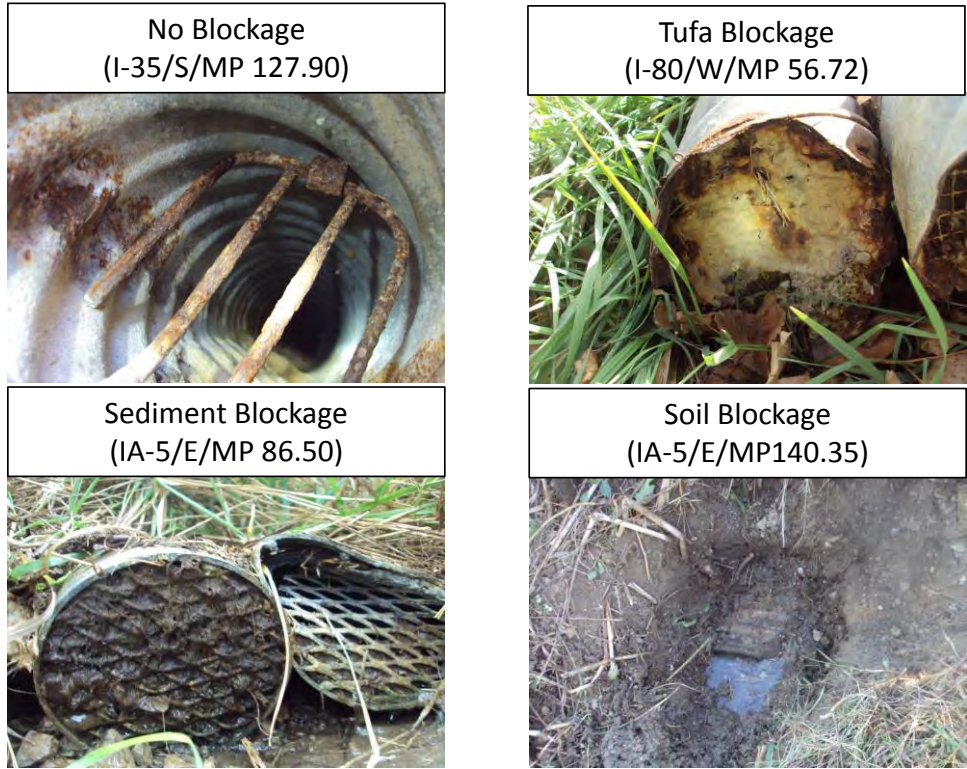
- No blockage (open): when the inside of the outlet pipe was in clean condition
- Tufa blockage: when there was build-up of calcium carbonate observed either inside the outlet pipe or nearby rodent guard screens
- Sediment blockage: when dirt or debris materials were deposited inside the outlet pipe or nearby rodent guard screens
- Soil/aggregate blockage: when the outlet was not exposed outside but covered by soil or aggregate

Figure 6. Drainage outlet conditions categorized by blockage

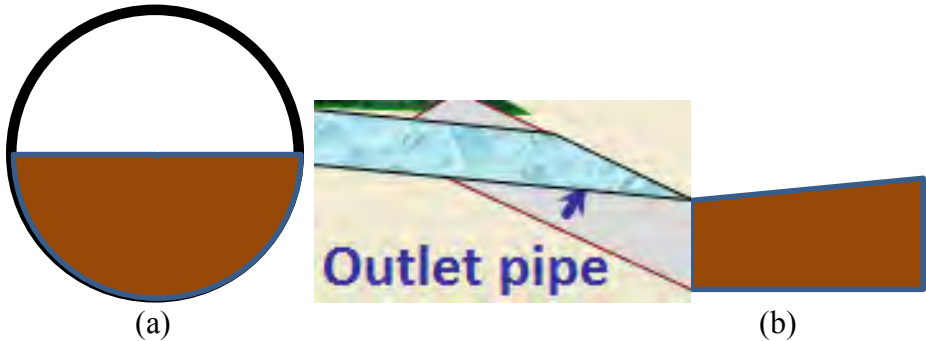
The functional condition of the outlet opening was rated in terms of percentage of blockage caused by coarse/fine materials accumulation. The slope condition of the surface at the outlet end was rated as “up-hill,” “down-hill,” and “parallel.” For instance, Figure 7(a) illustrates a 50 percent outlet blockage rating and Figure 7 (b) illustrates an “up-hill” slope condition. Any pavement distresses observed near the inspected drainage outlet location were also recorded (images and videos).

Figure 7. Subdrain outlet functional rating based on visual observation: (a) 50 percent blockage, and (b) up-hill condition of surface at the outlet end

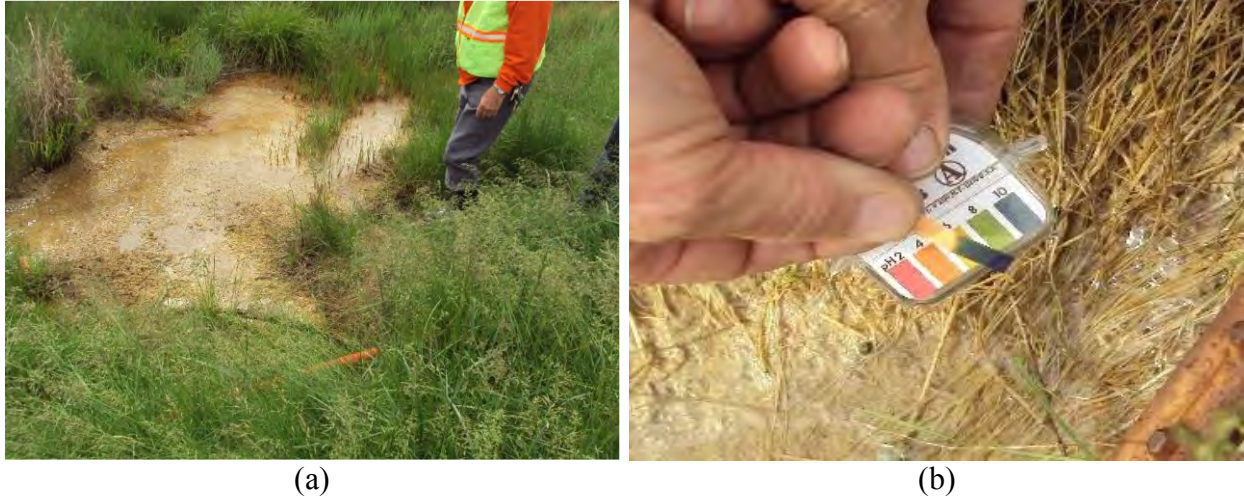
As seen in Figure 11(a), vegetation kills, referred to as “dead zones,” were observed in the vicinity of the drain outlet that carried tufa materials. The high-pH and high-alkalinity characteristics of tufa (see Figure 11(b)) could have possibly contributed to the observed vegetation kills. However, environmental assessment studies focusing on the impact of tufa on roadside vegetation are very limited, and none of them have reported it to be an environmental hazard (Snyder and Bruinsma 1996).

Figure 11. Vegetation condition in the vicinity of drain outlets carrying tufa materials (I-35/N/MP141.30): (a) vegetation kill (dead zone), (b) water from the drainage outlet pipe showing a pH value of 10

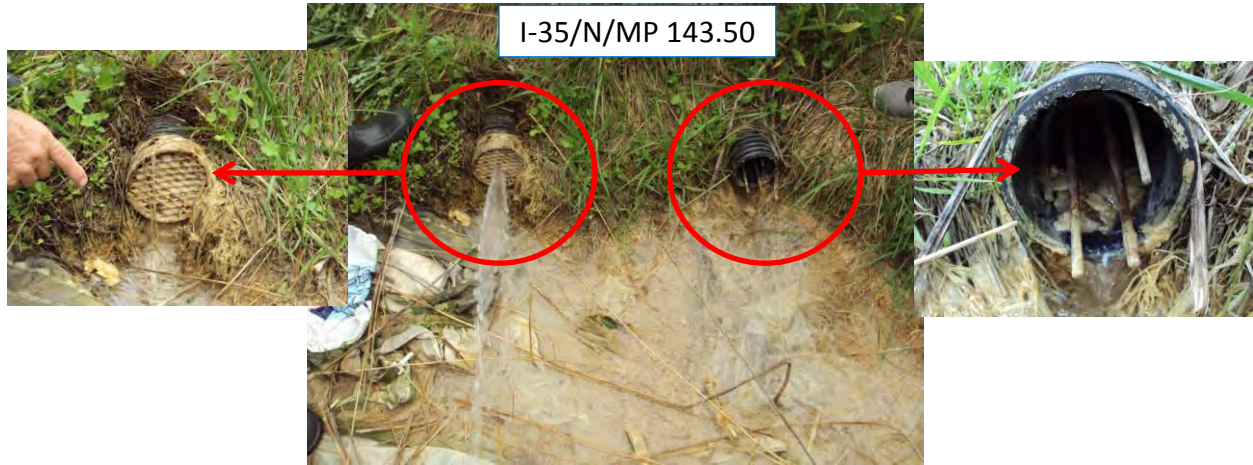
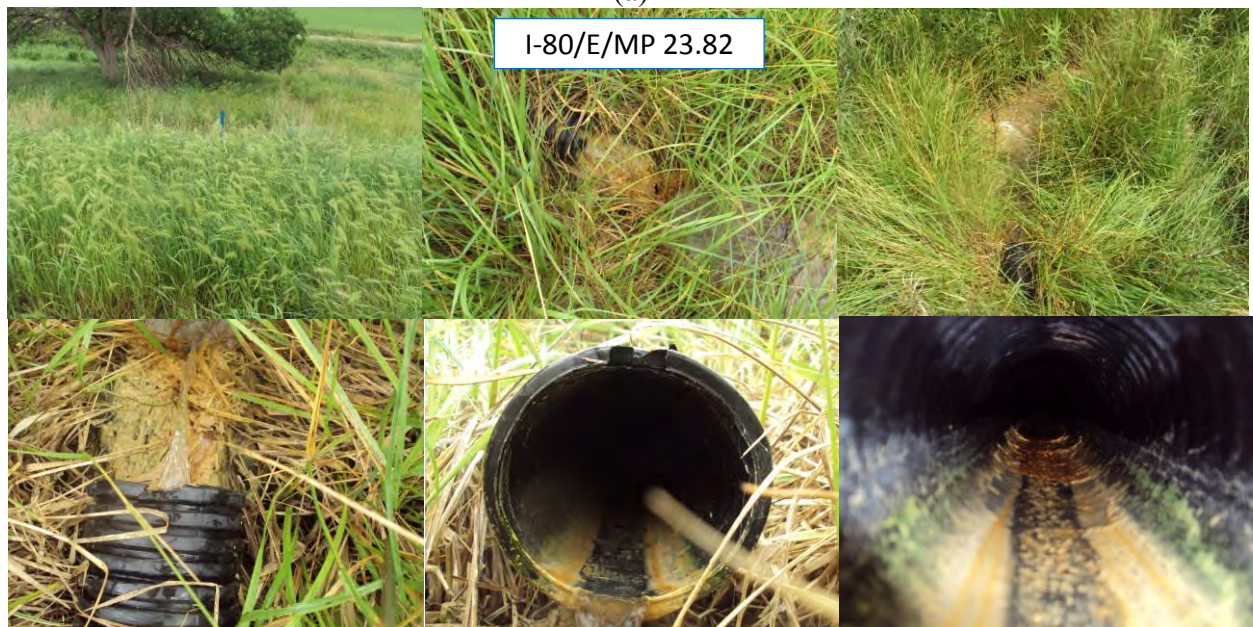
As seen in Figure 14(a), the mesh screen–type rodent guard (even in plastic outlet pipe) exacerbates the clogging of the outlet by blocking the free flow of draining water. Although tufa is still observed in the plastic outlet pipe with fork-shaped rodent guards, the amount of tufa inside the pipe is not enough to be able to cause clogging. Removal of the rodent guards in plastic outlet pipe, as shown in Figure 14(b), often seems to prevent the tufa blockage problem.

Figure 14. Smaller amount of tufa blockage issues observed with the use of plastic outlet pipe in newly constructed JPCP sites containing RPCC base materials: (a) I-35/N/MP143.50 and (b) I-80/E/MP23.8

- The use of a gate/mesh screen-type rodent guard has the potential to cause outlet blockage. Considering that very little rodent evidence was observed in Iowa subdrainage outlets during field investigations, it is highly recommended that these rodent guards not be used to cover drainage outlets in Iowa.

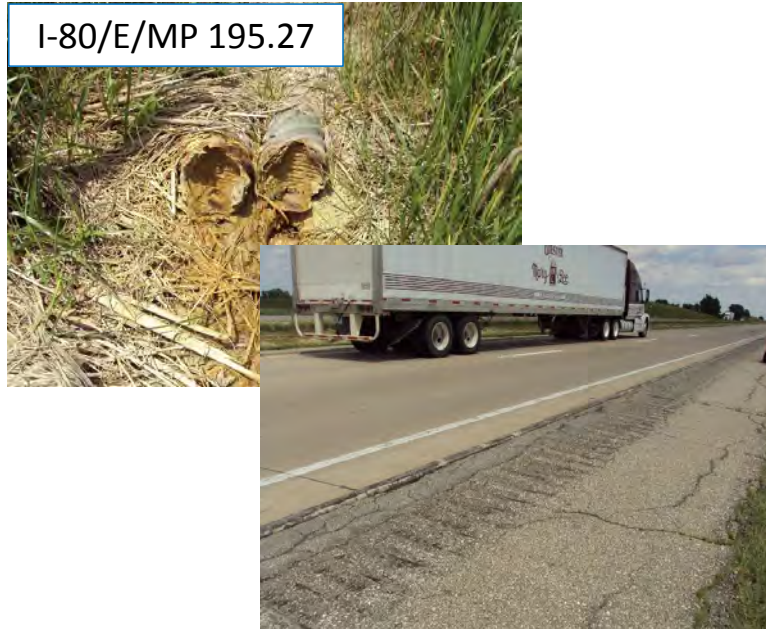
More instances of shoulder distresses (shoulder drop or cracking), as shown in Figure 16(a), were observed near blocked drainage outlet locations than near non-blocked locations at JPCP sites during both fall 2012 and summer 2013 (see Figure 16(b)). Especially note that shoulder distresses were observed near a majority (above 70 percent) of blocked drainage outlet locations during summer 2013. These results indicate that the blocked drainage outlet conditions in JPCPs have a significant impact on pavement shoulder distress development.

Figure 16. Outlet locations with shoulder drop/cracking in newly constructed JPCP sites: (a) an example on I-80/E/MP195.27 and (b) shoulder distress conditions with respect to subsurface drainage outlet condition

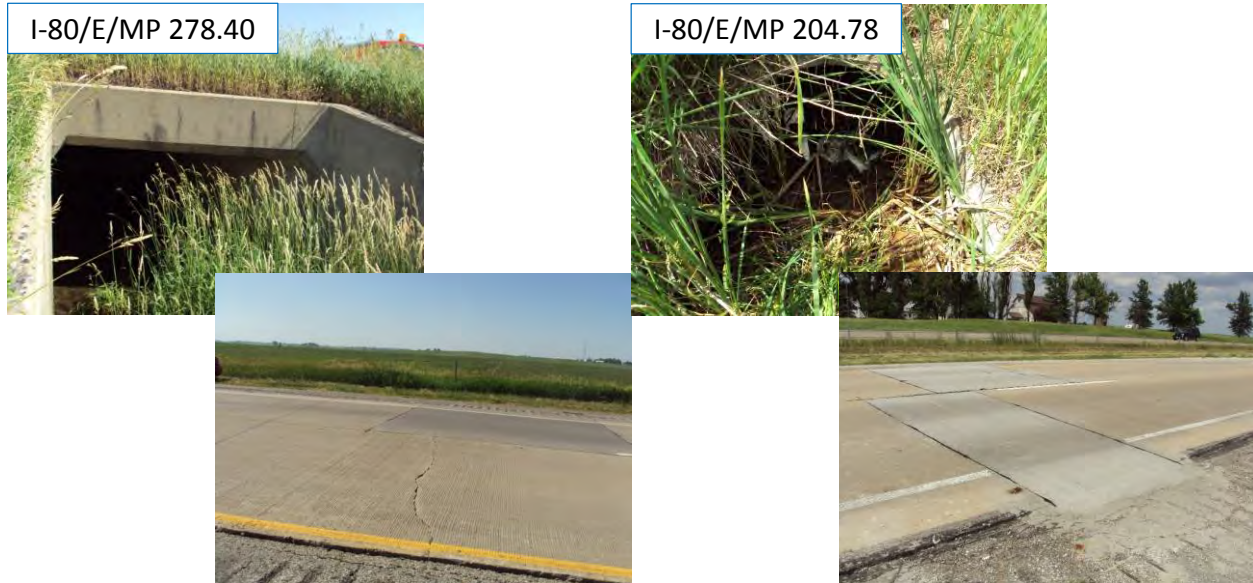
As described previously, pavement surface locations having a high severity of moisture-related distress or patching were also inspected in Phase II forensic testing to see if these are related to drainage problems. Transverse cracking or patching was more often observed where culverts only or culverts with drainage outlets (see Figure 17) were placed rather than just the drainage outlets. These observations indicate that these pavement surface failures are possibly caused by the culvert rather than the subdrain system.

Figure 17. Cracking/patching observed near culvert-only/culvert with drainage outlet locations in newly constructed JPCP sites

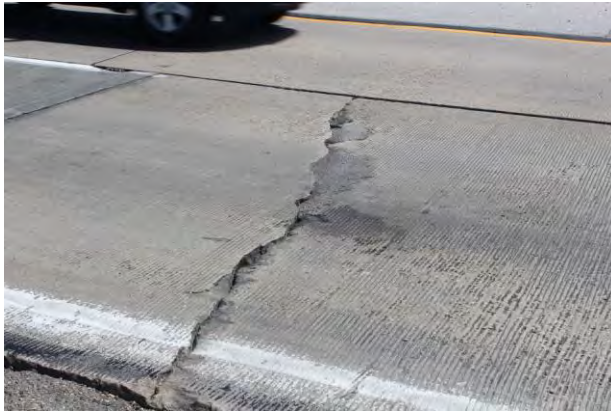
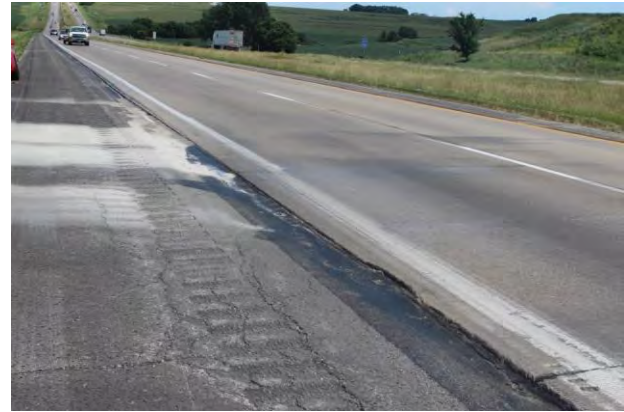
- Pavement type: JPCP (11.5 in PCC/10.0 in subbase)
- Subbase aggregate type: RPCC
- Construction year: 2005
- AADTT: 8,093
- Transverse cracking with water coming out

- Pavement type: JPCP (11.0 in PCC/8.0 in subbase)
- Subbase aggregate type: Virgin
- Construction year: 1986
- AADTT: 8,093
- Faulting with water coming out

Figure 18. Moisture-related damage observed on JPCP sites where no drainage outlet was found

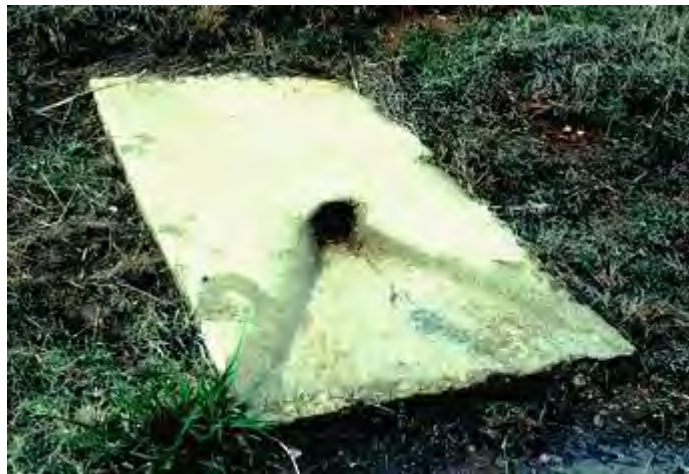
The presence of a headwall (Figure 26) can potentially prevent blockage of drainage outlet pipes from vegetation and debris, reduce erosion, and prevent damage to drainage outlet pipes from maintenance activities (i.e., grass mowing on roadside).

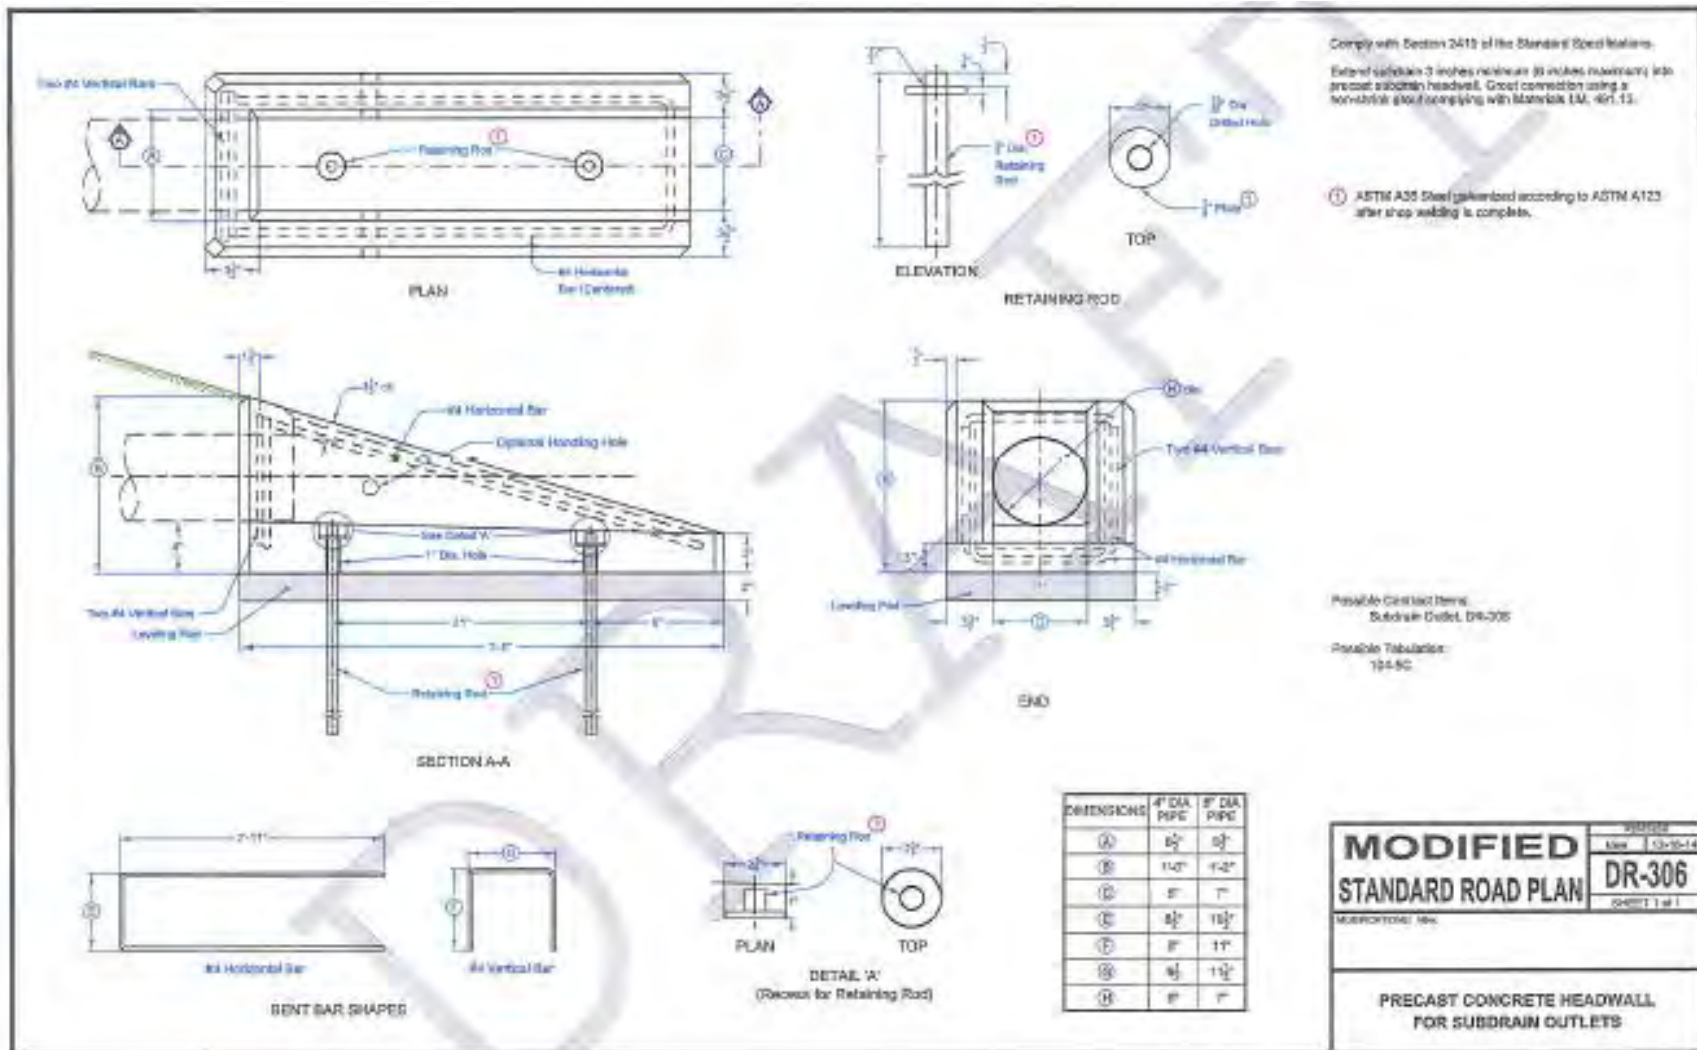
The Iowa DOT recently adopted a draft precast concrete headwall specification for subdrain outlets under Modified Standard Road Plan DR-306 (Figure 27).

Figure 27. Draft precast concrete headwall specification adopted by Iowa DOT for subdrain outlets

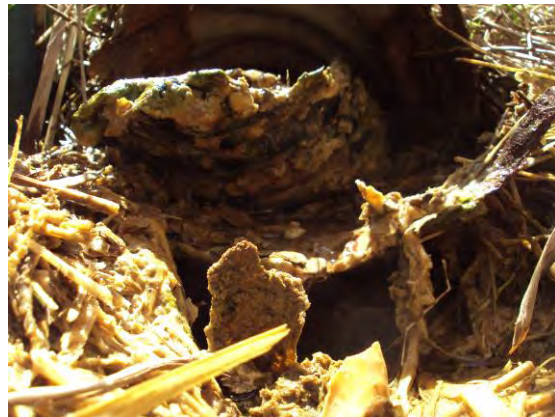
Tufa blockage extends back into the pipe

Damaged and tufa formation at outlet

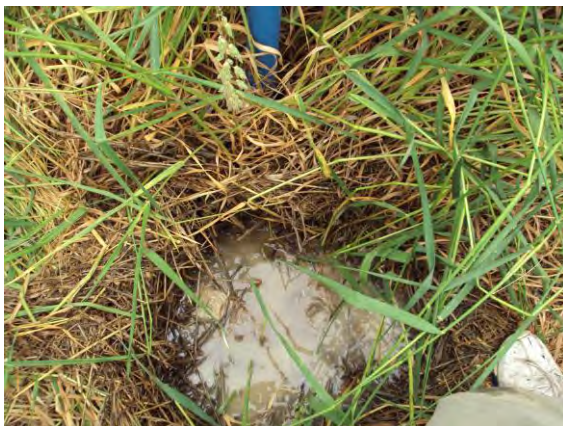
- Cracking due to culvert

Soil blockage with standing water

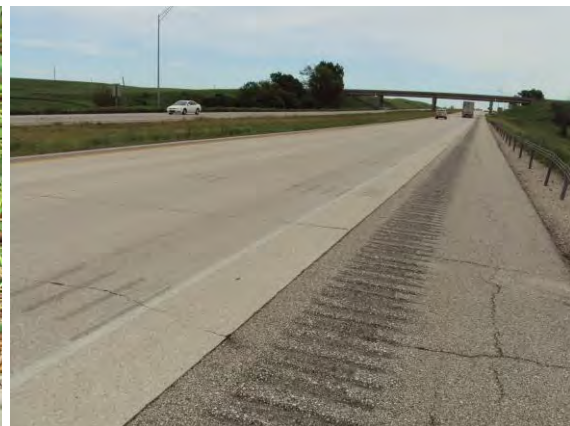
Transverse cracking due to culvert

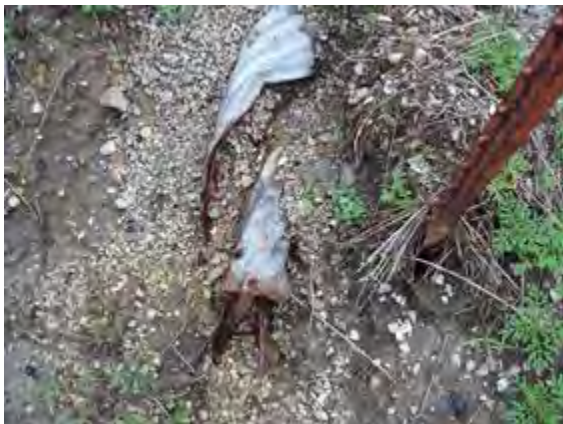
Broken pipe

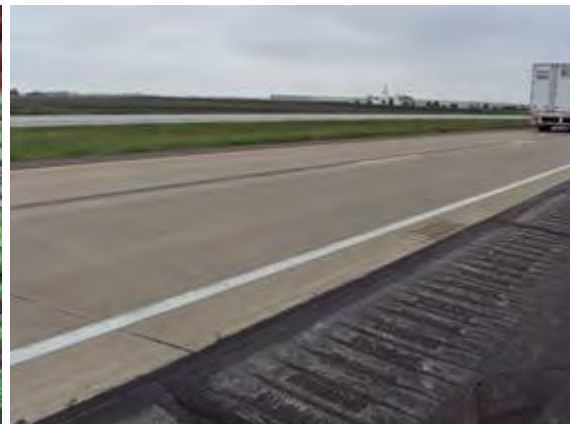
No pavement surface distress

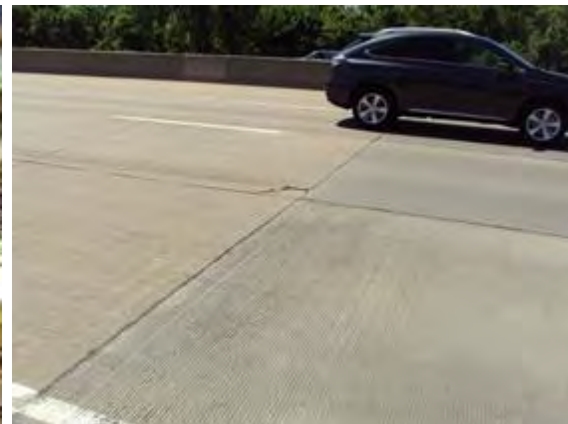
Covered pipe

Small corner crack

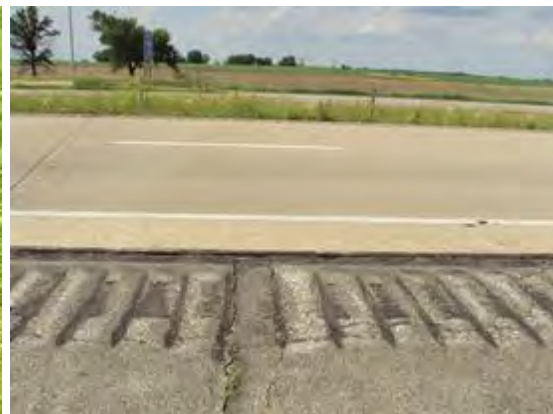
Pipe damaged during tufa removal

No pavement surface distress

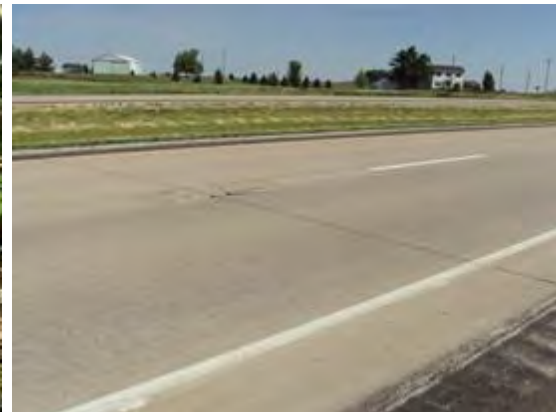
Soil blockage

Corner crack

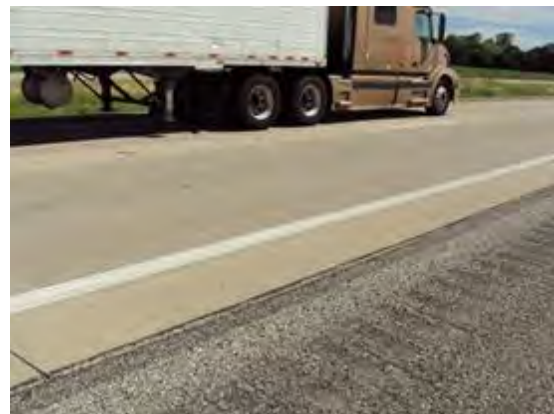
No blockage

Transverse cracking

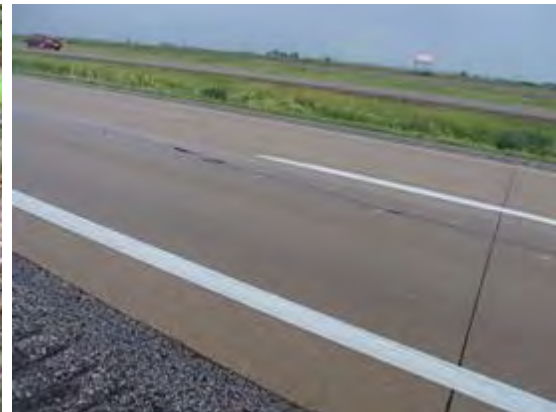
Tufa blockage

Longitudinal cracking

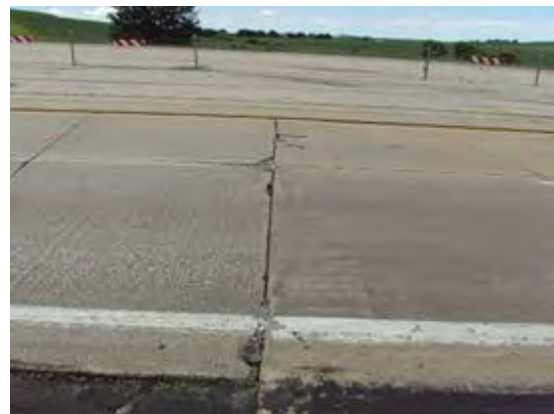
Tufa blockage

Corner cracking

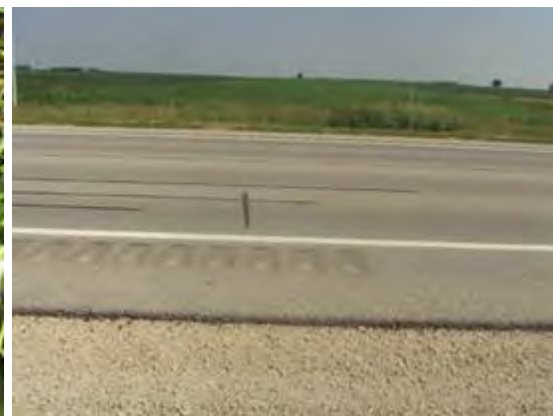
Soil blockage

Longitudinal and transverse cracking patching

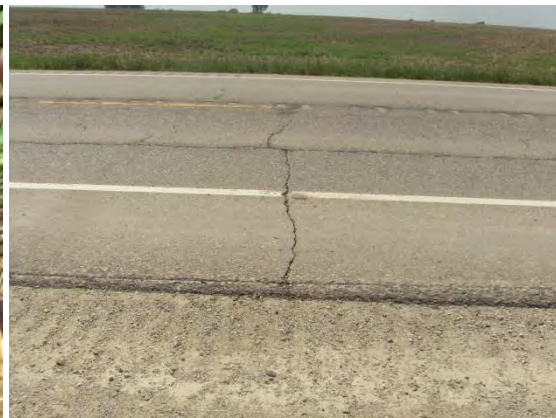
Soil blockage

Longitudinal and transverse cracking

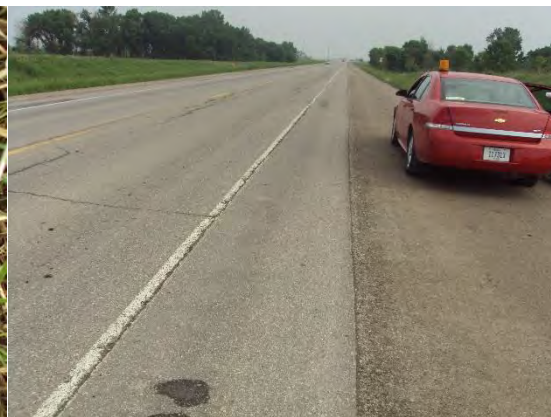
Sediment blockage

Longitudinal and reflection cracking

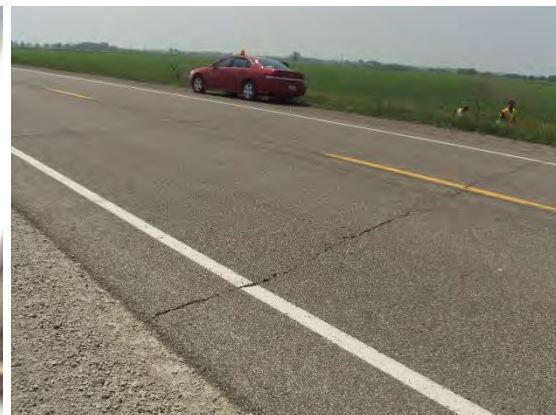
Sediment blockage

Reflection cracking

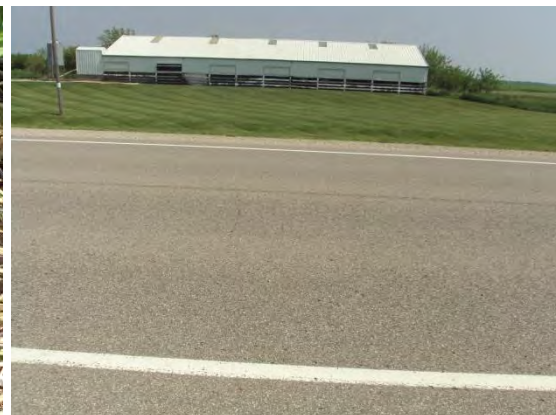
Soil blockage

Transverse cracking

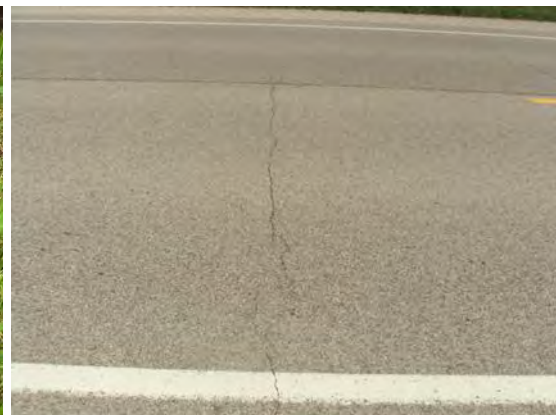
Soil blockage

Transverse cracking

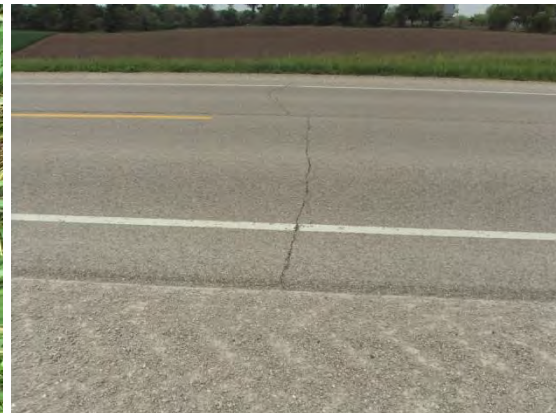
Soil blockage

Transverse cracking

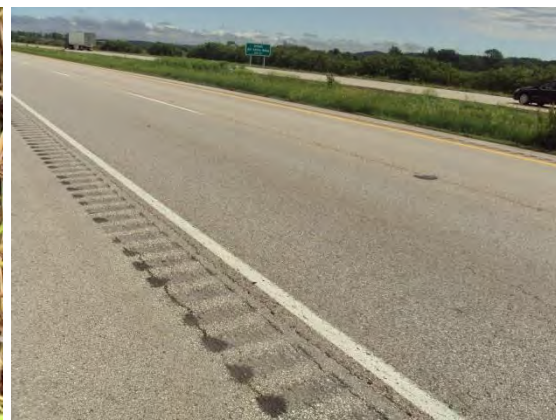
Soil blockage

Longitudinal cracking

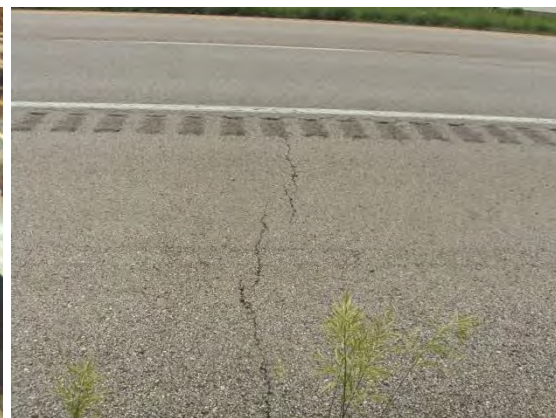
Soil blockage

Transverse cracking

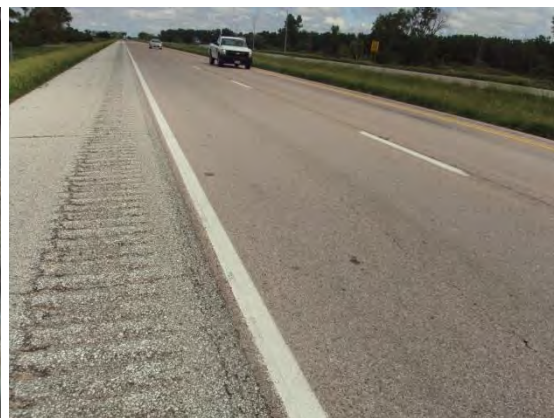
Sediment blockage

Longitudinal cracking

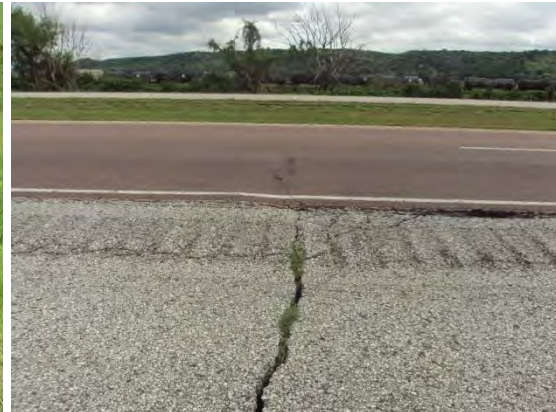
No drainage outlet

Transverse cracking/rutting

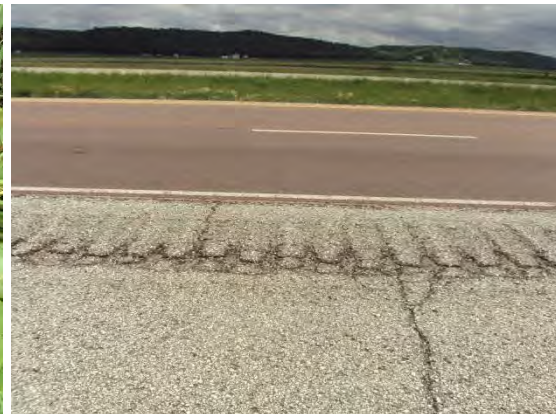
Soil blockage

Transverse cracking

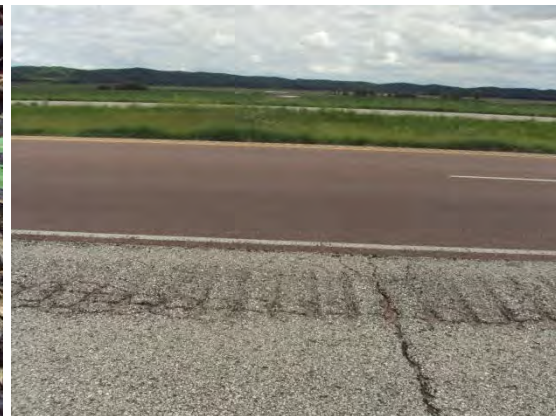
Sediment blockage

Rutting/transverse cracking

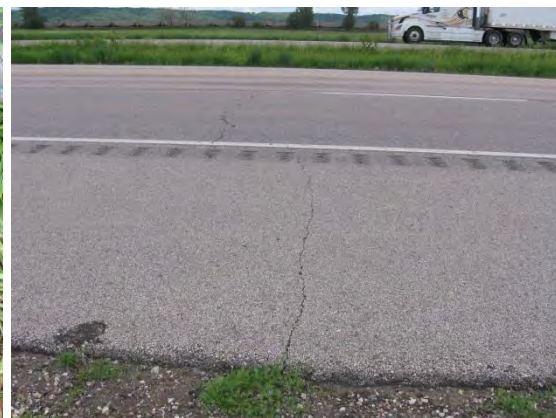
Soil blockage

Transverse cracking

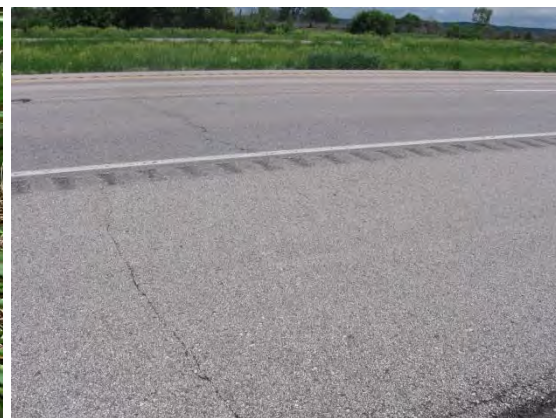
Soil blockage

Transverse cracking

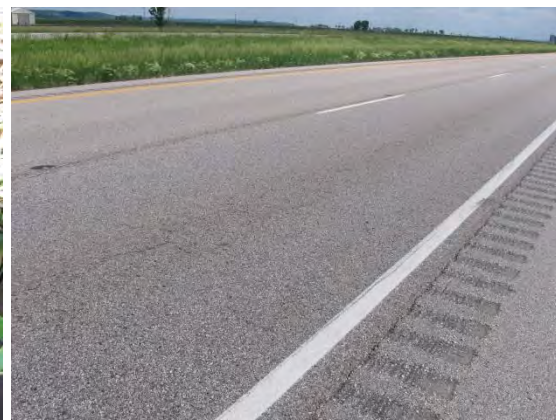
Soil blockage

Longitudinal cracking

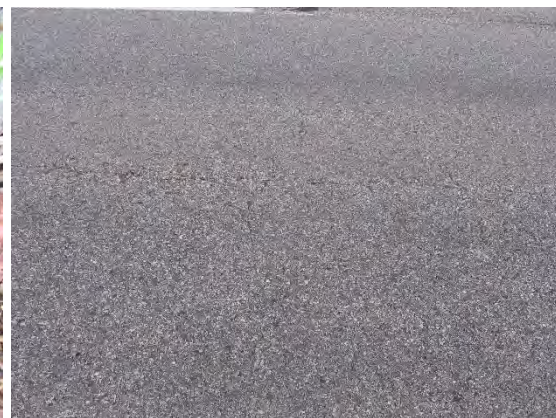
Sediment blockage

Alligator cracking

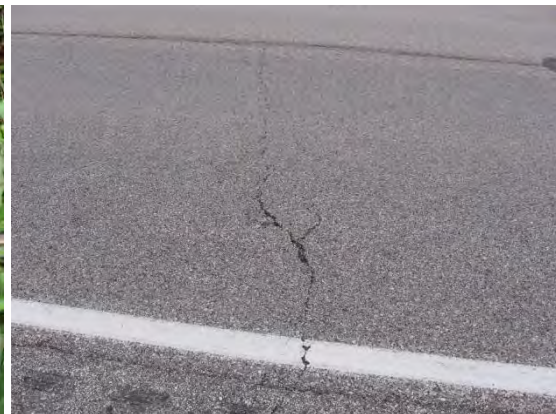
Soil blockage

Transverse cracking

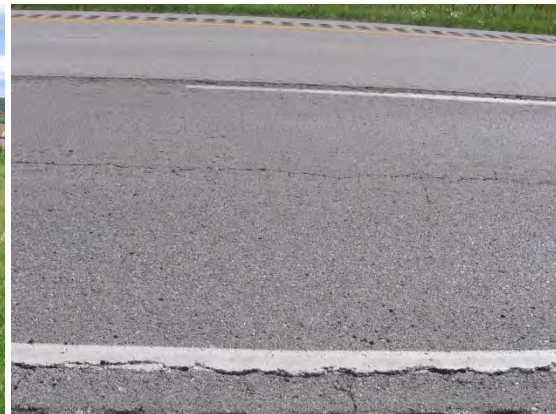
No drainage outlet

Alligator and transverse cracking

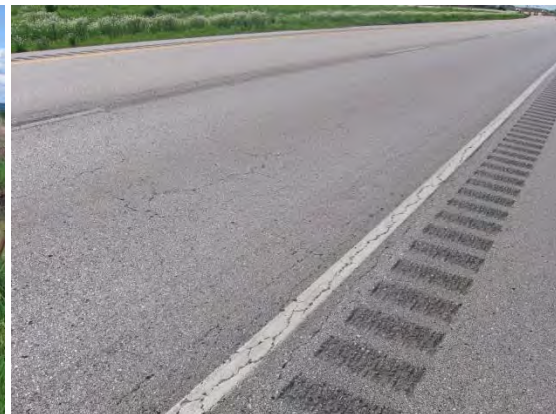
No drainage outlet

Alligator cracking/corner erosion damage

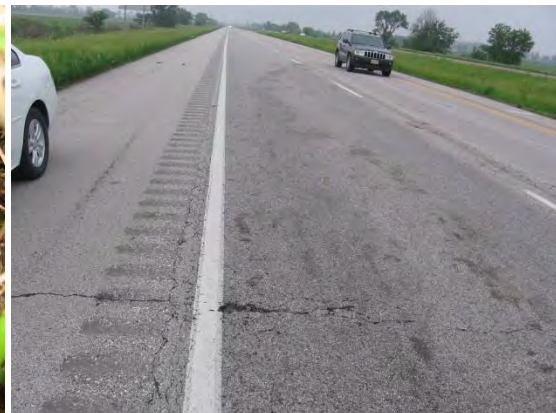
Soil blockage

Longitudinal and transverse cracking/rutting

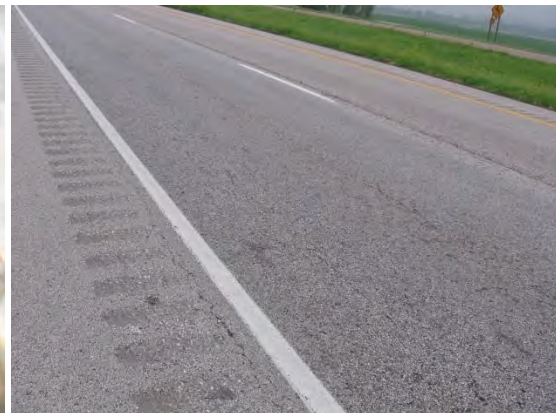
Sediment blockage

Alligator cracking

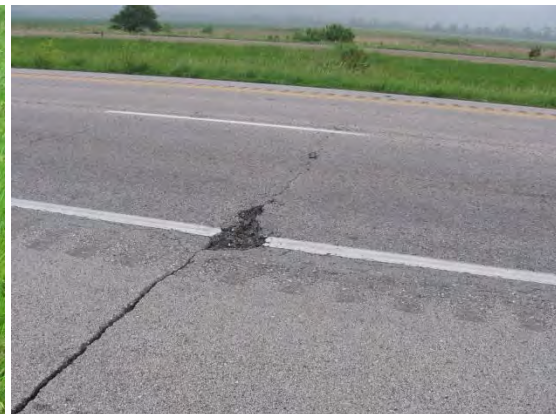
No drainage outlet

Transverse and alligator cracking

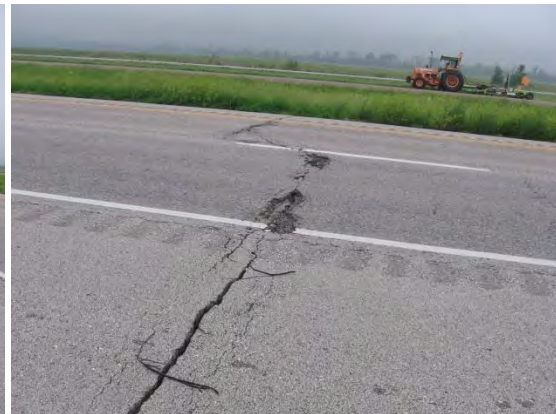
No drainage outlet

Transverse and alligator cracking

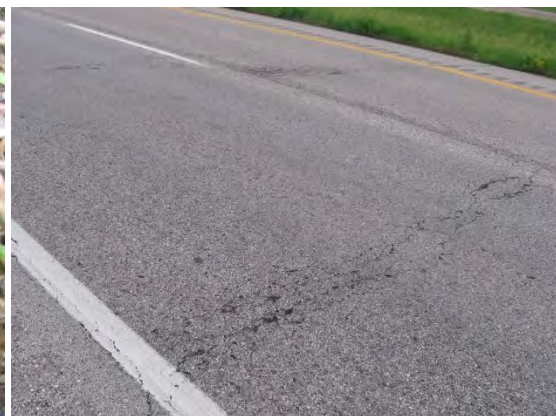
Sediment blockage

Transverse and alligator cracking/rutting

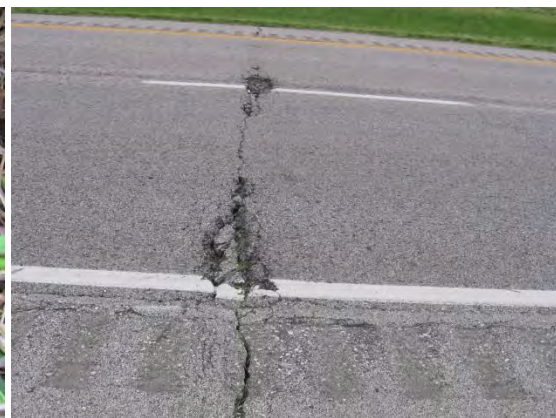
Soil blockage

Transverse and alligator cracking

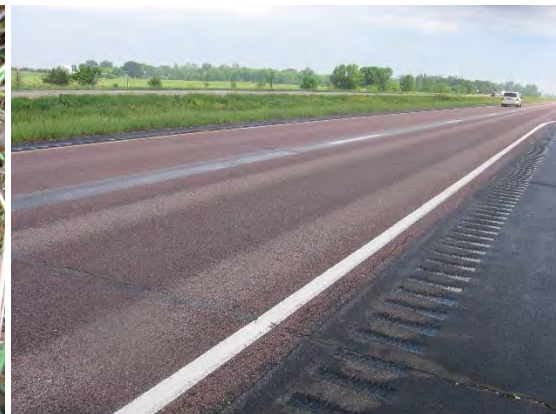
Soil blockage

Reflection cracking

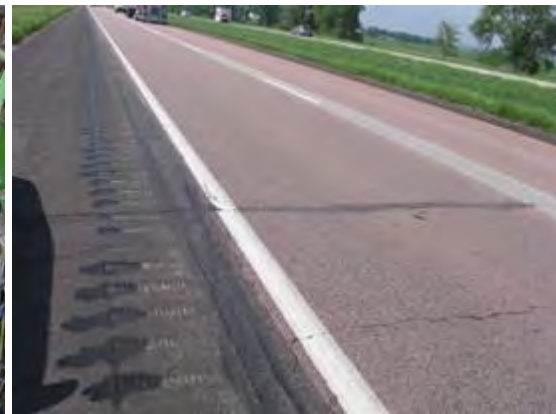
Soil blockage

Reflection and transverse cracking

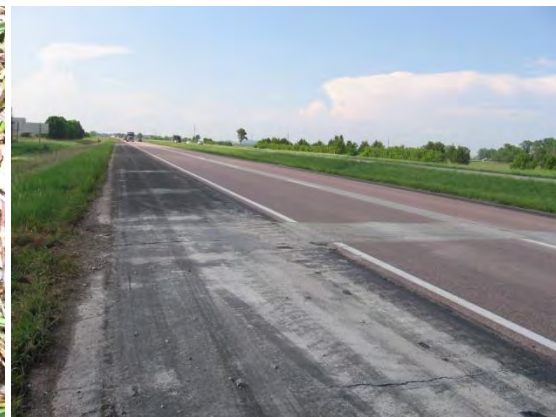
Soil blockage

Reflection cracking/concrete patching

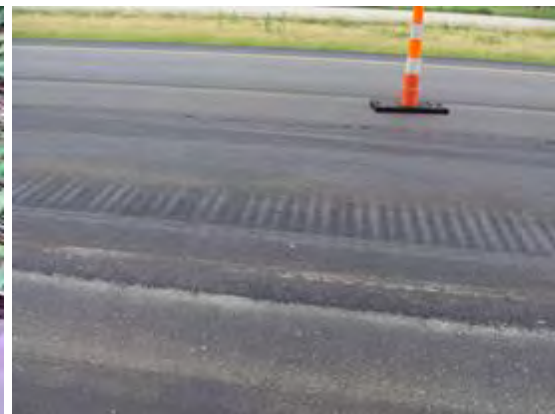
Tufa blockage/damaged outlet pipe

New HMA overlay
