4. Field Testing and Demonstrations

The objective of the field demonstrations of this research was to evaluate the performance of four non-destructive assessment techniques: BVRCS, 3DOBS, passive infrared thermography, and active infrared thermography. These remote sensing methods were used to assess the condition of selected bridge decks, a major element in a bridge that provides protection from the environment to the superstructure and substructure, indicates overall bridge health, and determines when preservation activities should be performed.

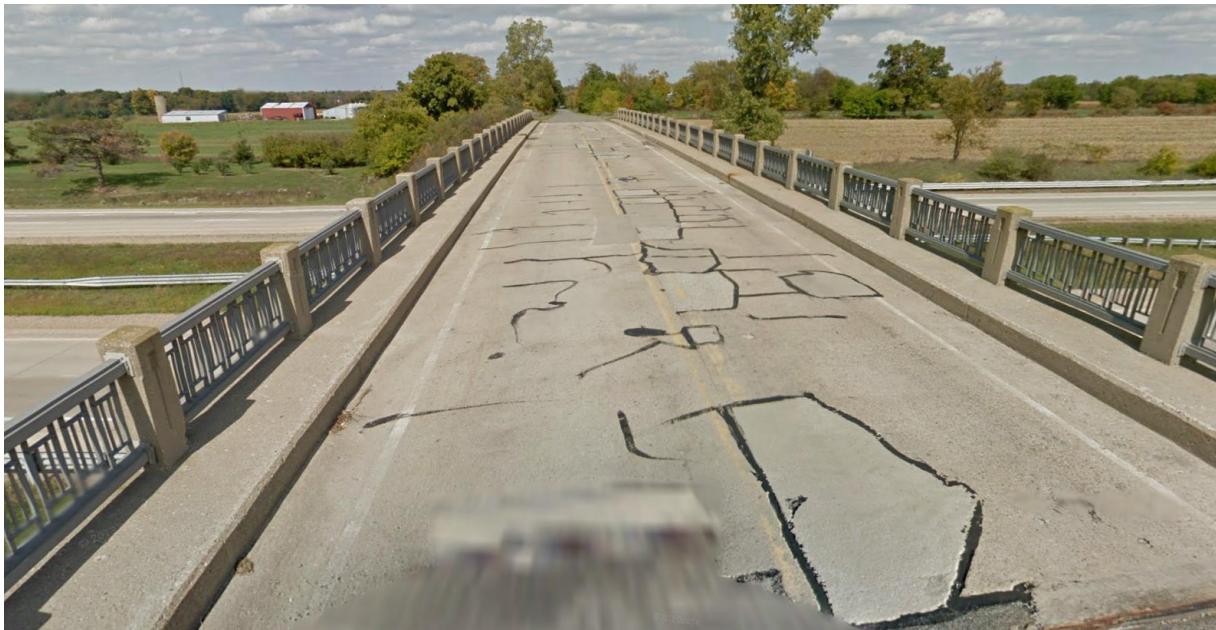
During the most recent bridge inspection on August 8th, 2013, the concrete deck surface was assigned a poor condition NBI rating of 4. A photograph of the current deck surface condition can be seen in Figure 4-2. With the main purpose of this deployment being the assessment of the 3DOBS high-resolution system and passive infrared thermography, the bridge deck was the main bridge component of interest. Only the surface of the bridge deck was evaluated for deficiencies, however, particular interest should be taken to spalling on many of the bridge beams that have left reinforcing steel and stirrups exposed. It was recommended that these areas be patched to preserve the integrity of the structure.

Figure 4-2: Deck Surface for 20 Mile Road Bridge.

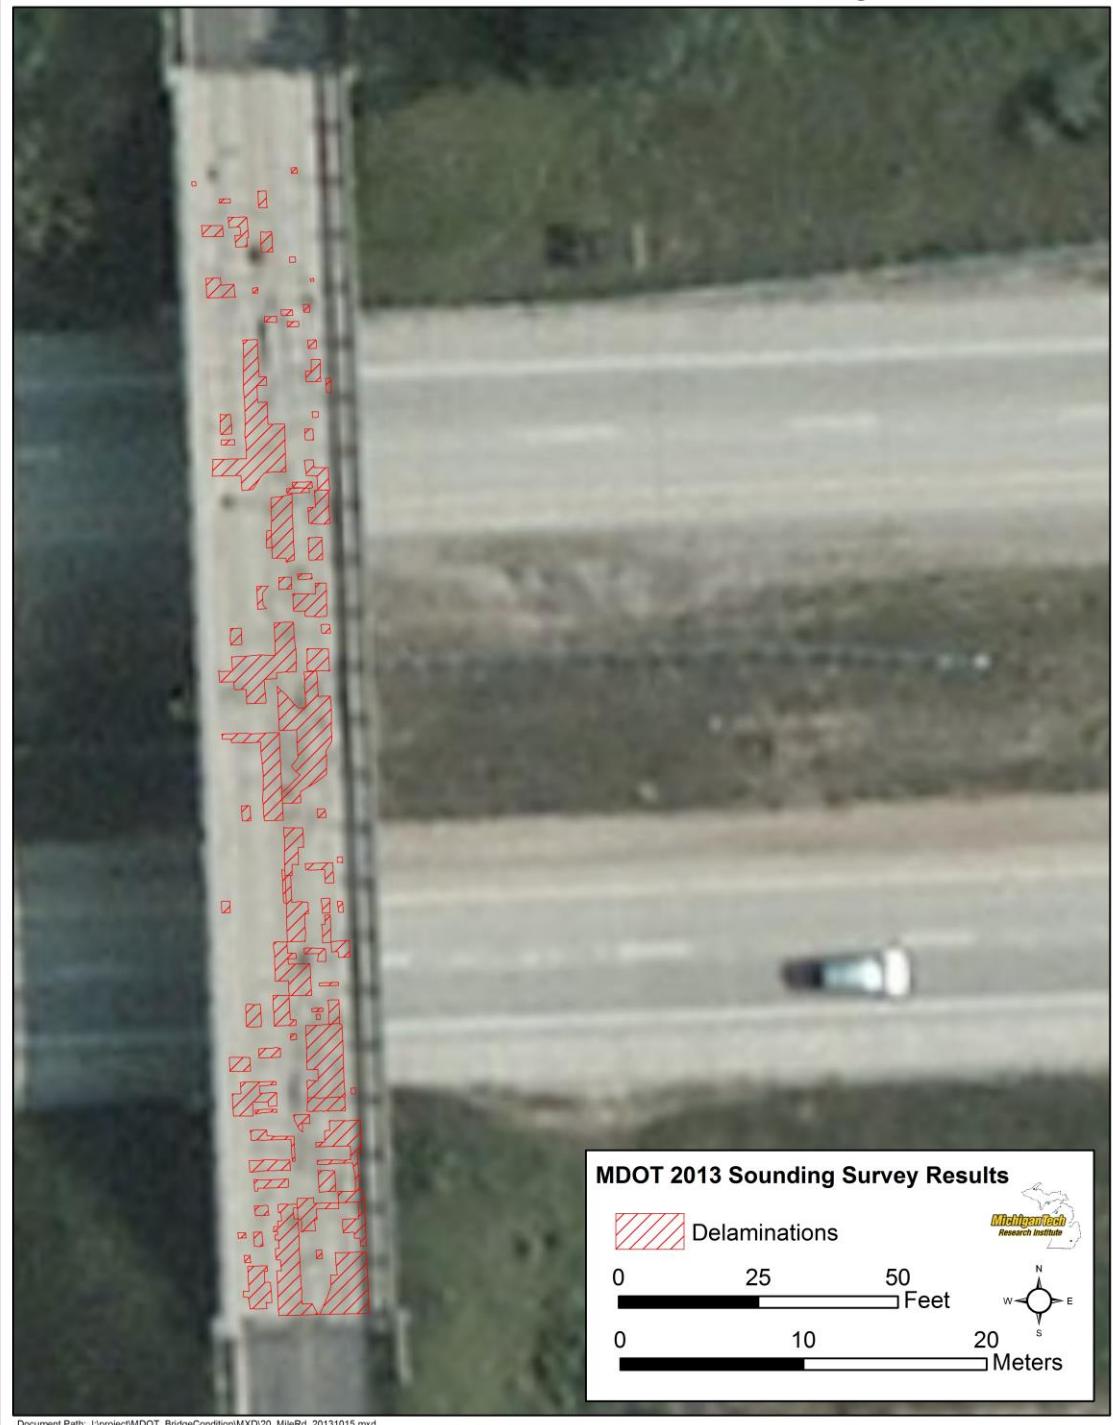
20 Mile Rd. Over I-94, Marshall, Michigan

Testing on 20 Mile bridge corresponded with the inspection of the bridge by MDOT. A sketch of the deck sounding was georeferenced as a GIS shapefile (Figure 4-3). The sounding determined that there was $1,276 \text{ ft}^2$ of delamination with 32 ft^2 of bit patching and scale which corresponded to 24% of the deck surface.

Figure 4-3: Georeferenced Sketch of the Results of the Deck Sounding Showing the Locations of Delaminations. The Total Area Delaminated is 1,276 ft².

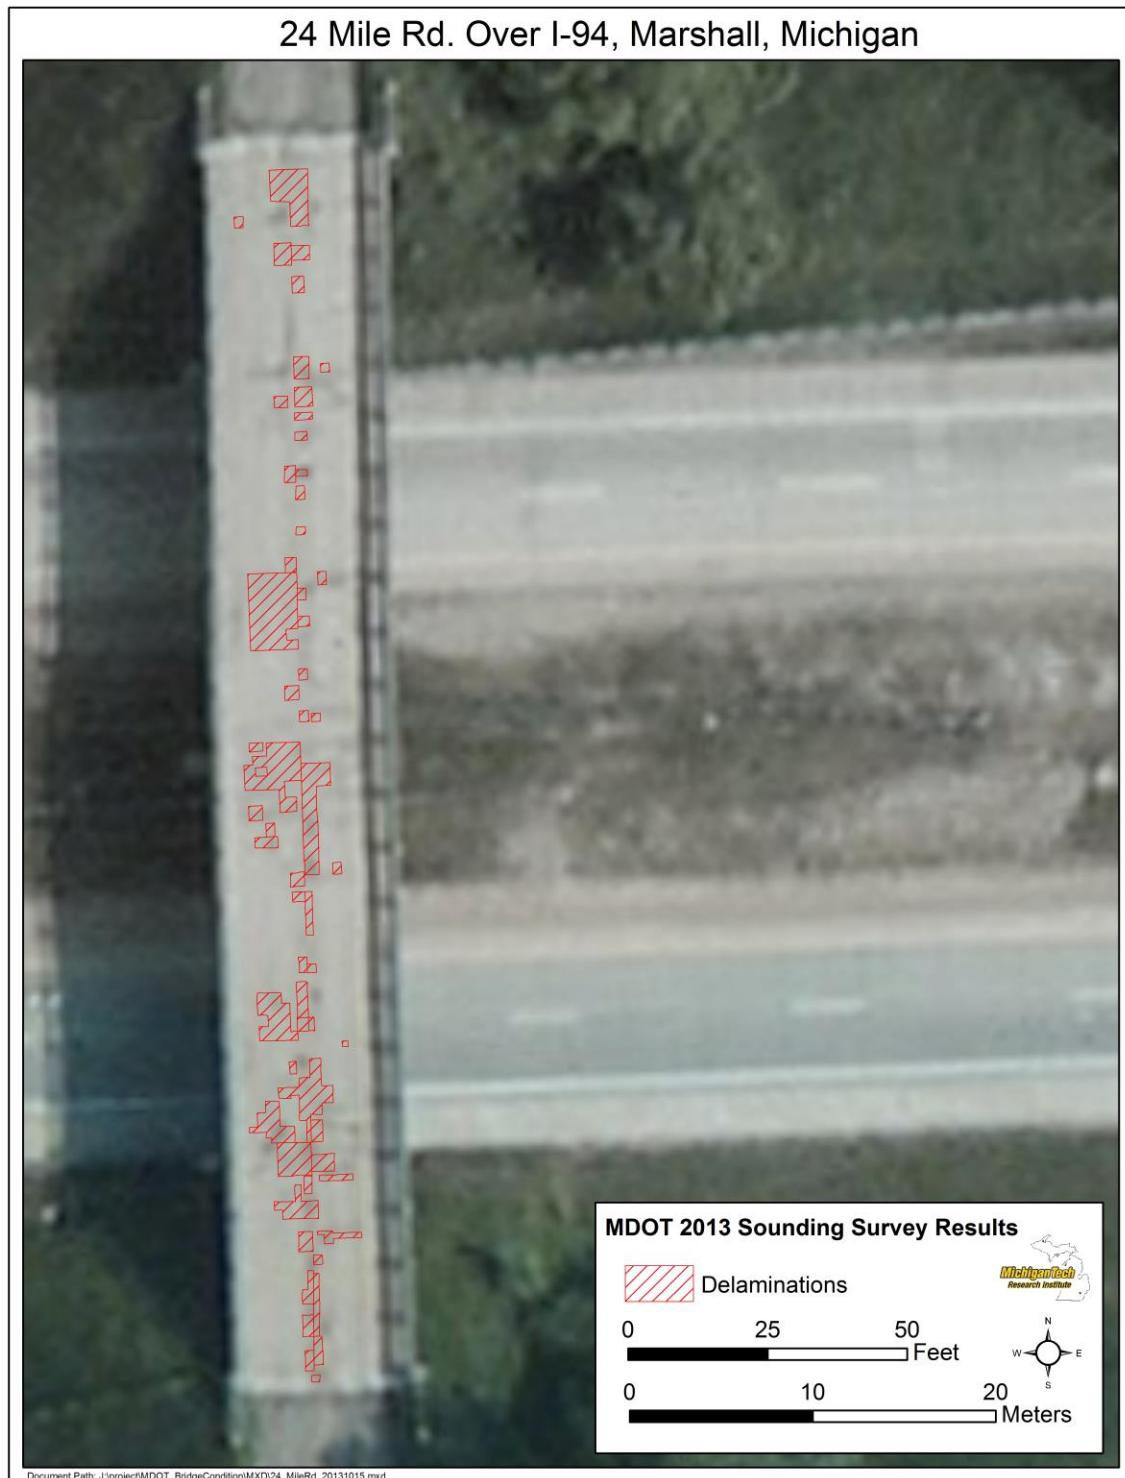
Like 20 Mile Road, testing on 24 Mile bridge corresponded with the inspection of the bridge by MDOT. A sketch of the deck sounding was georeferenced as a GIS shapefile (Figure 4-6). The sounding determined that there was 762 ft^2 of delamination with 13 ft^2 of bit patching and scale which corresponded to 14% of the deck surface.

Figure 4-6: Georeferenced Sketch of the Results of the Deck Sounding of 24 Mile Rd Showing the Locations of Delaminations. The Total Area Delaminated is 762 ft²

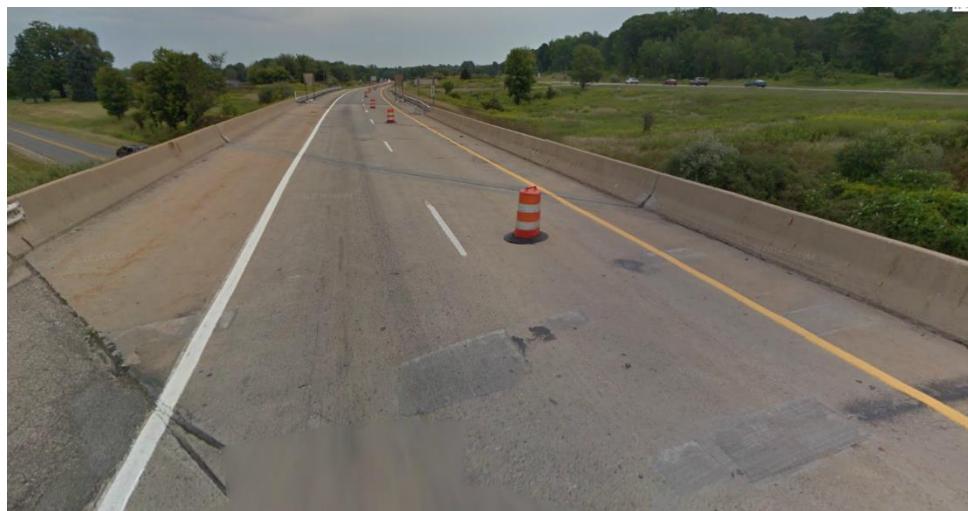
The inspection report for structure No. 5002 indicated considerable amounts of concrete patches, spalling, and delaminated areas across the deck surface. A photograph of the structure can be seen in Figure 4-8. Several transverse cracks were also apparent over the structure. Expansion joints were missing much of their sealer resulting in some cracking and spalling at the deck surface as well as the bottom surface of the deck.

Figure 4-8: MDOT Structure No. 5002 SB US-131 Bridge Deck.

In the case of both bridges, it has been recommended that sealer be applied to expansion joints where deterioration has occurred. Concrete overlay on both bridge decks was also reported for consideration.

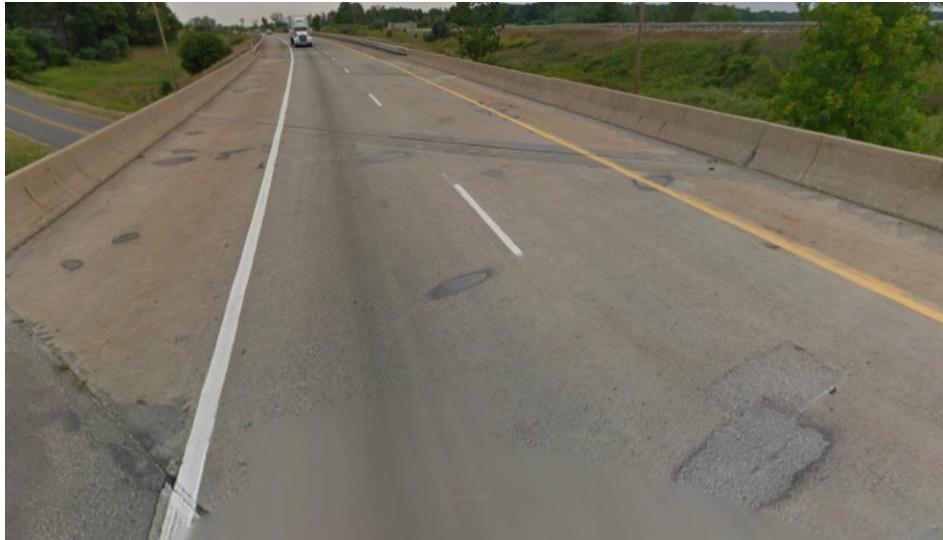
The inspection report for structure No. 5003 indicated that about 26% of the deck surface area was spalled, bit patched or delaminated and about 15% was patched with concrete. Various degrees of cracking were present over the surface of the structure with some occurring around expansion joints where a majority of the sealer was missing. Spalls and cracks on the underside of the bridge deck have originated near joints where water has migrated through the structure. Figure 4-9 shows the north bound structure.

Figure 4-9: MDOT Structure No. 5003 NB US-131 Bridge Deck.

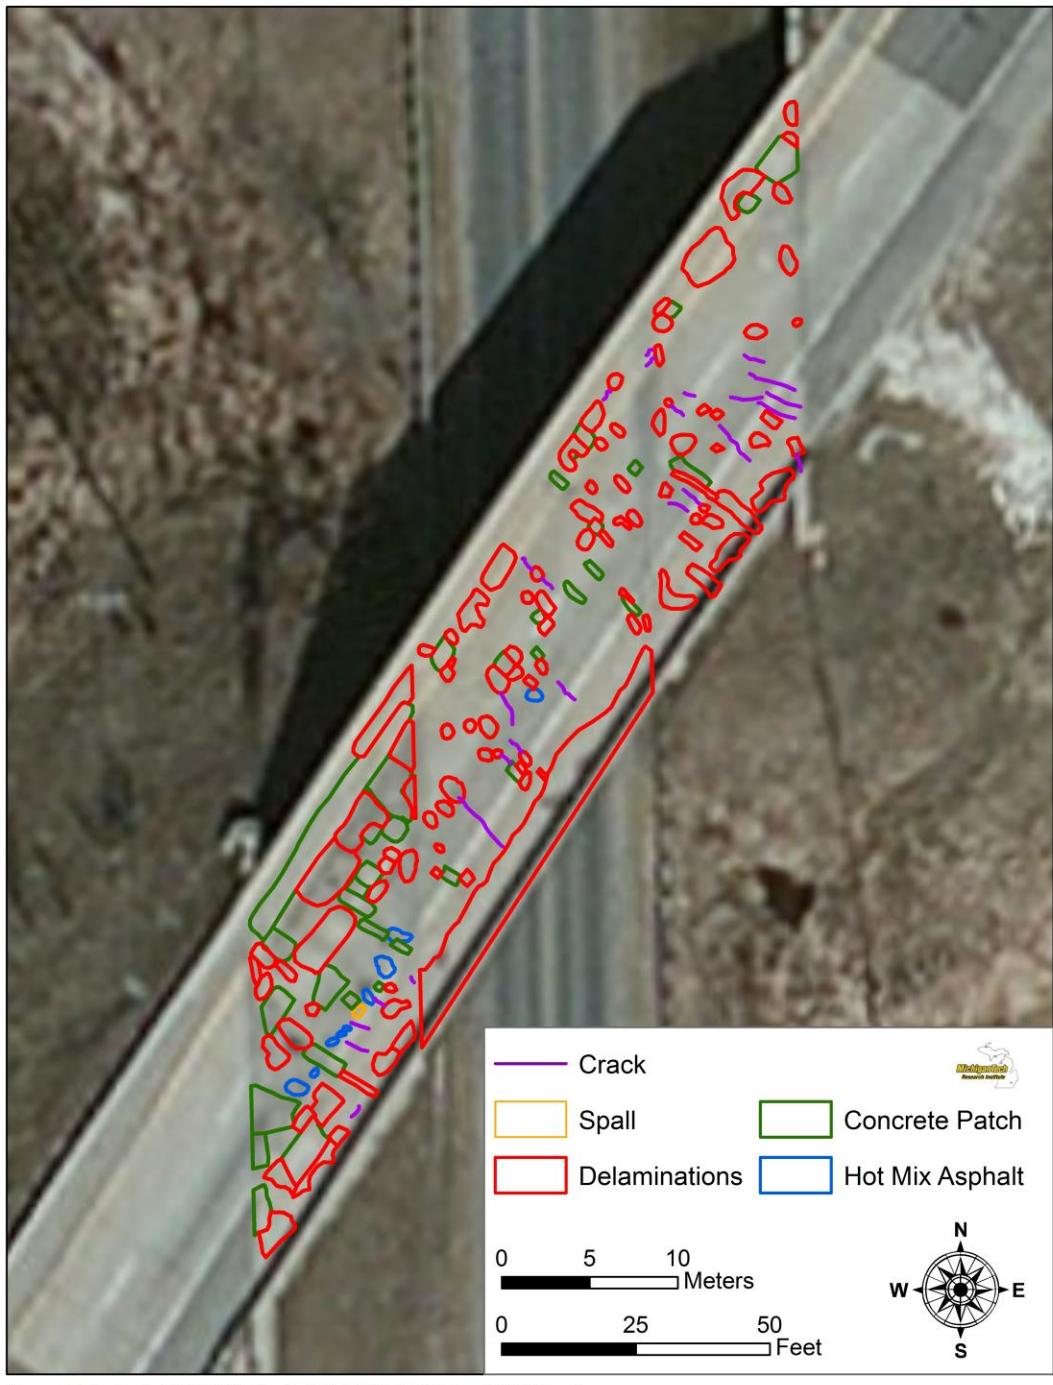
Bridge Deck Distress Markings: US 131 Northbound Over White Creek Avenue

US-131 had significantly more vehicle traffic than the previous two bridges. This meant that lanes had to be closed prior to the collection of data by the MDOT inspectors and 3DOBS high-resolution. A sketch of the deck sounding was georeferenced as a GIS shapefile (Figure 4-10 and Figure 4-11). The MDOT sounding determined that there was $2,072 \text{ ft}^2$ of delamination on the north bound lanes (Figure 4-10) and 759 ft^2 of delaminations on the south bound lanes (Figure 4-11).

Figure 4-10: Georeferenced Sketch of the Results of the Deck Sounding of the North Bound Bridge of US-131 Showing the Locations of Delaminations, Cracking and Spalls.

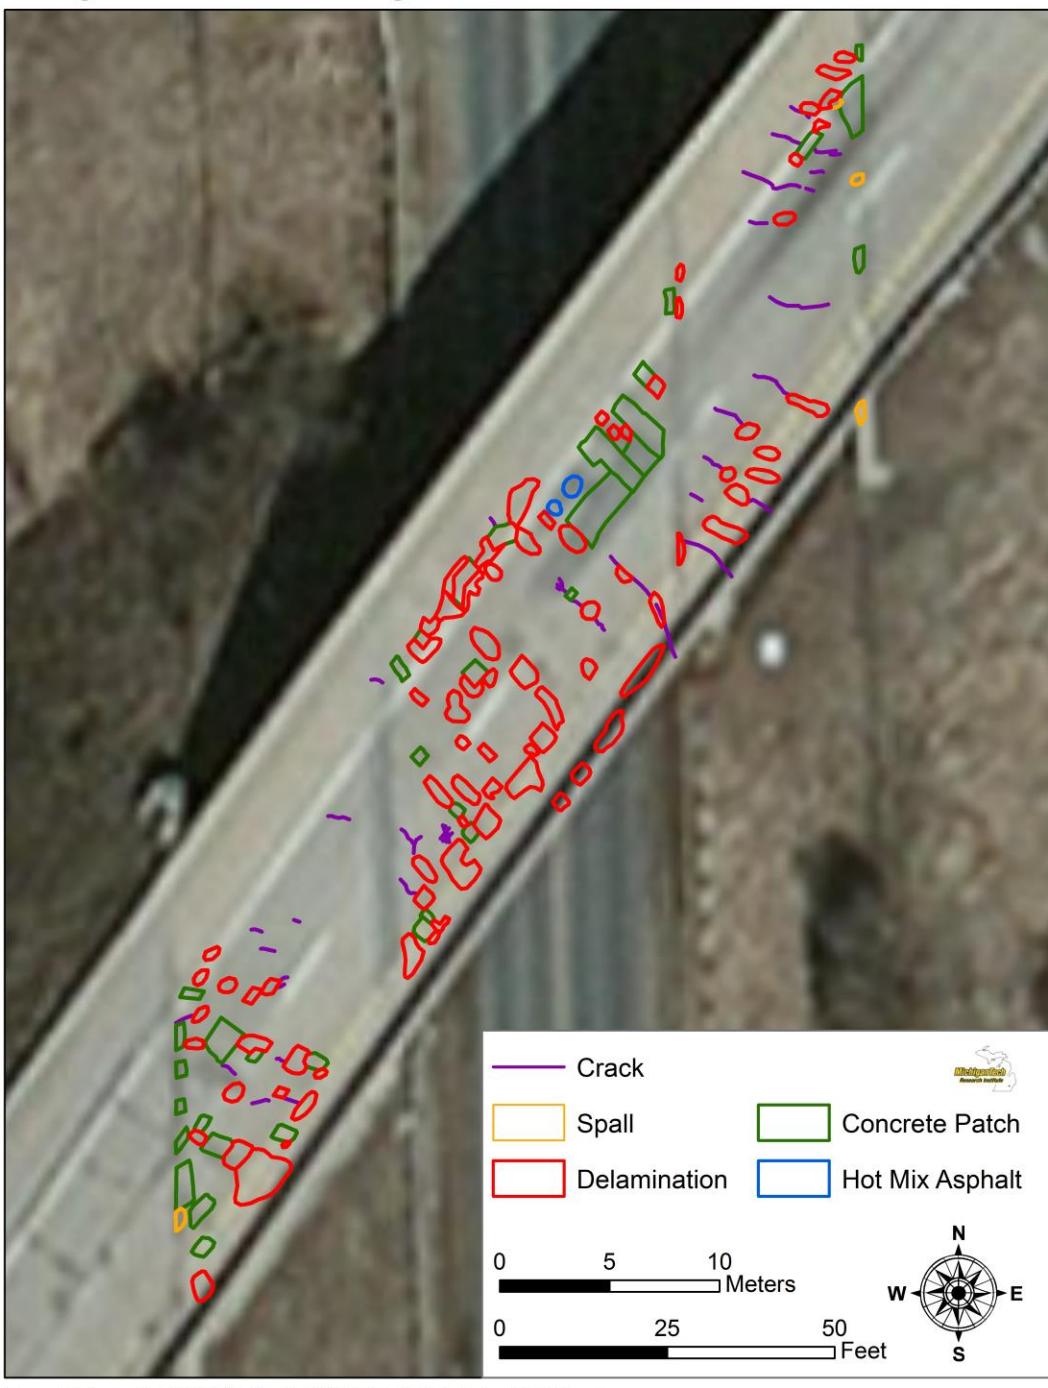
Bridge Deck Distress Markings: US 131 Southbound Over White Creek Avenue

Figure 4-11: Georeferenced Sketch of the Results of the Deck Sounding of the South Bound Bridge of US-131 Showing the Locations of Delaminations, Cracking and Spalls.

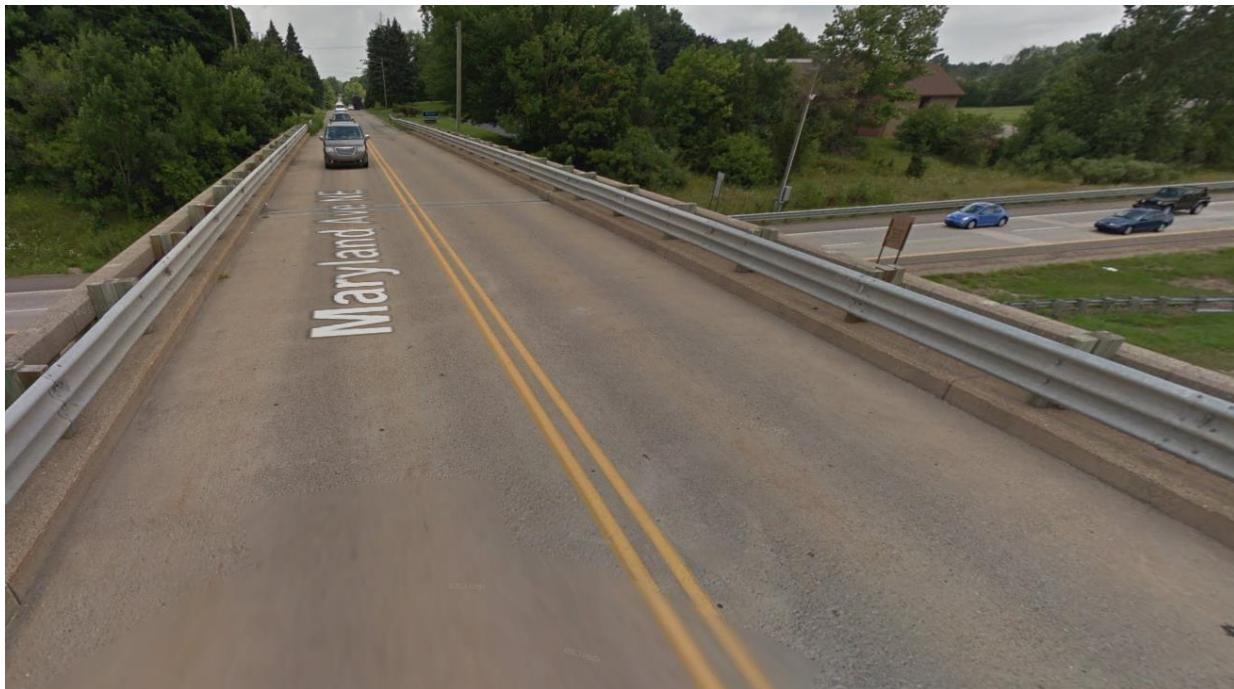
The concrete deck surface was assigned an NBI rating of 6 during the most recent inspection on May 16th 2012. Figure 4-13 shows a photograph of the bridge deck. Because only 3DOBS and the passive infrared thermography testing methods were implemented on this structure, only the condition of the top deck was of interest. Neither the underside of the deck or the superstructure were tested for deficiencies at this location. However, it should be noted that end repairs have been made to fascia beams to prevent further deterioration and extend the service life of the bridge. Shallow spalls that have exposed reinforcing steel on the east fascia beams but still leaves the superstructure in good condition with a rating of 7.

Figure 4-13: Current Condition of the Maryland Avenue Bridge Deck

The inspection report indicated scattered areas of diagonal cracking on the bridge deck, some of which were associated with delaminations. A majority of the identified cracking occurred at the corners of the structure spans. Minor amounts of spalling have left reinforcing steel exposed on the east deck fascia beams but a total of less than 2% of the deck was reported cracked, spalled, or contained delaminations. A majority of the cracking and spalling was reported to occur at joints other than expansion joints.

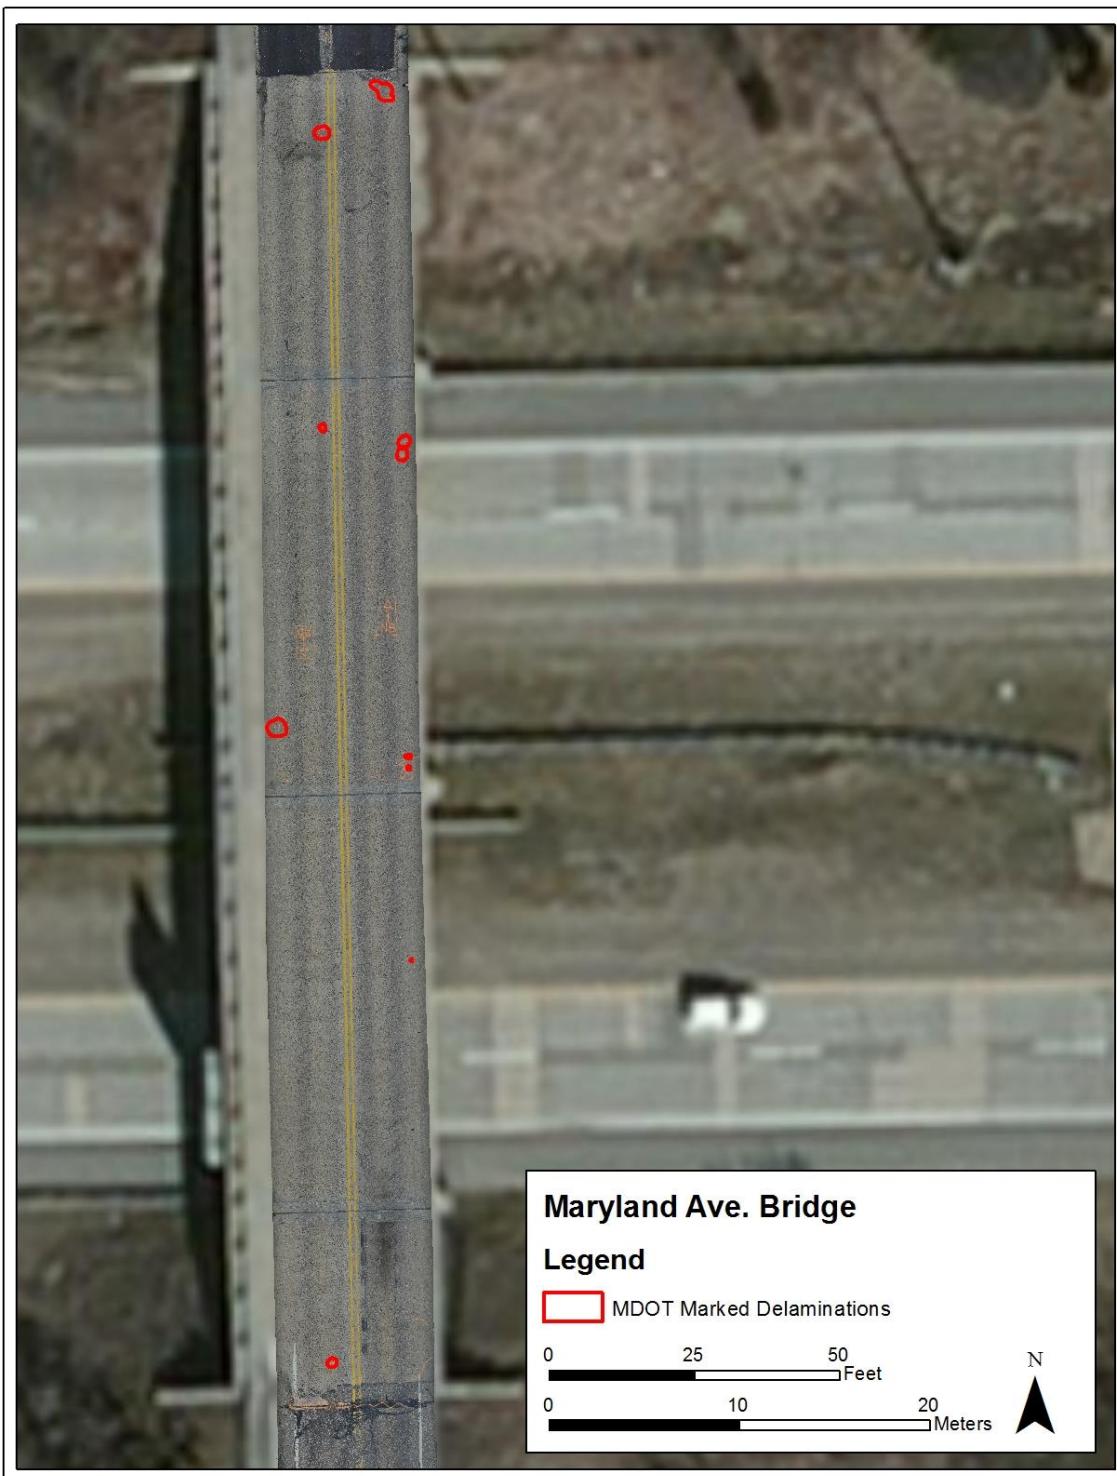
The Maryland Ave. bridge was inspection of the bridge by MDOT the same day that the combined system deployed. A sketch of the deck sounding was georeferenced as a GIS shapefile (Figure 4-14). The sounding determined that there was 108 ft² of delamination with 13 ft² of bit patching and scale which corresponded to 14% of the deck surface.

Figure 4-14: Georeferenced Sketch of the Results of the Deck Sounding of Maryland Ave. Showing the Locations of Delaminations.

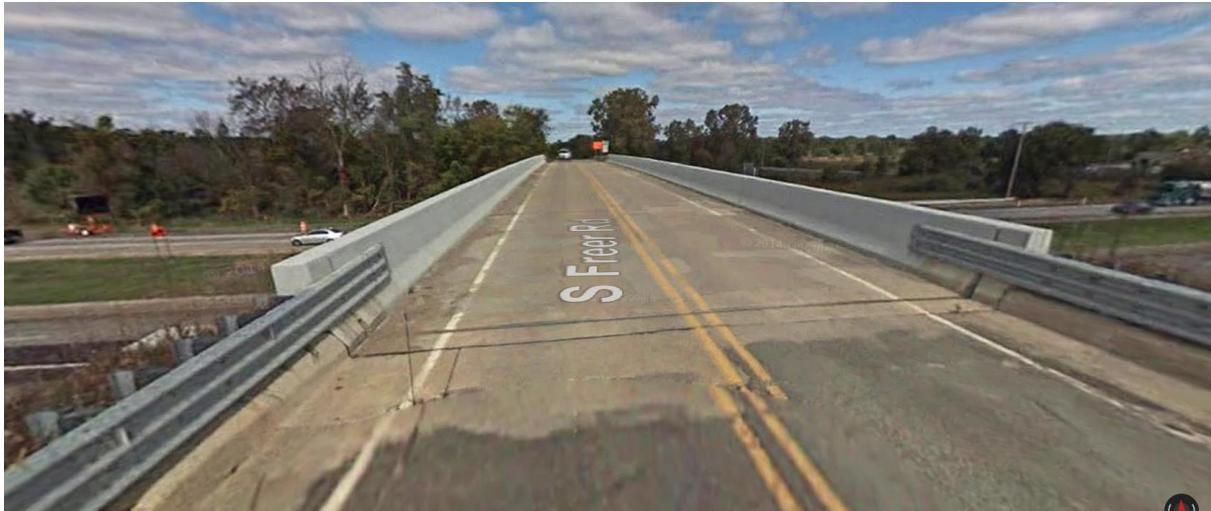
Upon completion of the most recent inspection on June 5th 2012, the deck surface received an NBI fair rating condition of 6 and can be seen in Figure 4-16. Because the active thermography

Figure 4-16: Bridge Deck of Freer Road Bridge.

The inspection report indicated that concrete patches were present in all spans of the structure. The patches were applied to prohibit further deck deterioration and prolong the service life of the bridge. Transverse and map cracking were also reported to be present in all spans of the structure. An estimated 85 ft^2 of delamination was additionally reported throughout the deck surface of the structure.

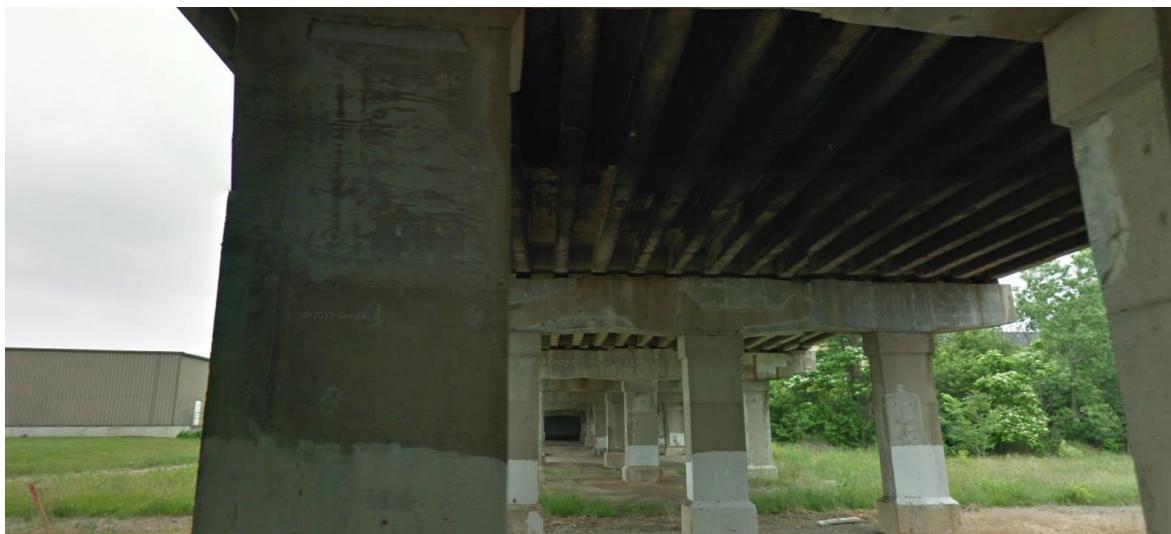
Figure 4-19: Current Condition of Bottom Deck Surface of Franklin Street Bridge.

The inspection report indicated various degrees of deterioration on the bottom deck surface. Replaced deck spans have remained in good condition but other spans contain considerable

amounts of spalling and cracking. In addition, soot buildup from locomotive exhaust was reported directly above the railroad line.
